# PN Composite Ltd.

Ambagh, Konabari, Gazipur  
(24.0201 N, 90.32127 E)

13 April 2014

# Observations

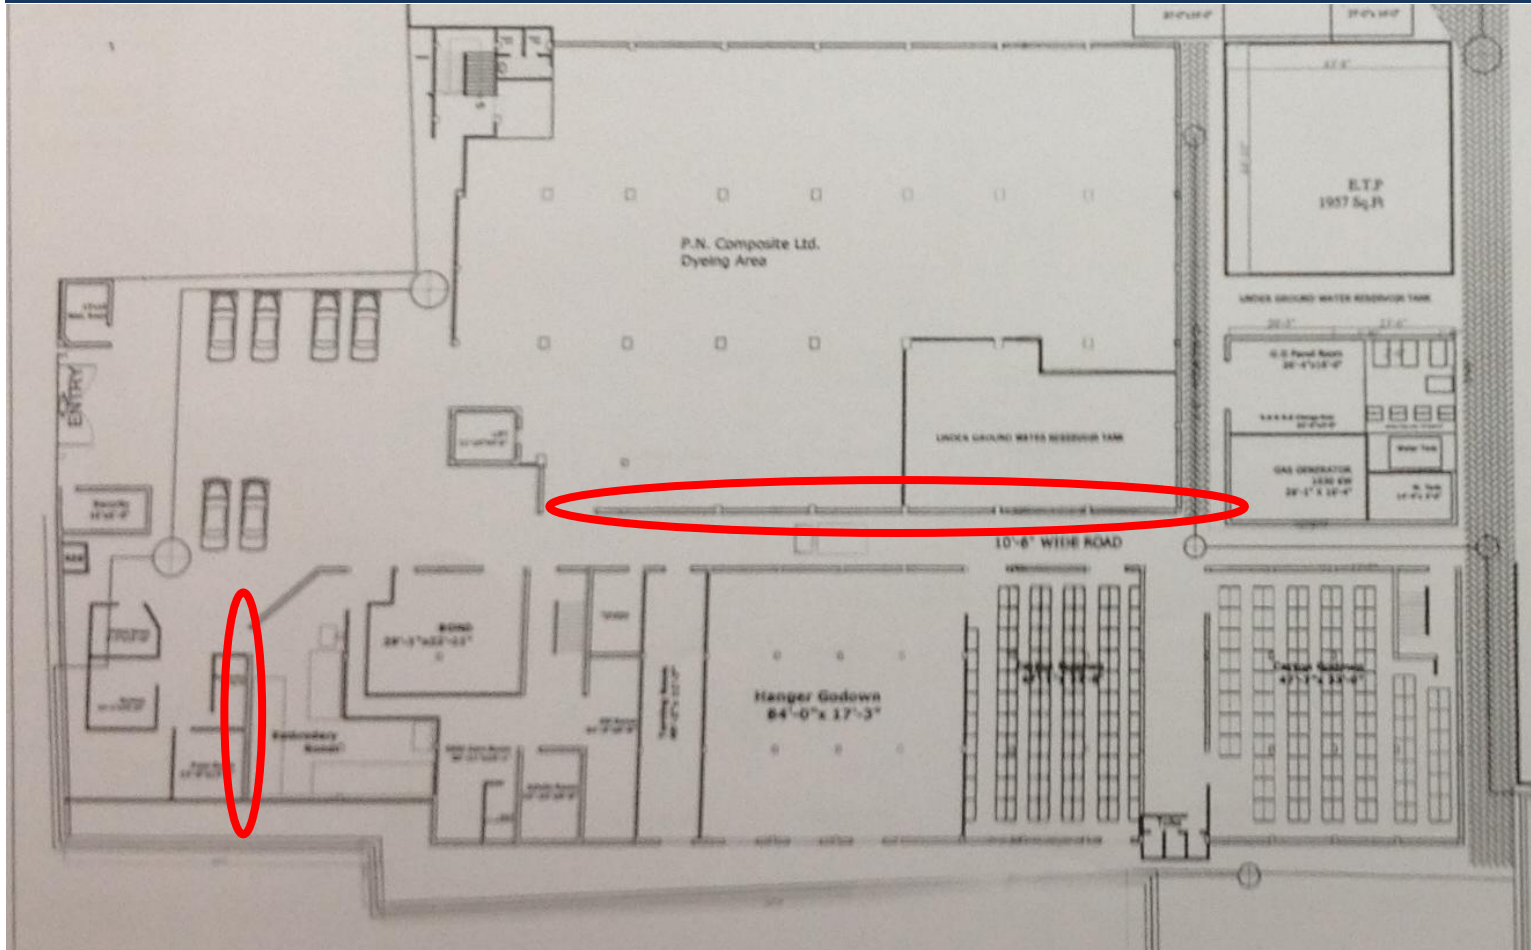
High stress levels in columns

Outline calculations indicate the circled columns below are highly stressed under their current loading condition.

| Item No. | Observation | Recommended Action Plan | Recommended Timeline |
|---|---|---|---|
| 1 | Stress levels in columns | Main Building: Temporarily cease all construction activities at Level 7. Ensure Level 6 remains unoccupied. Loading in the zone highlighted above to be limited to 1.5kN/m <sup>2</sup> (Levels 2 to 5) and 2.5 kN/m <sup>2</sup> (Level 1). | Immediate - Now |
| 2 | Stress levels in columns | Factory Engineer to review design, loads and stresses in all columns. | Immediate - Now |
| 3 | Stress levels in columns | Verify insitu concrete stresses either by 100mm diameter cores or existing cylinder strength data for cores from 4 columns. Verify grade of steel reinforcement used. | Immediate - Now |
| 4 | Stress levels in columns | A Detail Engineering Assessment of entire Main Building to be commenced - see attached Scope. | Immediate - Now |

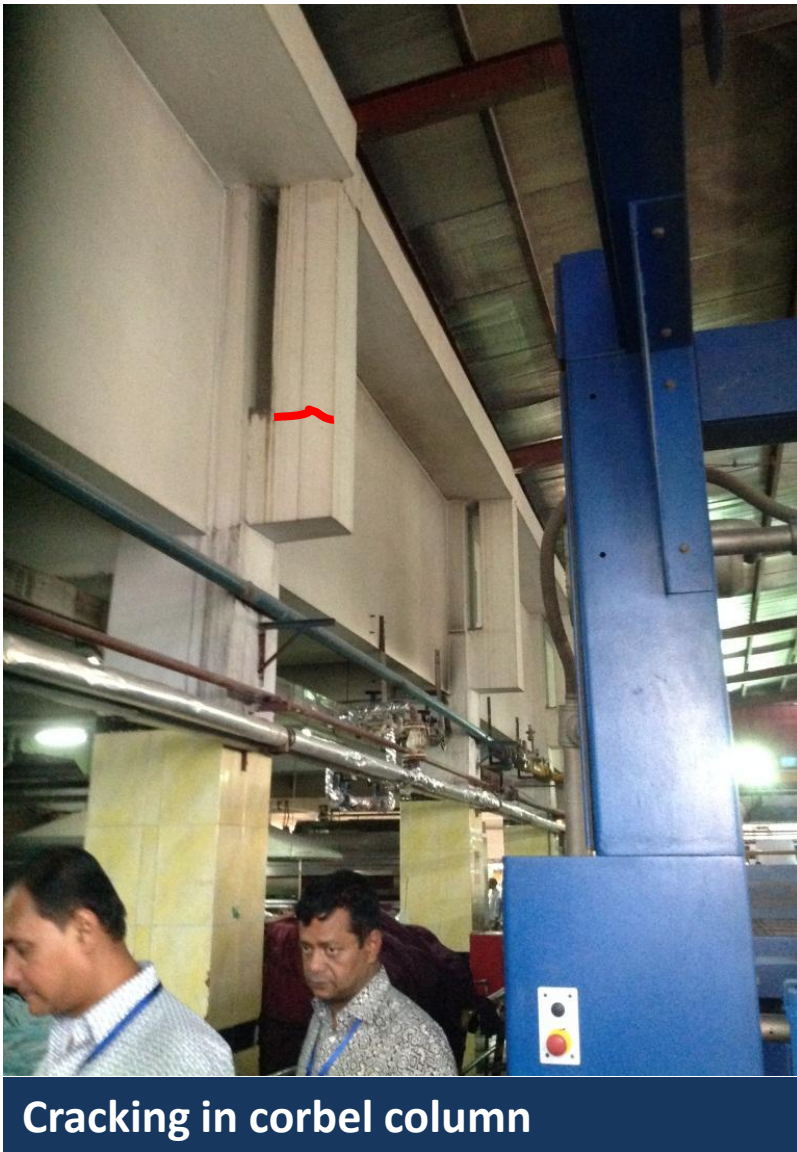
Cracking was observed from Level 2 in the corbel column.

| Item No. | Observation | Recommended Action Plan | Recommended Timeline |
|---|---|---|---|
| 9 | Cracking in corbel column | Factory Engineer to investigate the corbel cracking, as part of the Detail Engineering Assessment (see Item 1) | 6-weeks |
| 10 | Cracking in corbel column | Make any necessary structural alterations as directed by the Engineer. | 6-months |

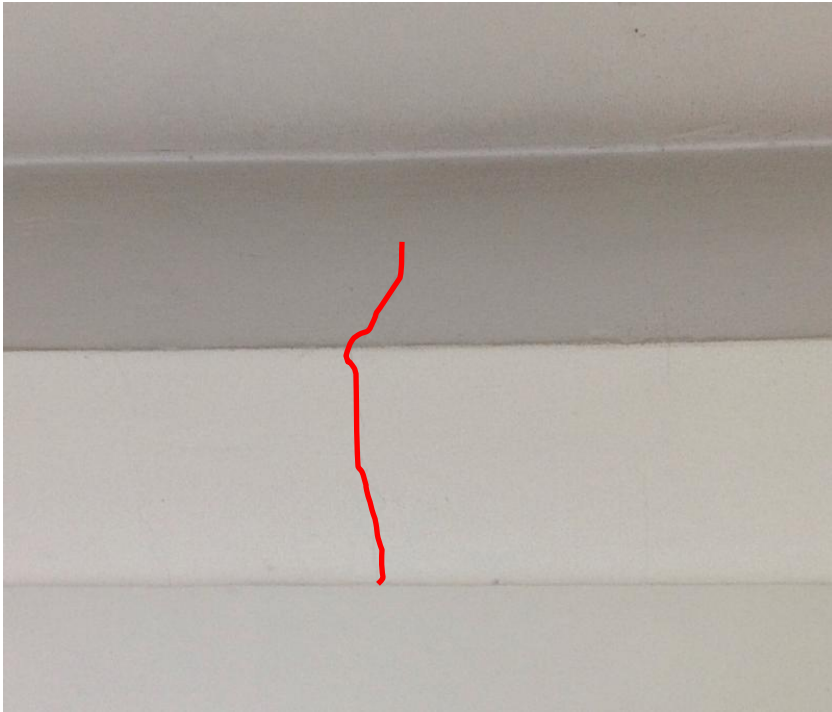
Cracking was observed in beams and/or floor slabs at most levels.

Cracking in beam

| Item No. | Observation | Recommended Action Plan | Recommended Timeline |
|---|---|---|---|
| 11 | Cracking in beams and slabs: mid-span and at movement joint | Factory Engineer to investigate if the cracking has any structural significance, as part of the Detail Engineering Assessment (see Item 1). | 6-weeks |
| 12 | Cracking in beams and slabs: mid-span and at movement joint | Carry out any remedial work as directed by the Engineer. | 6-months |

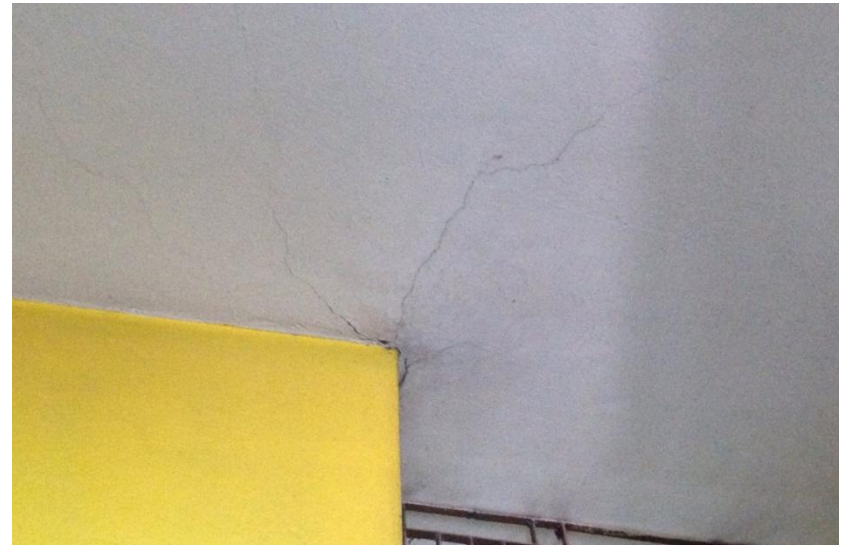
Cracking in slab

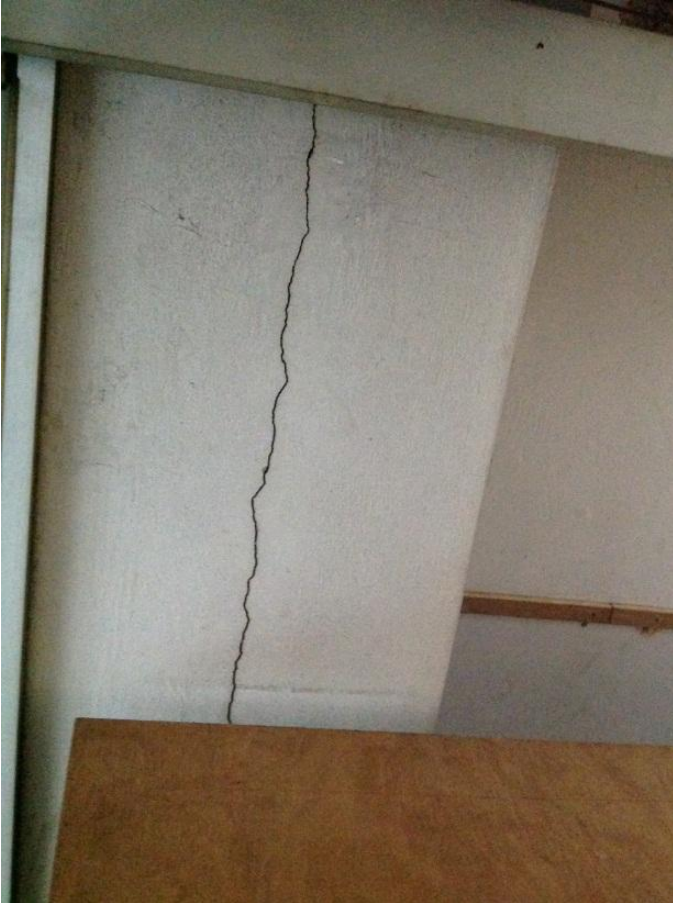
Cracking was observed at the two expansion joint locations in the slabs and beams.

Cracking in beam

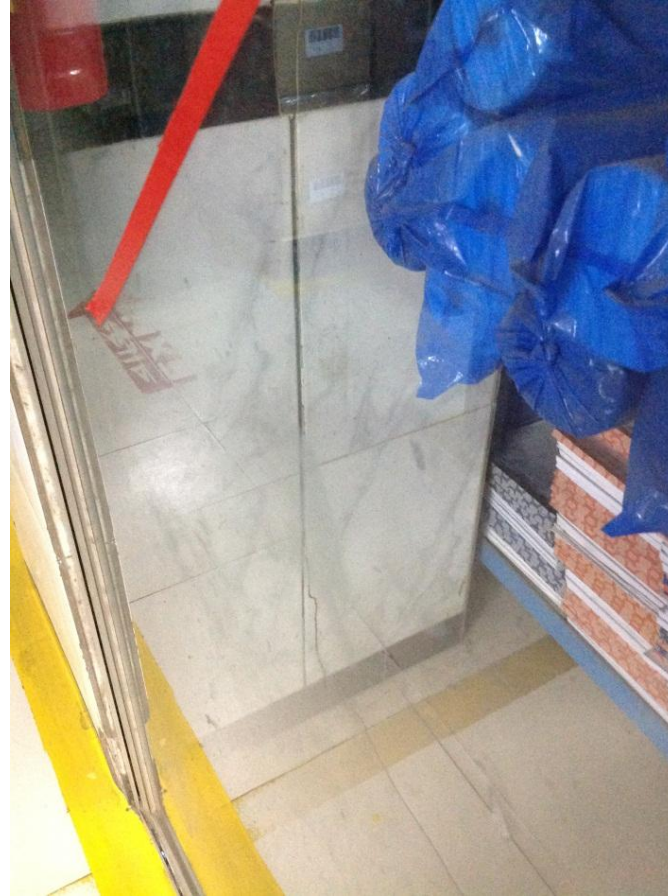
Cracking in slab

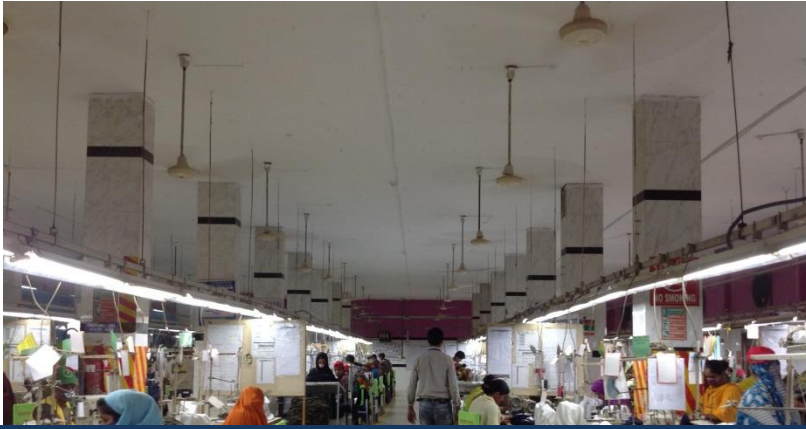
Flat slab at Level 3 Ceiling

Several observations in the main factory building did not correlate with the information presented in the structural drawings.

- Structural system (beams vs. flat slab)
- Beam locations
- Column sizes
- Grid dimensions

| Item No. | Observation | Recommended Action Plan | Recommended Timeline |
|---|---|---|---|
| 13 | Discrepancies between structural drawings and actual observations | Factory Engineer to update the drawings to “as constructed” status to reflect the actual site dimensions and column locations as part of the Detail Engineering Assessment. The drawings should show the integrated building (dyeing, garments and offices). | 6-weeks |

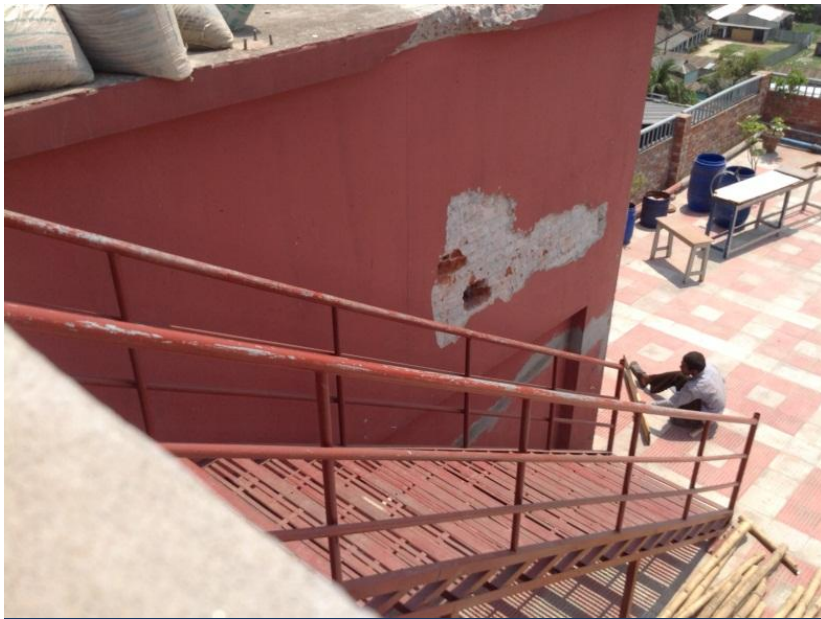
A portion of the water tank slab is being raised to create head-room for stair access onto the roof.

Water tank slab alteration

| Item No. | Observation | Recommended Action Plan | Recommended Timeline |
|---|---|---|---|
| 14 | Water Tank slab alteration | Factory Engineer to check construction to ensure compliance with design intent. | 6-weeks |
| 15 | Water Tank slab alteration | Make any alterations as directed by the Engineer. | 6-weeks |

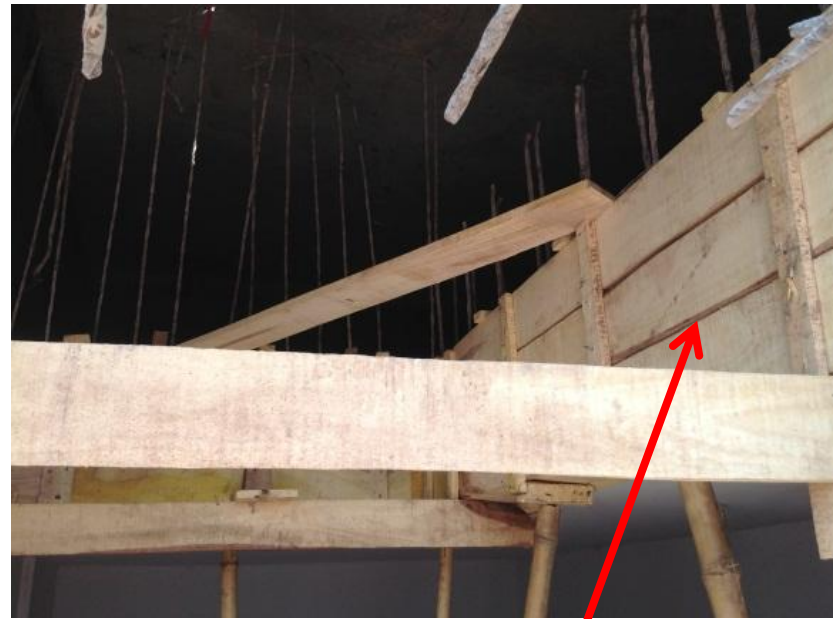
Water tank slab  
being raised

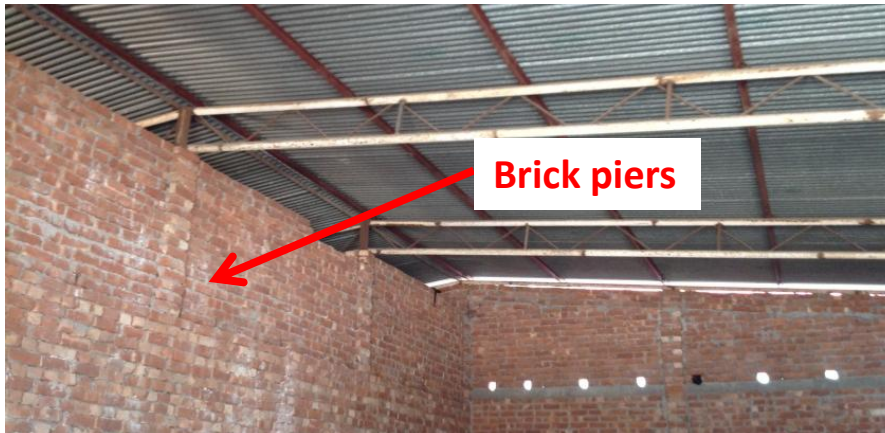
Steelwork supported on smaller brick piers

| Item No. | Observation | Recommended Action Plan | Recommended Timeline |
|---|---|---|---|
| 17 | Apparently non-engineered structures | Factory Engineer to check the capacity of the masonry wall panels under horizontal and vertical loading and make any necessary alterations. | 6-months |

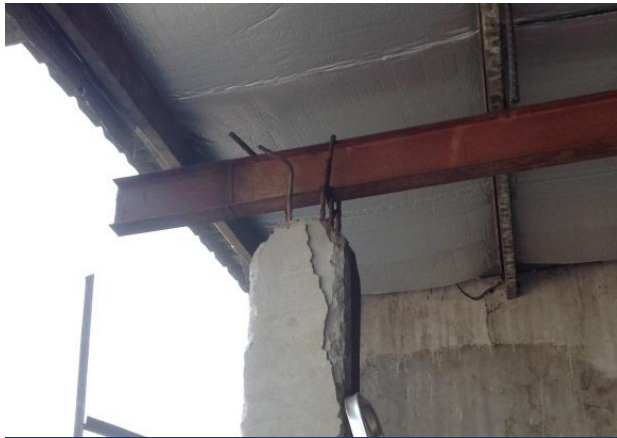
Non-engineered connection

| Item No. | Observation | Recommended Action Plan | Recommended Timeline |
|---|---|---|---|
| 16 | Apparently non-engineered structures | Factory Engineer to check the capacity of the lightweight roofs to Shed Buildings and to Main Roof areas under horizontal and vertical loading, and make any necessary alterations. | 6-months |

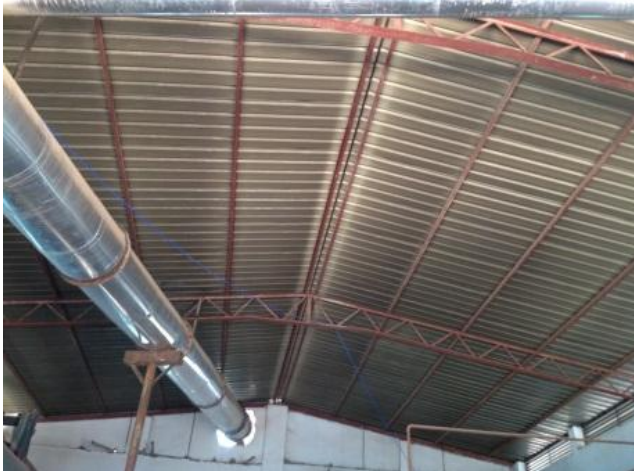
Lack of roof bracing

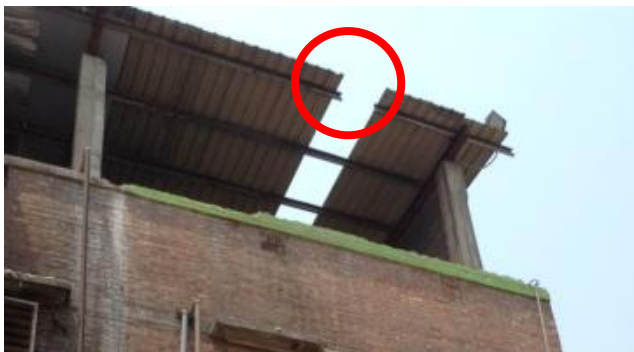
Cut roof purlin

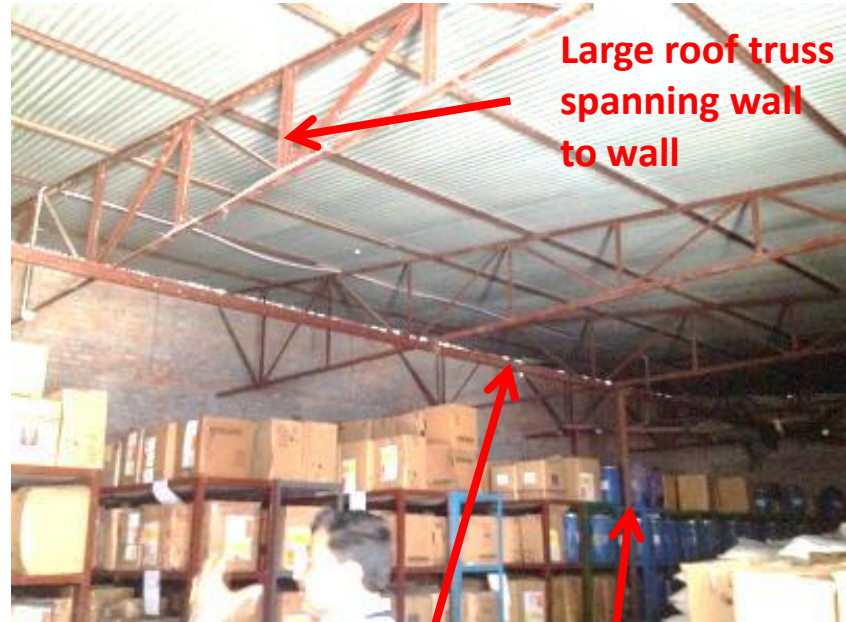
Unclear load path

Beam under  
roof truss

Column  
supporting roof  
truss and beam
