# Moon Readywears Ltd.

Beron, Diakhali, Asulia, Savar  
(23.937438,90.299281)  
13 April 2014

# Observations

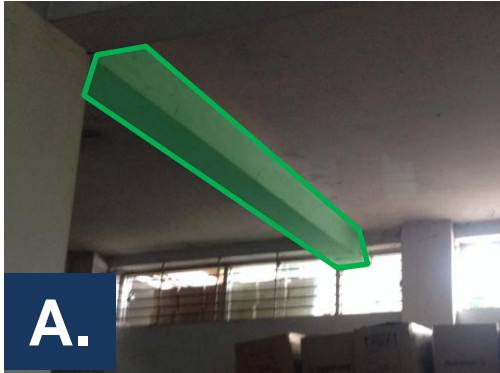
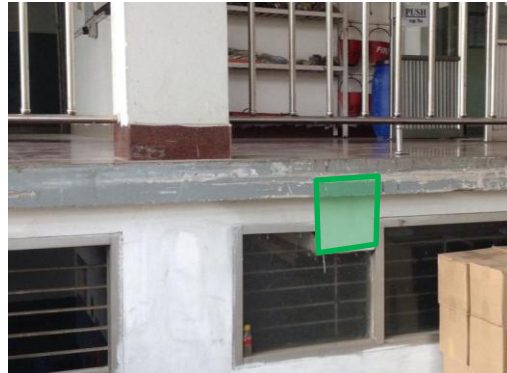
- A. As built edge of lift core and adjacent column do not align as shown on structural drawings. Beam cantilever created.
- B. From review of the level 6 soffit it is clear the beam support arrangement within the men's toilet area does not match other floors. Design load path at level 6 unclear.

- Undertake a detailed as built survey of building 1 and 2 recording all undocumented structures and extensions.
- Record relevant materials used in construction.
- Building engineer to check design where discrepancies exist. Design appropriate strengthening and/or additional support as required.

- Construct strengthening and/or additional support specified by the building engineer.
- Complete as-built drawings for buildings 1 and 2 incorporating any remedial or strengthening works undertaken.

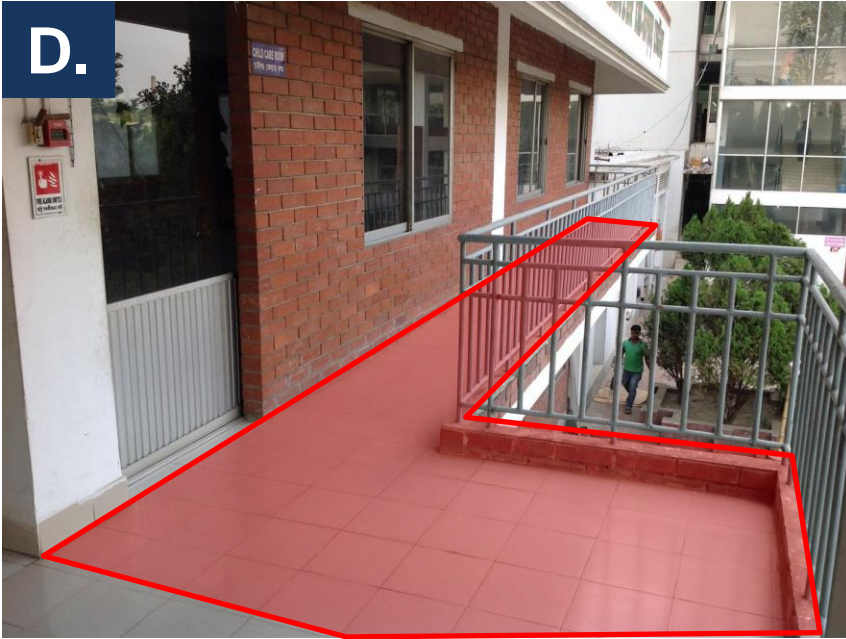
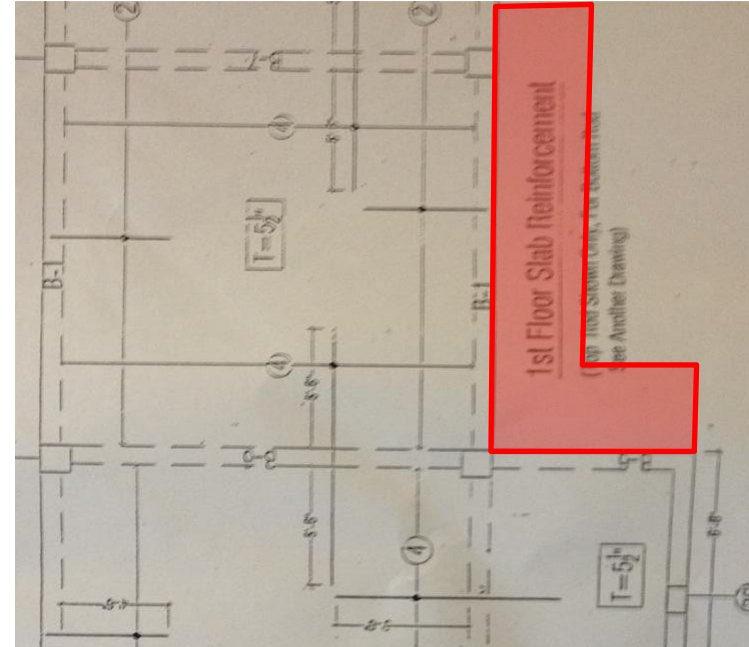
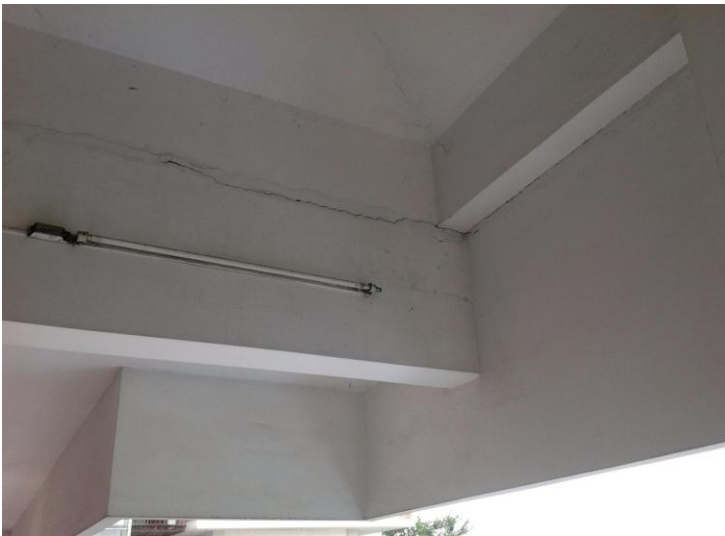
D. Undocumented first floor slab cantilever noted above in red. Similar cantilever is reflected in roof above. Deflection induced distress observed in non structural elements. Concrete cracking in roof perimeter downstand likely induced by hanging load path to cantilevered roof edge.

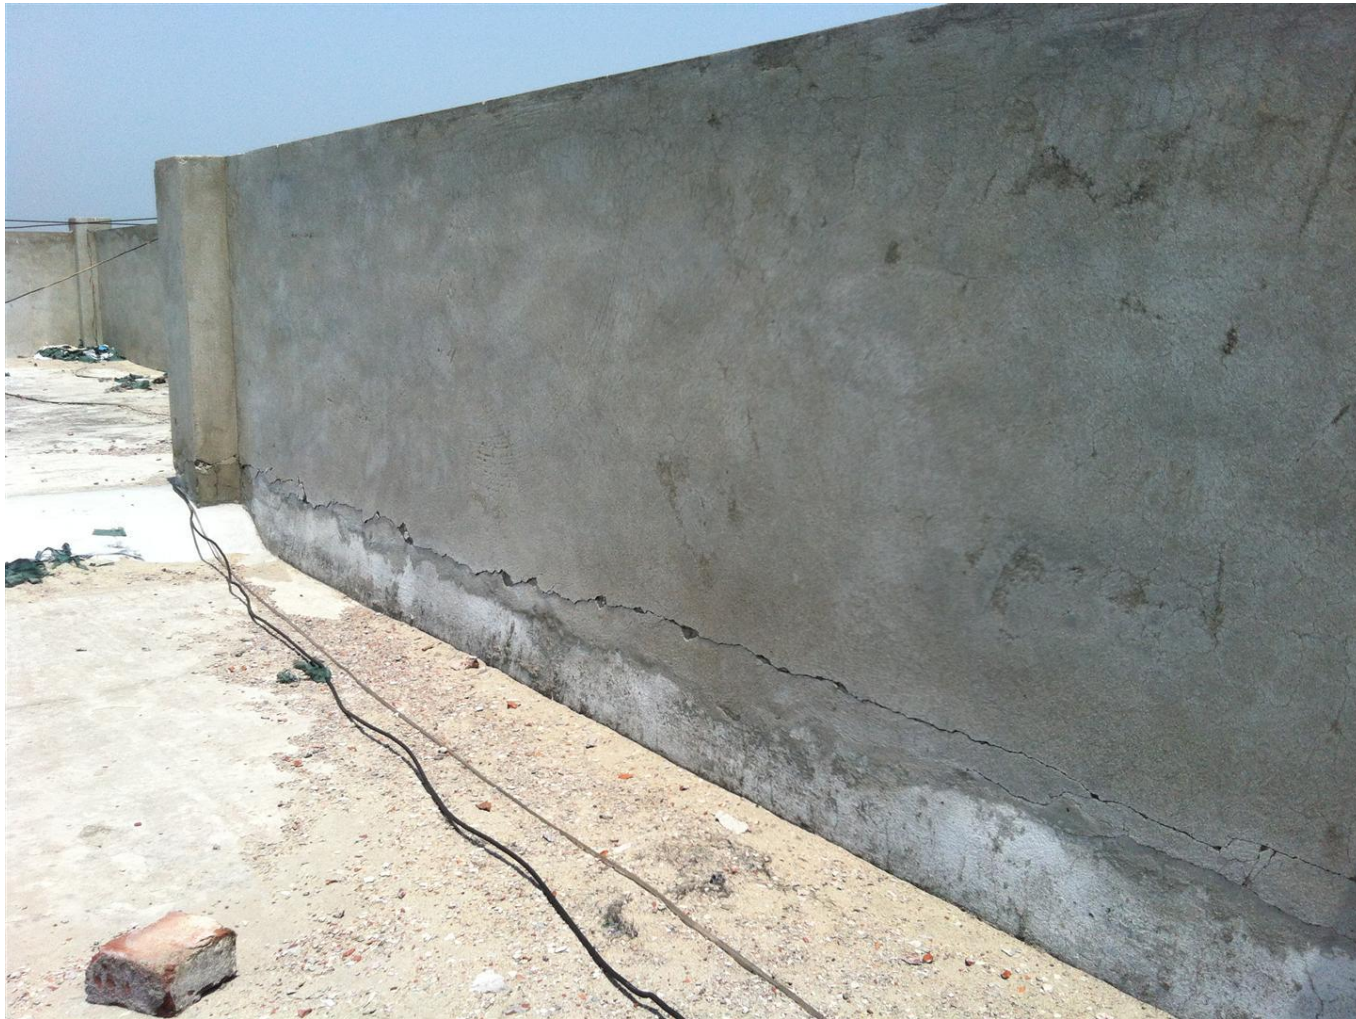
Undocumented non-engineered roof parapet shows signs of severe distress. Large cracks evident at base of cantilever within wall and pier. Redundancy limited.

- Secure top of parapet to top of roof floor slab using details specified by the building engineer.

- Building engineer to review design of roof parapet and specify any strengthening and/or additional support required in the permanent condition.

- Construct strengthening and/or additional support specified by the building engineer.
- Complete as-built drawings for parapet incorporating any remedial or strengthening works undertaken.

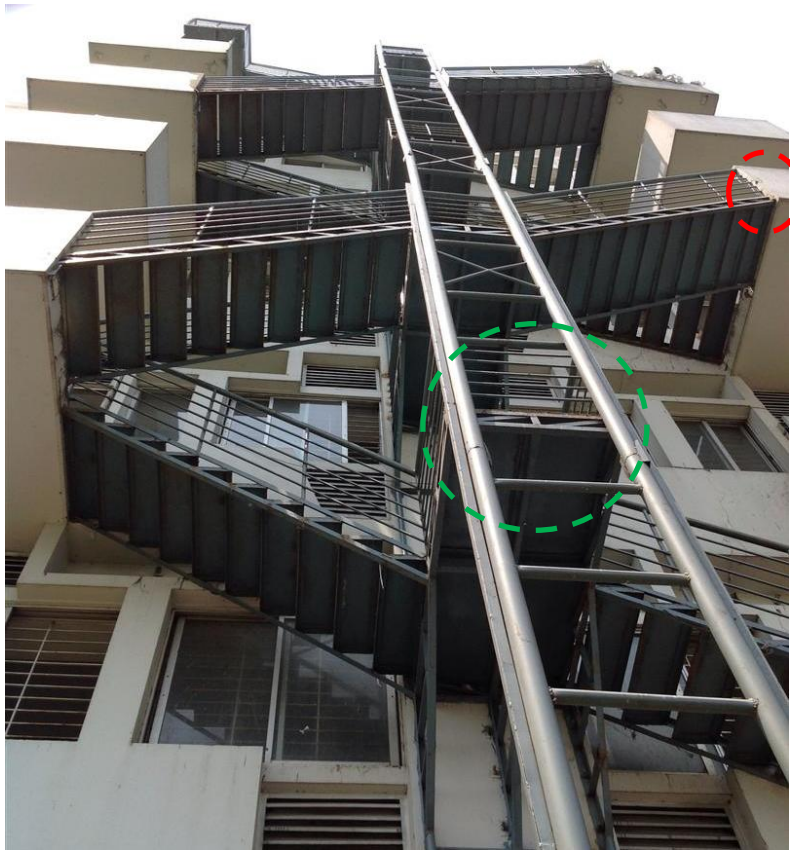
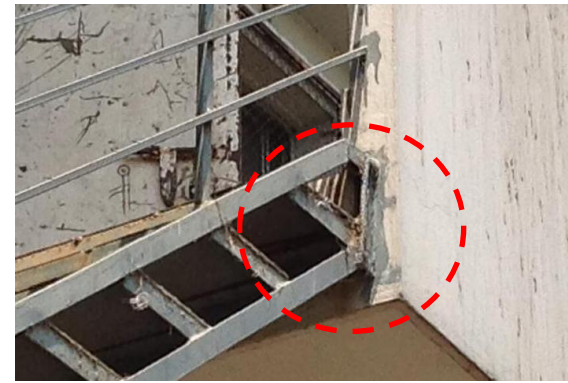
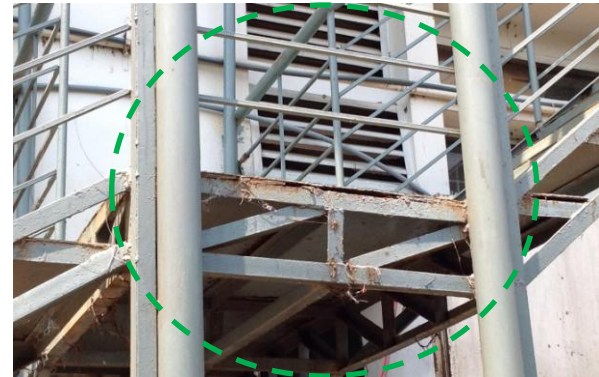
- Steel stairs and RC landings are not documented on structural drawings.
- Stair bridges across movement joint from ground to level 3.
- Corrosion evident at treads and landings.
- Stringer welded connection to undocumented concrete landing reinforcement susceptible to corrosion, fatigue and large axial forces. Axial forces induced by main building thermal movement due to bridging of movement joint by stair.
- Stair braced at each floor level.

- Building Engineer to review **escape stair** structural elements and all connection details for full access loads on stairs.
- Building engineer to design appropriate strengthening works as required.
- Factory manager to manage and co-ordinate any strengthening works with the fire escape strategy for all areas.
- Factory Engineer to review single storey support buildings and advise on any strengthening or demolition works required.

- Complete strengthening works and/or demolition. Complete as built drawings for single storey structures and escape stairs.

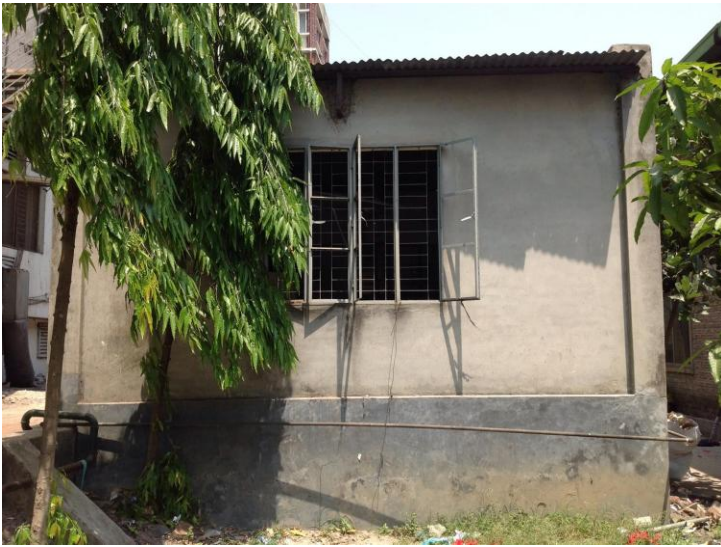
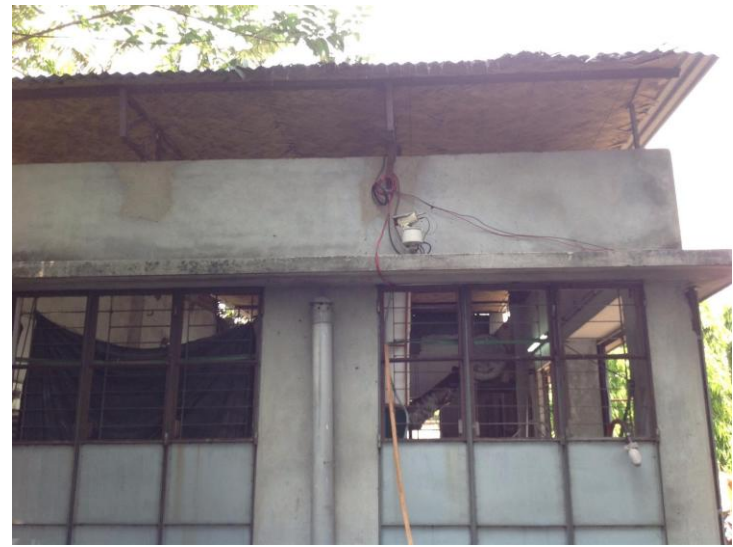
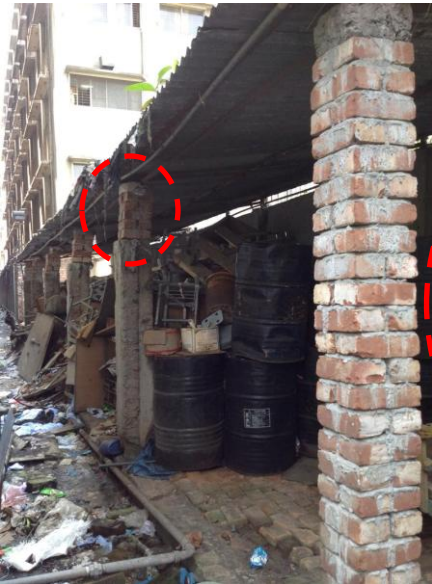
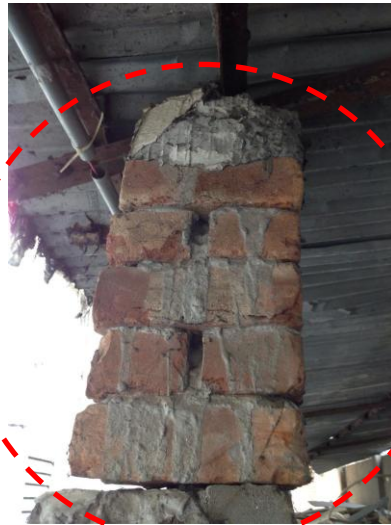
Numerous single storey small buildings, remote from the main buildings identified, are not included in structural documentation and are not specifically addressed in this structural inspection report. Note the uninhabited structure pictured left is clearly unsafe and should be demolished or remediated as per the building engineers instructions immediately.

- Provide temporary support to the site structure circled in red within observation 3.

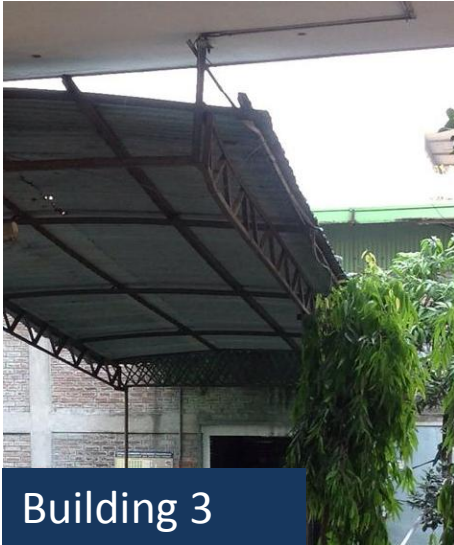
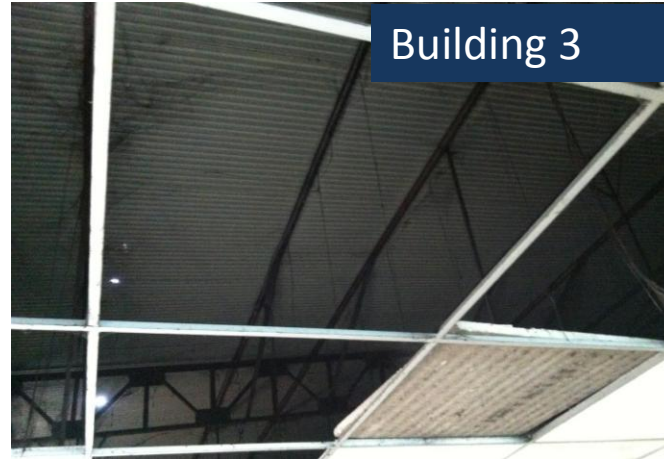
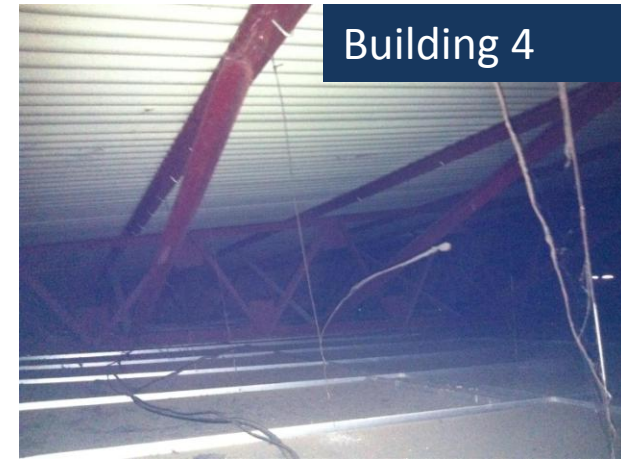
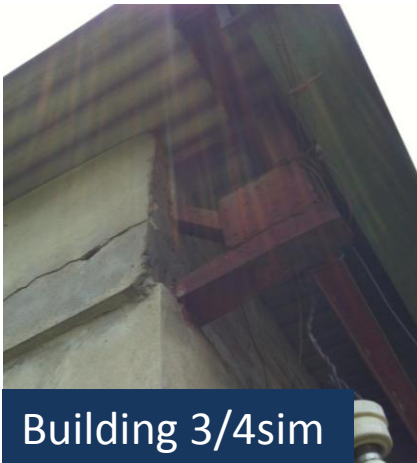
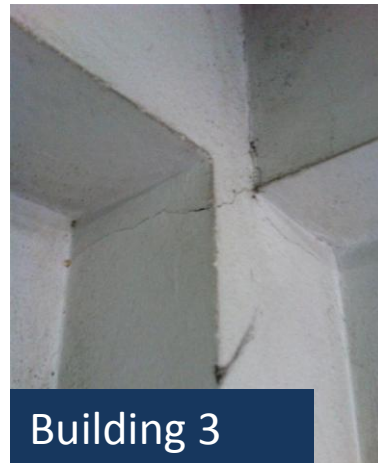
- No relevant drawings for building 3 and 4 steel and concrete structure including trusses, connection details, reinforced concrete structure, foundations, ground floor slab details.
- Member arrangement and connection configuration suggests buildings have not been engineered.
- Lateral stability of steel roofs unresolved.
- Signs of distress in both structures evident.

- Undertake Detailed Engineering Assessment **of Building 3 and 4**. Pay particular attention to structural stability, steelwork connection details, the as built concrete frame and determining if the as built foundation systems is appropriate.

- Carry out all recommendations resulting from the Detailed Engineering Assessment.
- Finalise appropriate structural as built drawings which incorporating the completed structural system.

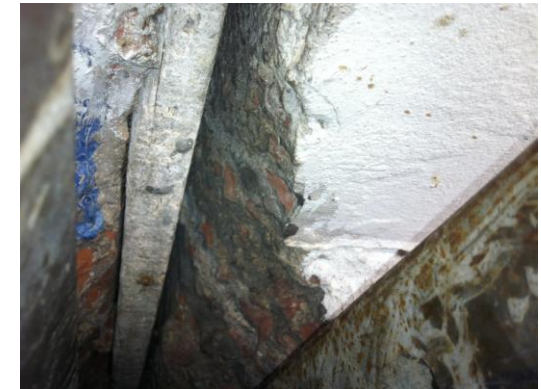
Building 1 slab

- Structural design documents specify natural stone and brick aggregate. SLAB-2 element designation not found within structural documents hence specification ambiguous.
- Brick aggregate observed throughout building 2 and within building 1 slabs and beams.
- It is not clear if brick aggregate concrete achieves minimum compressive strength required by design. I.e. 3000 psi specification is consistent with stone aggregate.
- Stone aggregate observed within building 1 columns.

- Building Engineer to organising sufficient coring (100mm min) to determine the in situ strength of reinforced concrete beams and slabs (building 1)
- Building Engineer to review design of all beams and slabs on the basis of actual in-situ strengths and advise appropriate load limits.
- Loading plans (see Item 7) to be based on as constructed capacities of beams, slabs and columns.
- Building Engineer to design any strengthening works required.

- Carry out any strengthening or remedial works recommended by the building engineer.
- Record as built materials for structural elements on as built drawings.

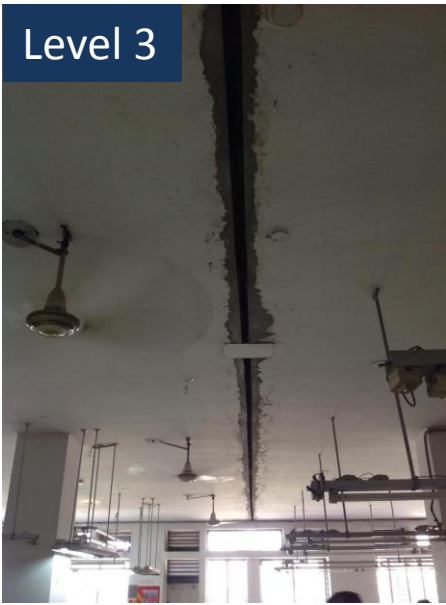
Level 3

- Structural design documents specify an expansion joint at all floors.
- Expansion joint filled with brick/render finish at level 1 and 2.
- Expansion joint not constructed above level 3.
- Lateral system design may not account for forced compatibility at levels where joint not installed/ improperly installed.

- Building engineer to review design of lateral load support system and floor diaphragms.
- Design review to ensure in plane loading of diaphragms is considered. E.g. shrinkage and thermal effects in combination with lateral loads as appropriate.
- Building engineer to review façade and advise if any remediation is necessary to ensure structural sufficiency for the full design life.

- Construct strengthening and/or additional support specified by the building engineer.
- Complete as-built drawings for any façade or primary structure modified to incorporate remedial works undertaken.

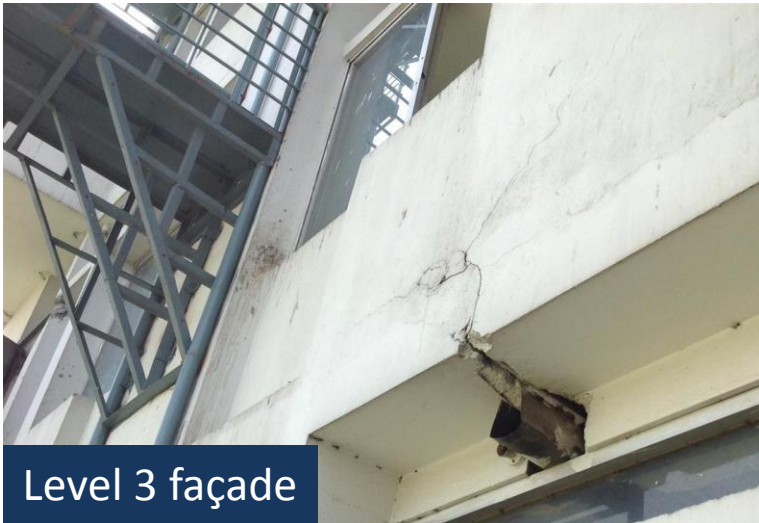
Level 3 façade

- Distress evident where façade bridges across movement joint.
- Distress in beams and slabs evident where movement joint not installed. Number and size of cracks is maximum at roof where thermal load magnitude is highest.

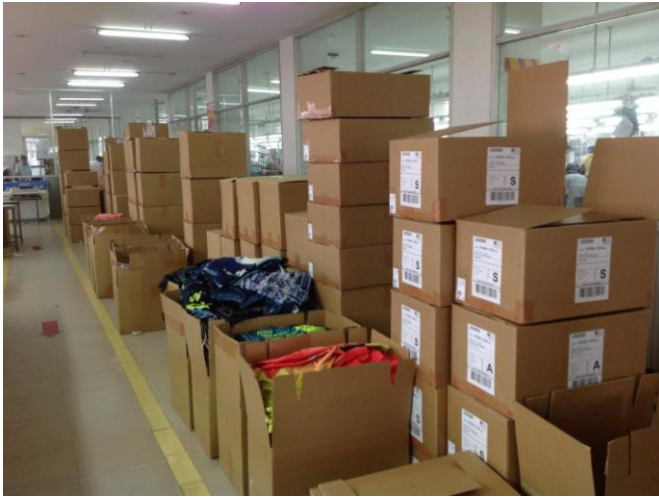
- Floor load management system incomplete as no loading plans observed at the suspended floors.
- Localised areas of storage loading.
- Heavyweight internal brick partitions constructed on suspended floors.

- Building engineer to produce loading plans to be displayed at each floor level. Allowable load allowance to be calculated considering existing super imposed dead loads (E.g. floor finishes and partition walls). Factory manager to actively manage floor usage in accordance with the loading plan.

- Continue to implement load plan.
