# Oasis Fashion Ltd (Unit 2)

Kashem Complex, Gacha Road, Gazipur  
(23.9366637, 90.3723368.24)

15<sup>th</sup> April 2014

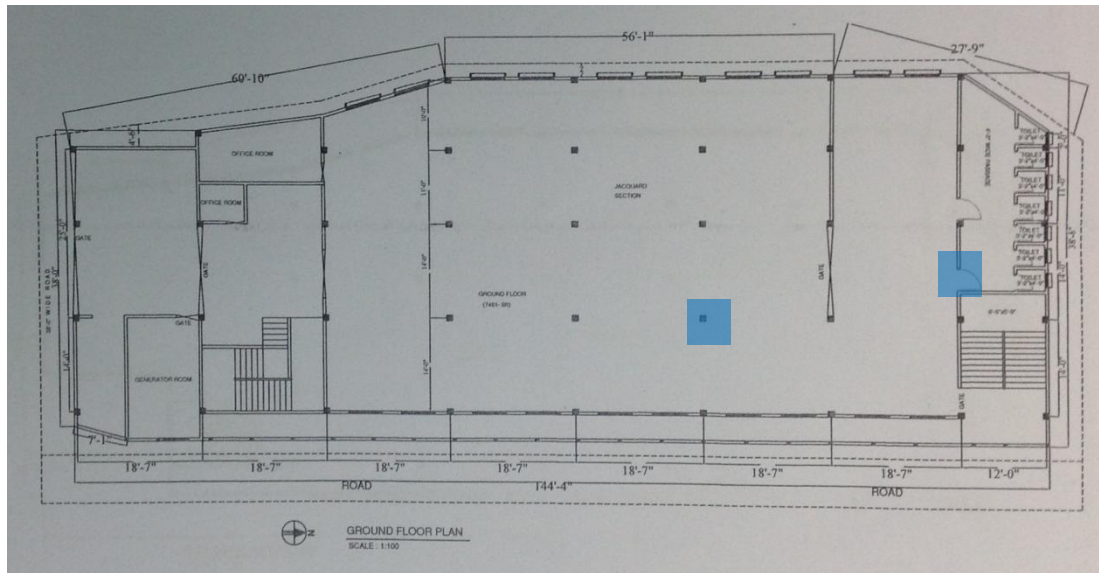
Ground Floor Plan

Cursory calculations indicate that the working stress of the columns at Ground Floor levels are at a high level. Detailed Engineering Assessment required.

- Building Engineer to review design, loads and column stresses in structure. A Detailed Engineering Assessment of Factory to be commenced – see attached scope.
- Verify insitu concrete stresses by taking 100mm diameter cores from 4 columns at ground floor level.
- Verify number and diameter of reinforcement bars in ground floor columns.

- Produce and actively manage a loading plan for all floor plates within the factory giving consideration to floor capacity and column capacity.
- Detailed Engineering Assessment to be completed.

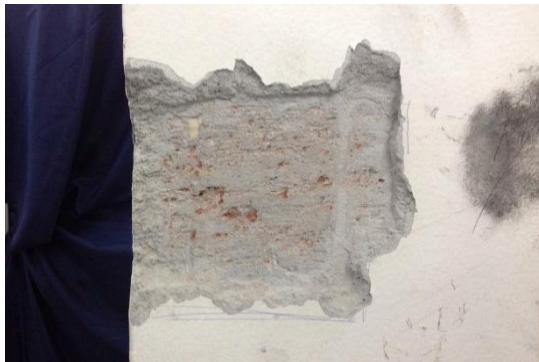
Construction of the main building began in 2006, with construction up to 6<sup>th</sup> Floor completed by 2012. A lightweight steel roof structure on RC columns, which covers approximately 50% of the floor area, was erected at Roof level in 2012, in lieu of a LGED-approved 7<sup>th</sup> storey. Brick aggregate was observed in the Ground Floor columns, in accordance with the As-built structural drawings. There is a discrepancy between the drawings and the constructed building in relation to the Ground Floor column reinforcement quantities. Grade 72 High Strength steel is called up in the structural drawings. No exposed reinforcement steel was visible for comparison.

Tested Column C/3 (Brick)

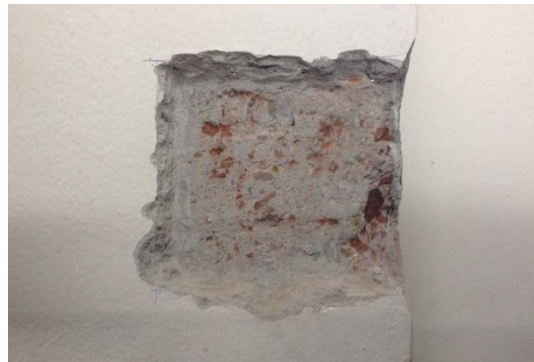
Tested Column D/5 (Brick)

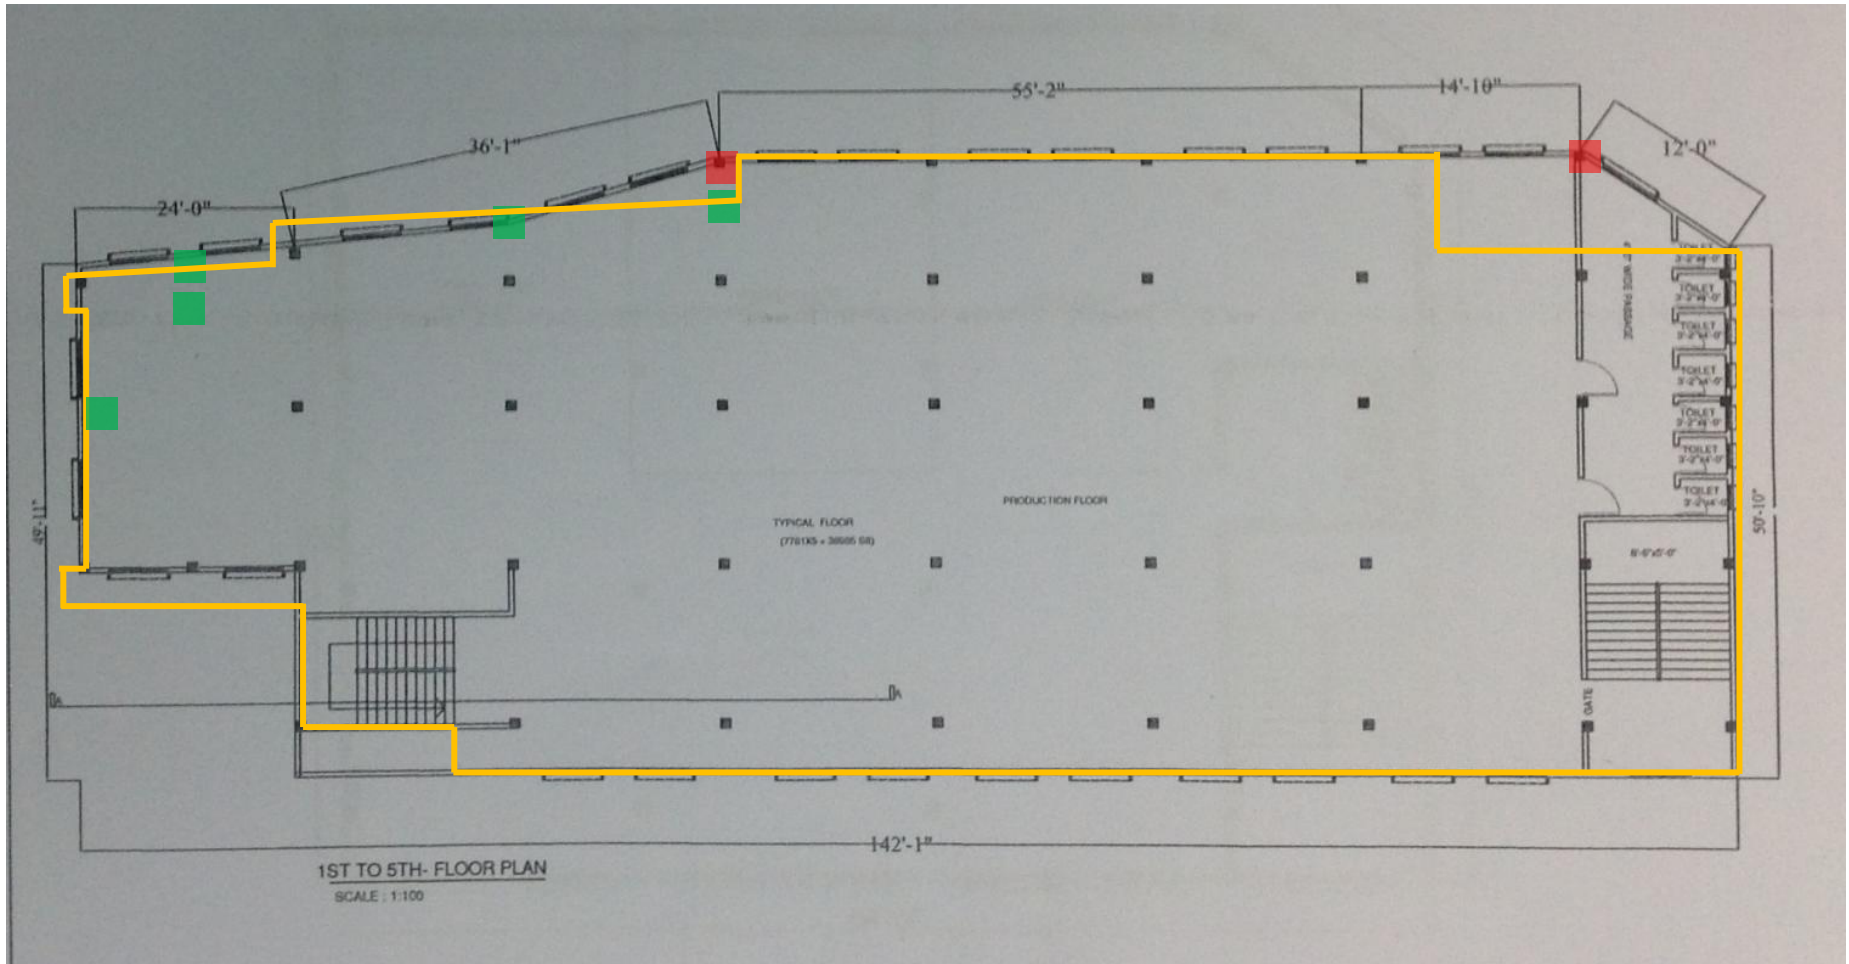
Typical Floor Plan

- Inconsistencies in construction type – the structural drawings appear to indicate simple flat slab construction, whereas flat slab with drops is observed at Ground, 1<sup>st</sup> and 2<sup>nd</sup> Floor levels (with some beam and slab observed to the South of the building), and beam and slab is observed at 3<sup>rd</sup>, 4<sup>th</sup> and 5<sup>th</sup> Floor levels;
- Inconsistencies in column / beam layout, particularly to the south of the building;
- Inconsistencies in building footprint, particularly to the south of the main building, and to Shed no. 2;
- Inconsistencies in rebar quantities;
- Slab thickness is called up as 6” in the drawings, whereas a minimum of 7” is observed;
- Banglalink Telecom tower above South stair is not called up in the drawings.

Additional Columns

Misplaced / Non-existent Columns

Apparent Building Footprint

Building Engineer to review and provide clarification.

- Engage a Building Engineer to survey the structure and prepare a full set of “as-constructed” drawings.

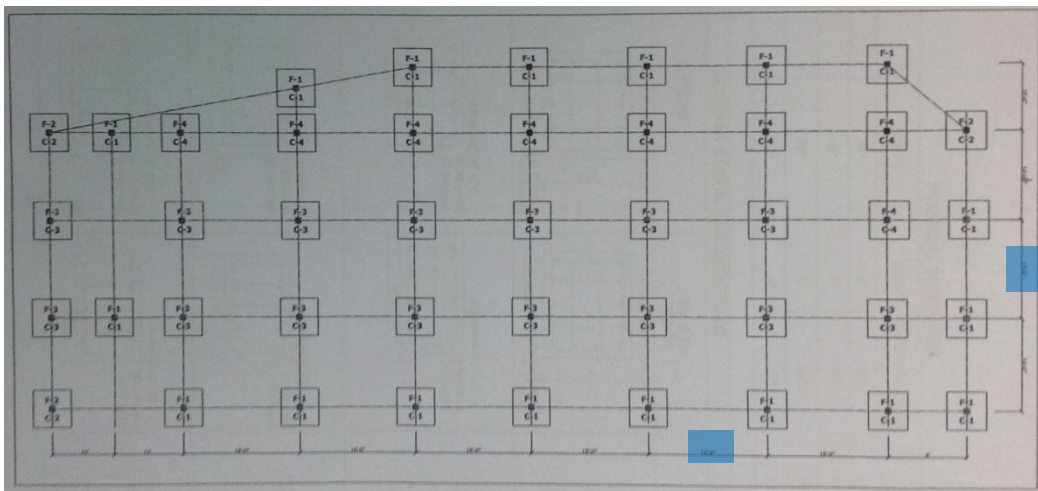
**Inconsistencies in Grid Dimensions:**  
The Column Layout Plan call up a maximum grid size of 18.7" x 14.0" for an internal bay, whereas the Ground Floor Plan calls up 18.0" x 15.6" for the same bay.

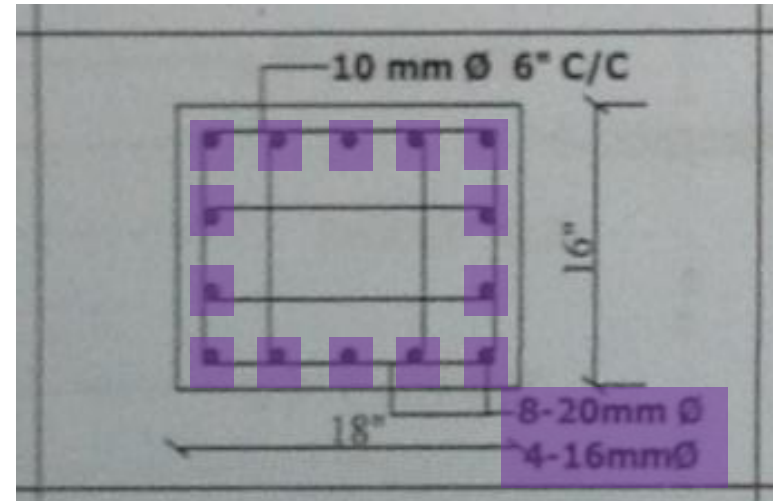
Inconsistencies in Rebar schedule

**Inconsistencies in Rebar Quantities:**  
The reinforcement quantity written in the schedule (8 + 4 = 12 bars) is different from that shown schematically (14 bars).

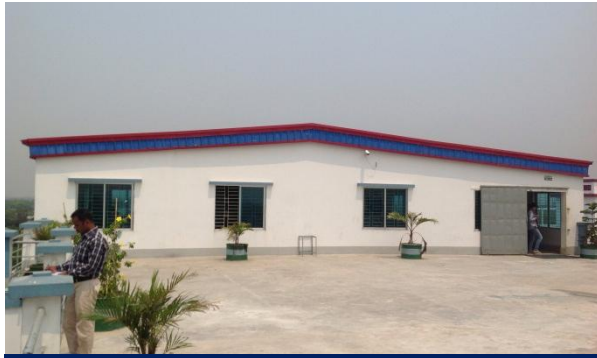
The factory compound comprises a number of lightweight structures, namely the Dining area at 6<sup>th</sup> Floor level, and the two large sheds at ground floor level. These structures, which consist of lightweight steel-trussed roofs on RC columns, do not appear to be engineered. Building Engineer to review the design of these structures, with special emphasis on connections and bracing, and to implement any upgrade works as required.

Dining Area at 6<sup>th</sup> Floor Level

- Engage a Building Engineer to check the capacity of the lightweight 'warehouse' structures / connection details and 6<sup>th</sup> floor structure/connection details and make any necessary alterations.

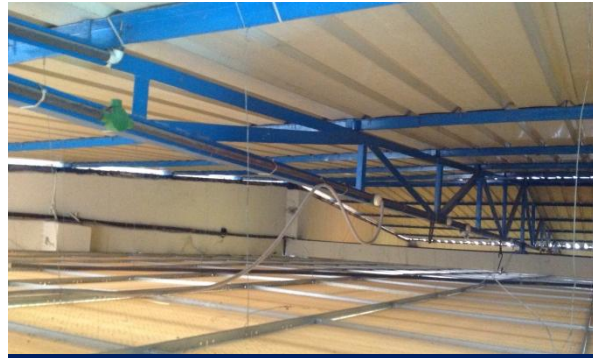
Steel Trusses to Dining Area Roof

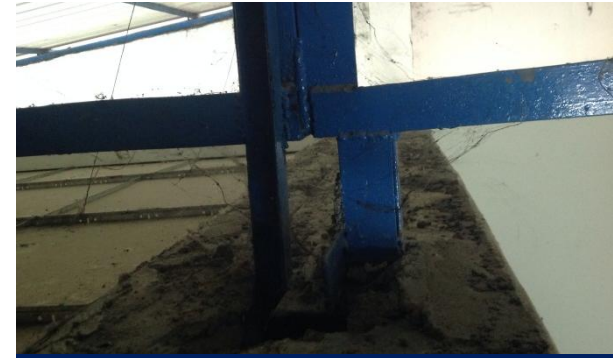
Truss to Column Connection Detail

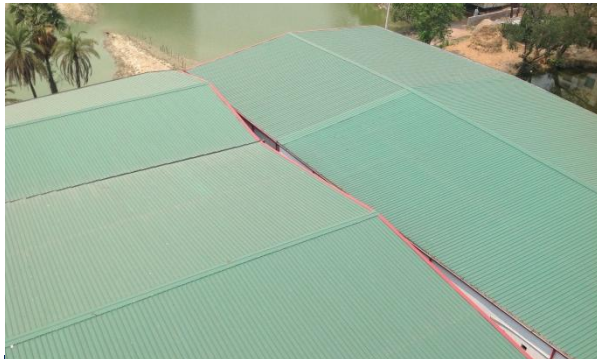
View of Sheds from Main Building Roof

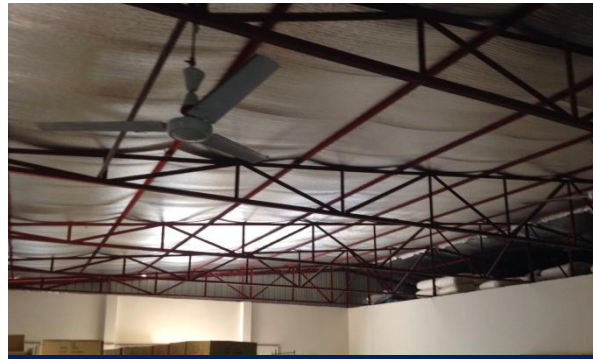
Lightweight Steel Roof to Ground Floor Shed 1

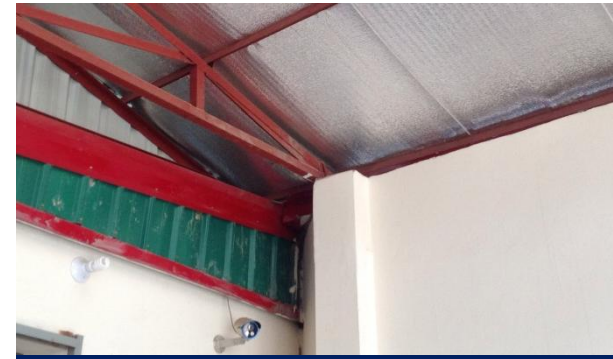
Truss to Column Connection Detail at Entrance to Shed 2

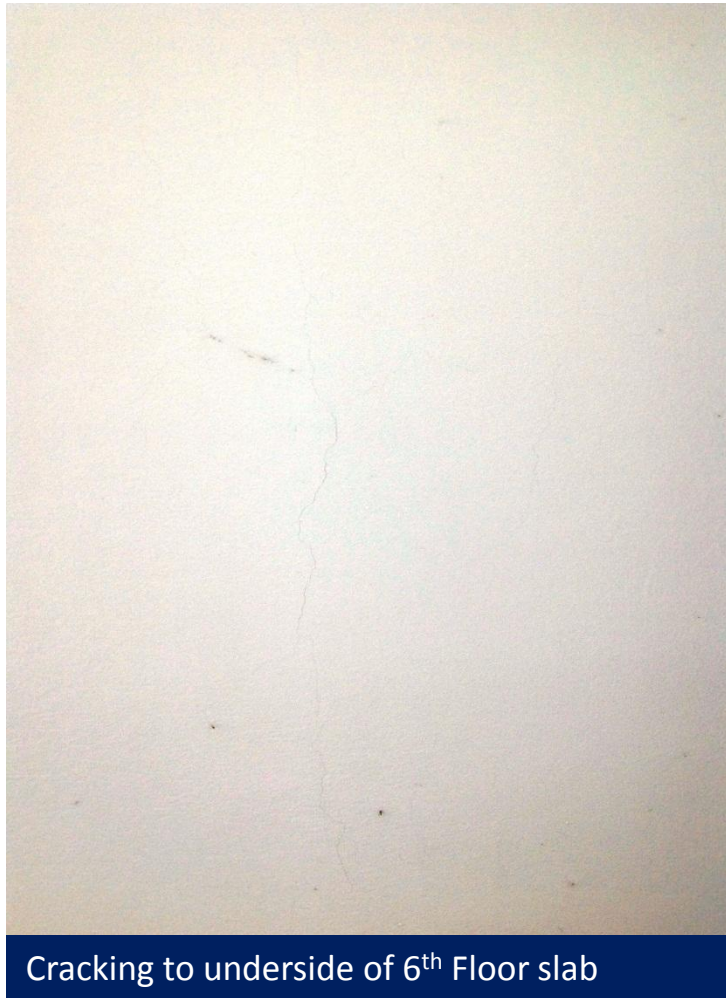
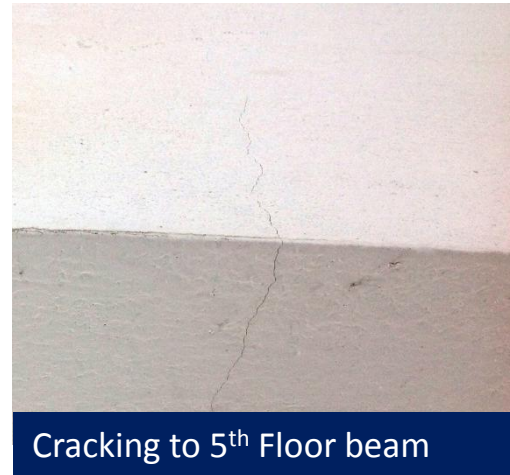
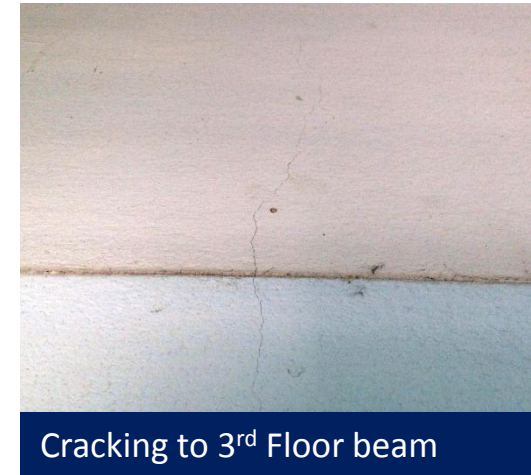
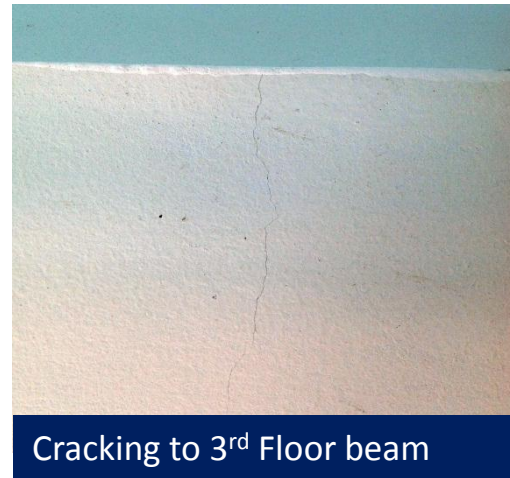
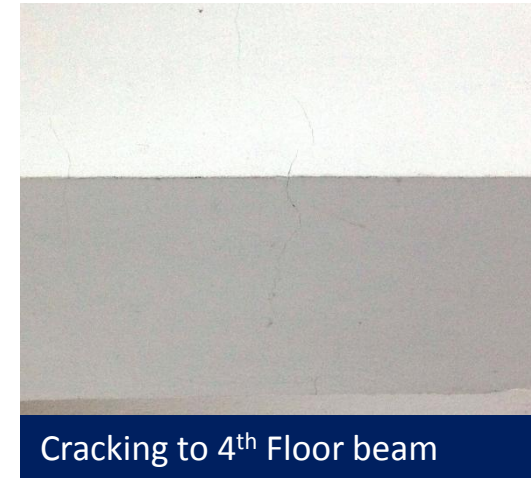
Hairline cracking was observed to the soffit of a number of beams and slabs at 3<sup>rd</sup>, 4<sup>th</sup> and 5<sup>th</sup> Floor levels. Building Engineer to investigate to see if cracks are present in structural concrete below plaster and carry out remedial works to the structure as required.

- Monitor cracks to beams and slab soffit. Engage an engineer to investigate if cracks are only in the plastering.
- Engage a Building Engineer to advise on load reduction and repair and strengthening of the slab if required.

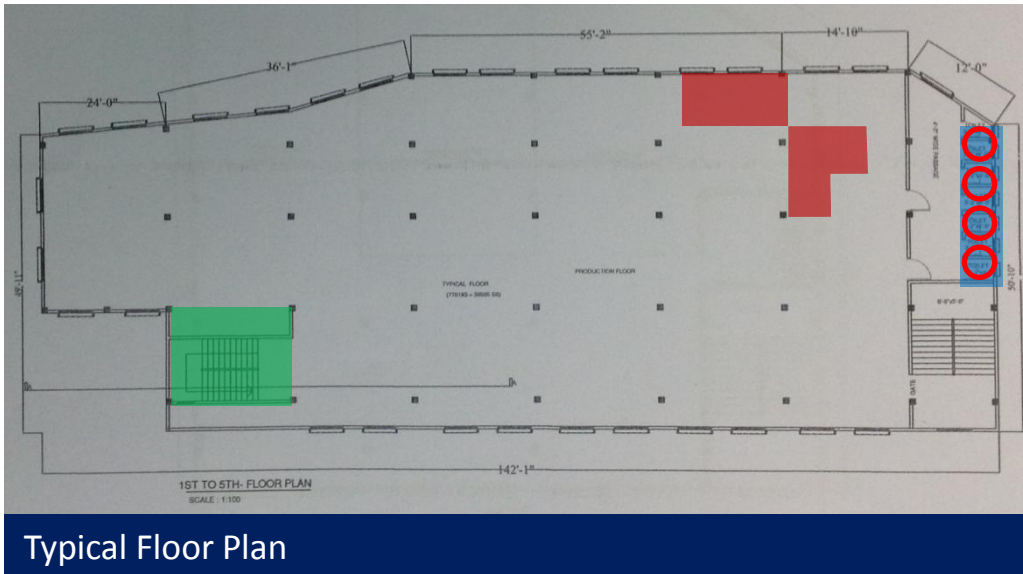
Typical Floor Plan

Areas of high loading were noted at the Banglalink Telecom tower above the South stairs at Roof level, the water tanks and plinths adjacent to the North stairs at Roof level, the toilet plinths to the North-West corner at all floors, and at the washing area machines and plinths at 1<sup>st</sup> Floor level. Building Engineer to check that the different slab constructions have been adequately designed to accommodate this loading.

- Banglalink Telecom Tower at Roof Level
- Water Tanks on 150mm Plinth (typical) at Roof Level
- Extent of Toilet Plinths to all Floors
- Extent of Washing Area Plinths to 1<sup>st</sup> Floor

- Engage a Building Engineer to investigate the loading from water tanks, telecommunication tower, toilet floor build-up and washing area plinths and equipment and advise on any necessary alterations taking account of floor capacity and column capacity.

- Make any structural alterations as advised by Factory Engineer.

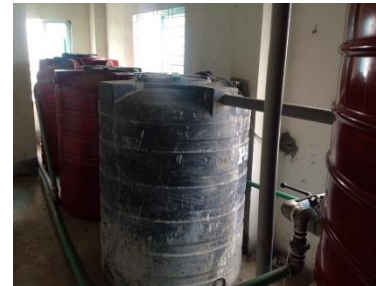
Water Tanks to Roof

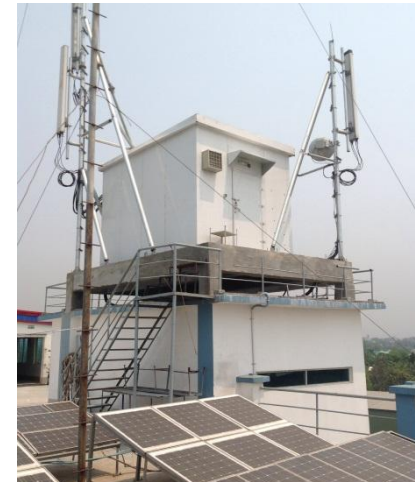
Telecom Tower

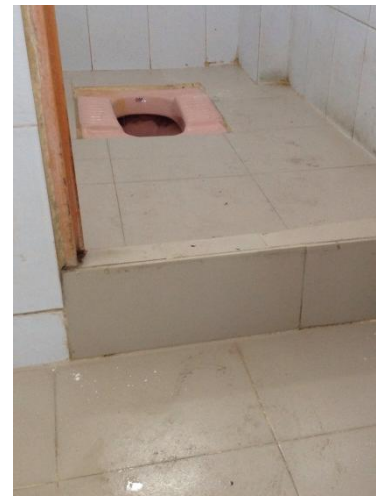
Toilet Plinths

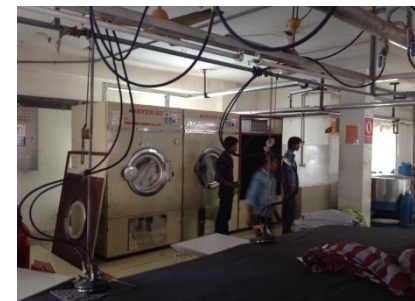
Washing Area
