# Manami Fashion Ltd (9705)

Kabirpur, Ashulia, Savar, Dhaka - 1349

06.April.2014

**ACCORD**  
on Fire and Building Safety in Bangladesh

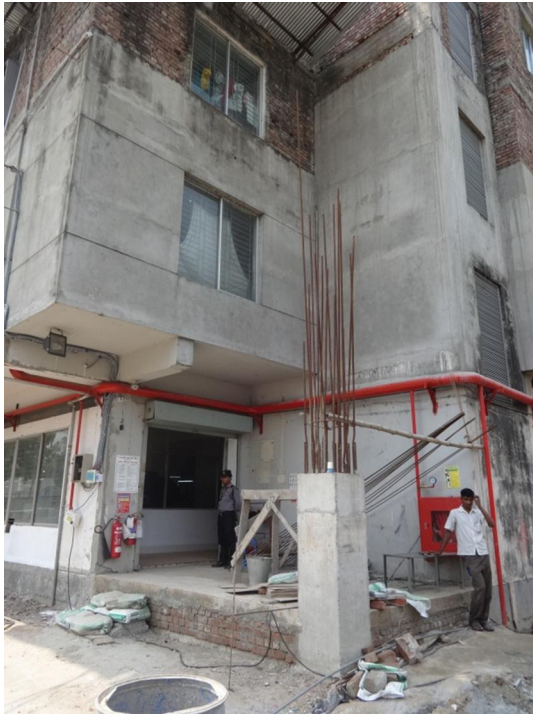
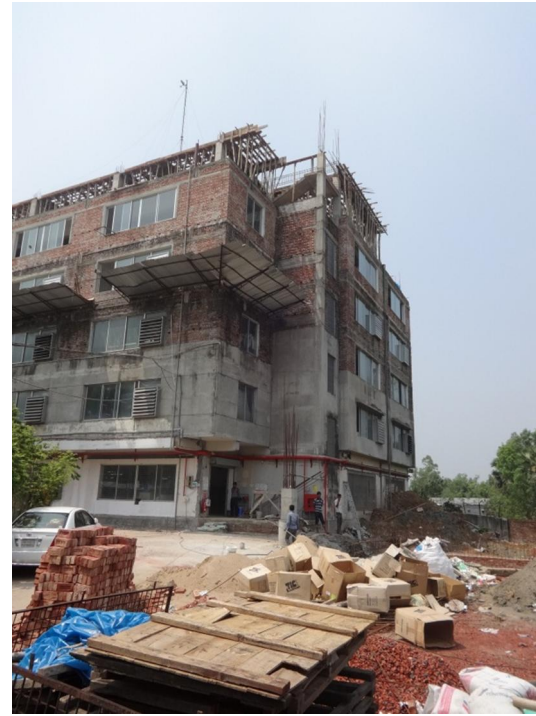
Staircase in South West corner of building did not match with construction drawings. Construction of corner infill with new staircase did appear to be under construction. Present cantilevered beams will have to be broken out so rebar can be fixed correctly as the new beams will span between columns.

Priority 1 Concern:  
The SW corner  
staircase has not  
been built in the  
correct location.

South West corner staircase not built in accordance with drawings..

- Update drawings to show present state.
- Ensure concrete cantilevers are broken out to allow rebar to be lapped when new beams are formed to make new staircase.

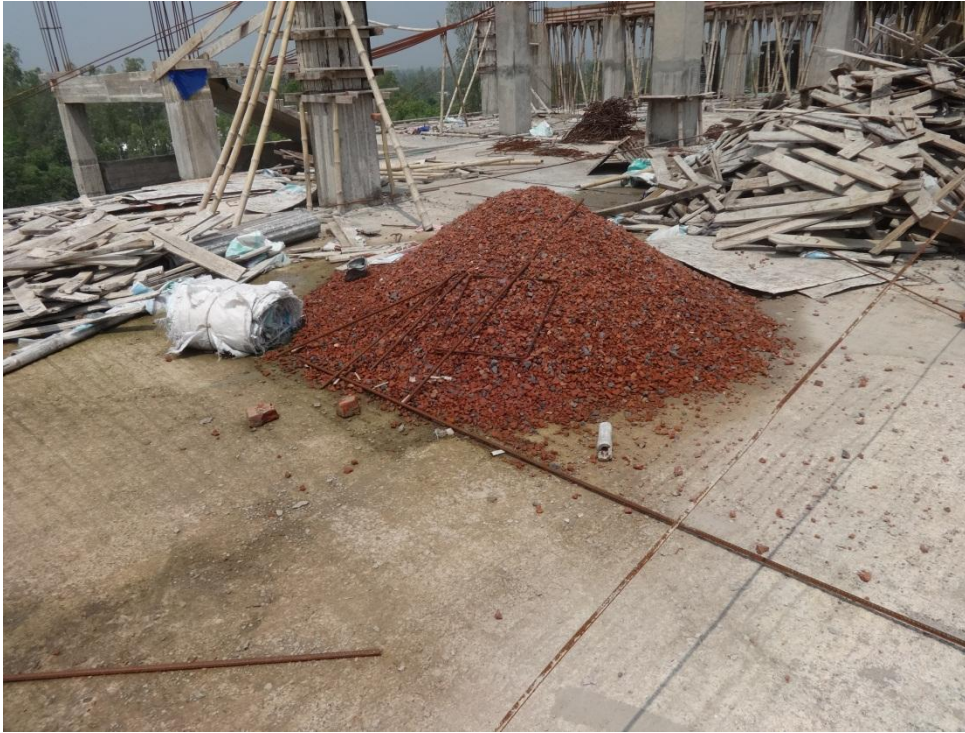
Brick aggregate and other construction materials are being stored on the roof.

Brick aggregate and other construction materials stored on present fifth floor (roof).

Priority 2 Concern

Stored building materials on roof.

- Remove all stored items from the roof. Do not store heavy building materials on the roof in future.

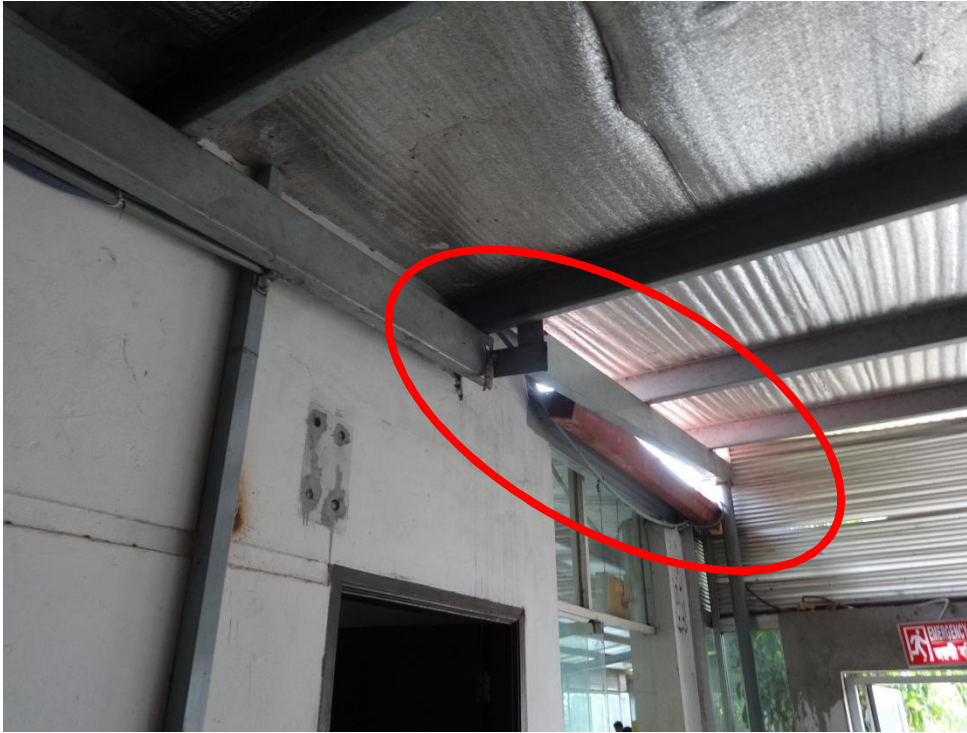
Poor steel connection details on the outhouse roof

Poor steel connection details between sheds one and two.

Priority 2 Concern

Inadequate steel connection details on purlin connections between sheds two and three.

- Carry out an engineering assessment to determine the extent of remedial works required.

- Carry out remedial works, strengthening beams and connections where required.

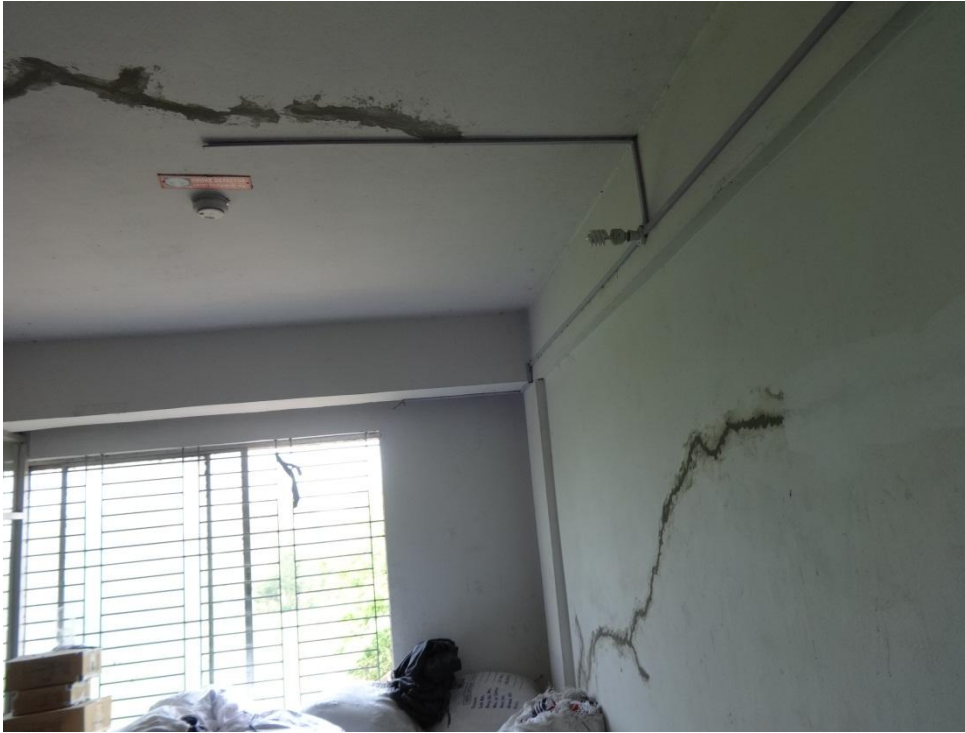
Cracks in slab and wall on the North side of the building

Cracks to the soffit of the slab and wall under an area being used for storage at present.

Priority 2 Concern

Cracks to soffit of slab and walls

- Carry out an engineering assessment to determine the capacity of the slab and the current loading.

- Display and manage loading plan to all floors.

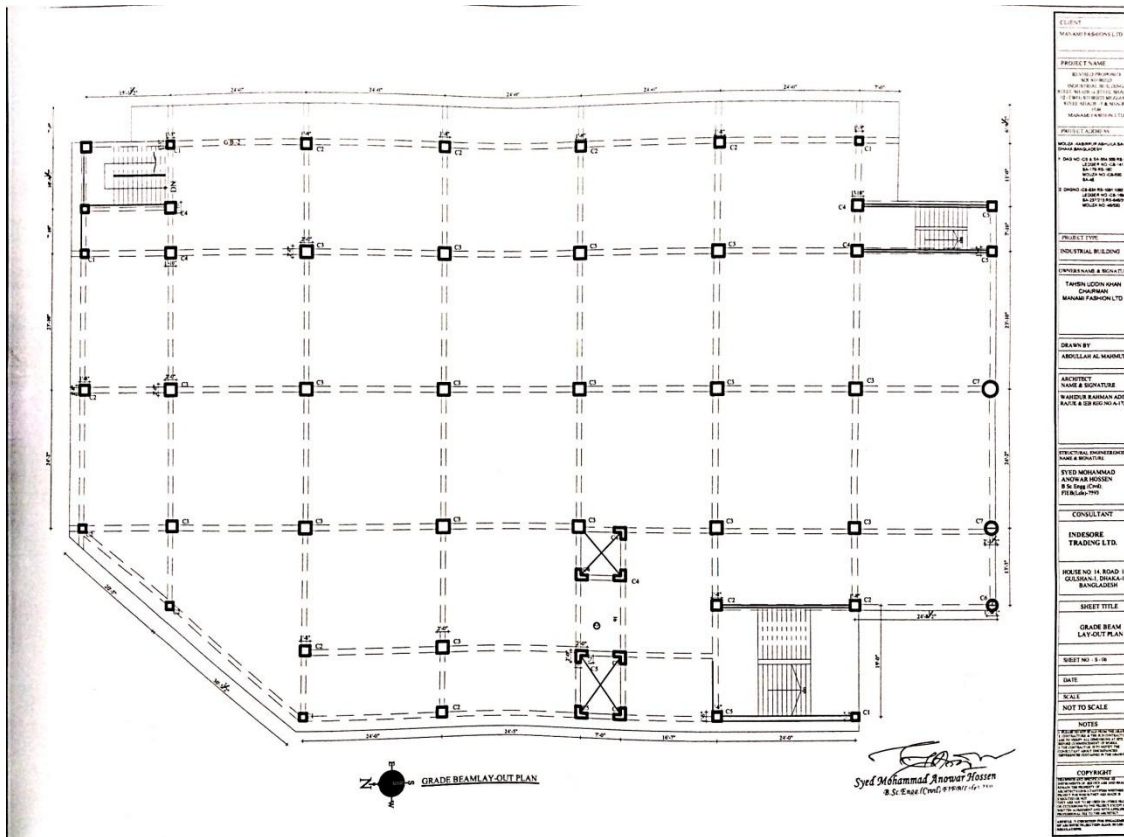
The building did not appear to have any shear walls. The stairwell walls, brick infill's, are all in the North-South plane

At present stability will be gained through partial sway frame action and masonry walls.

We require that these items be investigated in a Detailed Engineering Assessment

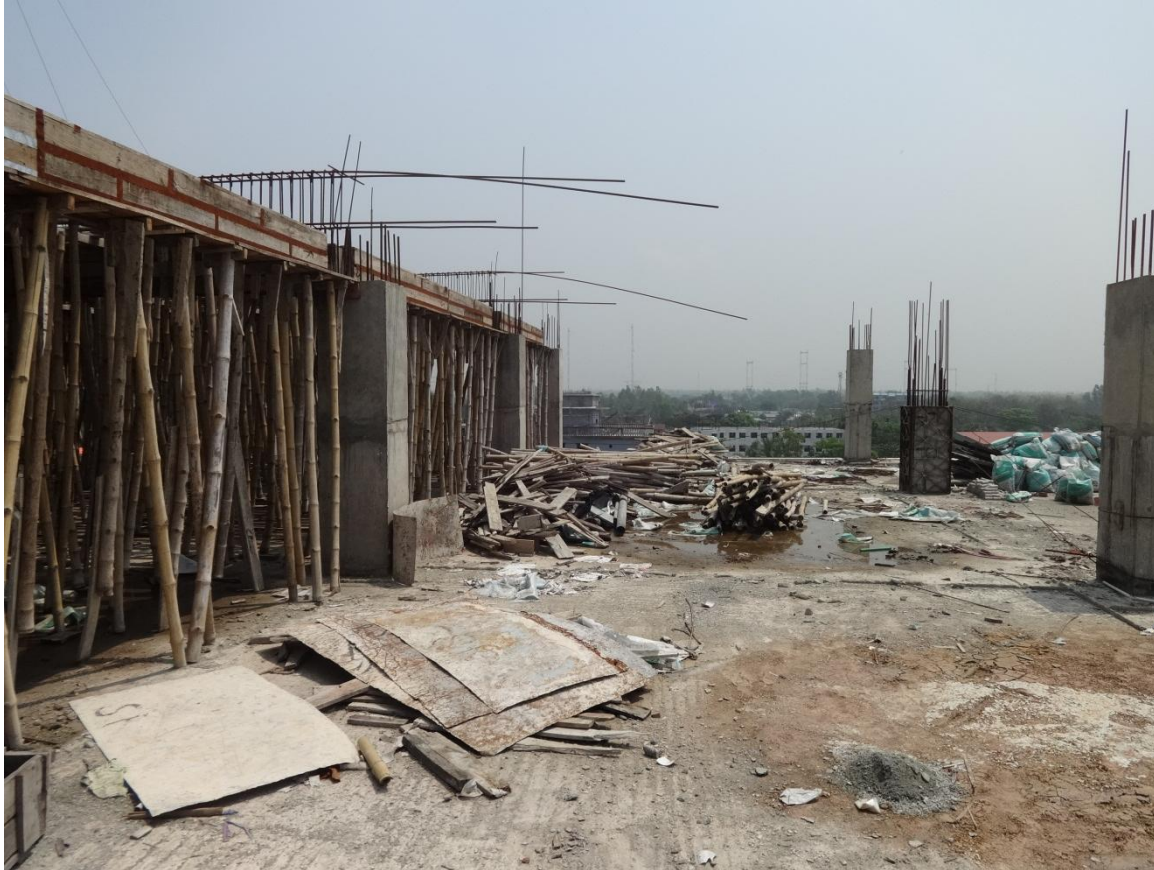
No waterproofing membrane was visible on the roof of the building. This means that any cracks in the surface finishes on the roof will allow water to seep into the concrete slab beneath the finishes, and cause long-term soaking of the slab. However the existing roof is temporary as an extra story is being built. The new roof should have a membrane.
