# Belamy Textiles Ltd. Golden Son Ltd

Khowaz Nagar, Azimpura, Karnafuli, Chittagong  
18 MARCH 2014

# Observations

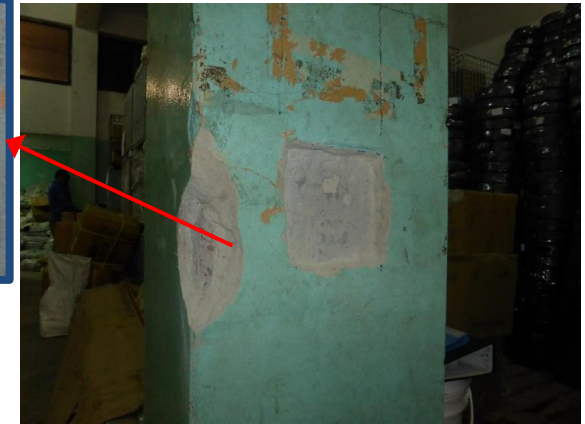
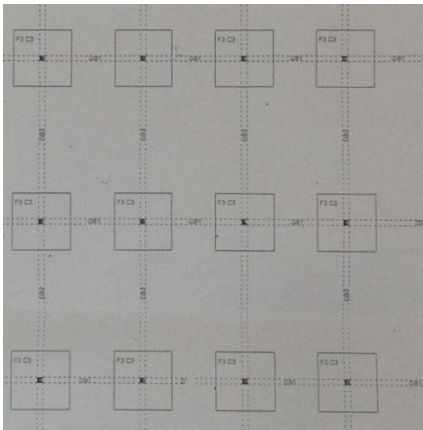
Outline calculations indicate column working stress is at high risk level.

Column sizes observed smaller than shown on structural drawings.

Observed as 380mm x 300mm vs 510 sq. according to design drawings.

Engineer is to perform detailed calculations and concrete tests to prove column size and (if required):

- Reduce loads by vacating floors and removing additional structures
- Reinforce columns

| Item No. | Observation | Recommended Action Plan | Recommended Timeline |
|---|---|---|---|
| 1 | High working stress observed in columns<br>See Executive Summary for further Immediate Actions regarding Live Load reduction | Factory Engineer to review design, loads and columns stresses for all columns | Immediate - Now |

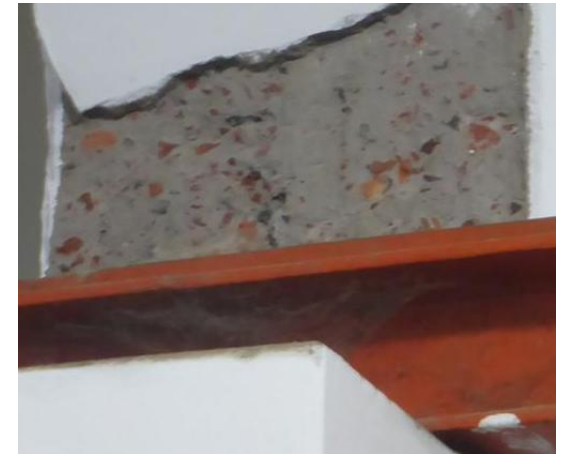
Brick Aggregate Observed

Highly stressed column

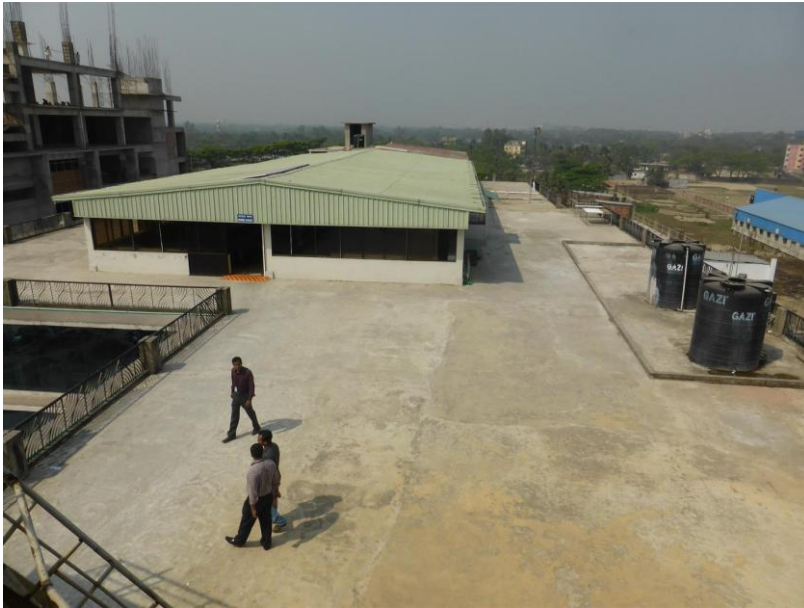
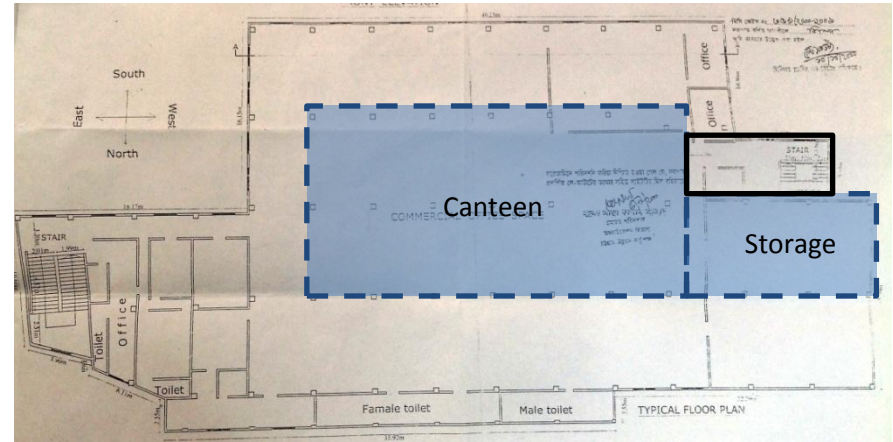
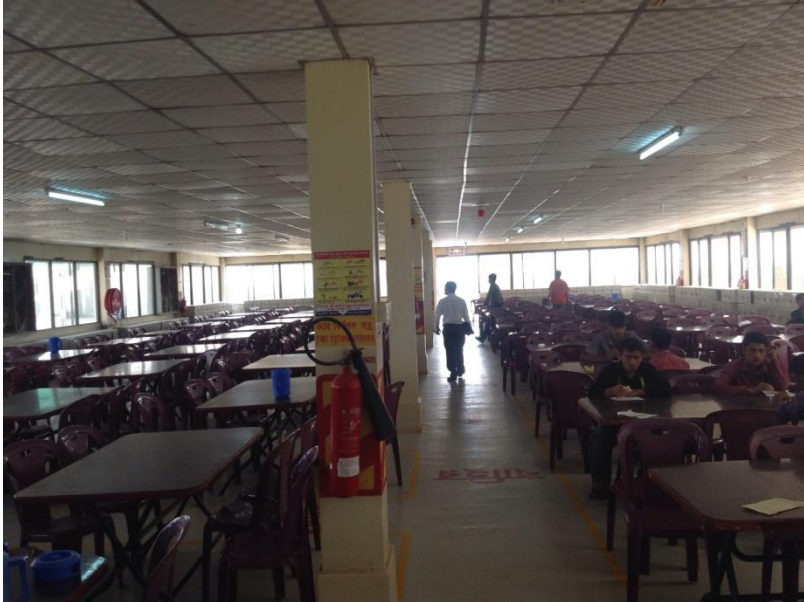
**Vertical extension on roof comprising lightweight steel trussed roof on concrete columns with brick masonry and glass infill.**

**No structural or design documentation provided for extensions.**

| Item No. | Observation | Recommended Action Plan | Recommended Timeline |
|---|---|---|---|
| 10 | Engineering Assessment of vertical extension for canteen on roof and additional loading from new adjoining building | Building engineer to verify structural design of additional structures. | 6-weeks |

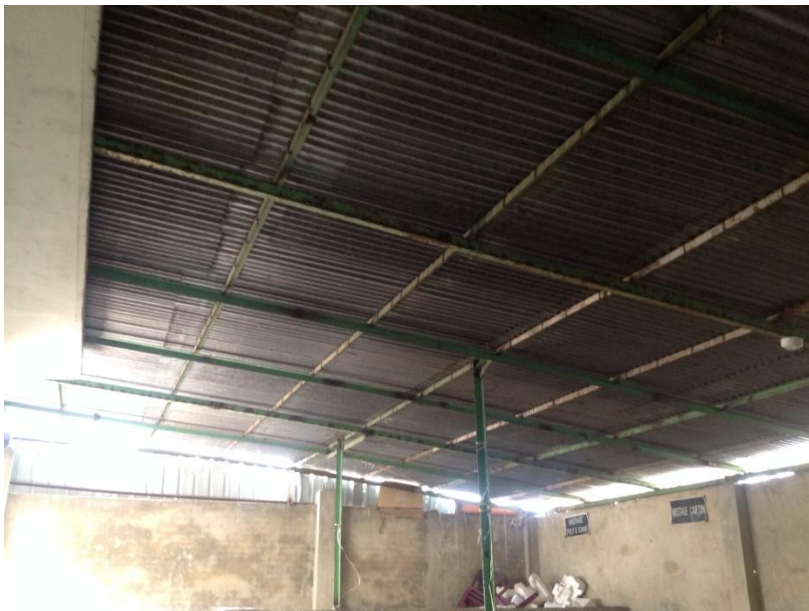
**Lightweight steel structure, not on permit plans, subject to wind uplift.**

**Adequacy of tie-downs and lateral stability need to be assessed by Building Engineer.**

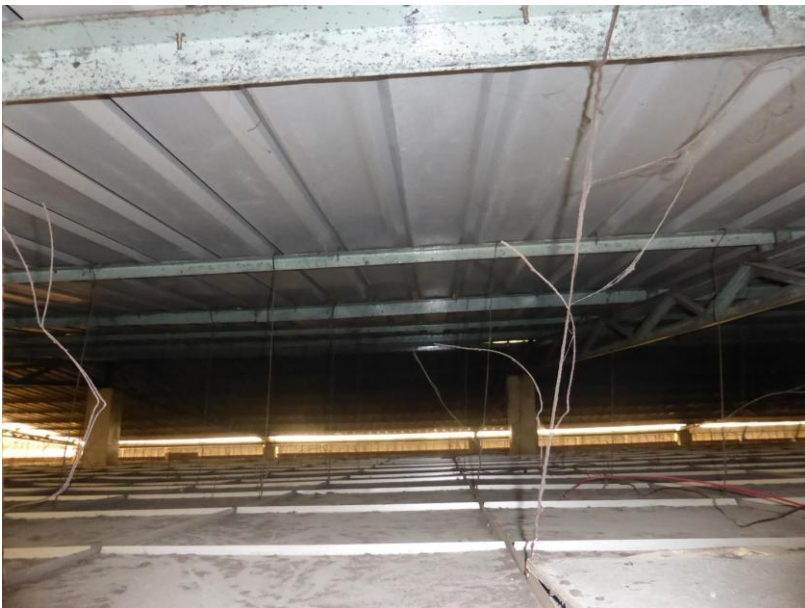
**Check on roof additions required**

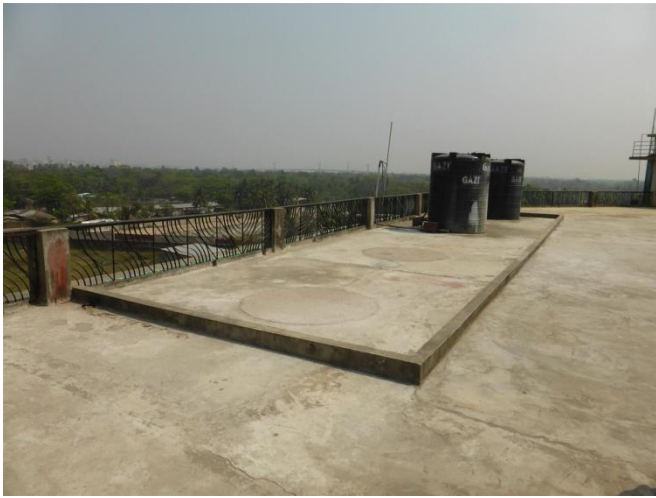
**Water tanks at roof level**

**Areas of high loading on structure.**

| Item No. | Observation | Recommended Action Plan | Recommended Timeline |
|---|---|---|---|
| 13 | Localised areas of high loading | Reduce loading on areas highlighted for immediate action as per item 1 | Immediate - Now |
| 14 | Localised areas of high loading | Create controlled loading plans for all floors, designating where storage can / cannot be placed, taking the findings of the DEA and of Item 1 into account | 6-weeks |

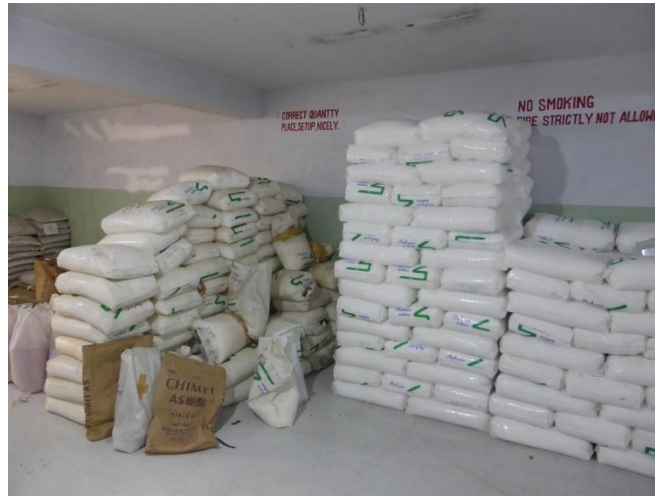
**Materials Store – 1<sup>st</sup> Floor**

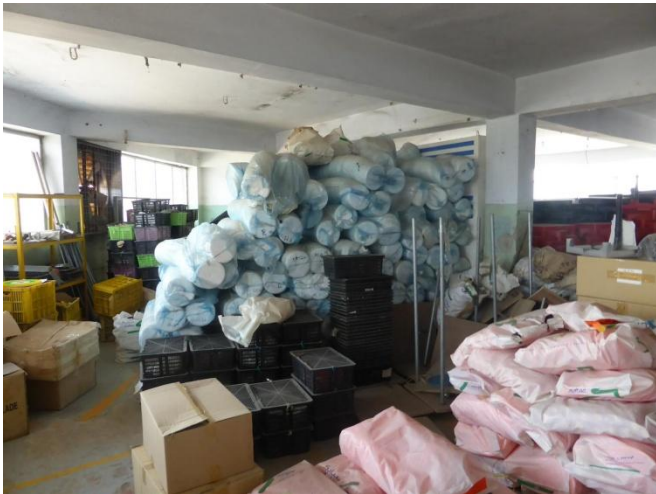
**Storage of Material Rolls**

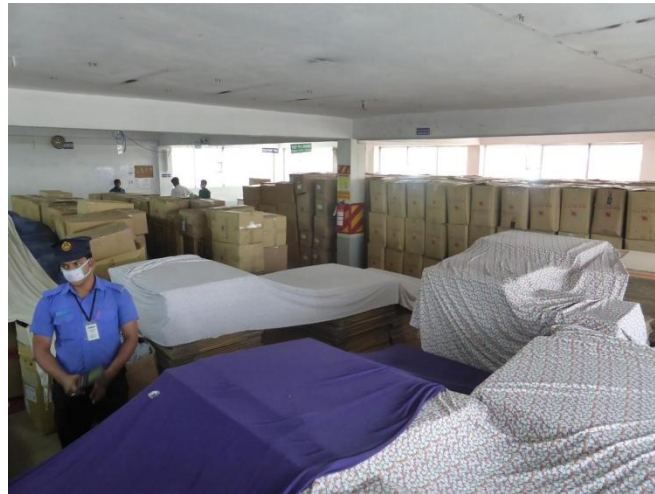
**Packaged Clothing**

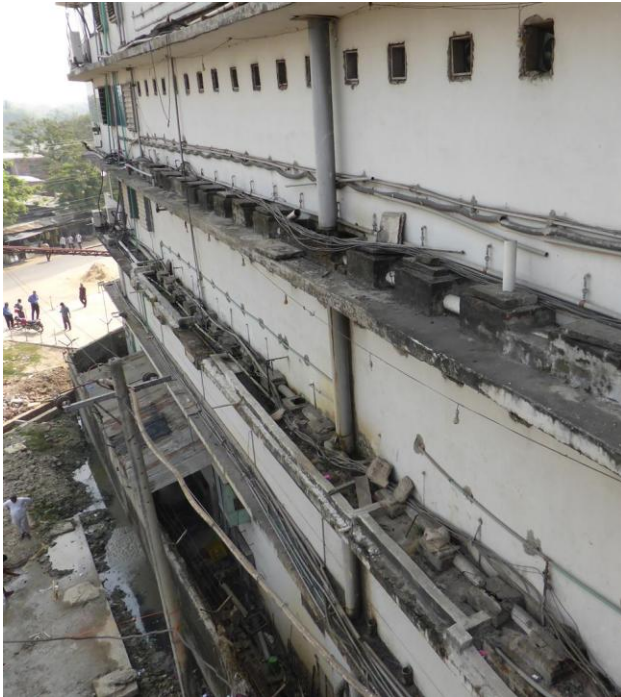
## High loading at facade line along the toilet blocks

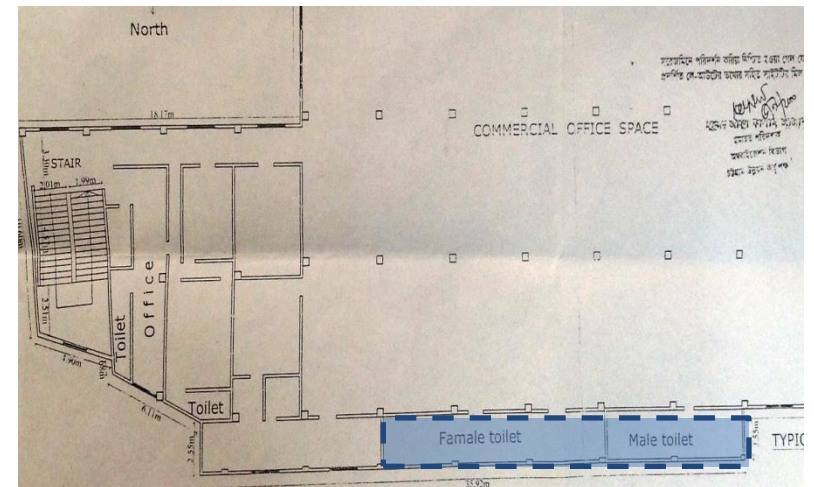
## Increased floor build-up and partition loads in toilets

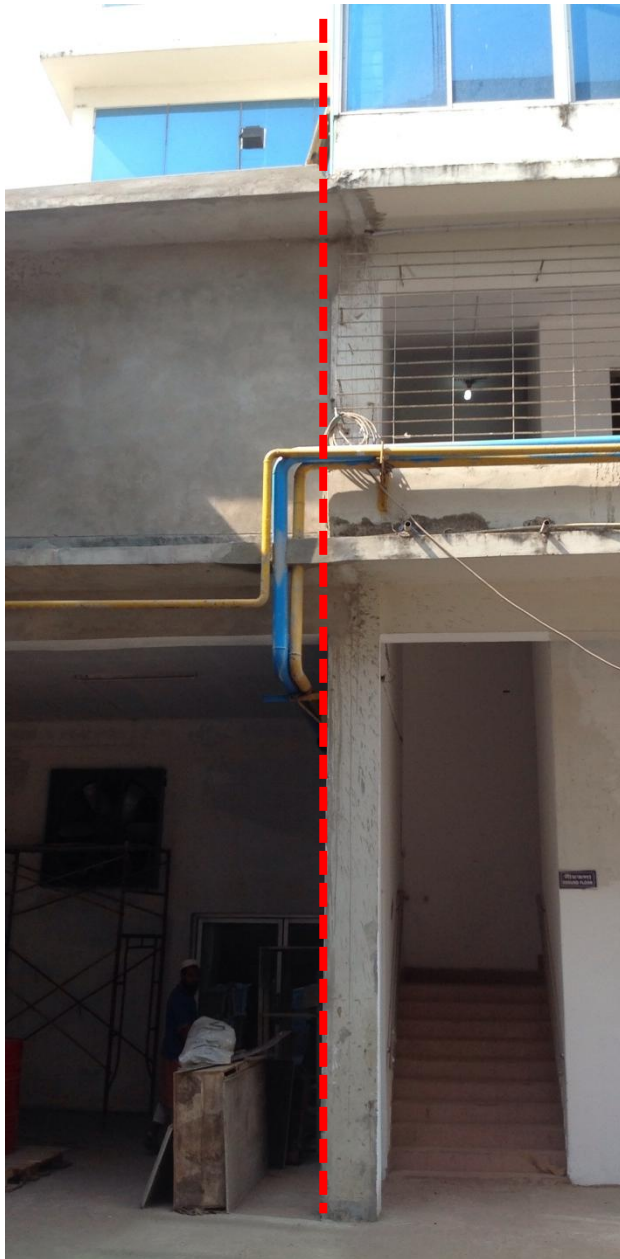
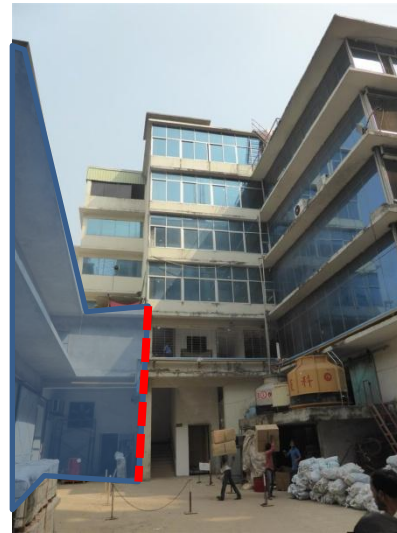
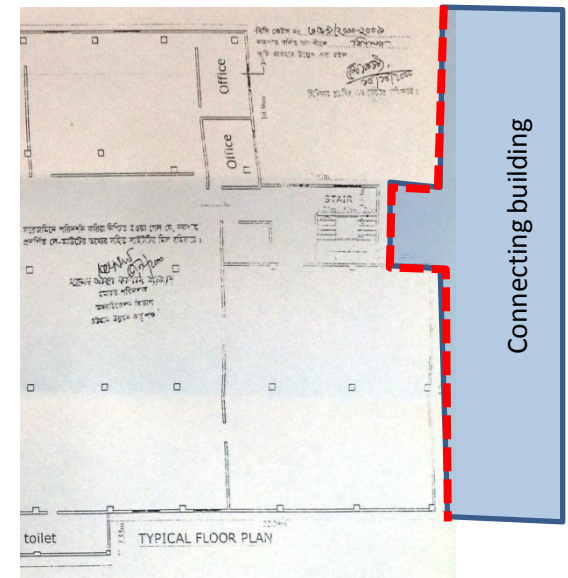
**No structural or design documentation provided for connected neighbouring building.**

**Shared columns between the extension and factory.**

| Item No. | Observation | Recommended Action Plan | Recommended Timeline |
|---|---|---|---|
| 11 | Engineering Assessment of vertical extension for canteen on roof and additional loading from new adjoining building | The Building Engineer should check the load plans and confirm that the main building structure is capable of safely supporting the additional structures, to ensure no over-loading | 6-weeks |

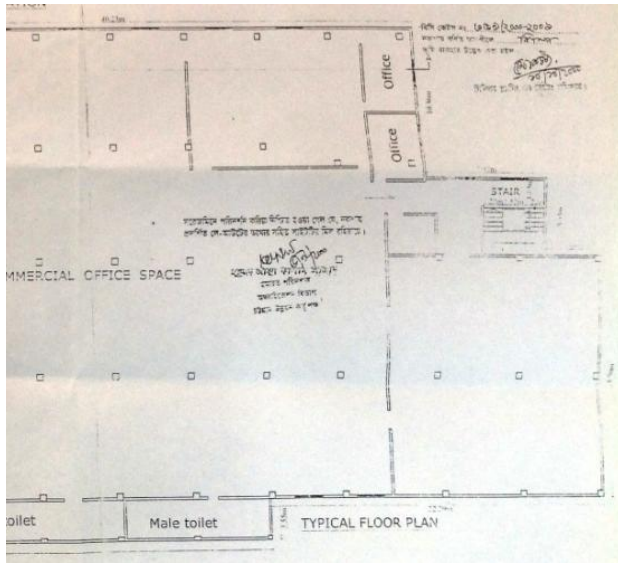
**Floor layout as per design documentation.**

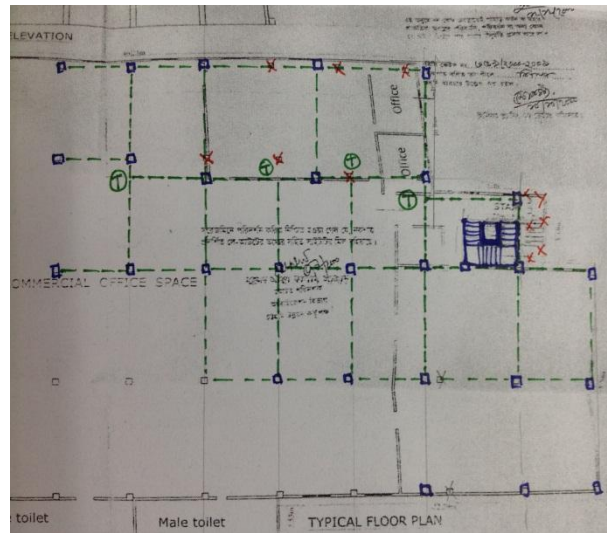
**Observed floor layout**

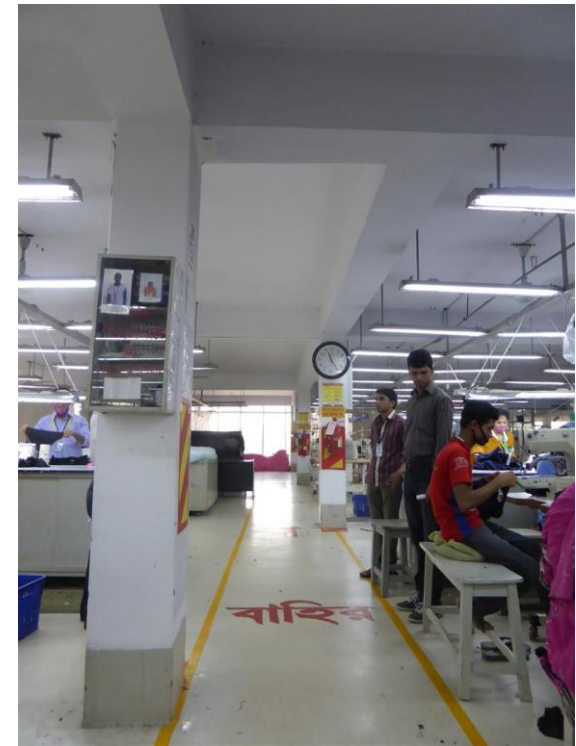
**Design drawings are not consistent with the as-built structure.**

**Differences in column locations and beam arrangement.**

**Floor beam acts as structural beam to transfer the reaction from the orthogonal floor beam to the column positions in a number of locations.**

| Item No. | Observation | Recommended Action Plan | Recommended Timeline |
|---|---|---|---|
| 19 | Modifications to building structure not reflected on the design documents (including double height space, gantry crane support & change of column size) | Building engineer to check, collect information and produce accurate and complete as-built documentation | <b>6-weeks</b> |

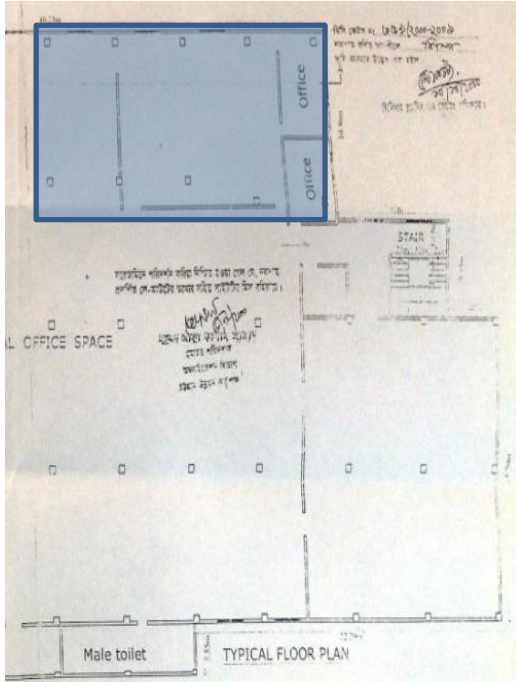
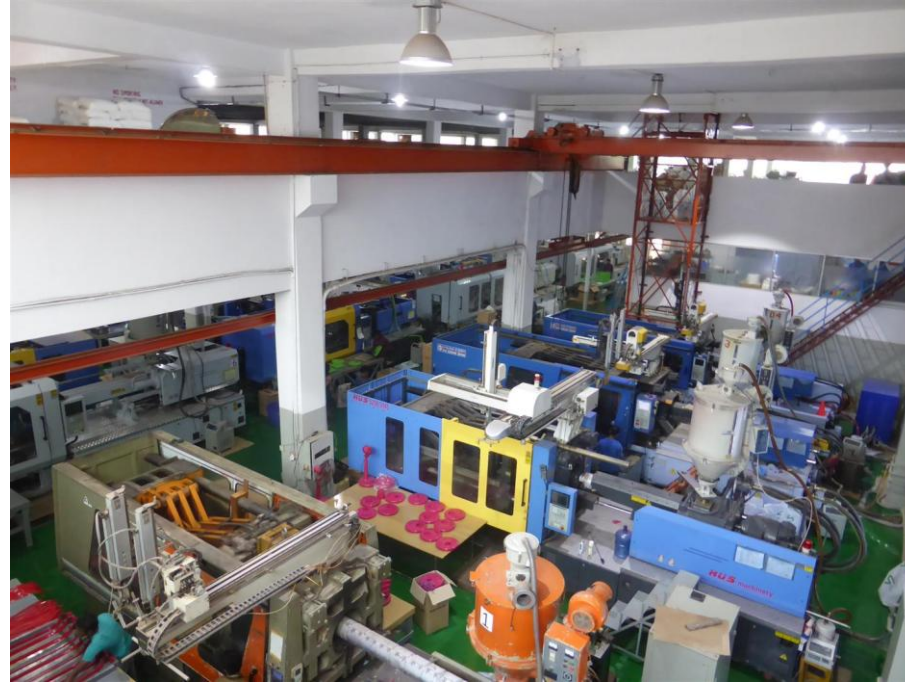
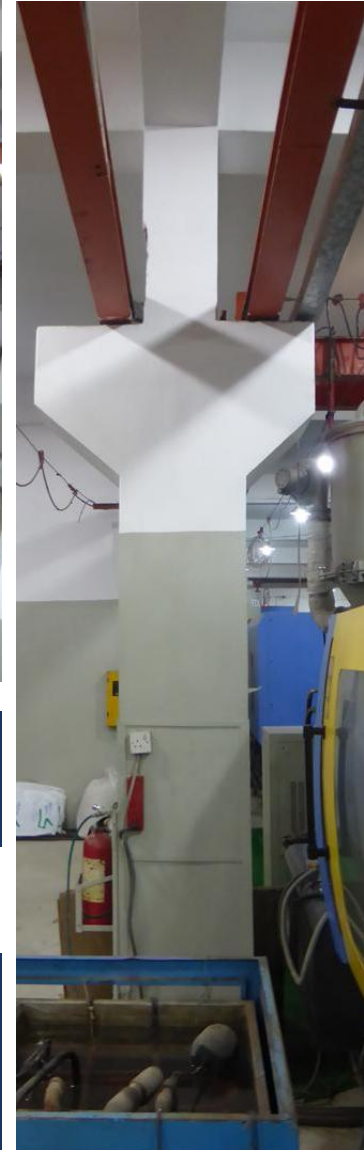
**Undocumented double-height space from ground level inconsistent with structural drawings.**

**Crane beams supported on column corbels in a number of locations on ground floor.**

| Item No. | Observation | Recommended Action Plan | Recommended Timeline |
|---|---|---|---|
| 18 | Modifications to building structure not reflected on the design documents (including double height space, gantry crane support & change of column size) | Slabs, Beams and supporting Columns that differ in load condition and span from original design to be assessed by the building engineer. | <b>6-weeks</b> |

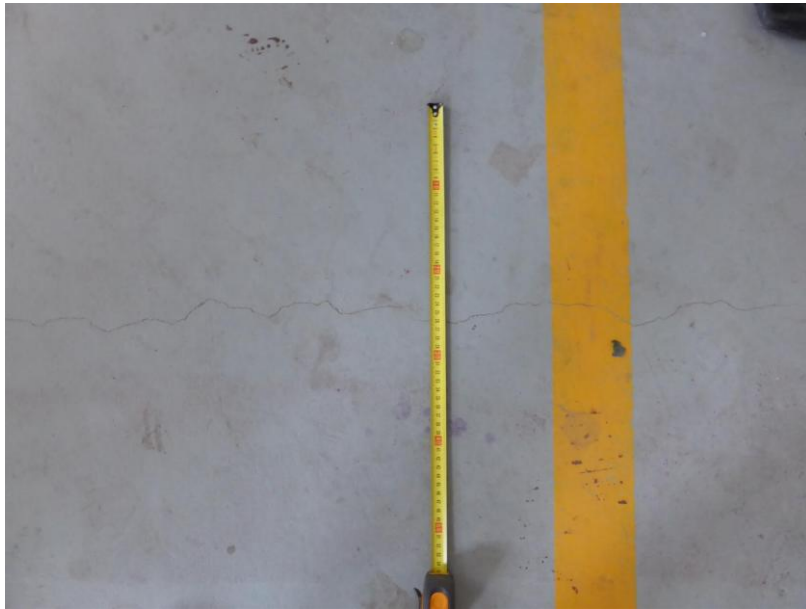
**Cracking on surface at a number of locations above long-spanning beams.**

**Cracks run parallel to beam span.**

| Item No. | Observation | Recommended Action Plan | Recommended Timeline |
|---|---|---|---|
| 22 | Cracking observed on structural elements | Sections of plaster finish and screeds to be removed to investigate if cracks penetrate into the building structure. | 6-weeks |

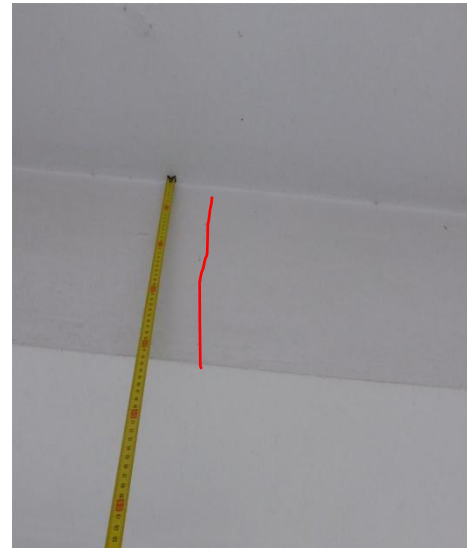
**Vertical cracking on a number of beams.**

**Evidence that selected beams have been recently decorated at locations consistent with cracks observed.**

| Item No. | Observation | Recommended Action Plan | Recommended Timeline |
|---|---|---|---|
| 23 | Cracking observed on structural elements | Verify that beam/slab has sufficient capacity to support applied load and structural arrangements | 6-weeks |

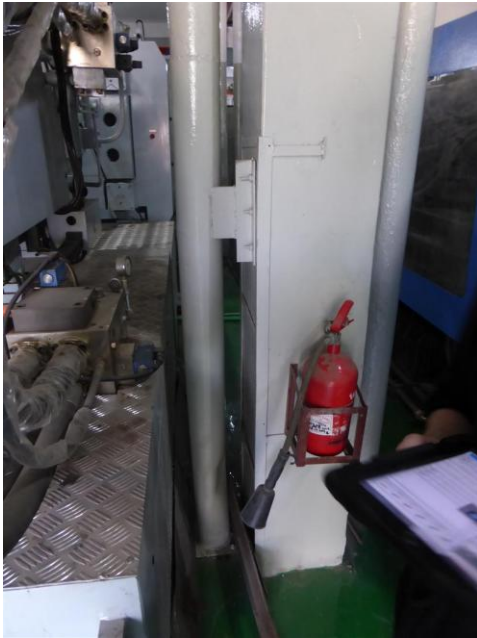
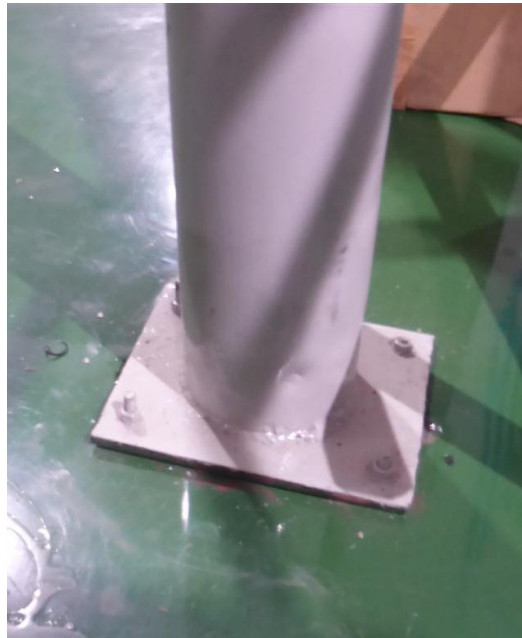
**Crane beam structure stabilised from beam and column elements.**

**Posts fixed directly to ground floor slab**

| Item No. | Observation | Recommended Action Plan | Recommended Timeline |
|---|---|---|---|
| 31 | Crane structure stabilised from structural elements | Building Engineer to verify that structural elements used to support the gantry crane have adequate structural capacity and stiffness for the applied loading | <b>6-weeks</b> |
