Shagore Garments Ltd. Optimum Garments Ltd.

Amir Complex, Plot 43, Sector 3, Uttara, Dhaka
(23.867624, 90.399812)
10th March 2014

Observations

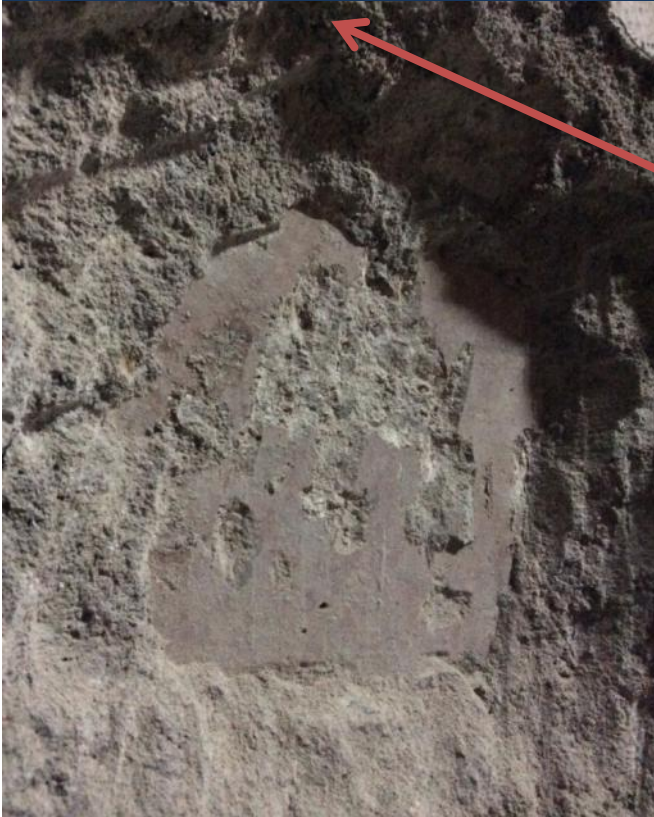
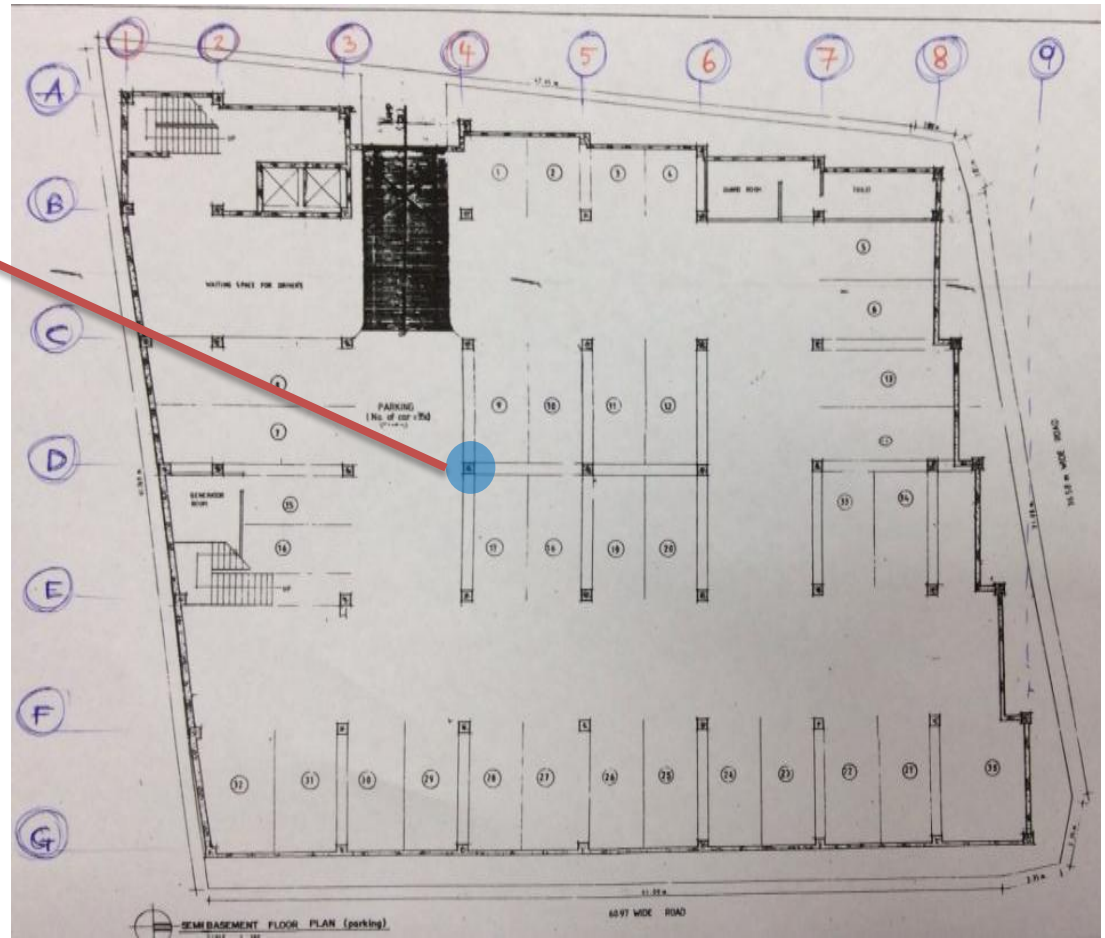
Column strengths

Building column tested

Stone aggregate

Design drawings are in good agreement with as-built structure. Opening up confirms aggregate type is stone throughout, and scanning on several columns indicates but cannot conclusively confirm high levels of reinforcement in agreement with drawings. Cursory calculations indicate working stress in the columns may be higher than designed for.

Item No.	Observation	Recommended Action Plan	Priority
1	Concrete Stress Levels in Columns	Remove loading from the area noted at levels 4,5,6,7,8 and 10 and ensure that these areas remain unoccupied. Retain the current unoccupied status of Level 3.	Immediate-Now
2	Concrete Stress Levels in Columns	Factory Engineer to review design, loads and columns stresses in all columns.	Immediate-Now
3	Concrete Stress Levels in Columns	Verify stress grade of reinforcement at Basement and Ground Floor by exposing steel in lightly loaded column. Verify insitu concrete strength either by 100mm diameter cores or existing cylinder strength data for cores from 4 columns.	Immediate-Now
4	Concrete Stress Levels in Columns	A Detail Engineering Assessment of Factory to be commenced, see attached Scope.	Immediate-Now
5	Concrete Stress Levels in Columns	Produce and actively manage a loading plan for all floor plates within the factory giving consideration to floor capacity and column capacity.	6-weeks

6	Concrete Stress Levels in Columns	Detail Engineering Assessment to be completed.	6-weeks
7	Concrete Stress Levels in Columns	Continue to implement load plan	6-months
8	Cracking in Beams supporting Levels 6,7 and 8	Engage an Engineer to investigate if cracks are only in the nominal render finish, in conjunction with the DEA	6-weeks
9	Cracking in Beams supporting Levels 6,7 and 9	If cracks are structurally significant, remove all items above the slab and close working areas below the affected areas . Engage an engineer to specify repairs and strengthening of the slab if necessary.	6-weeks

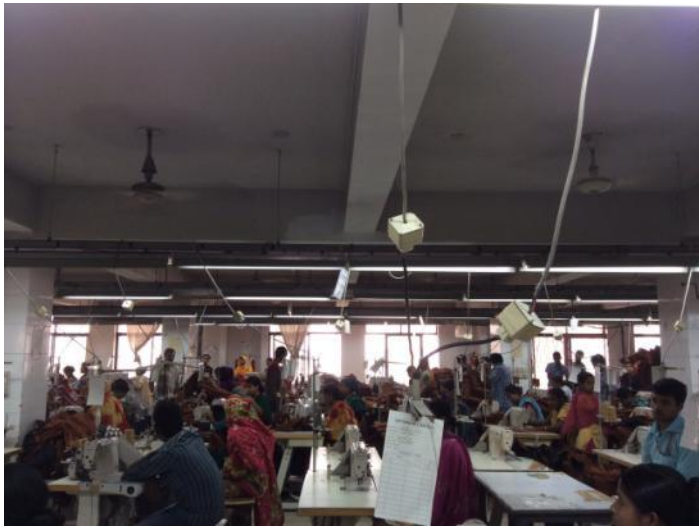
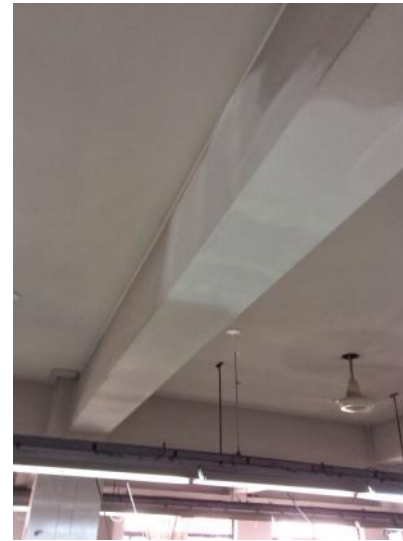
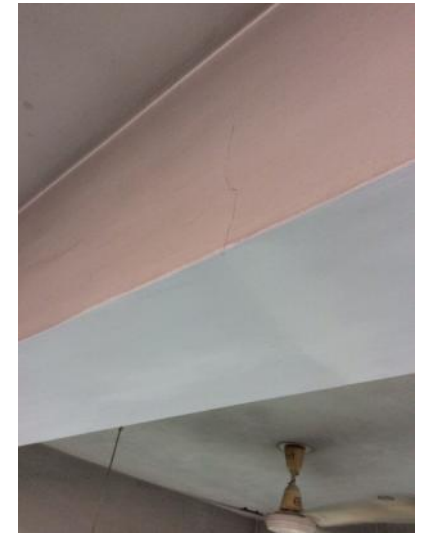
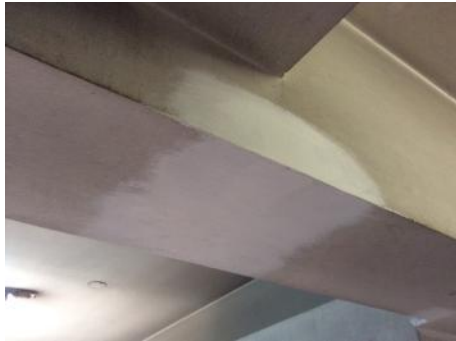
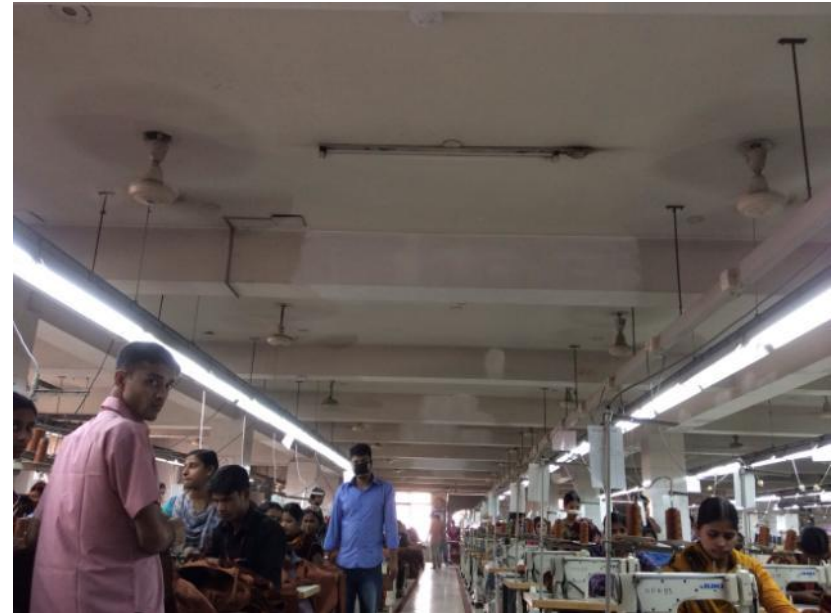
Cracking in beams and slabs

Cracking to undersides and side of beams particularly on L7 but also on other levels. Cracks have been repainted in most locations. Building Engineer to check cracks in beams and define a repair system, if required.

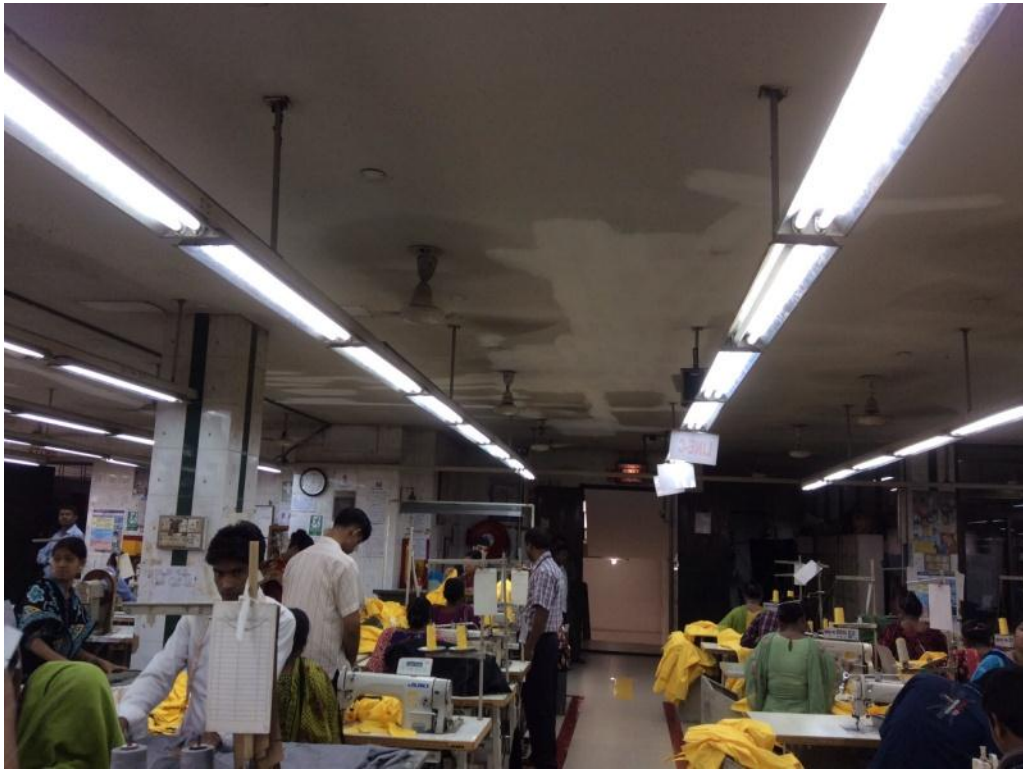
Cracking in downstand beams

Cracking in flat slabs on underside of level 9

Item No.	Observation	Recommended Action Plan	Priority
10	Cracking in soffit of slab at Level 9	Engage an Engineer to investigate if cracks are only in the nominal render finish, in conjunction with the DEA	6-weeks
11	Cracking in soffit of slab at Level 9	If cracks are structurally significant, remove all items above the slab and close working areas below the affected areas . Engage an engineer to specify repairs and strengthening of the slab if necessary.	6-weeks
12	Storage loading at Levels 4,5,6,7,8 and 9	The Structural Engineer should check the capacity of the slab floors and columns against the design loading.	6-weeks
13	Storage loading at Levels 4,5,6,7,8 and 9	A Detail Engineering Assessment of Factory to be completed.	6-weeks
14	Storage loading at Levels 4,5,6,7,8 and 9	Produce and actively manage a loading plan for all floor plates within the factory giving consideration to floor capacity and column capacity.	6-weeks

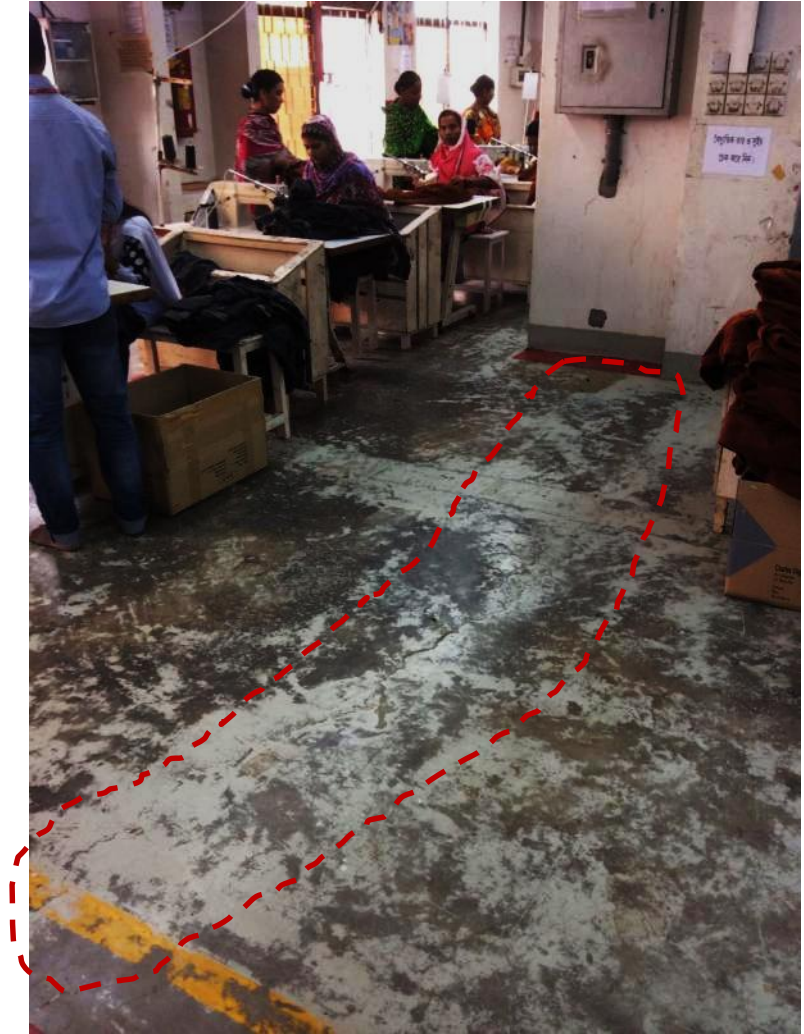
Cracking in slabs

Cracking to tops of slabs e.g. on 6th floor

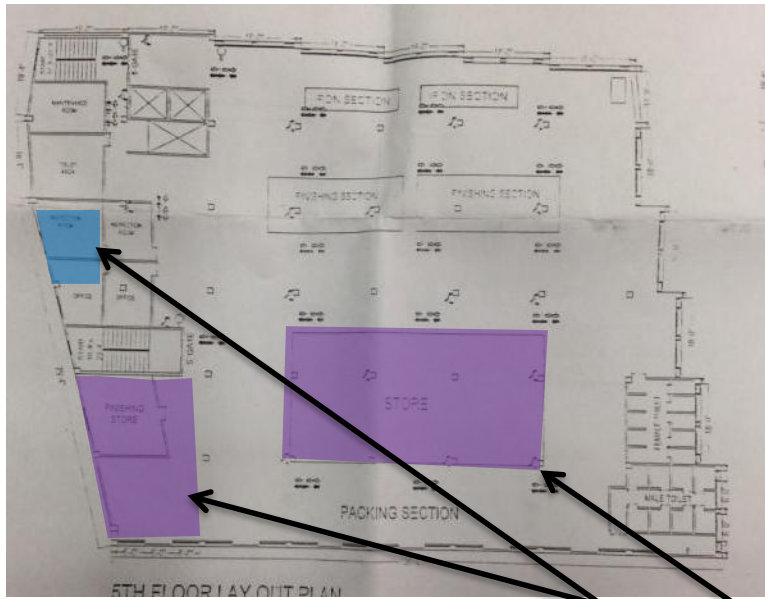
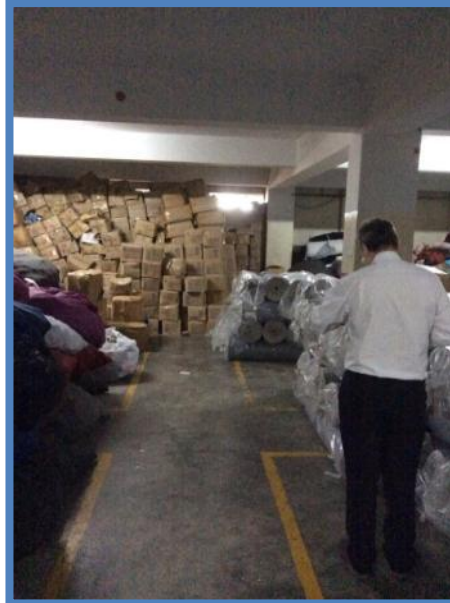
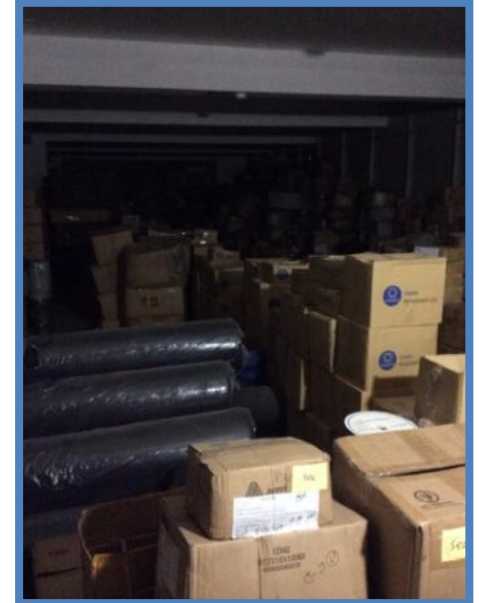
Floor loading – storage areas

High live loads arising from storage loads and additional tanks e.g. in kitchen area. Selected examples shown below.

Storage areas in the same plan location on most levels

Some kitchen areas with additional tanks on some levels

Loading plans (i.e. plan and height restrictions) to be introduced to prevent future overloading – to be developed by building engineer

15	Storage loading at Levels 4,5,6,7,8 and 9	Continue to implement load plan.	6-months

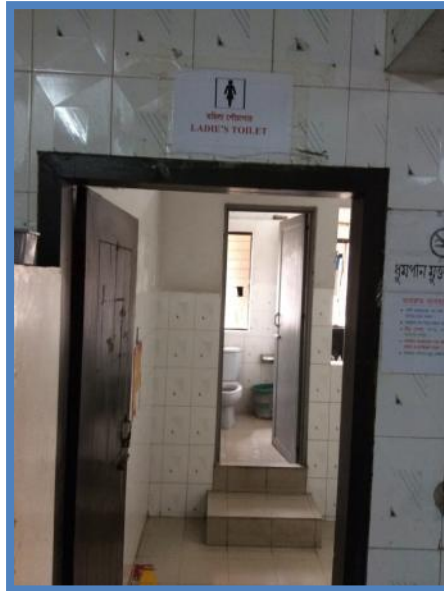
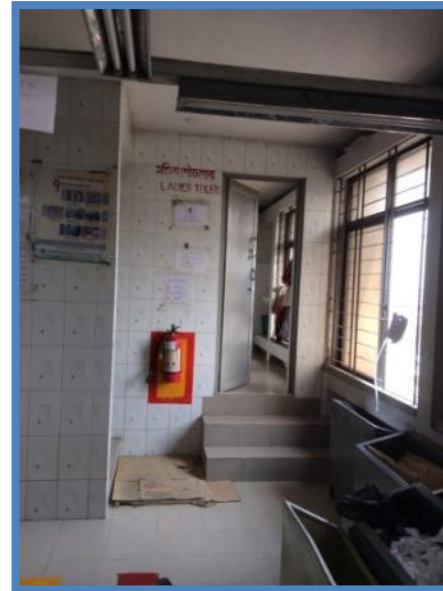
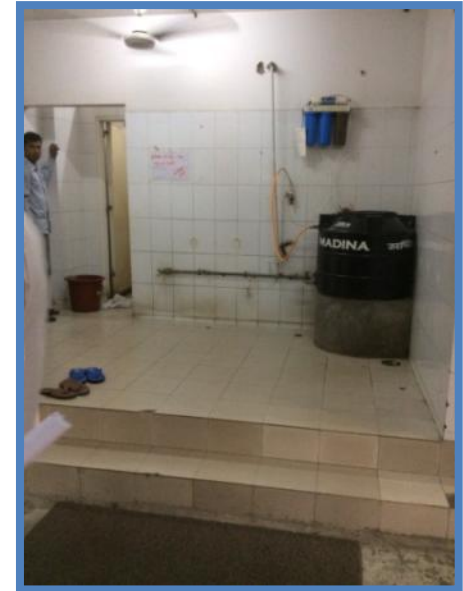
High loads arising from heavy toilet floor build-up, up to 500mm thick

Heavy toilet build-up in these locations on most floors

Item No.	Observation	Recommended Action Plan	Priority
16	Check on Column and Slab stresses due to high loading in toilet areas.	Building's Engineer to ensure the structure is not loaded beyond capacity by the high loading from high build up in toilet areas.	6-weeks
17	Check on Column and Slab stresses due to high loading in toilet areas.	Building Engineer to create controlled loading plans for all floors.	6-weeks
18	Check on Column and Slab stresses due to high loading in toilet areas.	Continue to implement load plan.	6-months
19	Large water tank over stair core in southwest corner of building	Building's Engineer to ensure the structure is not loaded beyond capacity by the high loading from high build up in toilet areas.	6-weeks
20	Large water tank over stair core in southwest corner of building	Building Engineer to create controlled loading plans for all floors.	6-months
21	Structural drawings are not in agreement with the arrangement of the building structure	Building engineer to carry out as built survey of the building, collect and produce accurate complete as-built drawings as part of Detail Engineering Assessment	6-weeks

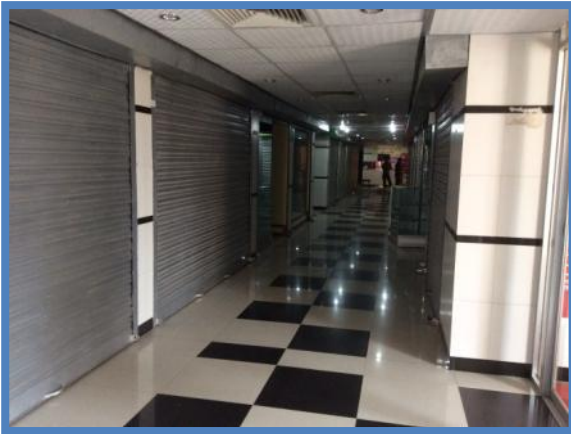
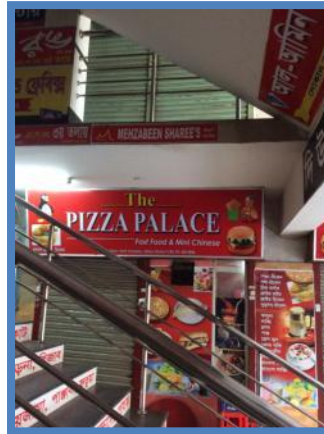
Floor loading – market floors

Dense layout of solid masonry partition walls throughout market area, with possibility of high storage loads once all levels fully occupied

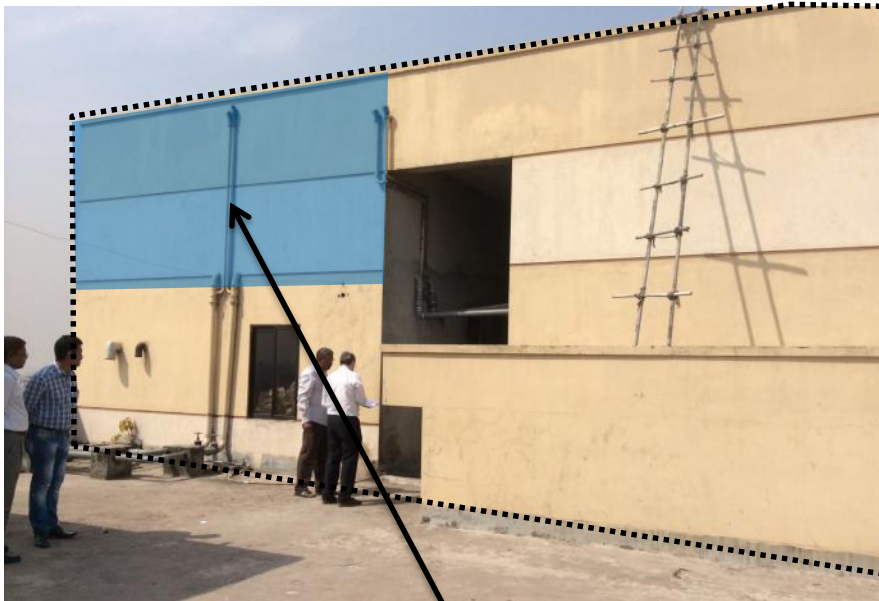
High tank loading on roof levels

Water tank height 2.3m over bay of stair core = 23kN/m²

Large concrete water tank over stair core not shown on drawings adds significant load to supporting structure

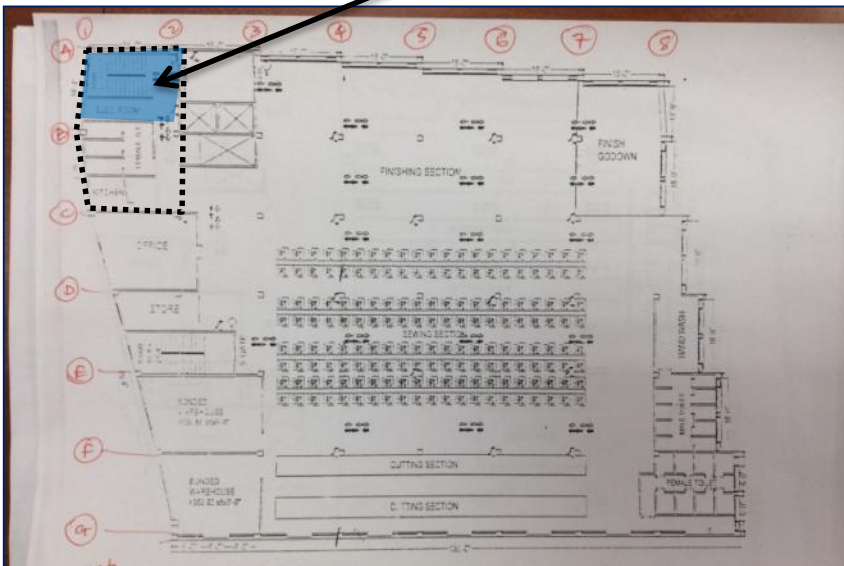
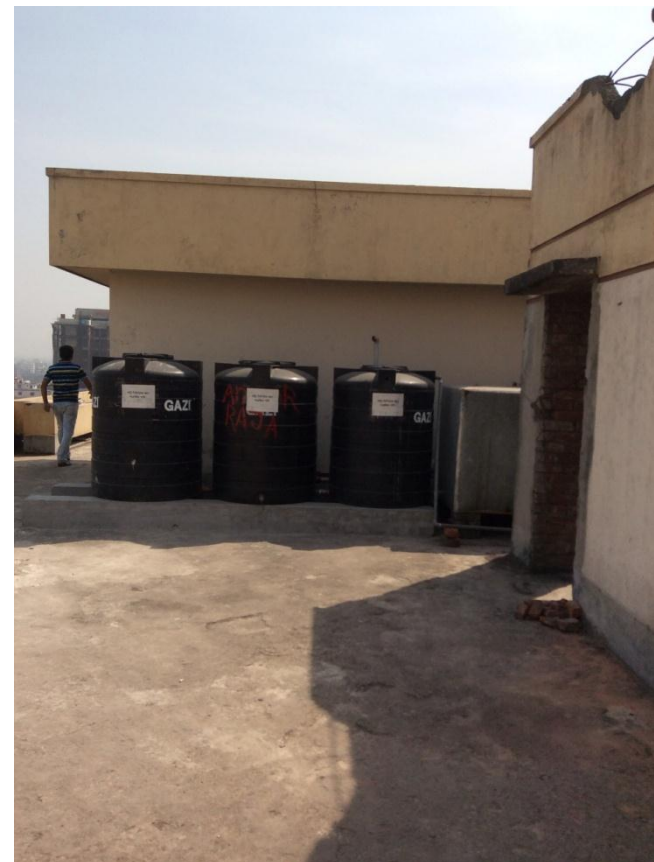
Other significant loading also arises from a group of plastic tanks at roof level

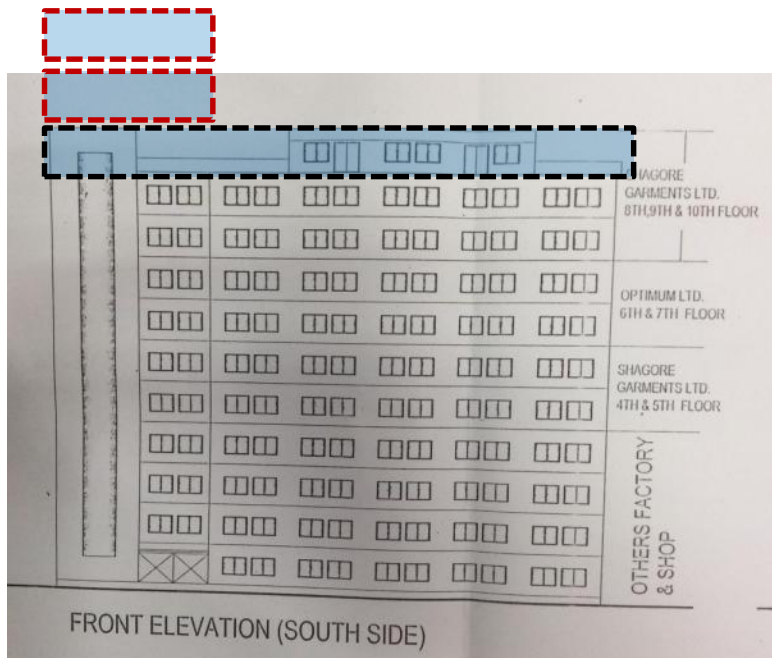
Drawings do not match structure as-built

L10 built completely rather than partially as shown on drawings and additional floor levels built above L10 in localized areas

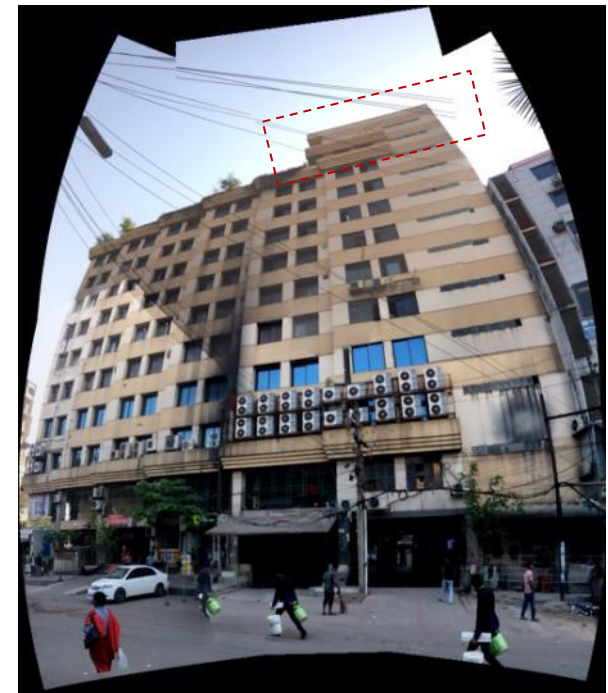
Structure switches from beam and slab to flat slab only at L9

The drawings do not match the as built structure in several locations. For example, additional floors have been added locally above the stair and lift cores, and the structural system changes at a higher level than the drawings indicate.
