# KNIT Concern Ltd. (9499)

No. 62, Water Works Road, Godnail Narayanganj – 1400, Dhaka Division, Bangladesh  
(+23.641536N, +90.514255E)

07.APRIL.2014

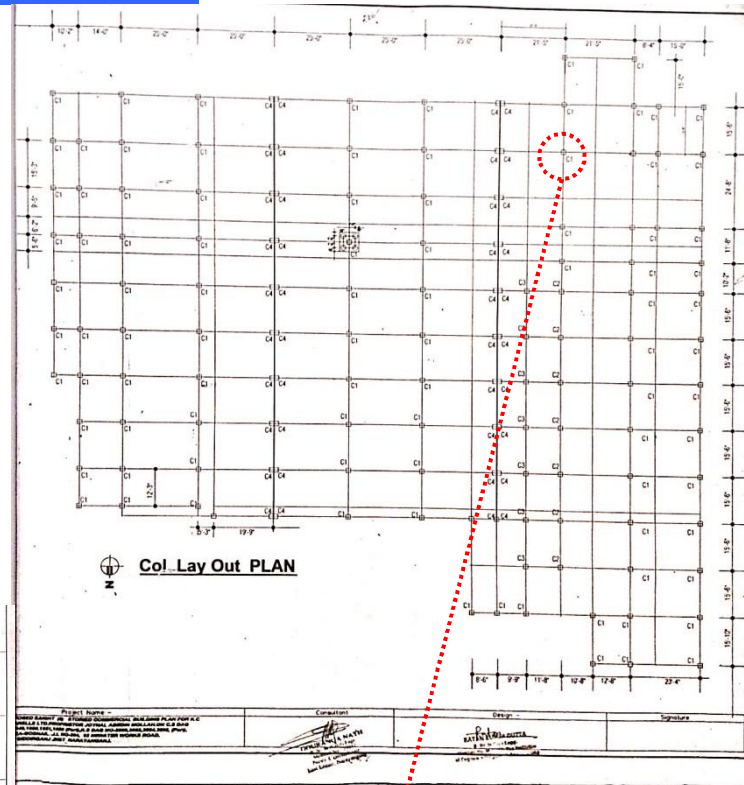
Column to be checked

Based on the load rundown analysis with the agreed minimum design live load assignment, the column in the clouded area seems significantly inadequate to carry the dead and live loads, giving a firm AMBER warning. The building was constructed before 2005, with brick aggregate.

**ITEM 1: (1<sup>st</sup> Priority 2) One column mentioned above has been found to possess insufficient loading capacity.**

There is one column has been found to possess insufficient loading capacity.

- Reduce the loads on all levels at the mentioned column location.
- Building engineer to review the design of the highlighted column.

- Cores should be taken to verify the actual in-situ concrete strength, to allow a review the design.

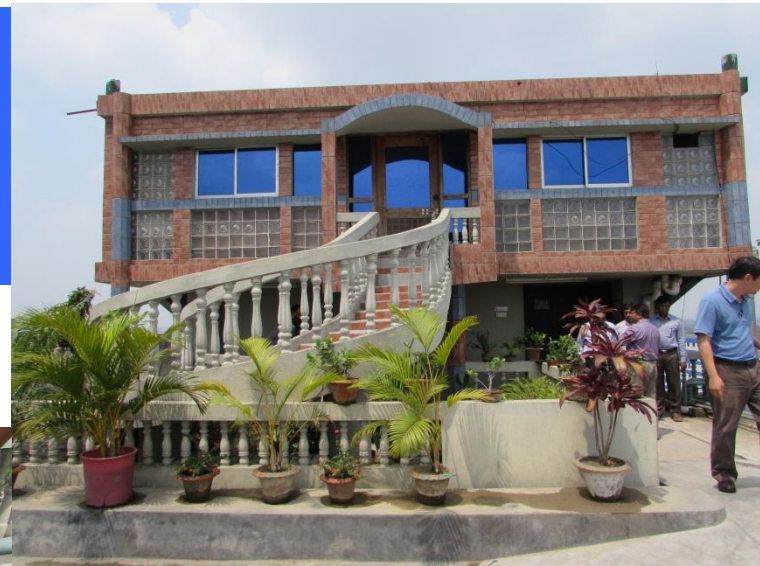
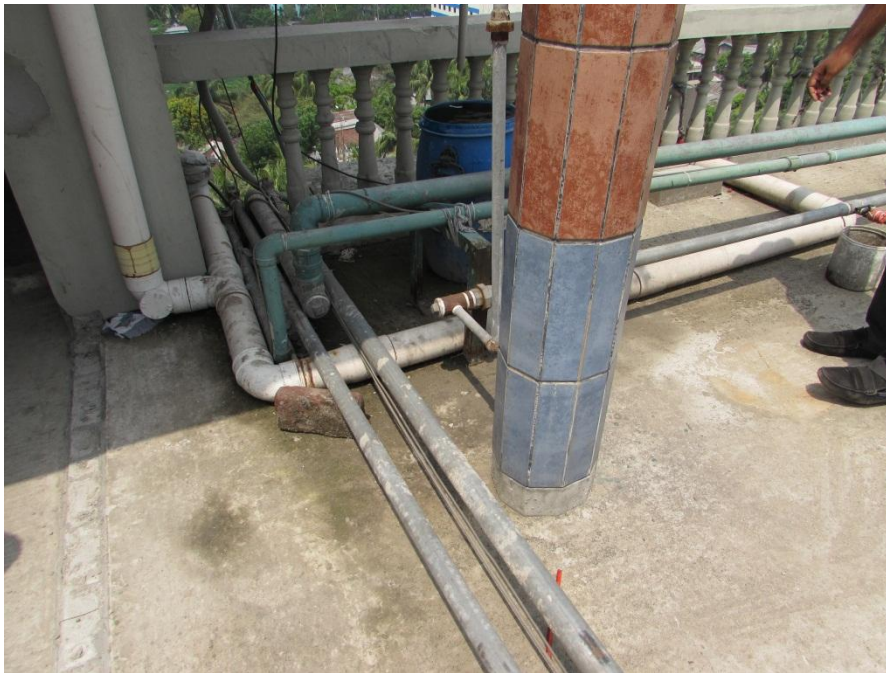
An additional construction over the stair location at roof level transfers its gravity loads directly to the roof slab system without any strengthening. The original building was not designed for these loads

The columns of new building are supported by existing flat slabs without any apparent strengthening.

**ITEM 2: (2<sup>nd</sup> Priority 2) The additional point loads on the slab due to the construction of new building at the roof top stair location**

The construction of new building on top the stair location is uncontrolled. Furthermore, the additional loads caused by the new building transfer directly to the flat slab system that was not designed to support them.

- This problem is subjected to review by building engineer to check the design of the existing structure.

- Consider demolishing the new building to relieve load.

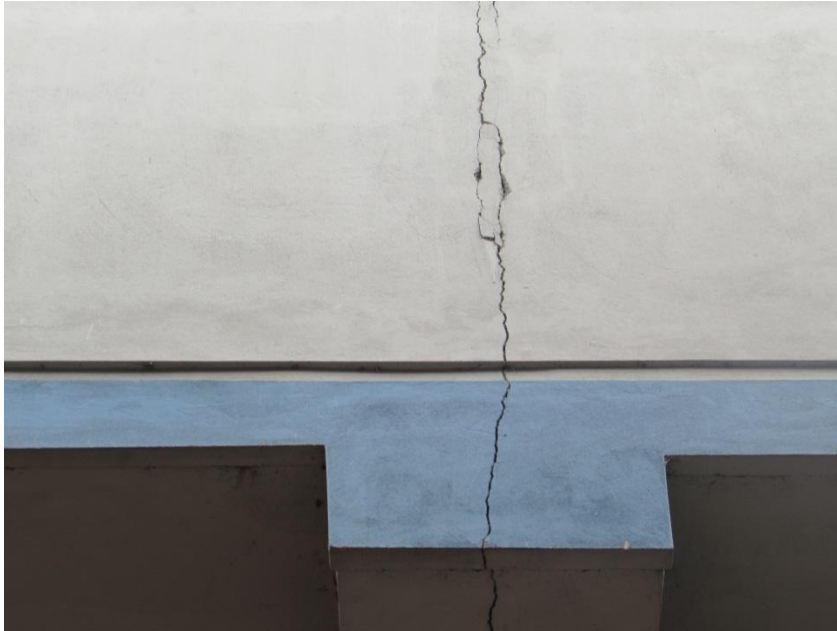
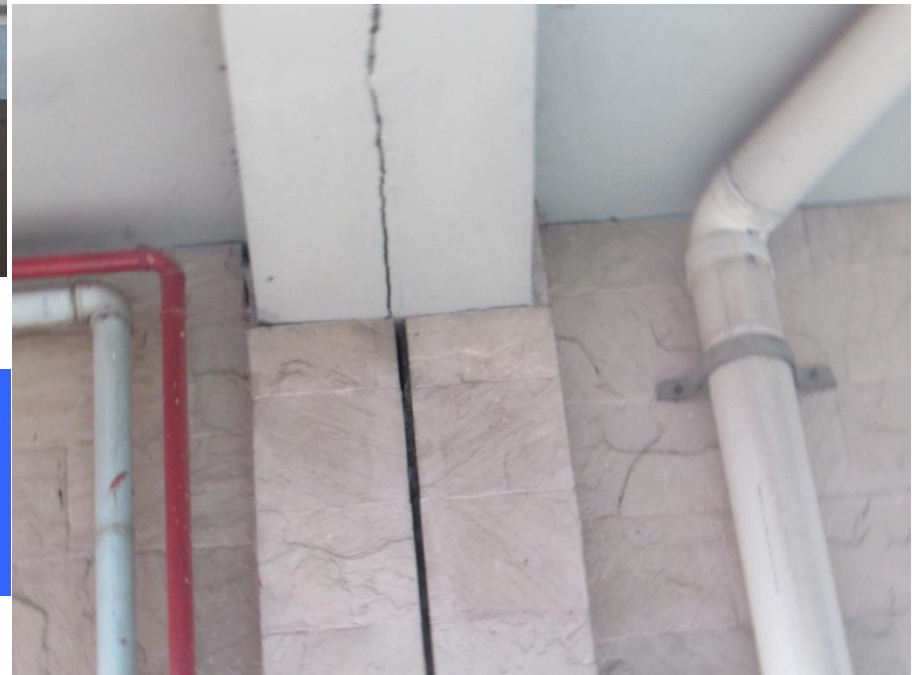
The visible cracks at movement joint locations. These cracks will increase the chance of water penetration resulting in failure of the perimeter wall.

**ITEM 3: (3<sup>rd</sup> Priority 2) Visible cracks at movement joint**

The visible cracks at the movement joint should be repaired any suitably sealed to stop the water penetration leading to the failure of perimeter wall.

- Consider removing existing screed, applying a new waterproofing membrane and reapplying the screed

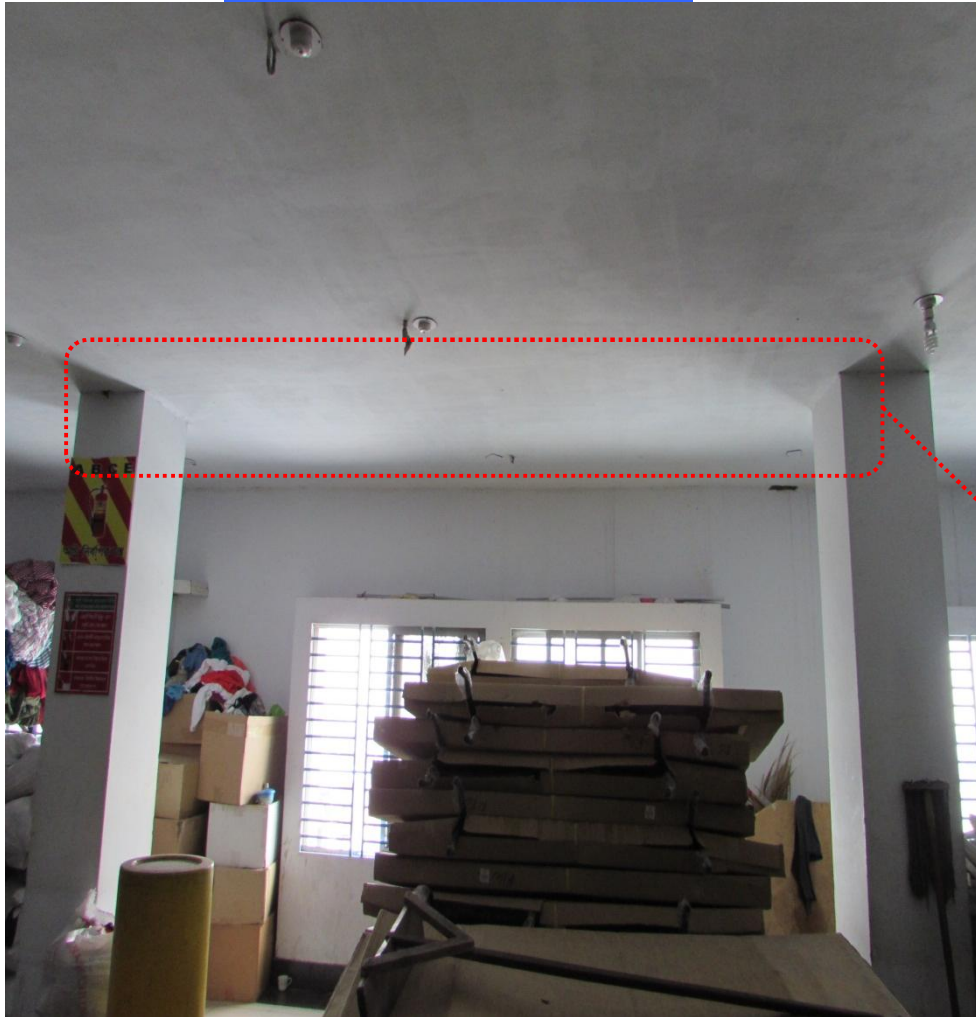
The structural design show the perimeter beams on all sides of the building. However, the as-built structure does not have these beams.

No perimeter beams

**ITEM 4: (1<sup>st</sup> Priority 3) Lack of perimeter beams on all sides of the slabs**

- Carry out full building survey using both intrusive and non-intrusive techniques.
- Carry out concrete strength test of structural elements to determine concrete strength.
- Building Engineer to fully check loading capacity of all components modified on site without any structural approval to establish whether or not the as-built components are able to sustain the loading.

- Based on the building survey, develop full structural records, and also propose strengthening works or repair works if the as-built structure appears to be insufficient in any way.

- Lack of perimeter beam needs to be investigated structurally to check long term deflections or any effects on the slab.
- Building engineer to check and provide the solution for lateral resisting requirements of the structure.

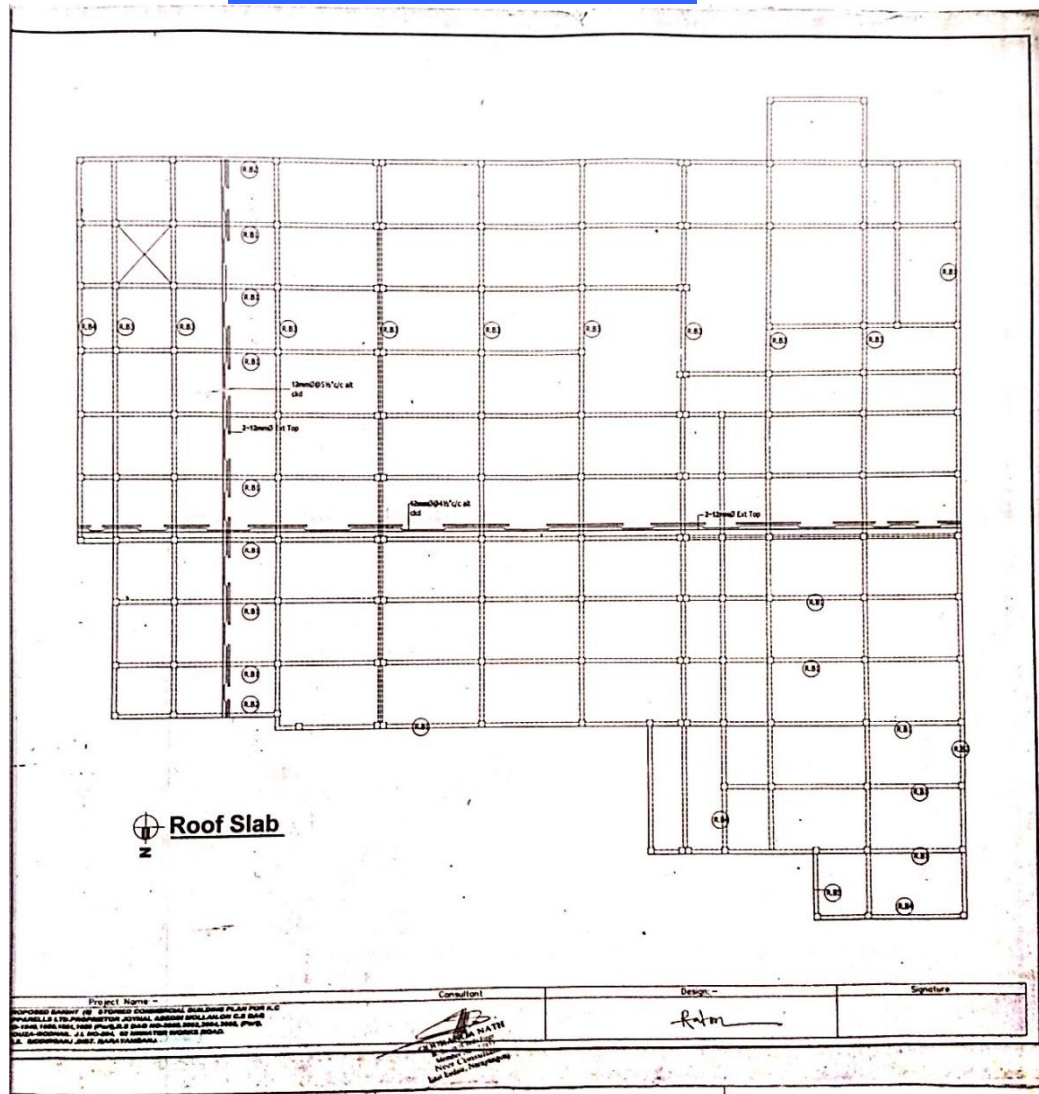
The 1<sup>st</sup> floor and the roof level floor totally differ from the structural design drawings. The floors were designed as beam & slab systems. However, flat slabs have been used instead.

**ITEM 5: (2<sup>nd</sup> Priority 3) Inconsistencies between the structural design and the as-built structure**

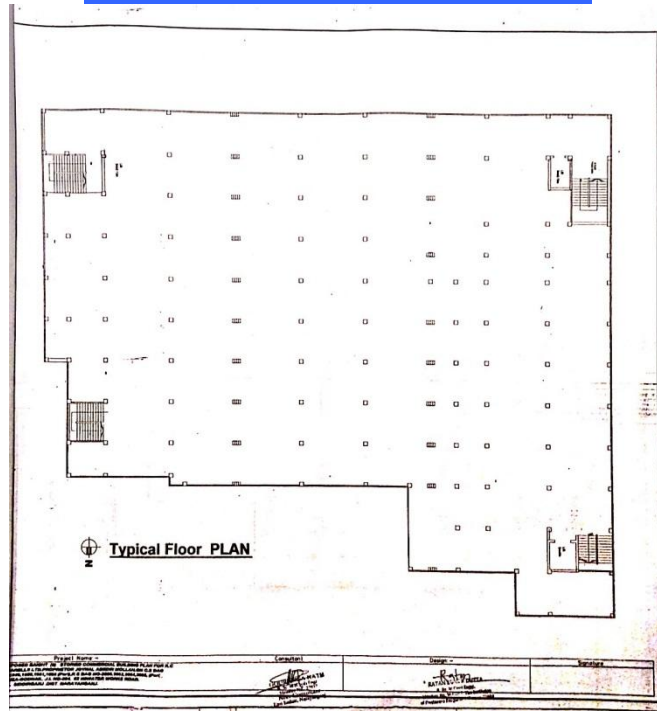
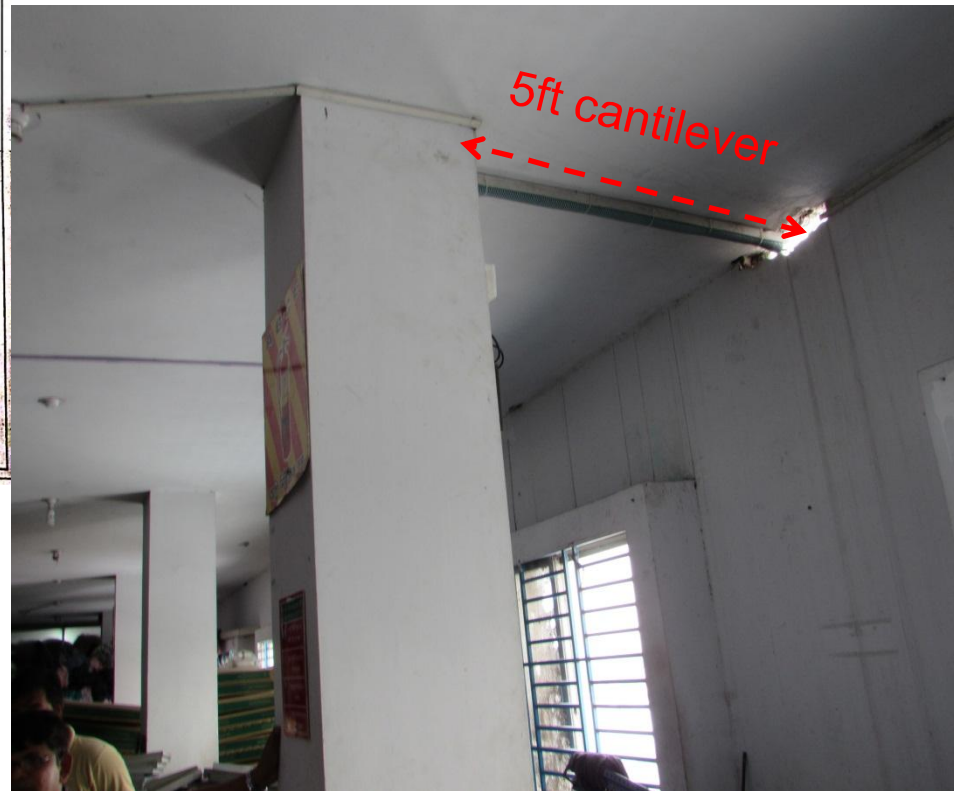
No cantilever from the original design

The slab cantilevers from level 2 to the roof level were not as designed. No record of these extensions is made on any drawings

**ITEM 6: (3<sup>rd</sup> Priority 3) No design for the slab cantilevers**

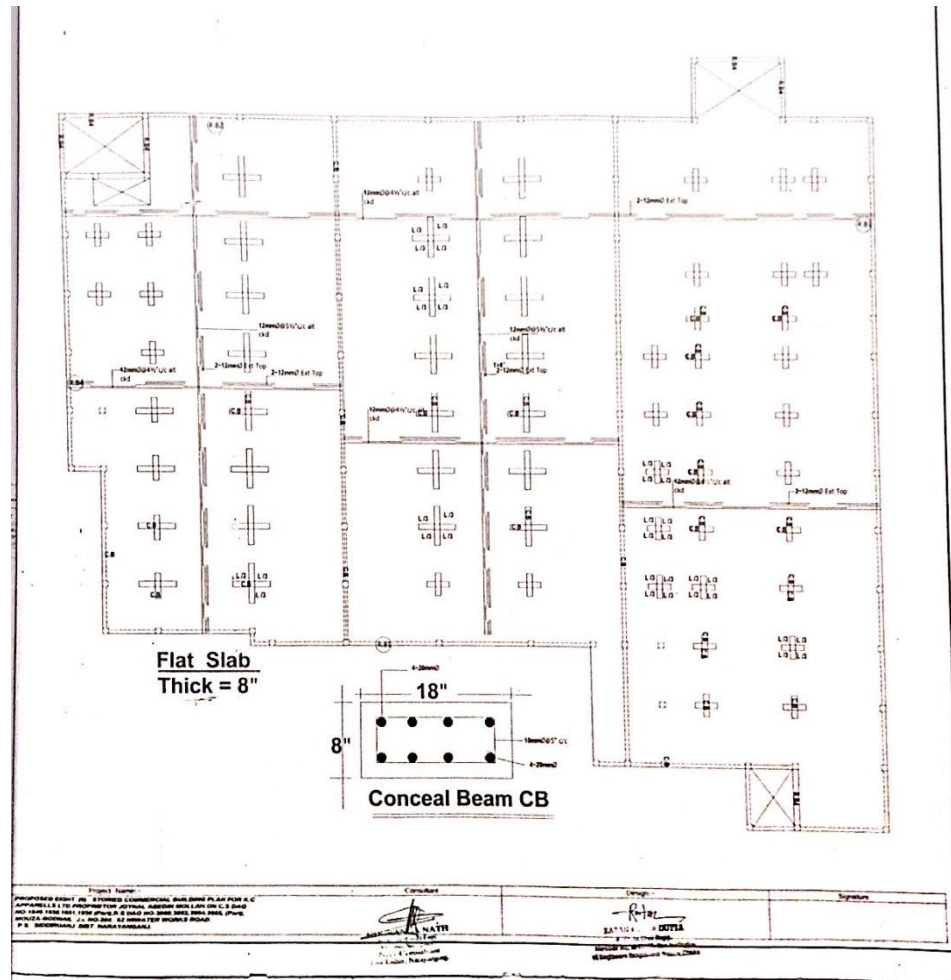
**ITEM 7: (4<sup>th</sup> Priority 3) No lateral load resistance system**

There are no perimeter beams on all sides of slabs and there is a lack of a lateral stability system.

We suggest that these items be investigated as part of a Detailed Engineering Assessment.

- As per the results of structural analysis, the building needs to be revised to accord with BNBC building codes with regard to lateral stability.
