Doreen Garments Ltd

50-60, Dakkhin Panishail, NK Link Road, Kashimpur, Gazipur, Dhaka
(23.987086, 90.260215)
2nd April 2014

Observations

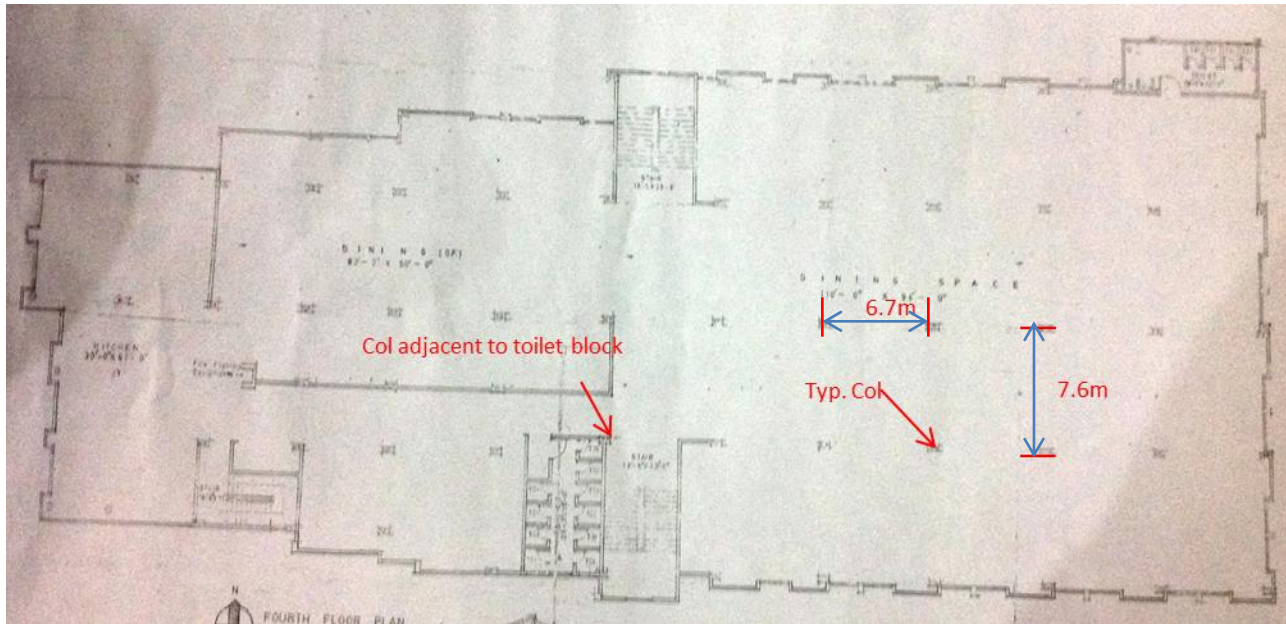
Main Building: High Column Loads

Main Building: High Column Loads- Detailed Engineering Assessment Required

REINFORCEMENT DETAILS				
COL. NO.	Below E.O.L.	Ground to 2nd Floor	3rd Floor	4th & 5th Floor
C1				
C2				
C2A				
C2B				
C3				
C3A				
C4				
C5				
C6				
C7				
C8

Preliminary calculations indicate that column working stress is at a high level in the main building. For columns adjacent to toilet areas, considerable loading was observed arising from numerous masonry partitions, plinths and reinforced concrete slab ceilings.

A Detailed Engineering Assessment of the building is required (see attached scope). The engineer is to perform detailed calculations based on the 'as constructed' structural arrangement, material properties and loading to verify column size suitability. If required, column loading shall be reduced, and columns possibly strengthened.

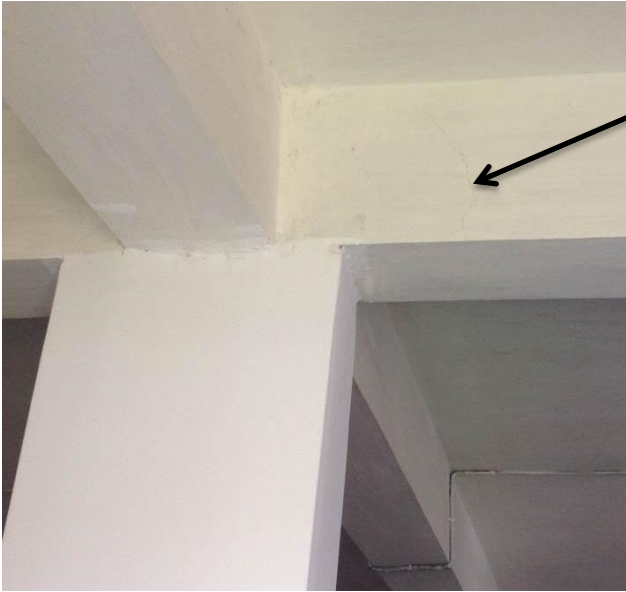
Main Building: Cracking in Beams and Slabs

Images are indicative of typical cracking to soffit of beams. Some cracking observed to slab soffits.

Item No.	Observation	Recommended Action Plan	Recommended Timeline
8	Cracking in beams and slabs at numerous floor levels	Engineer to investigate if cracks are only in the nominal render finish, in conjunction with the DEA	6-weeks
9	Cracking in beams and slabs at numerous floor levels	If cracks are structurally significant, remove all items above the slab and close working areas below the affected areas . Engage an engineer to specify repairs and strengthening if necessary.	6-weeks
10	Apparently non-engineered steelwork to roofs	Building engineer to check the capacity of the steel roofs to stair cores and electrical substation and make any necessary alterations	6-months

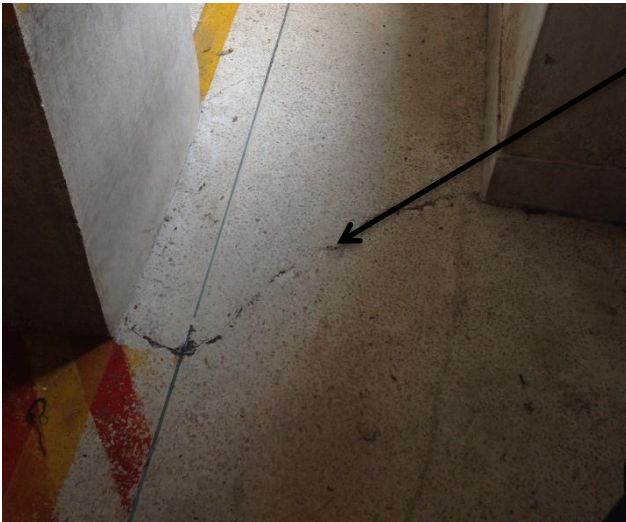
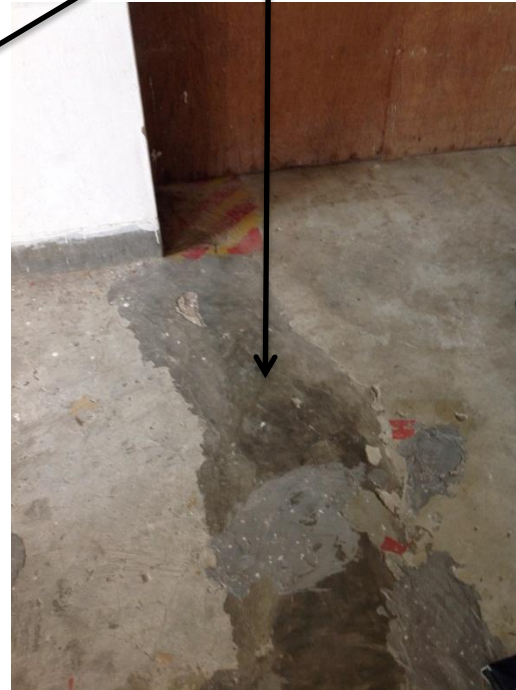
Main Building: Beam and Slab Cracking

Cracking observed to top of Level 4 slab adjacent to Grid G/12, as well as in a number of locations to cantilever slabs on Grids A and K at Levels 1 and 2.

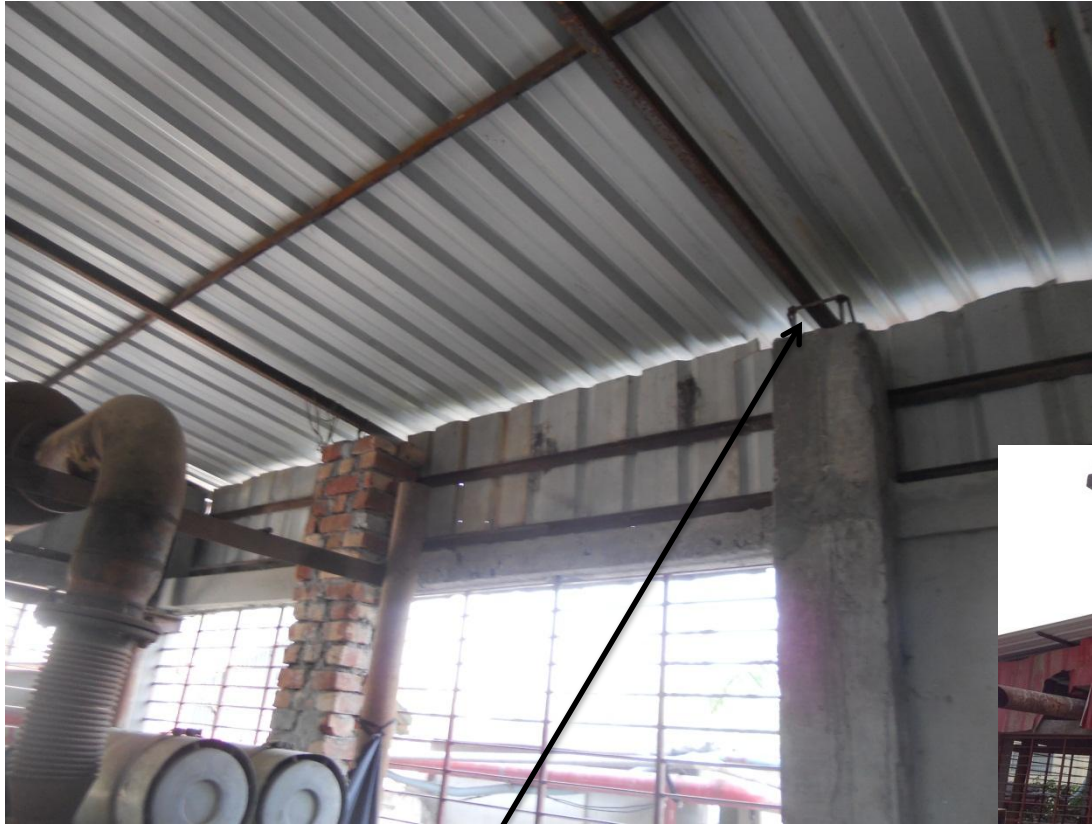
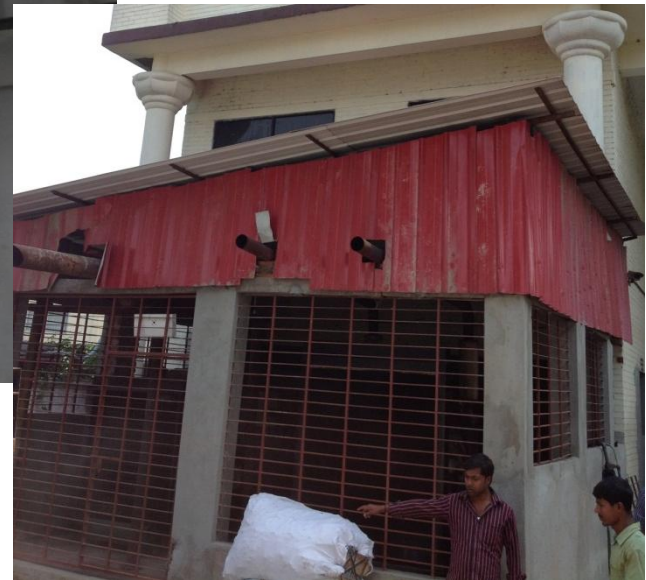
Assumed Non-Engineered Structures: Electric Room

Electric room structure appears to be 'non-engineered'.

Electric room roof purlin supported off column exposed link bar reinforcement.

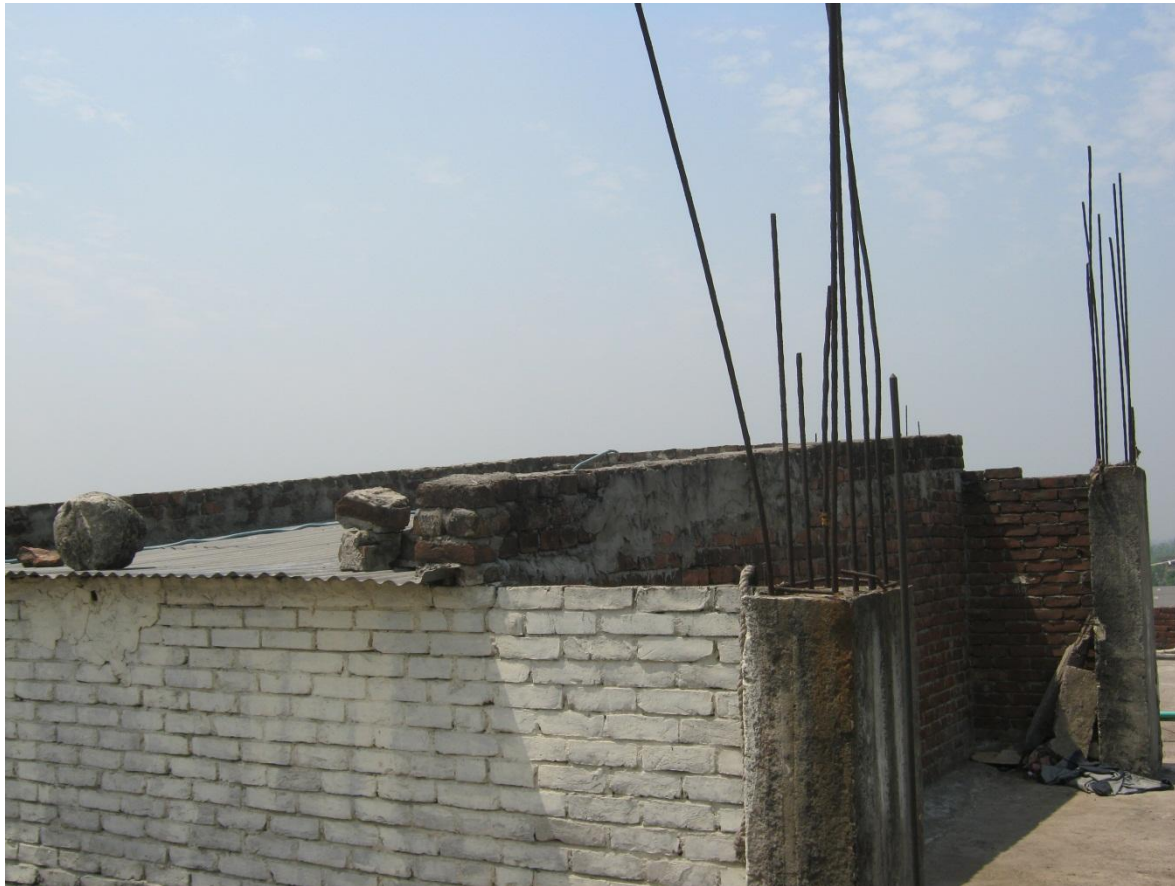
Assumed Non-Engineered Structures: Stair Core Roofs

The stair core roof structures appear to be non-engineered, with concrete blocks or bricks used for ballast to hold roof sheeting in place.
