Divine Textiles Ltd

Pollibiddut, Shafipur, Gazipur, Dhaka
(24.03977N, 90.25669E)

22 March 2014

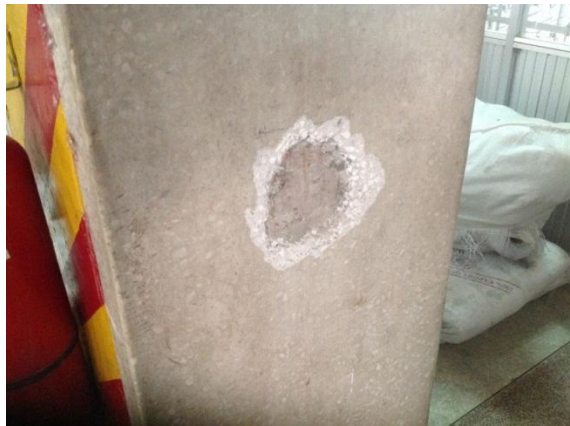
Stone chips were found in the columns of the 6 and 8 storey buildings, while brick chips were found in the columns for the 4 storey building

Tested Basement Column 8 Storey Building – Stone Chips

Cursory calculations indicate that column working stress is at a high level in the columns in all three factory buildings. An outline of each building is given below.

While our calculations show that the column working stresses are not critical, they are still in excess of normal levels. Therefore, the Building Engineer is to perform detailed calculations and concrete tests to ascertain the adequacy of the columns and (if required):

- Reduce loads
- Reinforce columns

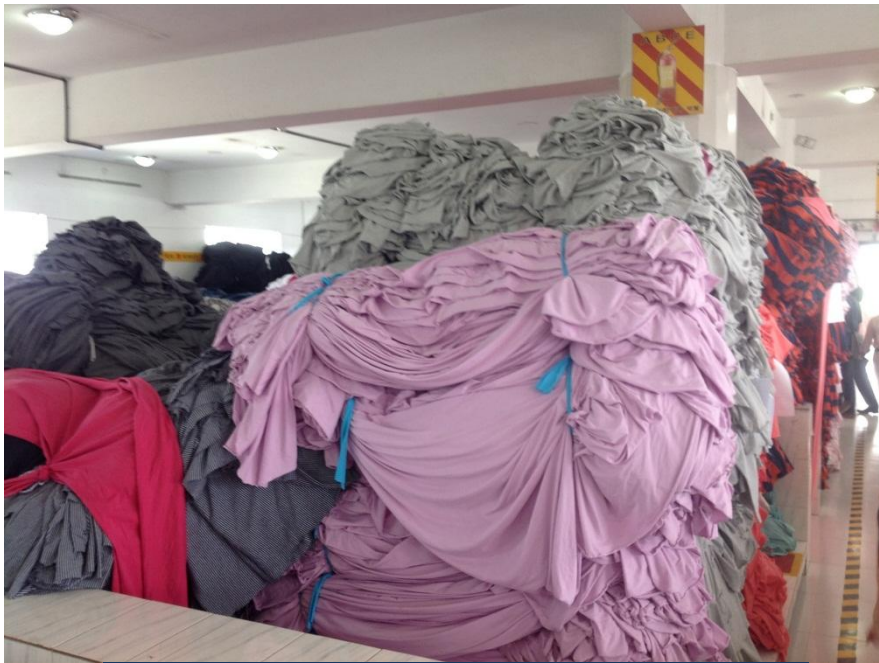
8 storey building - 4th Floor Storage Area

Uncontrolled stacking of material

Building Engineer to prepare controlled loading plans for all floors which will designate where storage can be placed.

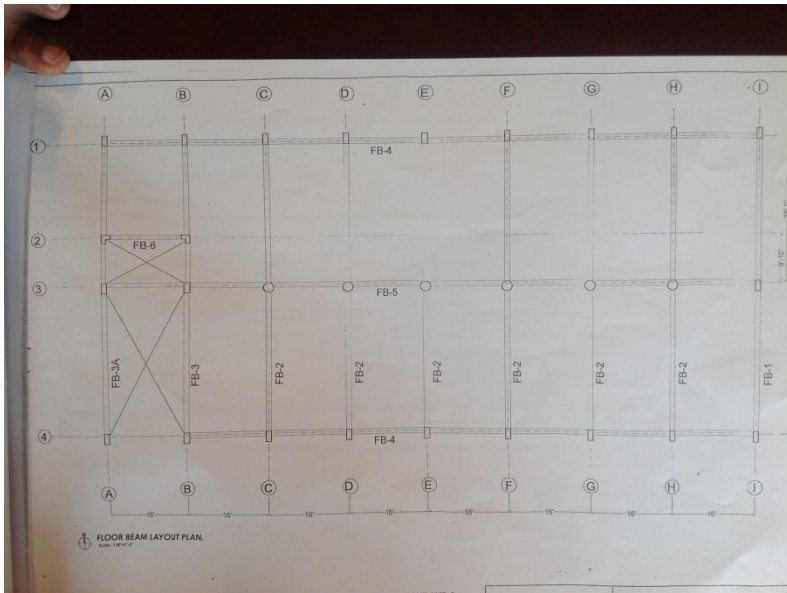
8 storey building typical plan

Longer grid dimension is 8.9 m (29' 2'') and not 8.53 m (28')

Building Engineer to survey as-built structure and update drawings.

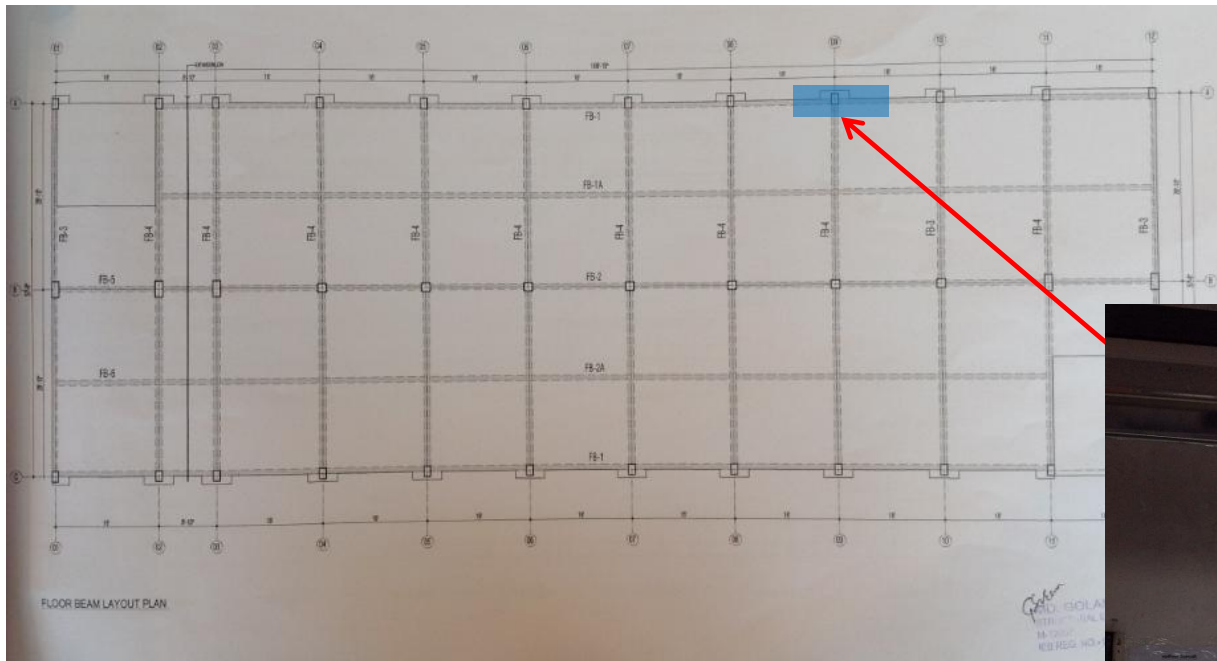
Water ingress on 4th floor of 6 storey building

Areas where water ingress is evident should be investigated and the cause of such should be remedied.

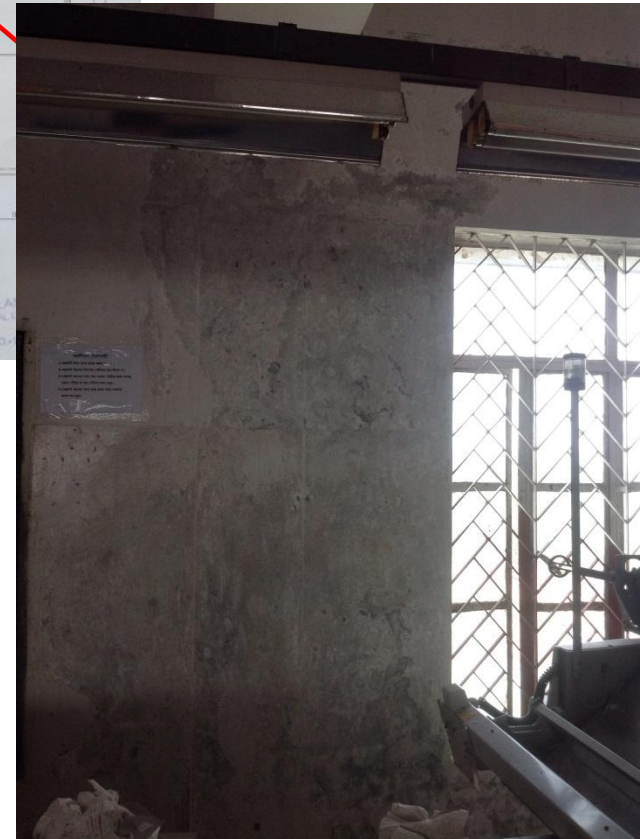
Water ingress

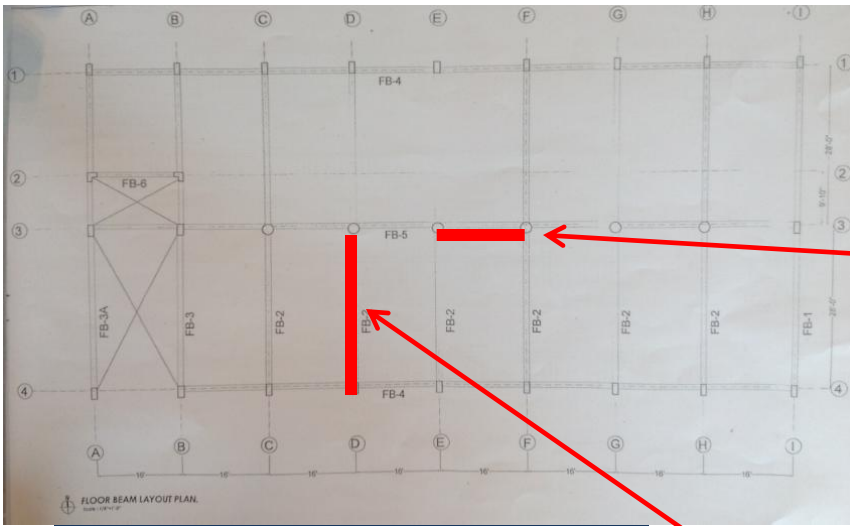
8 storey building – Typical floor plan

Crack Locations

All beam cracks to be reviewed by removing plaster to confirm that cracks do not extend into structure.

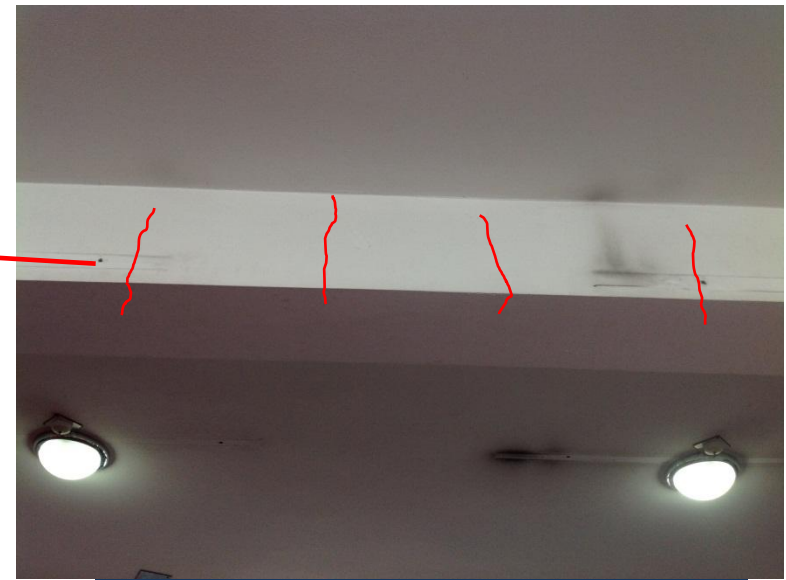
Cracking in beam supporting 5th floor

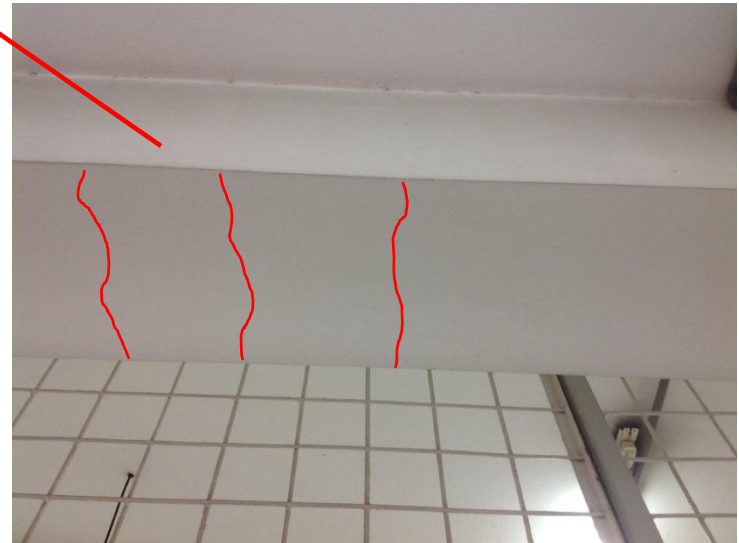
Cracking in beam supporting 2nd floor
