# Apparel Gallery Ltd.

147-148, Norshingpur, Asulia, Savar, Dhaka  
(23.929985N,90.304914E)

23 March 2014

# Observations

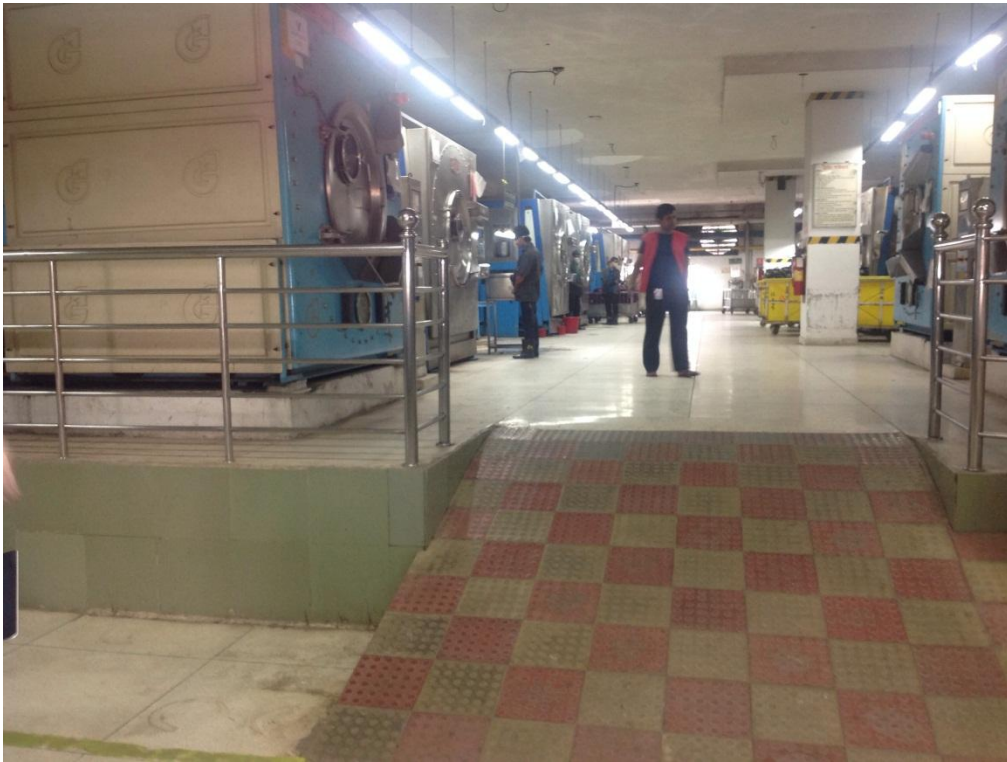
**Heavy loading due to raised floor area on  
Ground Floor**

Raised floor area,  
build up unknown.

Item No.	Observation	Recommended Action Plan	Recommended Timeline
1	Building 1 Heavy loading due to raised floor area on Ground Floor	A full Detailed Engineering Assessment is to be commenced for columns in the area of the raised platform at ground floor	<b>Immediate - Now</b>
2	Building 1 Heavy loading due to raised floor area on Ground Floor	Until DEA is complete reduce load at all levels to less than 1.5kN/m <sup>2</sup> and especially from stacked garments from area highlighted on page 5	<b>Immediate - Now</b>
3	Building 1 Heavy loading due to raised floor area on Ground Floor	At ground floor (grid B2-D4) remove the second lift of raised platform and investigate the construction of the lower platform. If found to be solid or filled with sand, remove material or evacuate areas above until structure and foundations proven.	<b>Immediate - Now</b>
4	Building 1 Heavy loading due to raised floor area on Ground Floor	Conduct concrete tests to prove concrete strength	<b>Immediate - Now</b>

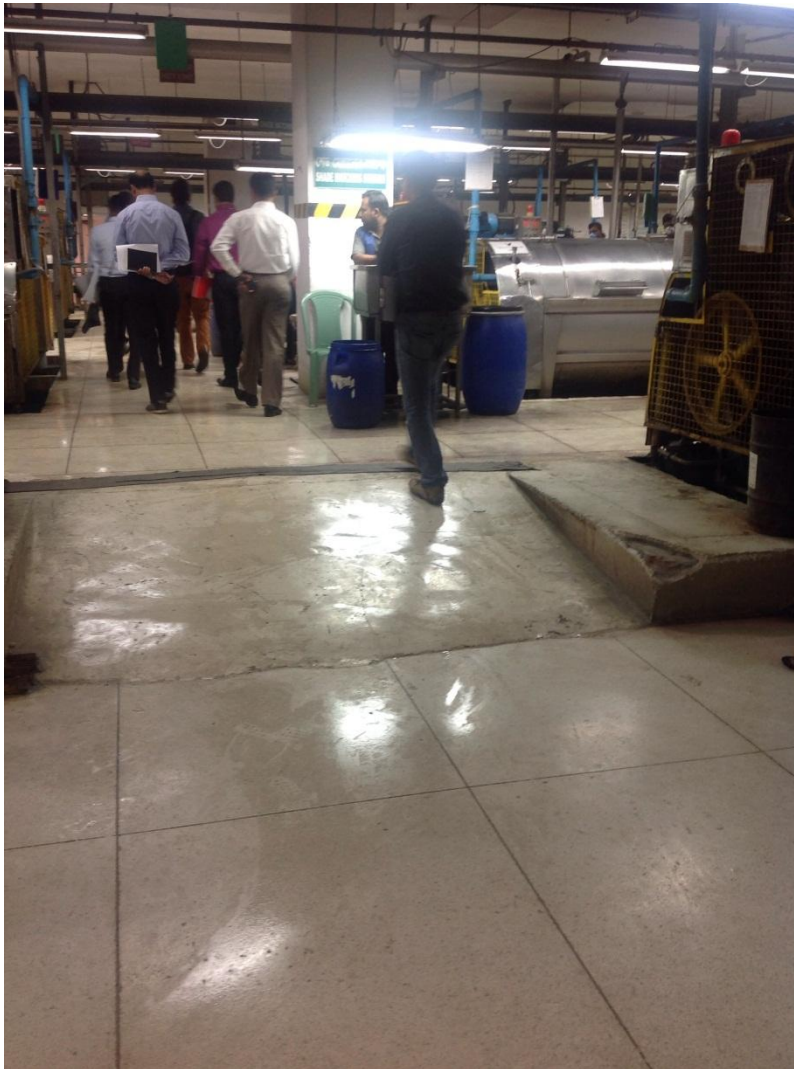
Raised floor area on top of raise area, not identified on drawings. Build up unknown.

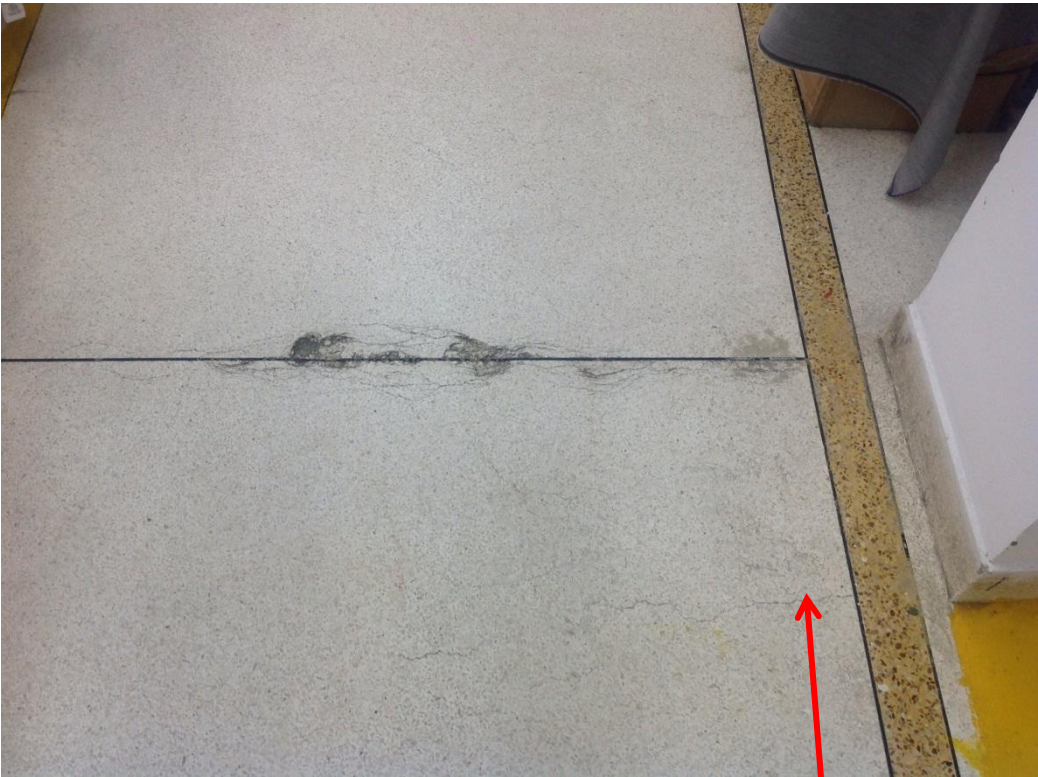
Multiple cracking in floor finish.

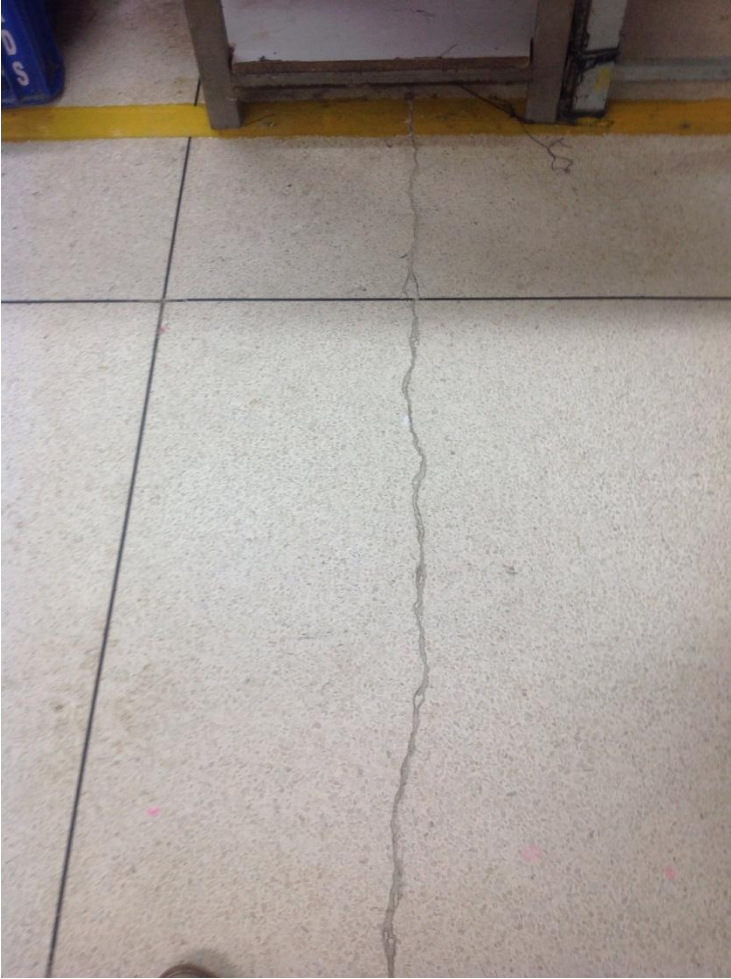
Floor cracking

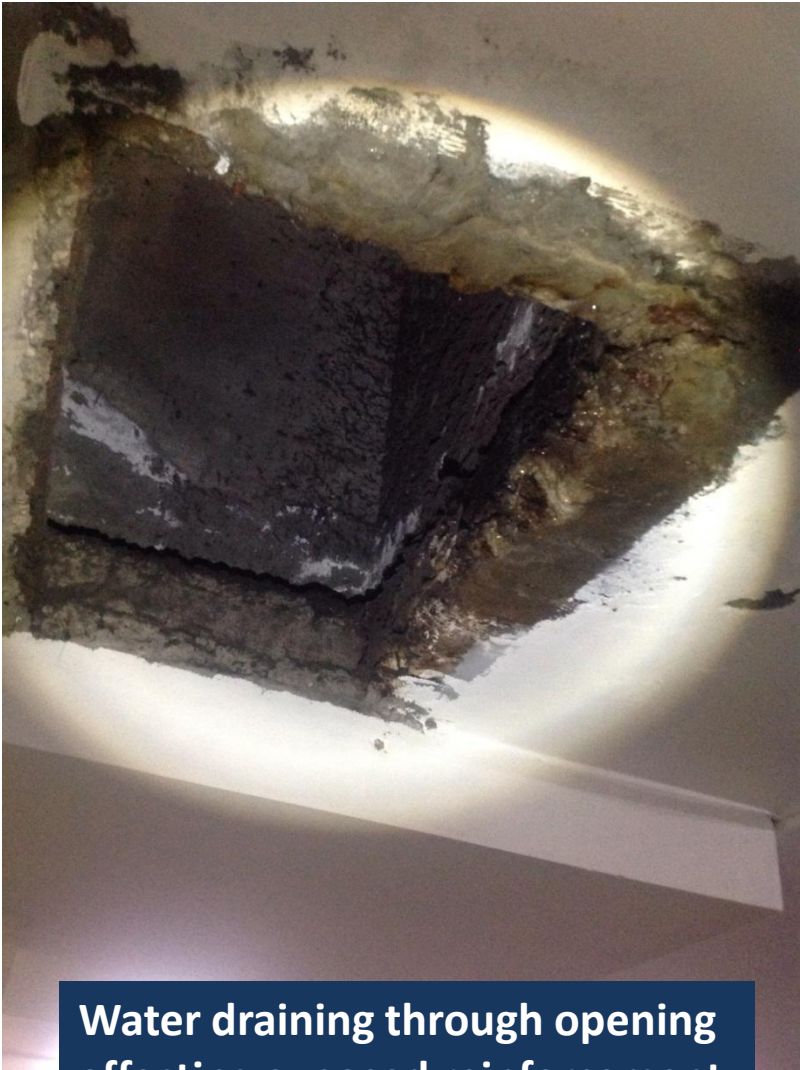
Opening in slab,  
exposed  
reinforcement.

Water draining through opening  
affecting exposed reinforcement.

Item No.	Observation	Recommended Action Plan	Recommended Timeline
12	Opening in floor with exposed reinforcement to be addressed by engineer and repaired	Remove source of water to avoid further corrosion to reinforcement. Clean all affected reinforcement back to bare steel. Repair concrete using suitable structural mortar	6-weeks
13	Opening in floor with exposed reinforcement to be addressed by engineer and repaired	Provide calculations showing the structural adequacy of floor with opening	6-months
14	Evidence of water draining down façade of building causing possible reinforcement corrosion, remove source of water/divert and check slab edges for spalling/corrosion	Engineer to inspect water leakage and damaged structure including the exterior and propose a suitable repair.	6-months
15	Roof partially removed. Timber joists and connection of cut steel rafters to be checked for uplift	Building Engineer to inspect section of roof that remains and verify its adequacy against uplift giving consideration to open door on roof	6-weeks

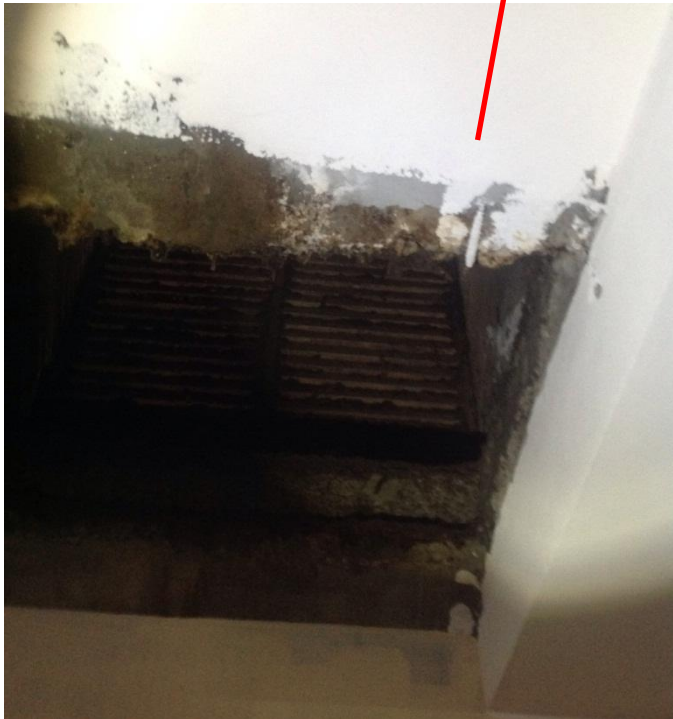
Opening in floor with exposed  
reinforcement and water ingress.

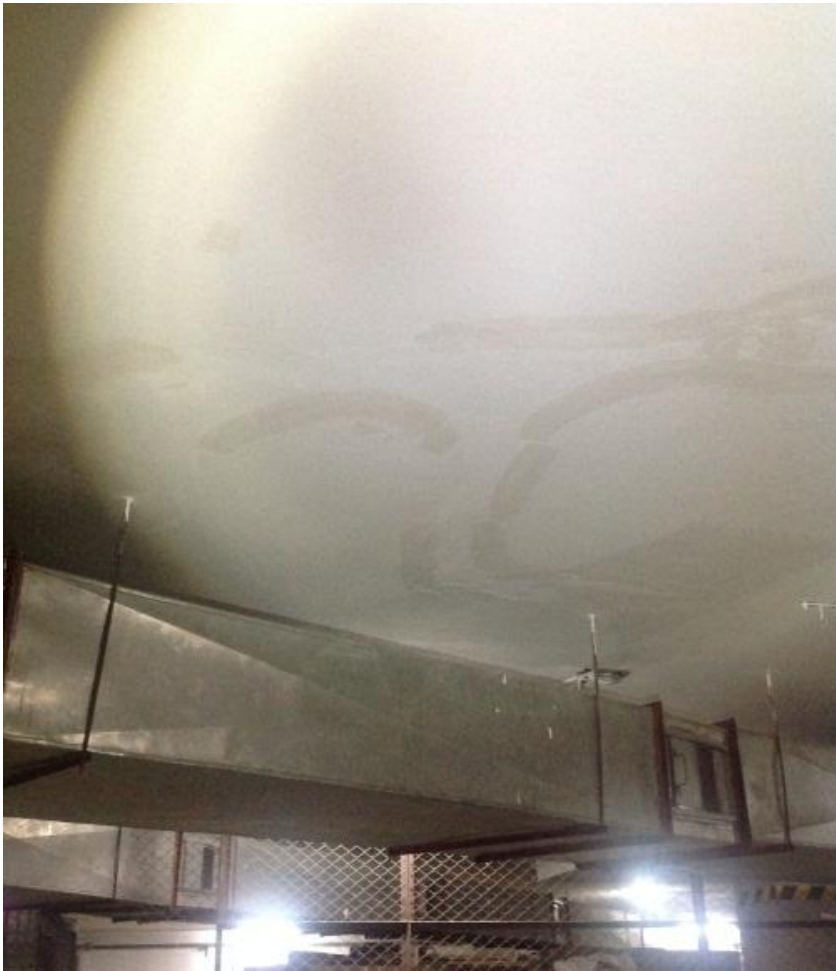
Recently repaired  
cracking in Soffit of  
ground floor slab  
adjacent to column  
with Basement  
slab cracking.

11	Evidence of repairs to cracks in soffit of ground floor under raised floor area's, repair should be removed by local engineer and reinforcement behind check for possible signs of corrosion	Repairs as detailed by the Building Engineer to be completed should investigations above reveal corrosion of reinforcement	6-months

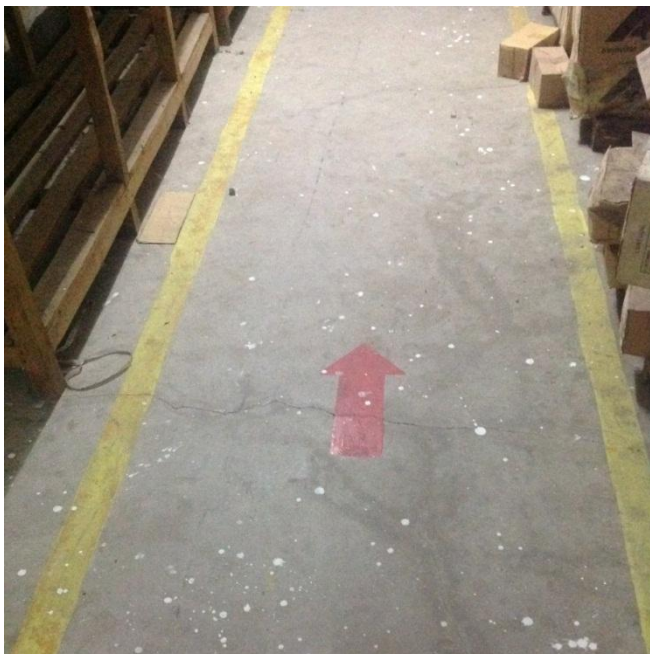
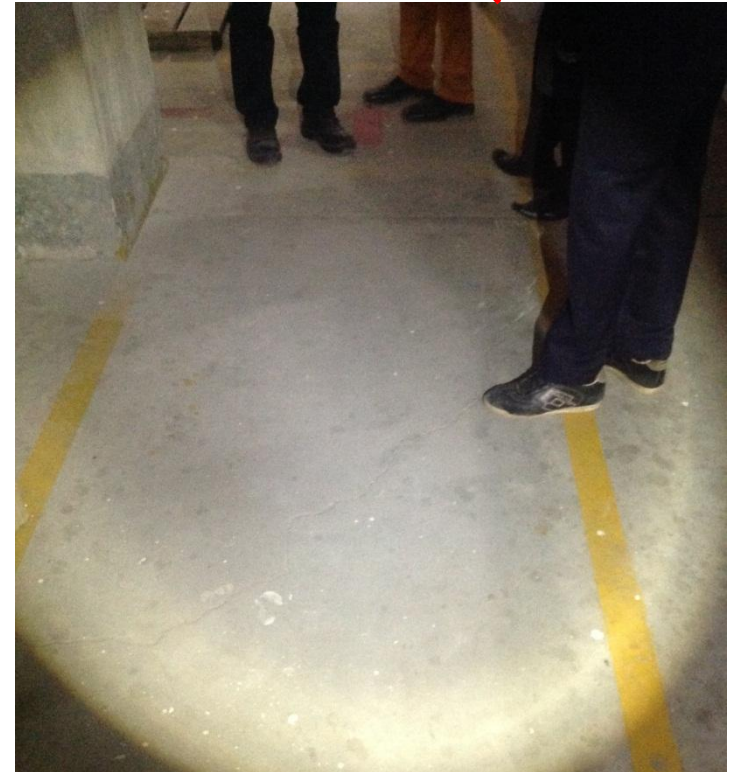
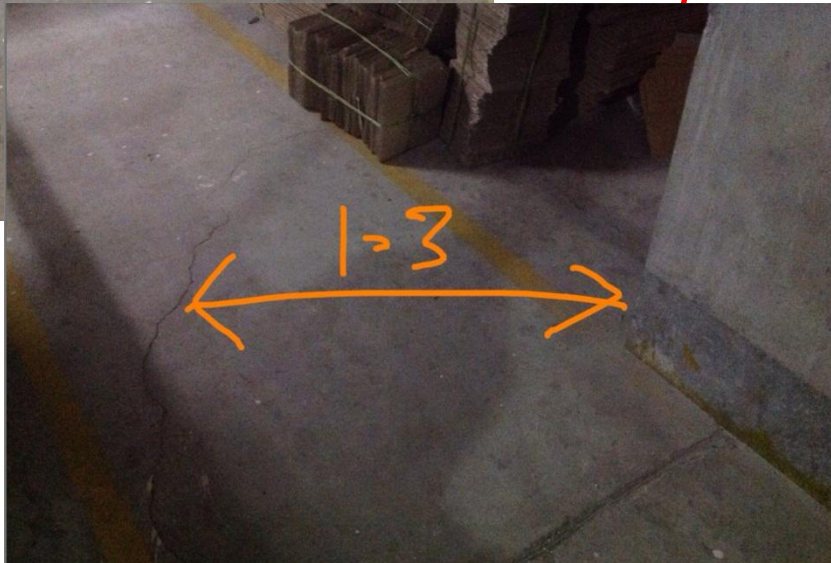
Cracking in Basement slab around column perimeter.

Cracking in basement slab

5	Building 1 Heavy loading due to raised floor area on Ground Floor	DEA to prove adequacy of foundations in the area B2 to E7 noting the cracking to basement slab at column D3. DEA to confirm if movement is still live as it was noted that the soffit of the ground floor slab had been freshly painted	<b>Immediate - Now</b>
6	Building 1 Heavy loading due to raised floor area on Ground Floor	Detail Engineering Assessment and strengthening / remedial works as specified by the building engineer to be completed	<b>6-weeks</b>
7	Building 1 Heavy loading due to raised floor area on Ground Floor	Produce and actively manage a loading plan for all floor plates within the factory giving consideration to floor capacity and column capacity.	<b>6-months</b>

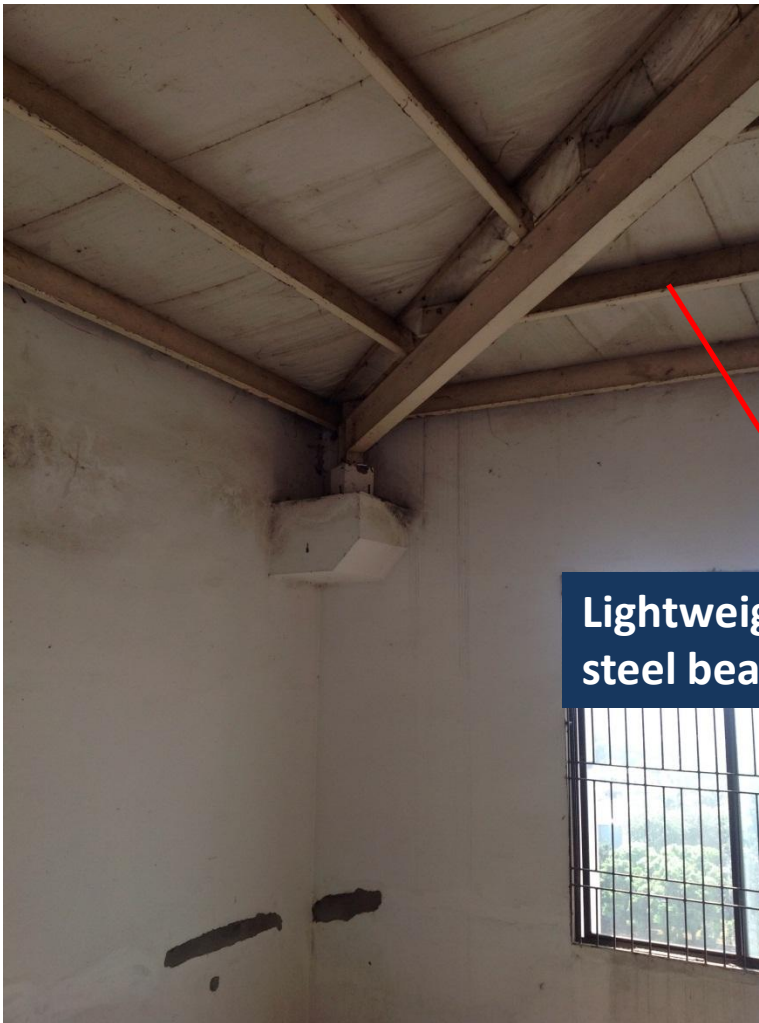
Lightweight timber roof on steel beam cut at one end

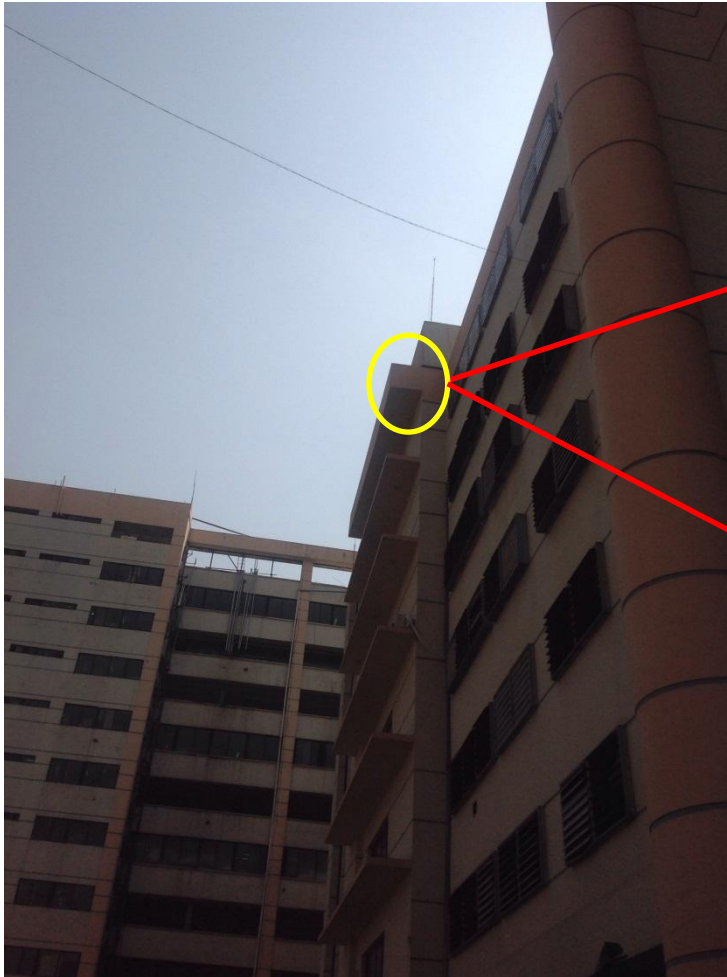
Vertical Crack between cantilever and main structure.

**Check if crack is structural or cosmetic.**

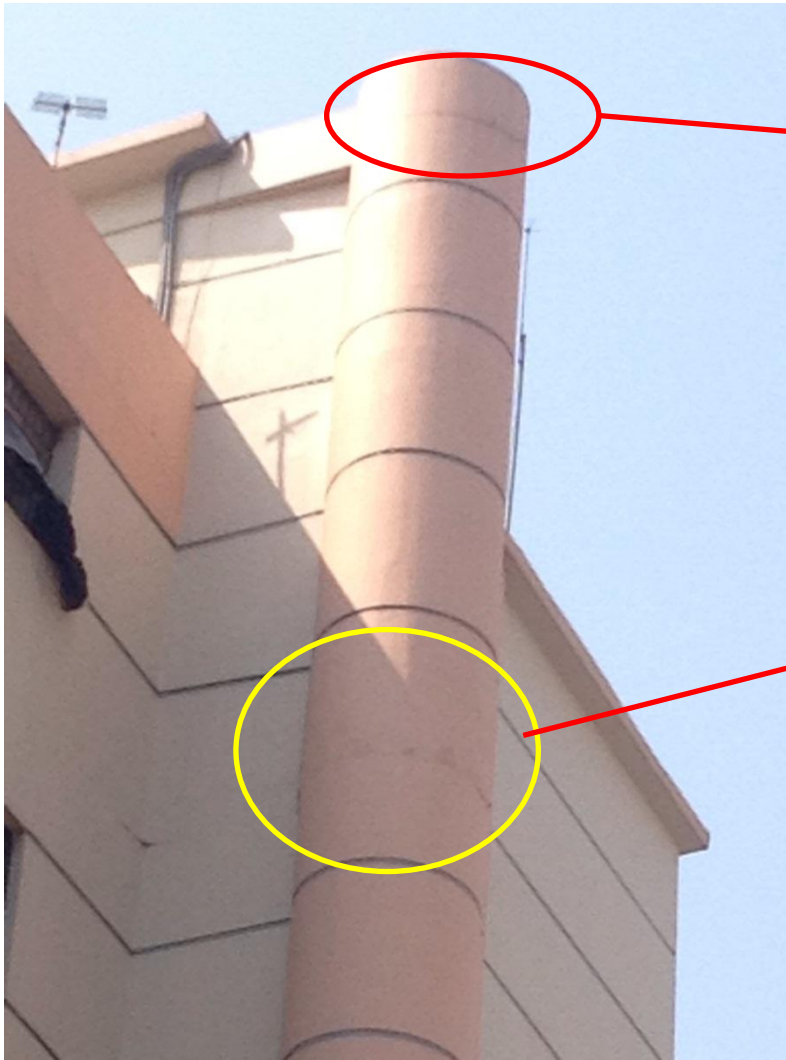
Horizontal  
Crack.

**Check if cracks are  
structural or cosmetic.**

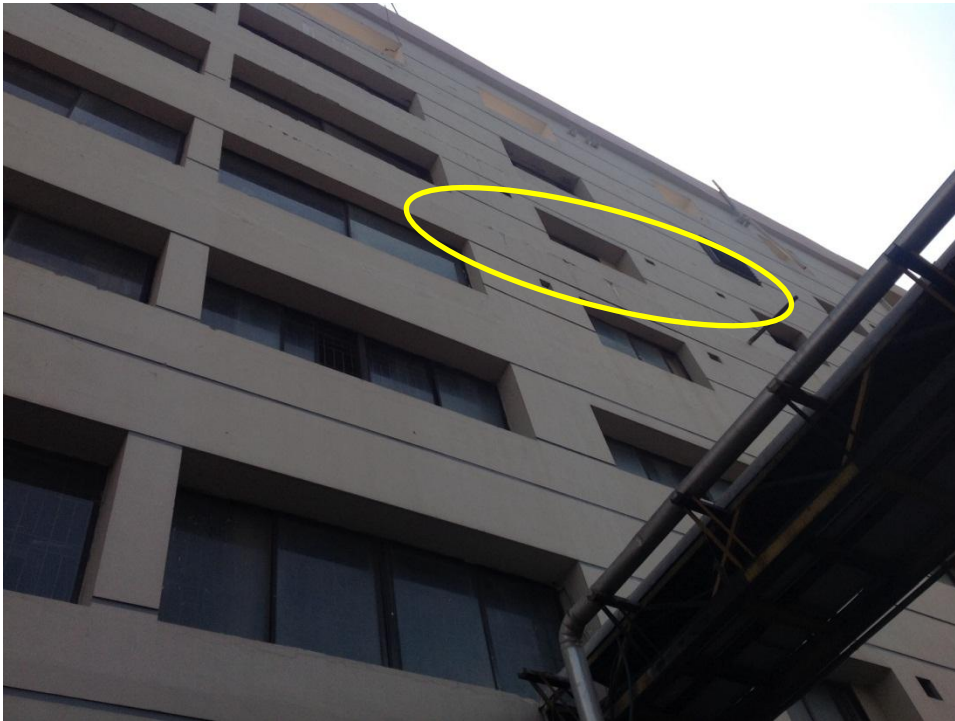
Spalling/Cracking, possibly due to corrosion of reinforcement.

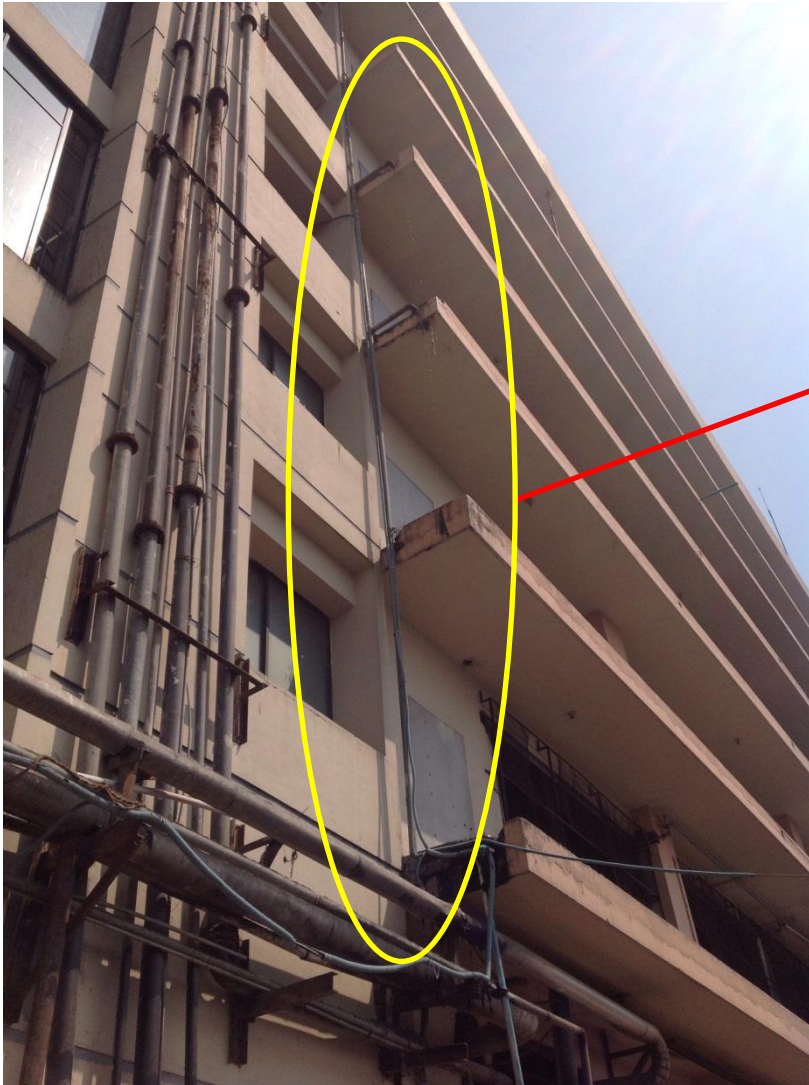
Water falling onto edges of all slabs, possible corrosion of reinforcement.

**Check for corrosion of reinforcement**

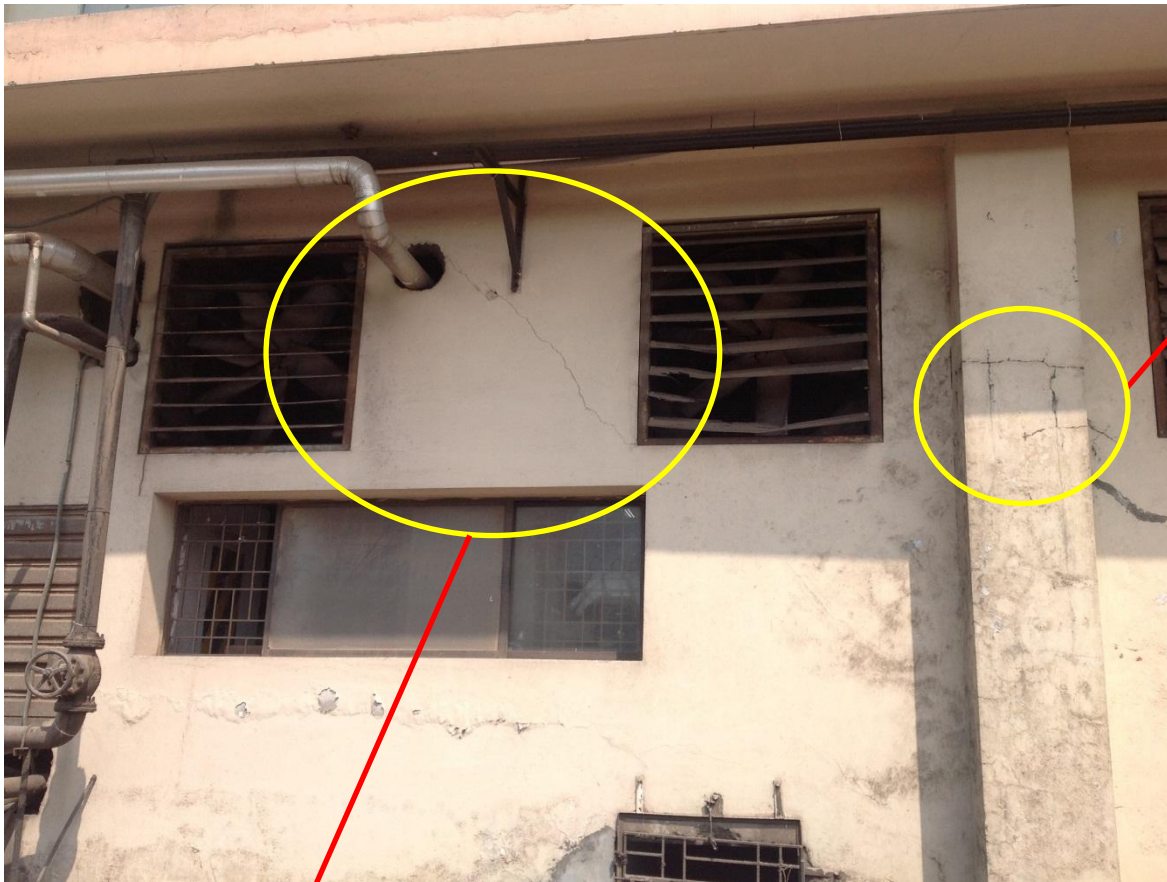
Cracking in column face.  
Remove render to check.

Diagonal Crack.  
Remove render to check.

Check if crack is structural  
or cosmetic.

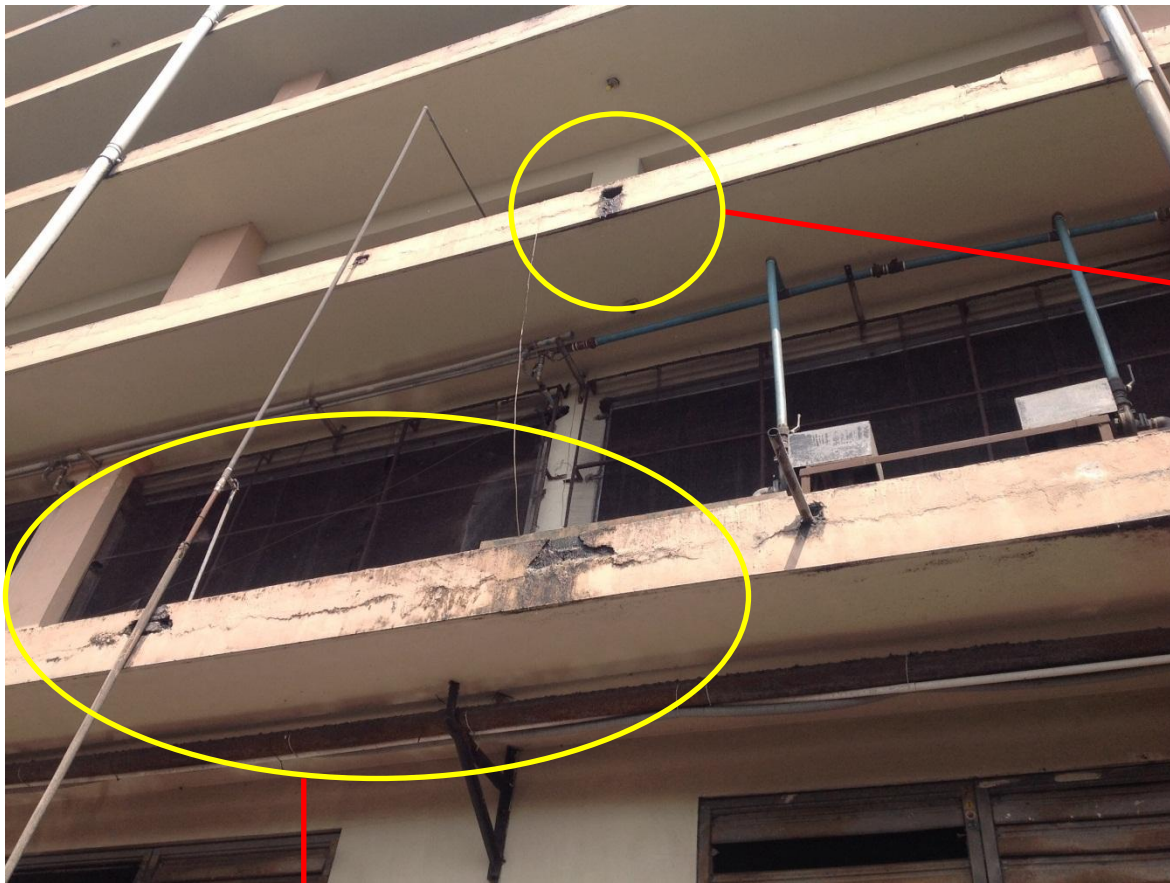
Drainage outlet falling onto cantilever edge below.

Cracking/Spalling.  
Confirm if reinforcement is  
corroded.

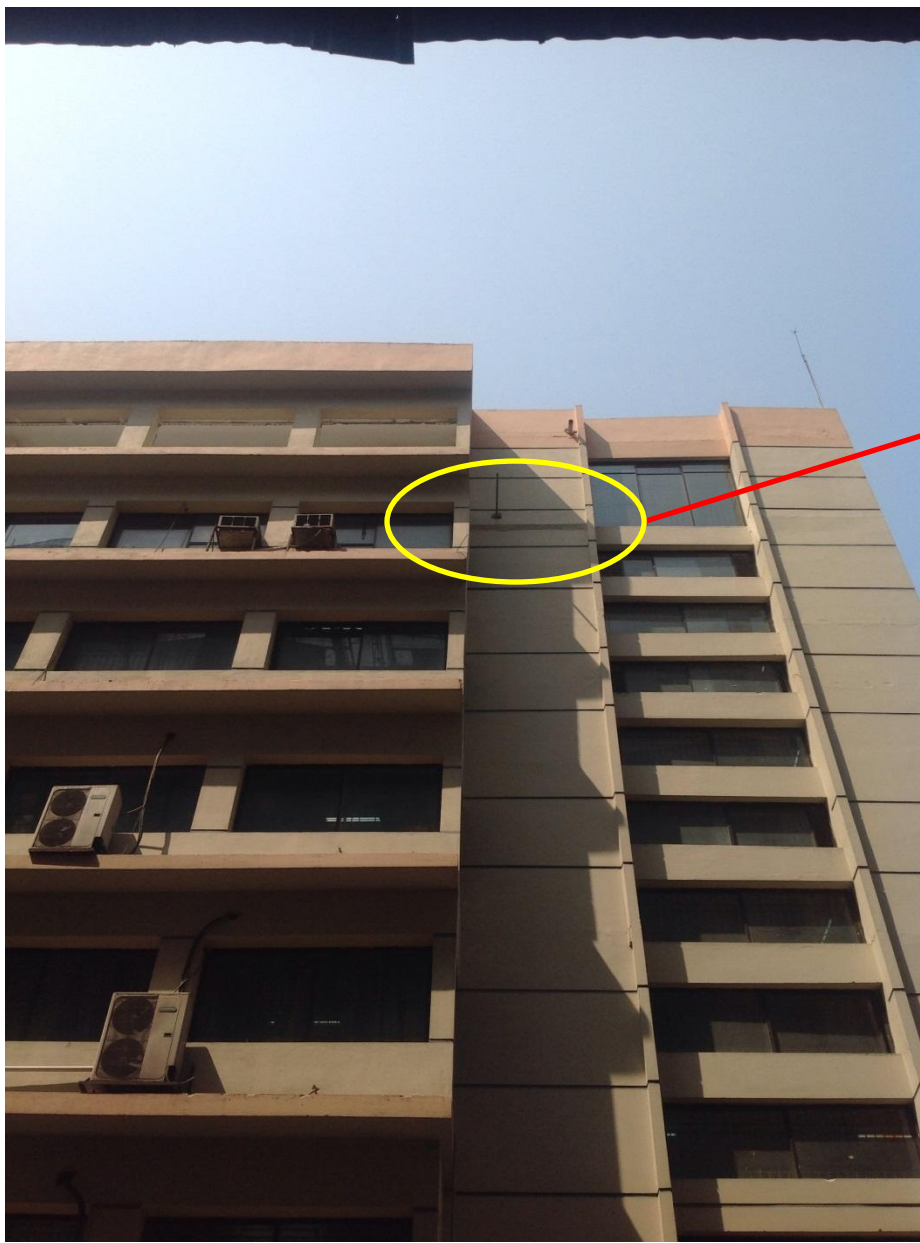
Façade steps out at 6<sup>th</sup> floor level possibly due to construction tolerances.

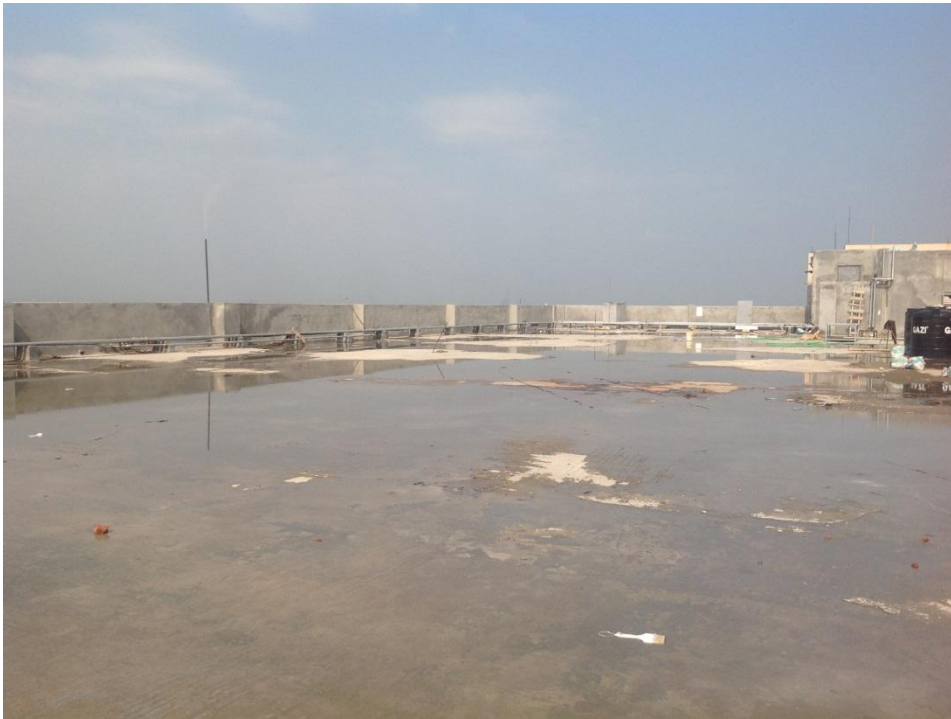
**Water ponding on  
unprotected  
concrete slab (roof  
structure removed)**

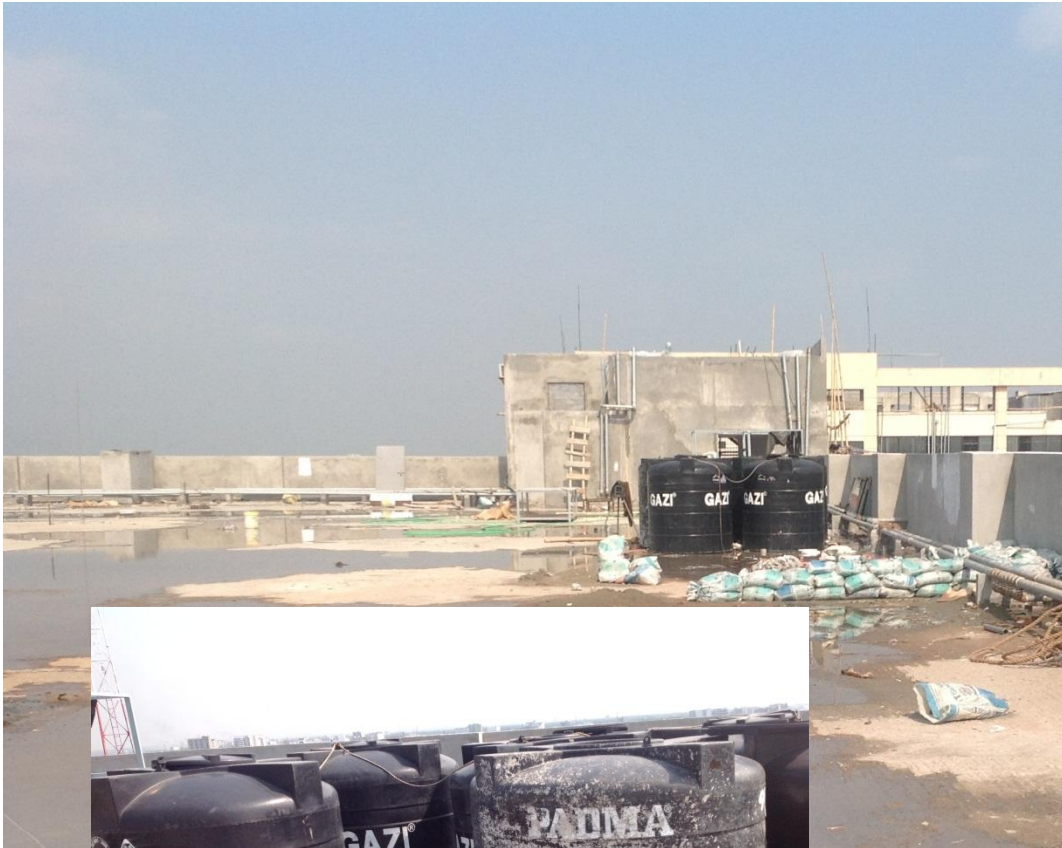
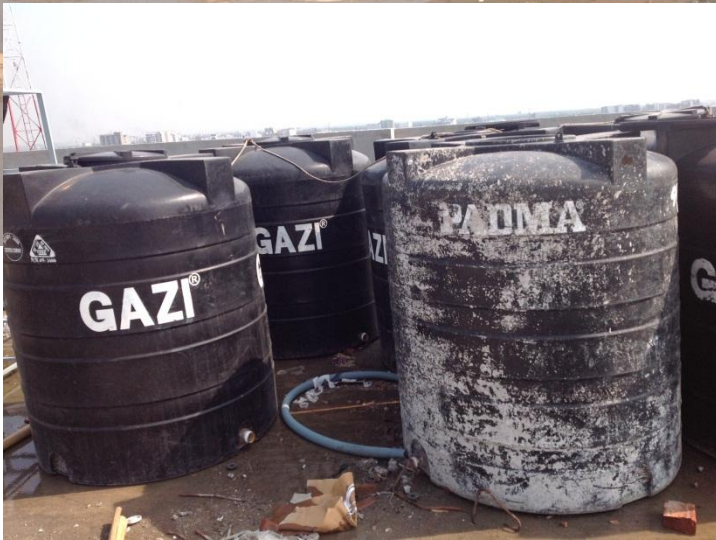
6 No. 2500L water tanks. (Currently not connected or filled)

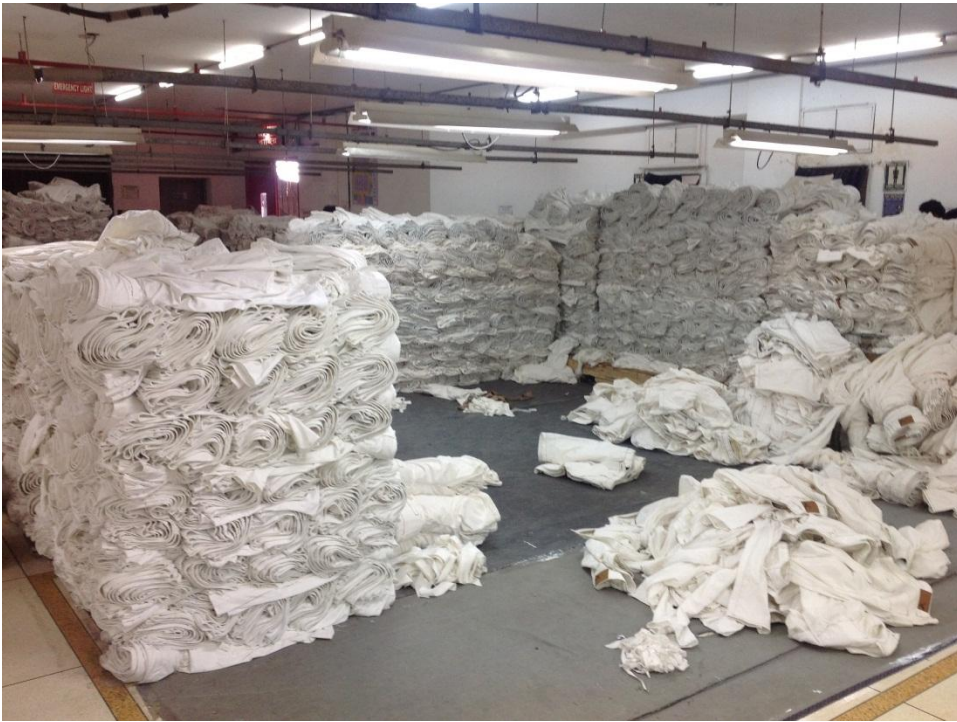
High storage loads

Item No.	Observation	Recommended Action Plan	Recommended Timeline
16	Building 2 Verify concrete strengths in columns in locations supporting bonded warehouse areas due to high observed loads	Factory Engineer to review design, loads and columns stresses in area identified above.	<b>Immediate - Now</b>
17	Building 2 Verify concrete strengths in columns in locations supporting bonded warehouse areas due to high observed loads	Verify insitu concrete stresses either by cores or existing cylinder strength data for columns. We note that cylinders have been provided for slabs and foundations but also note that these elements were specified with a different concrete mix and target strength.	<b>Immediate - Now</b>
18	Building 2 Verify concrete strengths in columns in locations supporting bonded warehouse areas due to high observed loads	Produce and actively manage a loading plan for all floor plates within the factory giving consideration to floor capacity and column capacity	<b>6-weeks</b>

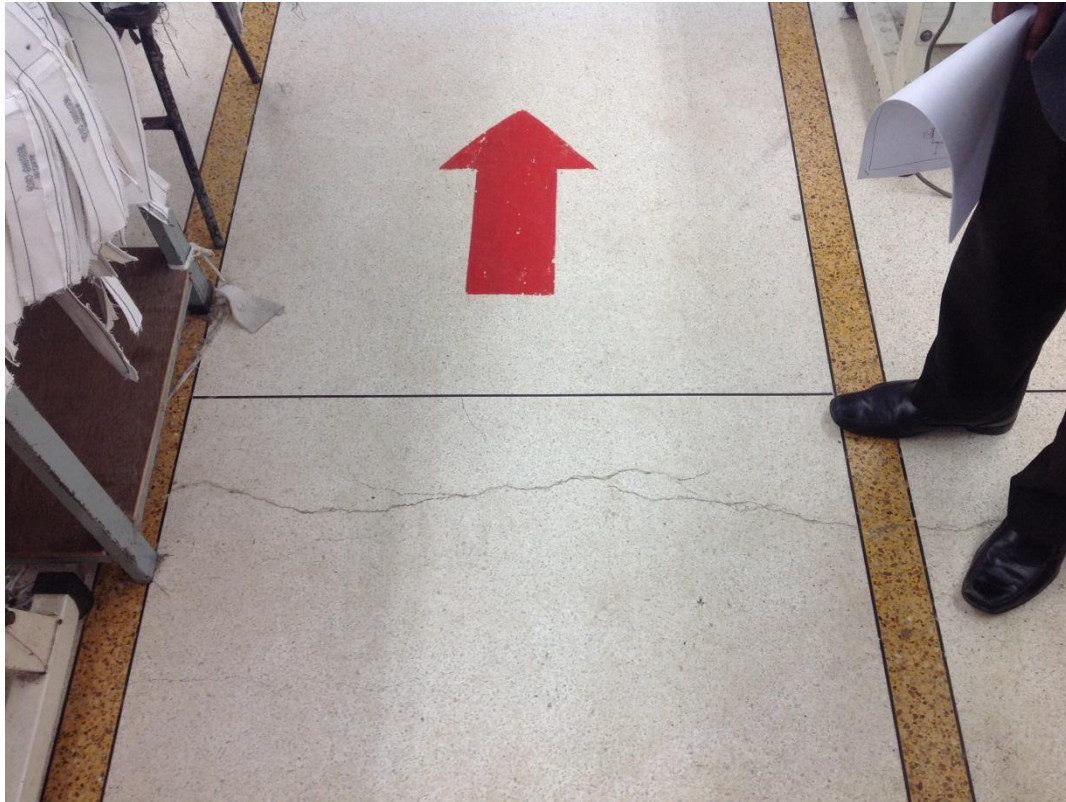
Cracking on  
column line.

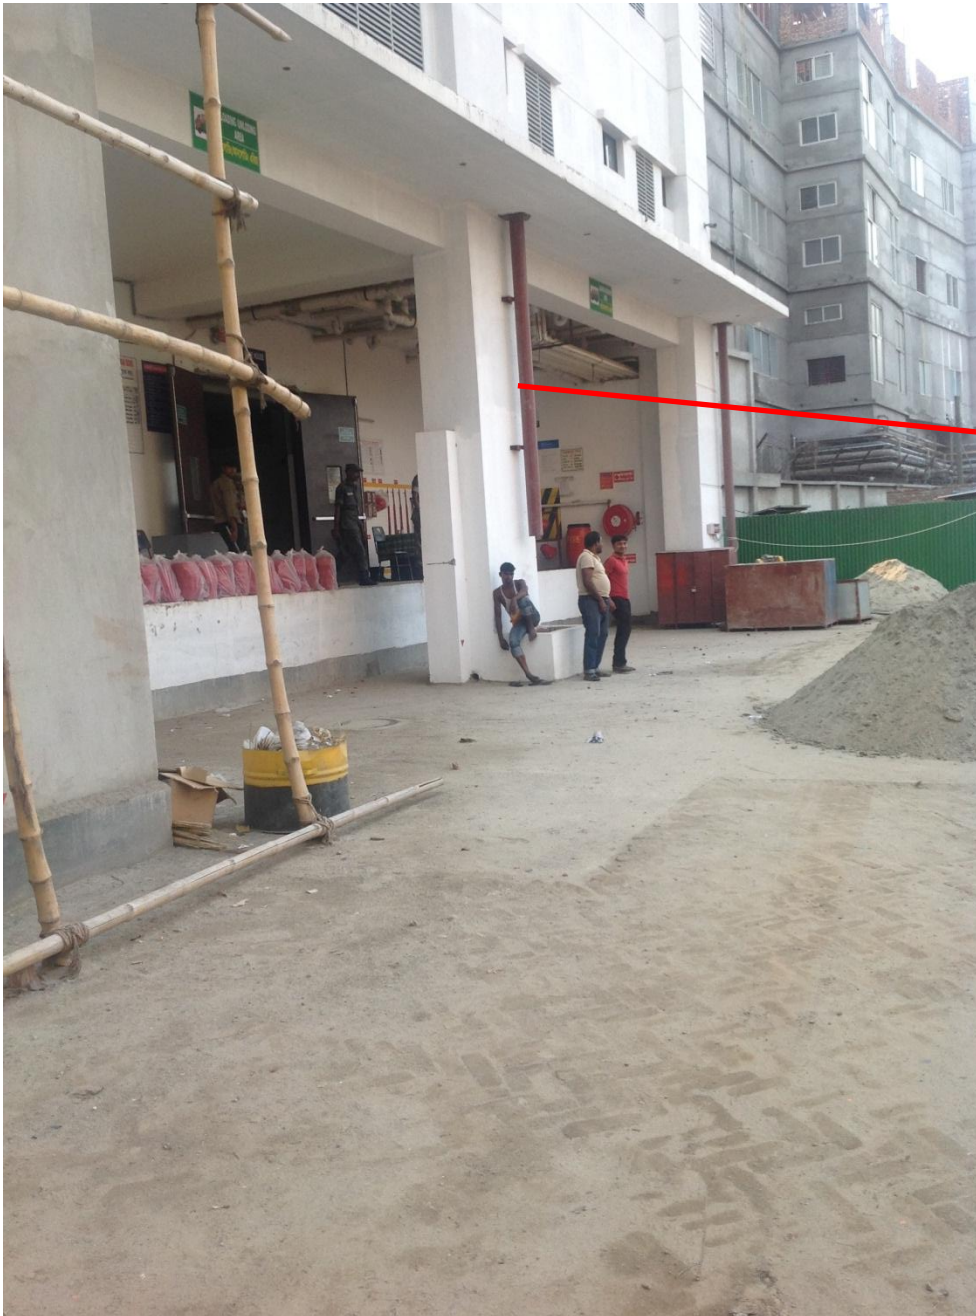
Column in loading bay vulnerable to vehicle impact.

Impact protection should be provided.
