Comfit Composite Knit LTD (Unit 2)

Amtola, Kathgora Bazar, Ashulia, Savar, Dhaka
(+23.907331N, 90.288456E)
29th March 2014

Executive Summary (Continued)

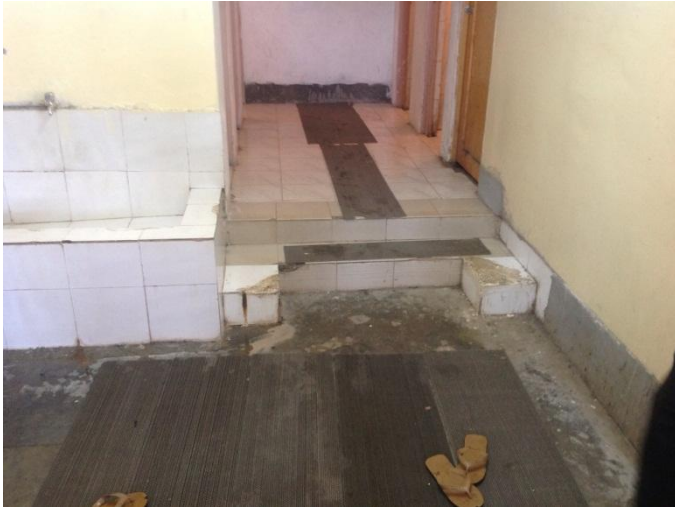
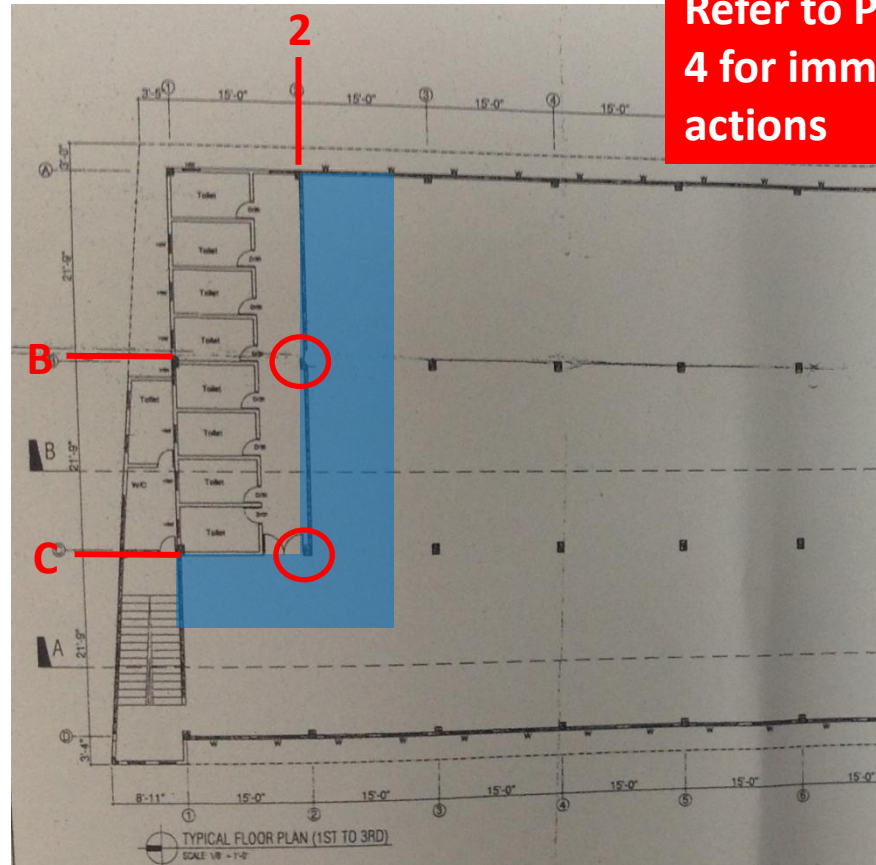
Columns appear to be stressed in excess of normal design limits

Due to the heavy floor construction in the toilet areas at 1st to 3rd Floors, outline calculations indicate that the columns on Gridline 2 are highly stressed to levels that require immediate review

Refer to Pages 3 and 4 for immediate actions

Area highlighted to be vacated and Specific design check to be carried out on columns at ground floor level which support heavy toilet floor construction

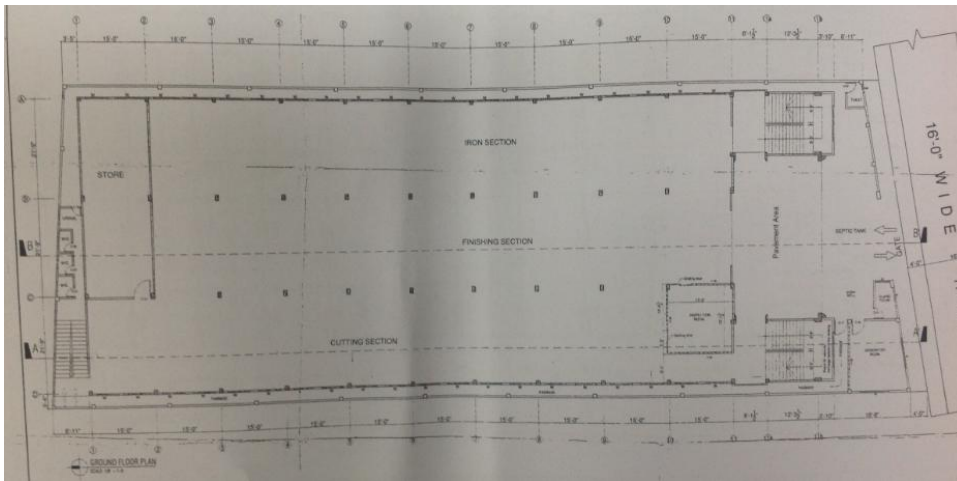
Typical column layout

Outline calculations indicate that column sizes appear to be smaller than required by code for the applied dead and live load, assuming typical concrete strength

Building Engineer to perform detailed calculations and concrete tests to prove column size and (if required) :

- Reduce loads further by preparation of allowable floor loading plans
- Carry out strengthening works

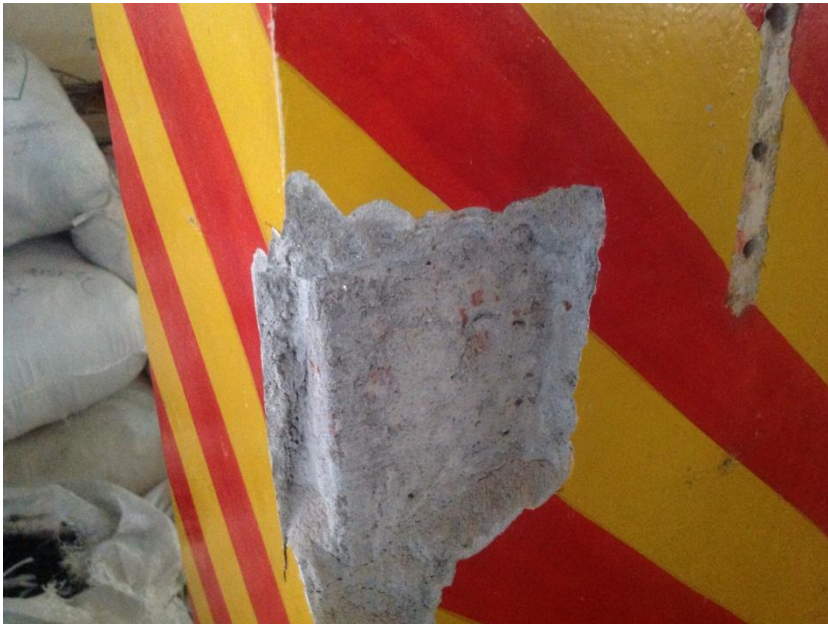
Tested Ground Floor Column – Brick Chip aggregate concrete

7 Column Strength

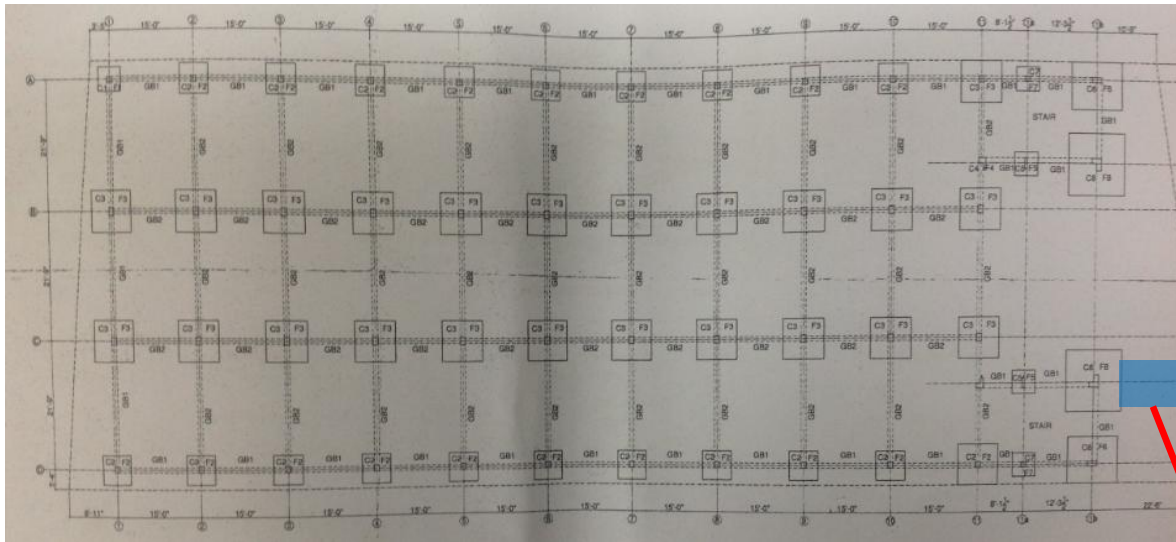
Foundation layout plan

Undermining of existing foundations during excavation for new generator bases.

Risk that the existing foundation is undermined by excavation. Building Engineer to review excavation and existing foundation depth immediately

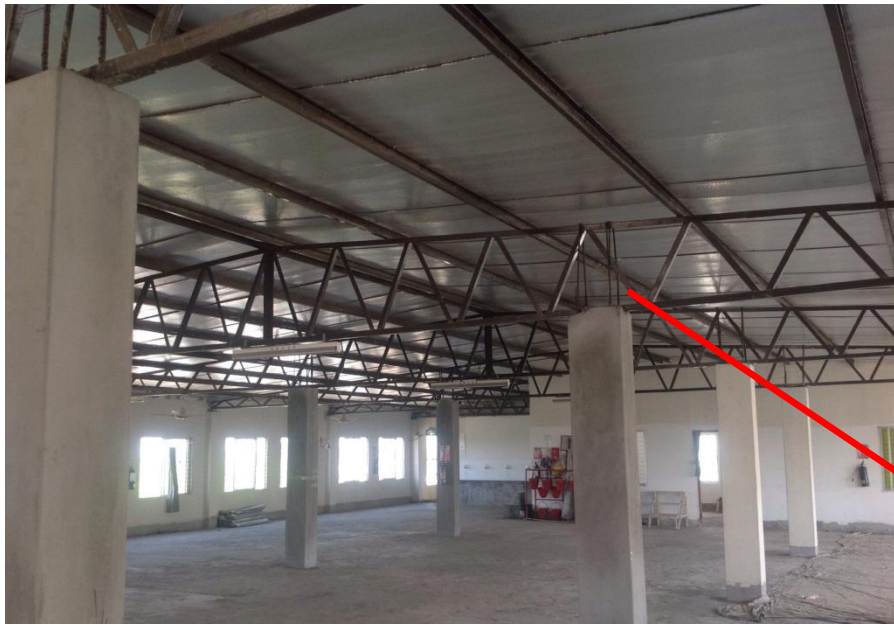
**Roof structure held in place with reinforcement from columns
Roof truss support to be checked**

**Bottom Chord of Truss not supported at connection node –
Check Bending of member.**

Roof structure not shown on the permit or structural design drawings.

Roof structure to dining area may be susceptible to wind uplift. Check required to confirm that the trusses to the steel roof over the dining area are adequately designed and braced to resist high wind loading. Building Engineer to review.

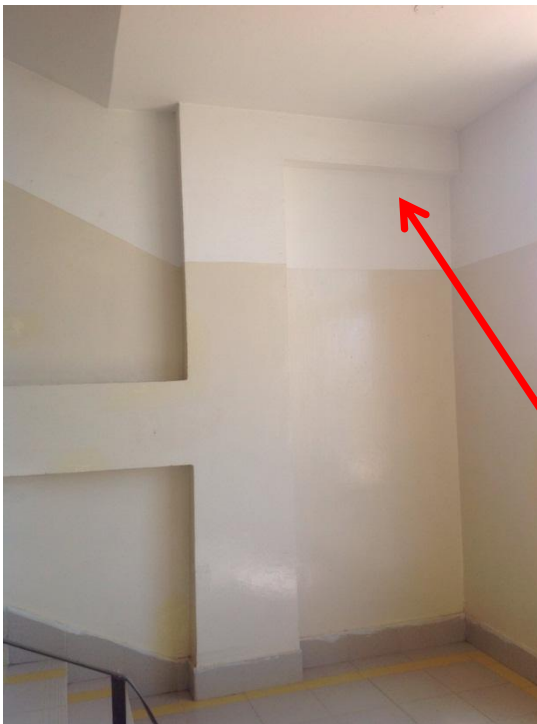
Stairwell cantilever beam

Cantilever to south end of stairwell has no back span apart from stairs

Engineer to verify as-built arrangement of stairwells, including cantilever beam, landing slab and supporting column adequacy.

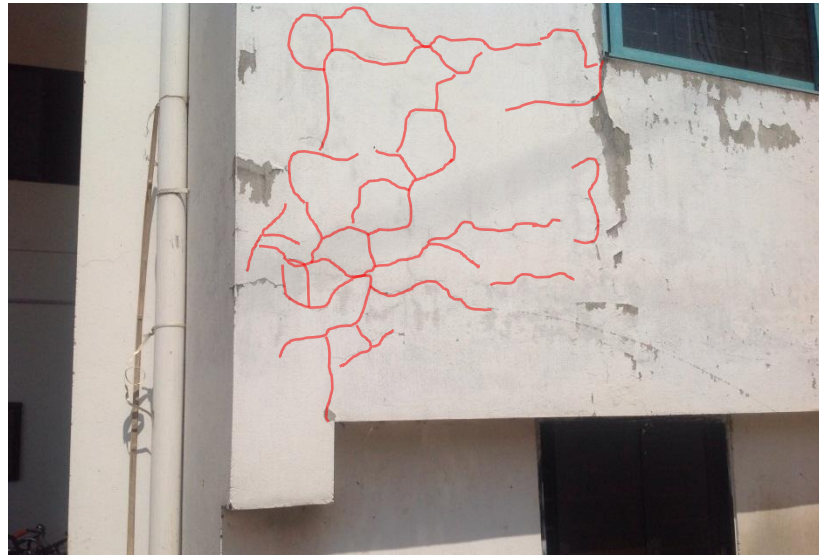
Cracking was noted in brickwork on exterior of stairwell

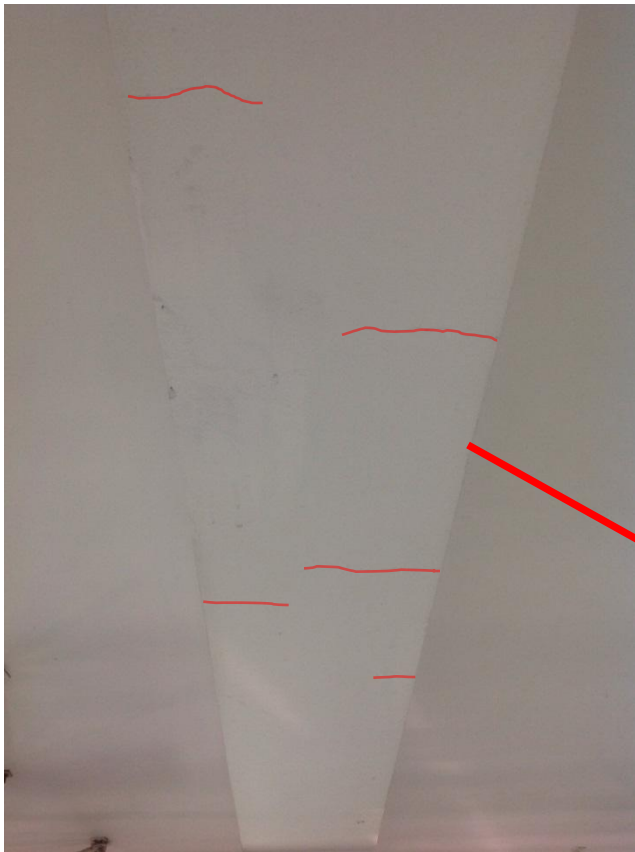
Hairline cracking to beams and soffits of slabs

Cracking at soffit to beam supporting 2nd floor slab

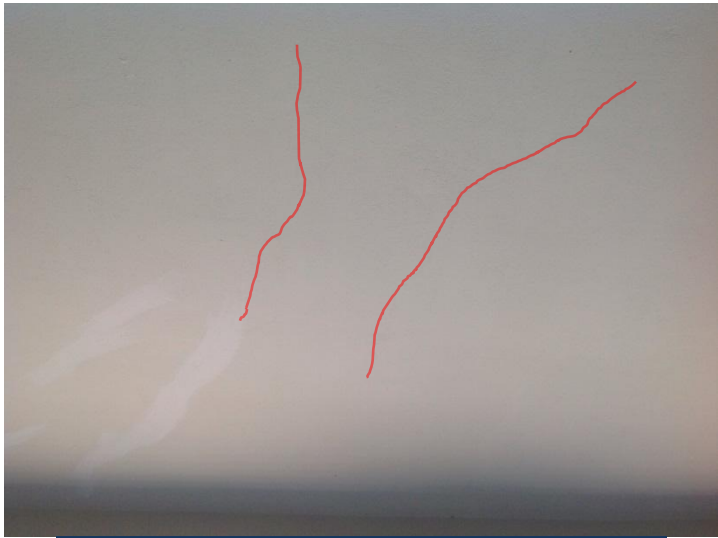
Cracking at soffit to fourth floor slab

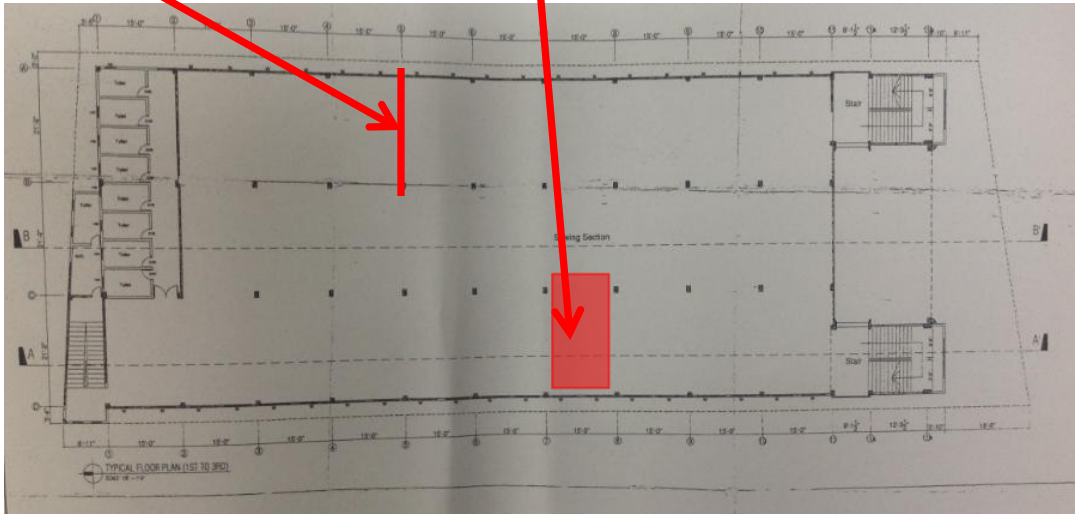
Typical plan showing crack locations on suspended slabs

Cracking to concrete structure

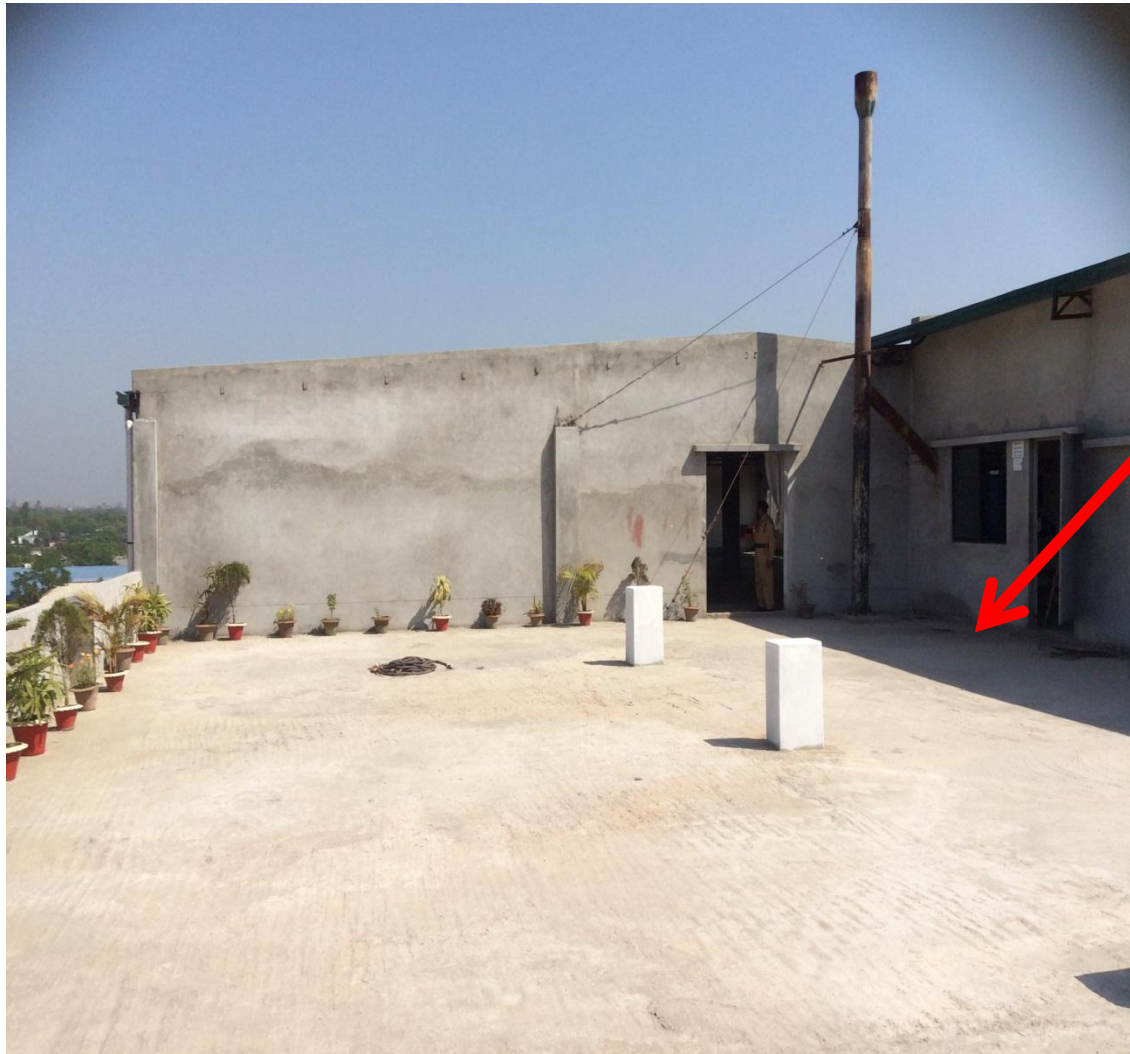
Roof slab does not have any protection from water ingress and limited falls to small drainage outlets.

Potential for water load and damage in heavy rainfall
