# Babylon Casualwear Ltd

## Aboni Fashions Ltd

## Suravee Garments Ltd

Plot-23,24, Tetulzhora, Hemayetpur, Savar, Dhaka  
(23.792784N, 90.254587E)  
29 March 2014

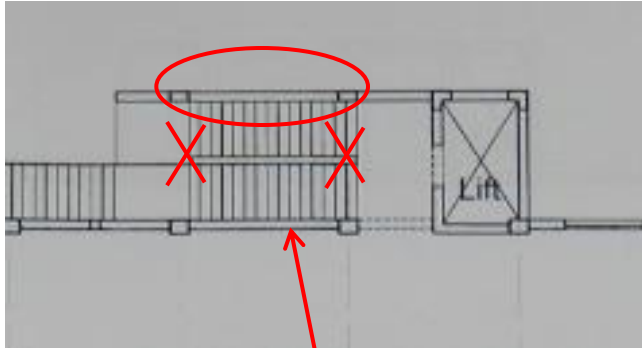
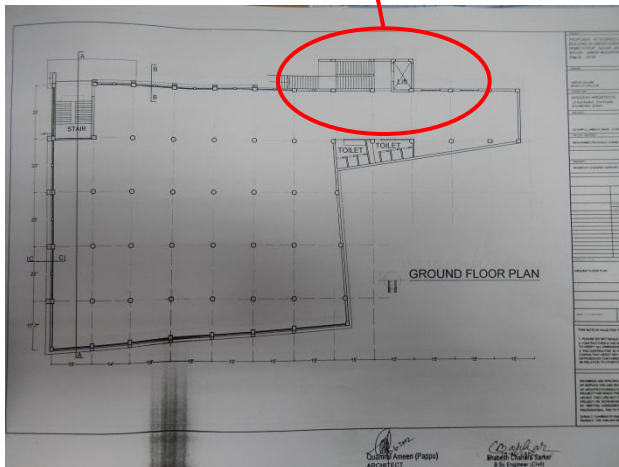
Typical Column Layout

Drawings below indicate column at external wall of stairs.  
X indicate external column location

Cursory review of the stairwell column layout has changed to a cantilever carrying 7 storey loads

Building Engineer to check that columns have been designed to accommodate applied loads.

| Item No. | Observation | Recommended Action Plan | Recommended Timeline |
|---|---|---|---|
| 1 | Cursory calculations indicate that the working stress of columns are at a high level in the external stairwell and other areas of Unit 1 | Maintain current use of the floors and do not change use or increase occupation, either of which could increase loading. | Immediate - Now |
| 2 | Cursory calculations indicate that the working stress of columns are at a high level in the external stairwell and other areas of Unit 1 | Factory Engineer to review design, loads and columns stresses in all columns | Immediate - Now |

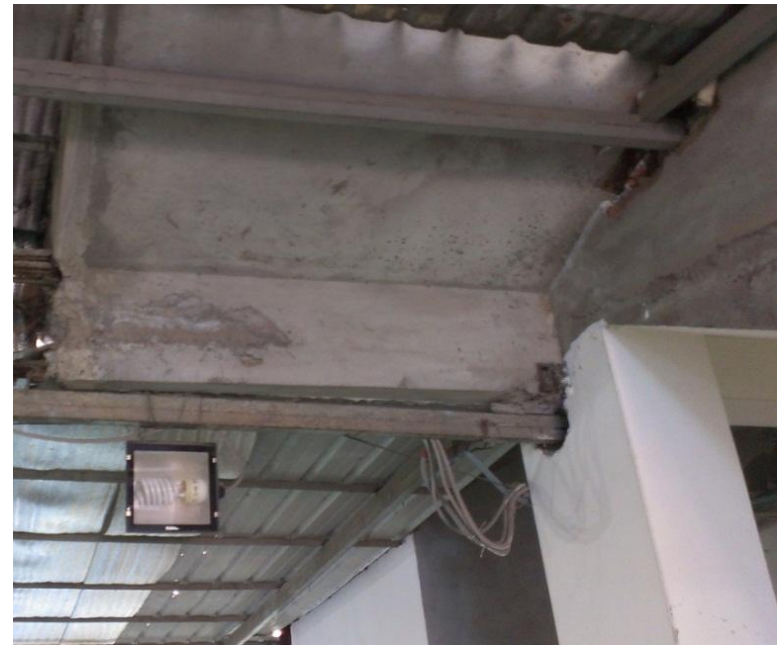
Photo taken of stairwell column as built

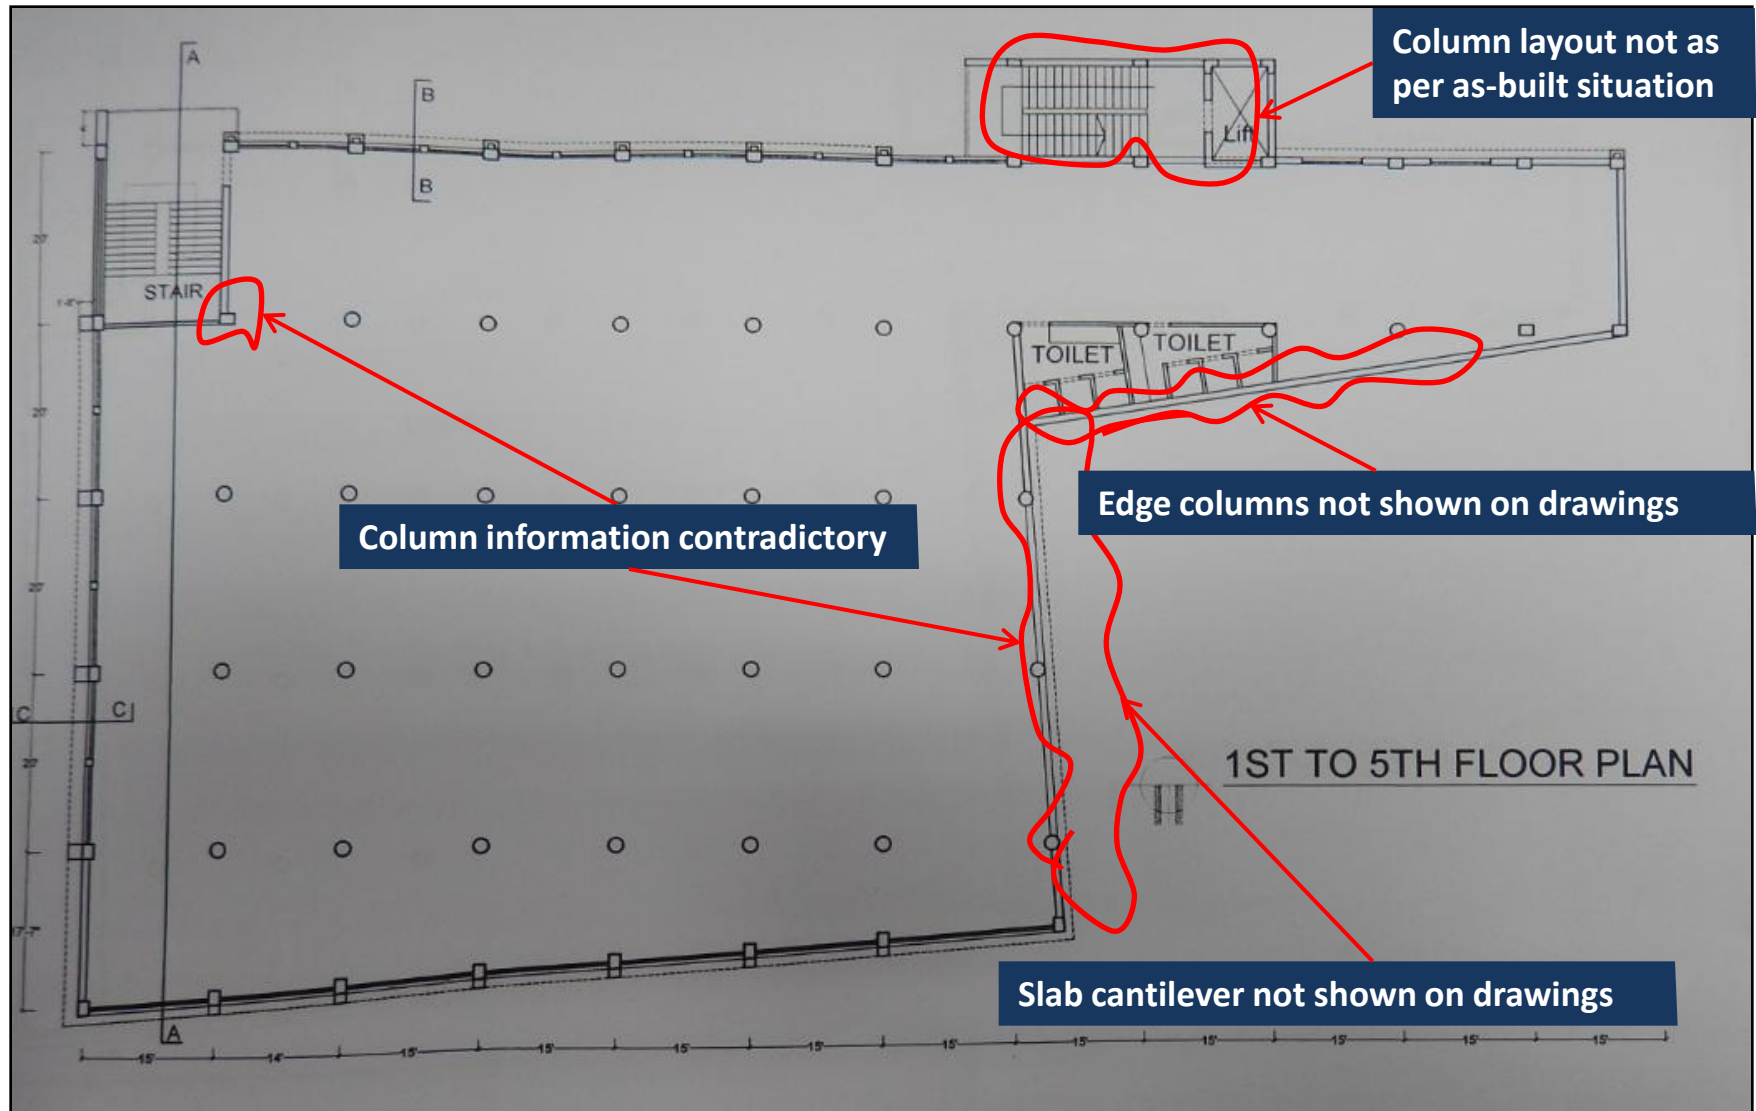
Drawing indicates a non-exhaustive list of discrepancies encountered

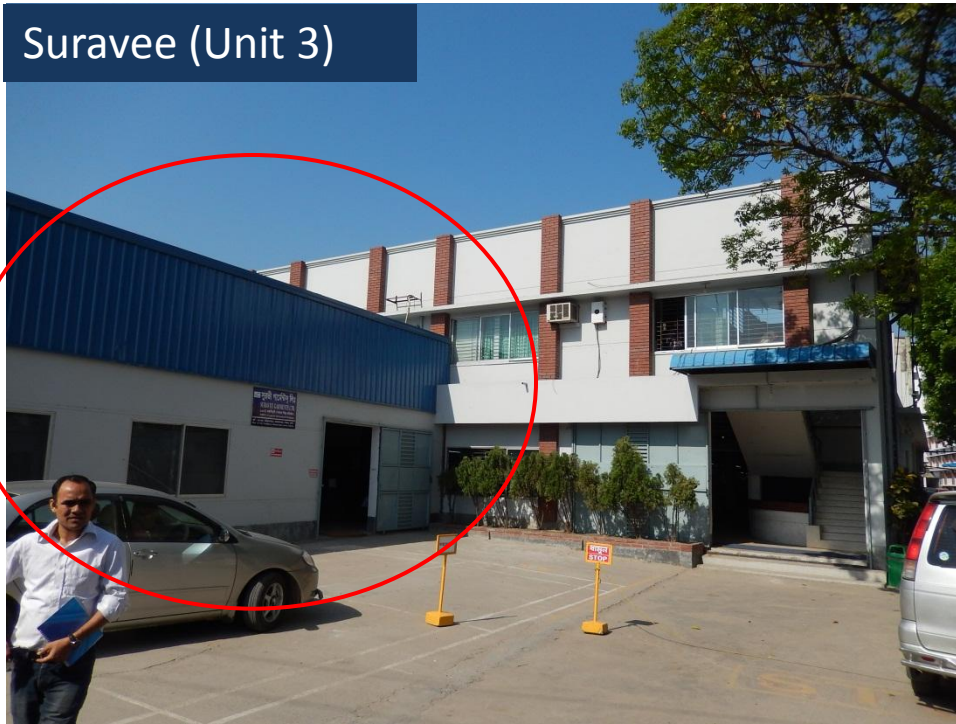
Horizontal extension to the ground floor of 3 storey building, comprising brick masonry walls with a lightweight steel trussed roof. No evidence of horizontal bracing.

No structural or design documentation provided for extension. Subject to uplifting forces.

Evidence of localised cracking at column caps.

| Item No. | Observation | Recommended Action Plan | Recommended Timeline |
|---|---|---|---|
| 8 | Engineering Assessment of undocumented horizontal extension (Unit 3) | The Building Engineer to check the load plans and confirm whether the main building structure is capable of safely supporting the additional loading on the structure from the floor extension | 6-weeks |
| 9 | Engineering Assessment of undocumented horizontal extension (Unit 3) | Building Engineer to provide detailed calculations for the Unit 2/3 structures and the associated light steel roof. These should confirm their ability to withstand all wind loading pressure, suctions and uplift forces | 6-months |
| 10 | Engineering Assessment of undocumented horizontal extension (Unit 3) | Building engineer to check, collect information and produce accurate and complete as-built documentation | 6-months |

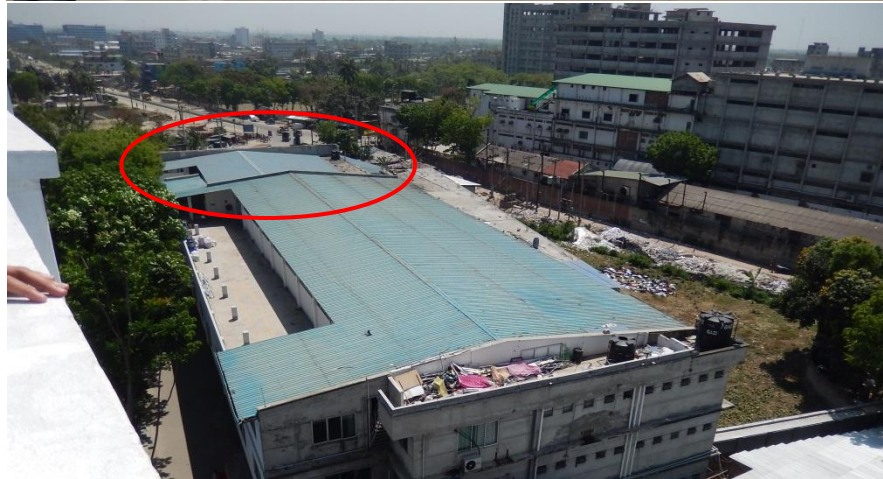
Areas highlighted show extents of new undocumented buildings

**Check on additions required**

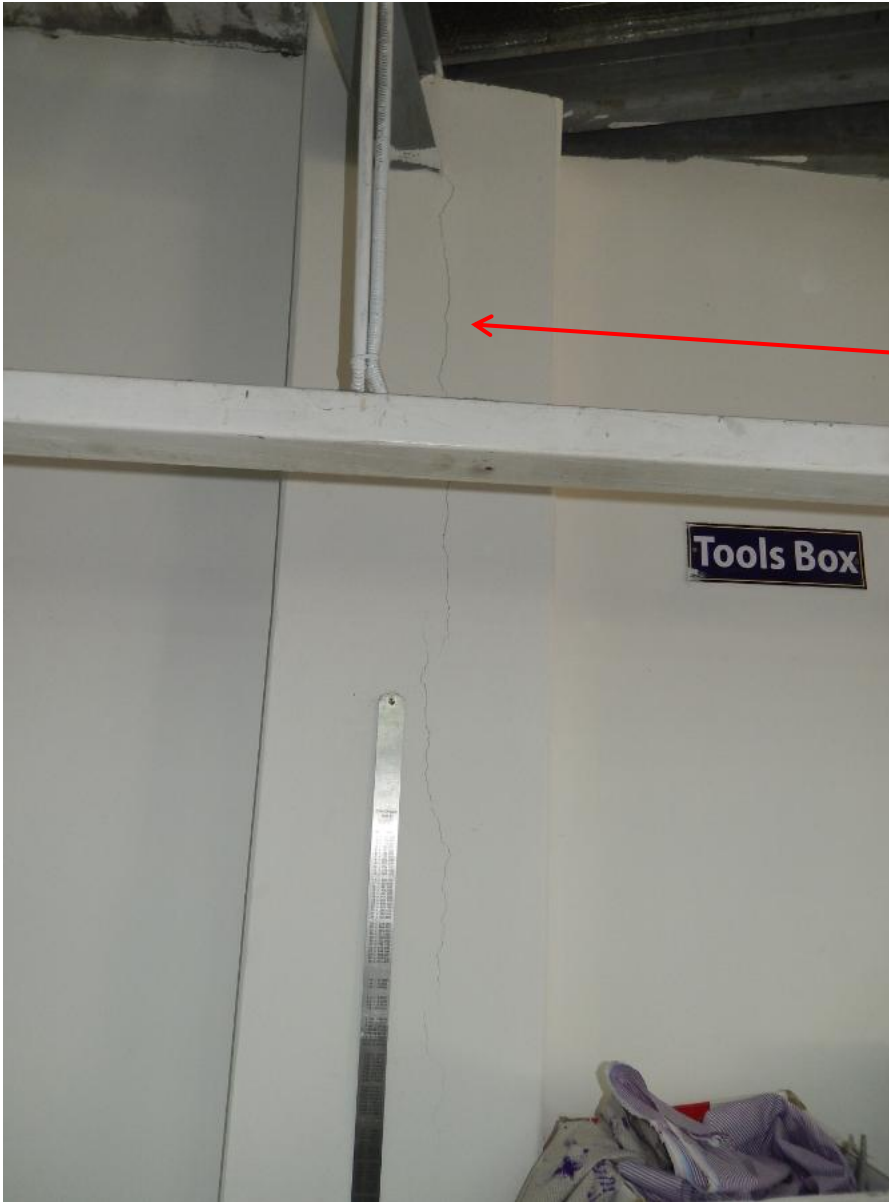
Suravee (Unit 3)

Evidence of localised cracking at column caps.

**Check on additions required**

| Item No. | Observation | Recommended Action Plan | Recommended Timeline |
|---|---|---|---|
| 11 | Cracking in column caps within sheds (Unit 3) | Extent of loading to be assessed on the brick columns and review of the current vertical cracking. The capacity of columns to be assessed to confirm that the structure is designed to carry these loads | 6-weeks |
| 12 | Cracking in column caps within sheds (Unit 3) | Produce detailed engineering drawings and calculations for the Unit 2/3 structures ensuring design meets the anticipated loadings | 6-months |

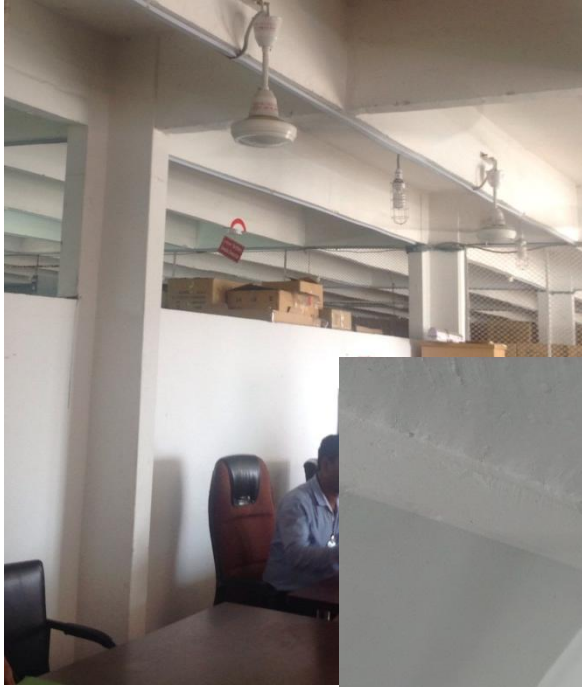
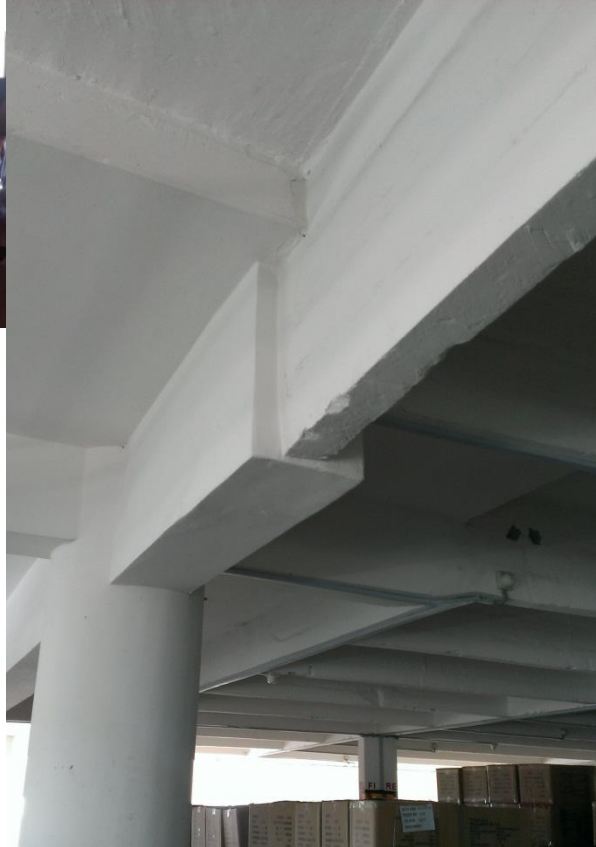
Roof level of 7 storey building has utilised pan slab & T columns in lieu of 2 way slab and circular columns. Particular focus on the transition (bottom left photo).

| Item No. | Observation | Recommended Action Plan | Recommended Timeline |
|---|---|---|---|
| 13 | Different design to the Unit 1 roof slab | Column and slab capacity to be assessed for existing loadings as part of Detail Engineering Assessment (see Item 1). | 6-weeks |
| 14 | Different design to the Unit 1 roof slab | Provide accurate as-built documentation as part of Detail Engineering Assessment | 6-months |

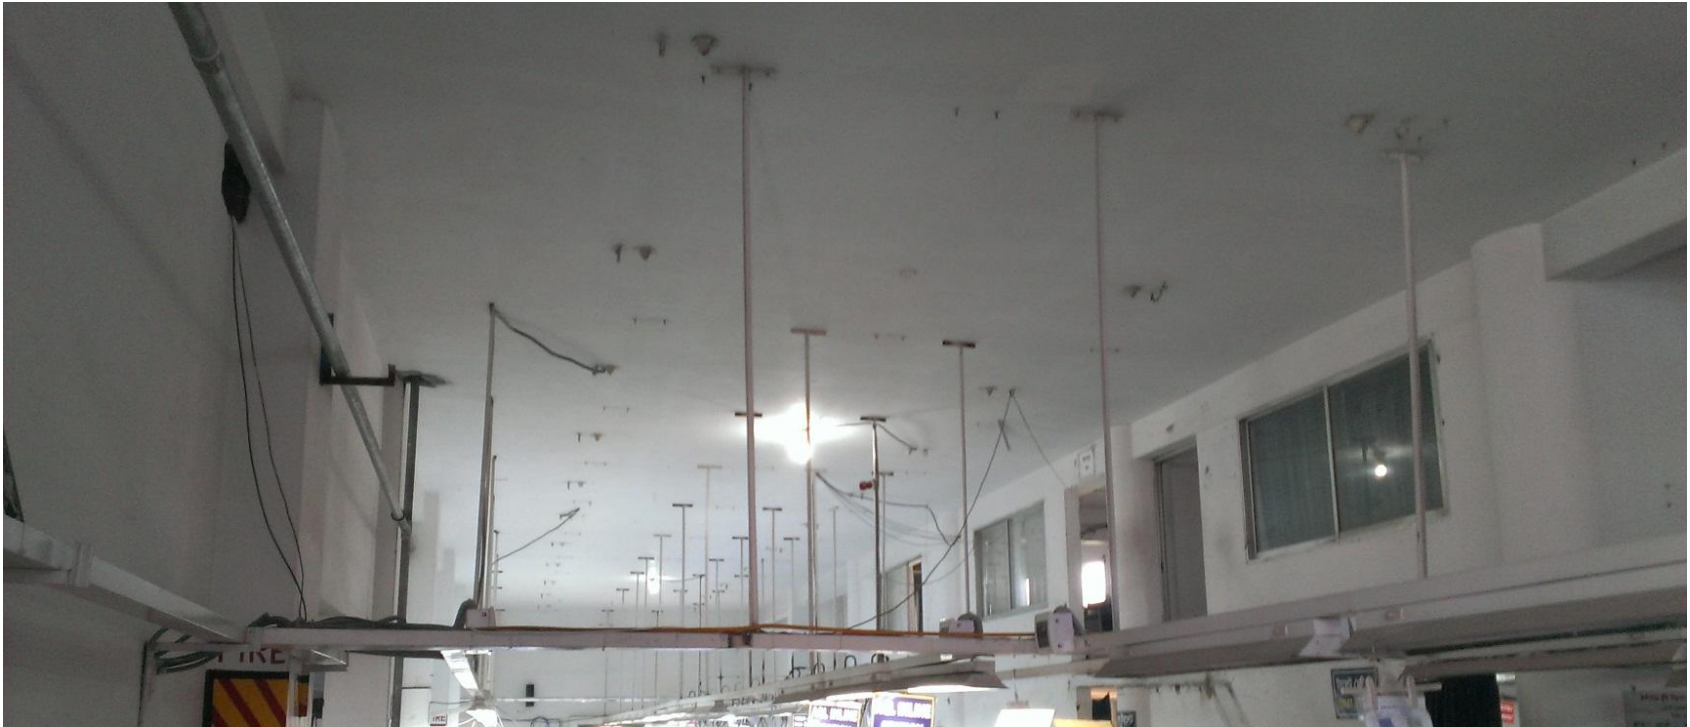
Level 1 slab of 7storey building has utilised a one-way slab in lieu of two-way slab in one section. Drawings do not indicate a one-way slab

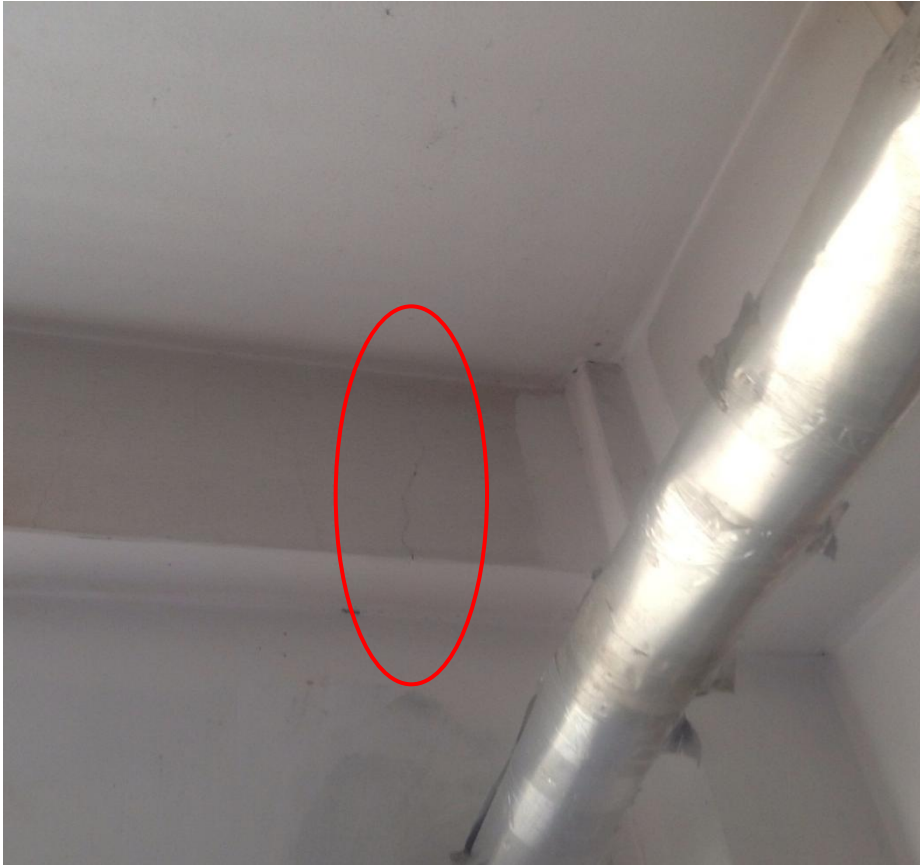
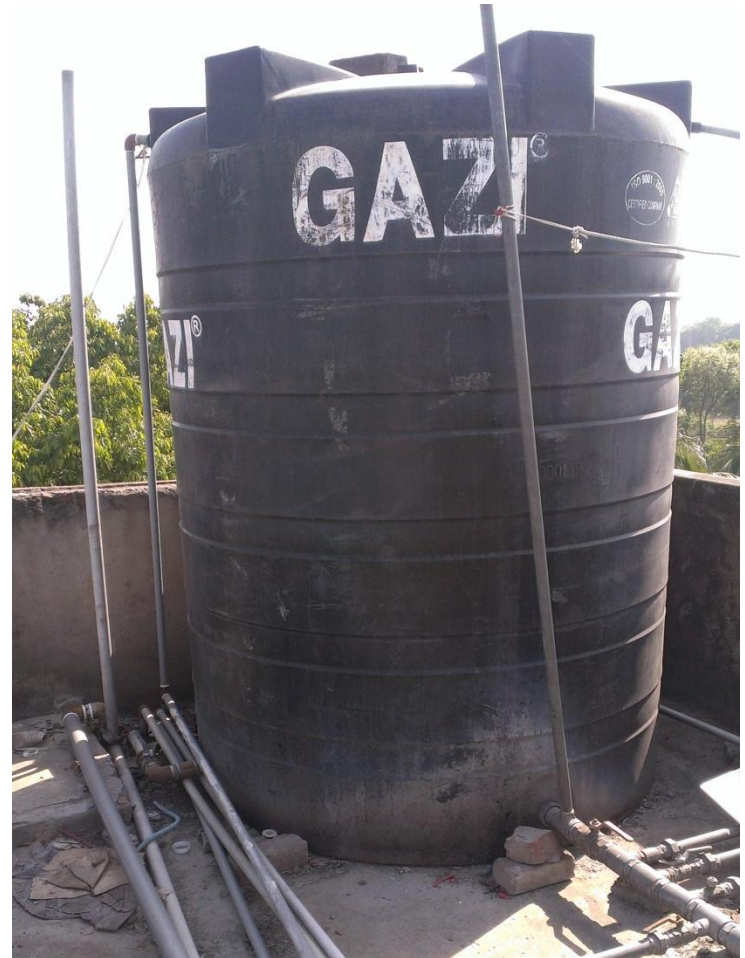
Vertical crack in column in proximity of water tank in Unit 2. Note tank sitting on slab without plinth.

| Item No. | Observation | Recommended Action Plan | Recommended Timeline |
|---|---|---|---|
| 15 | Crack in beam adjacent to water tank location – Unit 2 | Building Engineer to assess whether the building structure can carry the additional point load and submit relevant design document | 6-weeks |
| 16 | Crack in beam adjacent to water tank location – Unit 2 | Building engineer to assess the crack in the beam. | 6-months |
| 17 | Crack in beam adjacent to water tank location – Unit 2 | Carry out remedial work if required. | 6-months |

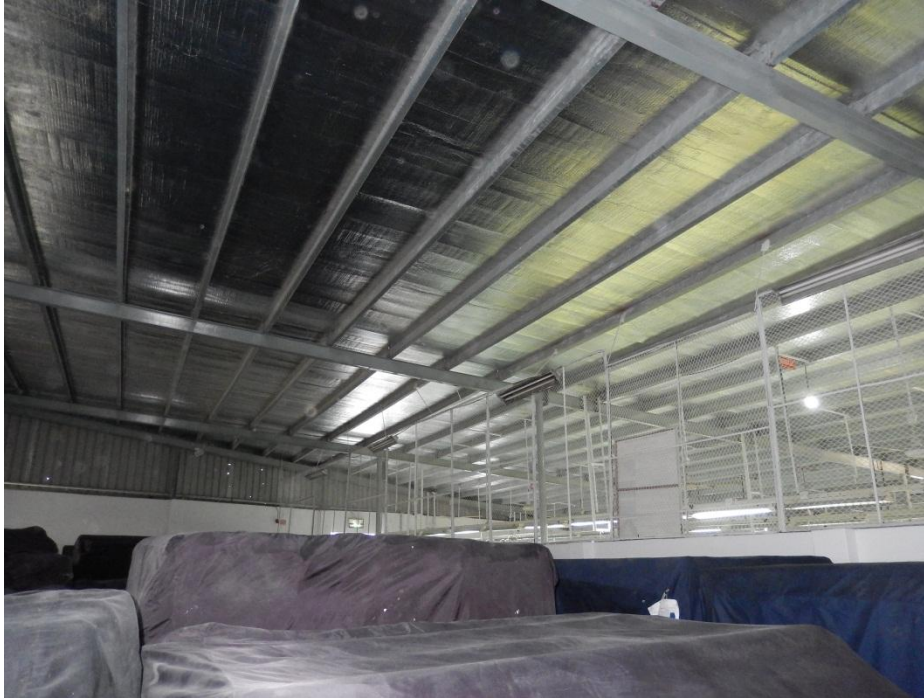
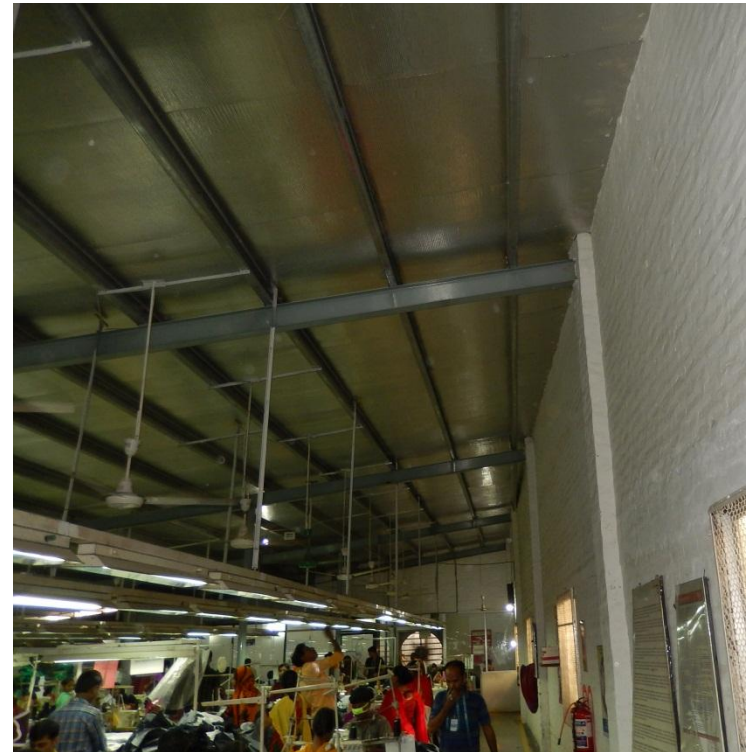
Within shed buildings, no lateral bracing/stability was noted during our reviews

| Item No. | Observation | Recommended Action Plan | Recommended Timeline |
|---|---|---|---|
| 18 | Lateral stability of single storey industrial buildings, and 2-storey steel frame building (Shed 1) | Building Engineer to assess whether building has an appropriate lateral stability system and submit relevant design document | 6-weeks |
| 19 | Lateral stability of single storey industrial buildings, and 2-storey steel frame building (Shed 1) | Carry out remedial work if required. | 6-months |
