# Pole Star Fashion & Design Ltd.

Sharifpur, National University, Gazipur, Bangladesh  
(23.96554N, 90.36843E)

06 April 2014

# Observations

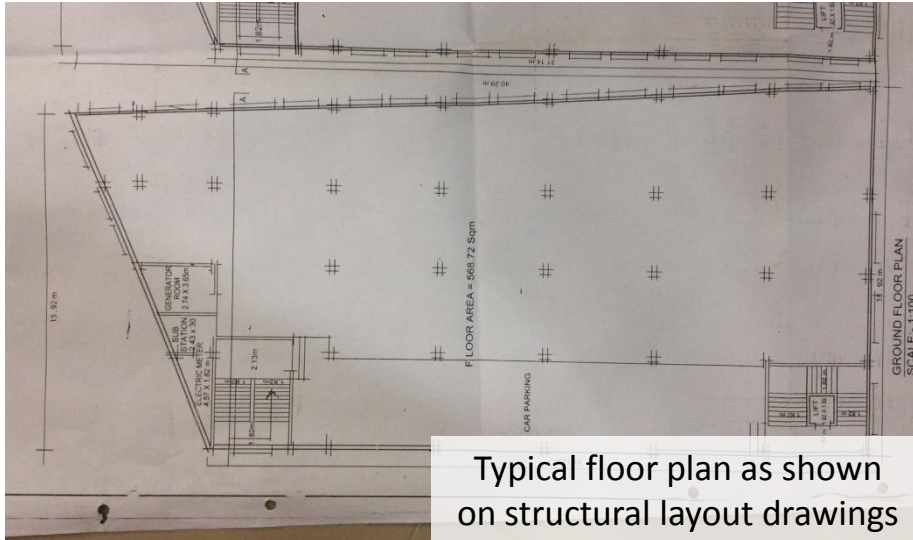
**Structural plans do not align with as-built layouts**

Structural layout drawings do not match as-built layout or industrial permit drawings.

Engineer to produce as-built drawings that are consistent with building frame.

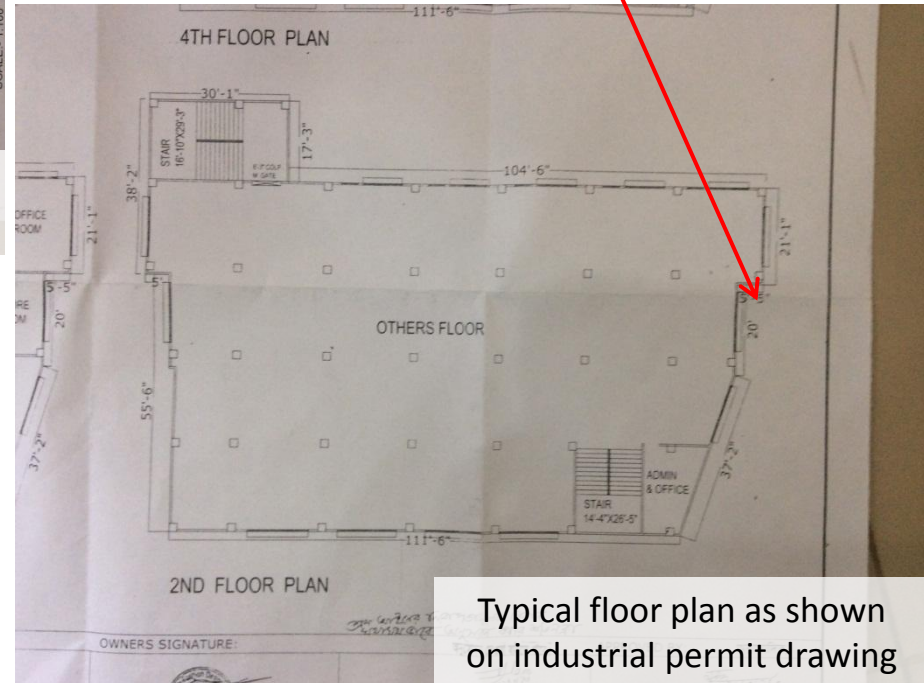
Building cantilevers beyond column line at first floor and above. As-built drawings to be created to suit

| Item No. | Observation | Recommended Action Plan | Recommended Timeline |
|---|---|---|---|
| 9 | Building documentation does not match as-built structure<br>– cantilevers, stair cores, external retaining walls | Building engineer to check, collect information and produce accurate and complete as-built documentation | <b>6-weeks</b> |

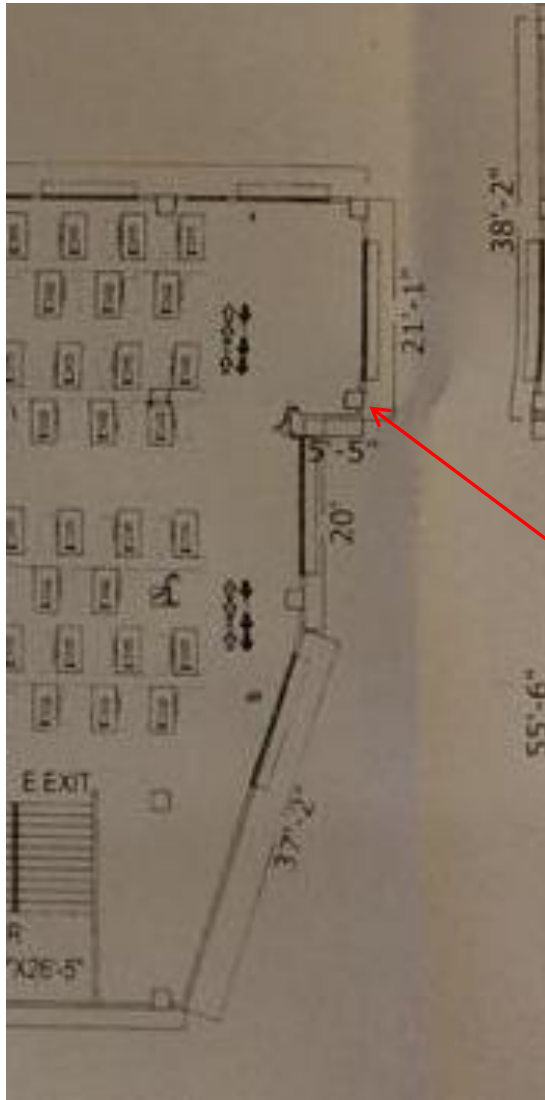
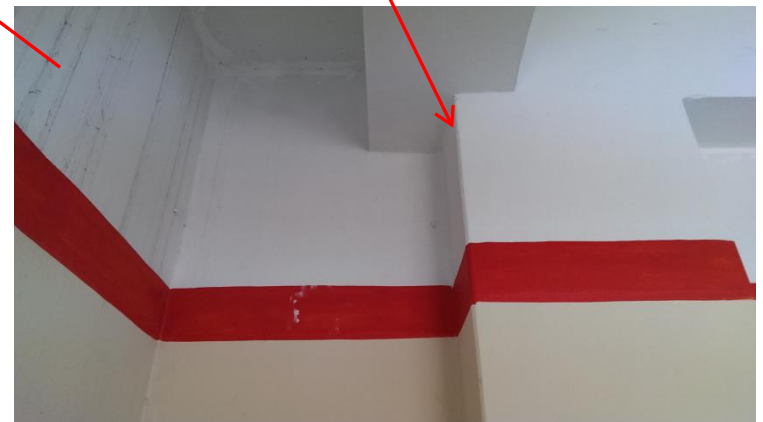
## Edge beam eccentricity

**Building plans do not correspond with as-built structural framing.**

Beams and columns shown to line through on drawings but are offset in reality. Engineer to confirm that beam has been designed and detailed for torsion and that column is designed for beam eccentricity.

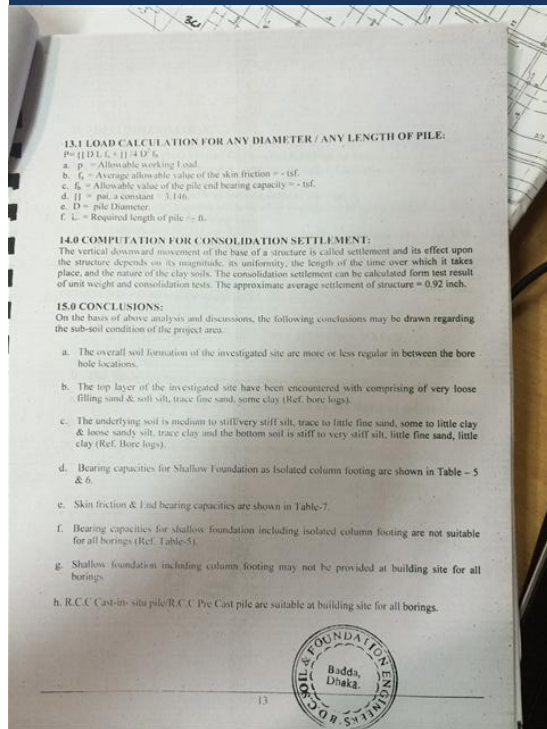
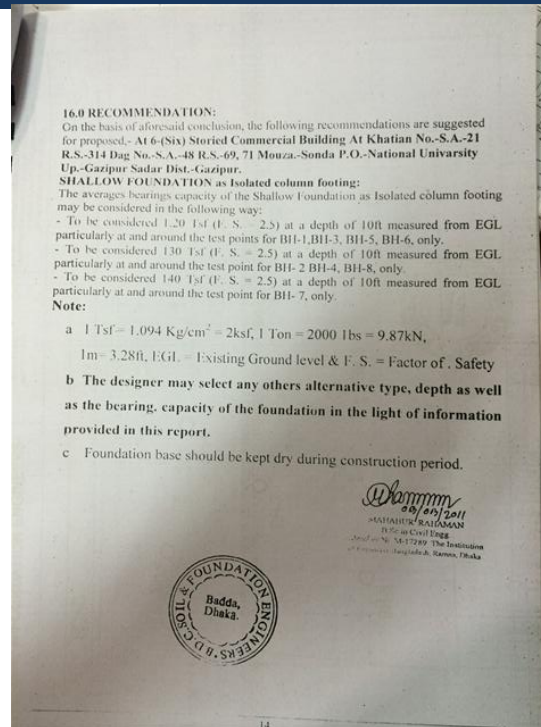
**Foundations & surrounding ground conditions**

Soils report states that “*Shallow foundations including column footings may not be provided at building site for all borings*”, but on next page it states “*shallow foundations as isolated column footings*”, which suggests that shallow foundations **are** allowed. Engineer to ascertain ground conditions and advise whether the foundation types used for the building are suitable.

| Item No. | Observation | Recommended Action Plan | Recommended Timeline |
|---|---|---|---|
| 14 | Uncertainty over advice on foundations in Soils Report | Building engineer to ascertain ground conditions and advise if the foundations used for the building are suitable. | 6-weeks |
| 15 | Uncertainty over advice on foundations in Soils Report | Carry out remedial work if required | 6-months |

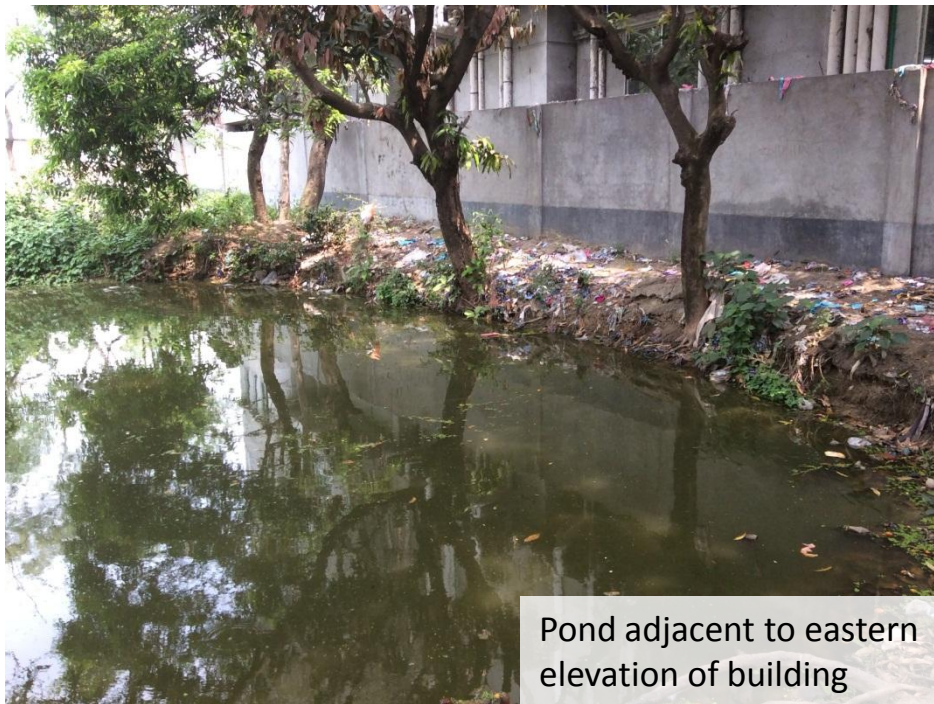
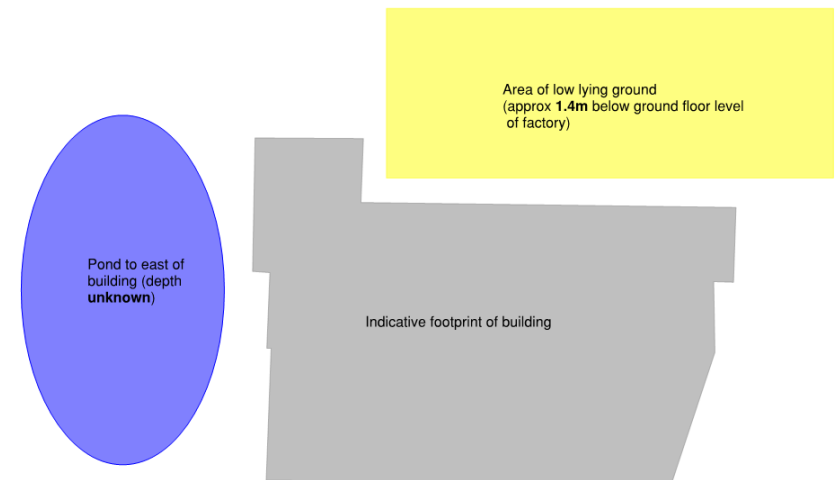
Around the building perimeter there are areas of lower ground e.g. in front of retaining wall and ponds close to building perimeter. These are not mentioned in the soils report. Engineer to confirm that these excavations and proximity to pond do not affect the building foundations. Suggest trial pits are dug to confirm foundation level.

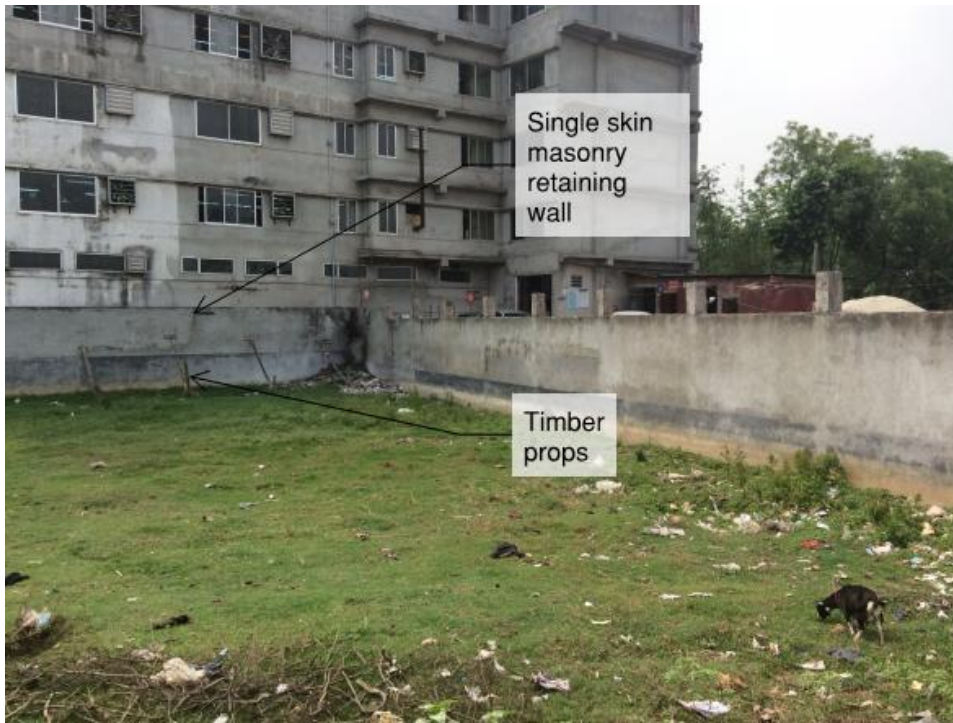
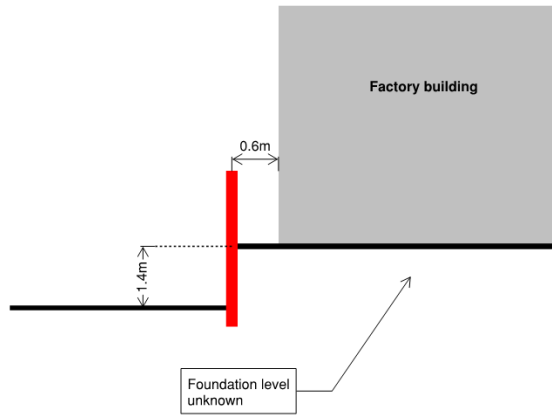
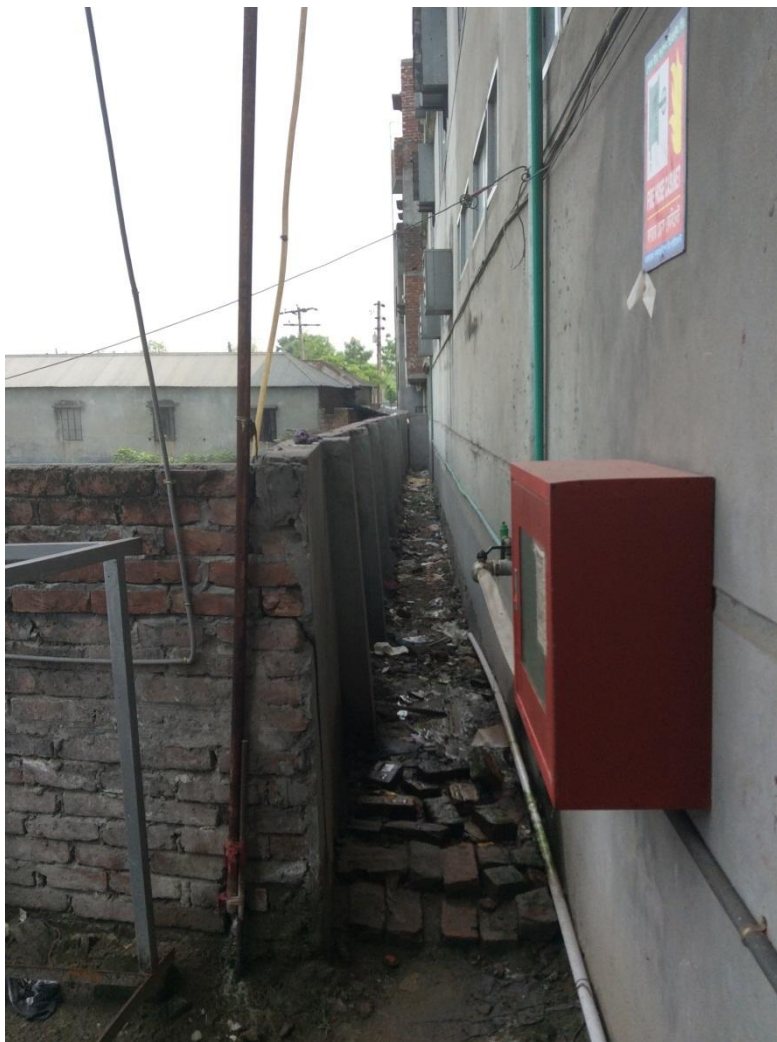
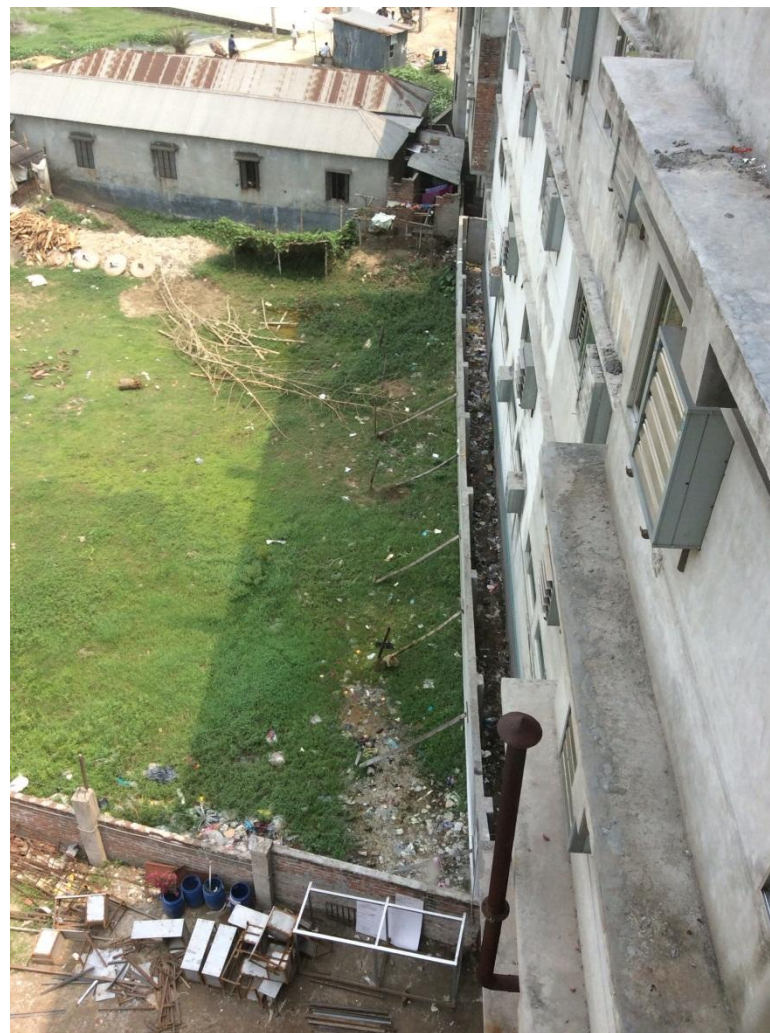
## Retaining wall(1)

No drawings available for single skin masonry wall along northern extent of building (approximate 0.6m from building perimeter). Wall is retaining approximately 1.4m earth on the building side.

Masonry wall appears to have deflected significantly but no movement evident in building façade or structure. Bamboo props appear to have been installed.

Engineer to confirm that foundation level of building is below retained soil and that building does not surcharge wall.

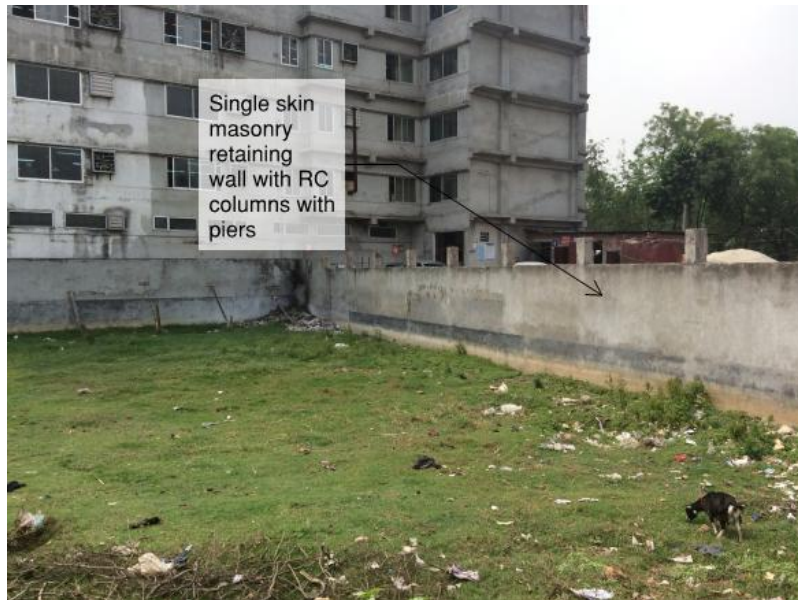
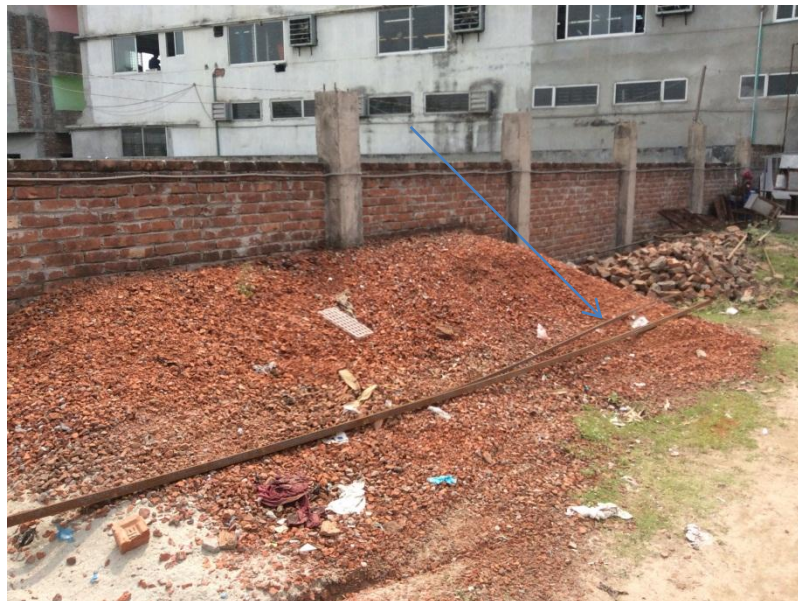
## Retaining wall(2)

No drawings available. It is understood this is supported by ground beams. Engineer to confirm how wall laterally restrains earth.

Column reinforcement was observed protruding above column. Factory owner to confirm whether additional structural modifications are planned to the wall.

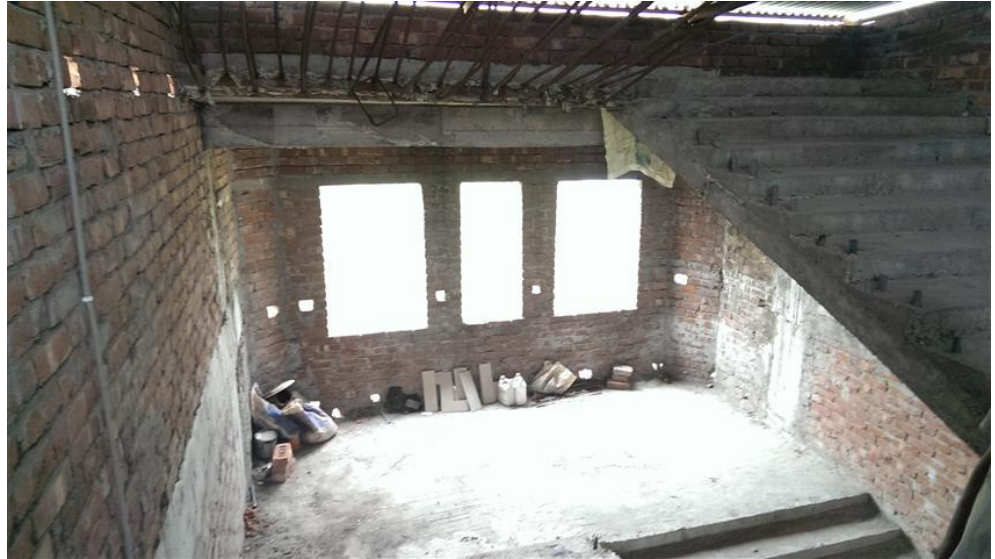
## Masonry pier stability

Piers appear slender, engineer to check design under horizontal and vertical loading.

| Item No. | Observation | Recommended Action Plan | Recommended Timeline |
|---|---|---|---|
| 16 | Undocumented structure – lightweight steel structure and masonry piers | Building engineer to assess light weight roof structure and masonry piers and confirm its ability to withstand all horizontal and vertical loading. Particular attention should be given the masonry within stair cores. | 6-weeks |
| 17 | Undocumented structure – lightweight steel structure and masonry piers | Carry out remedial work if required | 6-months |

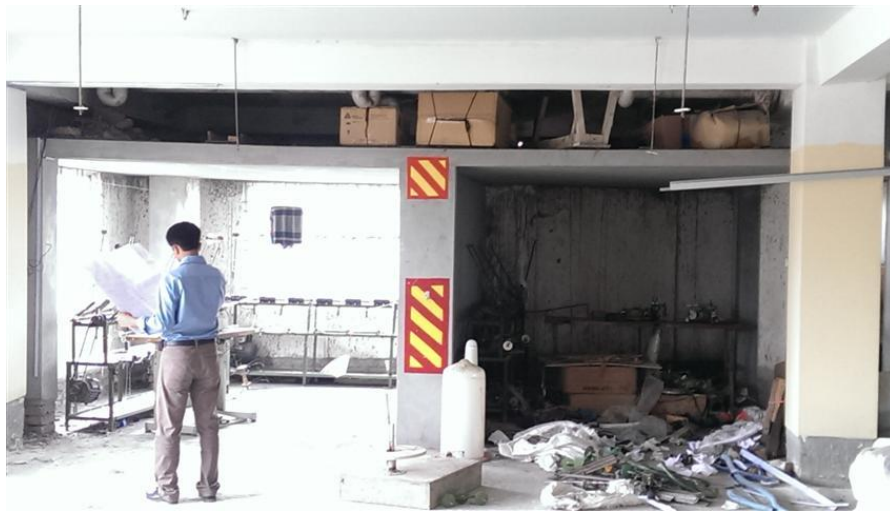
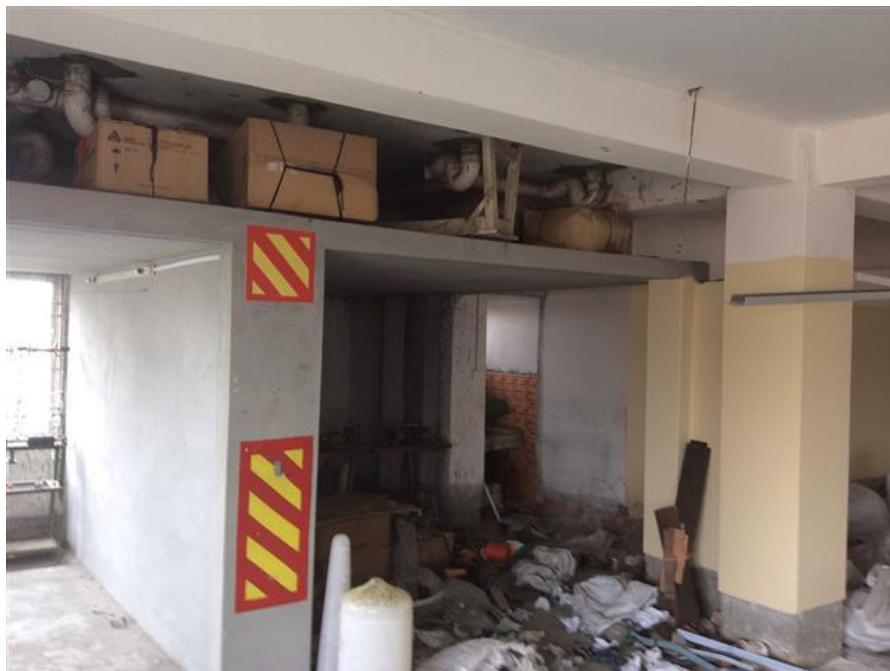
**High loading in area of double slab**

At second floor (currently being fitted out) there is a 135mm thick ceiling slab at high level.

The floor slabs are subject to high loads due to selfweight of the walls, ceiling slab and storage on the ceiling.

Engineer to check load capacity of floor slab and confirm whether floor slab has sufficient capacity to store materials.

| Item No. | Observation | Recommended Action Plan | Recommended Timeline |
|---|---|---|---|
| 12 | Localised areas of high loading in buildings | Extent of build-up loading in toilet and wash areas to be surveyed. Weight of water tanks on roof, and concrete ceiling slab at high-level 2nd floor, to be assessed. The capacity of floor & roof slabs to be assessed to confirm that the structure is designed to carry these loads. | 6-weeks |

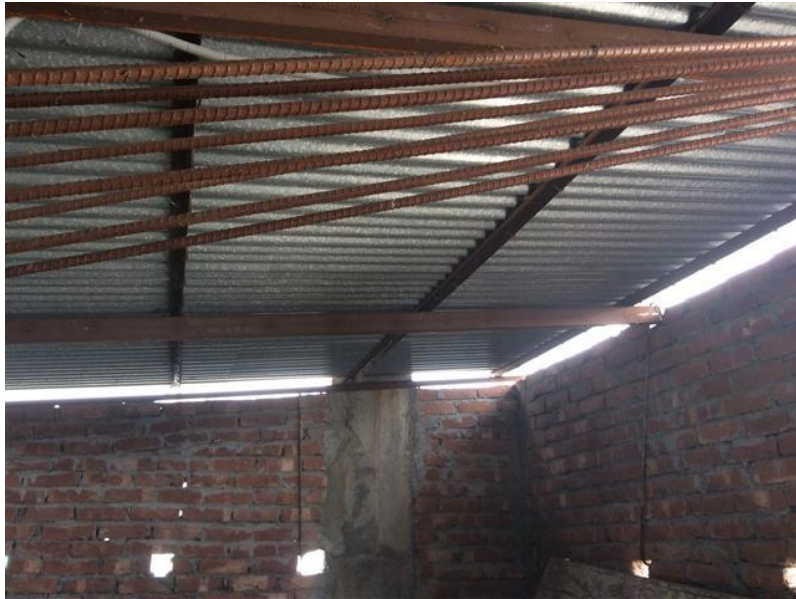
Roof covering to staircase is formed of corrugated iron sheet supported by small steel angle. Lengths of angle appear to have been tack-welded together

Engineer to confirm that structure is suitable for design loadings.

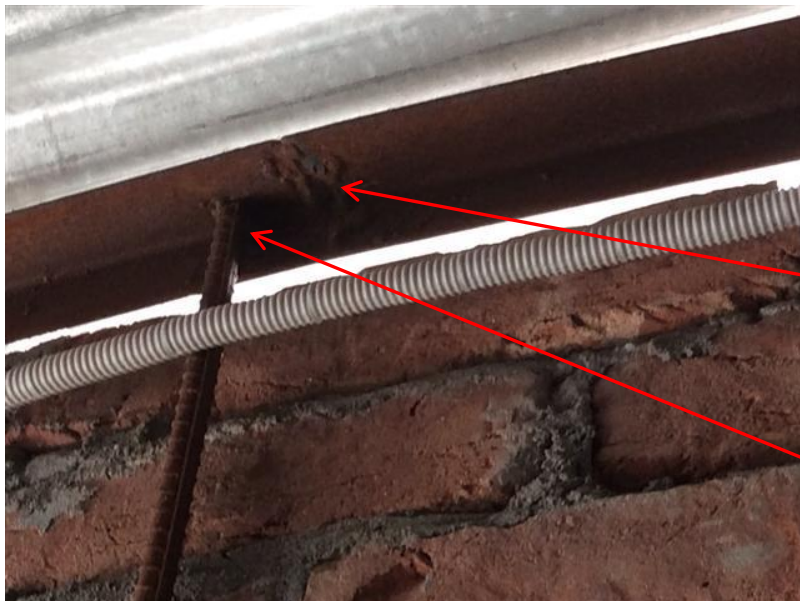
Tack weld between lengths of angle

Roof tied down by welding angle to reinforcement and tying reinforcement to masonry wall.

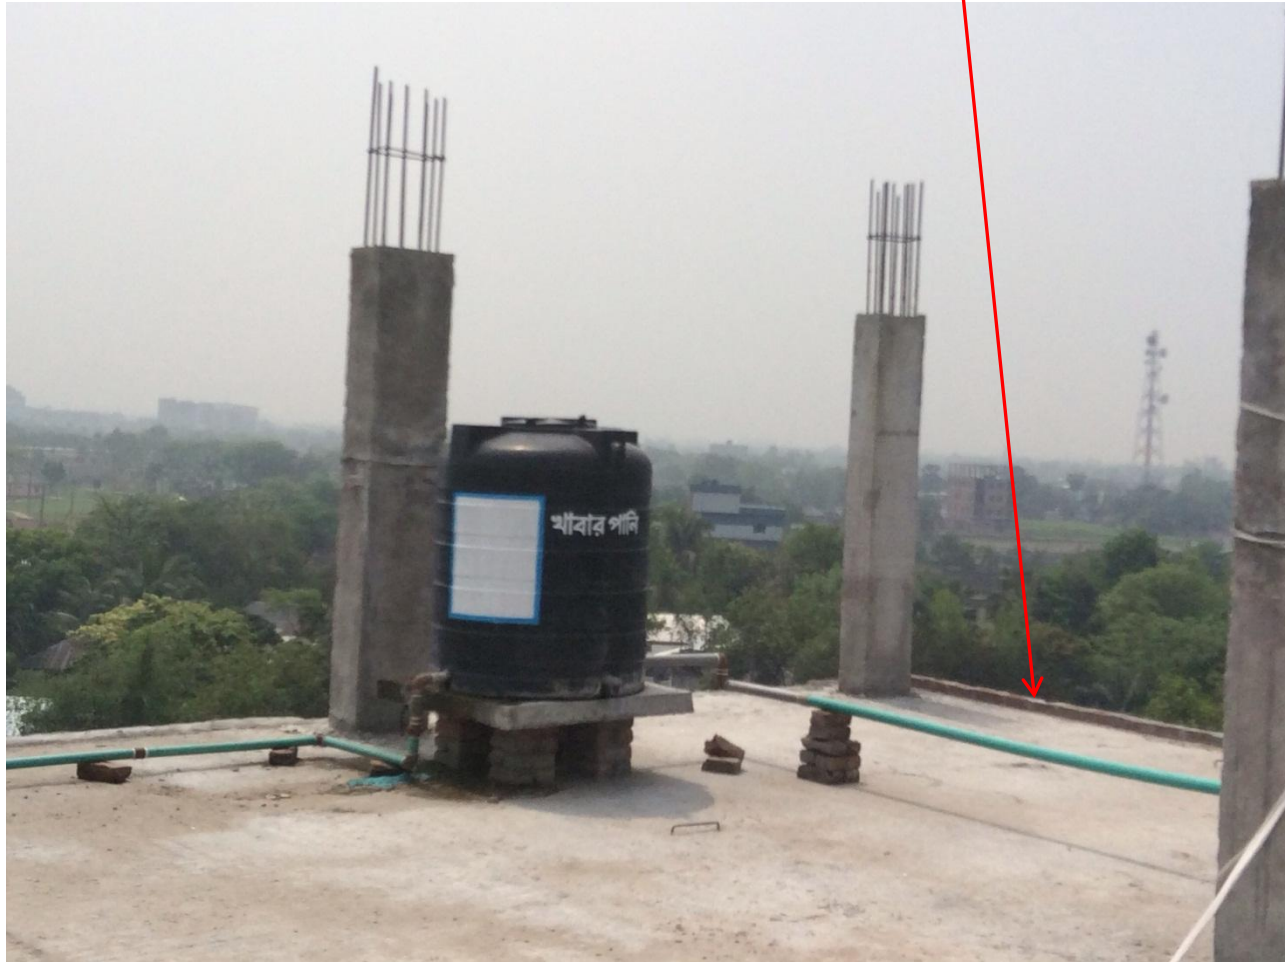
**Edge protection during construction**

## No edge protection when laying masonry façade at 5th floor level.

- Risk of masonry falling and injuring people at ground floor level, and risk of construction workers falling from this level.

| Item No. | Observation | Recommended Action Plan | Recommended Timeline |
|---|---|---|---|
| 18 | Non-structural item - Edge protection at roof | Provide edge protection to protect members of the public from falling building material, and to protect construction workers from falling from a height | Immediate - Now |
