# The Shanin Corporation Ltd

12/1 Hossain Uddin Khan, 1<sup>st</sup> Lane Lalbagh, Dhaka -1211  
(23.720837, 90.377902)  
8<sup>th</sup> April 2014

# Observations

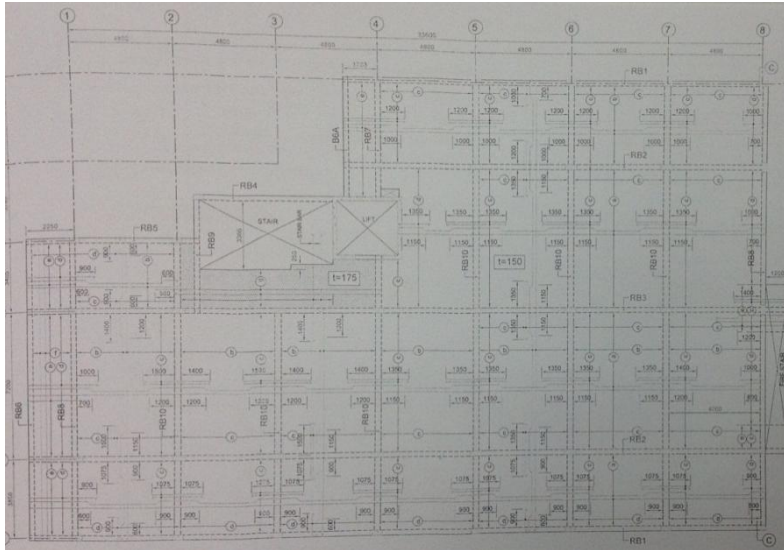
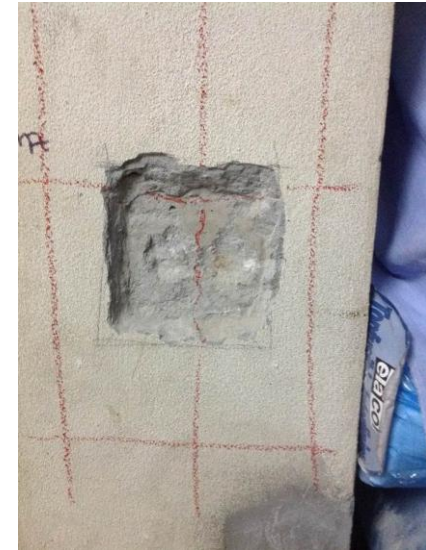
## Building 1: High Column Loads

Preliminary calculations indicate that column working stress is at a high level in Building 1. Significant loading was observed arising from the additional rooftop factory area and the concrete water tank, and in particular columns supporting large bays and cantilever structures were found to be highly stressed.

A **Detail Engineering Assessment** of the building is required (see attached scope). The engineer is to perform detailed calculations based on the as-constructed structural arrangement, material properties and loading to verify column size suitability. If required, column loading shall be reduced, and columns possibly strengthened.

| Item No. | Observation | Recommended Action Plan | Recommended Timeline |
|---|---|---|---|
| 1 | Building 1 - Verify load capacity of all columns | Maintain current use of the floors and don't change use or increase occupation, either of which could increase loading | Immediate - Now |
| 2 | Building 1 - Verify load capacity of all columns | Building Engineer to review loads, design, and concrete stress for all columns in building | Immediate - Now |
| 3 | Building 1 - Verify load capacity of all columns | Verify insitu concrete stresses either by 100mm diameter cores or existing cylinder strength data for minimum 4 columns | Immediate - Now |
| 4 | Building 1 - Verify load capacity of all columns | A Detail Engineering Assessment of Factory to be commenced - see attached scope | Immediate - Now |

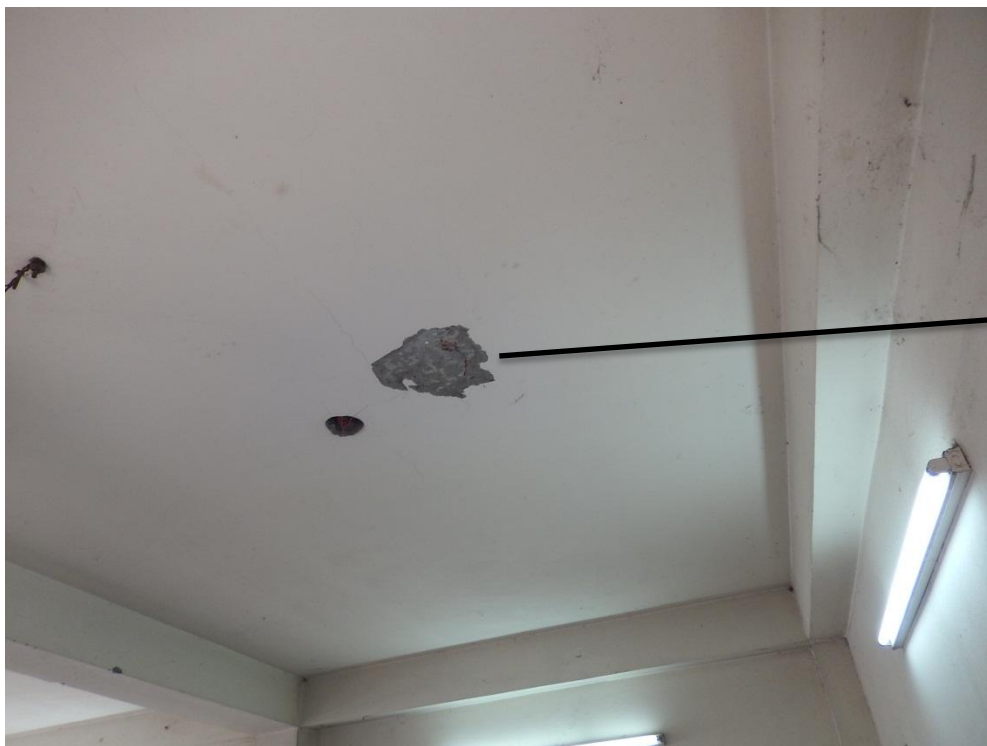
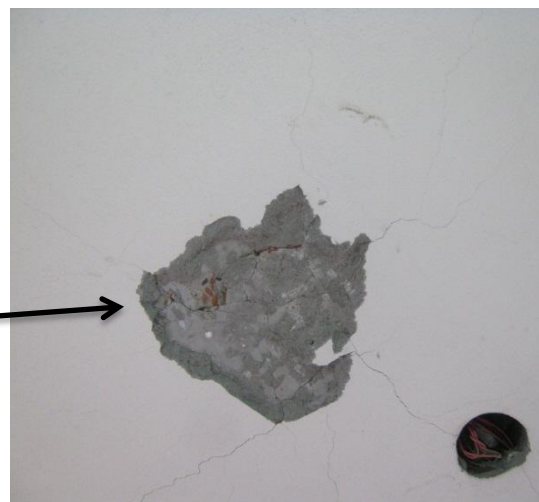
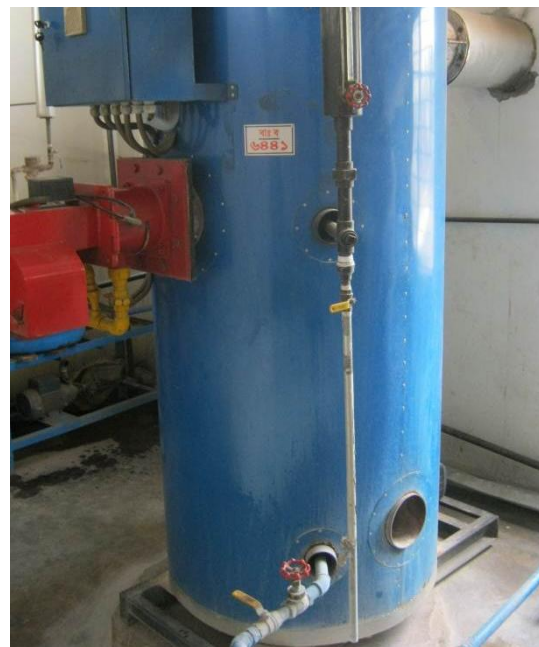
## Building 2: Level 1 suspended slab showing signs of distress

## **Building 2: Level 1 suspended slab showing signs of distress**

To the underside of the Level 1 slab the plaster has cracked and locally fallen-off, and the underside of the structural slab is exposed which also appears to be cracked. This cracking is located under one of the boilers located on the Level 1 slab above.

| Item No. | Observation | Recommended Action Plan | Recommended Timeline |
|---|---|---|---|
| 9 | Building 2 - Level 1 suspended slab showing signs of distress | Building Engineer to ascertain the load-carrying capacity of the Level 1 slab and beams within the building and make proposals for remediation measures (such as load reduction and strengthening), if required | 6-weeks |
| 10 | Building 2 - Level 1 suspended slab showing signs of distress | Implement actions arising from engineering review | 6-months |
| 11 | Building 2 - Level 1 suspended slab showing signs of distress | Produce and actively manage a loading plan for the Level 1 floor plate within the building, giving consideration to floor capacity, column capacity and foundation capacity | 6-months |

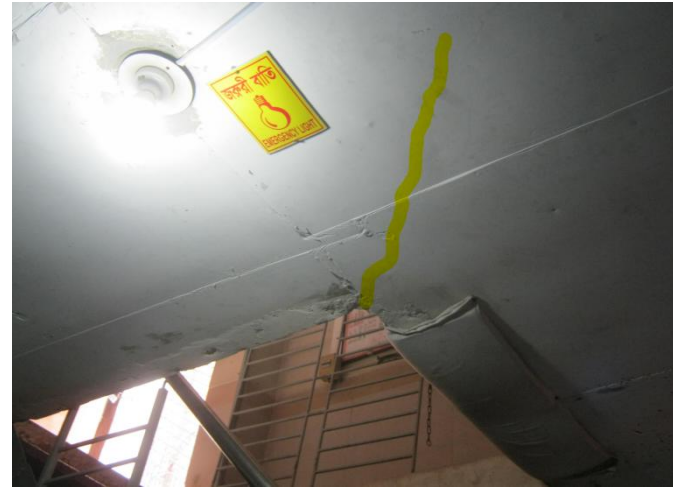
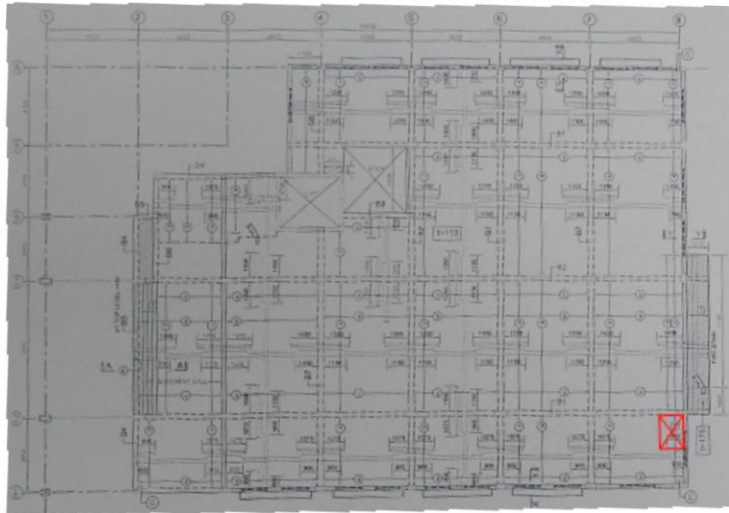
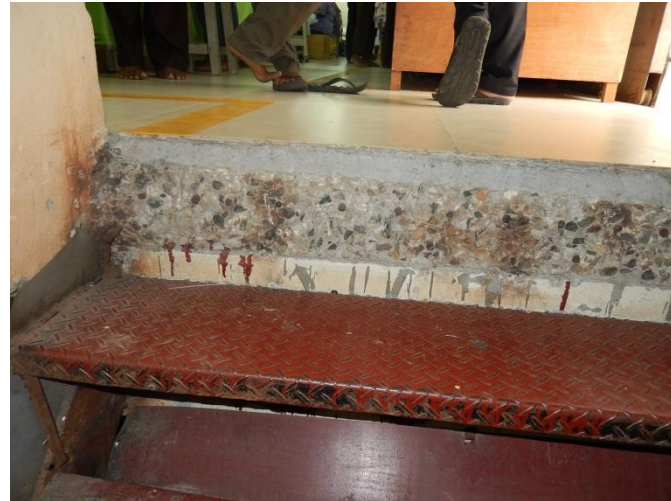
## Building 1: Apparently non-engineered opening in Ground Level slab

# **Building 1: Apparently non-engineered opening in ground level slab**

An opening has been formed in the ground level (suspended) slab for the insertion of stairs down to the basement. Cut ends of the reinforcement bars are exposed. Cracking was observed in the soffit of the Ground level slab from the corner of the new opening near the centre of the slab panel.

| Item No. | Observation | Recommended Action Plan | Recommended Timeline |
|---|---|---|---|
| 12 | Building 1 - Apparently non-engineered opening formed in Ground Level slab for insertion of new Basement stairs | Building Engineer to investigate and monitor diagonal crack in soffit of slab at corner of formed opening | 6-weeks |
| 13 | Building 1 - Apparently non-engineered opening formed in Ground Level slab for insertion of new Basement stairs | Engineer to advise on load repair and strengthening of the slab if required | 6-weeks |
| 14 | Building 1 - Apparently non-engineered opening formed in Ground Level slab for insertion of new Basement stairs | Engineer to specify measures to reinstate corrosion protection to ends of exposed cut slab reinforcement | 6-weeks |
| 15 | Building 1 - Apparently non-engineered opening formed in Ground Level slab for insertion of new Basement stairs | Implement actions arising from engineering assessment | 6-months |

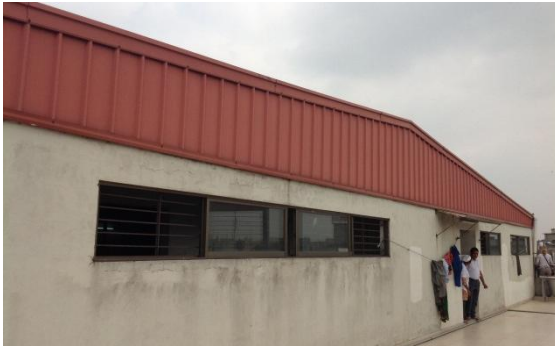
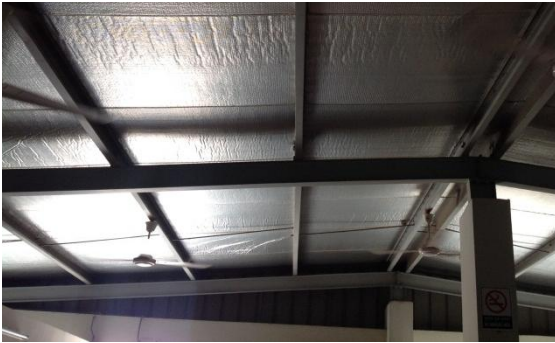
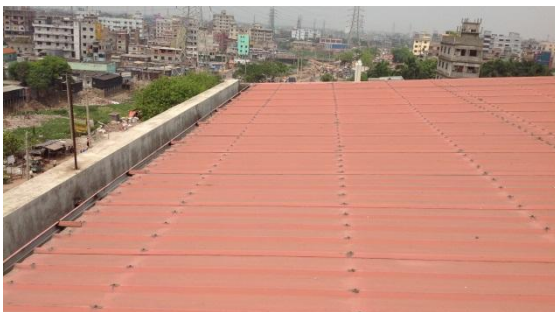
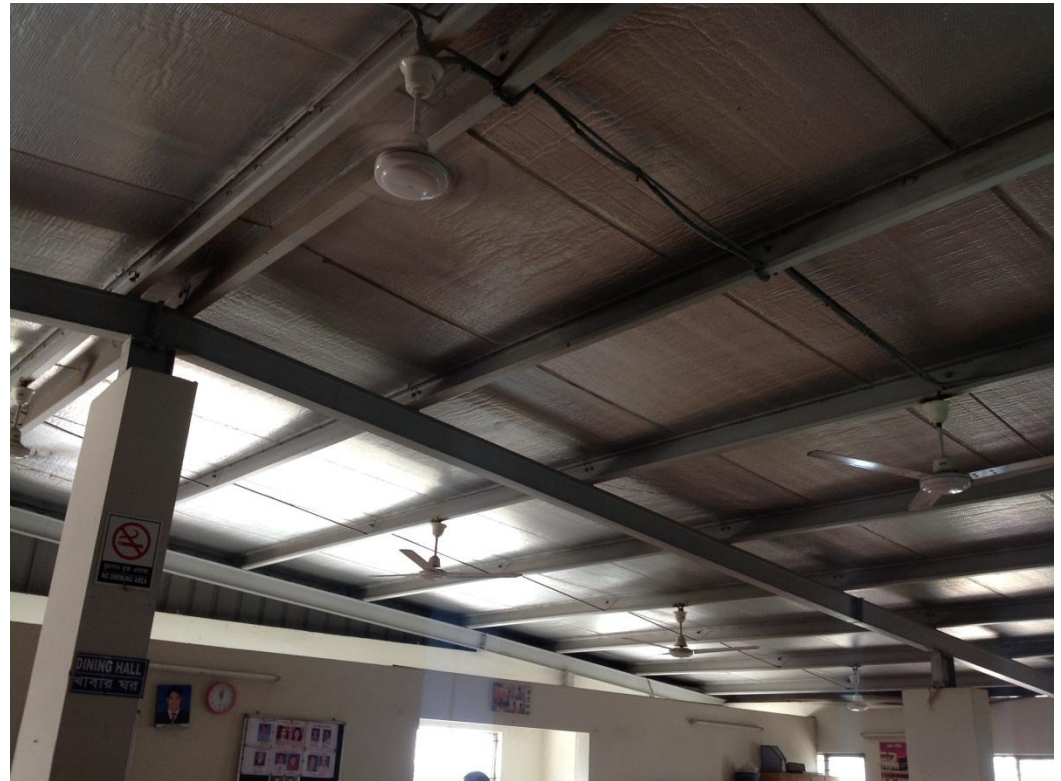
## Building 1: Unclear lateral stability system to Level 7 steelwork roof

# **Building 1: Unclear lateral stability system to Level 7 steelwork roof**

It is believed that the steelwork roof structure over Level 6 is stabilised by column cantilever action, but this could not be verified. No vertical bracing or 'plan' bracing was evident.

| Item No. | Observation | Recommended Action Plan | Recommended Timeline |
|---|---|---|---|
| 16 | Building 1 - Unclear lateral stability system to Level 7 steelwork roof | Building Engineer to investigate the structural adequacy of the roof, with particular regard to the lateral stability system | 6-weeks |
| 17 | Building 1 - Unclear lateral stability system to Level 7 steelwork roof | Engineer to specify any remedial measures that may be required, such as strengthening | 6-weeks |
| 18 | Building 1 - Unclear lateral stability system to Level 7 steelwork roof | Implement actions arising from engineering assessment | 6-months |

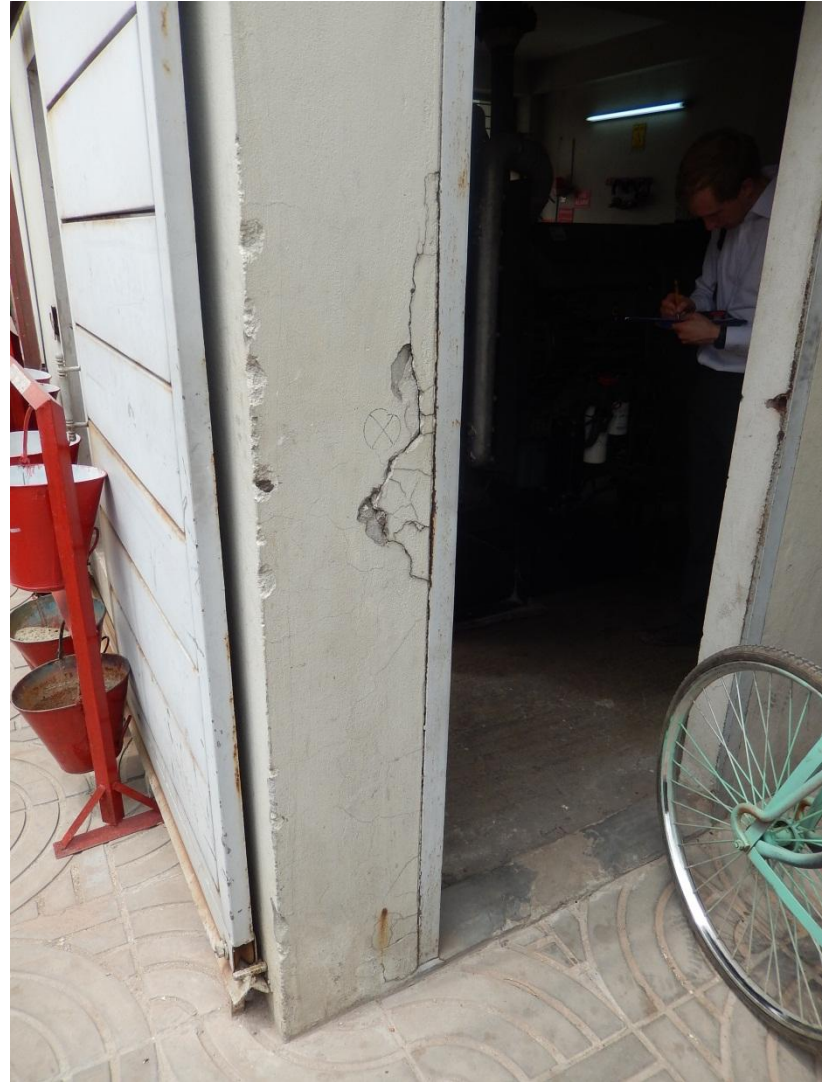
## Building 2: Cracks in column plaster

## **Building 2: Cracks in column plaster**

The plaster to the corner column of Building 2 is cracked adjacent to the door frame.

| Item No. | Observation | Recommended Action Plan | Recommended Timeline |
|---|---|---|---|
| 19 | Building 2 - Cracks visible in column plaster | Building Engineer to investigate whether column cracks are restricted to the plastering | 6-weeks |
| 20 | Building 2 - Cracks visible in column plaster | Engineer to make proposals for remediation measures in column structure if necessary (e.g. load reduction, column strengthening, etc.) | 6-weeks |
| 21 | Building 2 - Cracks visible in column plaster | Implement actions arising from engineering assessment | 6-months |
