# Rahmat Sweaters (BD) Ltd Logos Printing & Design Ltd

Telirchala, Mouchak, Kaliakoir, Gazipur  
(24.03152N, 90.30217E)

9<sup>th</sup> April 2014

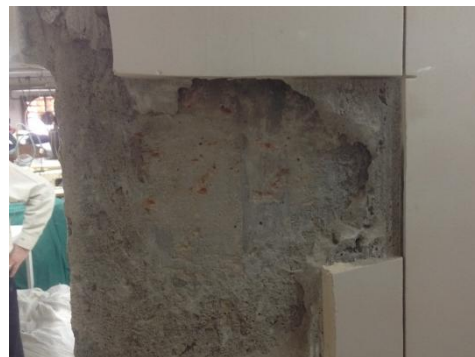
Tested Column D/3 (Brick)

Brick aggregate was observed in the RC columns, which coincides with the information gathered during the interview that brick chips were used in all concrete elements. Mild steel reinforcement ( $f_y = 40000\text{psi}$ ) was noted in the Structural Drawings, and the number of bars shown in the drawings coincides with the number of bars observed at Ground Floor level using the Ferros scanner. The size of the columns measured on site also appears to coincide with the drawings.

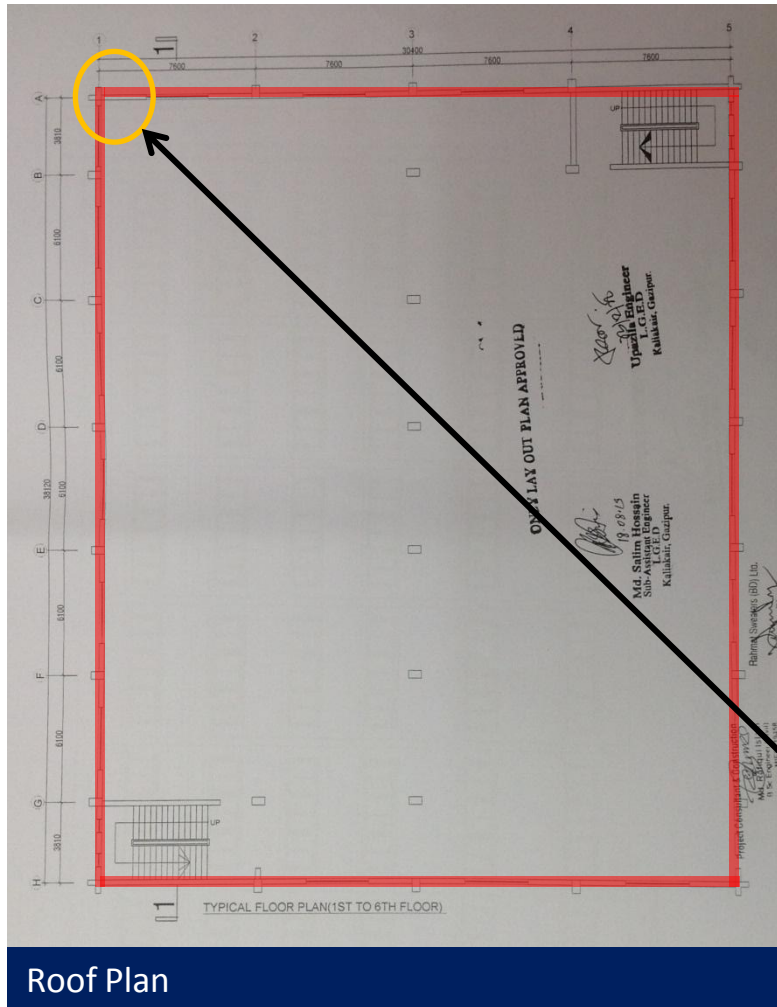
Roof Plan

There is a concern about the lateral stability of the free-standing wall to the perimeter of the 6<sup>th</sup> Floor Roof (typically 5m high). Furthermore, what appears to be a ring beam at the top of the wall is incomplete. Building Engineer to investigate lateral stability of the wall for lateral loading, and to carry out any remedial works as required.

— Perimeter Wall      ○ Incomplete Ring Beam

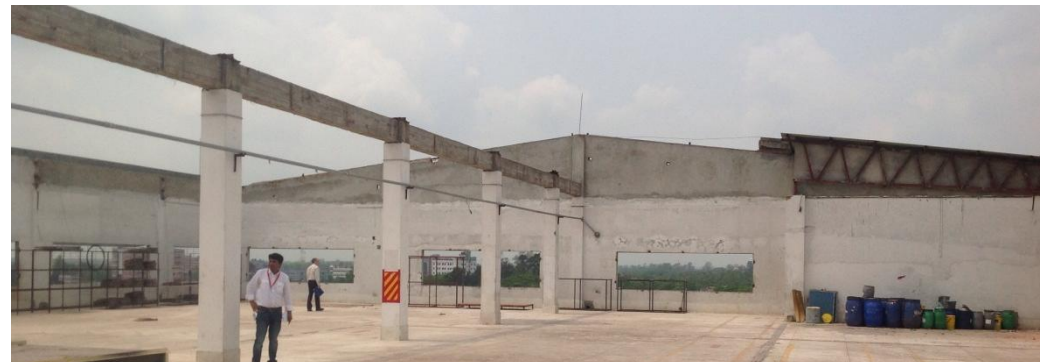
5m high wall to perimeter of Roof level

| Item No. | Observation | Recommended Action Plan | Recommended Timeline |
|---|---|---|---|
| 8 | High freestanding walls at Roof Level. | Factory Engineer to investigate the structural capacity of the freestanding external walls at roof level, as part of the Detail Engineering Assessment. | 6-weeks |

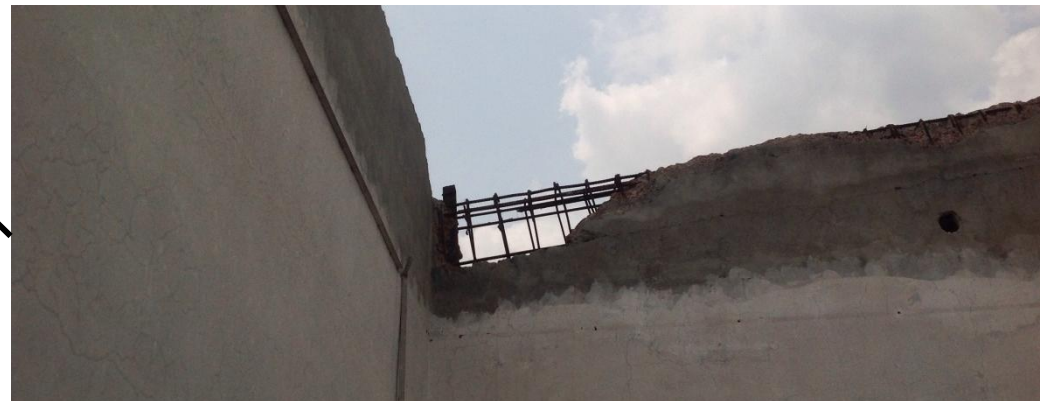
Exposed reinforcement to section of gable-end ring beam

| Item No. | Observation | Recommended Action Plan | Recommended Timeline |
|---|---|---|---|
| 9 | High freestanding walls at Roof Level. | Complete concrete beam on gable with exposed reinforcement, and make any other structural alterations as advised by the Engineer. | 6-months |

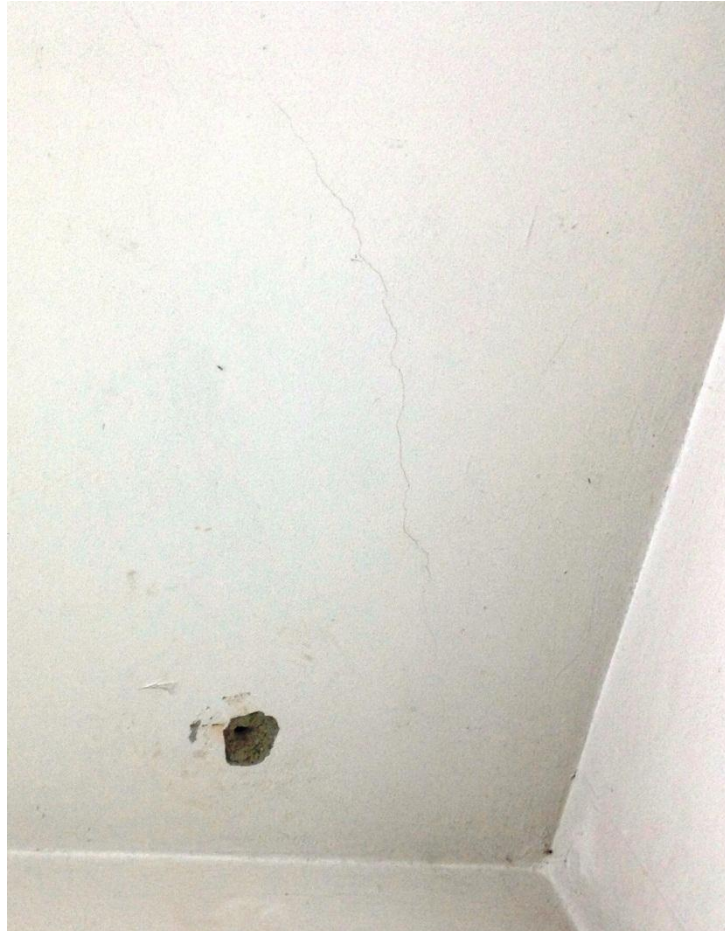
Hairline cracks were noted to the underside of beams and slabs at 2<sup>nd</sup>, 3<sup>rd</sup>, 4<sup>th</sup> and 5<sup>th</sup> Floor levels. Building Engineer to investigate and carry out remedial works to the structure as required.

Cracking to underside of 5<sup>th</sup> Floor slab

| Item No. | Observation | Recommended Action Plan | Recommended Timeline |
|---|---|---|---|
| 10 | Hairline cracking in beams and some slab soffits at 2nd to 5th Floor levels | Factory Engineer to investigate if the cracking is structural or exists only in the render, as part of the Detail Engineering Assessment. | 6-weeks |
| 11 | Hairline cracking in beams and some slab soffits at 2nd to 5th Floor levels | Carry out any remedial work as directed by the Engineer. | 6-months |

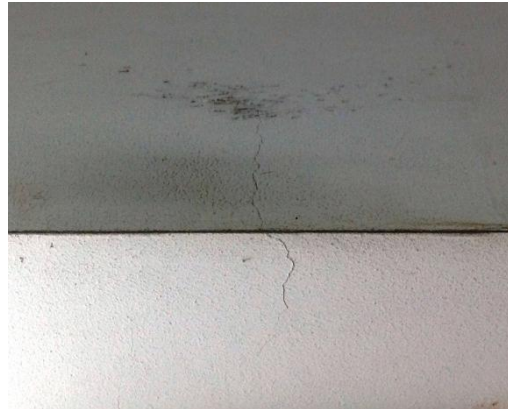
Cracking to 5<sup>th</sup> Floor beam

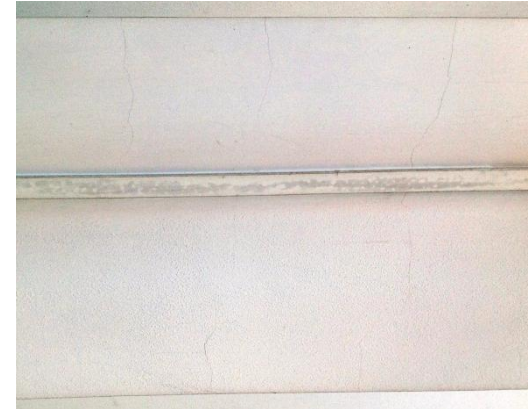
Cracking to 3<sup>rd</sup> Floor beam

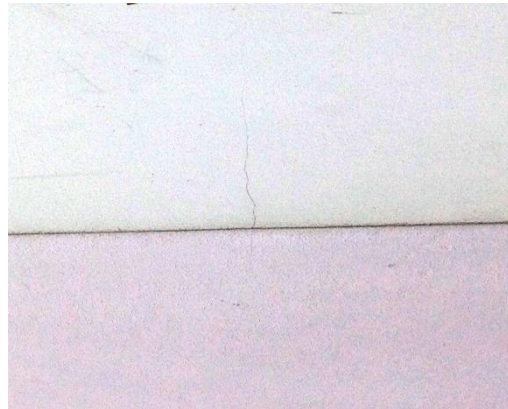
Cracking to 2<sup>nd</sup> Floor beam

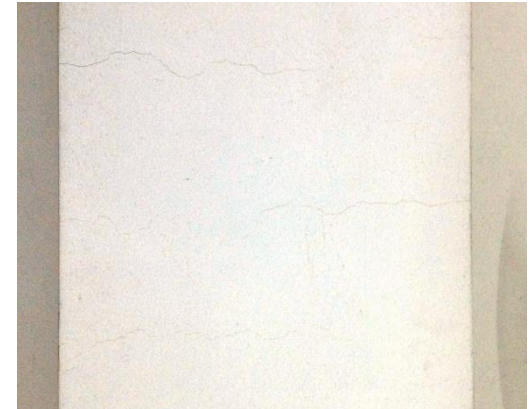
Cracking to 3<sup>rd</sup> Floor beam

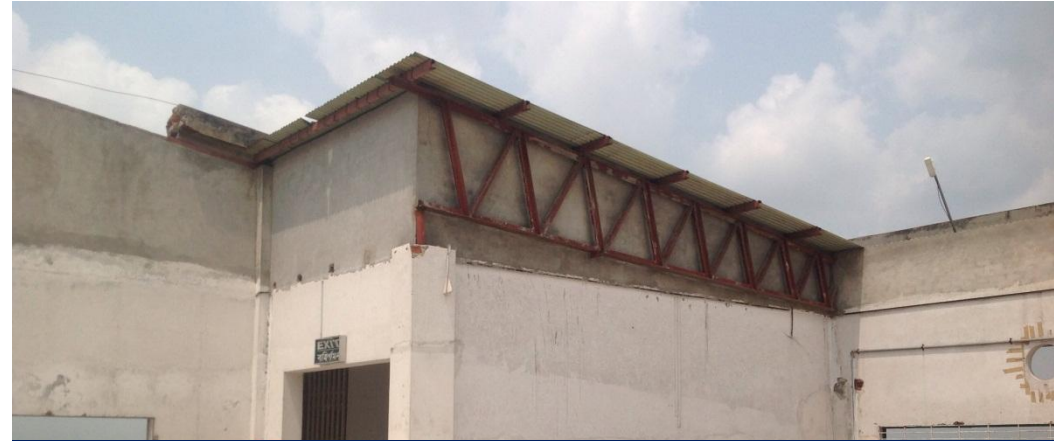
Building Engineer to review the design of the lightweight roof structures to the Ground Floor Boiler / Chemical rooms to the West of the building and to the South-East staircore roof, and to implement any upgrade works as required.

Lightweight Roof to Staircore

| Item No. | Observation | Recommended Action Plan | Recommended Timeline |
|---|---|---|---|
| 12 | Apparently non-engineered roof structures. | Factory Engineer to check the capacity of the lightweight roofs and make any necessary alterations. | 6-months |

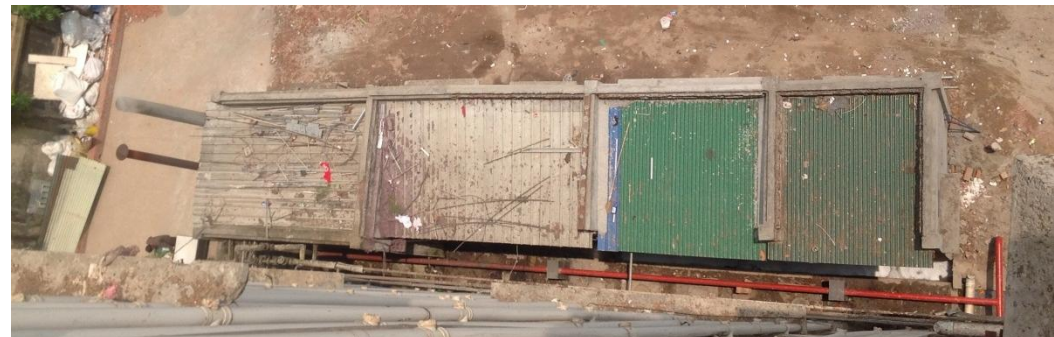
Lightweight Roofs to Boiler / Chemical Rooms
