Naz Knitwear Ltd (10653)

Anwar Plaza, Ganakbari, Savar

07.APRIL.2014

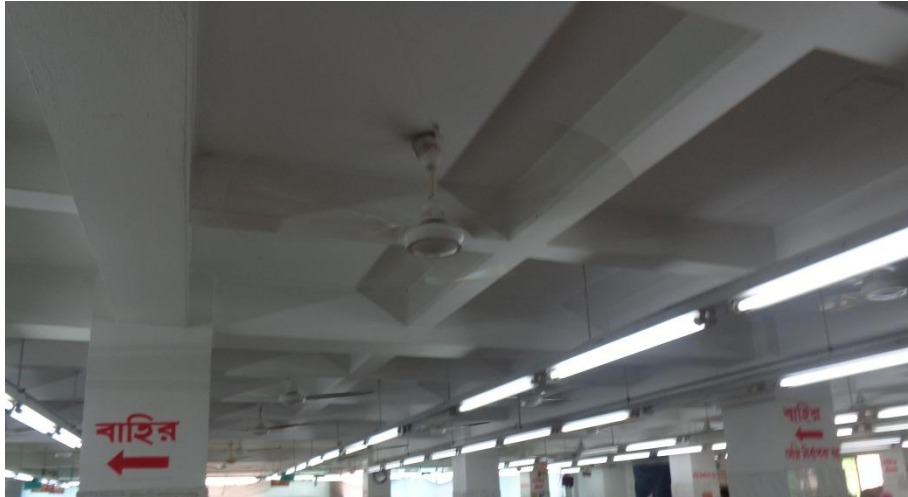
Underside of 3rd Floor Slab

**Uncertainty Regarding Flat Slab/Beam Slab Locations
and Corresponding Lateral Stability**

Structural drawings were unclear as to which levels of the building were intended to be flat slabs and which were intended to be beam slab arrangements as no beam layout plans were provided nor were beams shown on slab reinforcing plans. Only the 3rd floor slab was constructed as a beam slab arrangement while all others were flat slabs. Additionally this leads to concern regarding the lateral restraint system. At all floors other than the 3rd floor slab (moment frames), there was no apparent lateral restraint system in place.

ITEM 1: (Priority 2) Structural drawings were unclear as to which floors have beams and which are intended to be flat slabs. Beams were observed only at the third floor slab while structural beam details indicate beams are at the ground floor level. Furthermore, no beam layout plans are provided and no beams are shown on floor slab reinforcing plans. The stories with flat slab arrangements lack an apparent lateral stability system.

- The original design engineer is to verify the construction and provide a letter confirming that slab construction has been built as intended.
- Commence a Detailed Engineering Assessment upon structure's lateral stability system.

- Implement any recommendations and remedial works required by the design engineer and/or the detailed engineering assessment.

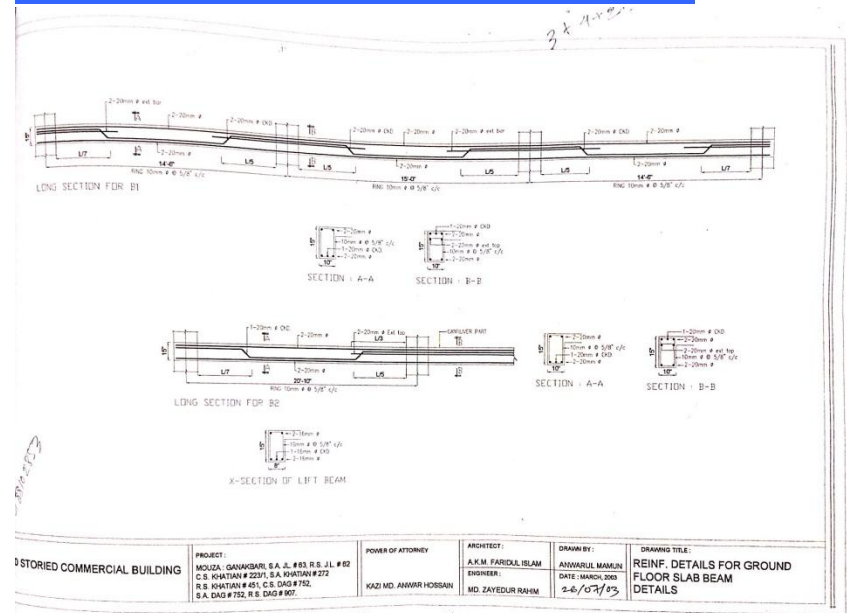
Ground Floor Slab Beam Details

Design Intent Uncertainty – Poor Structural Drawings

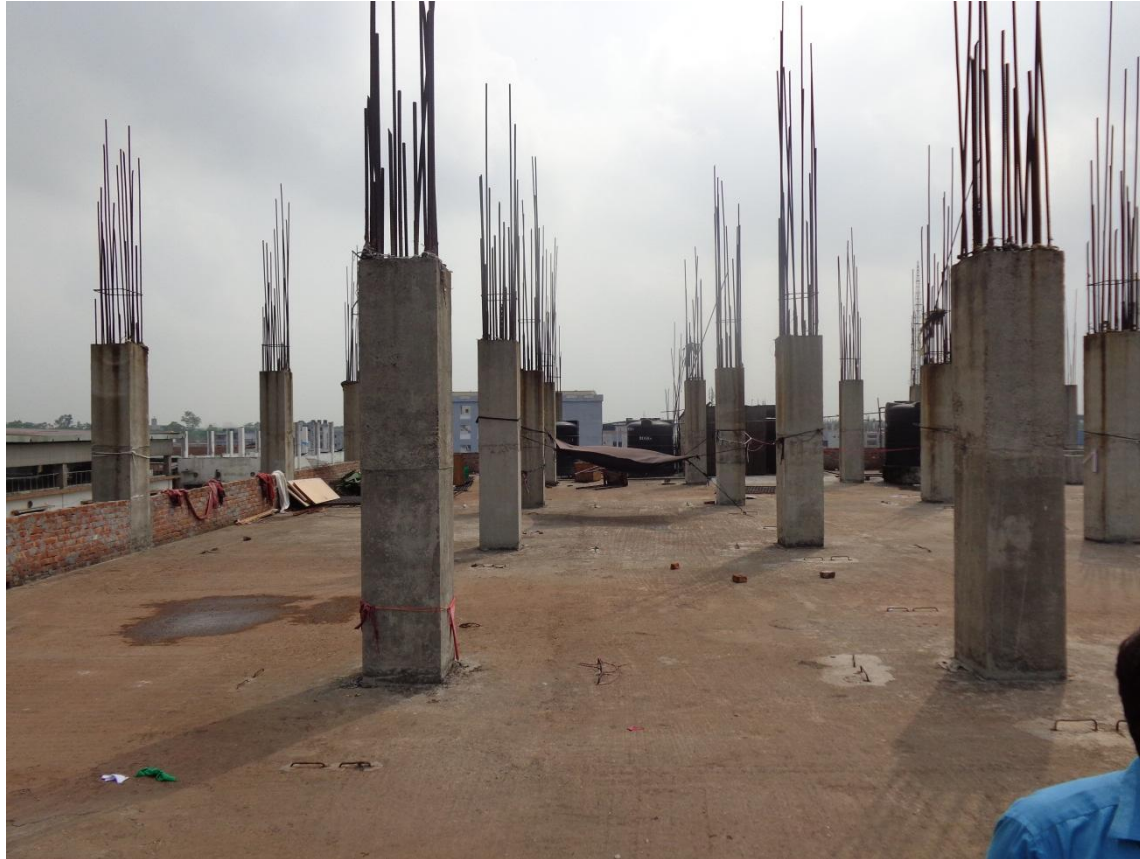
5th Floor/Current Roof Level

Intention of Additional Construction

The factory staff indicated the intent to continue with the addition of further stories in 2015. Based upon column load run-downs, the building is not suitable for more than one additional storey. However, permit approval and construction documents indicate a potential for 5 additional stories.

ITEM 2: (Priority 2) The construction documents indicate potential for a 10 storey building while construction is currently halted at the 5th floor slab. It was put forth that further stories will be added in 2015. However, column checks indicate structural adequacy of columns for only one additional storey.

- If more than 1 additional storey is to be added, have the detailed engineering assessment from Item 1 include the feasibility of the addition of further stories within its scope.

- Carry out any remedial works required recommendations of the detailed engineering assessment.

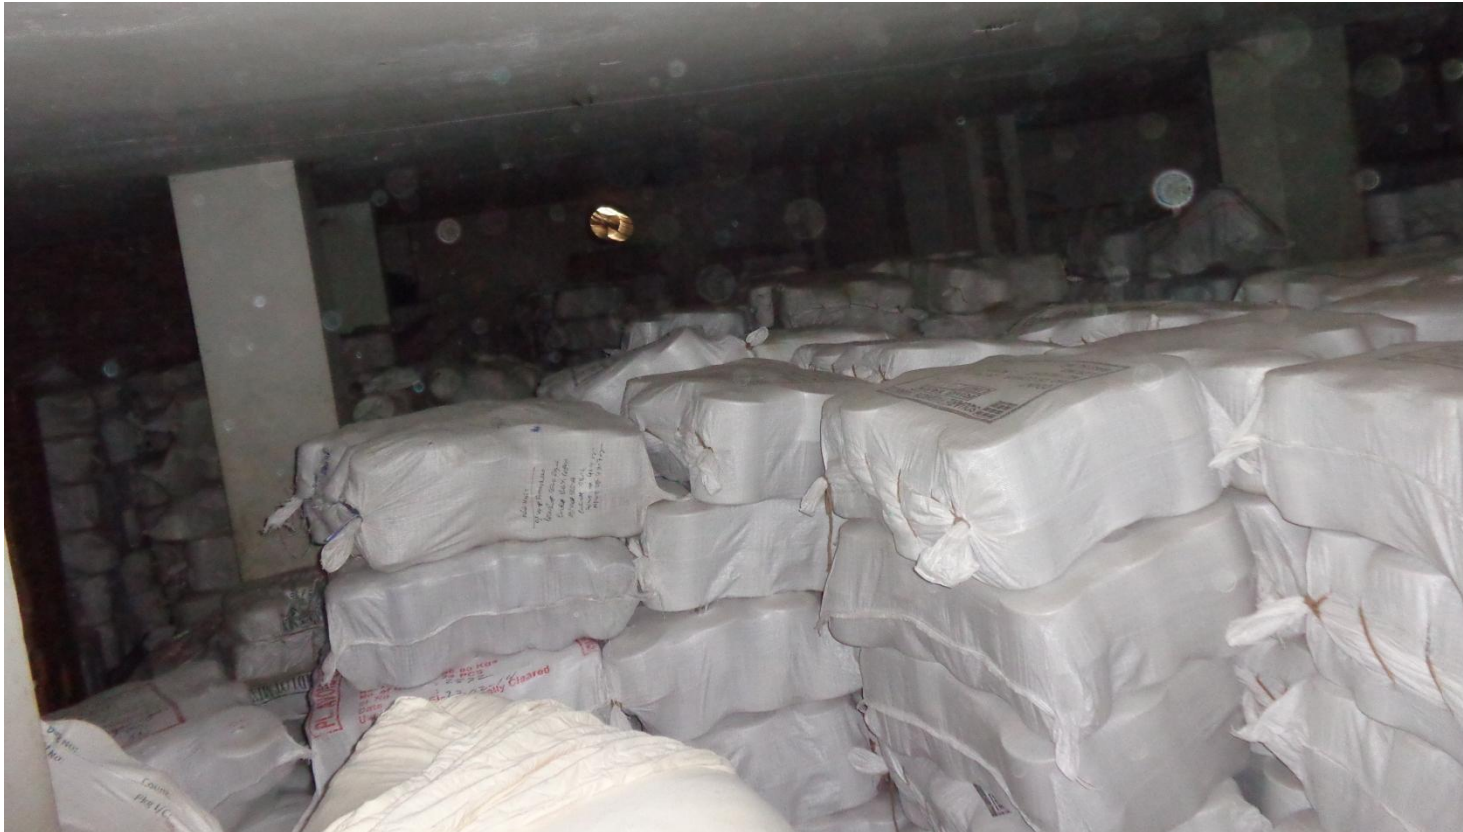
No Formal Loading Plan Available and High Level of Storage Observed at Ground Floor

No formal loading plan was available at the time of inspection. Storage was in general minimal and localized. However thread roll storage at the ground floor was higher than desirable and was estimated at approximately 6 kPa.

Lack of Floor Loading Plan and High Ground Floor Storage

ITEM 3: (Priority 3) No floor loading plan was provided or being enacted. While storage loads were generally below minimum allowable levels, there were heavy storage loads at the ground floor level.

- Reduce storage at ground floor level to design floor load.

- Develop and actively manage a loading plan for all floor plates within the factory giving consideration to slab, beam and column capacity.

- Continuously manage floor loading plan.
