# Midland Knitwear Ltd. (9511)

Ramarbagh, Kutubpur, Fatullah, Narayangonj, Bangladesh

08.APRIL.2014

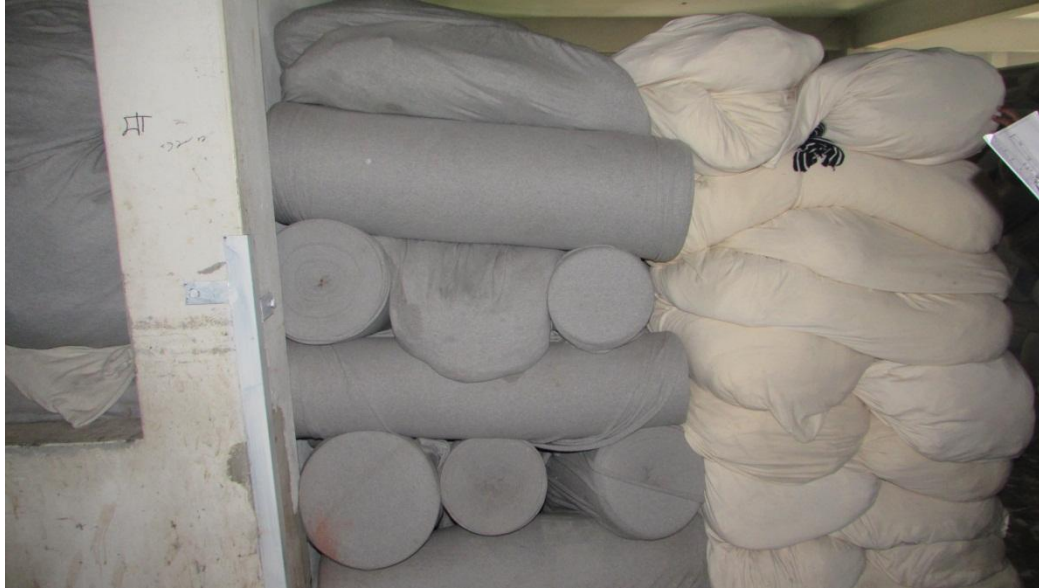
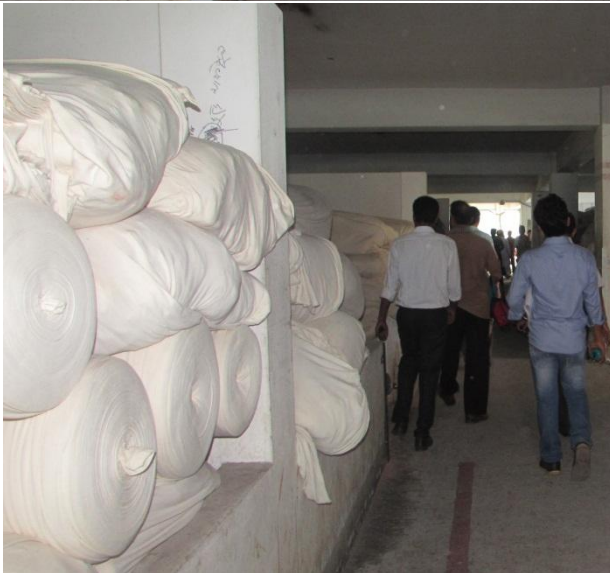
Each bag of fabric is estimated to be approximately 25kg. As they are stacked 10 bags high, and arranged 2 bags per layer, the weight of each layer is approximately 50kg, resulting in a total weight of 500kg per stack.

Based on a plan area of 1m x 1m per stack, the equivalent live load per stack is estimated to be:  
 $500/(1.0 \times 1.0)\text{m}^2 = 500 \text{ Kg/m}^2$

The maximum designed live load is 350Kg/m<sup>2</sup> (as per provided loading plans- 70psf-approximately 350Kg/m<sup>2</sup> ).

The loading intensity appear to be excessive in some locations

- Immediately reduce stacking height of fabric rolls to ensure total load does not exceed 3.5kPa (70psf)
- Building engineer to verify the compliance of using the machines on 2<sup>nd</sup> floor of building 1

- Mark the maximum allowable height of fabric stacking to ensure full compliance
- Building engineer to verify the loading capacity of the roof beams of building 1 to support the water tank of 5000Kg

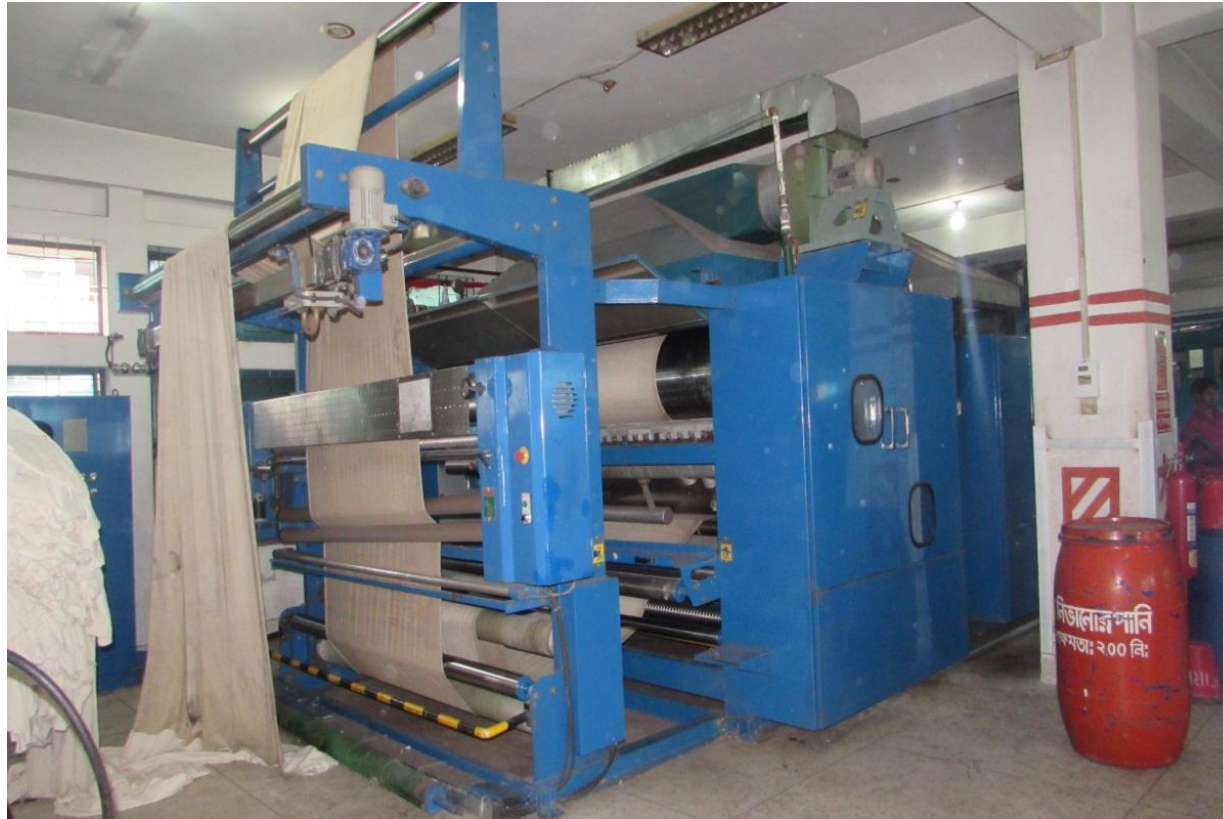
At the site, the building engineer had no information on the machines. We were not able to assess their weights. We can not therefore judge the compliance of the actual loading plan

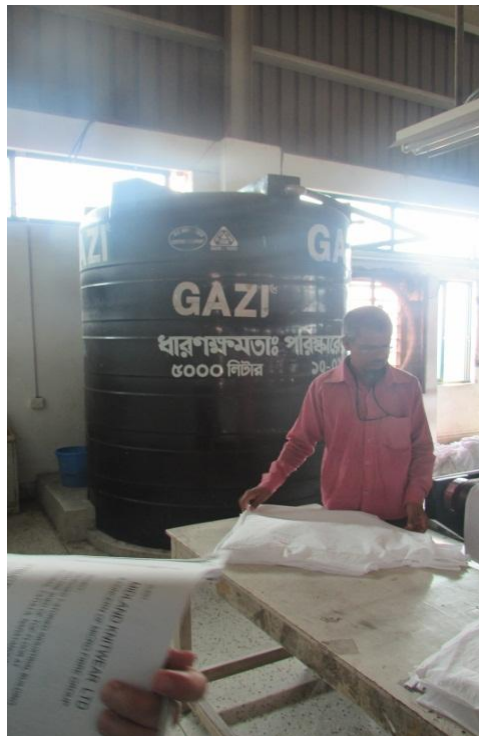
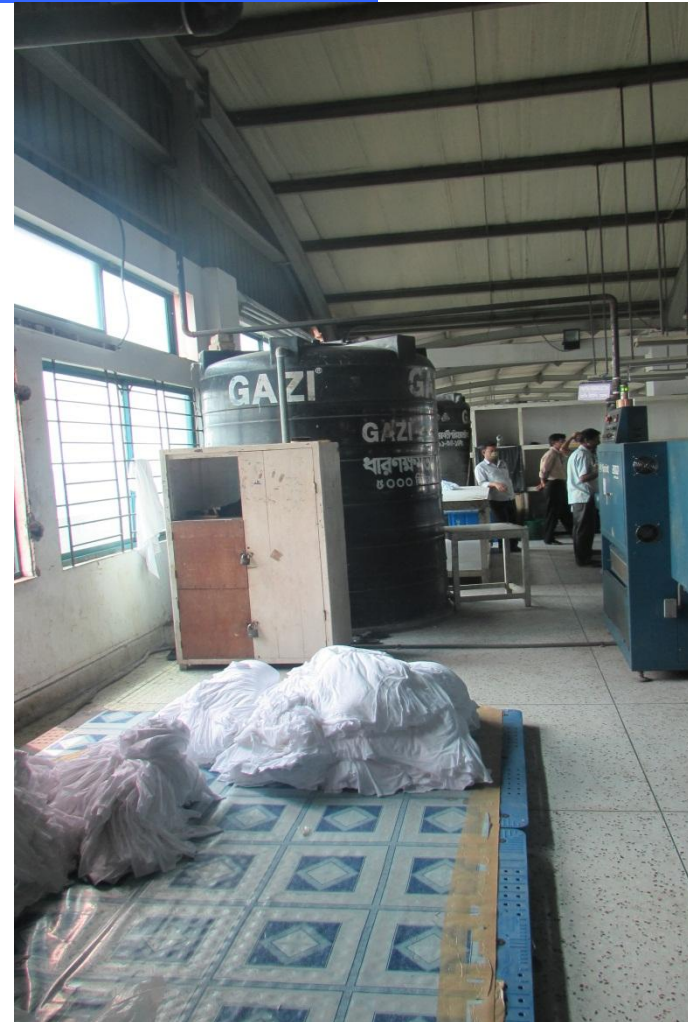
The provided loading plan shows the water tank at 2000Kg. However the actual weight of water tank on the roof floor was noted at 5000Kg

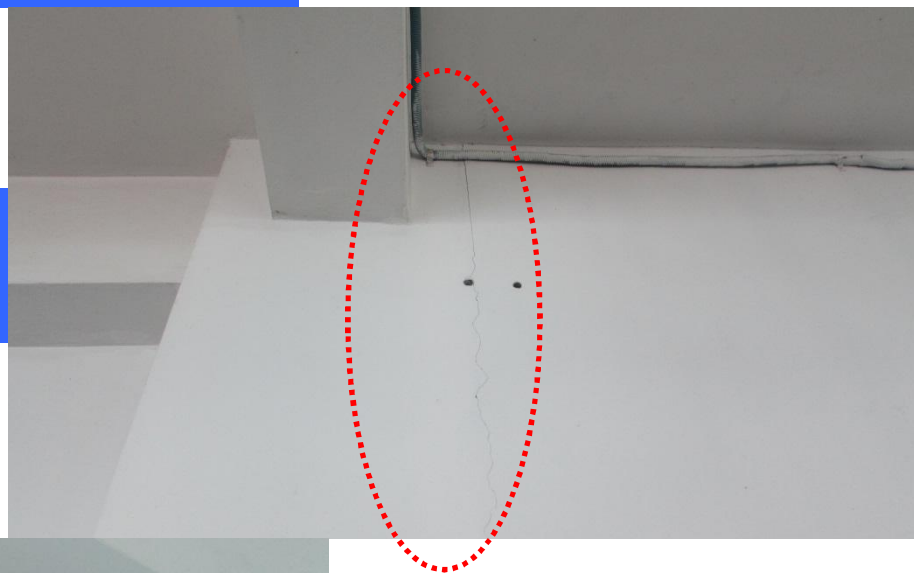
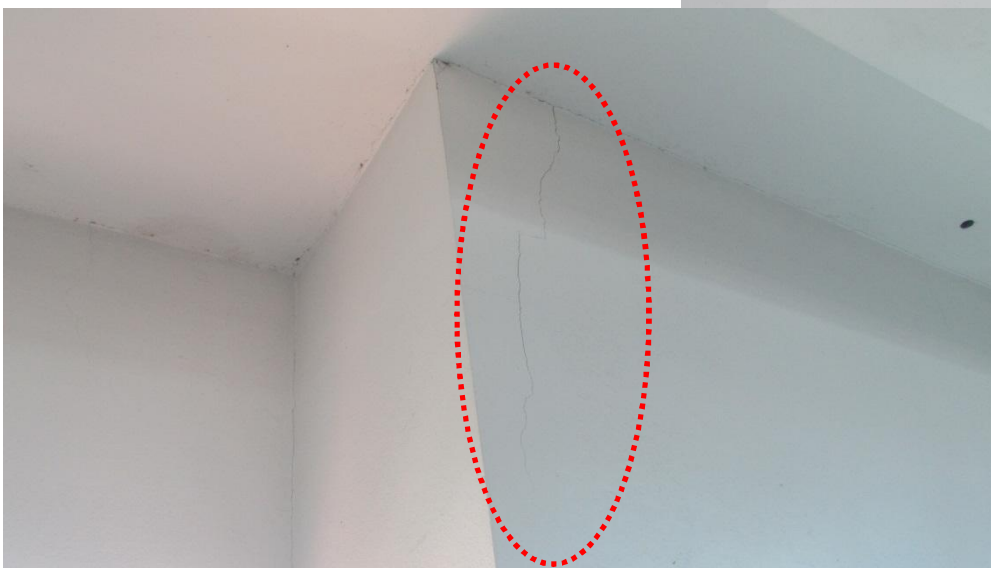
Some cracks are observed at site on partition wall in building 2. However no sign of water penetration is present.

Some cracks are visible on the partition walls at some locations in building 2

- Consider removing existing screed, reapplying the screed with a new waterproofing layer (building 2)
