# **FIRE SAFETY INSPECTION REPORT**

**SASHA GARMENTS LTD.**  
**HASHEM PLAZA, GANAKBARI, ASHULIA**

**ACCORD**  
on Fire and Building Safety in Bangladesh

July 10, 2014

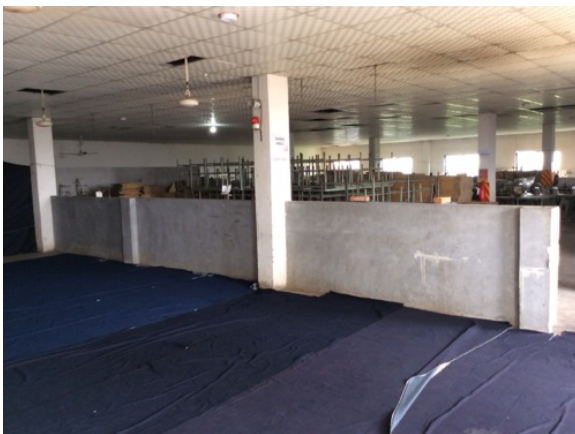
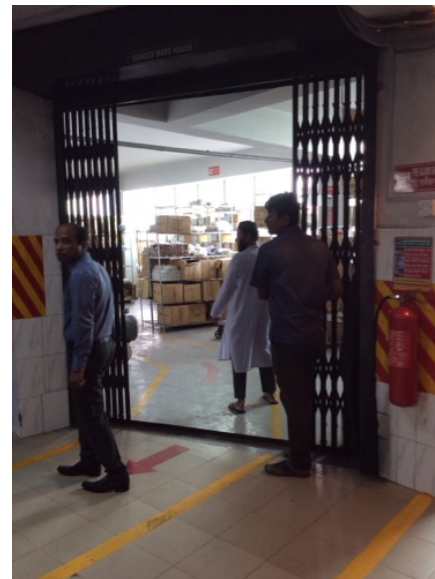
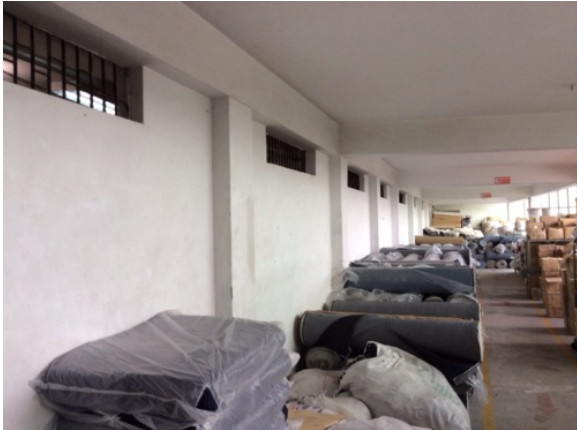
| F-1 | Fire Rated Construction | The dedicated storage rooms on the 6th and 4th floors are not separated form the adjacent working area by means of fire rated construction (non-rated door and unprotected openings). | Provide dedicated storage rooms separated by minimum 1-hr fire-rated construction. | Within 3 months |

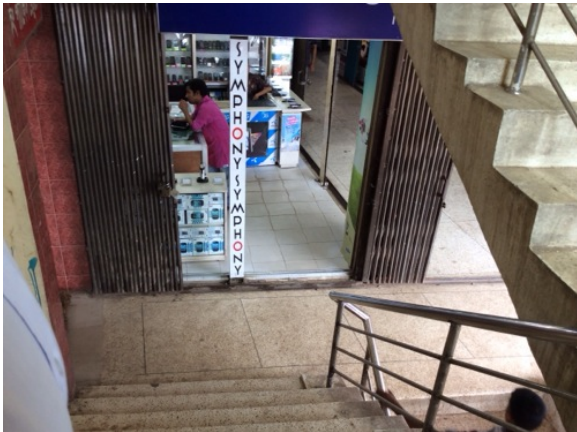
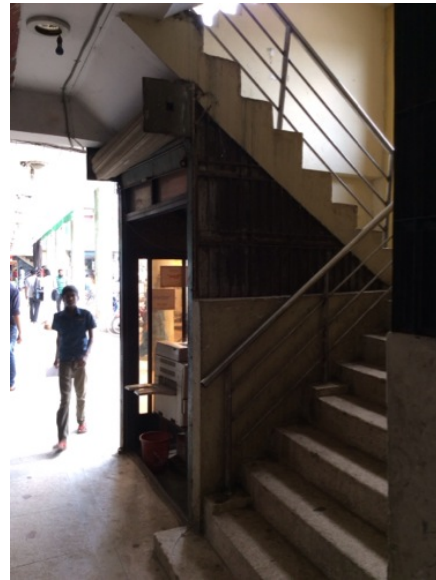
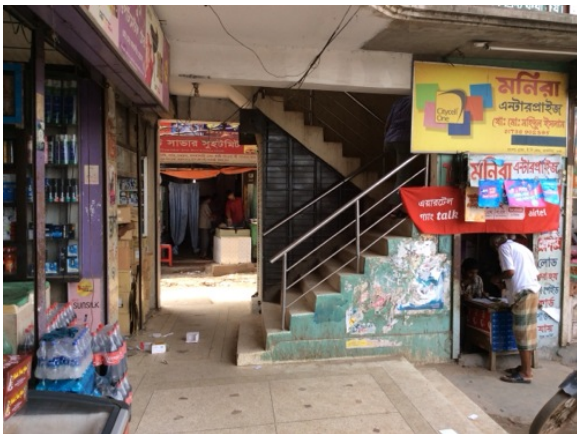
| F-2 | Fire Rated Construction | All the exit stairs are not separated from work areas on all floors by fire-rated construction. The western stairs are open to the market areas on the ground and 1st floors due to unenclosed stairwells. | Provide minimum 1.5-hr fire rated doors and seal all unprotected openings to separate the exit stairs from work areas and other building spaces on all floor levels. Ensure that the fire doors are self-closing and positive latching and that they are provided with fire exit (panic) hardware where serving production floors.<br><br>If fire doors are required to be held open for functional reasons, provide automatic-closing devices tied to the fire alarm system. | Within 3 months |

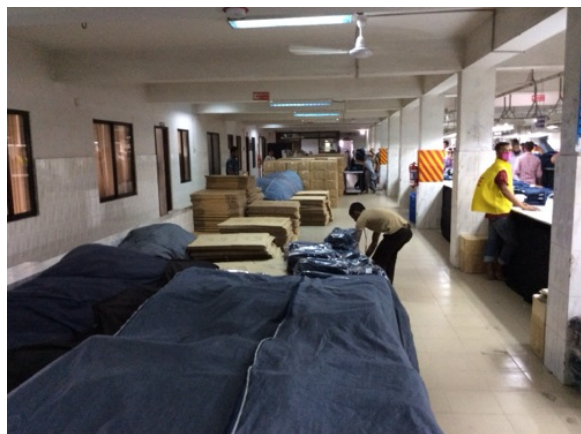
| F-3 | Fire Rated Construction | Transient storage areas on the 4th floor is not separated form the adjacent working area by means of fire rated construction (non-rated door and unprotected openings). | <p>Provide dedicated storage rooms separated by minimum 1-hr fire-rated construction.</p> <p>Where separate storage rooms are not feasible, provide defined storage areas and limit the storage arrangement as follows:</p> <ul style="list-style-type: none"> <li>- Maximum height of 2.4m and maximum area of 23m<sup>2</sup></li> <li>- If sprinkler protected: maximum height of 3.66m and maximum area of 93m<sup>2</sup></li> </ul> <p>Separate areas of unenclosed combustible storage by a minimum clear distance of 3m.</p> | Within 3 months |

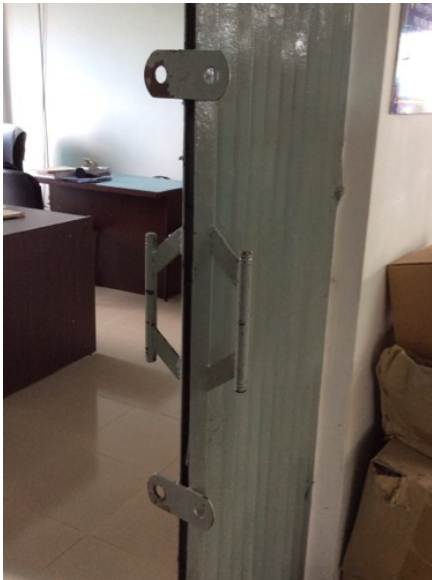
| F-4 | Egress | Egress doors and gates with locking features are provided at all exit stairs, building exits and exit discharges. | <p>Remove locking features from all egress doors / gates.</p> <p>If locks are required for security reasons, utilize special door locking features complying with NFPA 101.</p> | Immediate |

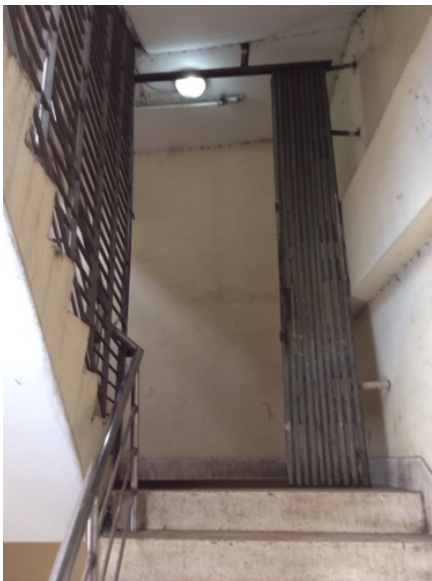
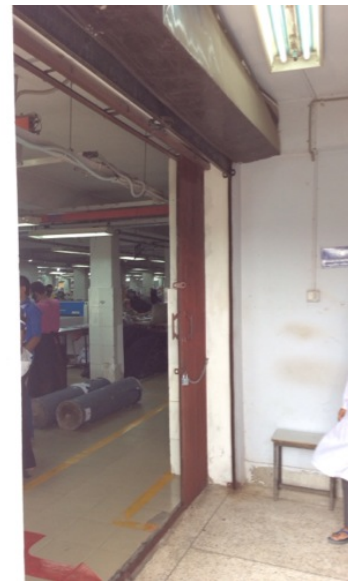
| F-5 | Egress | Collapsible gates / sliding doors are provided at all exit stairs, building exits and exit discharges. | Replace all gates / sliding doors along the means of egress with side-hinged, swinging egress doors.<br><br>If locks are required for security reasons, utilize special door locking features complying with NFPA 101. | Within 1 month |

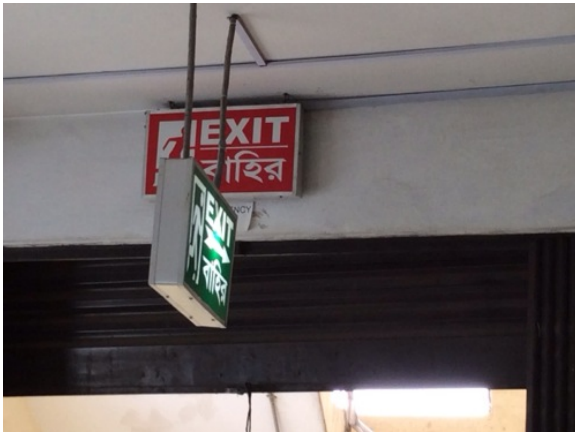
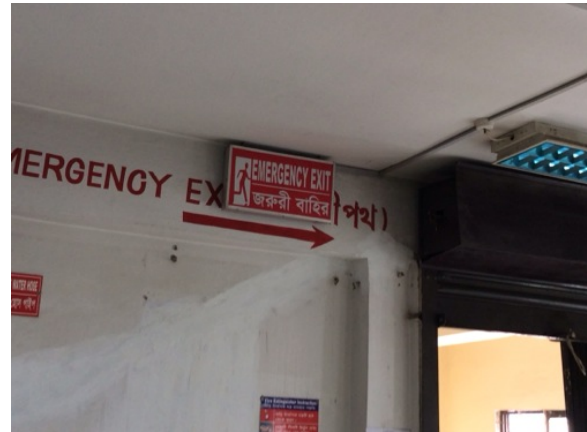
| F-10 | Egress Lighting | Exit signage were not illuminated (burned out, broken, etc.) on the 4th floor. | Regularly inspect all exit signage and replace/install lights as needed to illuminate signs. | Within 1 month |
