# Mascotex Limited (9505)

Shataish road, 31/32, khartail, Tongi, Gazipur  
(+23.859604N, +90.396385E)

08.April.2014

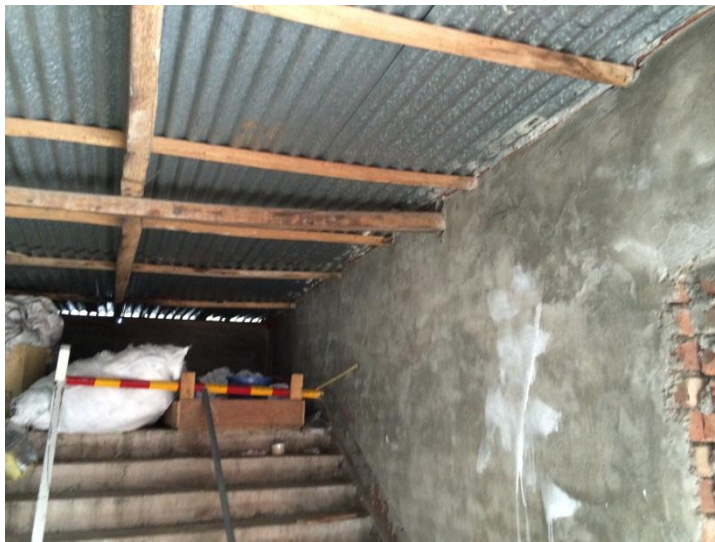
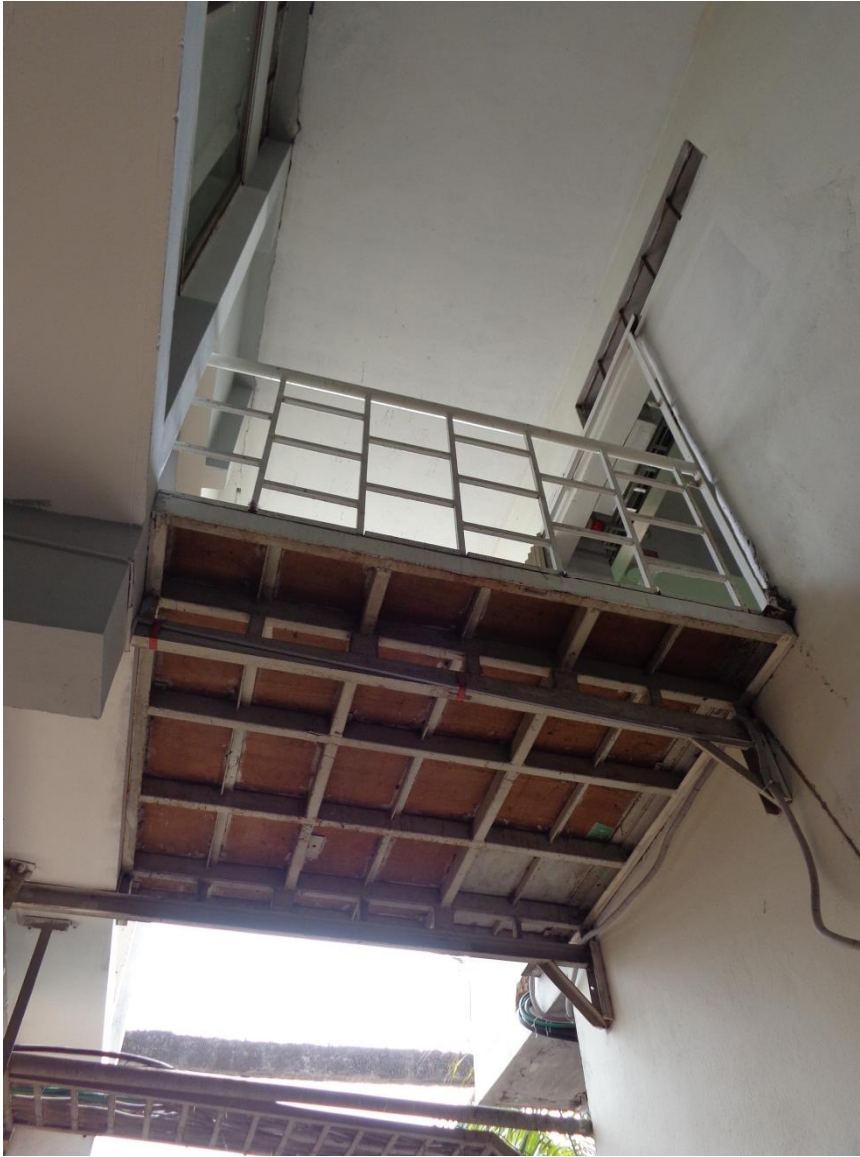
Staircase's roof at Front building, made of corrugated steel sheet decking and wood in an improvised manner. This roof must be checked by engineer. No apparent tie-downs were seen to prevent roof from flying off in high wind.

- Include in Detailed Engineering Assessment of Factory, see attached scope.

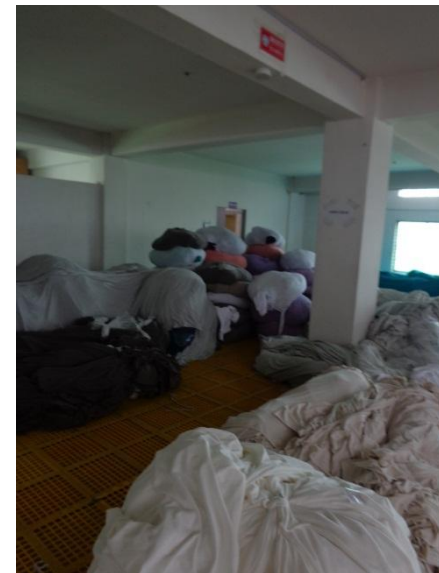
No loading plan in place on the upper floors to insure full compliance with specified design loads. Applicable to back and front buildings.

No loading plan in place

- Factory Engineer to produce and actively monitor a loading plan for all floor plates within the factory complex, with consideration given to slab, column and foundation capacities.

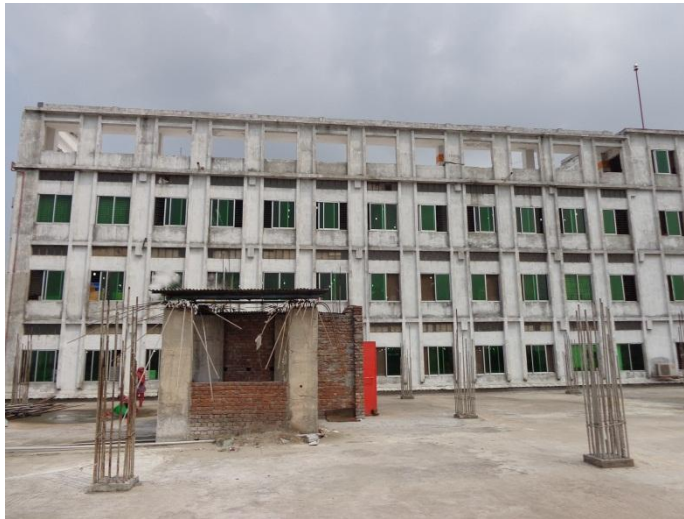
No waterproofing membrane was visible on the roof of the back and front buildings. This means that any cracks in the surface finishes on the roof will allow water to seep into the concrete slab and cause long-term soaking of the slab and possibly cause damage to the concrete and the reinforcement.

**Roofs floors do not appear to have any waterproof membrane to protect lower floors from water ingress.**

- Apply a new waterproofing membrane.
