# **FIRE SAFETY INSPECTION REPORT**

**EVER FASHION TONGI LTD.**

**PLOT # D-204,205,206, BSCIC INDUSTRIAL AREA,  
TONGI, GAZIPUR**

July 12, 2014

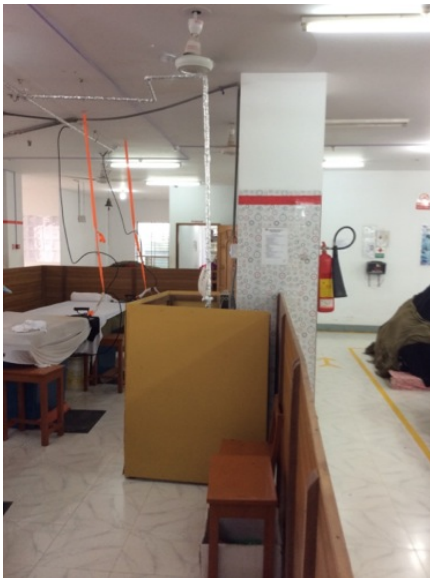
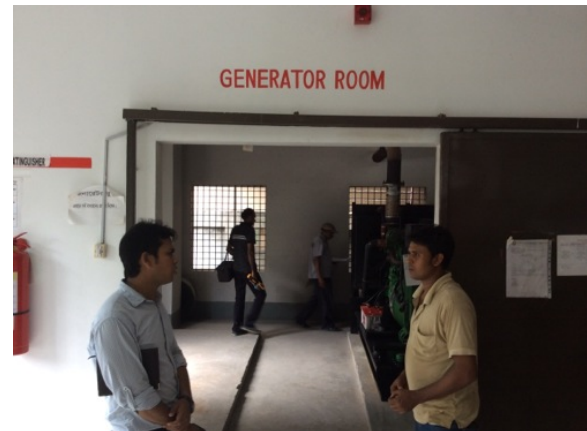
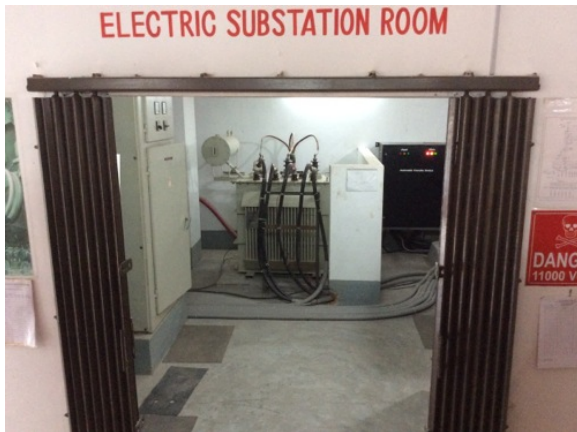
| No. | Category | Finding | Recommendation | Remediation Timeframe |
|---|---|---|---|---|
| F-1 | Fire Rated Construction | The boiler, generator and transformer rooms on the ground floor are not separated by fire-rated construction (openings and non-rated doors). | Separate the boiler, generator, transformer rooms by a minimum 2-hr fire-rated construction. Seal and/or protected all openings to maintain the required fire separations. | Within 3 months |

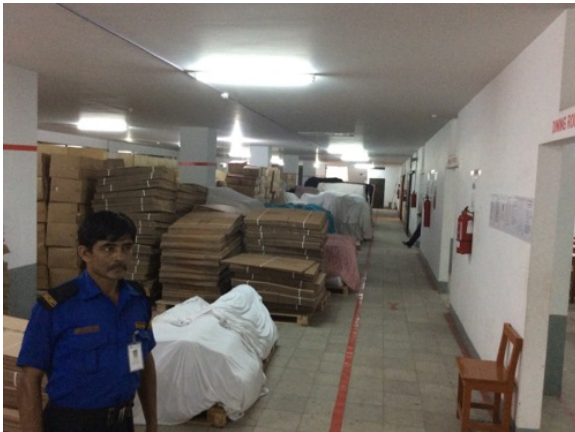
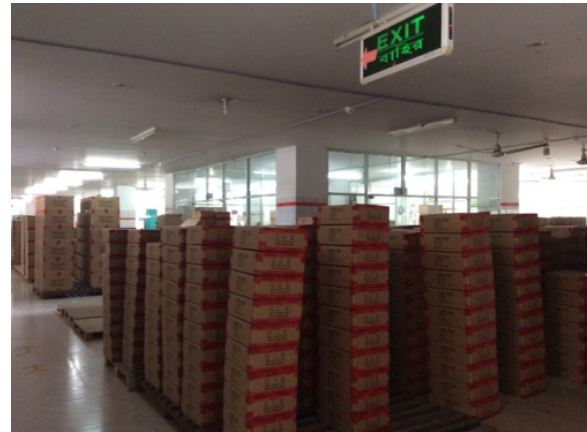
| F-2 | Fire Rated Construction | Areas used for combustible storage on the basement and ground floors are not separated by fire-rated construction. | <p>Provide dedicated storage rooms separated by minimum 1-hr fire-rated construction.</p> <p>Where separate storage rooms are not feasible, provide defined storage areas and limit the storage arrangement as follows:</p> <ul style="list-style-type: none"> <li>- Maximum height of 2.4m and maximum area of 23m<sup>2</sup></li> <li>- If sprinkler protected: maximum height of 3.66m and maximum area of 93m<sup>2</sup></li> </ul> <p>Separate areas of unenclosed combustible storage by a minimum clear distance of 3m.</p> | Within 3 months |

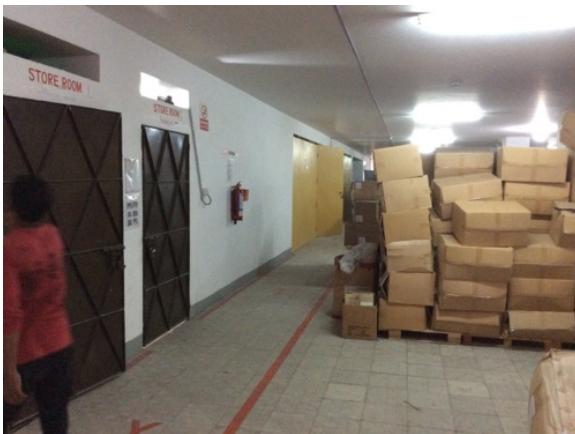
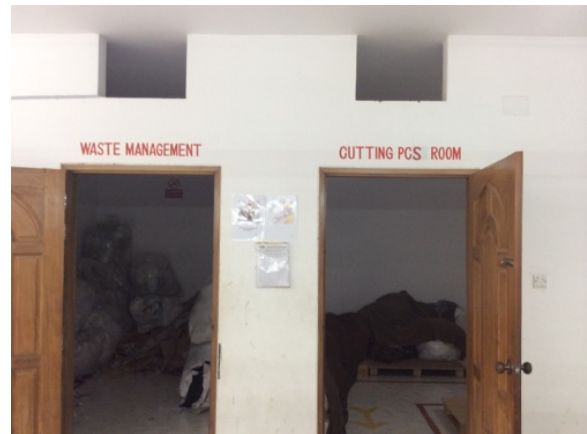
| F-3 | Fire Rated Construction | Rooms used for combustible storage on the basement and 1st floors are not separated by fire-rated construction. | Provide dedicated storage rooms separated by minimum 1-hr fire-rated construction. | Within 3 months |

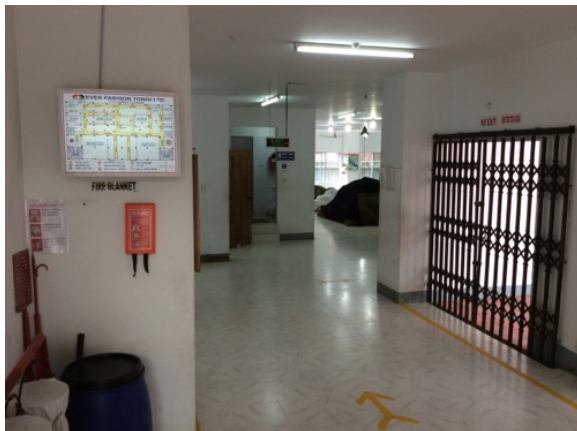
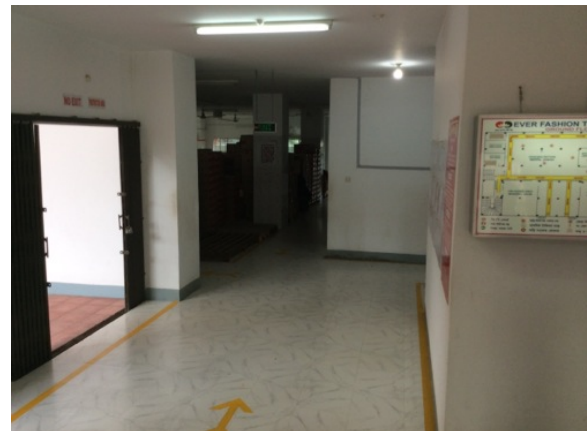
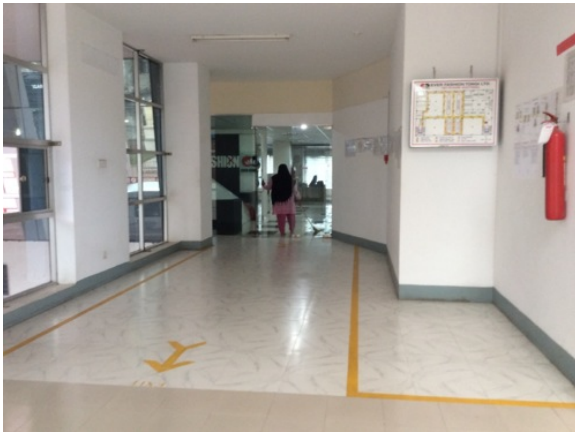
| F-4 | Fire Rated Construction | The south exit stair on the ground and 1st floors and the north exit stair on the ground floor are not separated from work areas by fire-rated construction. | Provide minimum 1.5-hr fire rated doors and seal all unprotected openings to separate the exit stairs from work areas on all floor levels. Ensure that the fire doors are self-closing and positive latching and that they are provided with fire exit (panic) hardware where serving production floors. | Within 3 months |

If fire doors are required to be held open for functional reasons, provide automatic-closing devices tied to the fire alarm system.

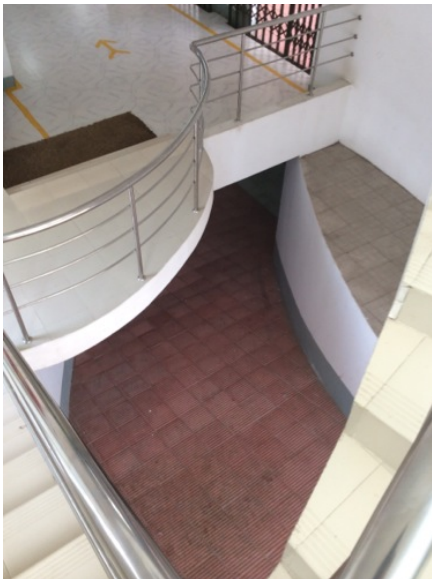
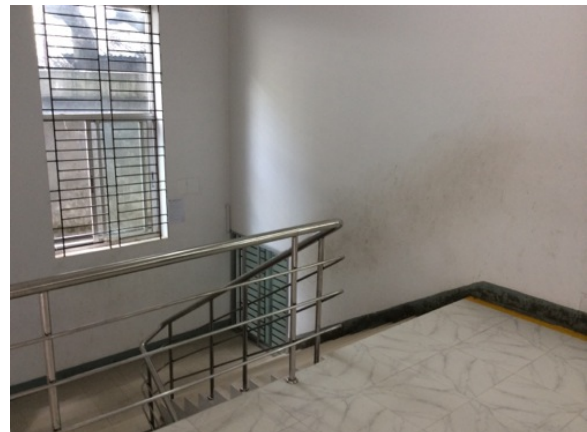
| F-5 | Fire Rated Construction | All exit stairwells on the ground floor are not enclosed from the basement in fire-rated constructions. | Provide minimum 2-hr fire-rated construction walls and minimum 1.5-hr fire-rated doors for continuous exit stairwell enclosure on the ground floor. | Within 3 months |

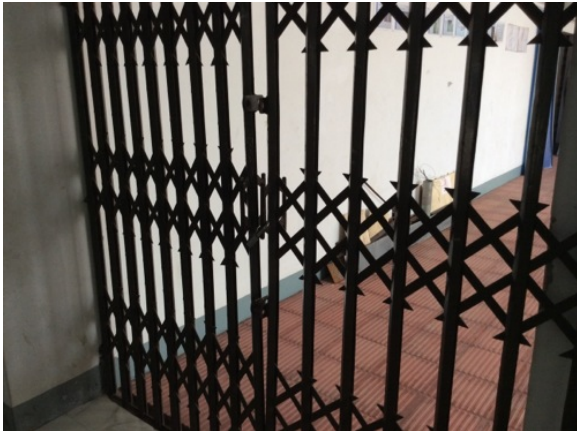
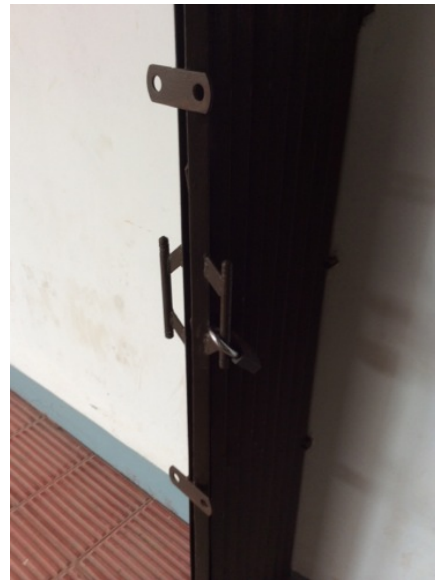
| F-6 | Egress | Egress gates with locking features are provided at building exits and exit discharge. | Remove locking features from all egress gates.<br><br>If locks are required for security reasons, utilize special door locking features complying with NFPA 101. | Immediate |

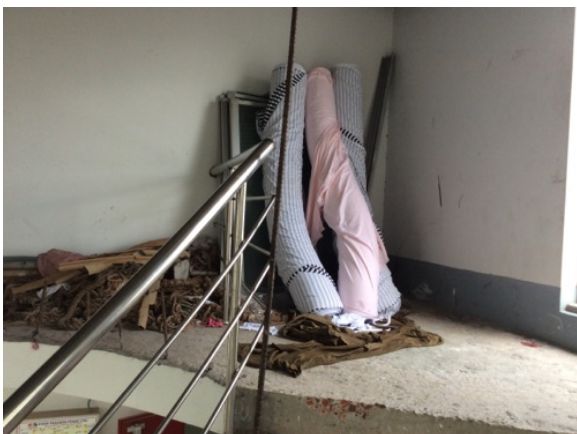
| F-7 | Egress | Storage was located in the north exit stair on the 2nd floor. | Remove all storage from exit stairs and egress paths. | Immediate |

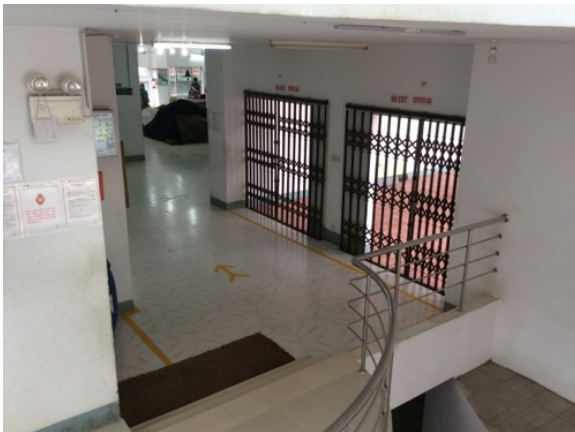
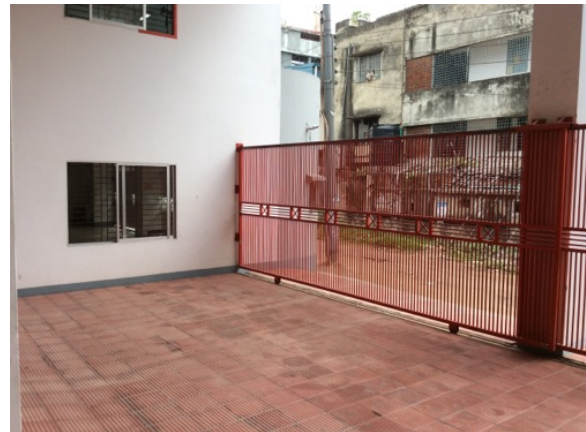
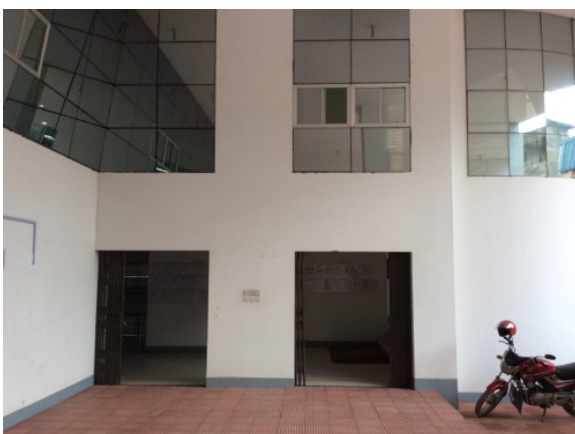
| F-8 | Egress | Collapsible gates are provided at building exits and exit discharge. | Replace all gates along the means of egress with side-hinged, swinging egress doors. | Within 1 month |

If locks are required for security reasons, utilize special door locking features complying with NFPA 101.

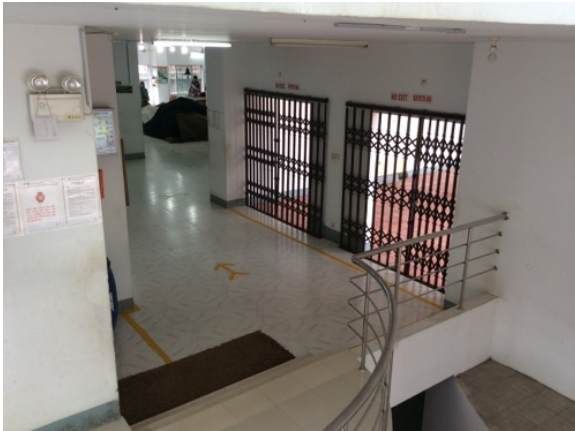
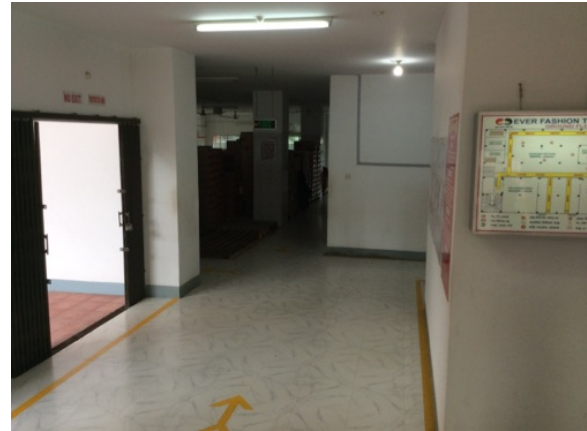
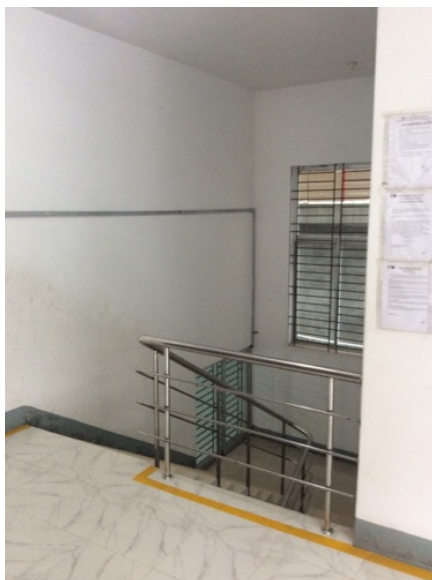
| F-9 | Egress | All exit stairs discharge to the interior of the building on the ground floor and openings (basement and work area) of discharge floor. | Provide 2-hr fire-rated exit passageway leading directly outside (vestibules to separate any storage areas) or Provide sprinkler protection for discharge floor in accordance with NFPA 13. | Within 6 months |

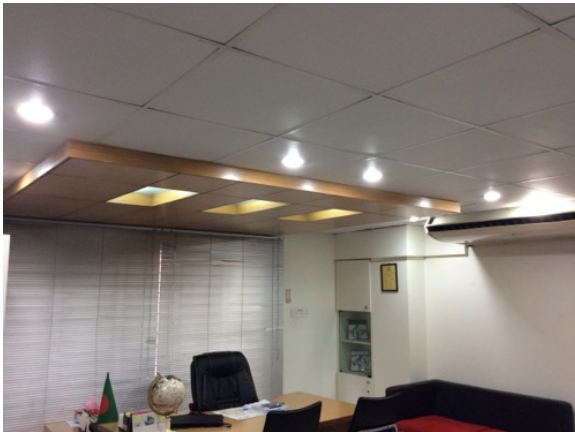
| F-10 | Fire Protection | Based off observations, the existing smoke detectors were not provided for the prayer rooms, staff canteen and maintenance room on the basement, the medical room, loading/unloading areas, spot removal room and child care on the ground floor, the director rooms, mini conference room, corridor in front of office area and cutting master room on the 1st floor and the mechanics room on the 2nd floor. | Based on ceiling configuration, provide additional detectors where needed, and space them in accordance with NFPA 72. | Within 1 month |

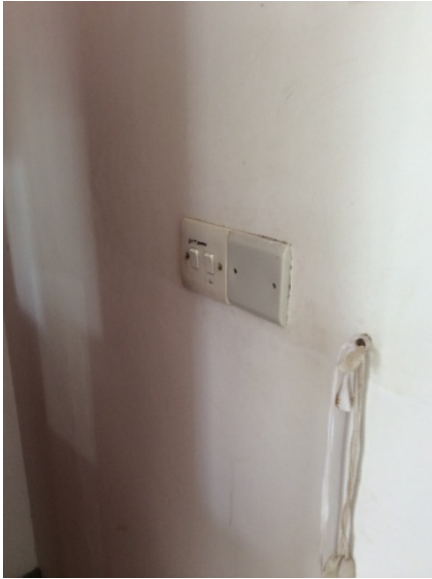
| F-13 | Egress Lighting | Manual on-off switch is provided for emergency lighting units. | Remove manual on/off switches from emergency lighting units to prevent them from being switched off. | Within 1 month |
