Millennium Textiles (Southern) Ltd (9596)

Bara Rangamatia, Zirabo, Ashulia, Savar

08.APRIL.2014

ACCORD
on Fire and Building Safety in Bangladesh

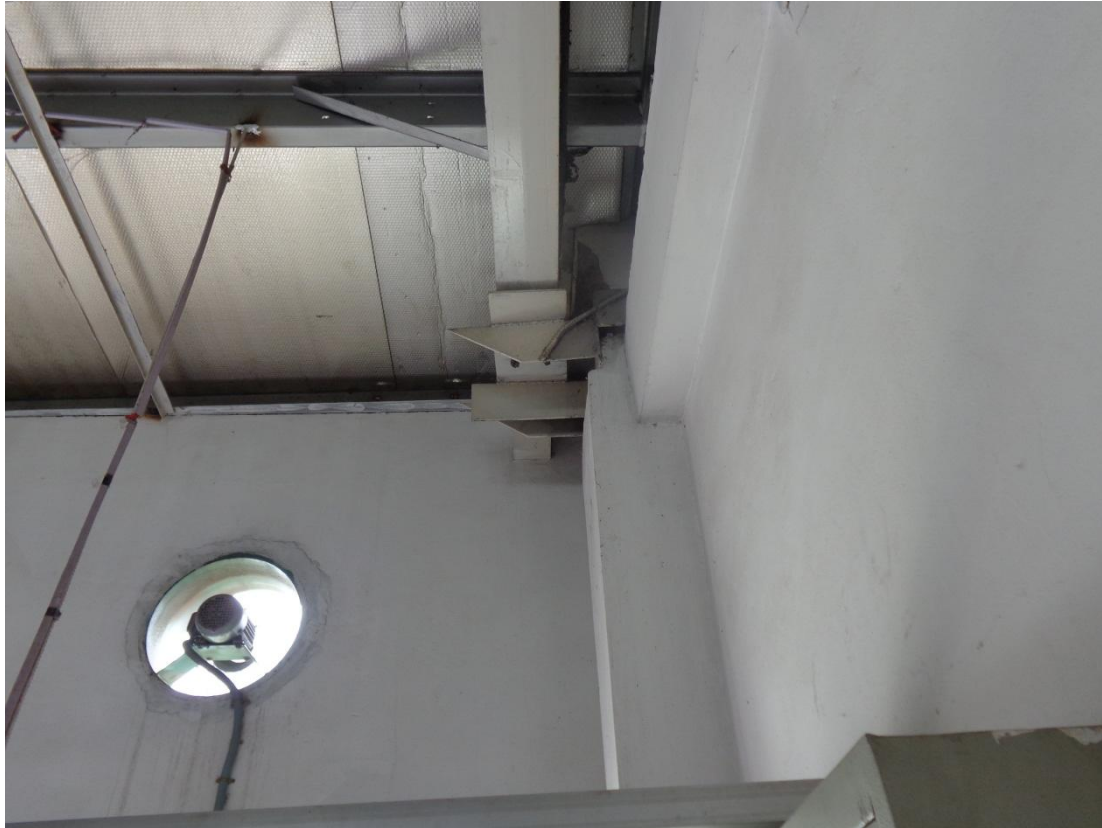
1 - Steel roof framing above the factory's 4th floor level

Connection between beam and column.

Steel roof framing above the factory's 4th floor level

- Detailed engineering assessment to verify the adequacy of the steel roof structure identified as the 1st priority 2 concern

- Carry out any recommendations put forth by the detailed engineering assessment

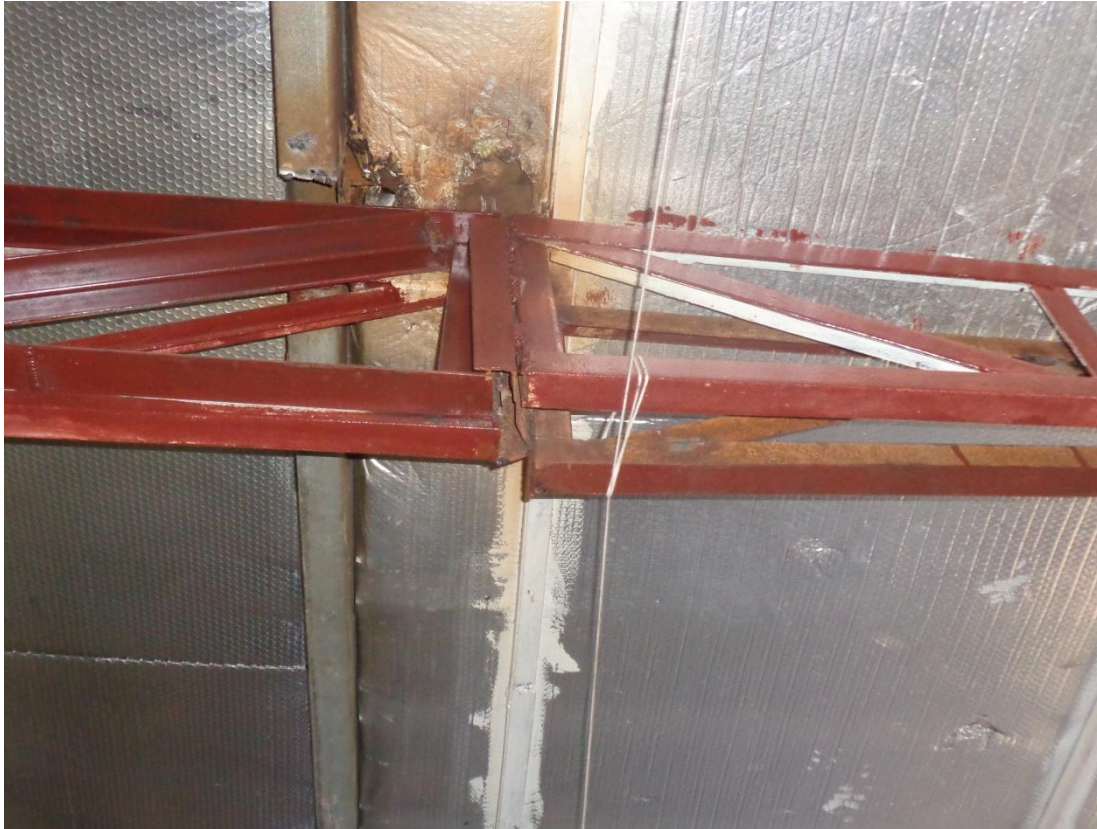
2 - Poorly Framed Steel Roofs framing within warehouse and dining area outbuildings

Connection between 2 truss sections

**Framed Steel Roofs framing within
warehouse and dining area outbuildings**

- As part of detailed engineering assessment verify the adequacy of the steel roof structures identified as the 2nd priority 2 concern

- Carry out any recommendations put forth by the detailed engineering assessment.

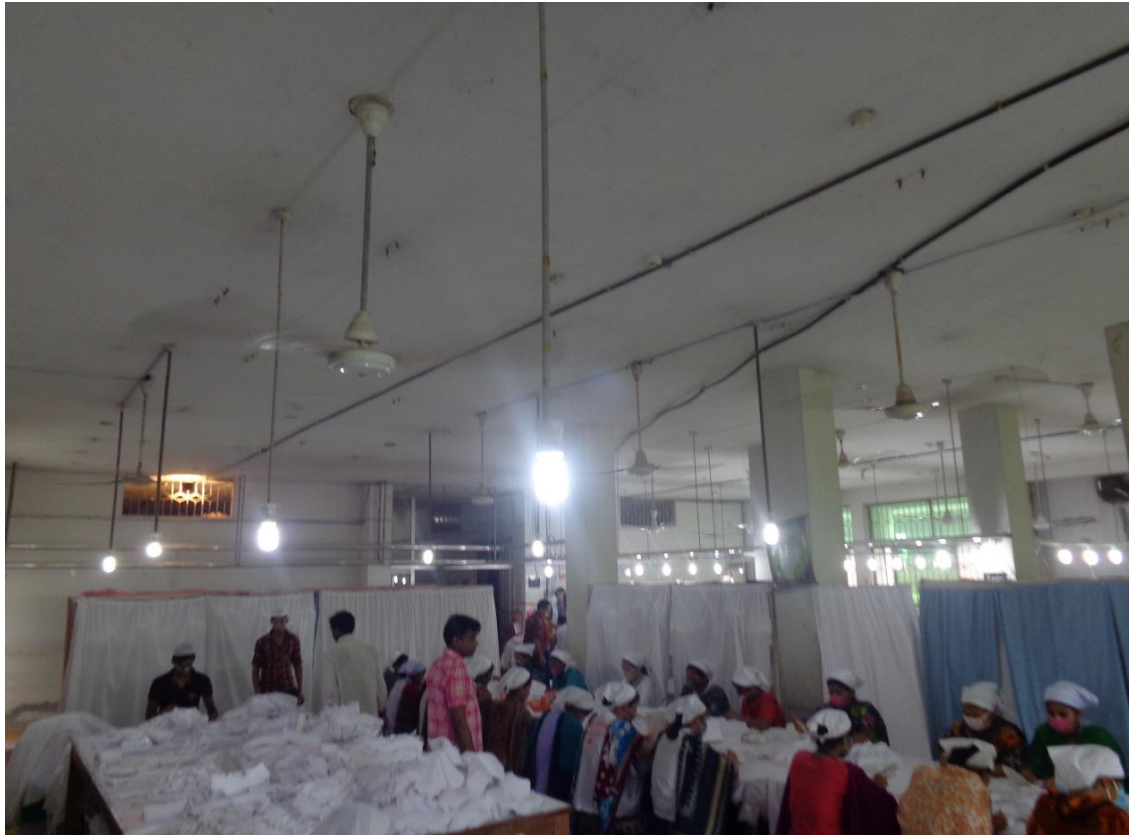
Lateral stability of the structure

No beams between the columns (flat slab construction)

- As part of the detailed engineering assessment verify the stability for the lateral loads

- Carry out any recommendations put forth by the detailed engineering assessment.

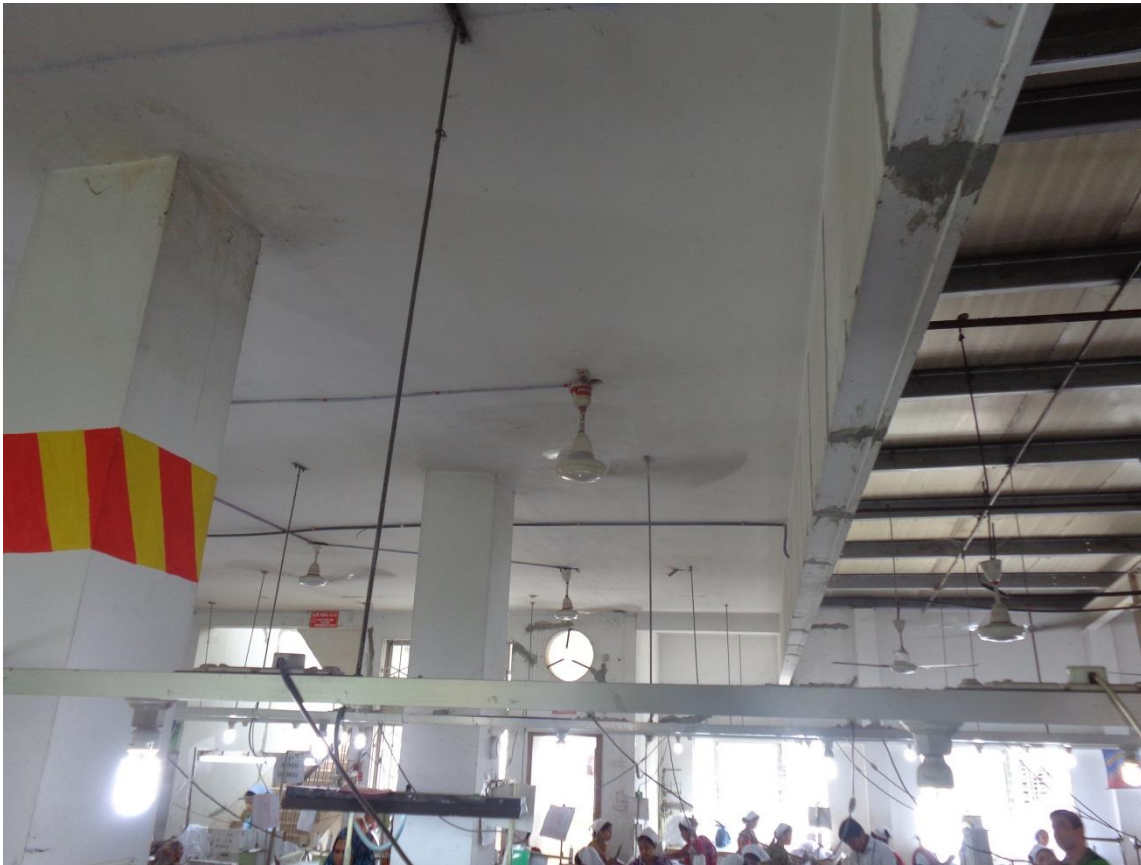
Roof Waterproofing

Water infiltration stains at underside of roof slab

Lack of roof waterproofing

- As part of the detailed engineering assessment verify the possibility of corrosion (steel rebar around the column)

- Carry out any recommendations put forth by the detailed engineering assessment.
