# Mastrade Int'l Garments Ltd. (10040)

Plot #72, Bypass Biswa Road, Mogarkhat, Gazipur - 1701, Bangladesh

09.APRIL.2014

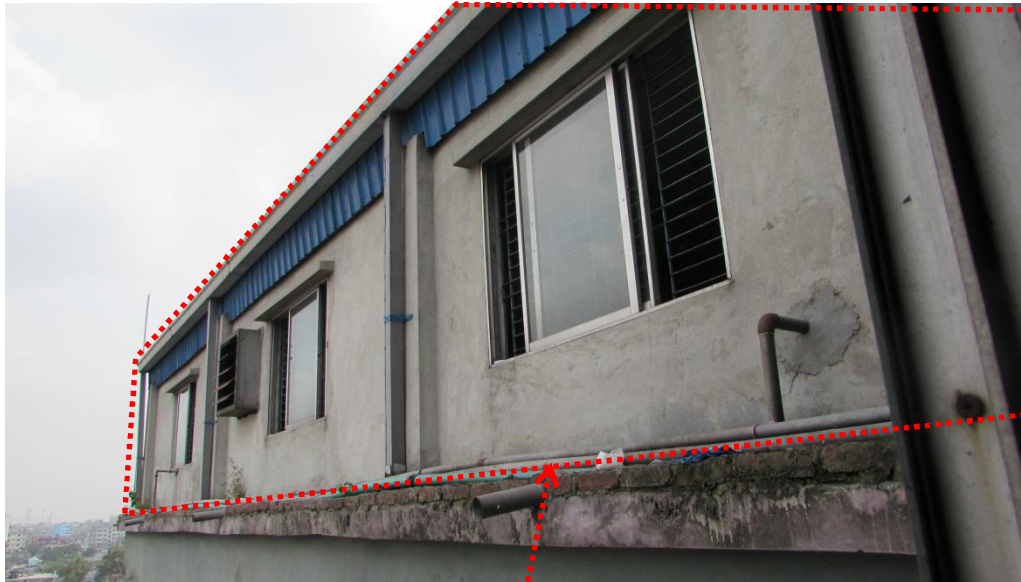
This new structure has been built on the existing roof

The building was constructed in 2008, with brick aggregate, and a total of 6 storeys. There is a significant change of the original building at the roof level. It is now covered by a steel framed roof on the steel purlins and beams and supported by concrete columns. The original concrete roof floor is used to support offices, a cutting area and storage. Based on the load rundown analysis following the agreed minimum design live load assignment, the columns have been found to possess loading capacity with a reduced factor of safety.

**ITEM 1: (1<sup>st</sup> Priority 2) All columns have been found to possess loading capacity with reduced factor of safety due to new construction of additional steel roof and some factory activities on the original roof level.**

The new construction of the steel roof and the additional factory activities at roof level mean the columns at ground floor level now have a very much reduced factor of safety.

- Remove all loading at roof level temporarily.

- Carry out a full building survey using both intrusive and non-intrusive techniques
- Carry out concrete strength tests of structural elements to determine concrete strength.
- Building Engineer to fully check the loading capacity, of all components modified on site without any structural approval, to establish whether or not the as-built components are able to sustain the required loading.

- Depending on the result of the above; potentially demolish all new construction at roof level.
- Produce and actively manage a loading plan for all floor plates within the factory giving consideration to slab and column capacities.

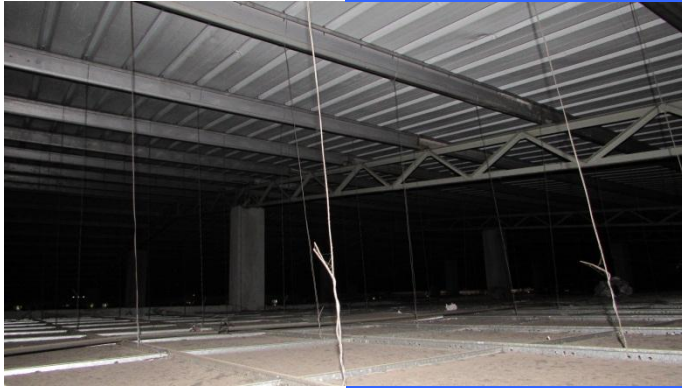
New steel roof

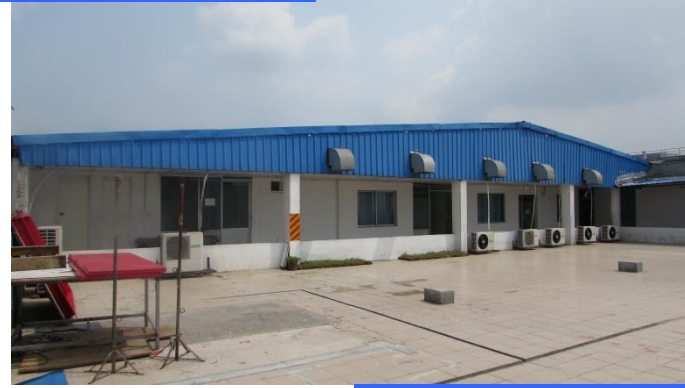
New office

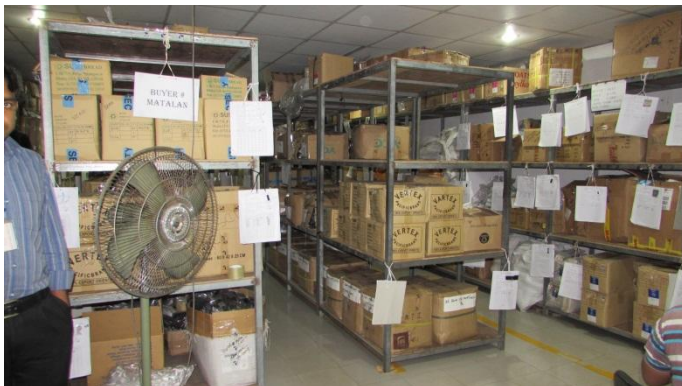
Part of the roof used for storage

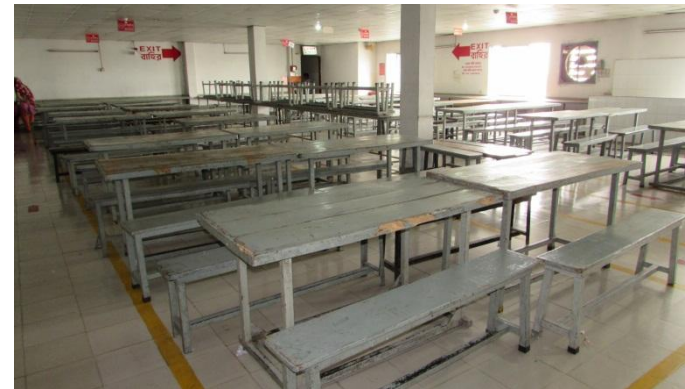
Dining hall

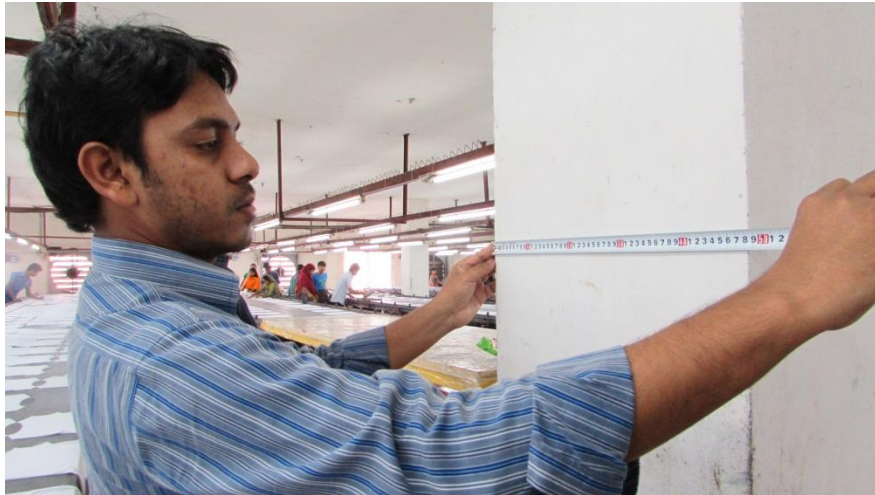
The as-built columns are smaller than those specified on the design drawings (480x480 vs 510x510)

These columns are supposed to be 510x510mm as per design

**ITEM 2: (2<sup>nd</sup> Priority 2) Most of as-built columns are smaller than those shown on the design drawings**

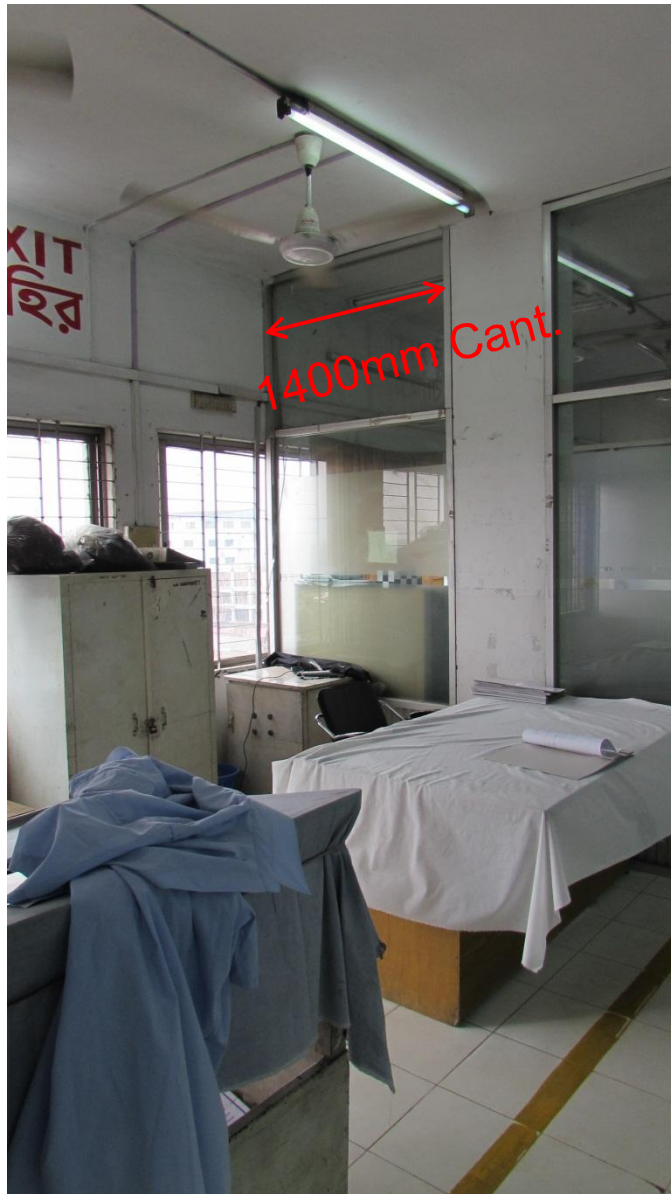
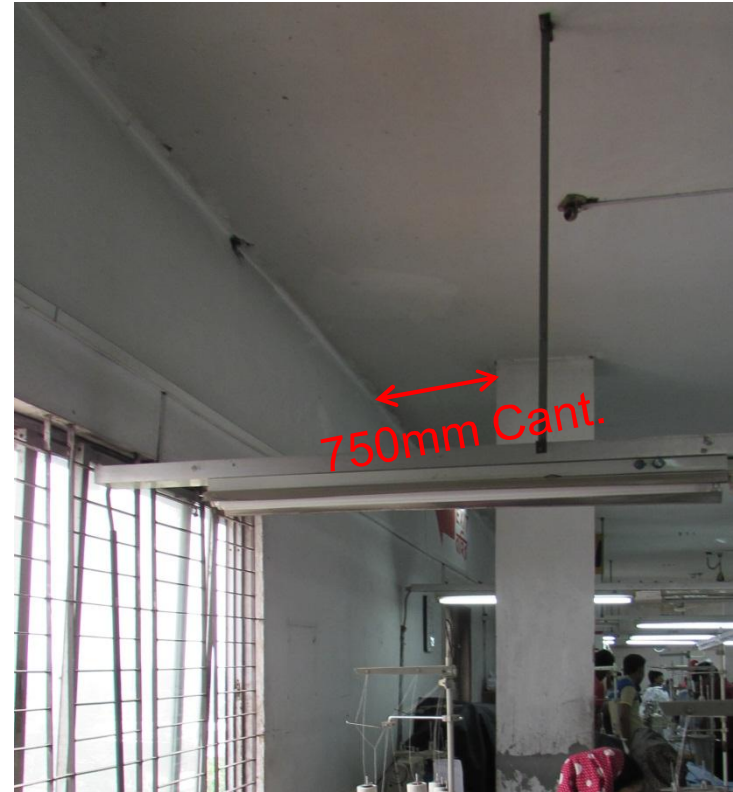
The slab is cantilevered out from the perimeter columns on the north and south sides. This is not documented on any structural drawing.

**ITEM 3: (1<sup>st</sup> Priority 3) The as-built slabs are cantilevered from the edge columns at the north and south sides.**

The as-built slabs do not match with the design drawings; cantilevers have been added on the north and south sides of the building.

- Carry out all of the same steps as described in Item 1 & 2.

- Based on the building survey, develop full up to date structural records, and also propose strengthening works or repair works if the as-built structure appears to be inadequate in any way.

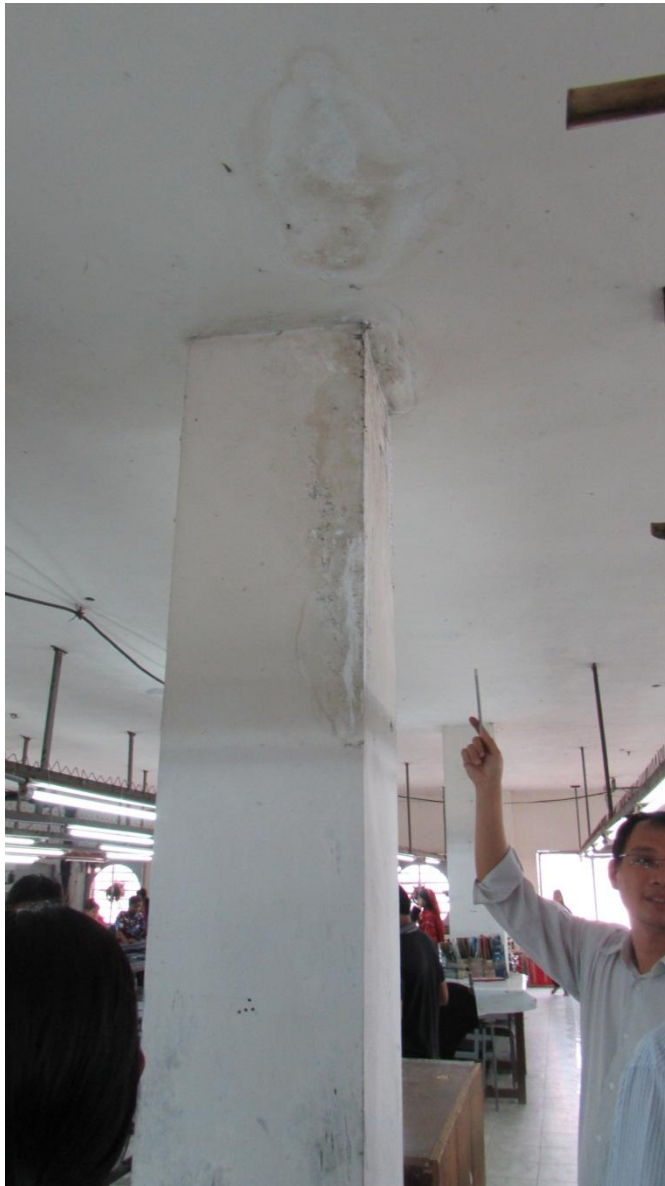
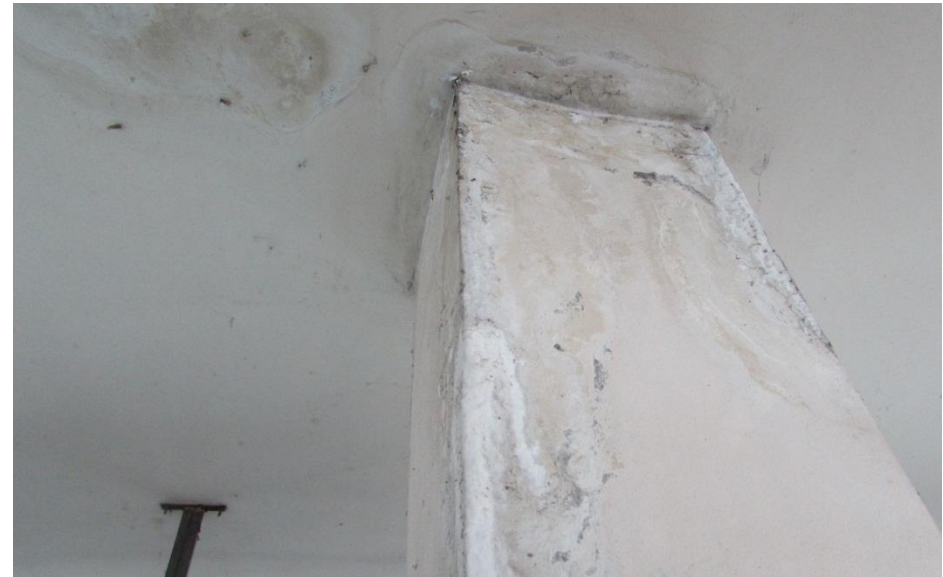
There are signs of water penetration at the underside of level 5. It could be the water from toilet on level 5. The reinforcement in this area of the concrete could have already started to corrode. This could potentially lead to the failure of certain members

**ITEM 4: (2<sup>nd</sup> Priority 3) There are signs of water penetration at the soffit of level 5**

Signs of water penetration on the soffit of level 5

- Provide propping to the damaged concrete areas (if slab and beam and column)

- The building needs to be repaired to prevent any further water penetration which could lead to the corrosion of reinforcement.
- Hack away the damaged concrete and expose reinforcement to check for corrosion.
- Carry out replacement of reinforcement and proper repair of the concrete with a suitable proprietary repair mortar.

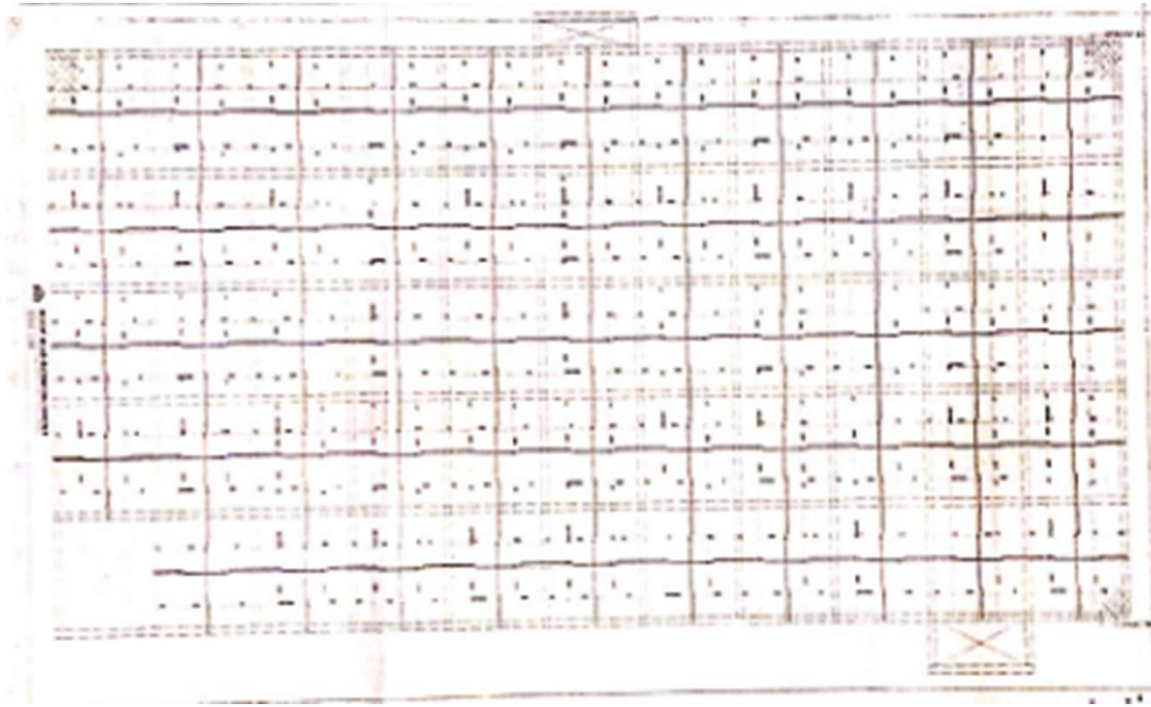
The building appears to lack a recognisable lateral stability system. The flat slab and concrete columns can not be considered as part of a lateral system without any strengthening column strips.

The slab shows the slab reinforcement as only (10mm and 12mm diameter bars)

**ITEM 5: (3<sup>rd</sup> Priority 3) Lack of the lateral system to support the building under wind or earthquake seismic loads.**

The structure lacks a recognisable lateral support system resisting wind or earthquake loads.

We require that these items be investigated in a Detailed Engineering Assessment

- A full structural analysis must be taken to check compliance with the relevant BNBC building codes with respect to lateral stability.
