# **FIRE SAFETY INSPECTION REPORT**

**SHANTA INDUSTRIES LTD**  
**PLOT#198-201/220-223, DEPZ, GANAKBARI**

**ACCORD**  
on Fire and Building Safety in Bangladesh

July 16, 2014

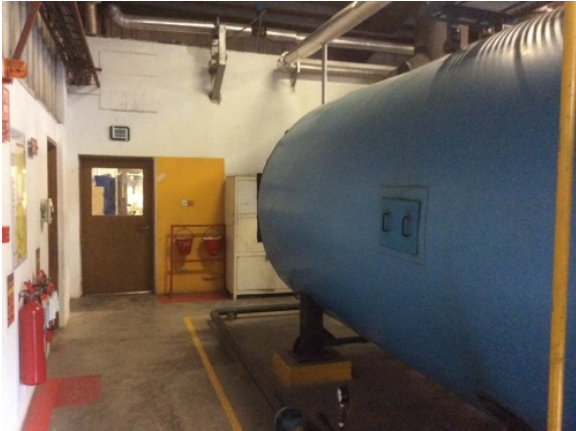
| No. | Category | Finding | Recommendation | Remediation Timeframe |
|---|---|---|---|---|
| F-1 | Fire Rated Construction | The boiler and generator rooms are not separated by fire-rated construction. | Separate the boiler and generator rooms by a minimum 2-hr fire-rated construction. Seal and/or protected all openings to maintain the required fire separations | Within 3 months |

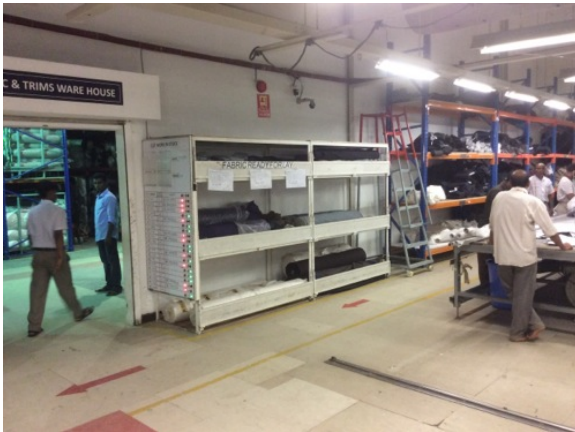
| No. | Category | Finding | Recommendation | Remediation Timeframe |
|---|---|---|---|---|
| F-2 | Fire Rated Construction | Rooms used for combustible storage are not separated by fire-rated construction. | Provide dedicated storage rooms separated by minimum 1-hr fire-rated construction. | Within 3 months |

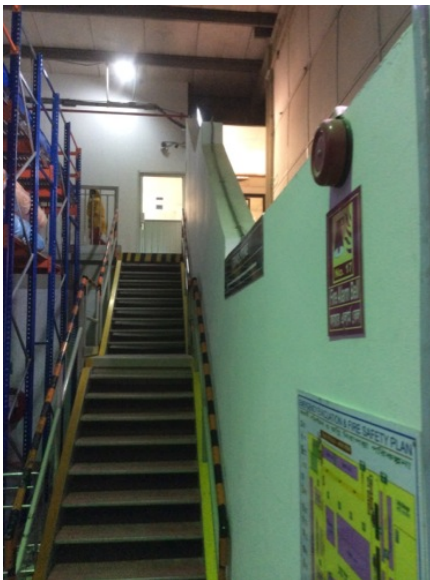
| F-3 | Fire Rated Construction | Egress paths from Office and Sample Mezzanines pass through storage rooms. | Modify stair arrangement to not pass through storage rooms. | Within 3 months |

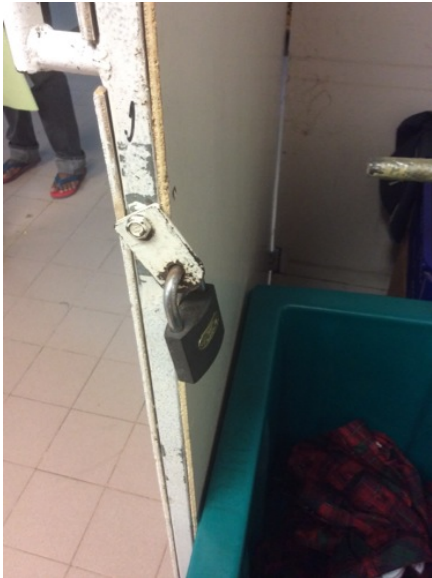
| F-4 | Egress | <p>Egress doors with locking features are provided at building exits and along egress routes.</p> <p>An Office Mezzanine door was fitted with an electronic lock.</p> | <p>Remove locking features from all egress doors.</p> <p>If locks are required for security reasons, utilize special door locking features complying with NFPA 101.</p> | Immediate |

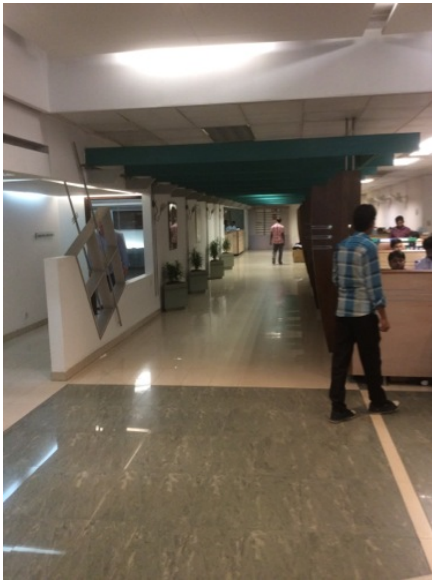
| F-5 | Egress | <p>Common path of egress travel in Office Mezzanine exceeds 30 m., with an approximate distance of 43 meters.</p> | <p>Reconfigure the egress arrangement to reduce the maximum common path of travel to not more than 30 m.</p> | Within 3 months |

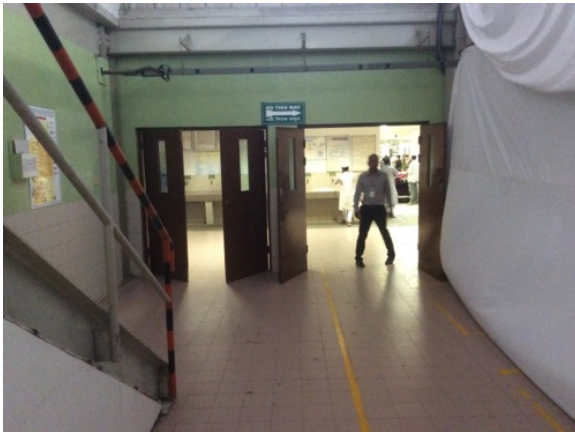
| F-6 | Egress | Egress doors serving 50 or more occupants from the Canteen Mezzanine do not swing in the direction of egress travel. | Modify the egress door to swing in the direction of egress travel. | Within 3 months |

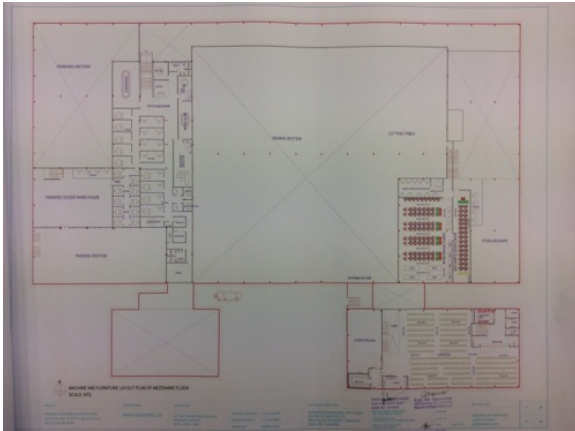
| F-7 | Egress | Exit capacity from the Canteen Mezzanine (264) is not adequate for the occupant load (650). | Reduce occupant load to not more than available exit capacity (264).<br><br>OR<br><br>Provide additional exits. | Within 3 months |

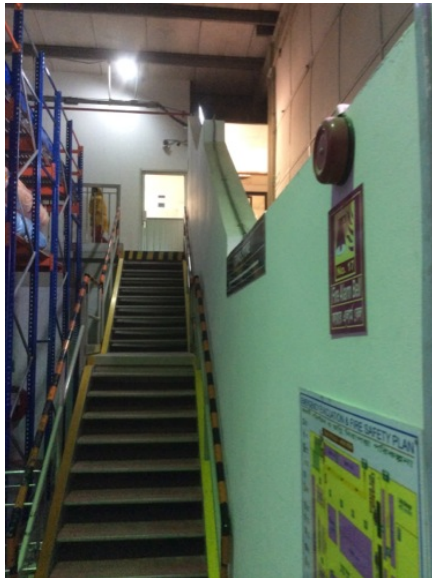
| F-8 | Egress | The exits from the Sample Mezzanine are not remotely located from each other such that a single fire event could compromise both exits. | Provide additional exits. | Within 6 months |

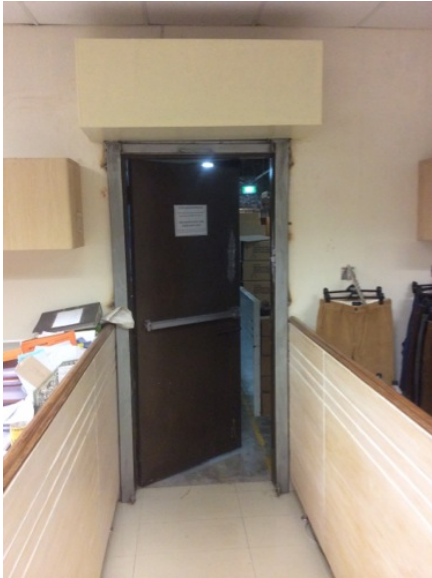
| F-11 | Egress Lighting | Exit sign not provided at multiple exits. | Provide exit signs above all exits to the exterior and all doors along egress paths. | Within 1 month |

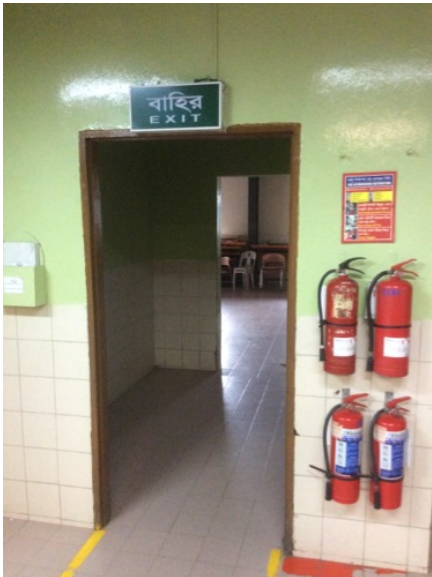
| F-12 | Egress Lighting | Exit signage not illuminated in multiple locations around the factory. | Regularly inspect all exit signage and replace/install lights as needed to illuminate signs. | Within 1 month |
