# Masihata Sweaters Ltd (9506)

South Panishail, BKSP, Kashimpur

09.April.2014

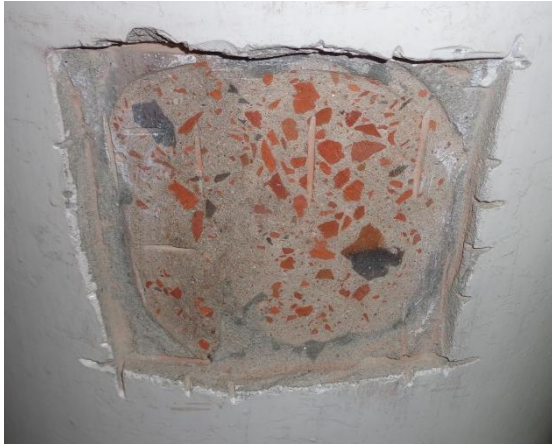
### Priority 1 – Major concern

Built in 2002 with brick stone chips , rebar strength was not provided (40ksi assumed)

Column does not reflect information provided on structural drawings which indicated 500mm dia. column with 22-20mm bars.

We surveyed a 450mm dia .column with 14-20mm bars . Two columns were Ferroscored.

Loading on typical column reflects approx 2 kPa, except in one sector where washing machines and other manufacturing equipment may be closer to 3 kPa (min). High brick partitions with plaster on both sides are also found at midspan in certain areas of building

**ITEM 1: Priority 1 - Concrete stress due to current loading is greater than 11,2 MPa as per calculation guidelines**

Action is to be taken to reduce loads (Action section)

Reduce loading on columns to acceptable stress level

- the first floor & two others need to be closed down, another floor's load needs to be reduced to just below 2.0kPa and the 5<sup>th</sup> floor needs to be restricted to no more than 2.0kPa
- Verify in-situ stress and material properties by testing 100mm dia. Concrete cores of 4 columns

- Commence Detailed Engineering Assessment
- Create and actively manage loading plan for all floors

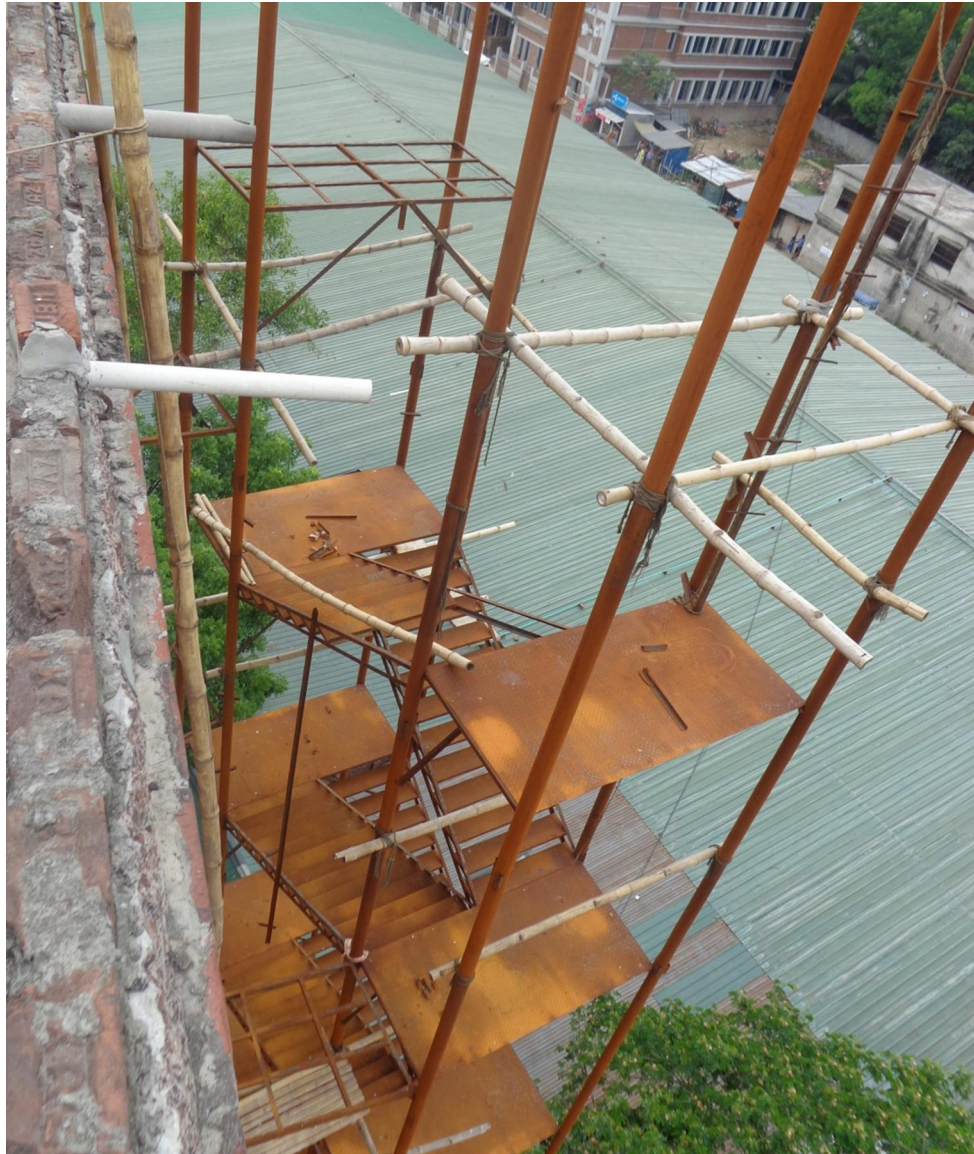
## 2<sup>nd</sup> Priority 1 Concern – Major concern

A stair case is presently being built along side the office building. This staircase is not braced properly and could present signs of instability during high winds. Furthermore, a detail engineering assessment should be carried out to ensure staircase has adequate capacity for live load.

**ITEM 2: Priority 1 - New exit staircase is poorly detailed and currently unrestrained & existing exit staircase has very slender columns and poor bracing detailing**

- Stabilize new staircase during construction

- Carry out a detailed engineering assessment of steel staircases evaluating capacity to gravity and lateral loads

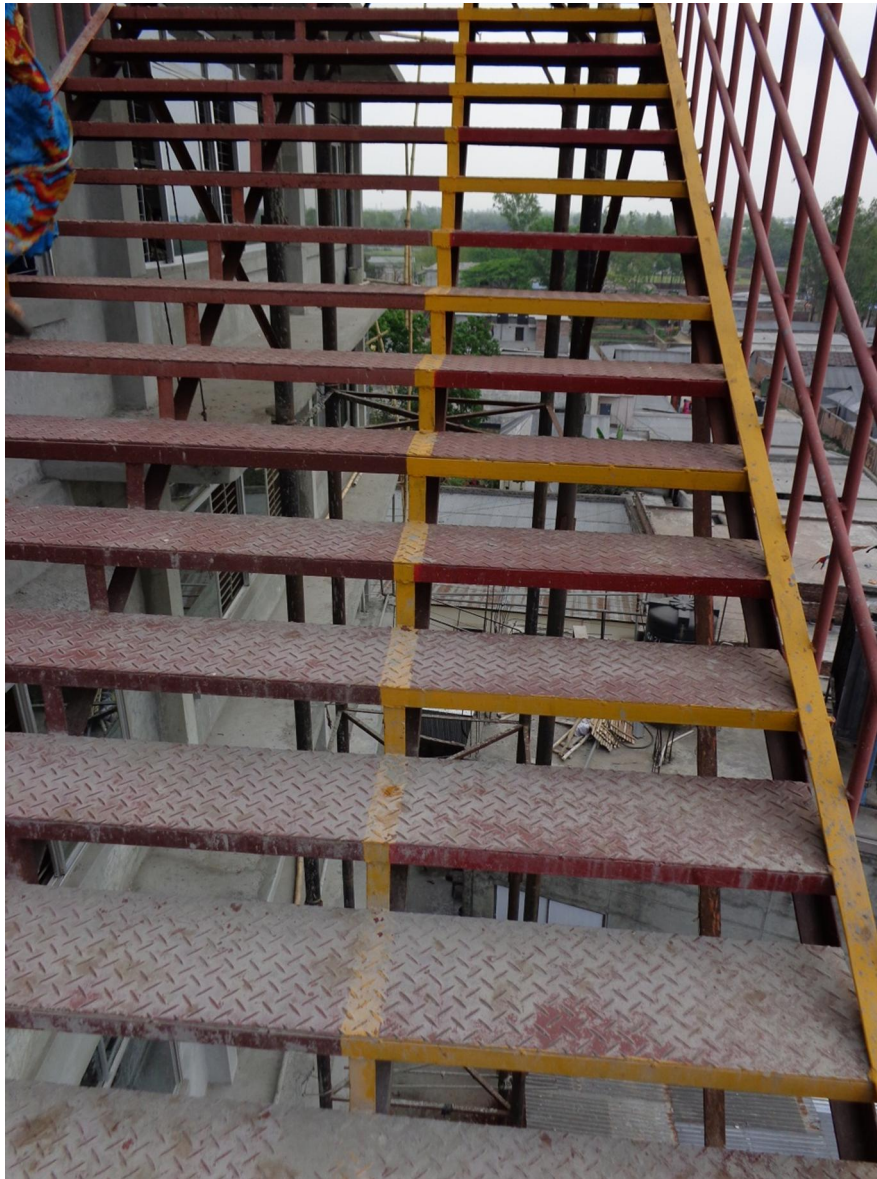
## 2<sup>nd</sup> Priority 1 Concern – continued

Structural steel elements of existing staircase seem very slender even though there are restraints. Furthermore, bracing of staircase is to be assessed. The steel kickers do not meet at nodes and may induce unwanted moments.

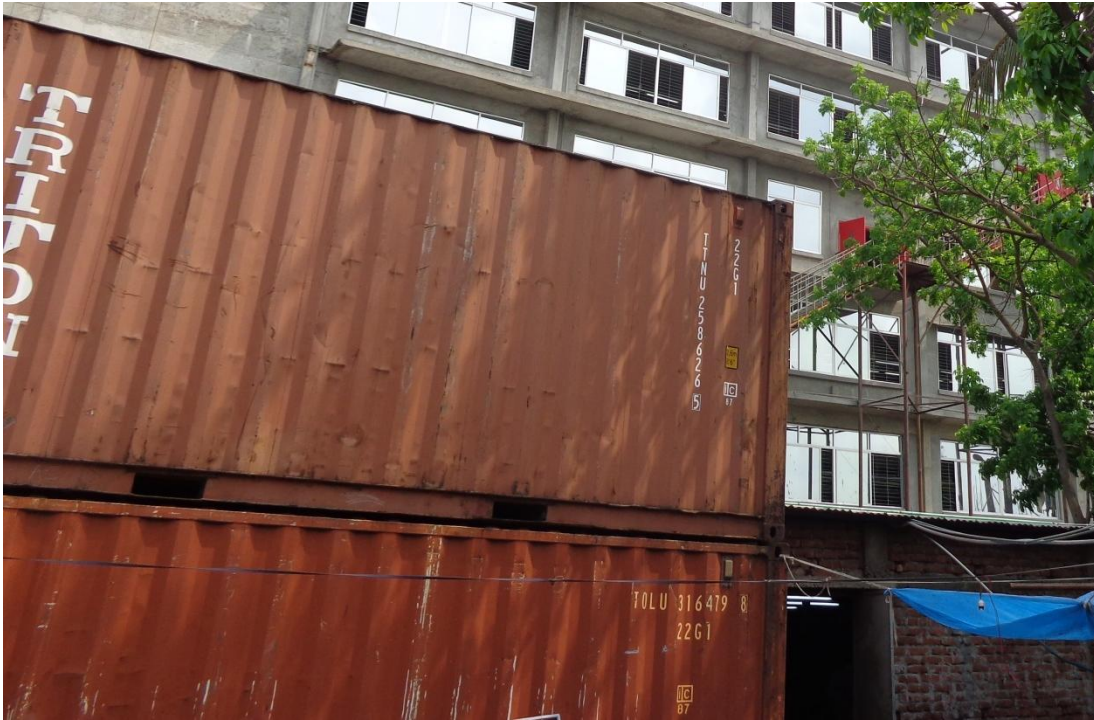
## Priority 2 Concern

In the courtyard, there is a shed complex with steel truss roof which, as typically found, are not tied down. Furthermore, lateral stability of these trusses should be assessed. We also found that certain containers were stacked and used as floor space.

**ITEM 3: Priority 2 - Steel trusses for sheds**

Steel work for sheds is to be investigated in a Detail Engineering Assessment

- Carry out detailed engineering assessment of steel work for sheds including lateral stability of trusses and tie down details for uplift forces

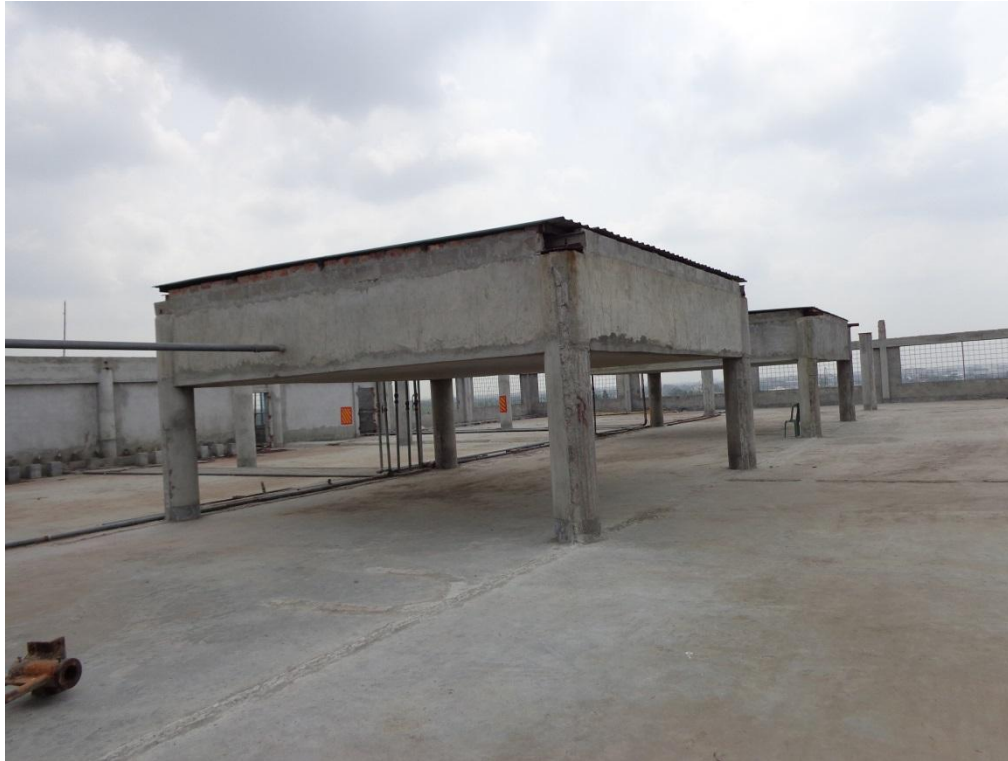
No waterproofing membrane was visible on the roof of the building. This means that any cracks in the surface finishes on the roof will allow water to seep into the concrete slab beneath the finishes, and cause long-term soaking of the slab. Same goes for water tanks at roof.

**ITEM 4: Priority 3 – No waterproofing membrane on the roof**

- Consider applying a new waterproofing membrane.
