# **Novel Hurricane Knit Garments Ltd (10162)**

## **Arabi Fashions Ltd (9473)**

Monipur, Hotapara, P.O. Bhabanipur, Mirzapur, Gazipur 1703, Bangladesh

09.APRIL.2014

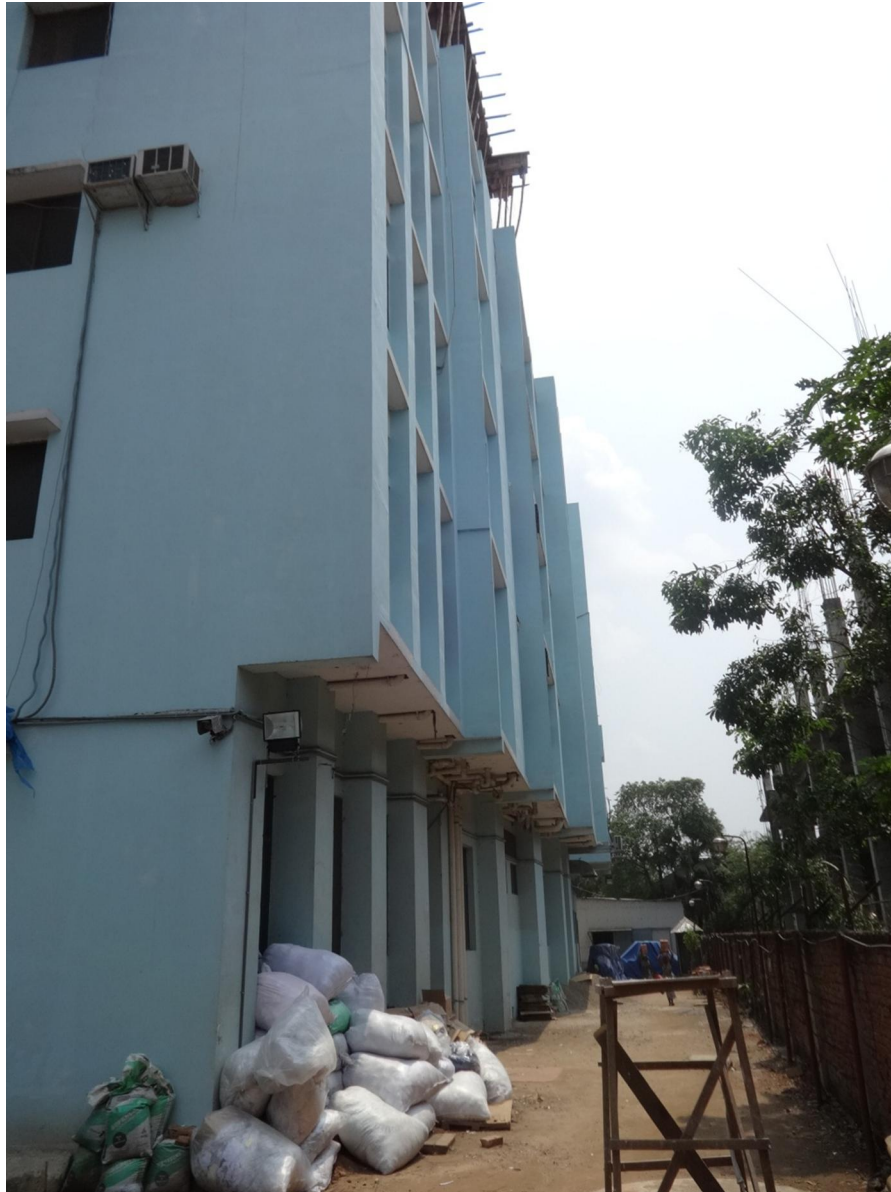
The West elevation steps in and out.  
The drawings show this to be a flush  
wall.

Priority 2 Concern

**ITEM 2: West elevation does not quite match drawings**

West elevation does not match with drawings

- Conduct engineering assessment to ensure frame is sufficiently robust.
- Update drawings to reflect as built condition.

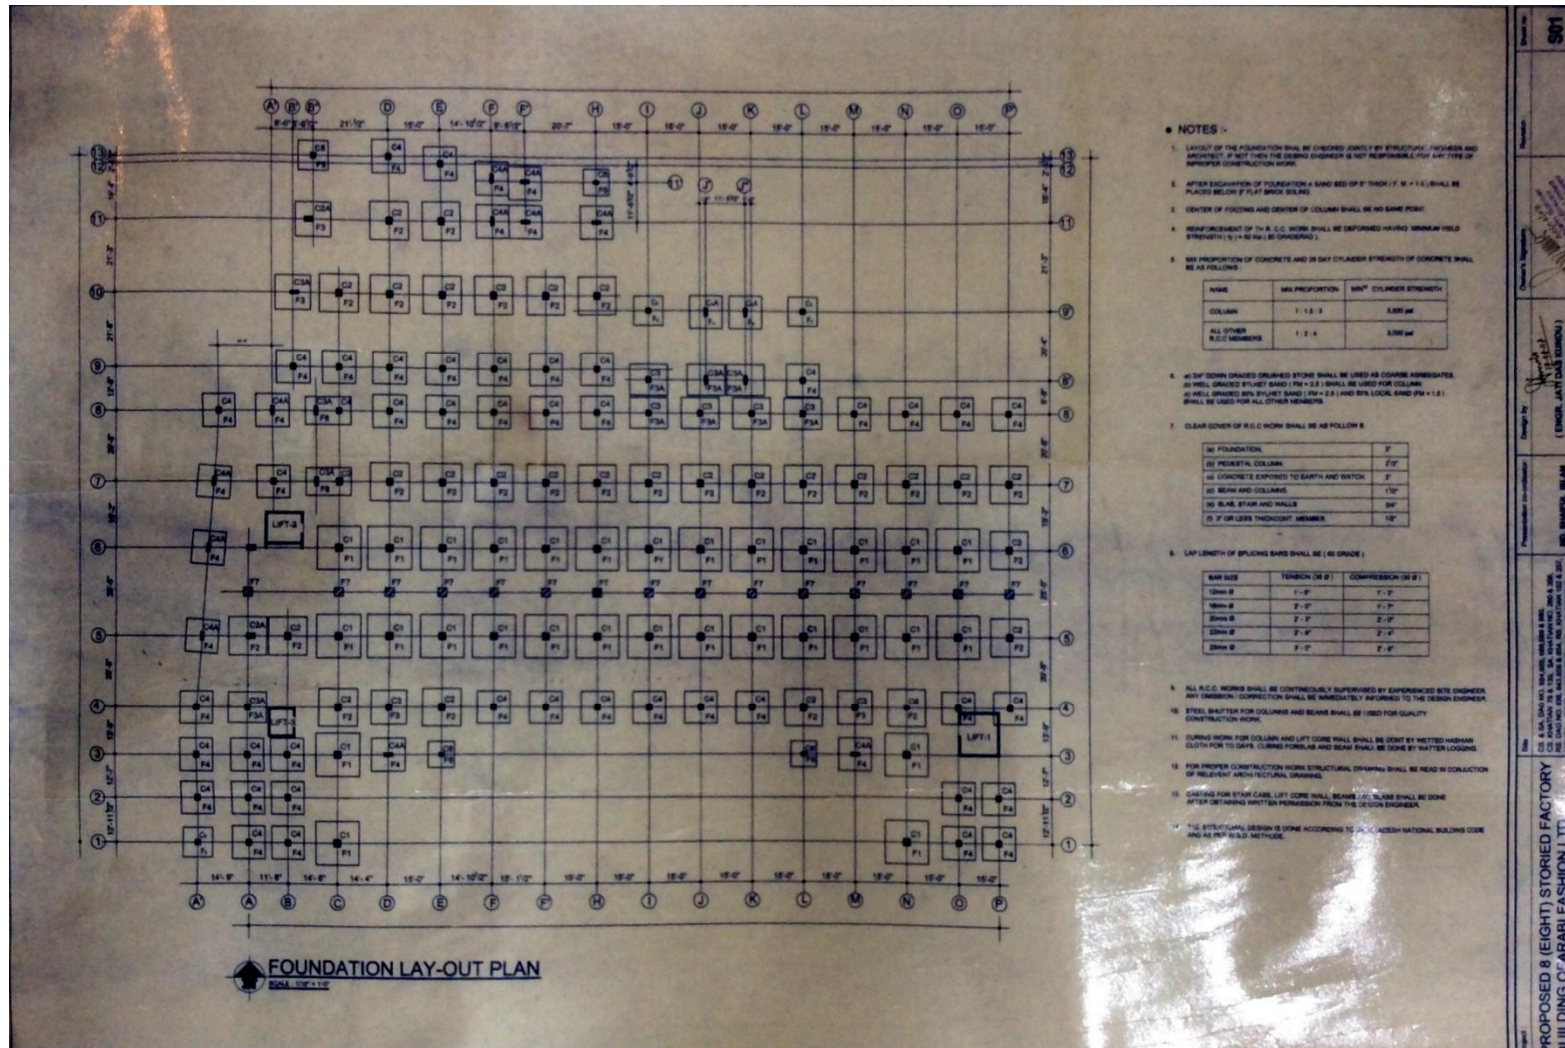
# Overall Stability System

We require that these items be investigated in a Detail Engineering Assessment

Core walls have been built in brick

**ITEM 1: Shear walls have brick infill not reinforced concrete**

The building does not appear to have any stability system, such as core walls / shear walls

- Conduct engineering assessment to establish if building is sufficiently stable under horizontal loading.

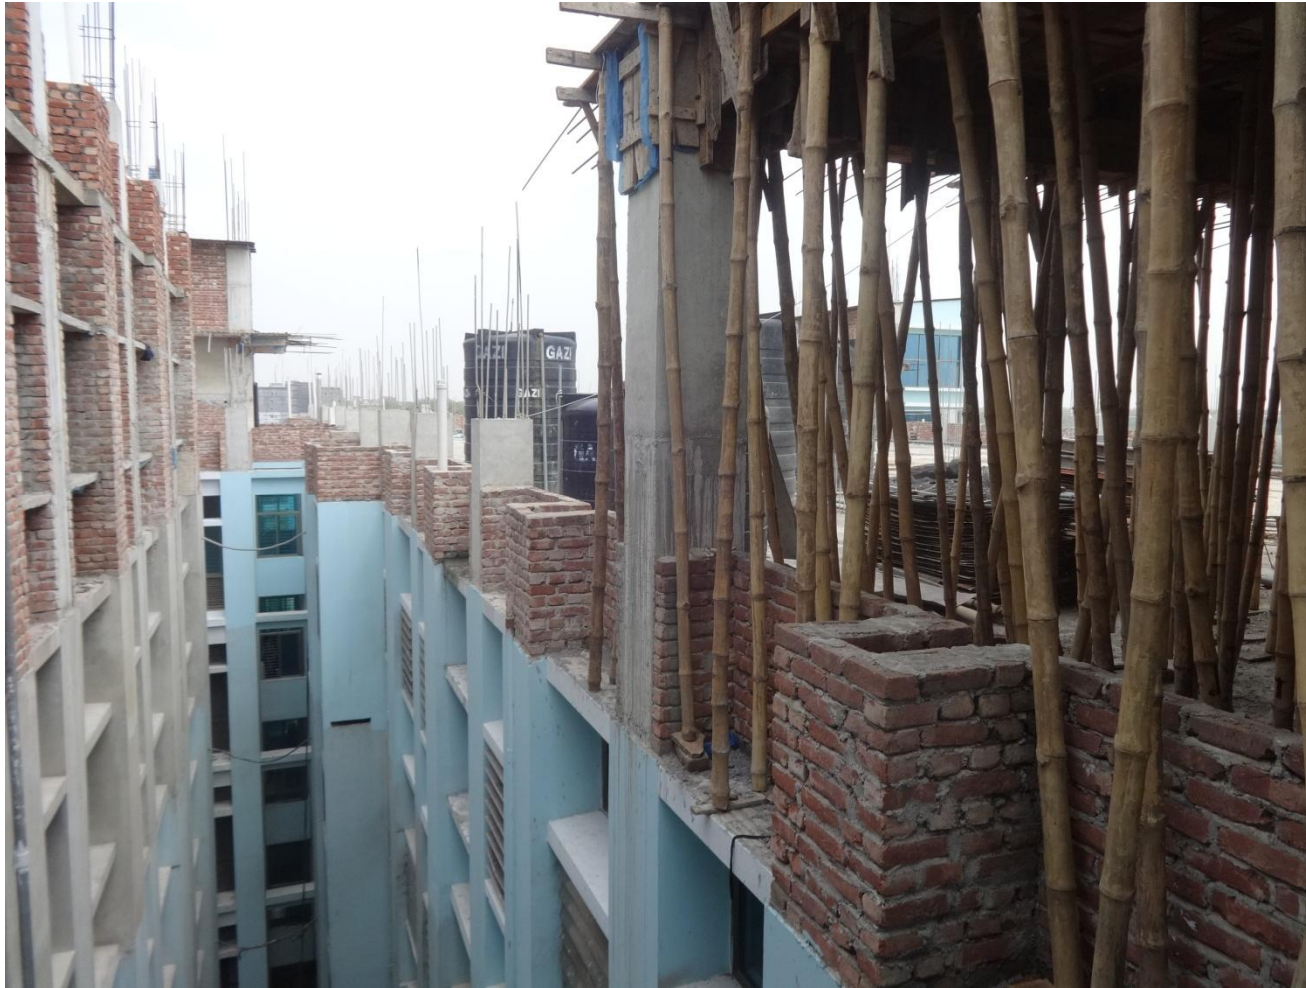
## Water Ingress at Roof Level

No waterproofing membrane was visible on the roof of the building. This means that any cracks in the surface finishes on the roof will allow water to seep into the concrete slab beneath the finishes, and cause long-term soaking of the slab. However the existing roof is temporary as an extra story is being built. The new roof should have a membrane.
