FIRE SAFETY INSPECTION REPORT

SATURN TEXTILE LTD.

**13/1, ABDUS SATTAS MASTER ROAD, GAZIPUR,
TONGI**

SUMMARY

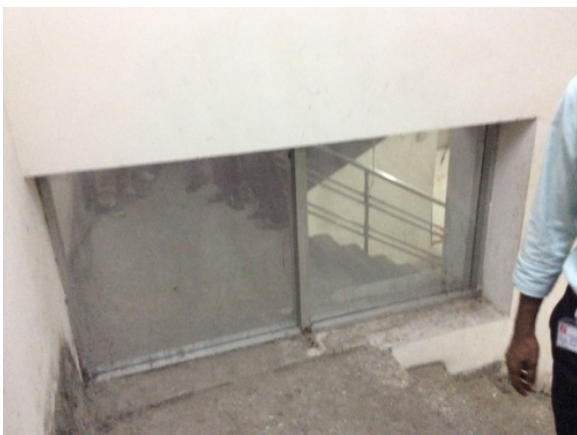
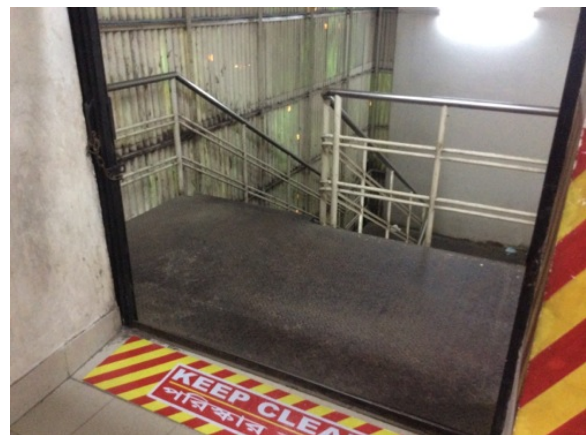
| No. | Category | Finding | Recommendation | Remediation Timeframe |
|---|---|--|--|---|
| F-1 | Fire Rated Construction | <p>The exit stairs are not separated from work areas and other spaces on each floor by fire-rated construction. Portions of the the stair enclosure at the east central (south) stair are non-rated window wall construction and should be replaced with fire-rated construction on each floor and at the ground floor to discharge.</p> | <p>Provide minimum 1.5-hr fire rated doors, seal all unprotected openings, and provide rated walls to separate the exit stairs from work areas and other building spaces on all floor levels. Ensure that the fire doors are self-closing and positive latching and that they are provided with fire exit (panic) hardware where serving production floors.</p> <p>If fire doors are required to be held open for functional reasons, provide automatic-closing devices tied to the fire alarm system.</p> | Within 3 months |

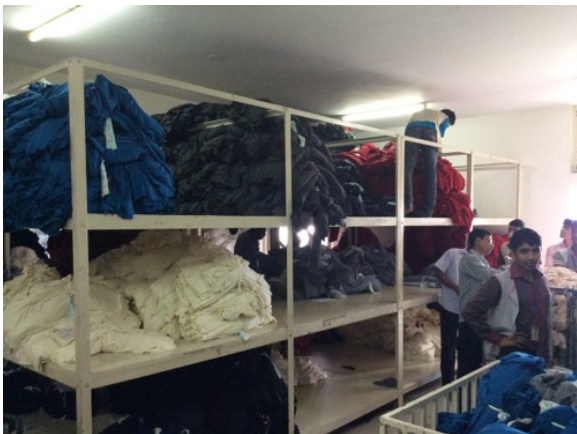
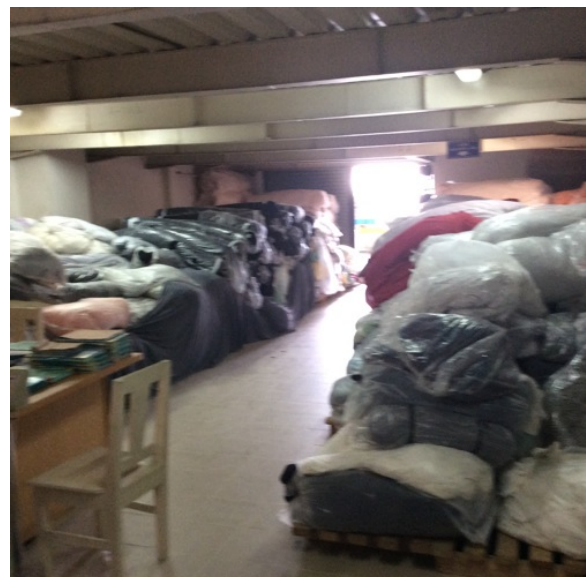
| F-3 | Fire Rated Construction | Rooms used for combustible storage are not separated by fire-rated construction. Some combustible materials were stored right up to the ceiling. Location: All floors. | Provide dedicated storage rooms separated by minimum 1-hr fire-rated construction. Do not store combustible materials within 18 inches of the ceiling. | Within 3 months |

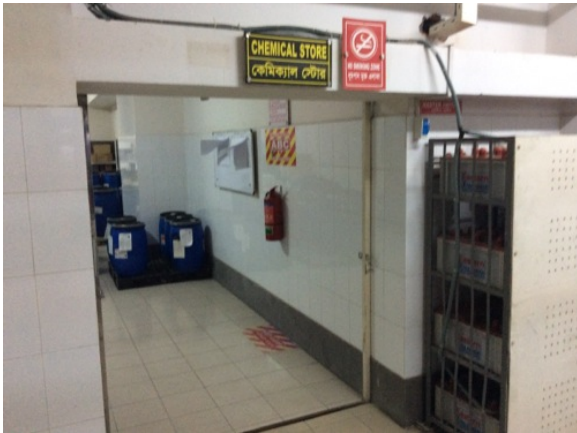
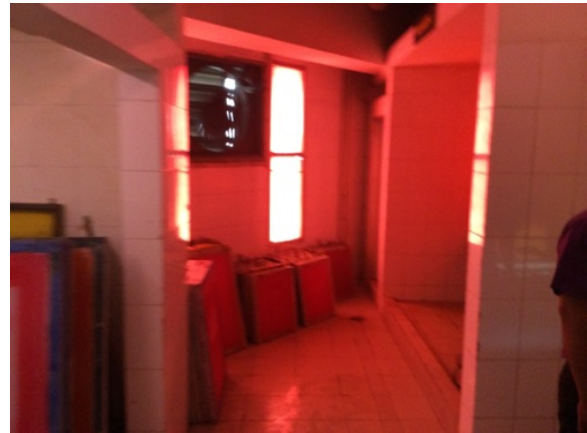
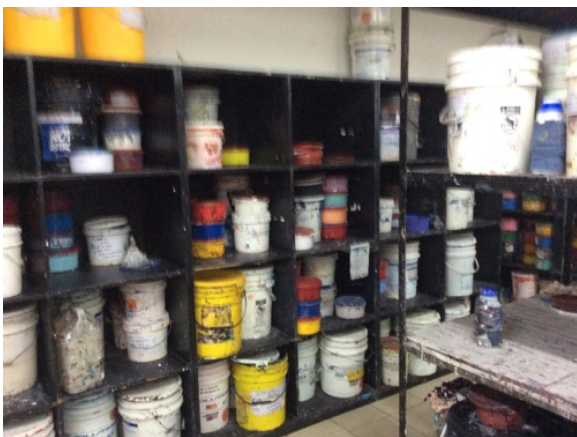
| F-4 | Fire Rated Construction | <p>Hazardous materials storage area is not separated by fire-rated construction (openings, non-rated doors, penetrations).</p> <p>Location: Chemical stores and printing materials in several storage rooms.</p> | <p>Separate the hazardous materials storage room by a minimum 2-hr fire-rated construction. Seal and/or protected all openings to maintain the required fire separations. Do not store hazardous or flammable materials in any areas other than hazardous material storage.</p> | Within 3 months |

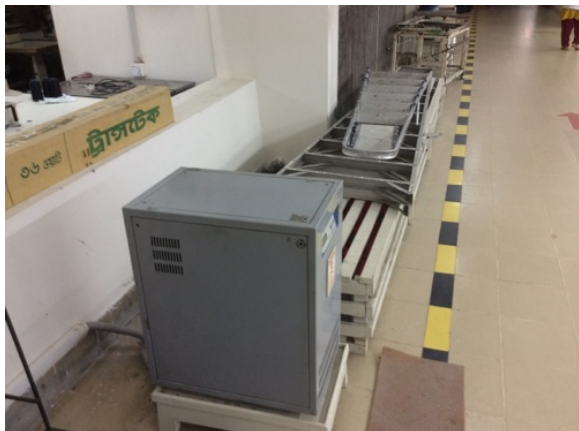
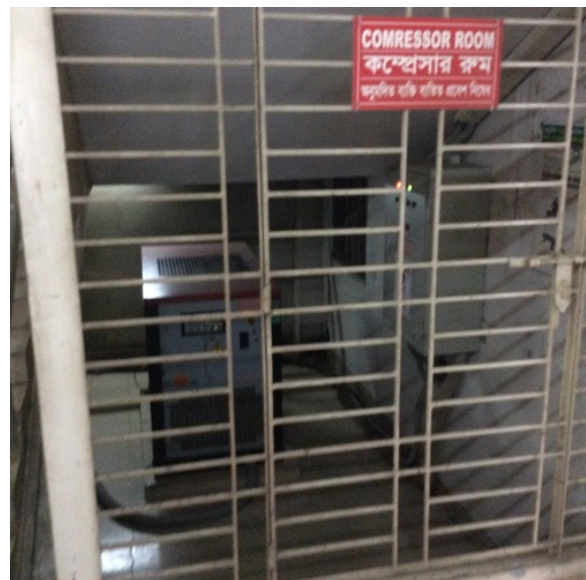
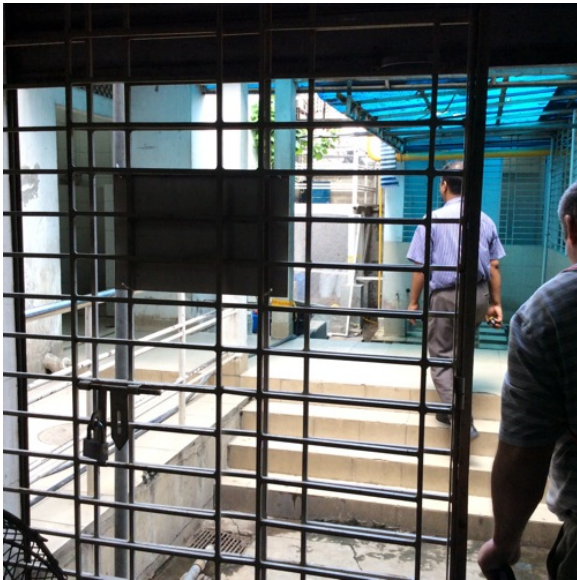
| F-5 | Fire Rated Construction | The boiler, generator, transformer, EMR rooms are not separated by fire-rated construction (openings, non-rated doors, penetrations). | Separate the boiler, generator, transformer, EMR rooms by a minimum 2-hr fire-rated construction. Seal and/or protected all openings to maintain the required fire separations | Within 3 months |

Location: Generator in basement, boiler (near exit) and transformer on ground floor, electrical rooms and IPS system on all floors, and equipment under the southwest stair at ground floor.

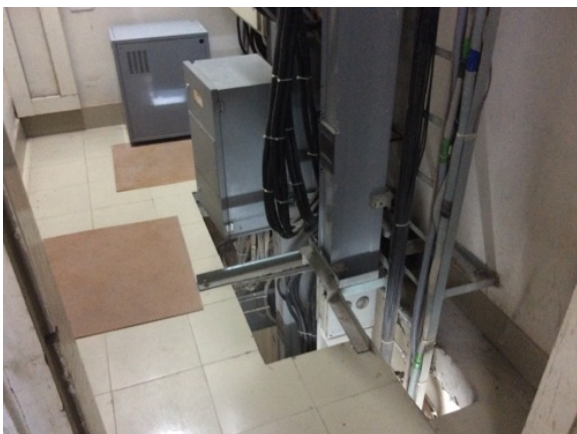
| F-6 | Fire Rated Construction | Unsealed penetrations and openings are located in the fire-rated floor/ceiling assemblies. Electrical room penetrations occur at all floors. | Provide a minimum 2-hr fire-rated shaft to separate the utility risers from each floor level. | Within 3 months |

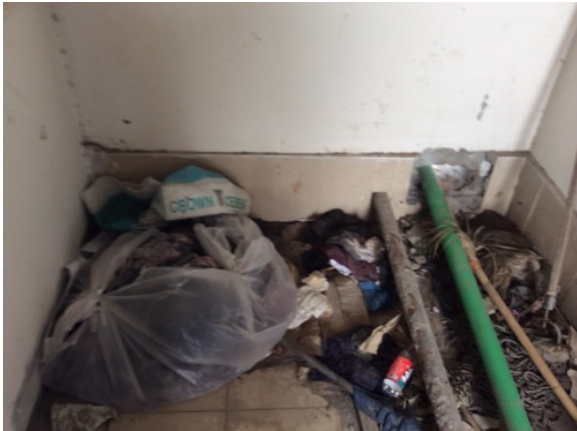
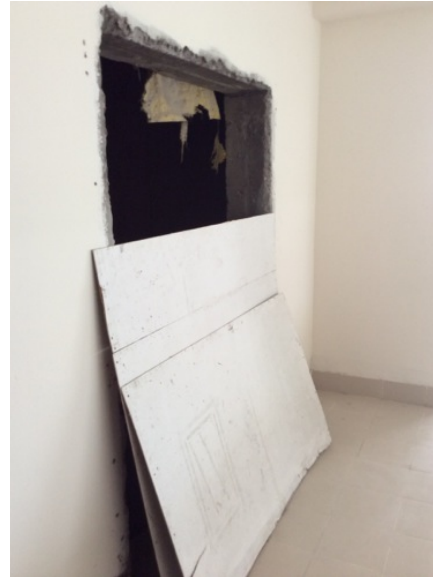
| F-7 | Fire Rated Construction | Unsealed penetrations and openings are located in exit stair enclosures and in the shaft for the future elevator adjacent to the the east central (south) exit stair. | Seal all penetrations and openings in exit stair enclosure walls and shaft for future elevator to maintain the fire separation. | Within 3 months |

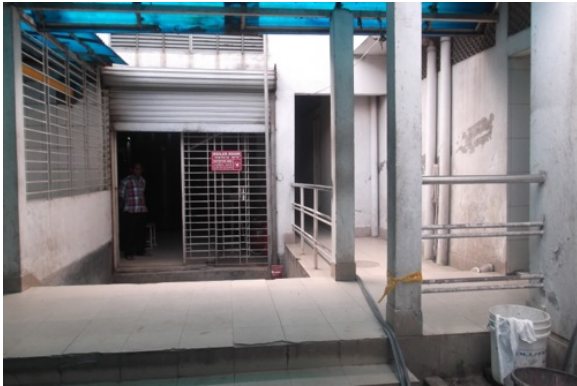
| F-8 | Fire Rated Construction | The exit discharge path to the south from the day-care and medical rooms is less than 10 ft wide and is not separated from the building interior from the exit to the point where the exit path re-enters the building and proceeds through the building to the east side. Also see the day-care finding and the common path of travel finding. | Seal all penetrations and openings to the interior of the building along the discharge path, up to a height of 10 ft., to provide a minimum 1-hr fire separation. | Within 6 months |

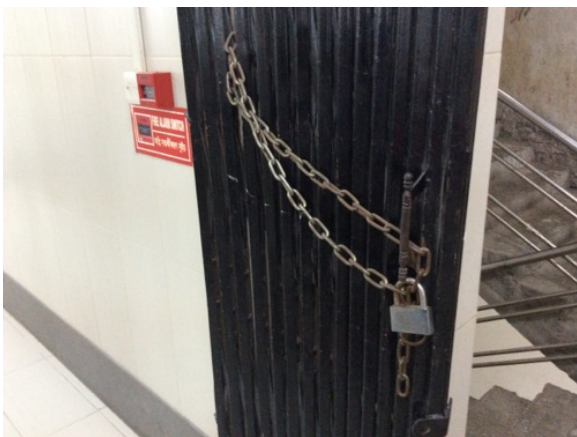
F-9 Egress

Egress doors / gates with locking features are provided at building exits, exit stairs, and along egress routes.

Location: All floors.

All gates/doors were open and unlocked during the inspection.

Remove locking features from all egress doors / gates.

If locks are required for security reasons, utilize special door locking features complying with NFPA 101.

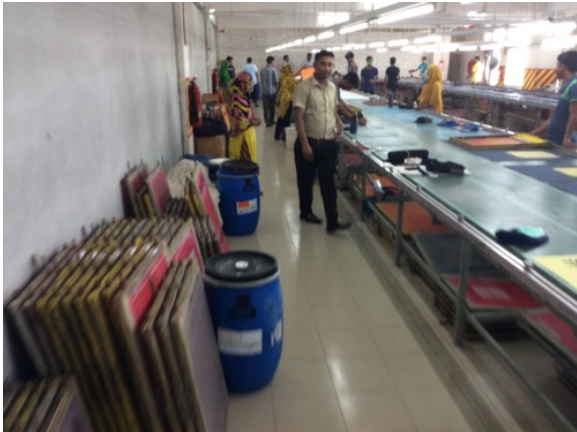
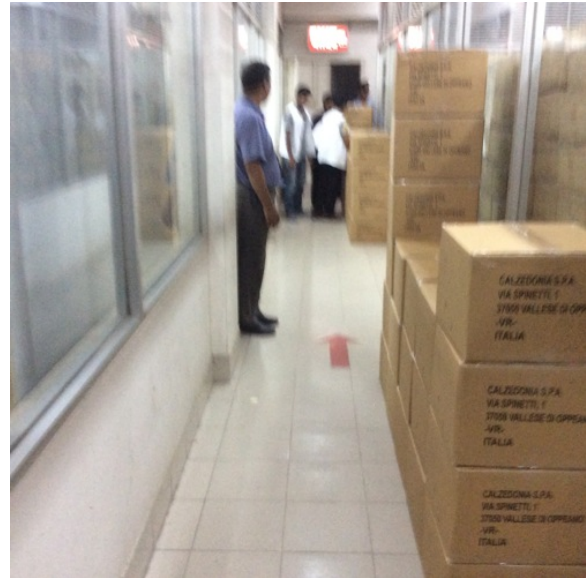
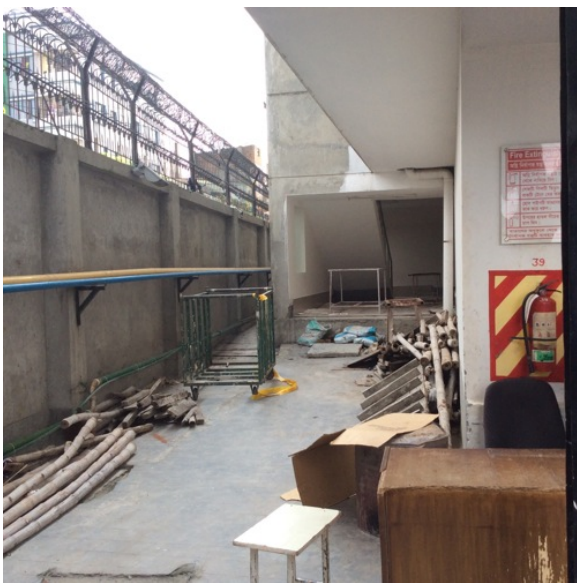
F-10 Egress

Storage was located in the egress path.

Location: Most production floors and storage rooms. The discharge for the southwest stair also contains storage.

Keep egress paths and stairs clear of storage.

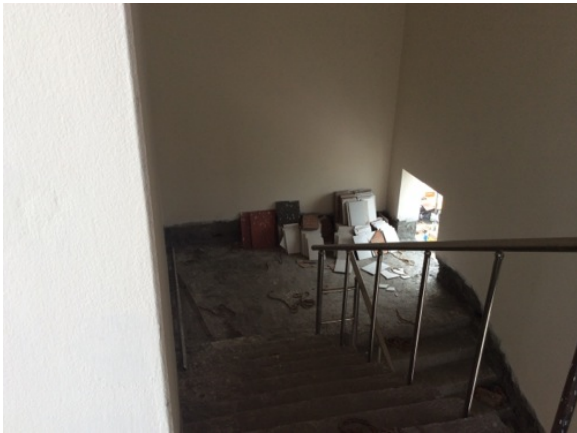
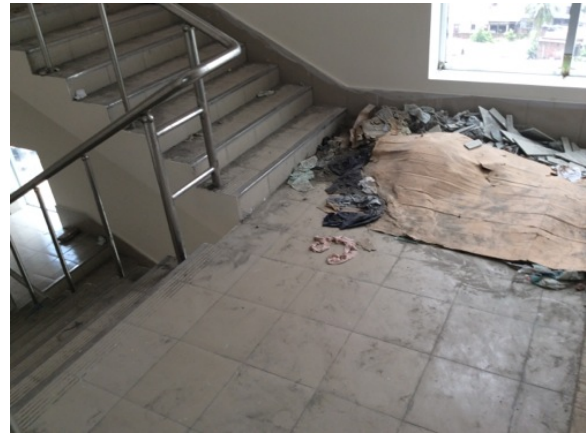
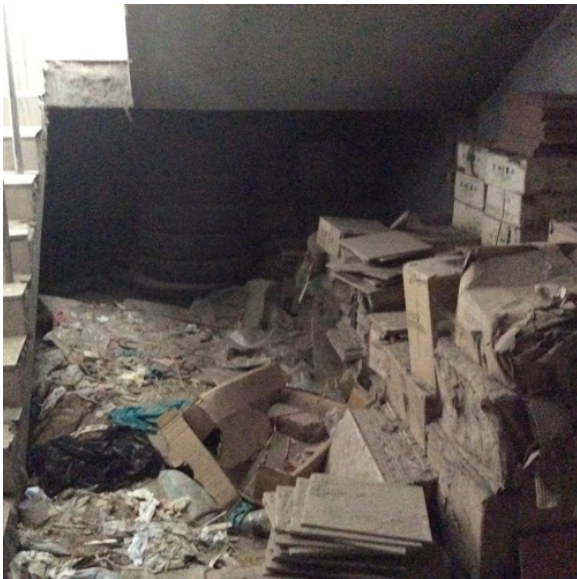
F-11 Egress Storage was located in the exit stair. Remove all storage from exit stairs and egress paths. Immediate

Location: All primary exit stairs at multiple floors.

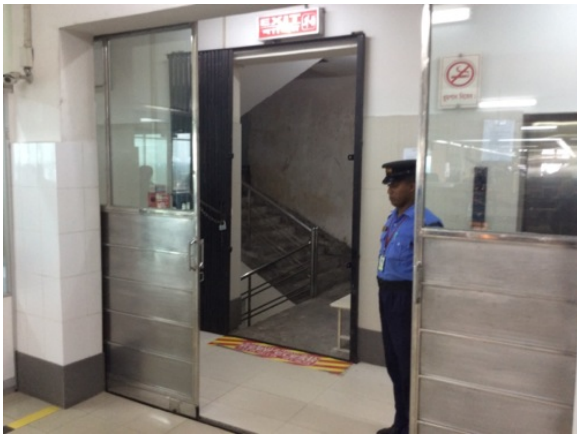
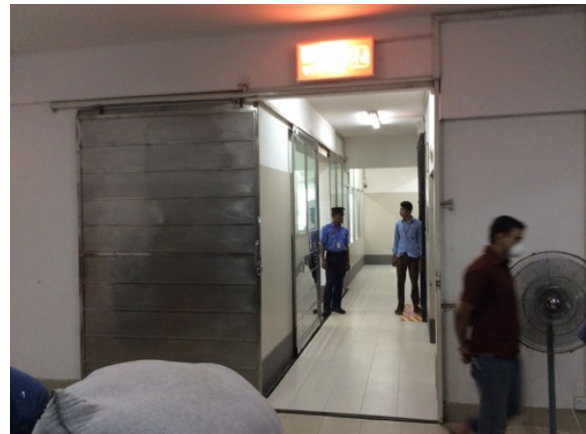
| F-12 | Egress | Collapsible gates / sliding doors are provided at building exits, exit stairs, and along egress routes. Location: All floors. | Replace all gates / sliding doors along the means of egress with side-hinged, swinging egress doors. If locks are required for security reasons, utilize special door locking features complying with NFPA 101. | Within 1 month |

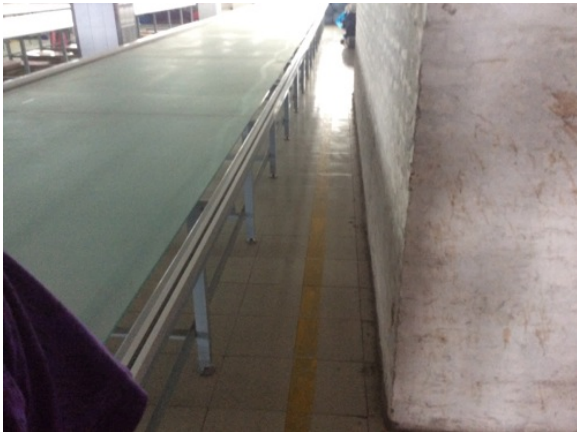
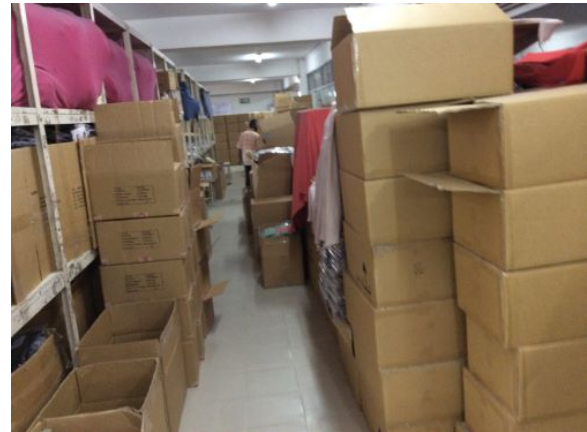
| F-13 | Egress | The width of egress aisles is less than 36-in. Location: 8th floor production and in storage areas on most floors. The discharge from the southeast stair at ground floor needs steps from the discharge opening down to grade to complete the required egress path. | Provide minimum aisle widths of 36-in. Provide steps from the floor of the southeast stair down to grade to complete the egress path. | Within 3 months |

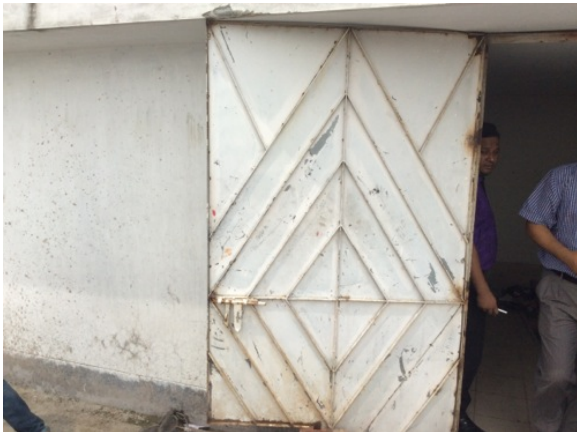
F-14 Egress

Exit stair door does not swing in the direction of egress travel.

Location: Northwest stair at roof.

Modify the egress door to swing in the direction of egress travel.

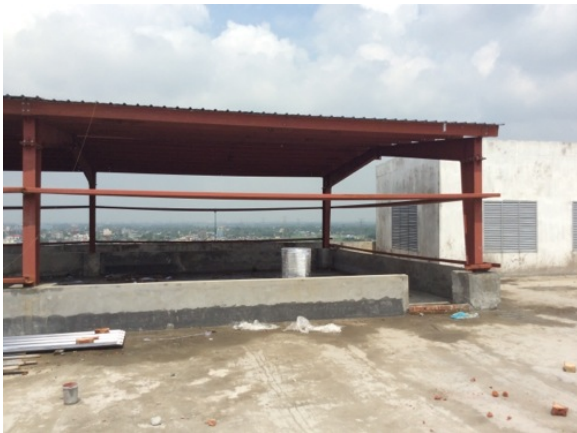
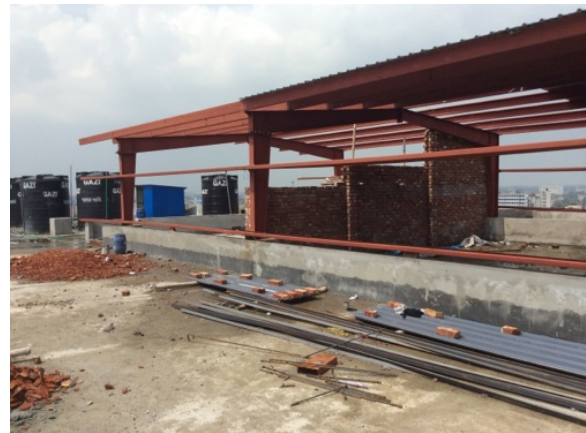
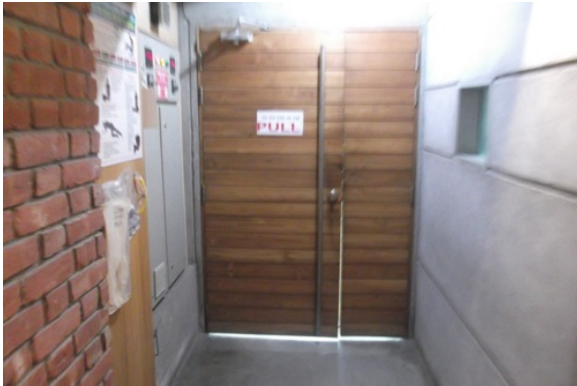
| F-15 | Egress | <p>A single means of egress is provided from the prayer rooms (under construction) on the roof, the mezzanine office area, and the west portion of the ground floor where the occupant load exceeds 49 persons.</p> <p>For the west portion of the ground floor see the common path of travel finding.</p> | <p>Provide additional means of egress for the prayer rooms on the roof and mezzanine office area.</p> <p>The door into the production area on the south end of the mezzanine office can be used as a second exit if a double-egress door and exit signage is provided.</p> | Within 3 months |

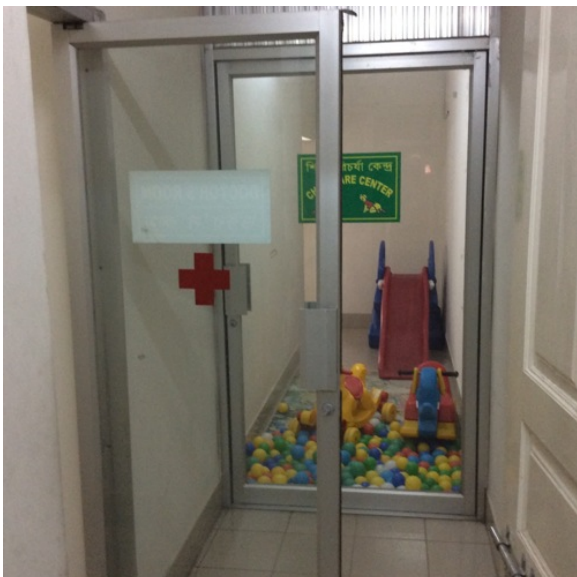
F-16 Egress

The day-care room does not have direct access to an exit within the maximum travel distance of 9m (30 ft).

Location: The day-care is in the southwest corner of the building and the nearest exit is on the east side of the building.

Relocate day-care room to a ground floor location with a maximum travel distance of 9m (30 ft).

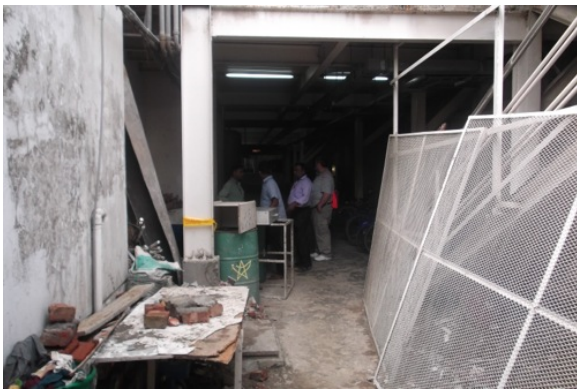
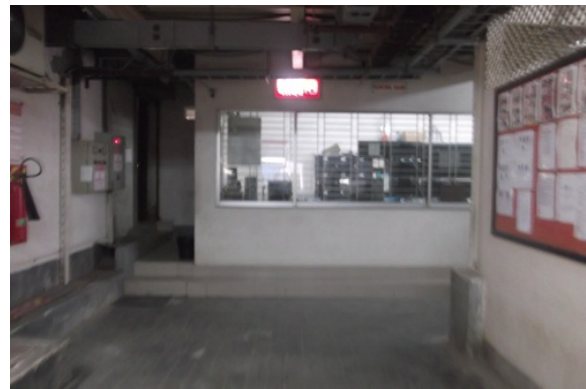
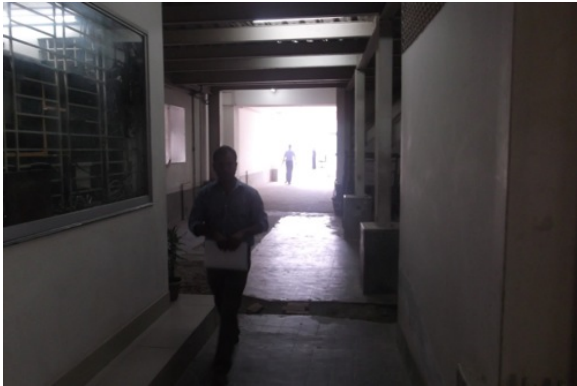
| F-17 | Egress | <p>Common path of egress travel exceeds 30 m.</p> <p>Location: The area on the west portion of the ground floor containing warehouse, offices, medical, day-care, and interior discharge of the southwest stair has only one effective path to reach the center discharge to the east side of the building. The discharge from the southwest corner reenters the building and follows the same interior egress route to the discharge.</p> | <p>Provide 2-hr fire-rated exit passageway leading directly outside (vestibules to separate any storage areas). or Provide sprinkler protection for discharge floor in accordance with NFPA 13.</p> | Within 3 months |

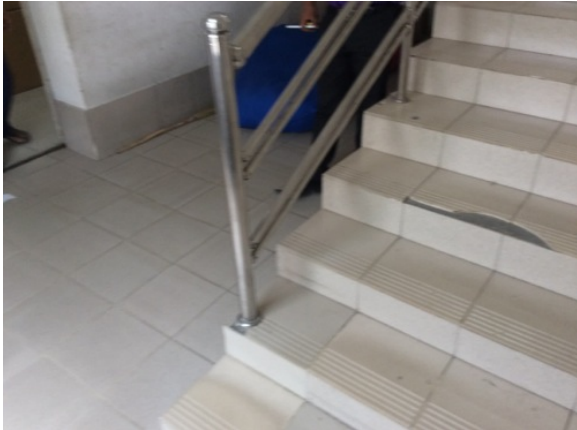
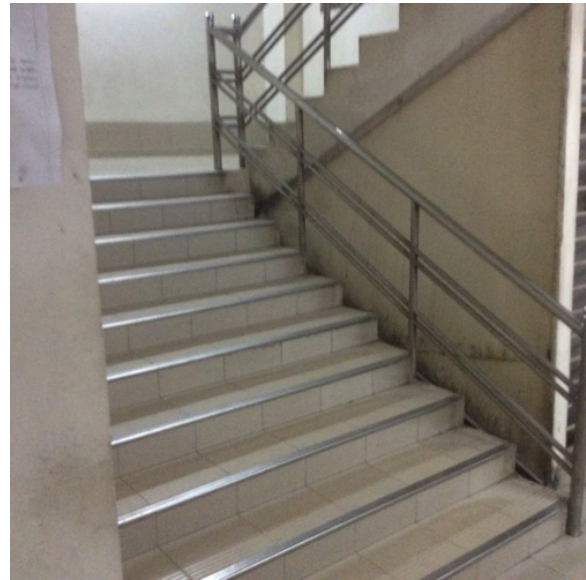
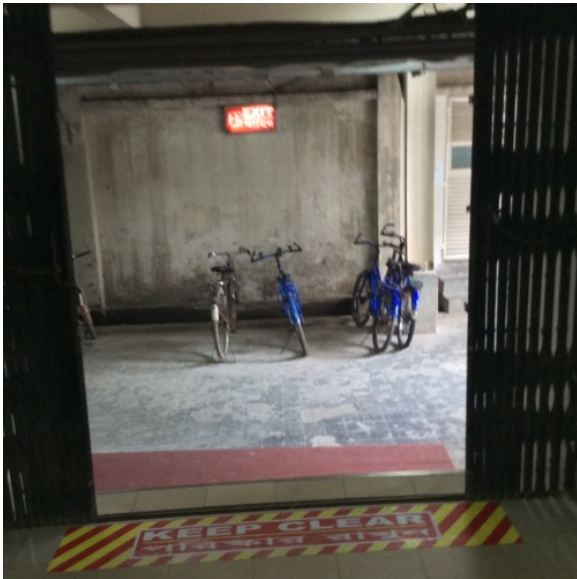
| F-18 | Egress | <p>Exit stairs discharge inside the building.</p> <p>Location: The northwest exit stair discharges inside on the 2nd floor and egress is directed to the north exit stair. The southwest exit stair discharges inside on ground floor and egress is through an unprotected path to the east side. The convenience stair from mezzanine to interior discharge on the ground floor in a warehouse is neither adequate nor required as an exit.</p> | <p>Provide 2-hr fire-rated exit passageway leading directly outside (vestibules to separate any storage areas).</p> <p>or</p> <p>Provide sprinkler protection for discharge floor in accordance with NFPA 13.</p> <p>Remove exit signage marking the convenience stair as an exit.</p> | Within 6 months |

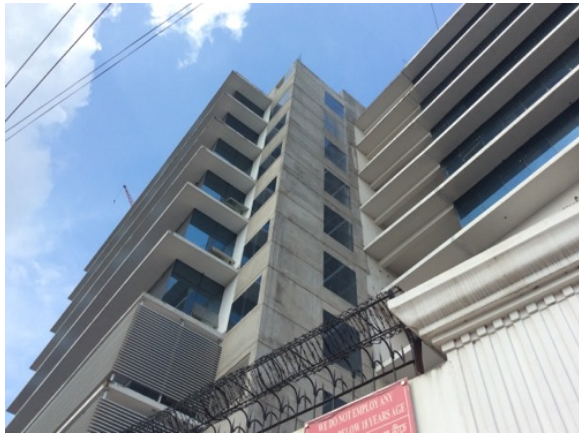
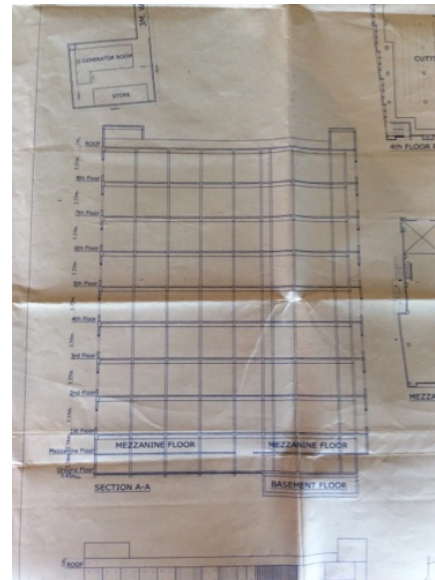
| F-20 | Fire Protection | The high-rise building has an occupied floor greater than 23m (75 ft) and is not provided with automatic sprinkler protection. The large occupant loads, heavy fuel loading, and anticipated extended egress times warrant sprinkler protection. | Provide automatic sprinkler protection throughout the building in accordance with NFPA 13. | Design within 6 months, install within 12 months |

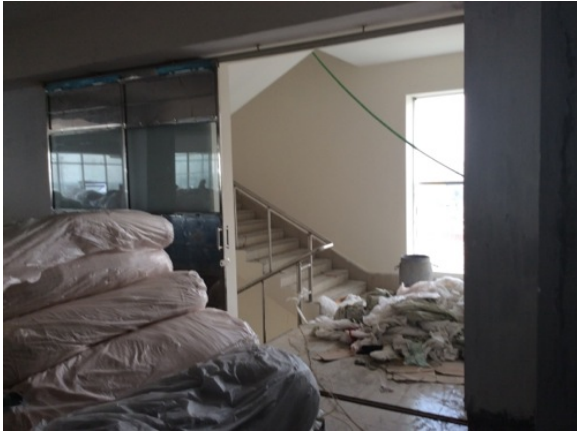
| F-23 | Egress Lighting | <p>Exit signs and emergency evacuation plans not provided at exit.</p> <p>Location: Exit signs missing from the southeast exit stair at most floors of the addition section of the building. Emergency egress signs need to be updated to show the addition. Emergency evacuation plans are missing from the east central (south) stair and the southwest stair.</p> | <p>Provide exit signs above all exits to the exterior and all doors to the exit stairs.</p> <p>Provide updated emergency egress plans at all exits to the exterior and all doors to the exit stairs.</p> | Within 1 month |

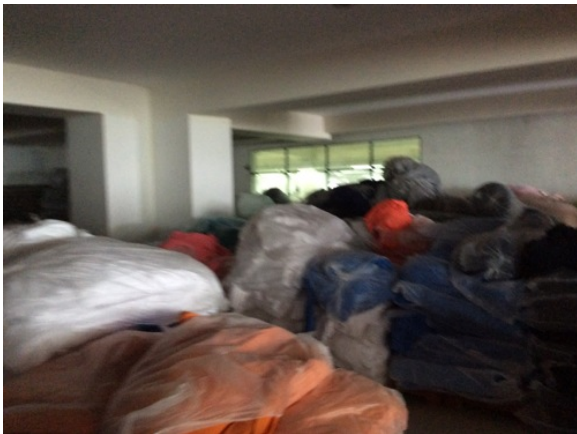
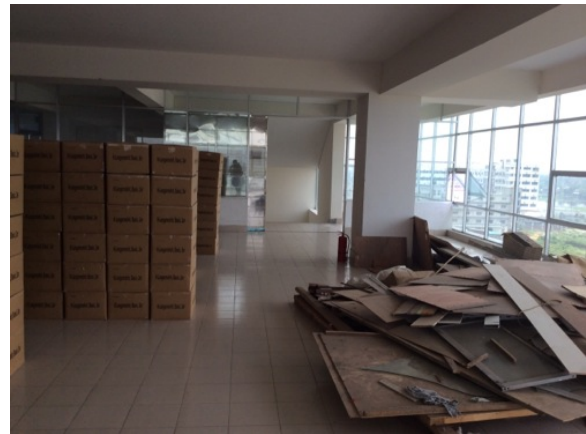
| F-26 | Egress Lighting | Based on the number and location of emergency lights observed, adequate illumination levels are not anticipated along egress routes. No lights in warehouse rooms. Location: All floors. | Test the emergency lighting system on each floor and provide additional emergency fixtures to provide adequate illumination along the means of egress. Provide a minimum illumination of 10 lux at the floor level within exit stairs and exit discharge paths and minimum 2.5 lux along exit access aisles. | Within 3 months |
