# Meditex Industries Ltd (9253)

Plot #912, Kashimpur Road, Konabari, Gazipur

## Client Summary Report

**ACCORD**  
on Fire and Building Safety in Bangladesh

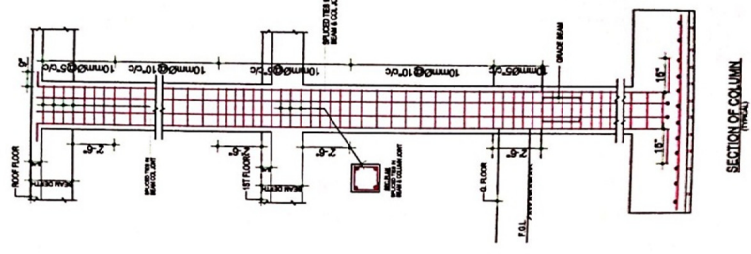
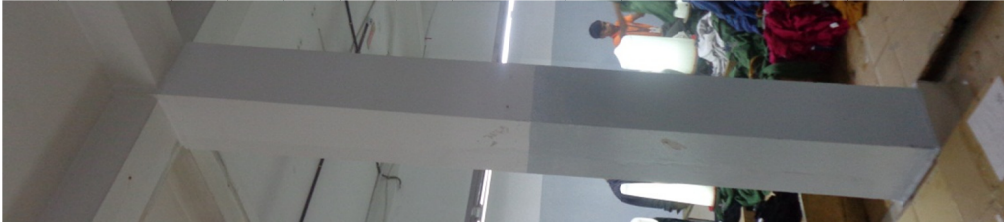
# High Column Stresses in Phase 2

Within phase 2 under minimum allowable live loads, column checks yield lower than desirable safety factors.

**ITEM 2: (Priority 2)** Column stresses within Phase 2 are higher than desirable even under minimum allowable live loads.

- Detailed engineering assessment scope to include assessment of adequacy of existing columns.

- Implement any works deemed necessary by the detailed engineering assessment.

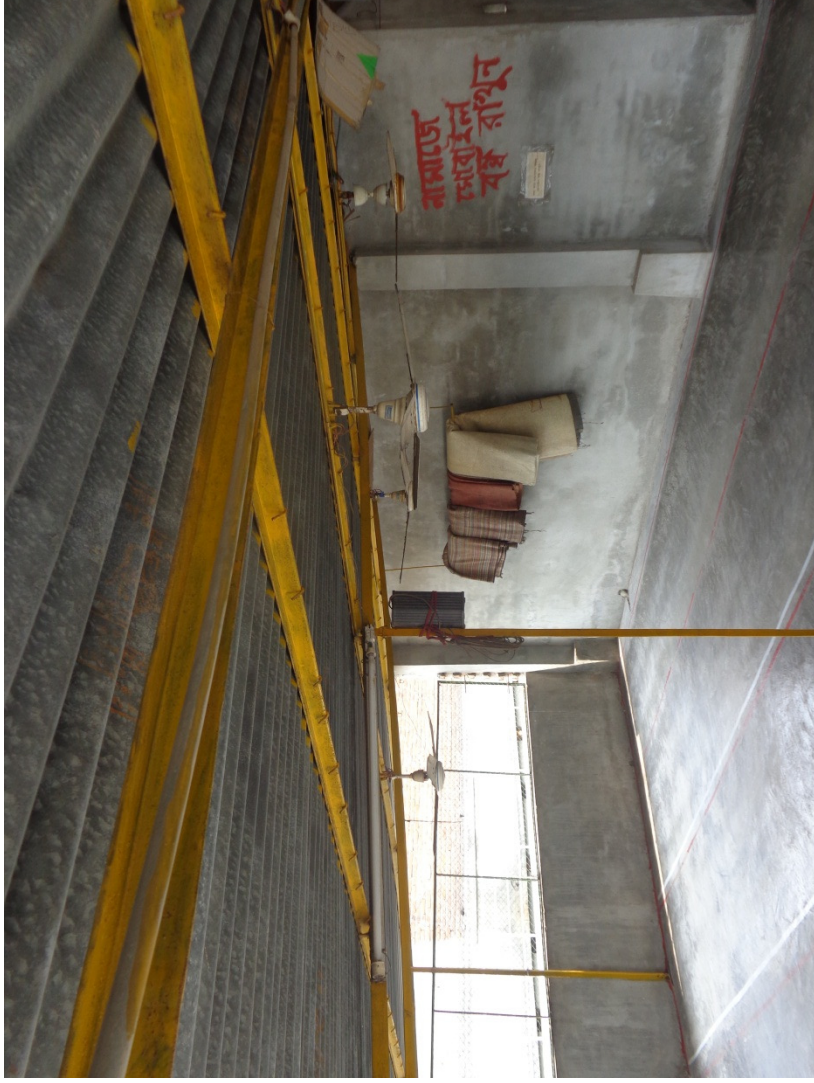
## Light Steel Framing at Rooftop Shed

Exceedingly light steel sections were observed framing the shade over the rooftop prayer area.

**ITEM 3: (Priority 2)** The prayer room shade at the rooftop level was composed of very light steel framing.

- Remove rooftop prayer room shade or detailed engineering assessment to comment on adequacy of steel shade framing to resist wind loads.

- If shade is not removed, implement any recommendations made by the detailed engineering assessment

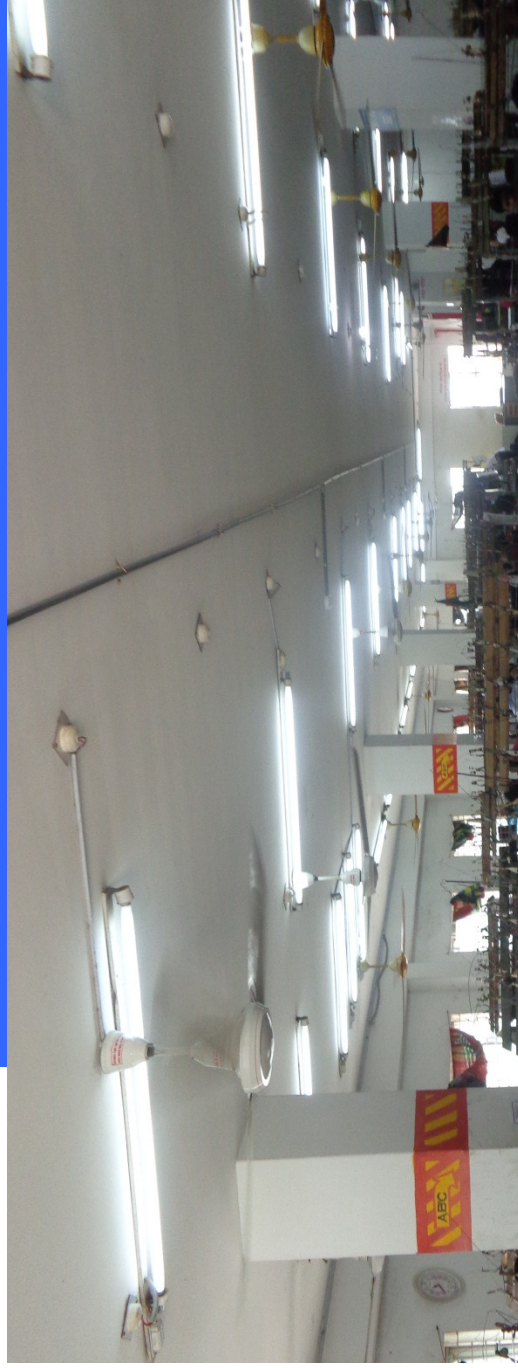
## Lateral Restraint System

Within Phases 3 & 4 there are flat slab configurations above the 1<sup>st</sup> Floor slab level. Additionally there are no shear walls or braced frames present. This creates uncertainty regarding the lateral stability of these structures.

**ITEM 4: (Priority 2)** Phases 3 & 4 are lacking an apparent lateral restraint system.

We require that these items be investigated in a Detailed Engineering Assessment

- Detailed engineering assessment to determine adequacy of structure to resist seismic and wind loads.

- Implement any works deemed necessary by the detailed engineering assessment.

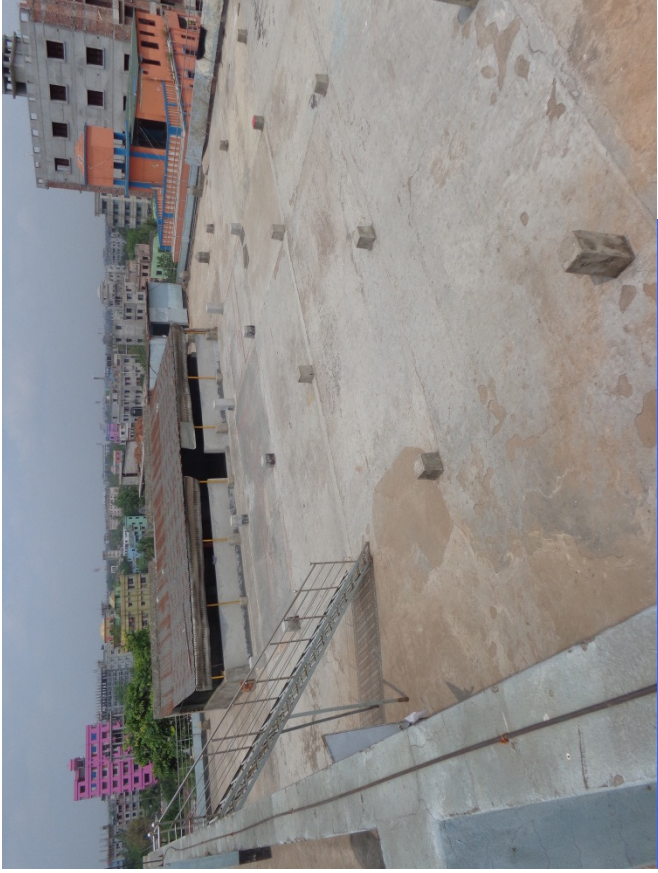
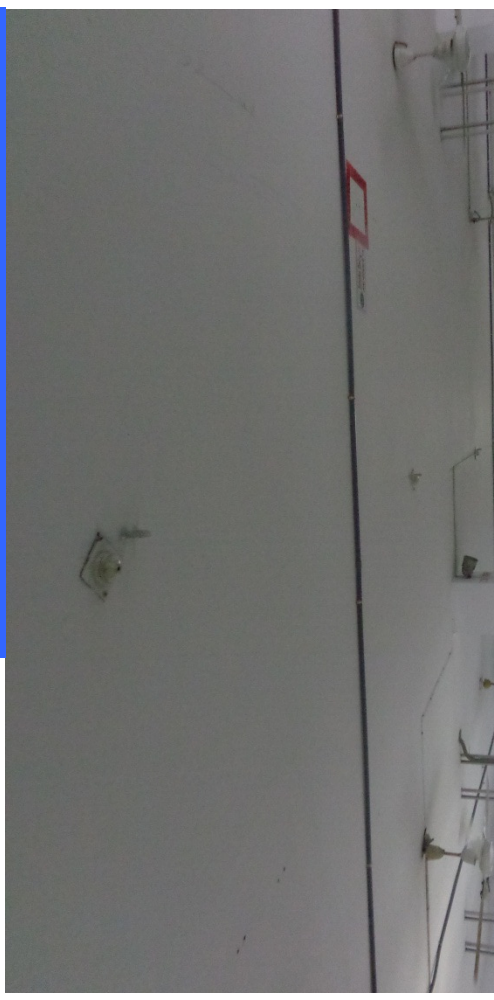
## Roof Waterproofing System

There was no waterproofing observed at the rooftop level

There was no evidence of water infiltration at the underside of roof slabs
