# Russel Apparels and Ekram Sweaters Ltd.

Mouza- Katali Bhaluka Mymensingh  
(24.380522,90.377870)  
23 April 2014

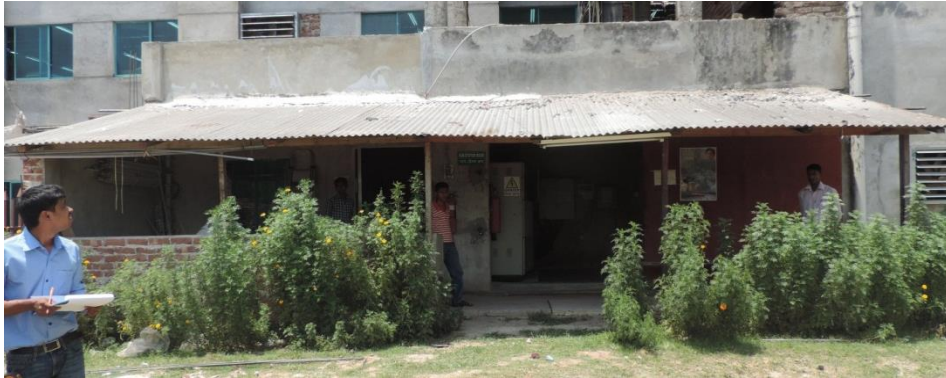
**Single-storey generator room**

A single-storey generator room has been added to the east side of the building next to the toilets although no permit was provided. Also, construction is on-going for an extension to the male toilets, and no permit was available.

| Item No. | Observation | Recommended Action Plan | Recommended Timeline |
|---|---|---|---|
| 1 | Non-Permitted Addition on East Side of Building | Engineering drawings and permit documents required | 6-months |

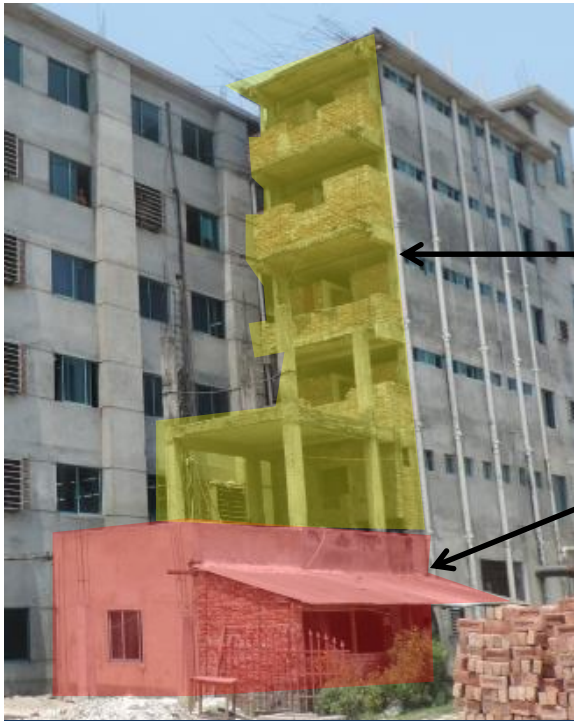
**Non-permitted additions**

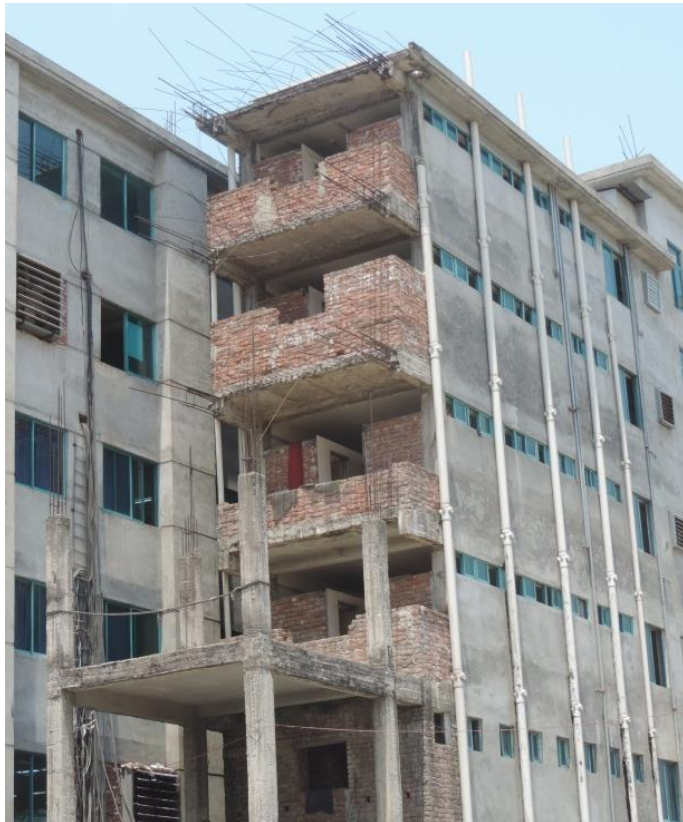
**Unfinished male toilets**

**The male toilets are currently under construction, while they are still in use. Appropriate precautions have not been taken to ensure the safety of the factory workers during construction.**

| Item No. | Observation | Recommended Action Plan | Recommended Timeline |
|---|---|---|---|
| 2 | Unfinished toilets with unstable temporary edge protection | Install proper temporary edge protection during construction phase | 6-weeks |
| 3 | Unfinished toilets with unstable temporary edge protection | Current temporary Balcony wall protection on slab edge needs to be properly designed and constructed | 6-months |

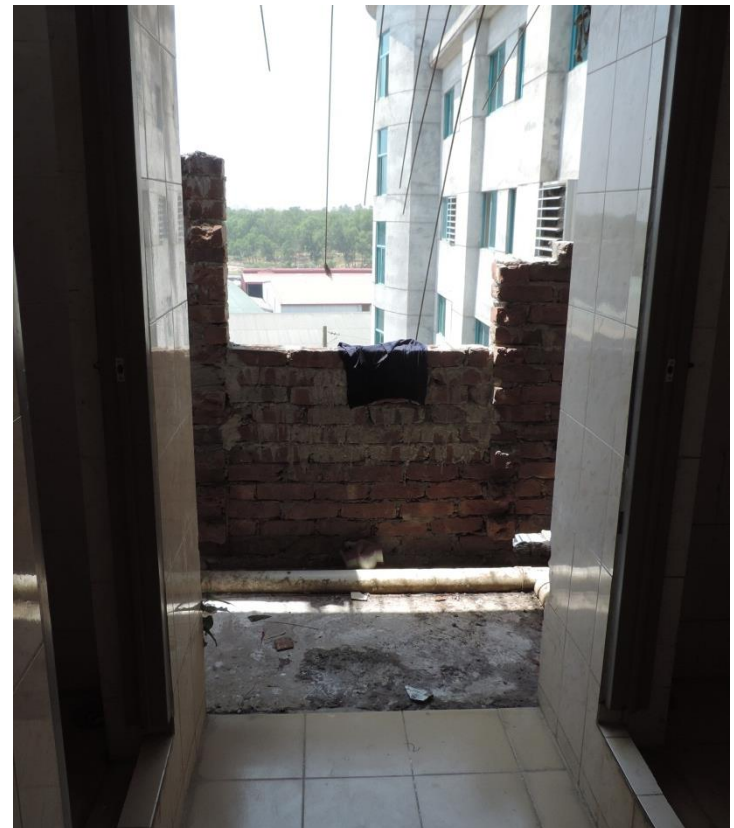
**View from inside male toilets**

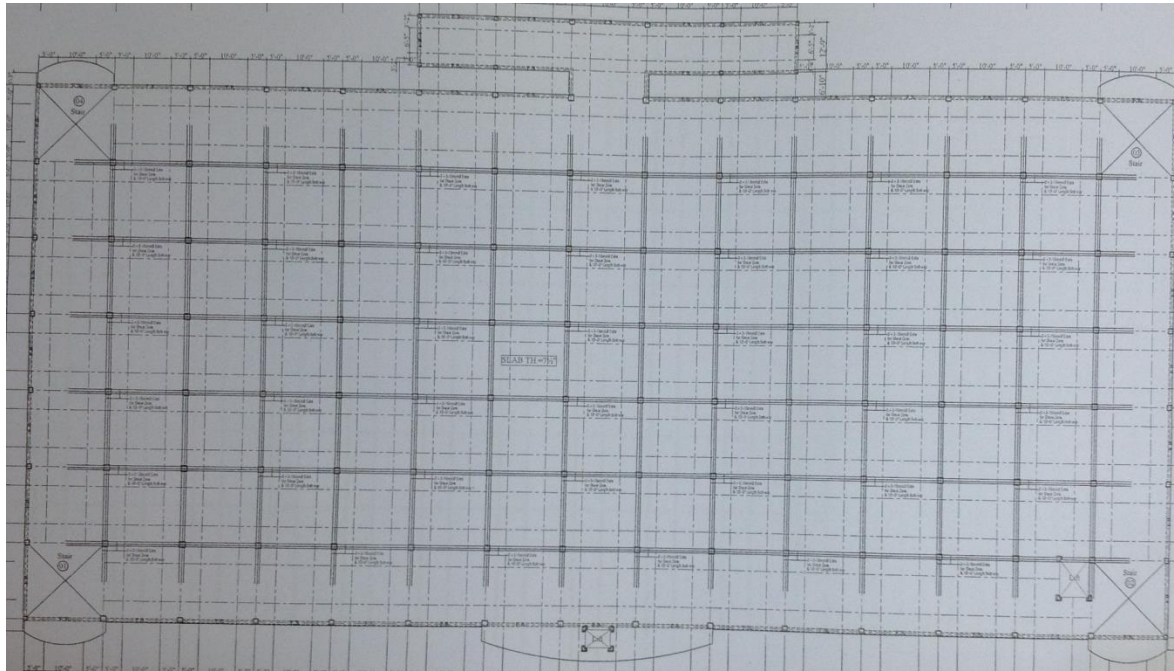
**Typical flat slab reinforcement plan**

The structural drawings for construction indicated flat slab at all floor levels. The 2013 As-Built drawings only indicate beams at the roof level. However, the structural system that has been built on all levels is beams with two-way spanning slabs.

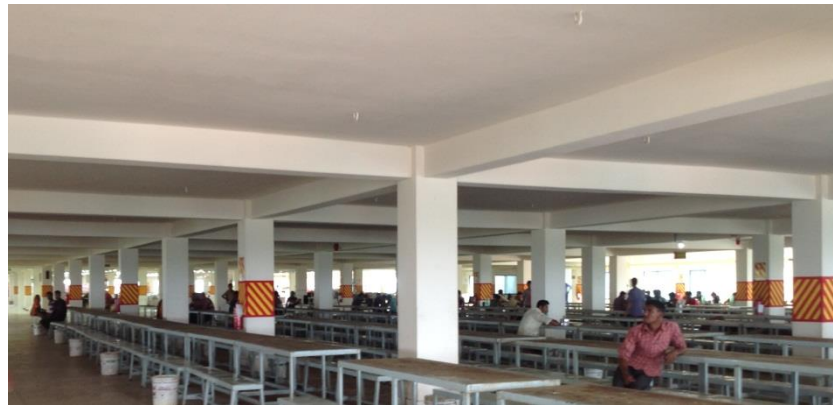
**Typical beam and slab structural system**

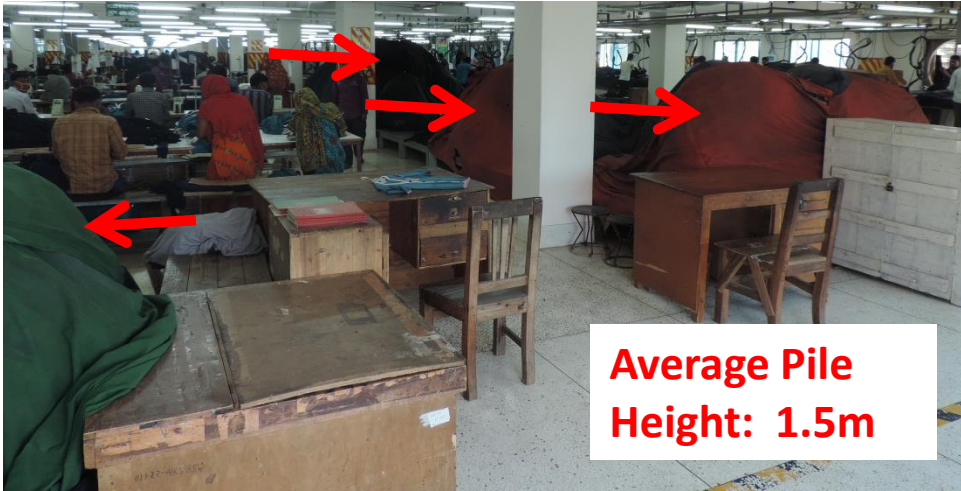
Storage loading was observed on the floor slabs on the 1<sup>st</sup> to 4<sup>th</sup> Floors in the factory building.

2.5 kN/m<sup>2</sup>  
estimated live load

Numerous piles of garments on floor slabs

| Item No. | Observation | Recommended Action Plan | Recommended Timeline |
|---|---|---|---|
| 4 | Loading on floors | A loading plan for all floors to be prepared and implemented for each level based on the capacity of the structure. Max height of storage to be implemented and loading not to exceed 3KPa until loading plans are complete. | 6-weeks |
| 5 | Loading on floors | Continue to implement loading plan | 6-months |

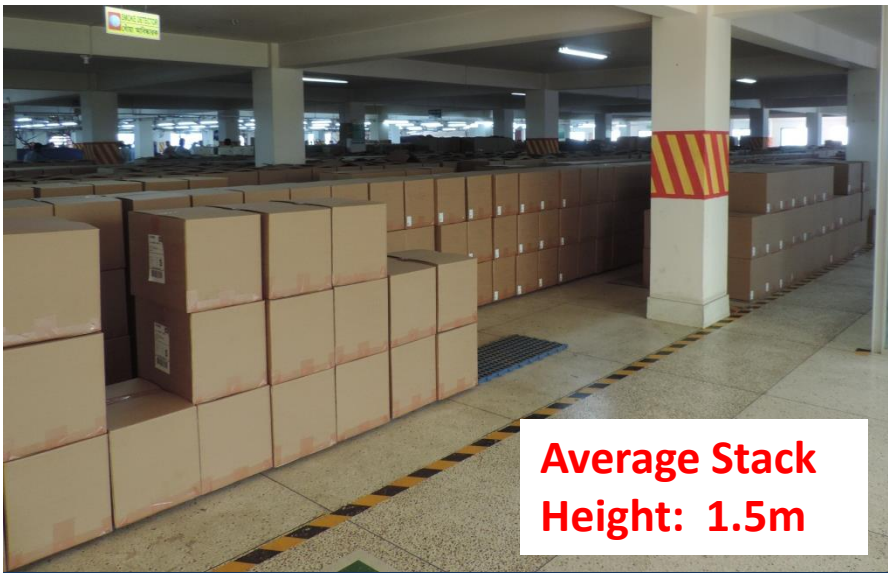
2.5 kN/m<sup>2</sup>  
estimated live load

Boxes at 1<sup>st</sup> Floor

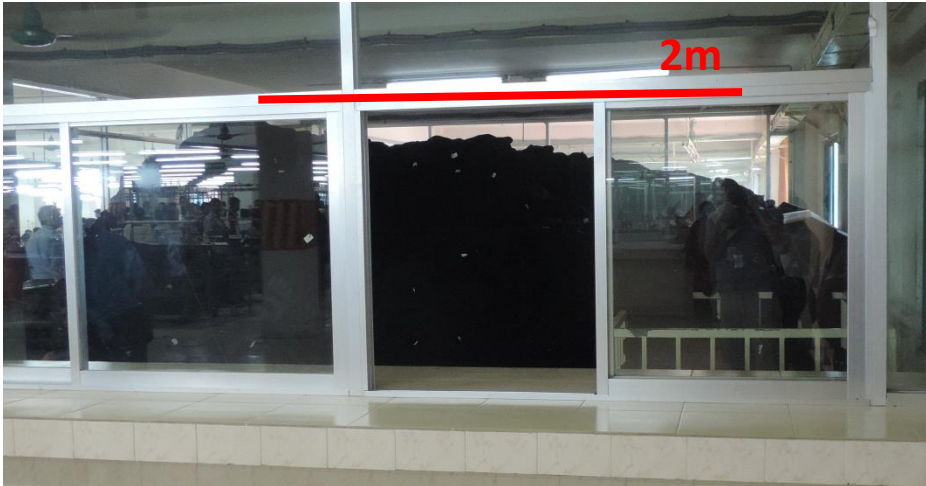
$3 \text{ kN/m}^2$   
estimated live load

Pile of wool clothing

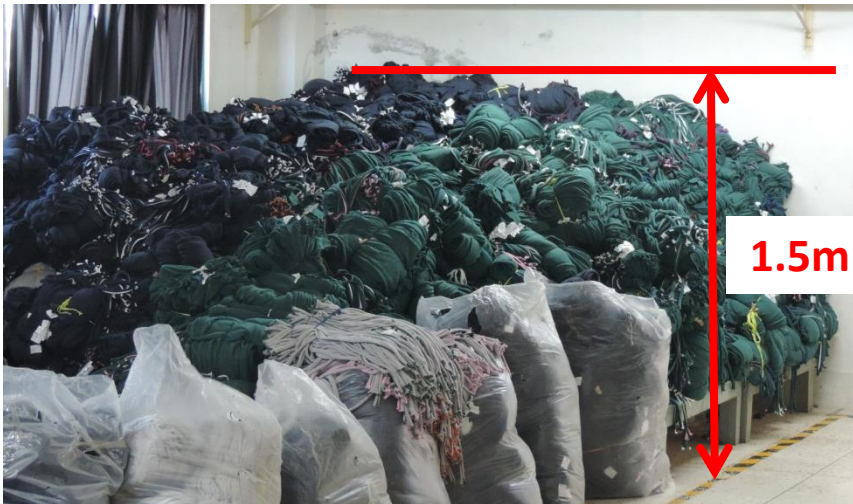
$2.5 \text{ kN/m}^2$   
estimated live load

Pile of knitwear

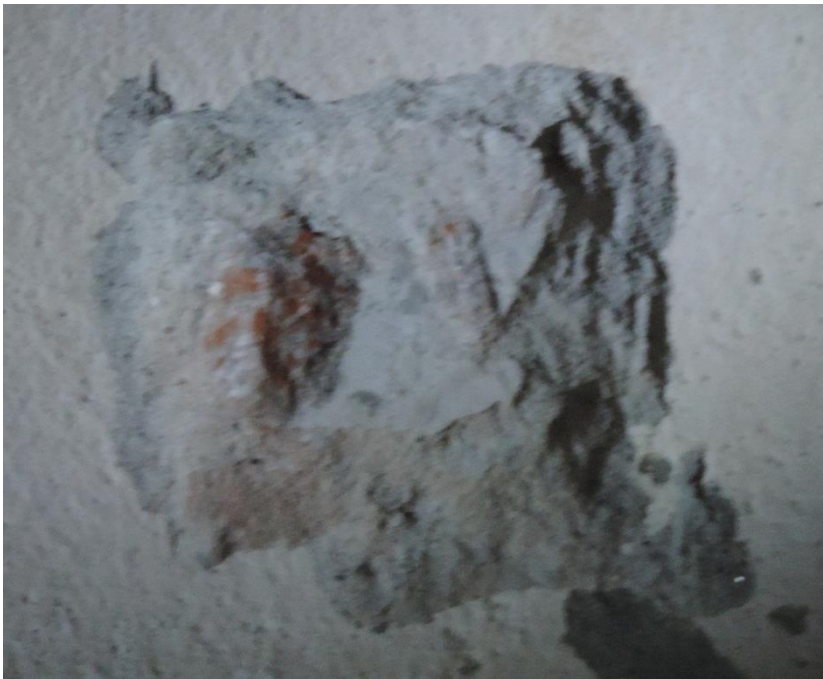
**Brick aggregate was observed in the  
Ground Floor columns and floor slabs.**

**Brick aggregate in Ground Floor column**

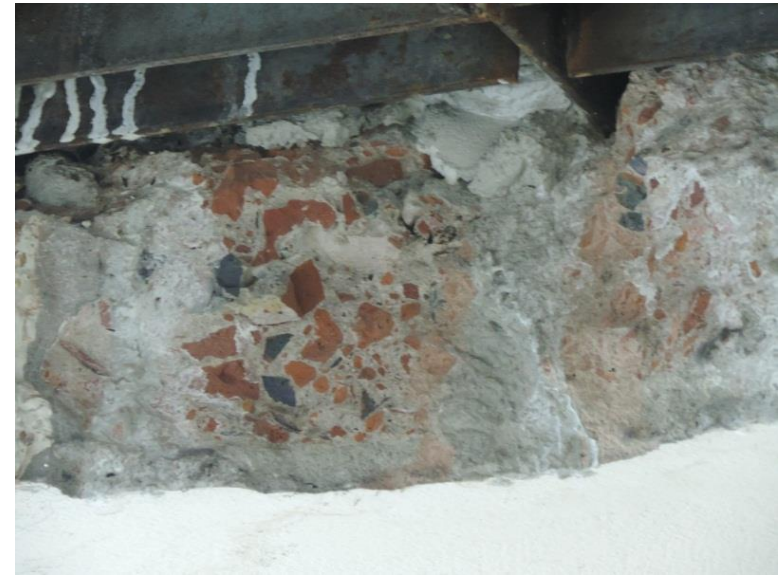
**Brick aggregate in floor slab**

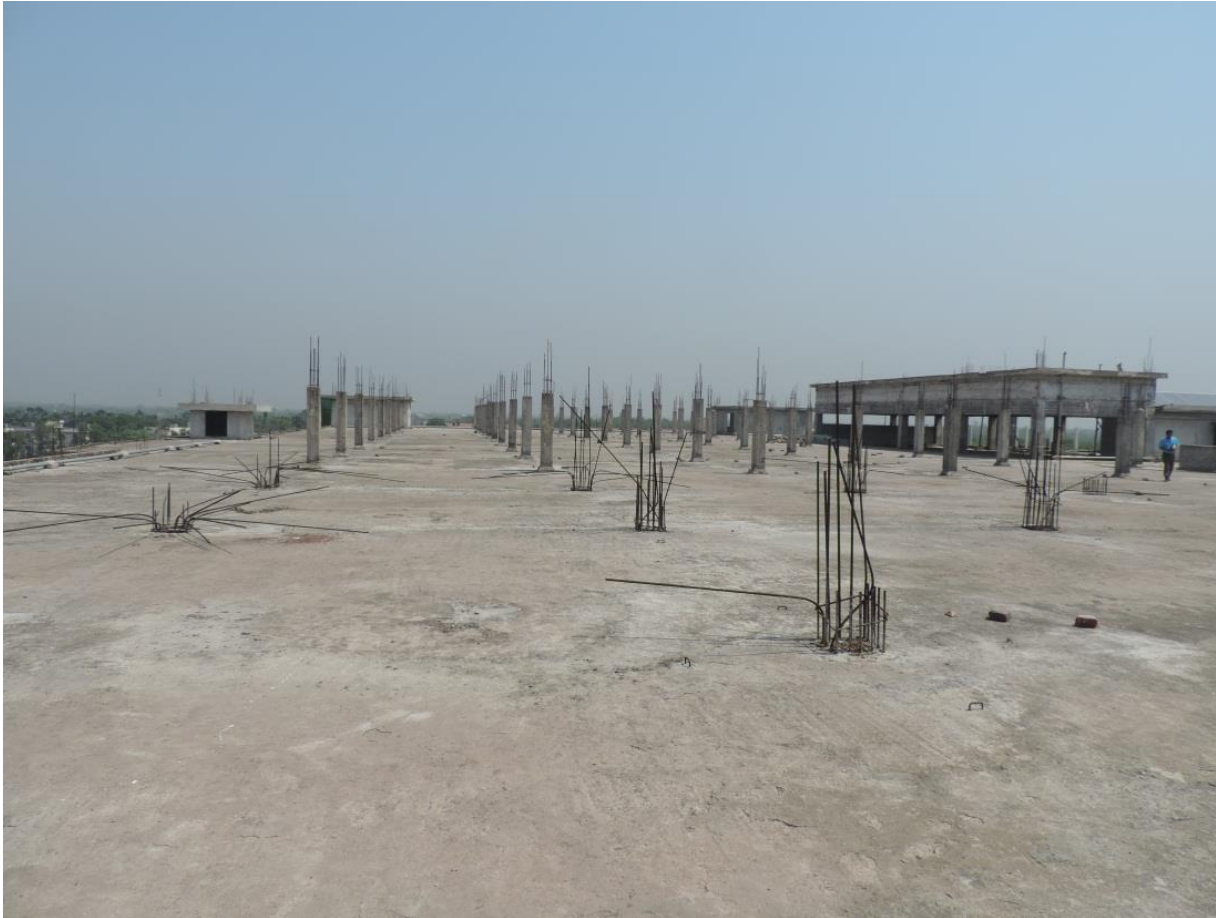
**A non-structural observation of concern is the lack of edge protection at the roof level of the 6-storey factory building.**

**Lack of edge protection at roof level**
