# Eco Fab Ltd.

228/1, Jogitala, BRRI, Gazipur-1701, Bangladesh  
(23.972848, 90.395301)

27<sup>th</sup> November 2016

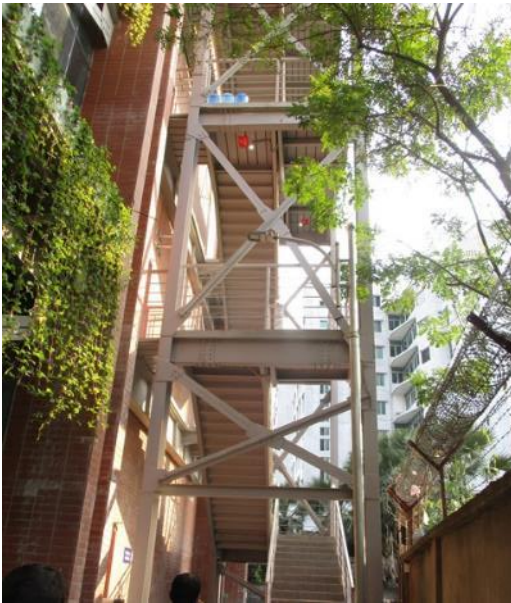
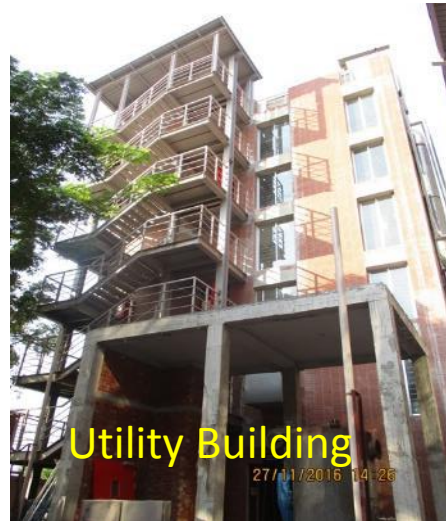
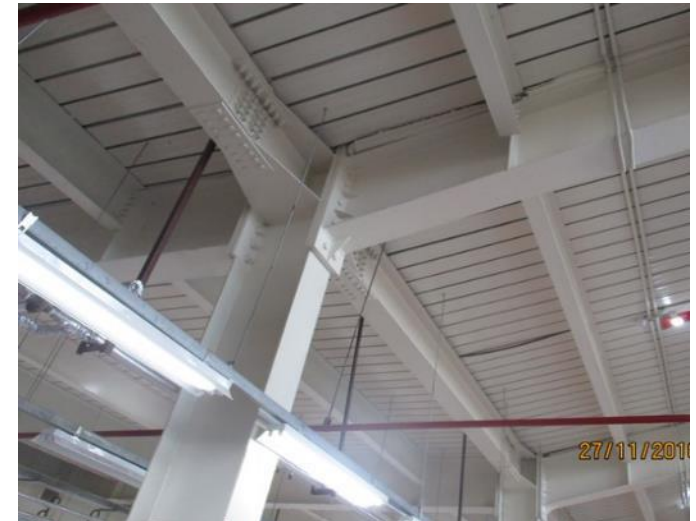
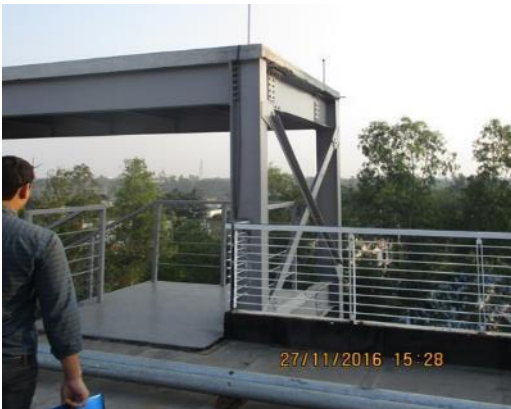
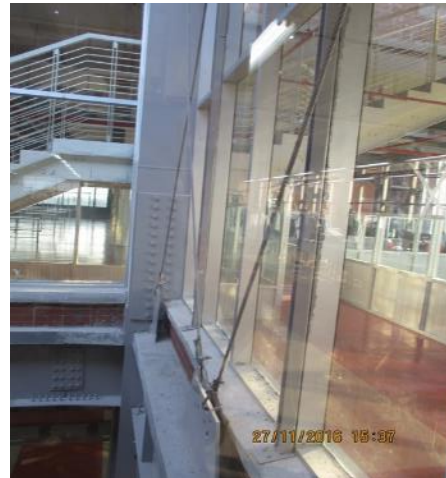
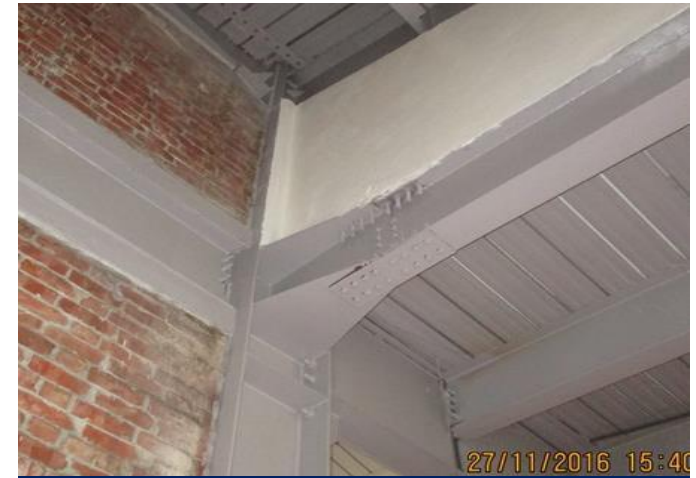
Structural drawings for external/internal steel stair for main building & utility building were not found

Connection details for steel section not found in provided drawings

| Item No. | Observation | Recommended Action Plan | Recommended Timeline |
|---|---|---|---|
| 1 | Inadequate structural drawing and Mismatch between provided drawing & as built condition | Factory engineer to check, collect information and produce accurate and complete as-built documentation | 6-weeks |

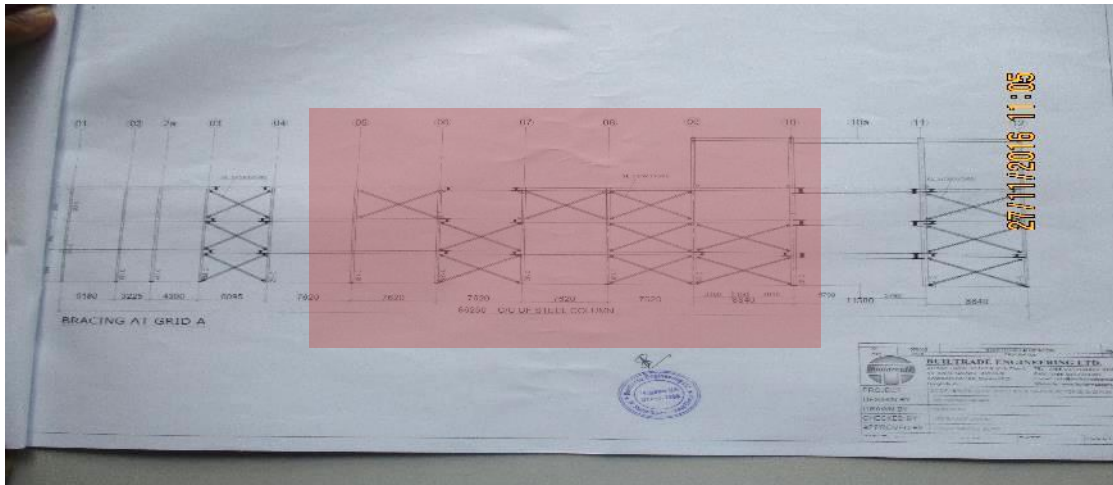
Mismatch found with provided bracing layout & as built condition.

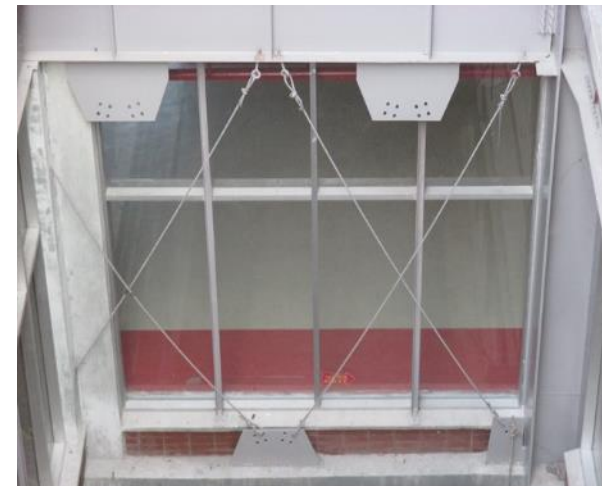
Loose cable bracings observed

| Item No. | Observation | Recommended Action Plan | Recommended Timeline |
|---|---|---|---|
| 2 | Lack of lateral stability | Building Engineer to review stability system for lateral loading as per BNBC. Building Engineer to design and detail structural upgrading work where necessary to ensure adequate stiffness of bracing system. | 6-weeks |

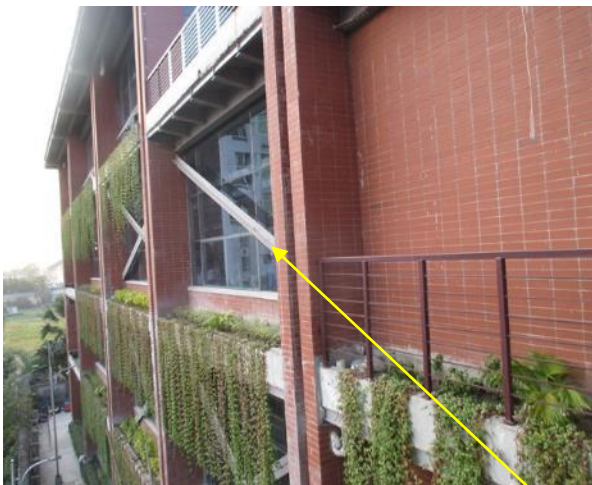
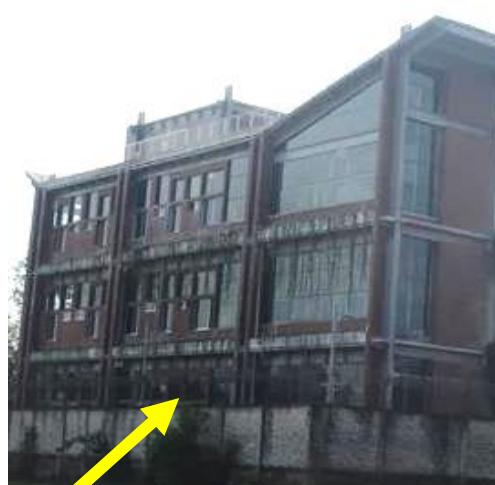
Bracings are not installed properly and no bracings found at west .  
Cross bracing found in single direction.

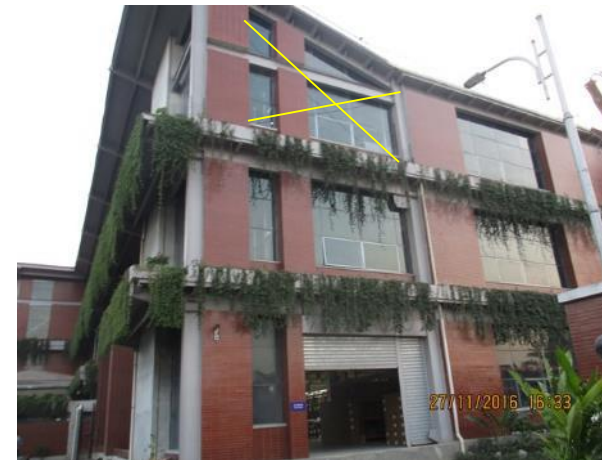
Cable Bracing are installed only  
on 2<sup>nd</sup> floor at North.

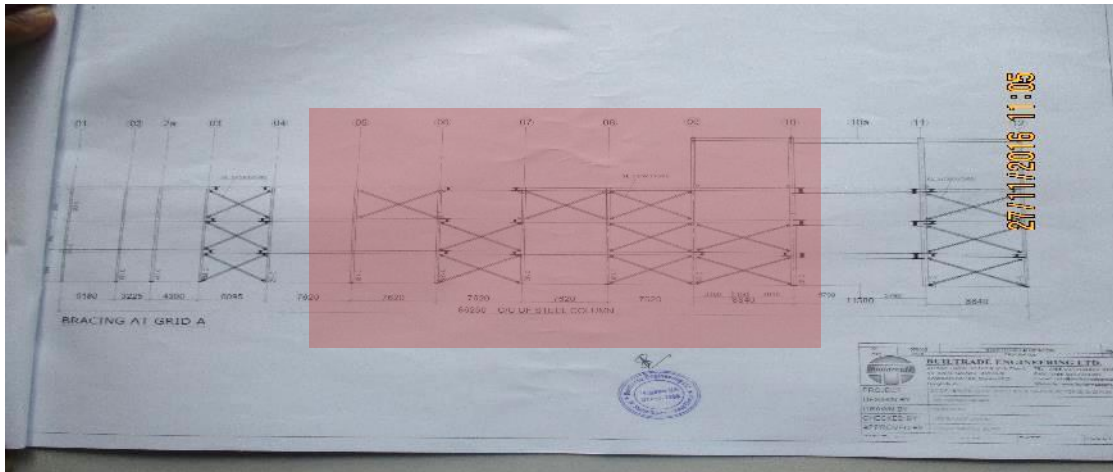
Mismatch found with provided bracing layout & as built condition.

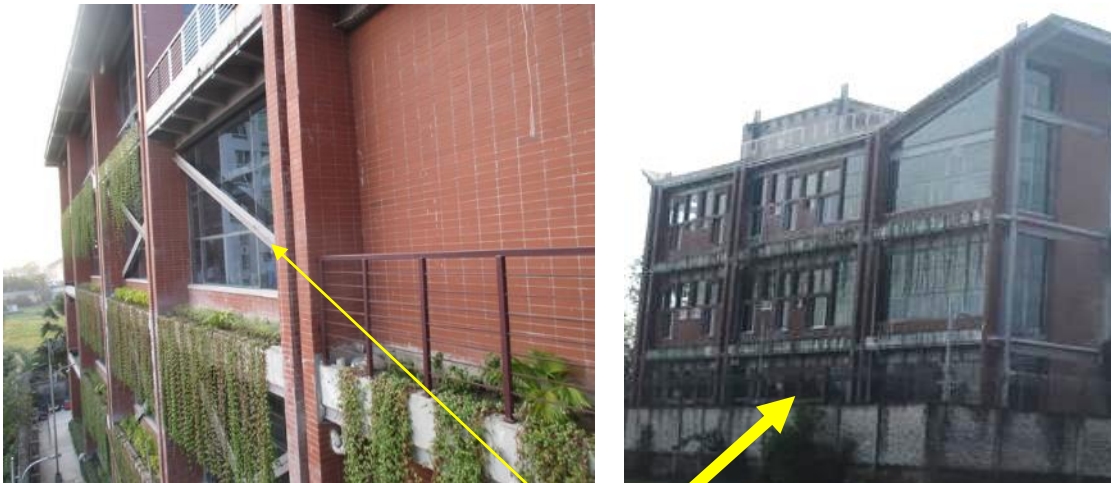
Bracings are not installed properly and no bracings were found at west . Cross bracing were found in single direction.

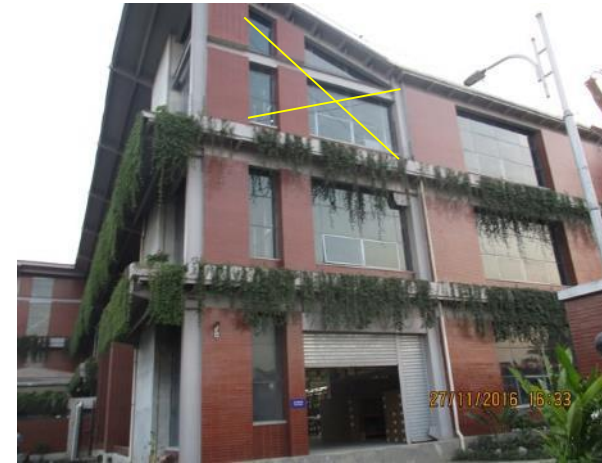
Cable Bracing are installed only on 2<sup>nd</sup> floor at North.

Over all stability was not clear and inadequate drawing was observed . Factory engineer is required to check the stability of the building against lateral load.

| Item No. | Observation | Recommended Action Plan | Recommended Timeline |
|---|---|---|---|
| 3 | Lack of lateral stability | Where required, remedial measures to steelwork to be carried out. | 6-months |

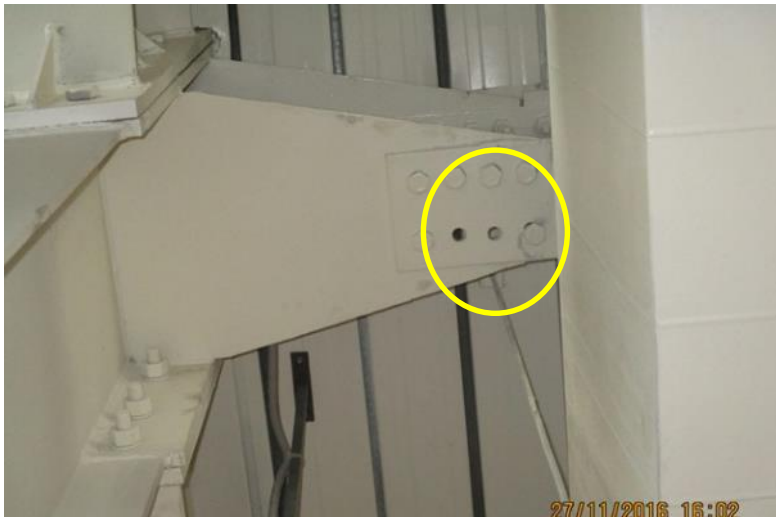
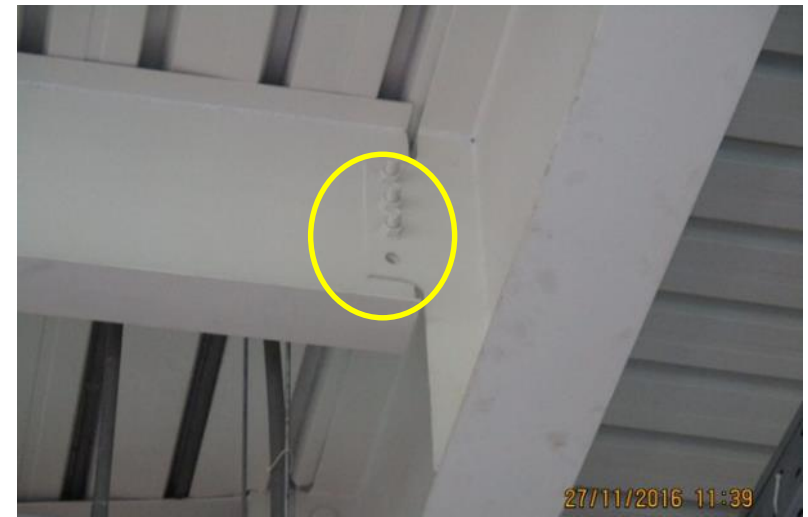
Main Factory Building

## **Bolt missing in several connection**

| Item No. | Observation | Recommended Action Plan | Recommended Timeline |
|---|---|---|---|
| 4 | Bolt missing in several connection | Qualified Structural Engineer to investigate the connection of building and suggest necessary remediation. | 6-weeks |

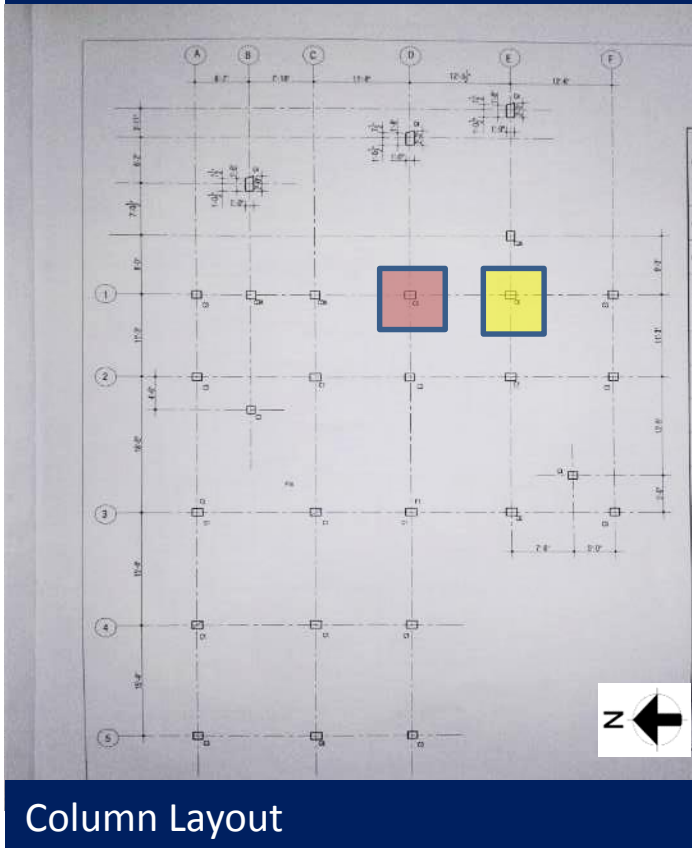
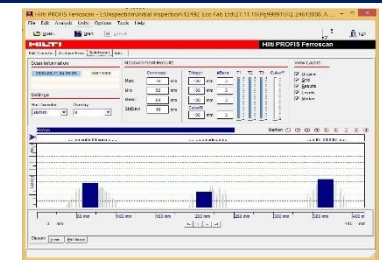
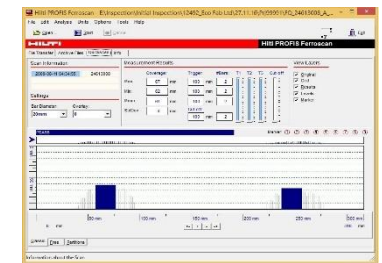
## Column size & nos. of rebar didn't matched with provided structure drawing.

■ C5 & ■ C6 Column sizes are measured (16x12) inch and (3x2) 8 nos. of rebar observed by ferro scan but column schedule shows different.

| Item No. | Observation | Recommended Action Plan | Recommended Timeline |
|---|---|---|---|
| 5 | Mismatch between provided drawing & as built condition | Building Engineer to update as-built drawing according to actual condition. | 6-weeks |

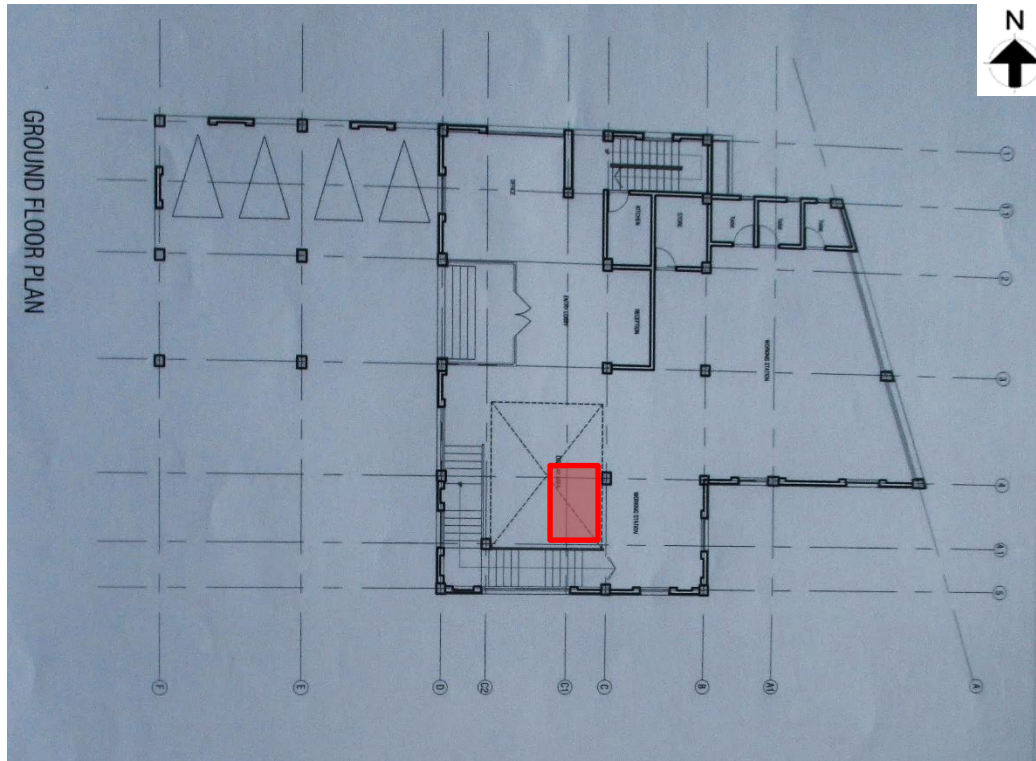
Undocumented steel capsule lift found under construction inside Admin building during inspection.

Foundation system is not clear for the capsule lift.  
No connection detail was available for the lift in the time of inspection.

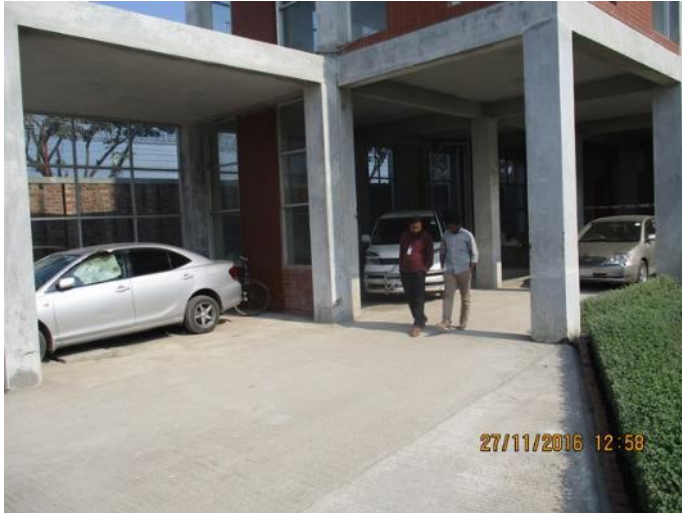
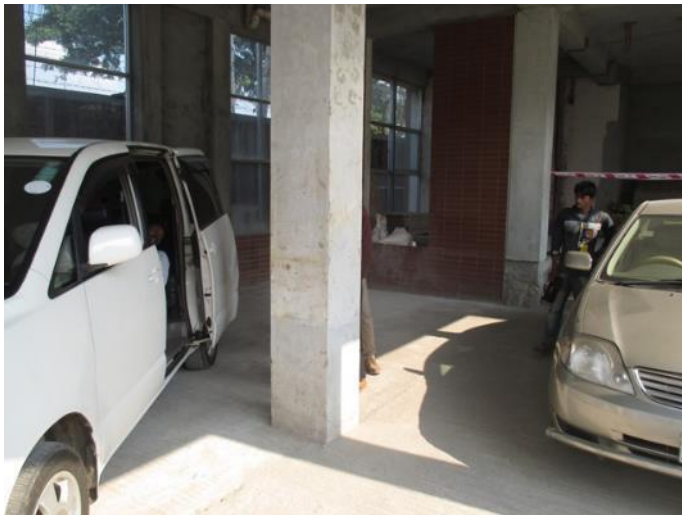
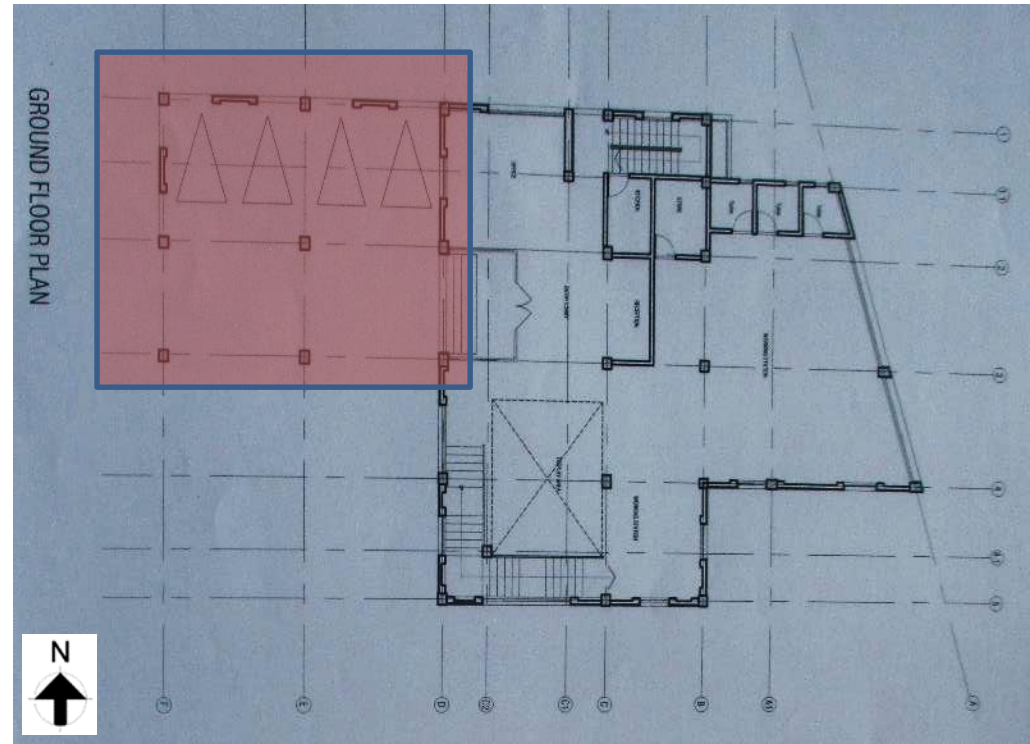
Impact protection not provided to columns on parking area at Admin building. Columns are susceptible to impact loading from vehicles.

| Item No. | Observation | Recommended Action Plan | Recommended Timeline |
|---|---|---|---|
| 6 | Columns exposed to impact loading from vehicle | Install a barrier to prevent vehicle impact in column. | 6-weeks |

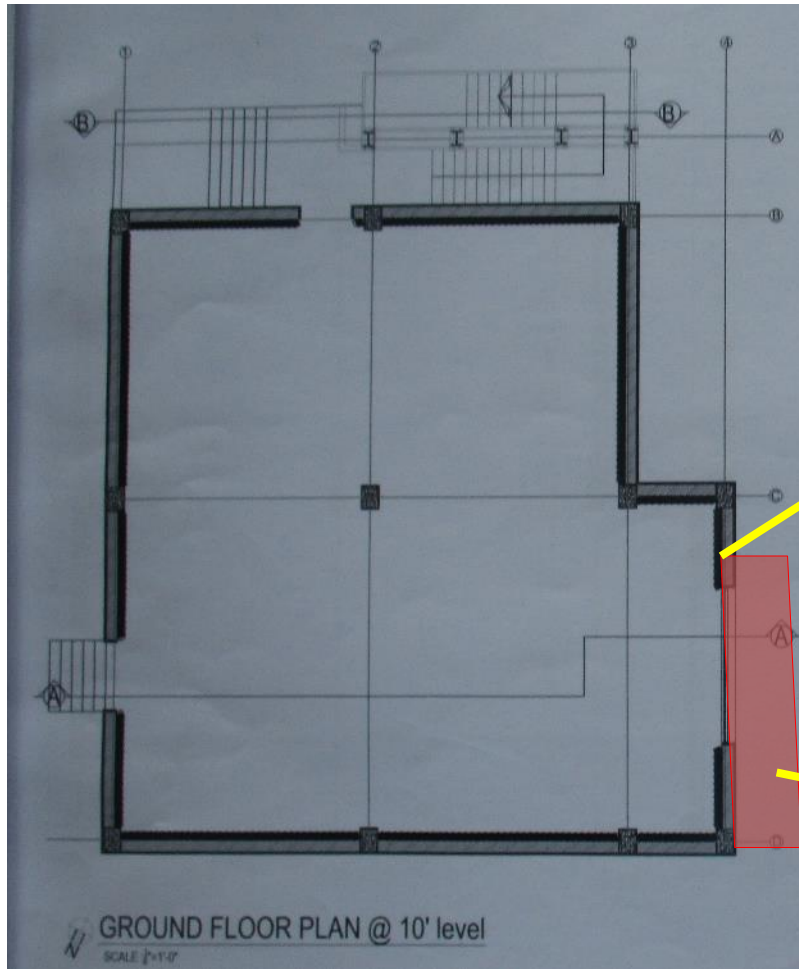
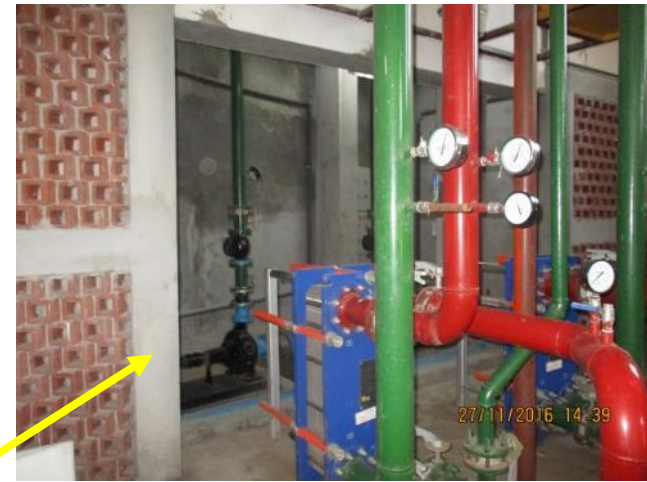
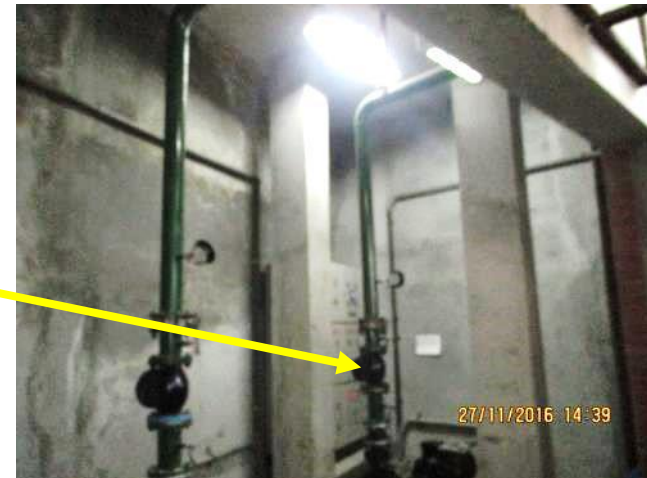
An extension were observed at west connected with main structure only on ground floor. No drawings were available for the extension. Foundation system is clear for the extension part.

| Item No. | Observation | Recommended Action Plan | Recommended Timeline |
|---|---|---|---|
| 7 | Discrepancies between Provided drawings and as built condition | Building Engineer to prepare accurate as-built structural drawing | 6-weeks |

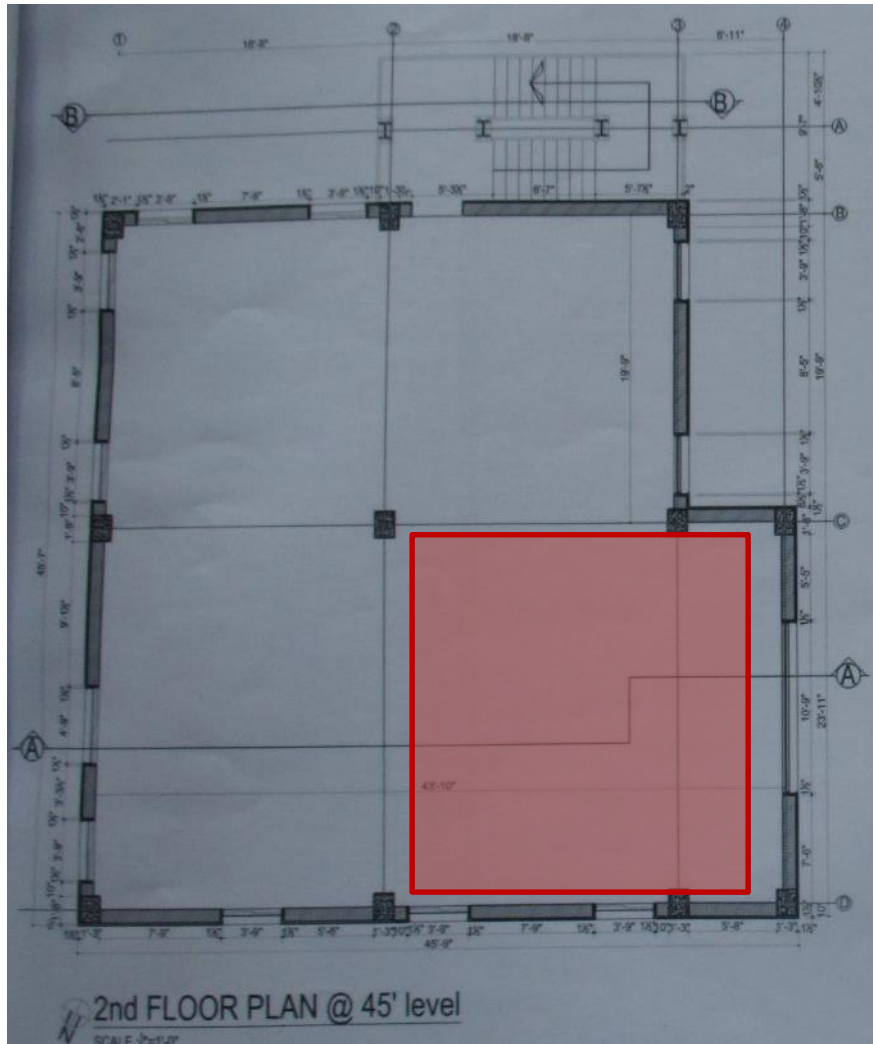
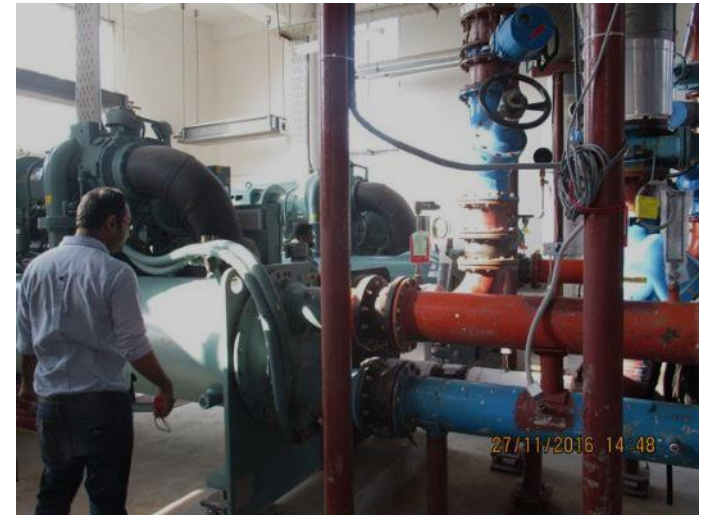
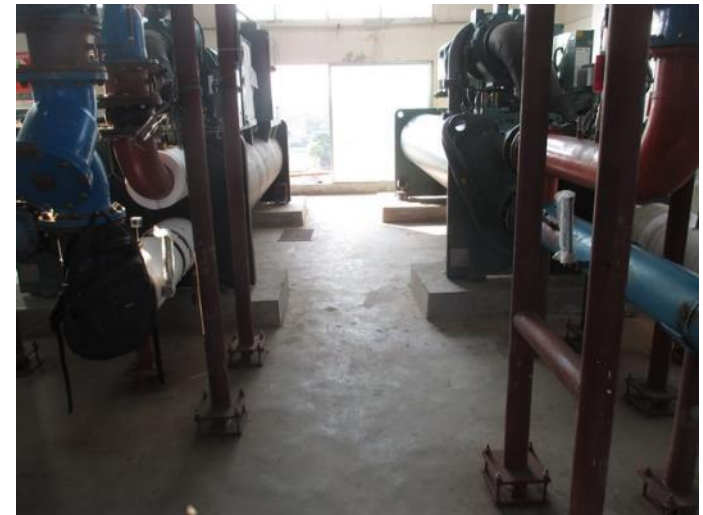
**Heavy machineries were found on 2<sup>nd</sup> floor**

Heavy machineries were found at on 2nd floor shown in red in layout.

| Item No. | Observation | Recommended Action Plan | Recommended Timeline |
|---|---|---|---|
| 8 | Heavy machineries were found on 2nd floor | Engage a Building Engineer to investigate the floor loading, and advise on any necessary alterations taking account of floor capacity and column capacity | 6-weeks |
| 9 | Heavy machineries were found on 2nd floor | Make any structural alterations as advised by Building Engineer | 6-months |

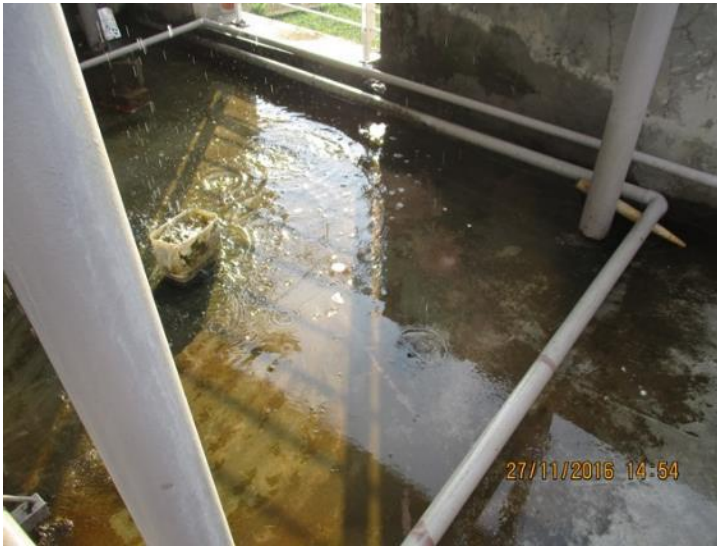
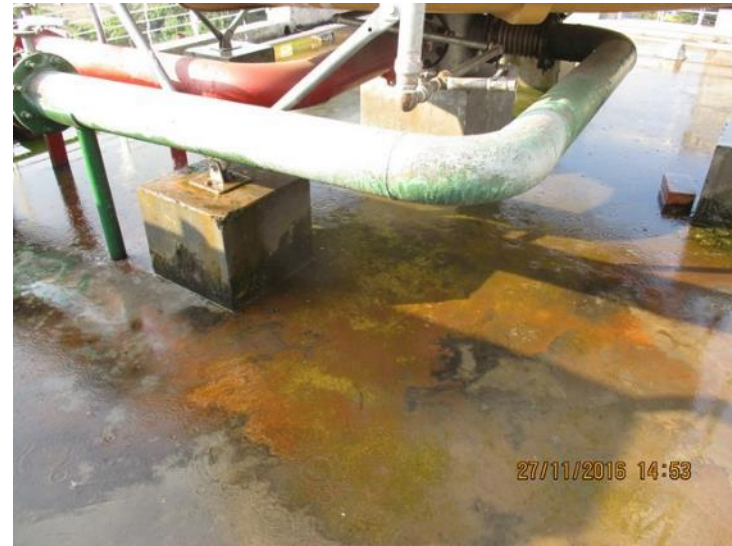
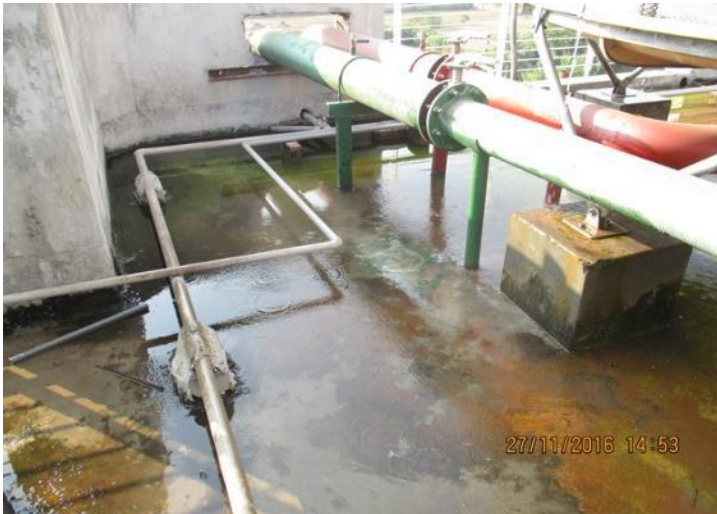
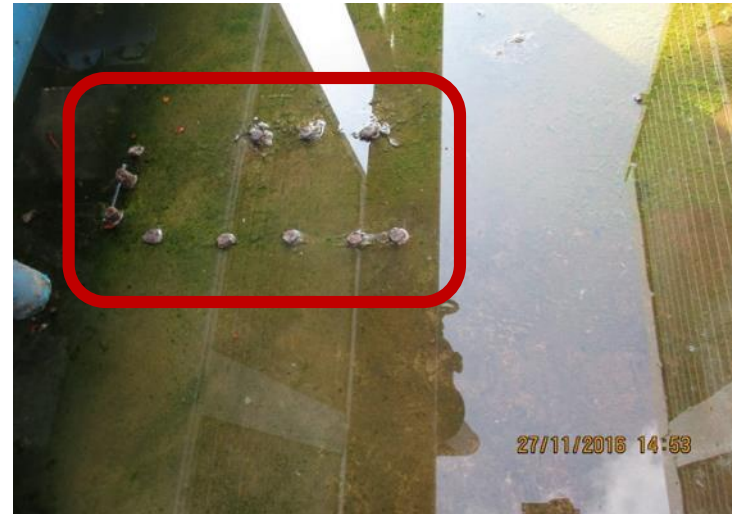
Due to overflow and lack of proper drainage system, water ponding were found at roof.

| Item No. | Observation | Recommended Action Plan | Recommended Timeline |
|---|---|---|---|
| 10 | Water ponding found at roof | Building engineer to review the roof drainage and implement any appropriate drainage system that will prevent water ponding on the roof. | 6-months |
