FIRE SAFETY INSPECTION REPORT

Factory Name: Renaissance Apparels Ltd. (New Building)

ACCORD ID: 12591

Date: 30 November, 2016

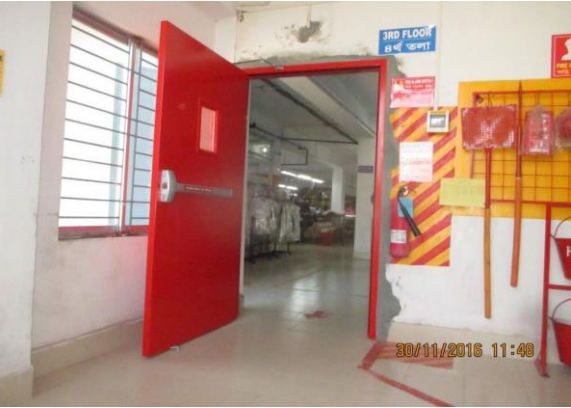
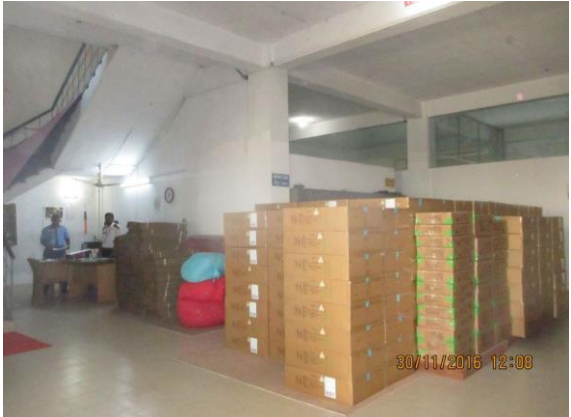
Sl No.	Category	Findings	Required Action	Remediation Time Frame	Pictorial Evidence
1	Fire rated construction	The exit stairs has been enclosed by fire rated wall and door except ground floor . Fire doors were found open by external device during inspection.	<p>Stair shall be enclosed with a minimum 2-hr fire-rated construction. Seal all unprotected openings and provide minimum 1.5-hr fire rated doors to separate the exit stairs from work areas and other building spaces on all floor levels. Ensure that the fire doors are self-closing, positive latching and that they are provided with fire exit (panic) hardware where serving production floors.</p> <p>If fire doors are required to be held open for functional reasons, provide automatic-closing devices tied to the fire alarm system.</p> <p>And The factory have to provide Certificate/Listing documents of existing fire doors to Accord for review.</p>	Within 3 months

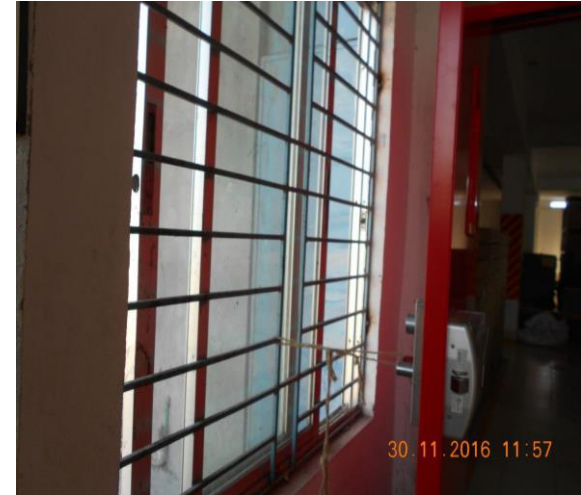
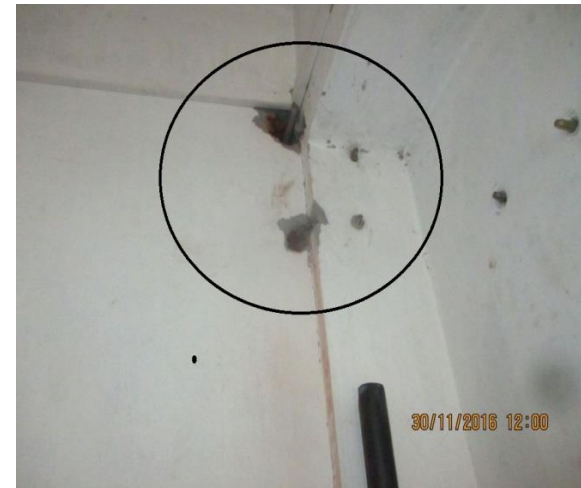
2 Fire rated construction

Unsealed penetrations and openings are located in exit stair enclosures.

Seal all penetrations and openings in the wall of exit enclosure walls (full thickness of the wall) by fire rated materials to maintain the fire resistance rating.

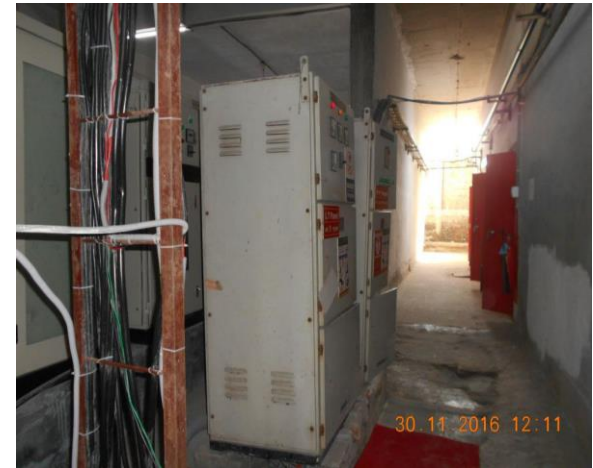
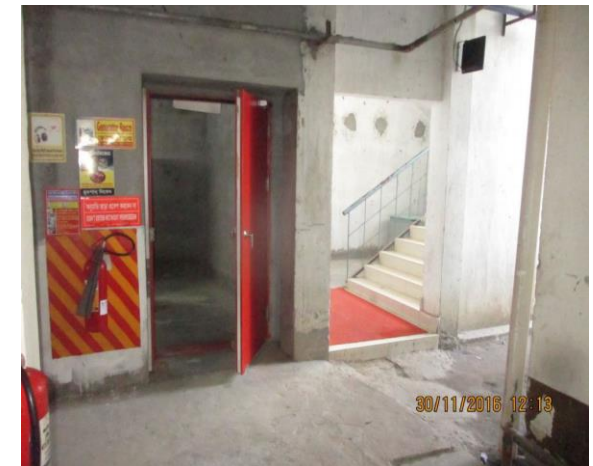
Location: Ground Floor

The boiler, generator, sub-station and compressor room is not separated by fire-rated construction (openings, non-rated doors, penetrations) and proper certification was not available for fire rated doors installed in the boiler, generator and compressor room.

Moreover Electrical panels have been installed in the corridor (between Dining & Utility) without separation

Separate the boiler, generator, transformer and compressor room by a minimum 2-hr fire-rated construction. Seal and/or protected all openings to maintain the required fire separations. and Submit proper certifications for installed fire doors to ACCORD for approval.

If fire doors are required to be held open for functional reasons, provide automatic-closing devices tied to the fire alarm system.

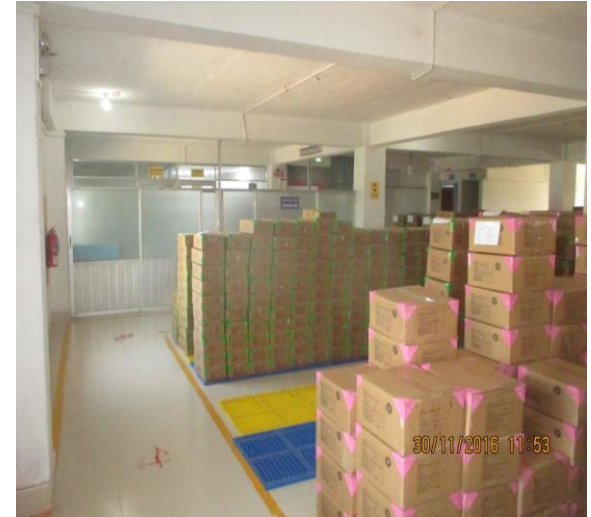
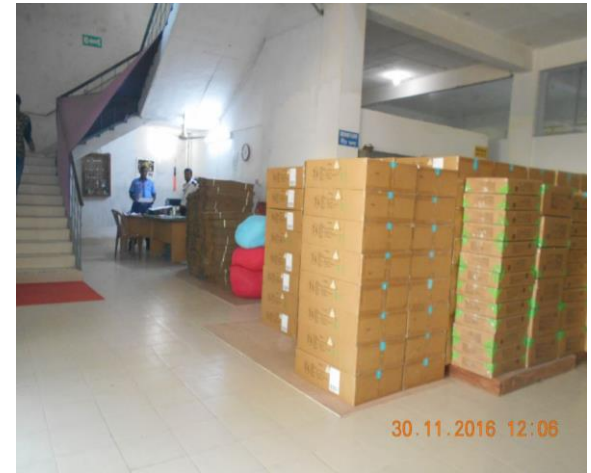
Location: Ground floor & 3rd floor

Rooms used for storage of combustible materials are not separated from the surrounding occupancy/areas.

Rooms used for storage of combustible materials shall be separated from the surrounding occupancy with a minimum 1 hour construction.

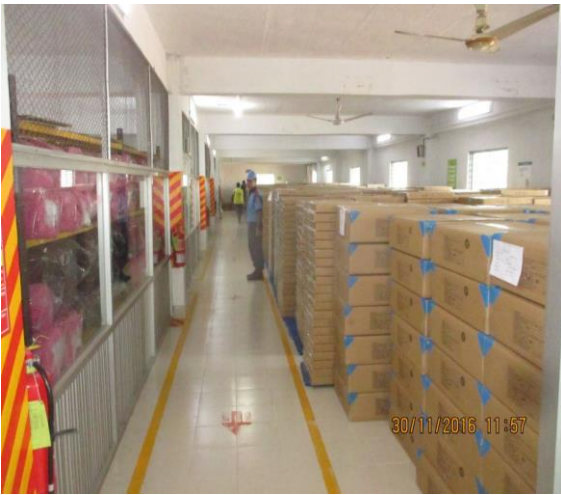
5	Fire rated construction	Areas used for in-process storage of combustible materials are open to the surrounding occupancy.	<p>Provide defined storage areas and limit the storage arrangement as follows:-</p> <ol style="list-style-type: none"> 1. General Condition: Maximum height of 2.4m and maximum area of 23m². Separate areas of unenclosed combustible storage by a minimum clear distance of 3m. 2. If sprinkler protected: maximum height of 3.66m and maximum area of 93m². Separate areas of unenclosed combustible storage by a minimum clear distance of 3m. <p>or</p> <ol style="list-style-type: none"> 3. Enclose the storage area from the surrounding occupancy with a minimum 1 hour construction. 	Within 3 months

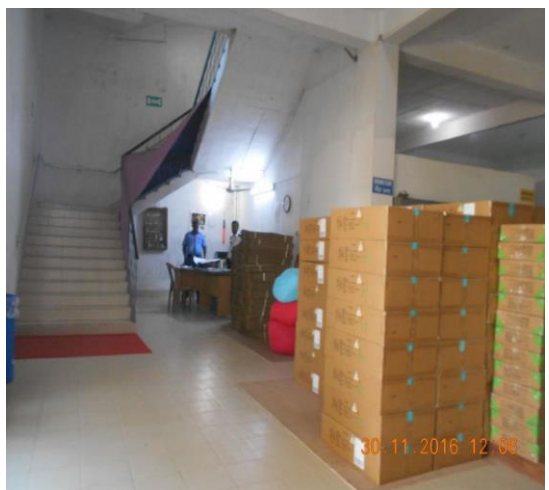
6	Egress	Storage was located in the exit stair.	Remove all storage from exit stairs.	Immediate

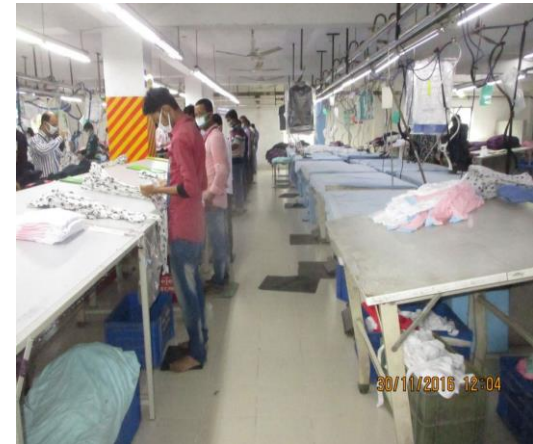
7 Egress The width of egress aisles is less than 36-in. Provide minimum aisle widths of 36-in. Within 3 months

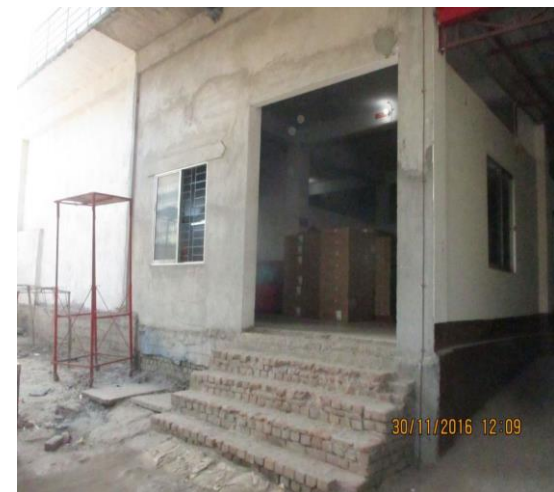
8 Egress Open sides of means of egress that exceed 760 mm (30 in.) above the floor or finished ground below but not provided with guard rail. Provide guards/rails having a minimum height of 760 mm (30 in.). Within 1 month

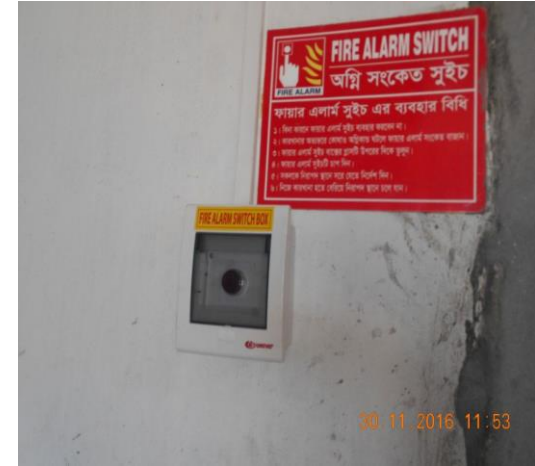
9	Fire Alarm & Detection System	The fire alarm system is antiquated, not a listed system, and does not provide alarm and notification features consistent with acceptable standards.	Replace the fire alarm system with a new, listed addressable fire alarm system in accordance with NFPA 72.	Design within 4 months, install within 9 months

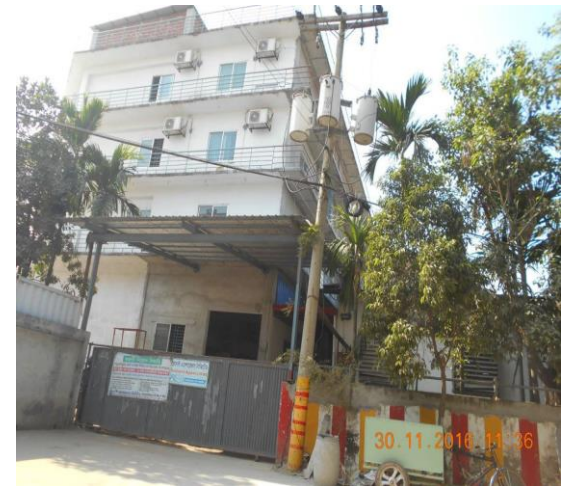
11	Water Based Fire Protection system	The existing building has an occupied floor greater than 20m (33 ft.) and is not provided with standpipe system protection.	Provide standpipe system protection throughout the building in accordance with NFPA 14 and ACCORD standards.	Within 3 months	
----	------------------------------------	---	--	-----------------	--

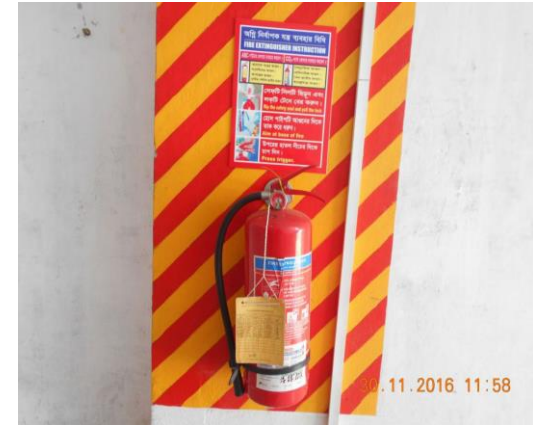
13	Fire Protection System	Inspection, testing and maintenance of portable fire extinguishers is not in accordance with NFPA 10.	Inspect, test and maintain the portable fire extinguishers and keep written records on-site, in accordance with NFPA 10.	Within 1 month	
----	------------------------	---	--	----------------	--
