# **FIRE SAFETY INSPECTION REPORT**

**IMPRESS NEWTEX COMPOSITE TEXTILE  
LTD. & NEWTEX DESIGN LTD.  
GORAI, MIRZAPUR, TANGAIL**

**ACCORD**  
on Fire and Building Safety in Bangladesh

June 24, 2014

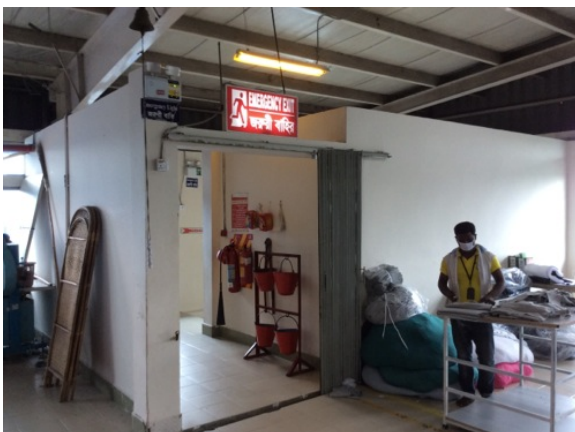
| No. | Category | Finding | Recommendation | Remediation Timeframe |
|---|---|---|---|---|
| F-1 | Fire Rated Construction | The exit stairs are not separated from work areas on each floor by fire-rated construction. Even though the fifth stair is not being counted as an exit stair it is still required to be separated like an exit stair since it is connecting four floors. | <p>Provide minimum 1.5-hr fire rated doors and seal all unprotected openings to separate the exit stairs from work areas and other building spaces on all floor levels. Ensure that the fire doors are self-closing and positive latching and that they are provided with fire exit (panic) hardware where serving production floors.</p> <p>If fire doors are required to be held open for functional reasons, provide automatic-closing devices tied to the fire alarm system.</p> | Within 3 months |

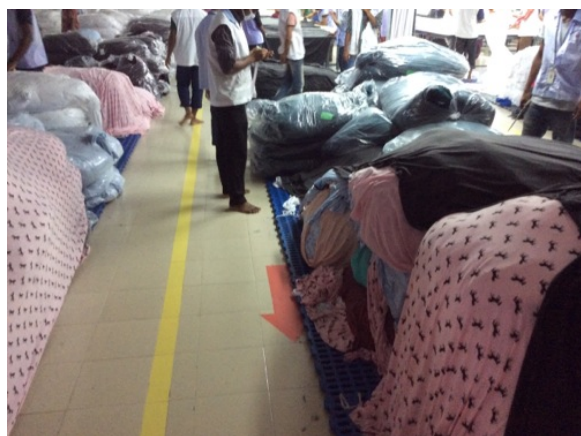
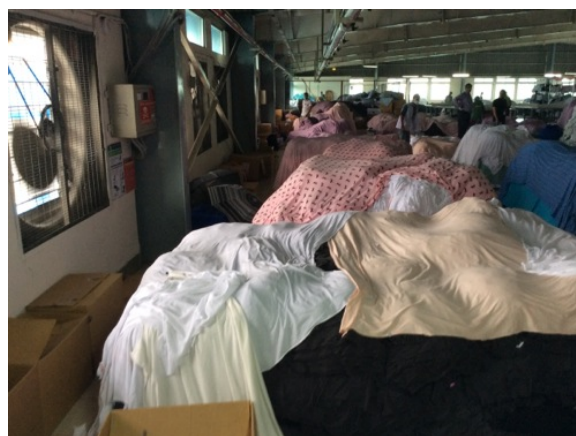
| F-2 | Fire Rated Construction | <p>Areas used for combustible storage are not separated by fire-rated construction.</p> <p>Location: All floors.</p> | <p>Provide dedicated storage rooms separated by minimum 1-hr fire-rated construction.</p> <p>Where separate storage rooms are not feasible, provide defined storage areas and limit the storage arrangement as follows:</p> <ul style="list-style-type: none"> <li>- Maximum height of 2.4m and maximum area of 23m<sup>2</sup></li> <li>- If sprinkler protected: maximum height of 3.66m and maximum area of 93m<sup>2</sup></li> </ul> <p>Separate areas of unenclosed combustible storage by a minimum clear distance of 3m.</p> | Within 3 months |

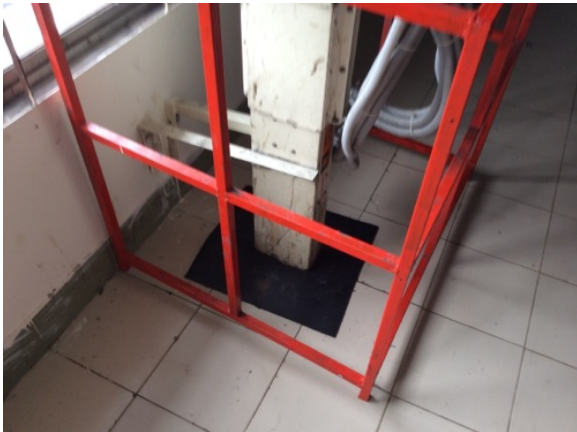
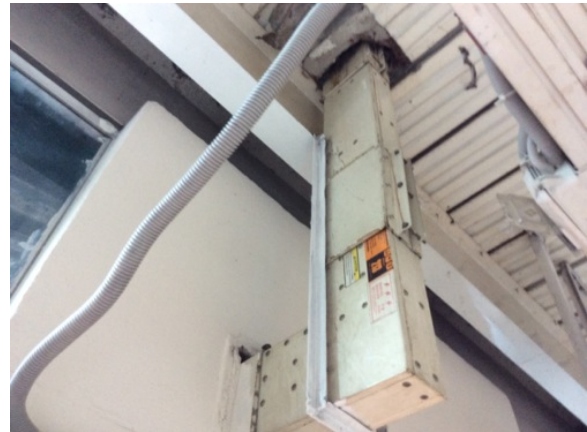
| F-3 | Fire Rated Construction | <p>Unsealed penetrations and openings are located in the fire-rated floor/ceiling assemblies.</p> | <p>Provide a minimum 2-hr fire-rated shaft to separate the utility risers from each floor level.</p> | Within 3 months |

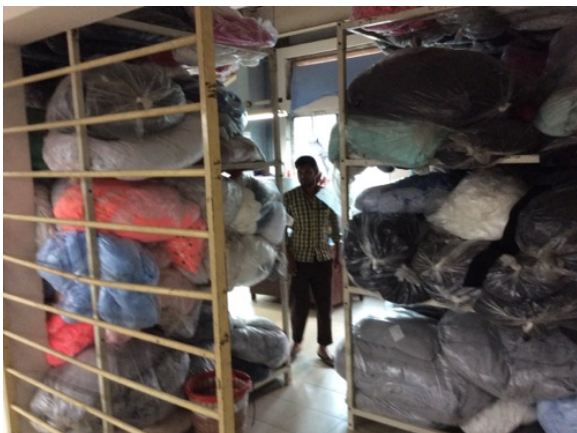
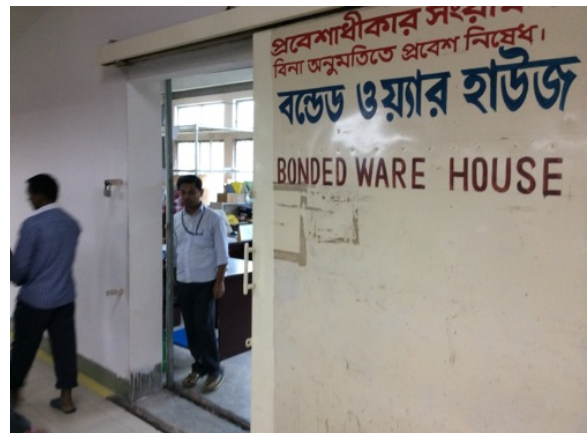
| F-4 | Fire Rated Construction | Storage rooms used for combustible storage are not separated by fire-rated construction. | Provide dedicated storage rooms separated by minimum 1-hr fire-rated construction. | Within 3 months |

Locations: All storage rooms and warehouses on all floors.

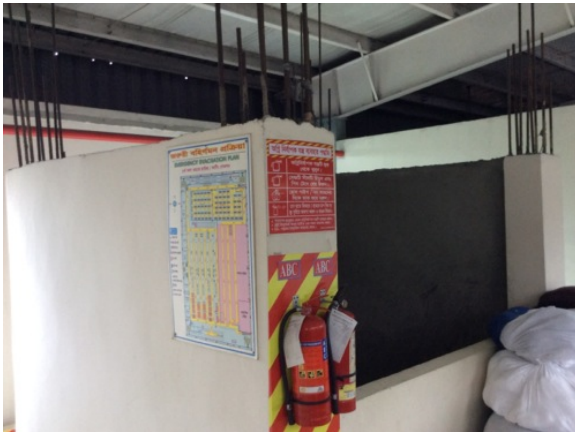
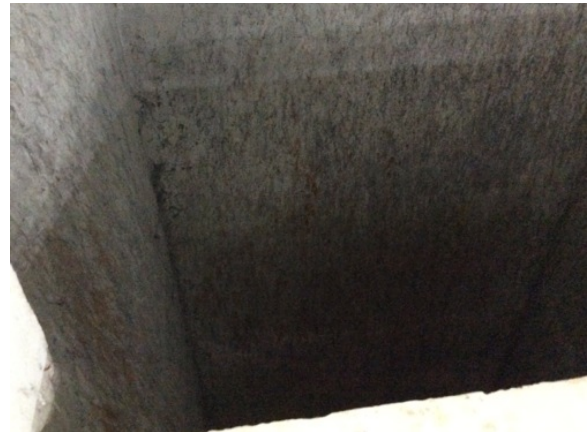
| F-5 | Fire Rated Construction | Unprotected openings are located in the shaft penetrating all floors for the future elevator. | Provide a minimum 2-hr fire-rated shaft to separate the location for the future elevator from each floor level. | Within 3 months |

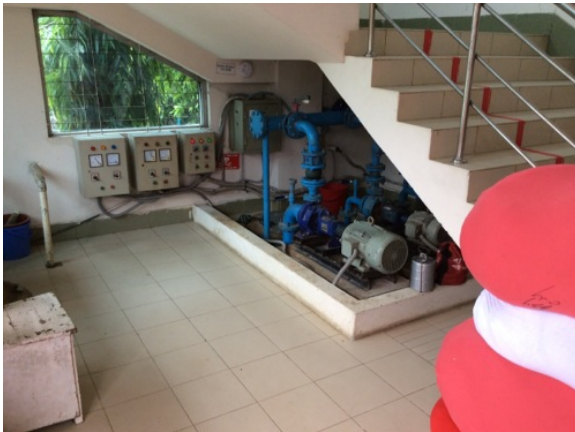
| F-6 | Fire Rated Construction | <p>The pump room is not separated by fire-rated construction (openings, non-rated doors, penetrations).</p> <p>Location: Pump is located under the northeast stair at ground floor.</p> | Separate the pump room by a minimum 2-hr fire-rated construction. Seal and/or protected all openings to maintain the required fire separations | Within 3 months |

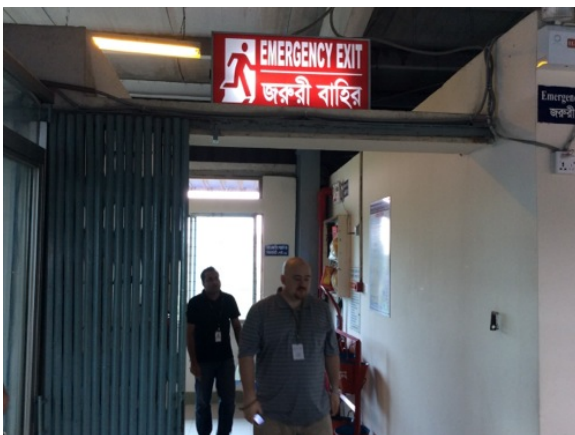
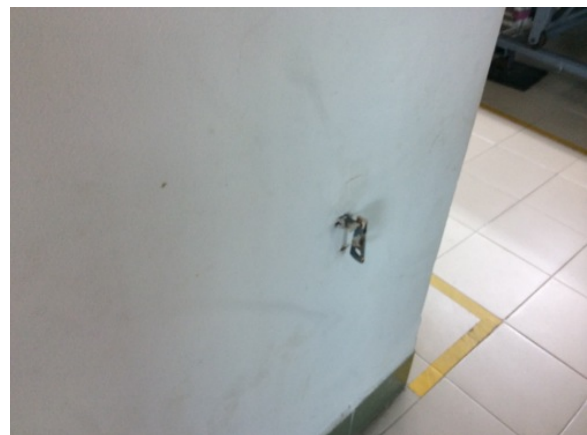
| F-7 | Egress | Egress doors / gates with locking features are provided at exit stairs and exit discharge.<br><br>Location: All stairs and discharges at all floors. All gates/doors were open and unlocked during the inspection. | Remove locking features from all egress doors / gates.<br><br>If locks are required for security reasons, utilize special door locking features complying with NFPA 101. | Immediate |

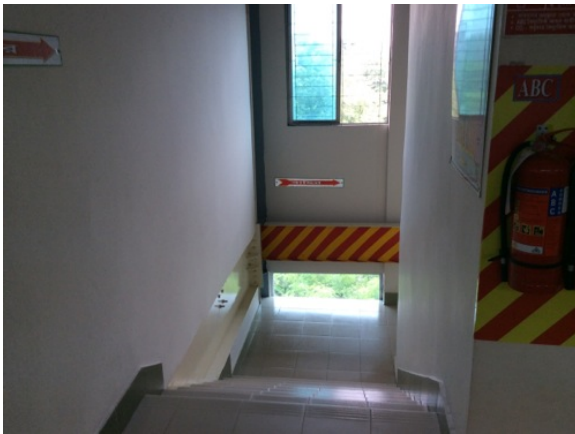
| F-8 | Egress | <p>Exit capacity is not adequate for the occupant load.</p> <p>Location: The exit capacity for both the 1st and 2nd floors is 853 and the occupant load is 900.</p> | <p>Reduce occupant load to not more than available exit capacity of 853 on 1st and 2nd floors or provide additional exits (the fifth exit stair on the south might be upgraded with fire-rated separation, handrails, signage, and lighting).</p> | Immediate |

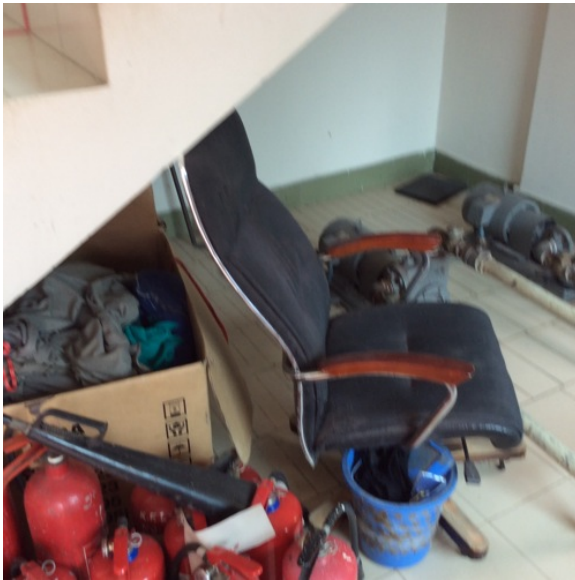
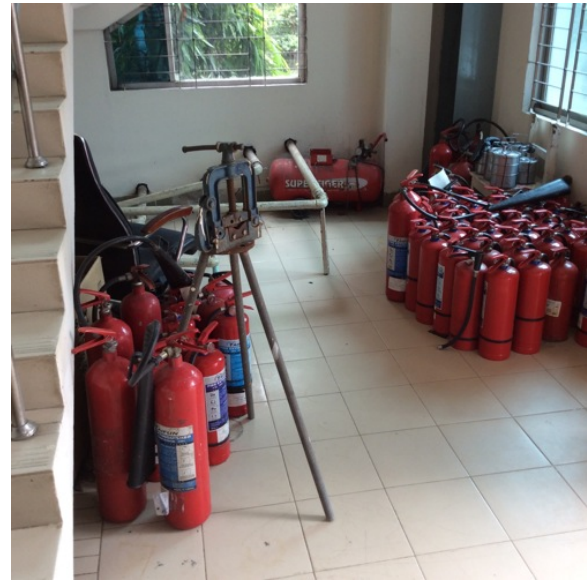
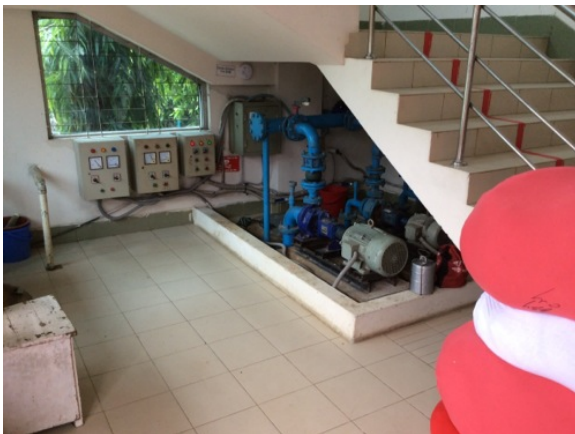
| F-9 | Egress | <p>Storage was located in the exit stair. Fixed pump equipment was mounted under one of the stairs.</p> <p>Location: Several floors of all stairs, particularly, at ground floor.</p> | <p>Remove all storage from exit stairs and egress paths.</p> | Immediate |

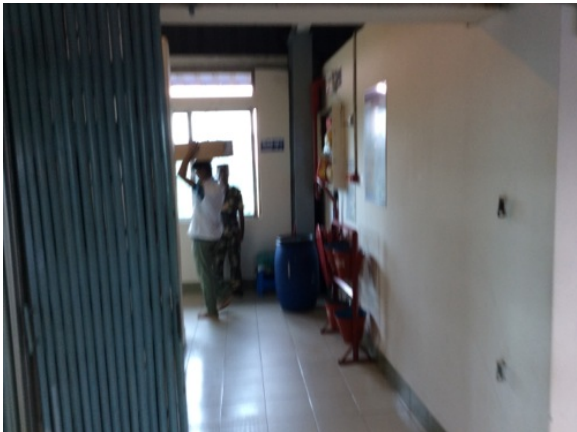
| F-10 | Egress | <p>Collapsible gates / sliding doors are provided at building exits, exit stairs, exit discharge.</p> <p>Location: All stairs at all floors.</p> | <p>Replace all gates / sliding doors along the means of egress with side-hinged, swinging egress doors.</p> <p>If locks are required for security reasons, utilize special door locking features complying with NFPA 101.</p> | <p>Within 1 month</p> |

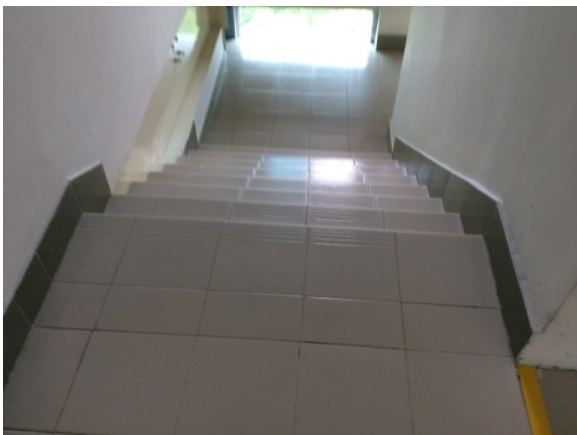
| F-11 | Egress | Handrails were not provided in the fifth stair on the south side. | Provide handrails on at least one side of exit stair. | Within 3 months |

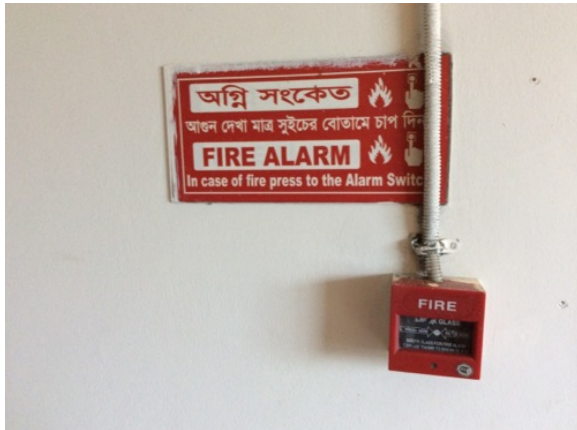
| F-12 | Fire Protection | The fire alarm system is antiquated, not a listed system, and does not provide alarm and notification features consistent with acceptable standards. | Replace the fire alarm system with a new, listed addressable fire alarm system in accordance with NFPA 72. | Design within 4 months, install within 9 months |

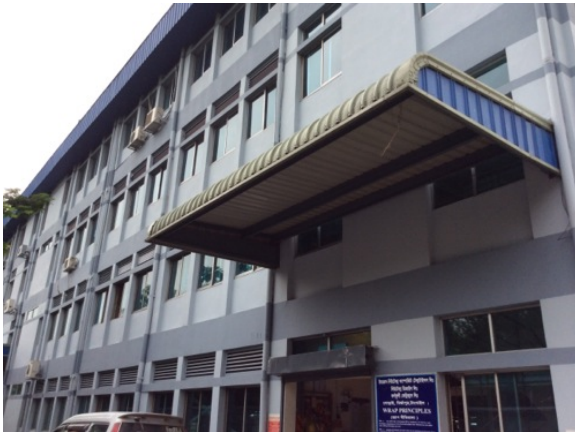
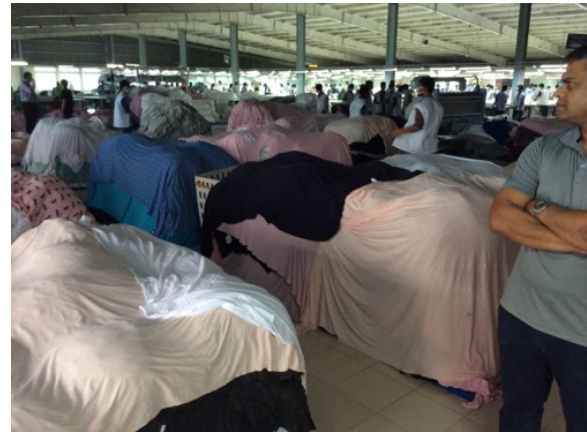
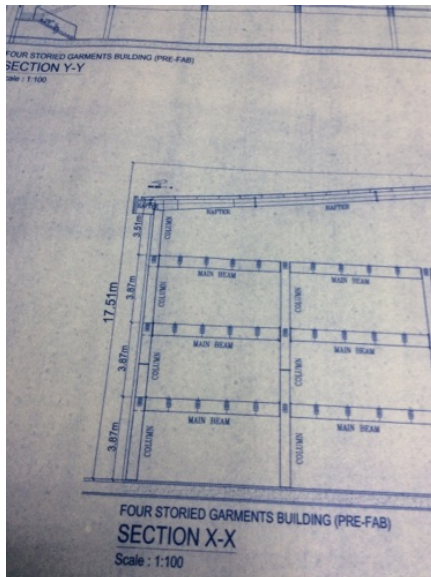
| F-13 | Fire Protection | The building is not a high-rise building. However, it is of non-rated steel construction and has a floor area and number of stories exceeding ACCORD standards. The building is not provided with automatic sprinkler protection. The large occupant loads, heavy fuel loading, and anticipated extended egress times warrant sprinkler protection. | Provide automatic sprinkler protection throughout the building in accordance with NFPA 13. | Design within 6 months, install within 12 months |

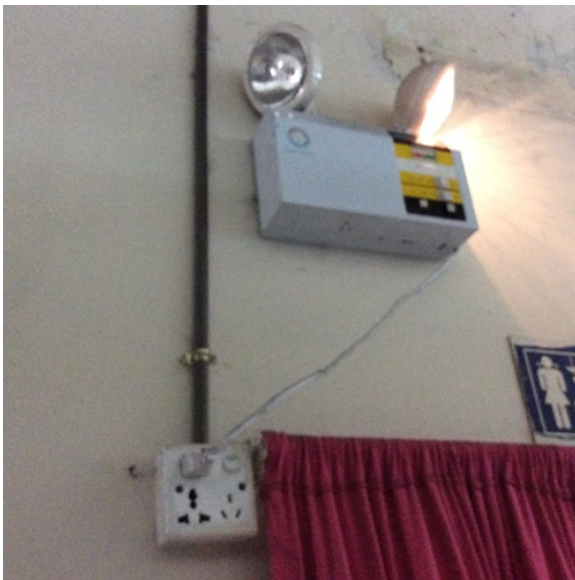
| F-16 | Egress Lighting | Emergency lighting did not function in test mode (burned out, broken, etc.).<br><br>Location: 3rd floor. | Regularly test the emergency lighting system on each floor and replace/repair lights as needed. | Within 1 month |

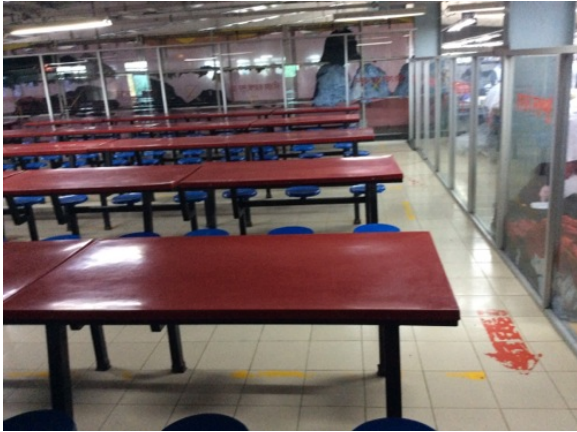
| F-17 | Egress Lighting | Exit sign not provided at exit.<br><br>Location: Temporary female dining area on the 3rd floor had two exits, but only one sign was provided. | Provide exit signs above all exits to the exterior and all doors to the exit stairs. | Within 1 month |

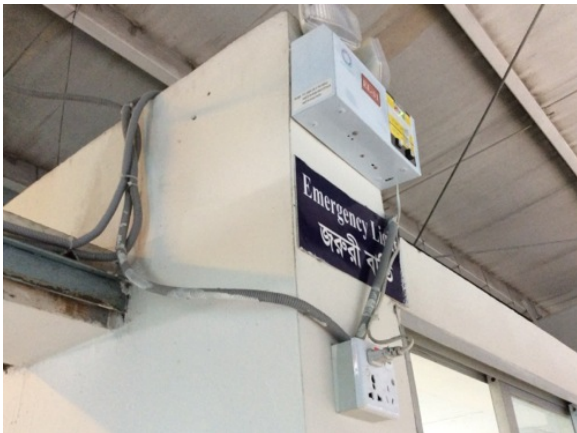
| F-18 | Egress Lighting | Manual on-off switch is provided for all battery powered emergency lighting units. | Remove manual on/off switches from emergency lighting units to prevent them from being switched off. | Within 1 month |
| | | Location: At all stairs and egress routes on all floors. | | |
