# Golden Refit Garments Ltd. (Extension)

589 Chirir Chala, Baghair Bazar, Bhabanipur, Gazipur, Bangladesh  
(24.167049, 90.427188)

14<sup>th</sup> November 2016

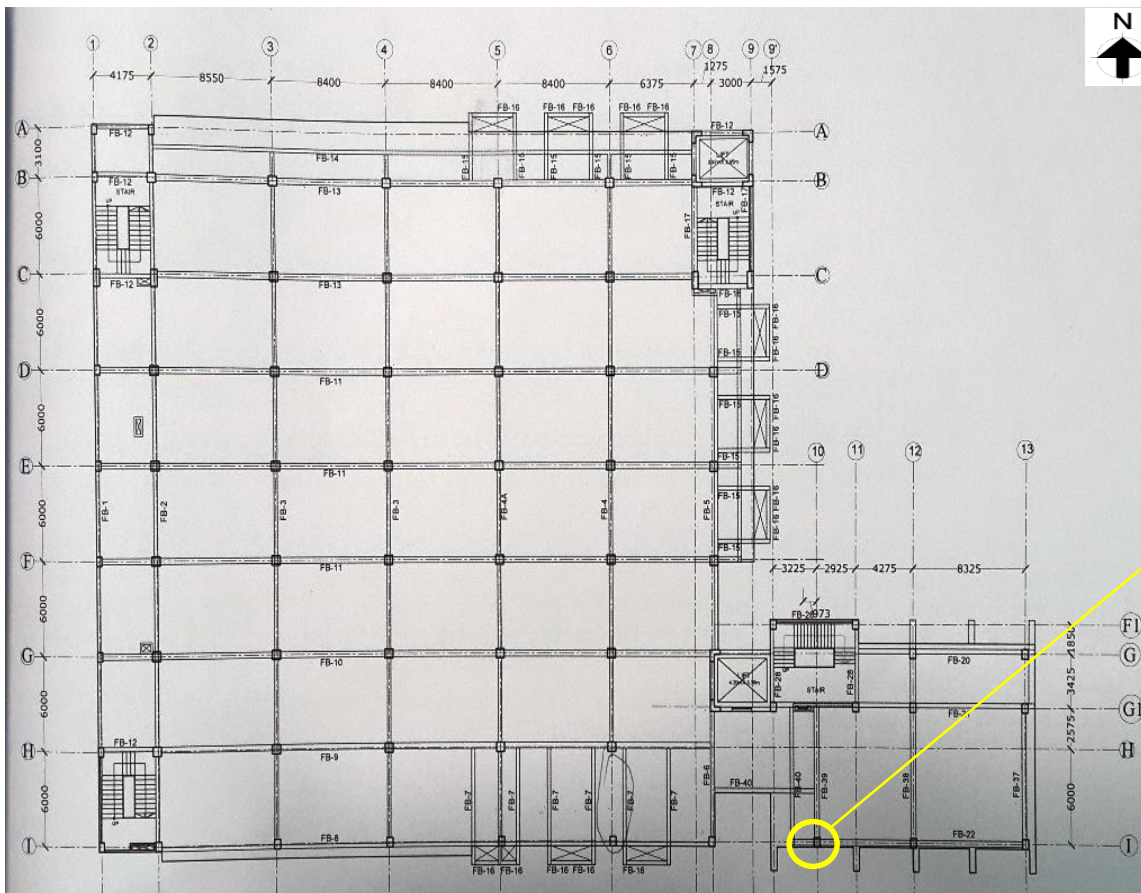
Column Layout

Impact protection not provided to columns at loading –unloading area. Columns are susceptible to impact loading from vehicles.

| Item No. | Observation | Recommended Action Plan | Recommended Timeline |
|---|---|---|---|
| 1 | Columns susceptible to vehicle impact | Install a barrier to prevent vehicle impact in column. | 6-weeks |

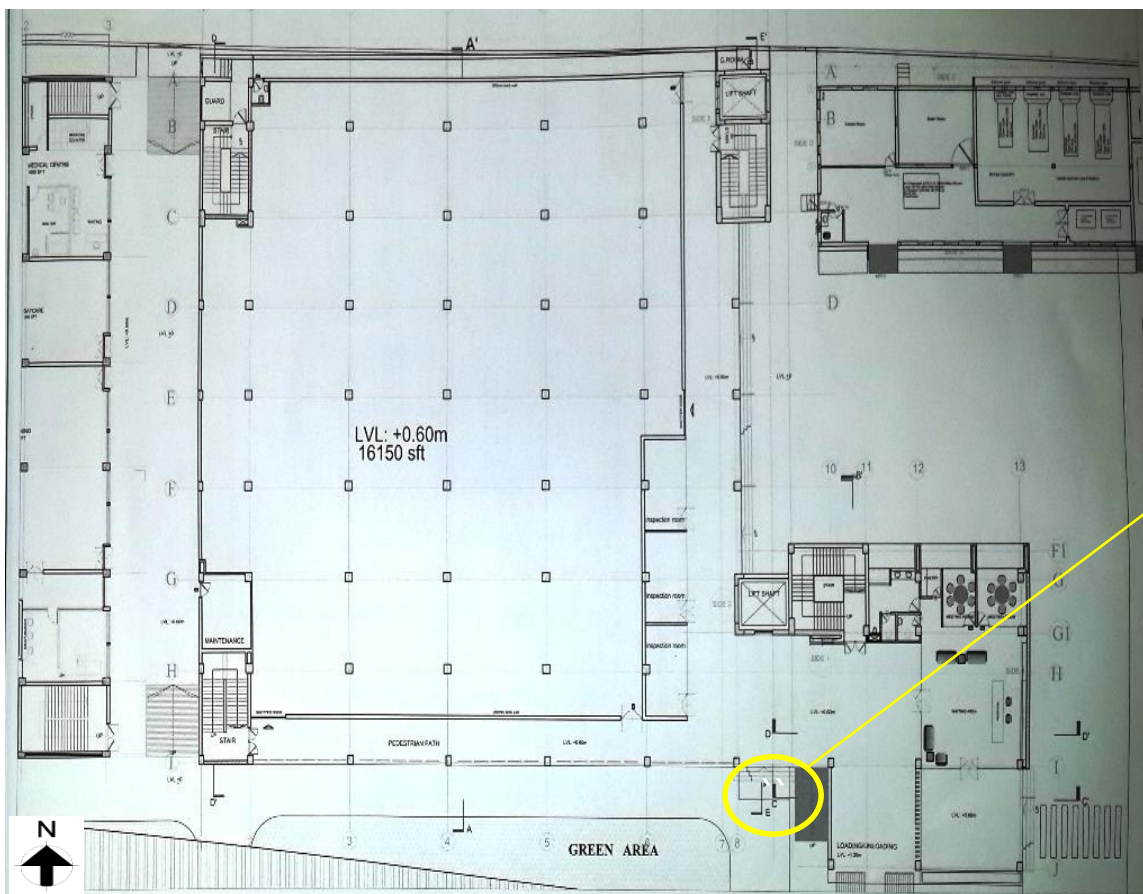
Architectural Drawing of Ground floor

Undocumented steel canopy observed in ground floor south side beside loading/unloading area.

| Item No. | Observation | Recommended Action Plan | Recommended Timeline |
|---|---|---|---|
| 2 | Undocumented steel canopy beside loading/unloading area | Building Engineer to update as-built drawing according to actual condition. | 6-weeks |

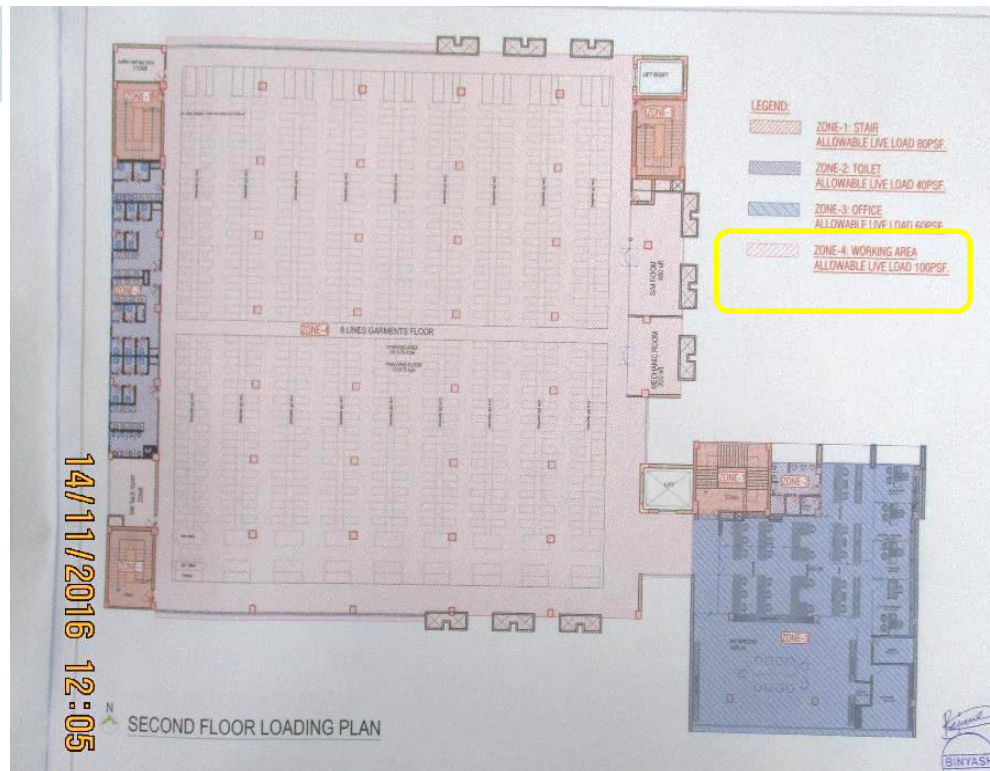
Factory is required to maintain the floor live load 2kpa until further verification by design engineer.

| Item No. | Observation | Recommended Action Plan | Recommended Timeline |
|---|---|---|---|
| 3 | Prepared load plan required to be verified | Maintain 2 Kpa load on all floors. | 6-weeks |
| 4 | Prepared load plan required to be verified | Produce and actively manage a loading plan for all floor plates within the factory giving consideration to floor capacity and column capacity if loading above 2kpa is considered. | 6-weeks |

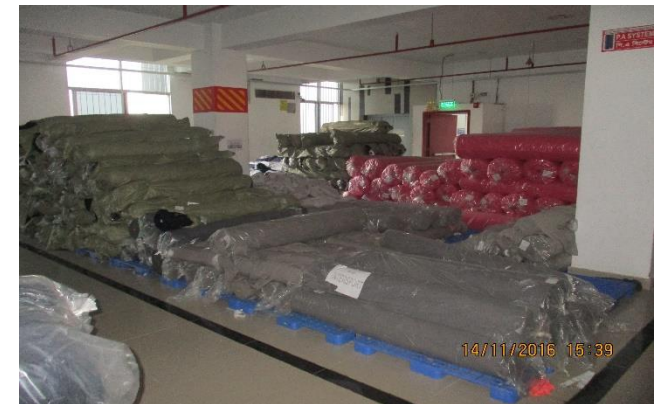
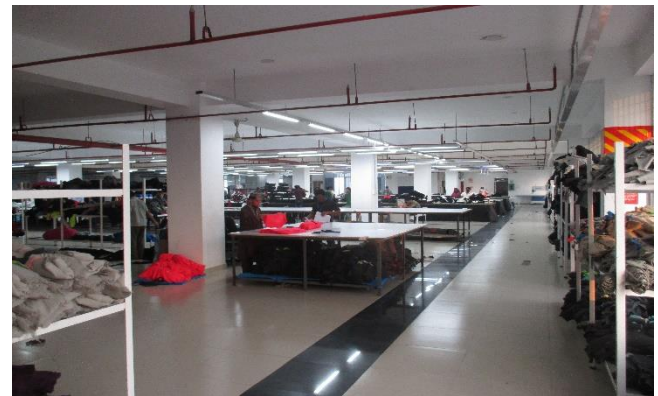
During inspection no over loading was observed and FOS calculation for internal column was found satisfactory considering 2kpa allowable floor live loading.

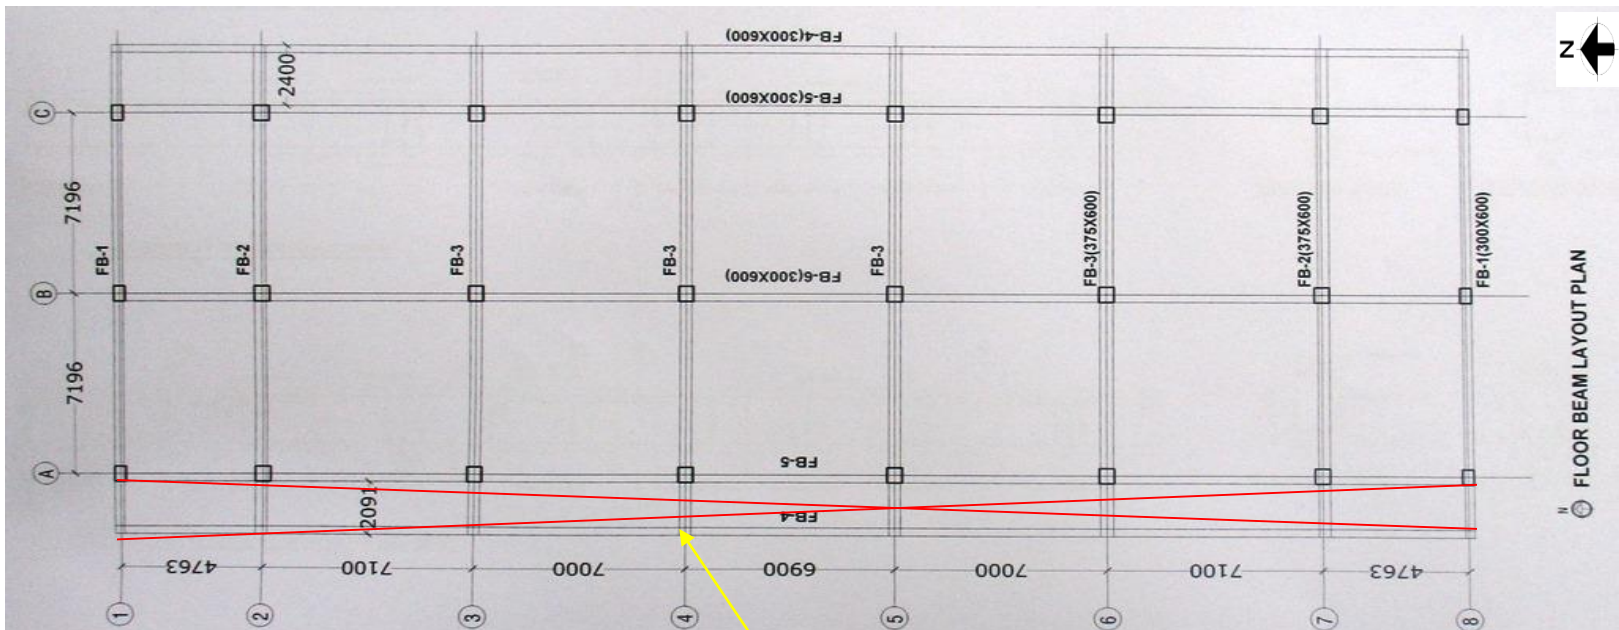
Beam layout of facility building

Structural drawing shows  
cantilever beam at east & west  
side on every floor but  
cantilever beam missing at west  
side in 2<sup>nd</sup>, 3<sup>rd</sup> & 4<sup>th</sup> floor.

| Item No. | Observation | Recommended Action Plan | Recommended Timeline |
|---|---|---|---|
| 6 | Discrepancies between Structural drawing and on-site condition. | Building Engineer to prepare accurate as-built structural drawing. | 6-weeks |

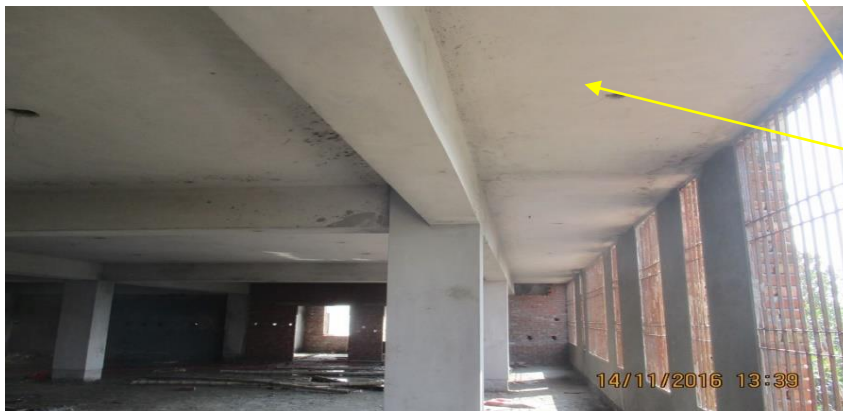
Cantilever beam missing at west side  
(2nd to 4<sup>th</sup> floor)
