# A.M. Design Ltd.

Diakhali, Beron, Jamgara, Ashulia, Bangladesh

3 May 2014

# Observations

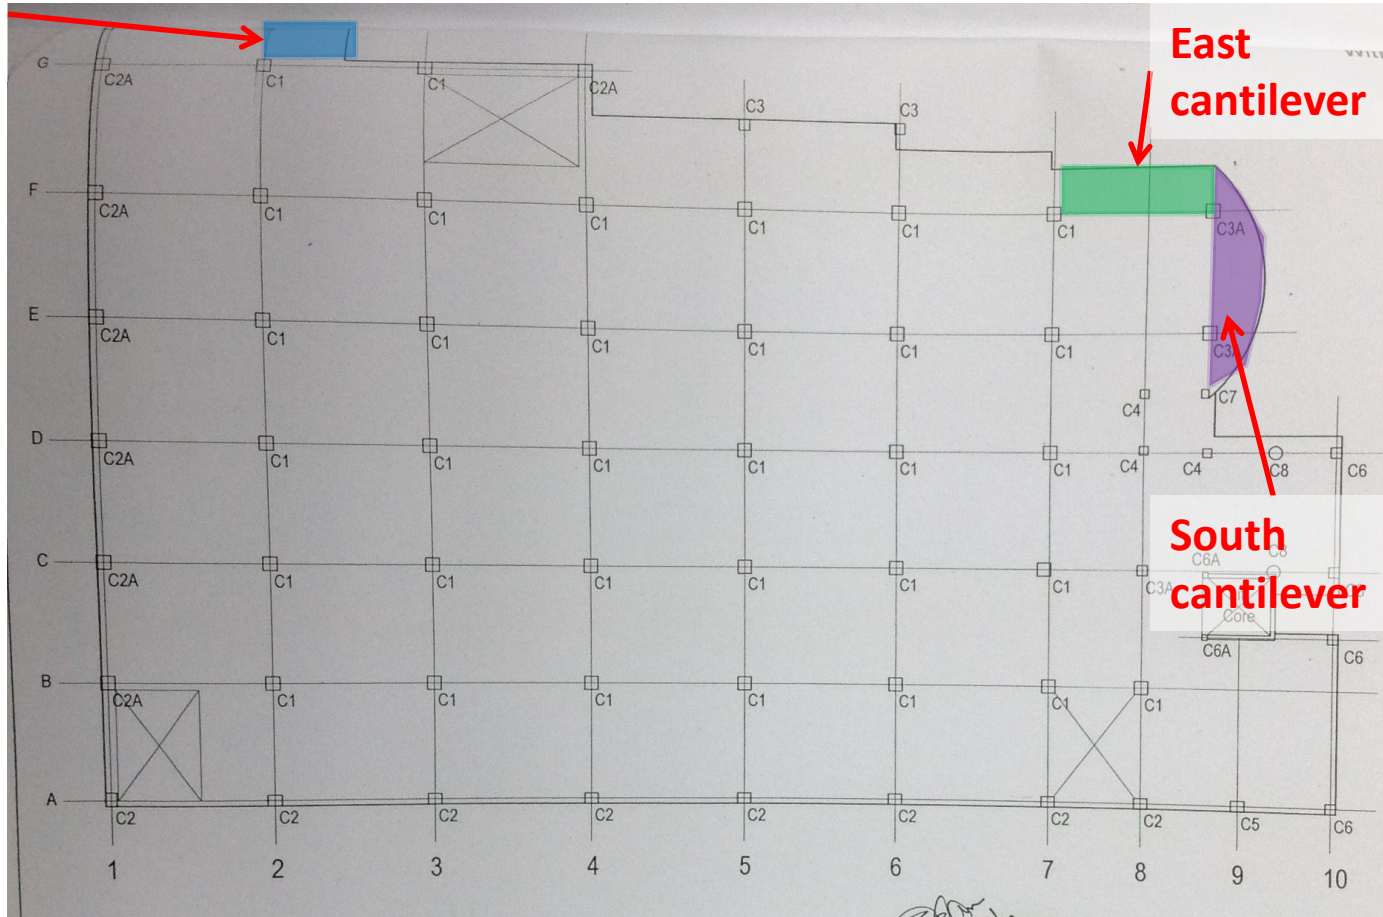
**Northeast  
cantilever**

**Cantilever slabs are particularly sensitive to heavy loading.**

**Washroom block housed within Northeast cantilever at first floor. Additional loading due to floor build ups in this area.**

| Item No. | Observation | Recommended Action Plan | Recommended Timeline |
|---|---|---|---|
| 1 | Sensitivity of cantilever areas to loading | Building Engineer to assess capacities of cantilever slabs and develop and implement loading plans for these areas as necessary | 6-weeks |

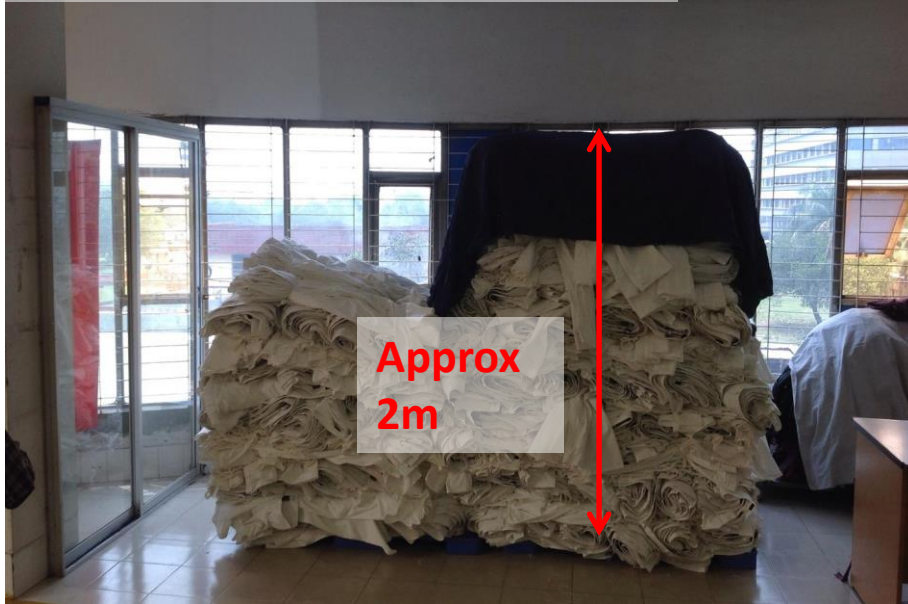
**South cantilever – second floor**

**South cantilever slab is used for material storage up to approximately 2m on second and third floors.**

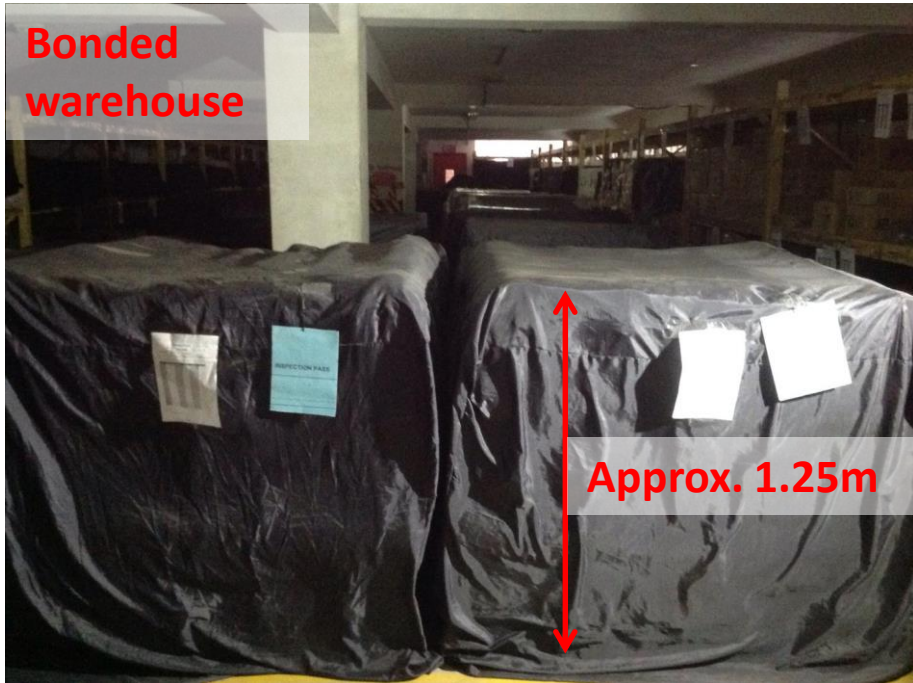
**Bonded  
warehouse**

**Material rolls in within bonded warehouse  
stacked to approximately 1.25m high.**

| Item No. | Observation | Recommended Action Plan | Recommended Timeline |
|---|---|---|---|
| 3 | Concentrated areas of high loading | Building Engineer to develop loads plans for all buildings, accounting for usage, floor build ups, solid partition walls and areas of concentrated loading. Factory management to implement load plans. | 6-months |

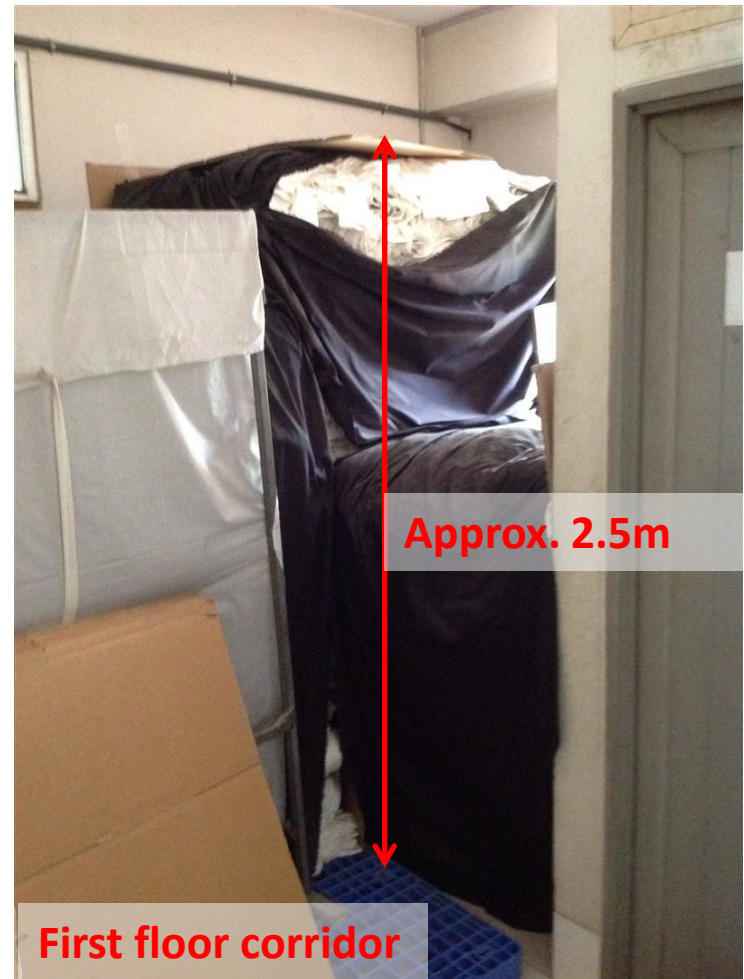
**Numerous locations of  
concentrated material storage  
throughout building. No loading  
management system in place.**

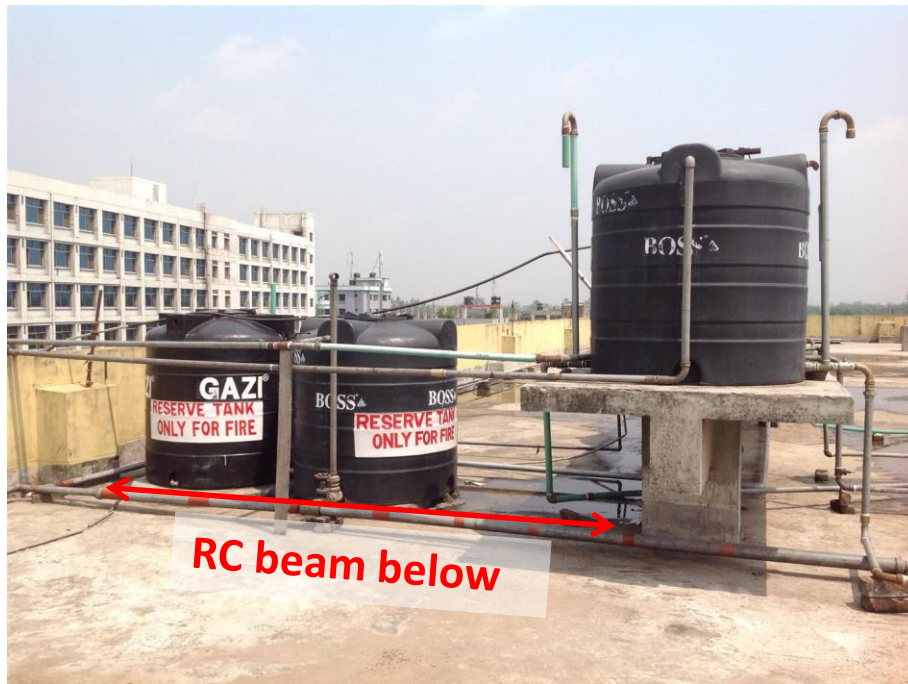
2 x 2000l plastic water tanks located on beam line between columns.

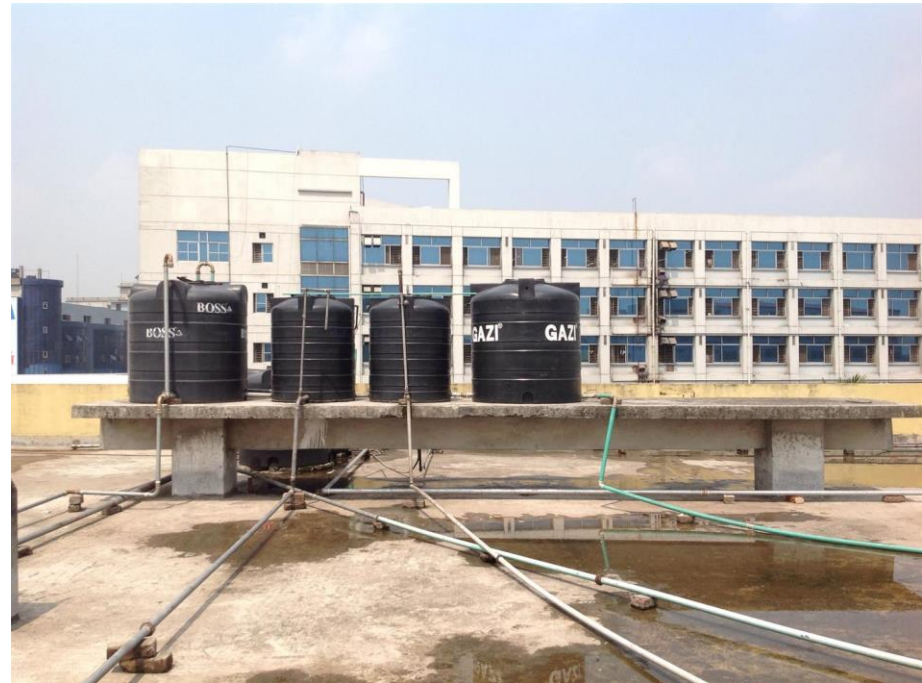
2 x 2000l and 2x 1000l plastic water tanks supported on reinforced concrete beam spanning between columns. No apparent drainage system for standing water on roof.

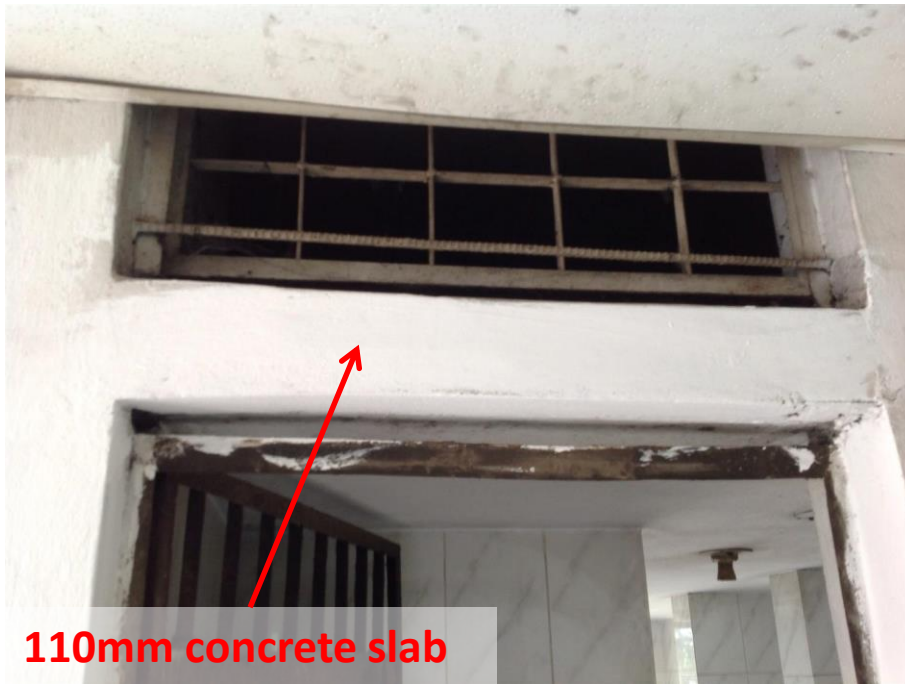
**110mm concrete slab**

**Additional dead loading observed in washroom areas:  
Up to 120mm solid build up on slab in toilet cubicles. 110mm slab above washroom. 175mm solid masonry walls with tile.**

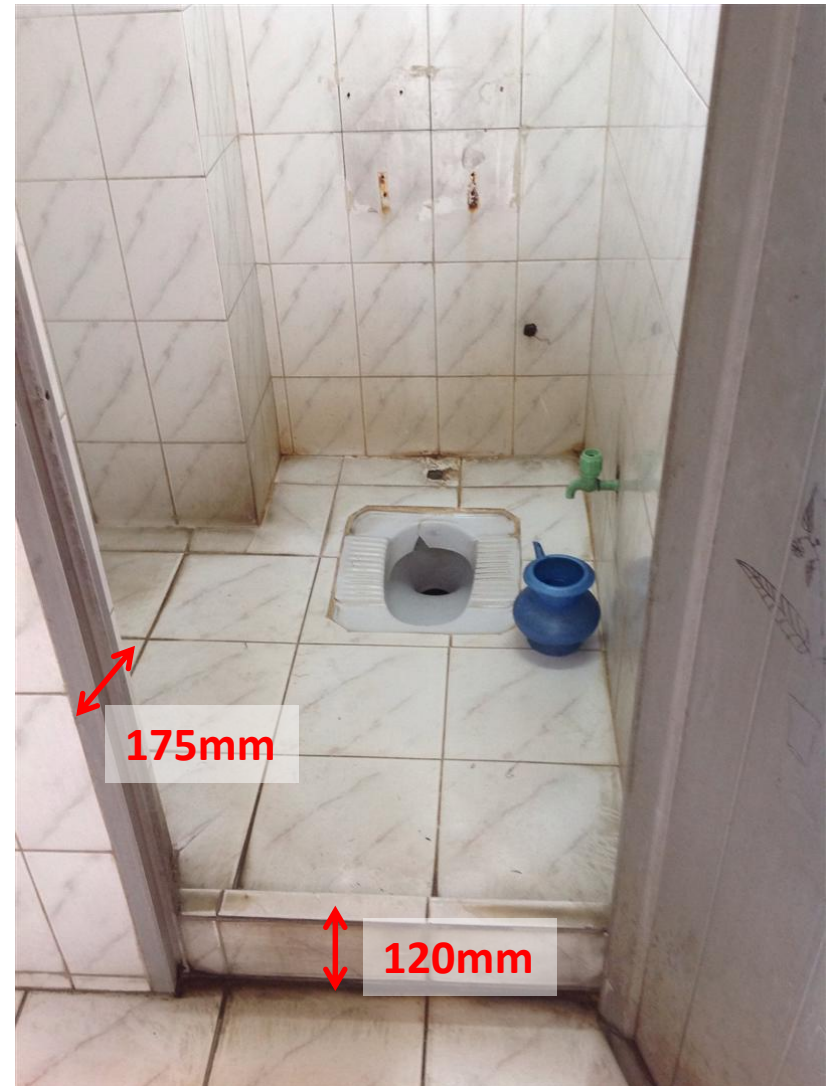
**175mm**

**120mm**

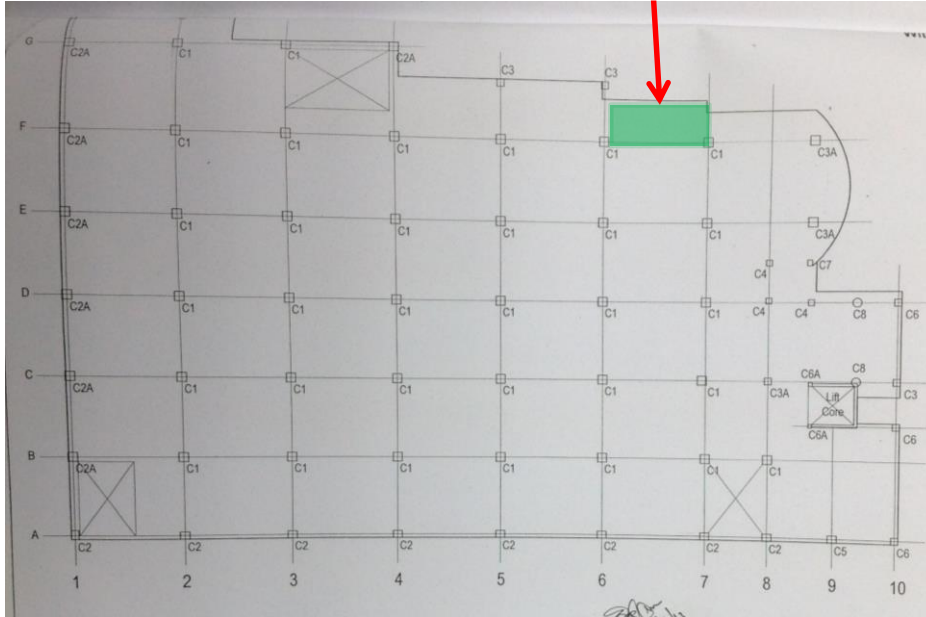
**Assumed one way spanning slab with no perimeter edge beam**

**East bay GL 6-7 does not have a downstand beam at the perimeter to support masonry infill walls. Deflection of slab evident by cracking observed on east façade.**

| Item No. | Observation | Recommended Action Plan | Recommended Timeline |
|---|---|---|---|
| 4 | No stiffening edge beam to assumed one way spanning slab GL 6/7 parallel to GL G | Building Engineer to confirm one-way spanning slab parallel to GL G (as assumed). IF slab is designed/constructed as a cantilever about GL F a verification of the slab design is required. | 6-weeks |
| 5 | No stiffening edge beam to assumed one way spanning slab GL 6/7 parallel to GL G | Building Engineer to monitor façade cracking due to unstiffened slab edge and restrict floor use with loading plans as defined in item 1 | 6-months |

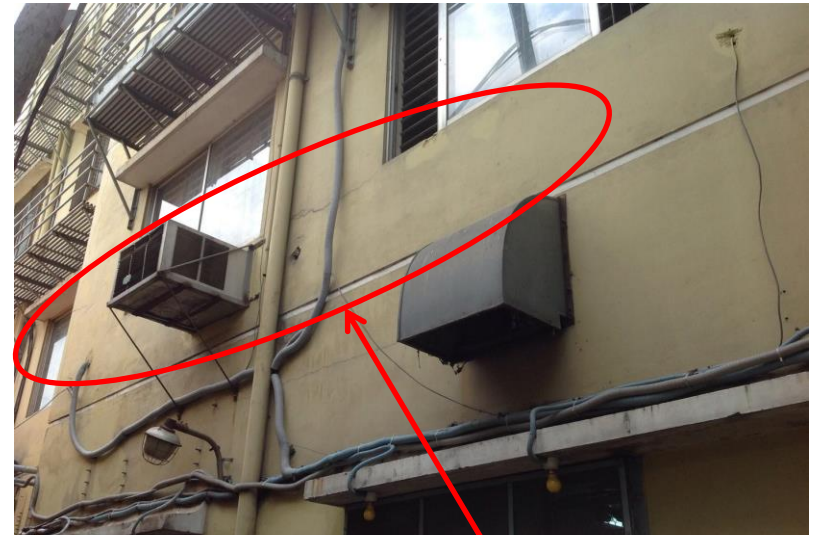
**Cracking in East facade**

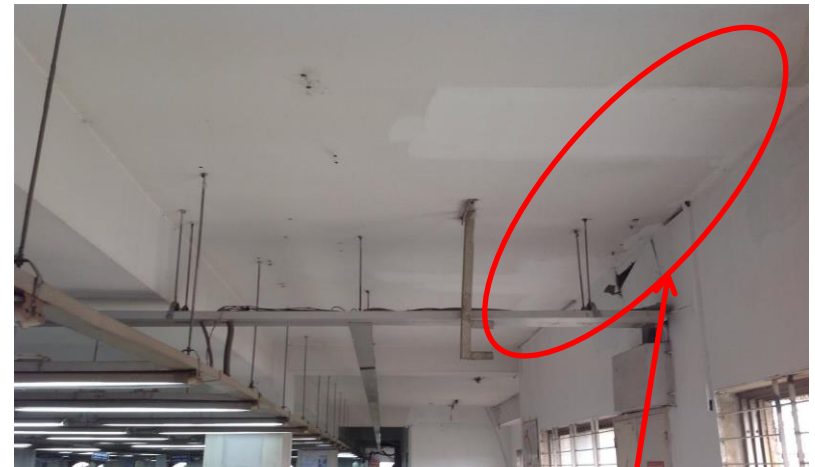
**No downstand beam provided**

**No stiffening edge beam to assumed one way spanning slab**

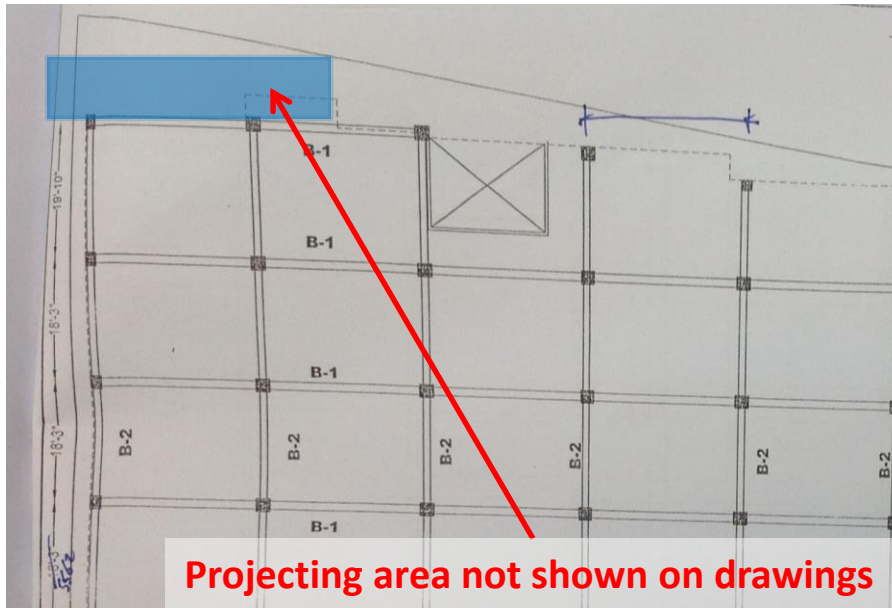
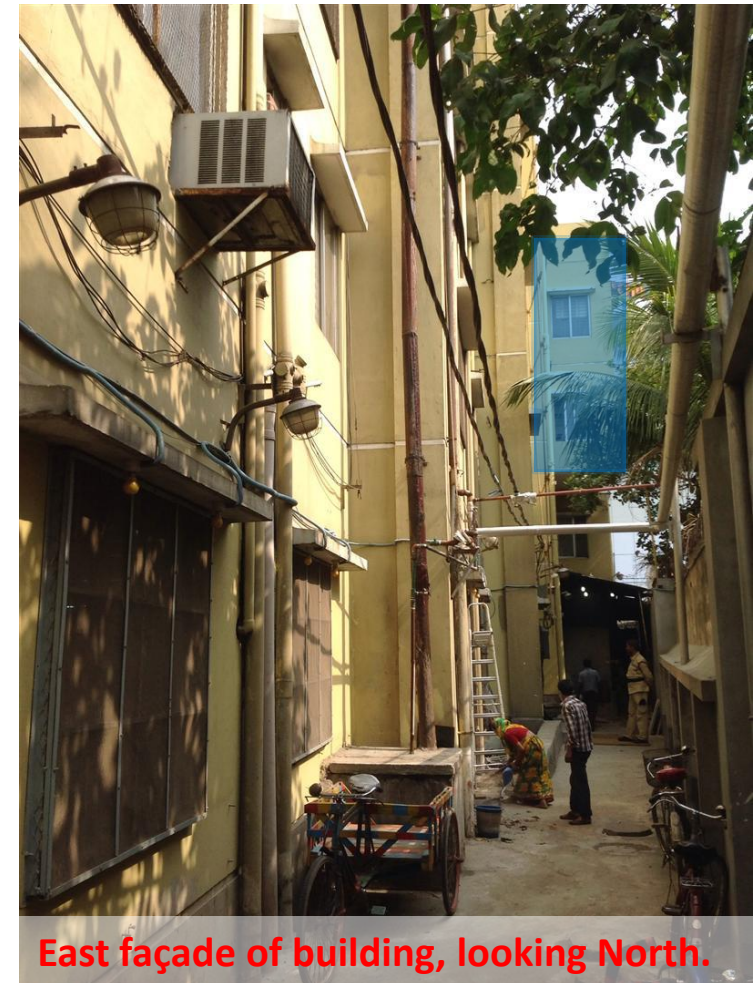
Structural drawings do not provide details for projecting area in North East corner of building. Architectural and permit drawings do show this area.

| Item No. | Observation | Recommended Action Plan | Recommended Timeline |
|---|---|---|---|
| 6 | Discrepancies between structural drawings and as built structure | As built structural drawings to be generated/updated for all buildings on factory complex. As built drawings to account for structural framing as observed on site. | 6-months |

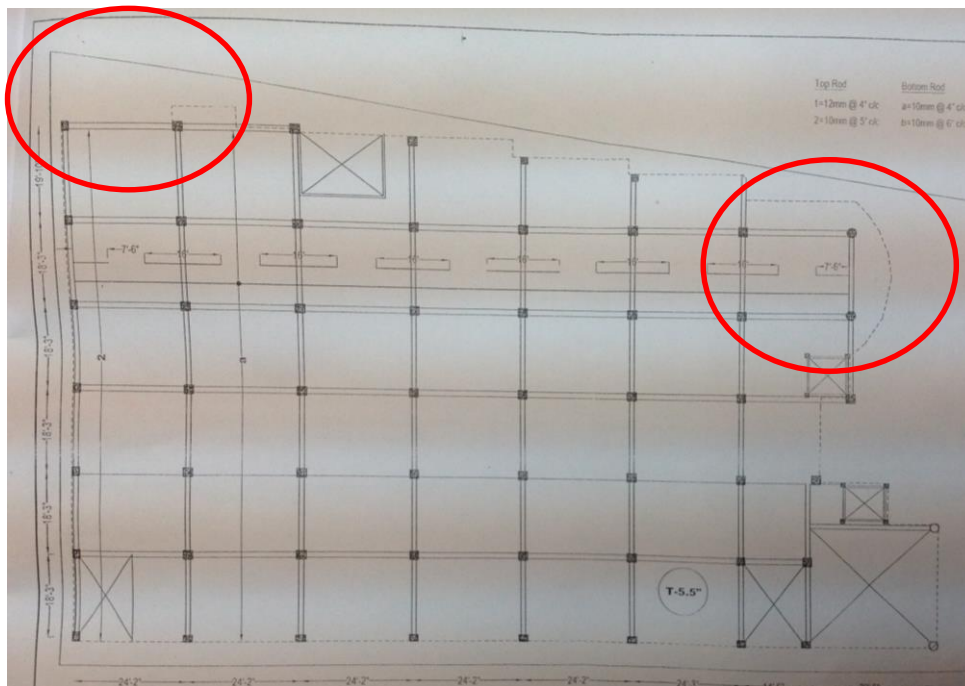
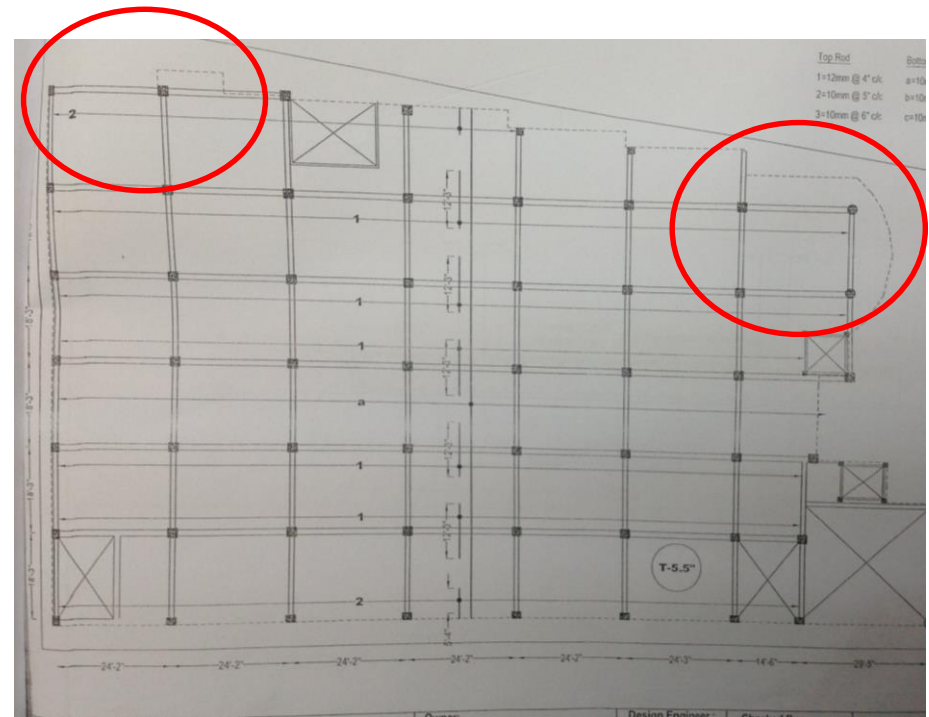
**Incomplete reinforcement structural drawings and no details for cantilever slabs to Northeast or South of building.**

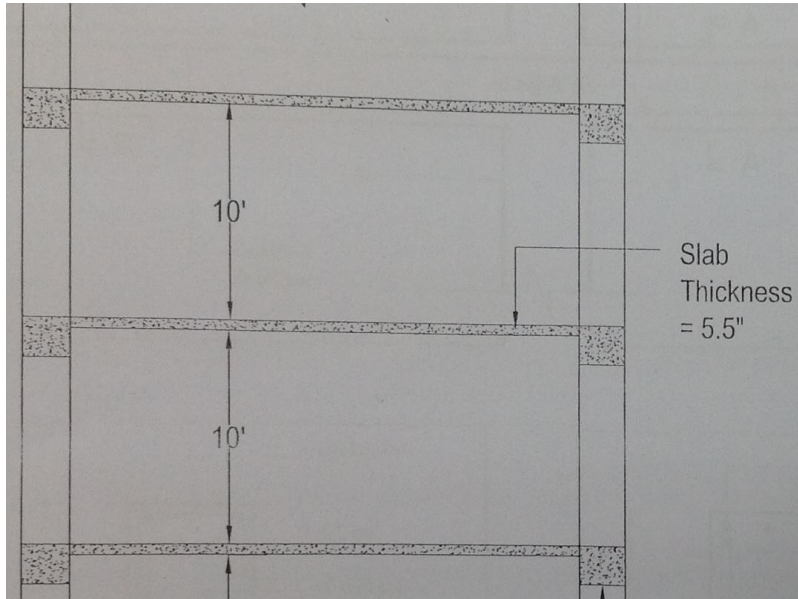
**5.5" thick slab indicated on drawings (140mm). Slab thickness observed on site varied between approximately 140mm and 170mm.**

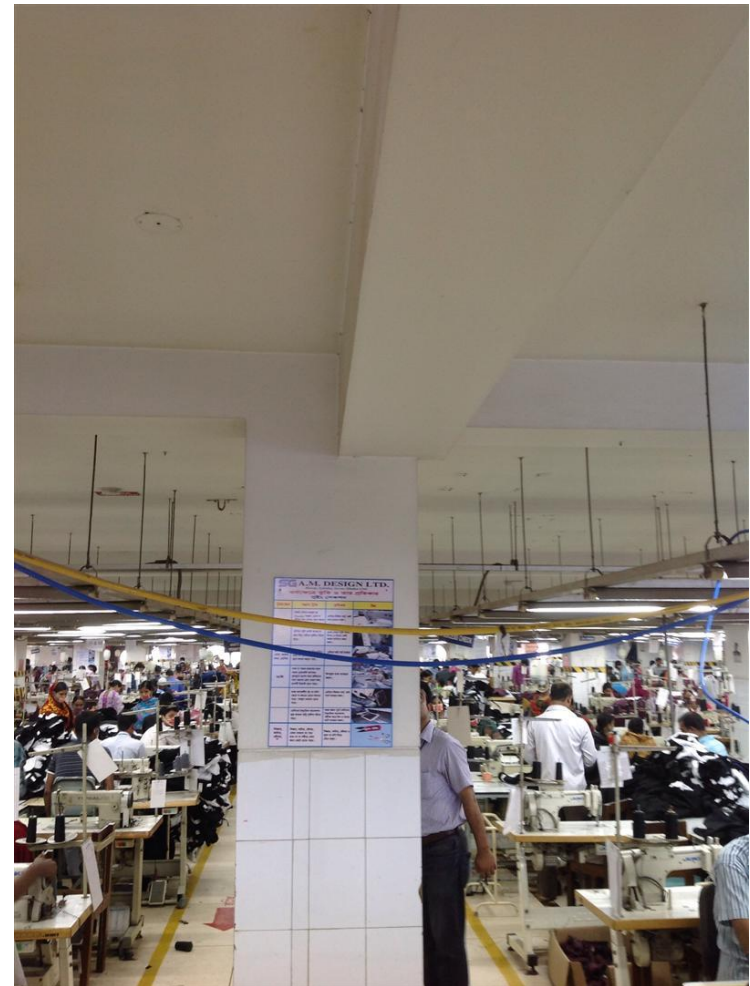
**Beam frames into column eccentrically in a number of locations.**

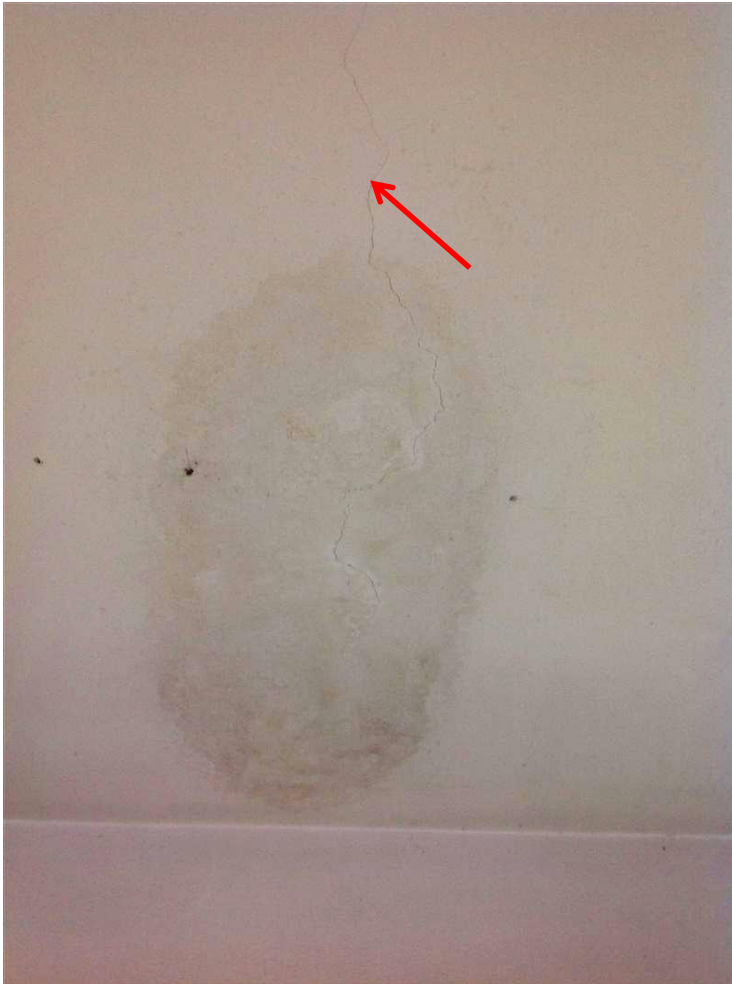
**Hairline cracks observed at soffit of roof slab. Evidence of dampness in at location of crack.**

| Item No. | Observation | Recommended Action Plan | Recommended Timeline |
|---|---|---|---|
| 8 | Minor hairline cracks observed in structural elements | Building Engineer to identify areas of structural cracking throughout building. | 6-months |
| 9 | Minor hairline cracks observed in structural elements | Building Engineer to continue to monitor size, length and location of structural cracking throughout. | 6-months |

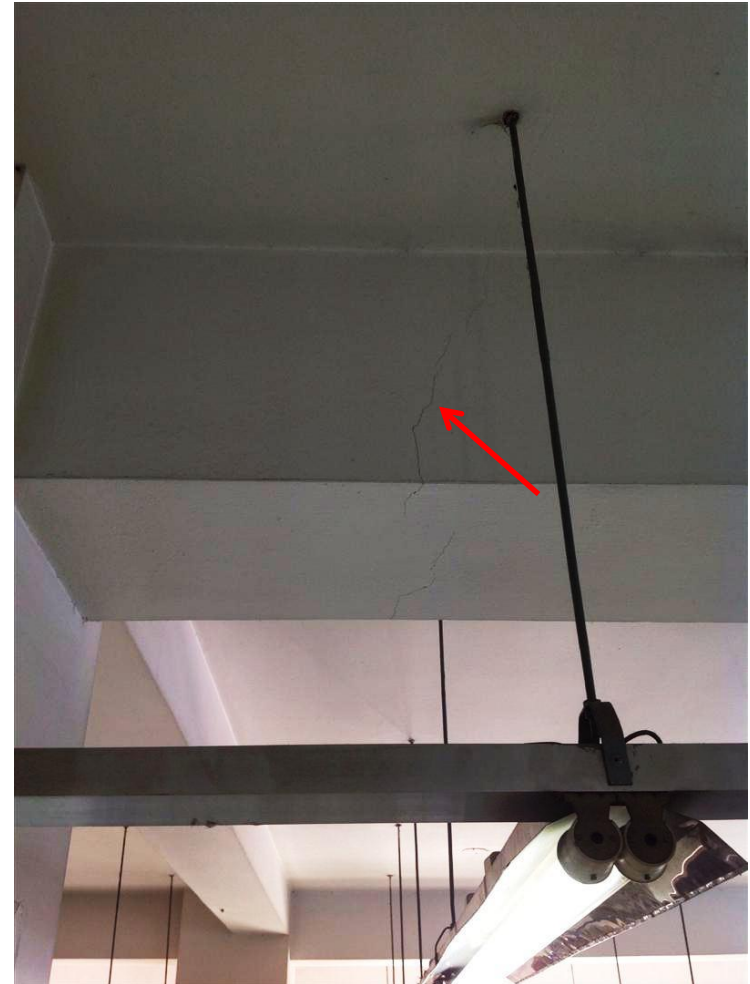
**Vertical cracking observed in sides and soffits of a number of beams throughout the building.**

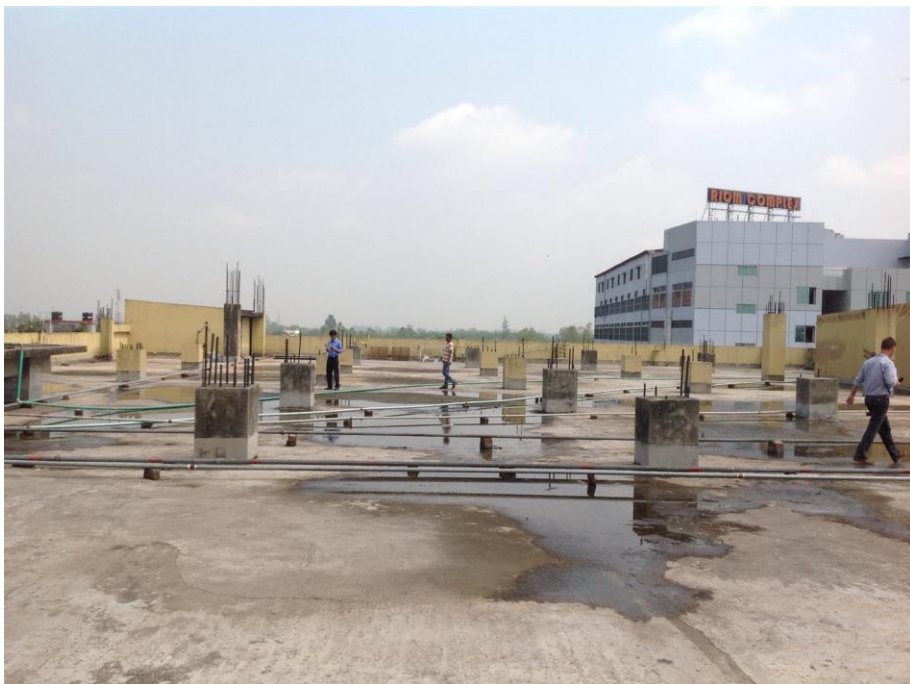
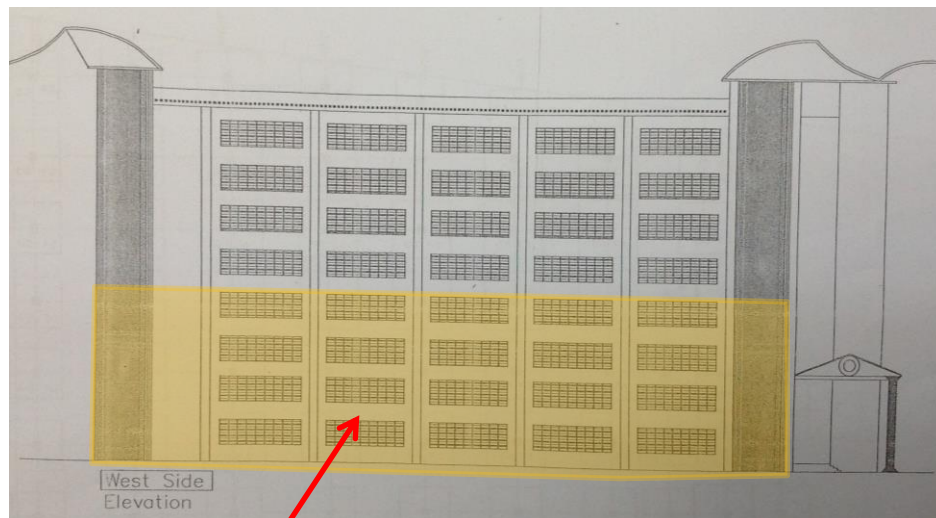
**Extent of constructed building**

Factory Management indicate that they intend to extend the structure vertically in the future. Four additional storeys are planned. Column reinforcement continues past slab level at existing roof.

Architectural drawings reviewed show complete eight storey building. Permit drawings do not indicate the number of storeys that have been approved.

| Item No. | Observation | Recommended Action Plan | Recommended Timeline |
|---|---|---|---|
| 10 | Future vertical extension | Prior to future extension commencing, Building Engineer to verify column capacities exceed future design loading, accounting for actual loading throughout existing building. Loading plans to be updated as required. | 6-months |

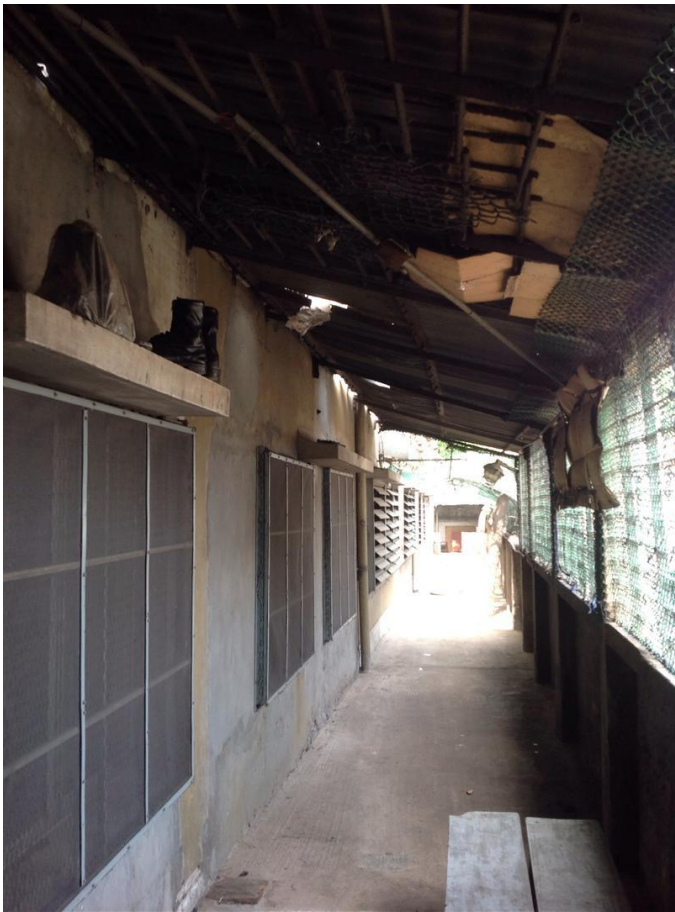
**Non-engineered structures**

**Numerous non-engineered lightweight structures around perimeter of building observed. Factory management indicate these structures are to be removed.**

| Item No. | Observation | Recommended Action Plan | Recommended Timeline |
|---|---|---|---|
| 11 | Non-engineered structures | Building Engineer to review the adequacy of non-engineered structures throughout complex. Particular attention should be paid to the stability of these structures and the holding down connection details. | 6-months |

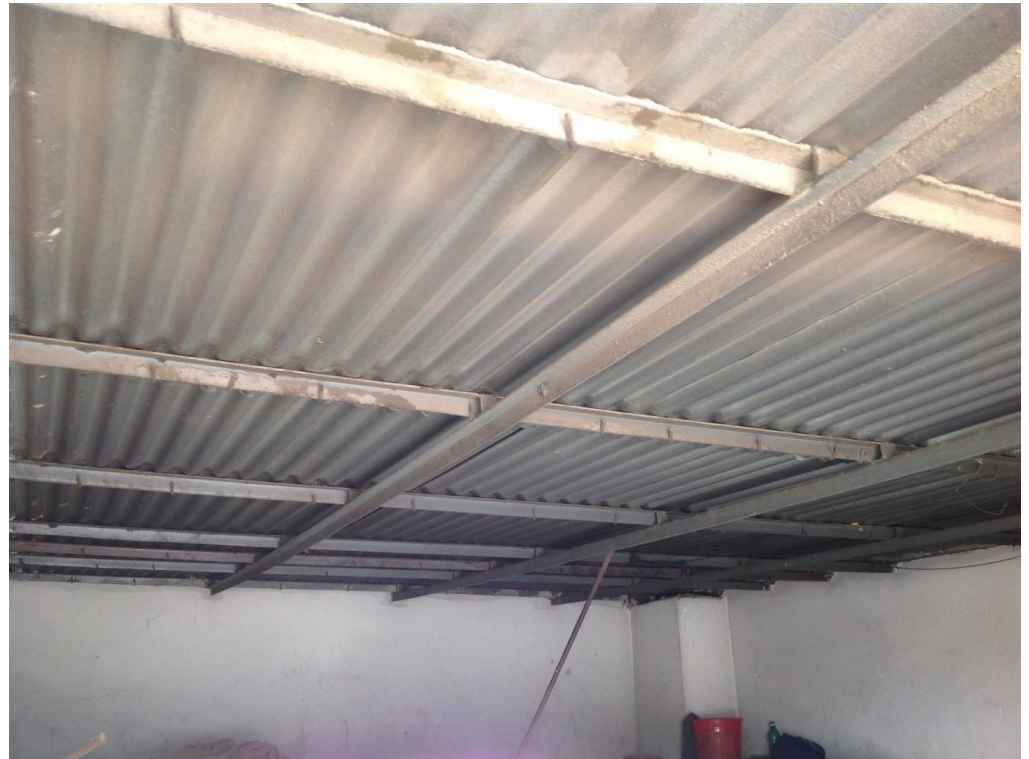
**Lightweight tin roof over staircore. Tin roof susceptible to wind uplift due to inadequate holding down details.**
