# Chantik Garments Ltd.

Kumkumari, Gouripur, Ashulia, Savar, Dhaka.  
(23.881988N,90.312175E)

10<sup>th</sup> May 2014

# Observations

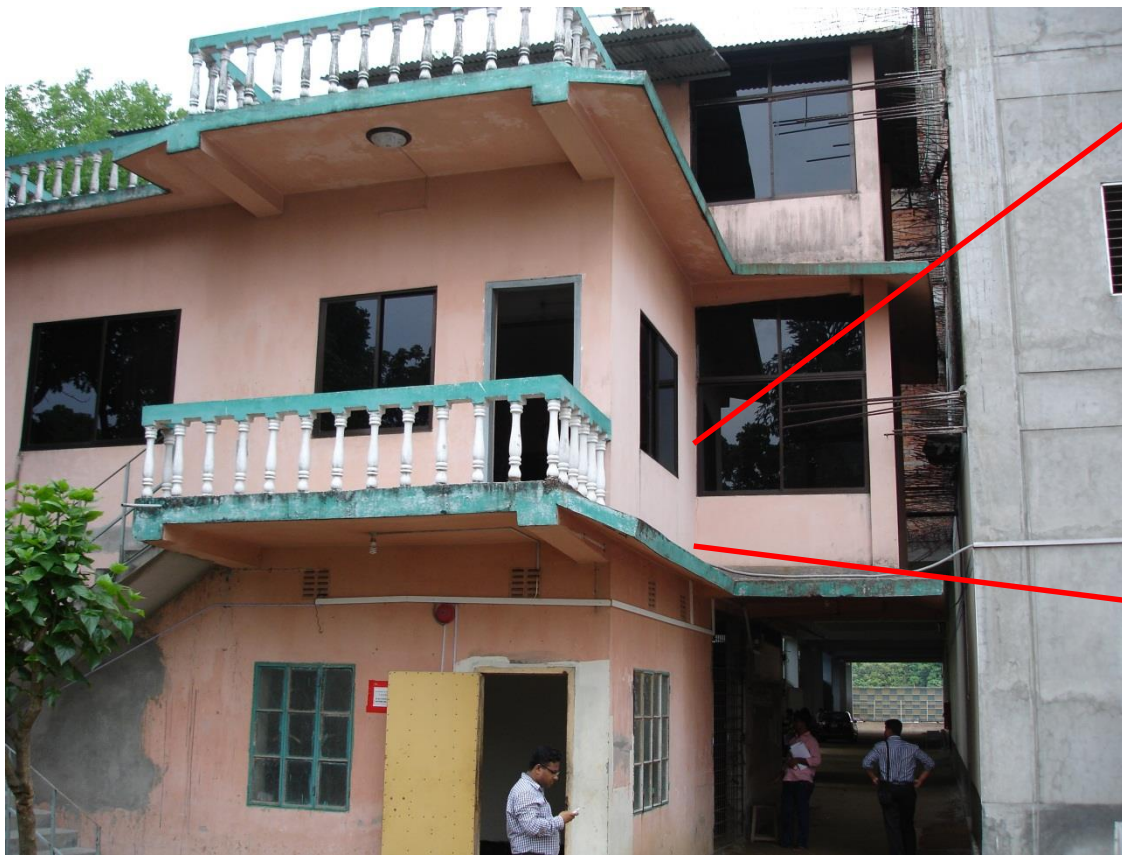
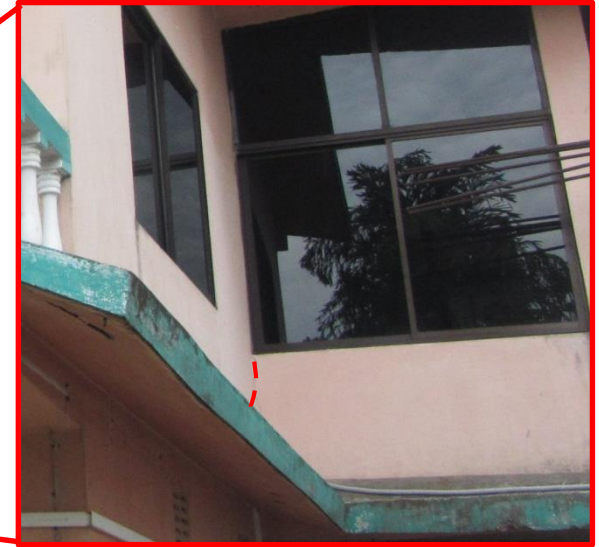
# Deflection of cantilever concrete beam

2.0 m long cantilever concrete beam in the unused building shows slight deflection resulting in a minor crack in the masonry above.

**ITEM 1:** Design/justification of cantilever concrete beam

Building Engineer to start monitoring crack and install temporary support in case of crack width increase. Engineer to carry out engineering assessment if building is to be used,

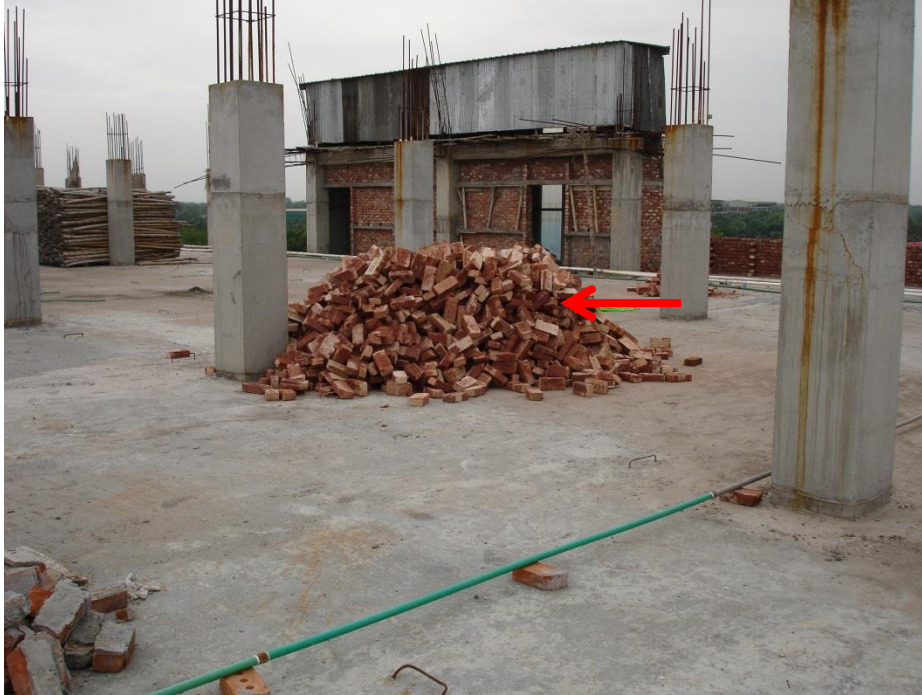
# High loading on roof slab

1.3 m high brick pile on roof slab of the processing building results in high loads on roof slab.

Building Engineer to make sure allowable loads are not exceeded during the construction stage. Loading to be controlled on roof with loading not to exceed  $2\text{Kn/m}^2$

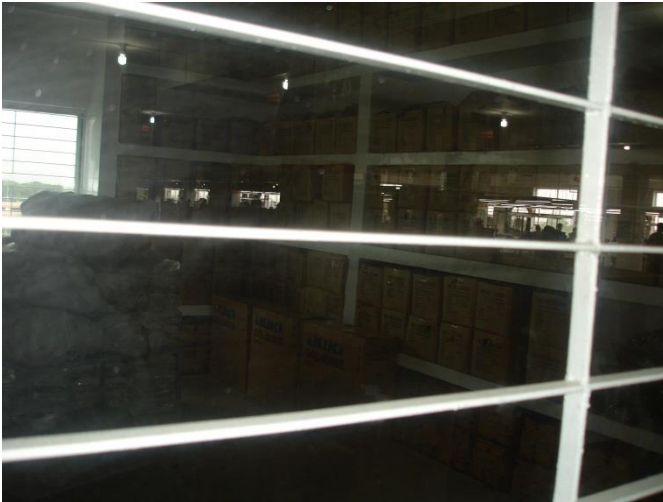
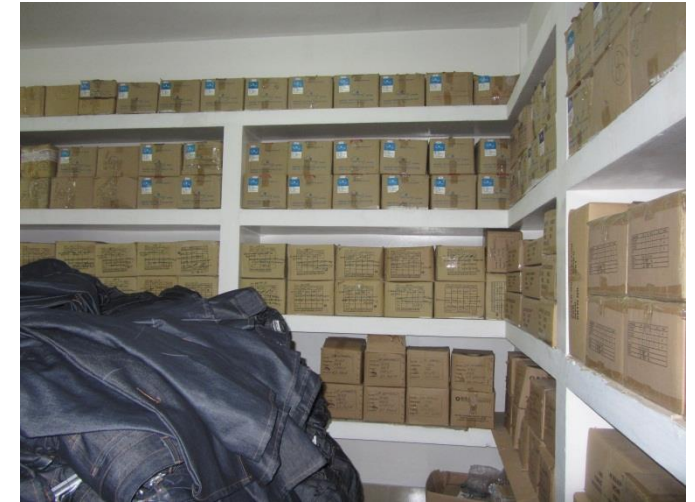
# Concrete shelves leading to high floor loads

Concrete shelves with masonry walls carry accessory boxes and apply high loads to the floor slabs. On the second and third floor there is also loose denim storage (approx. 1.6m high) in the same area.

Building Engineer to ensure loading plans are displayed and that floor loads are being managed.
