# **FIRE SAFETY INSPECTION REPORT**

**Factory Name: Day Fashions Limited**

**Date: 8th December, 2016**

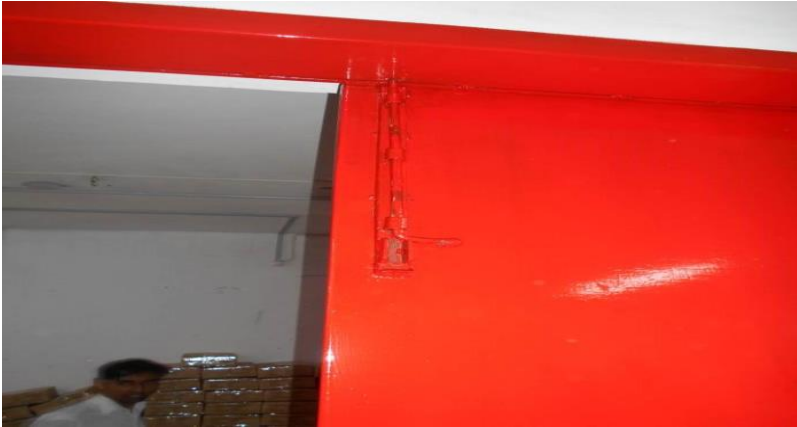
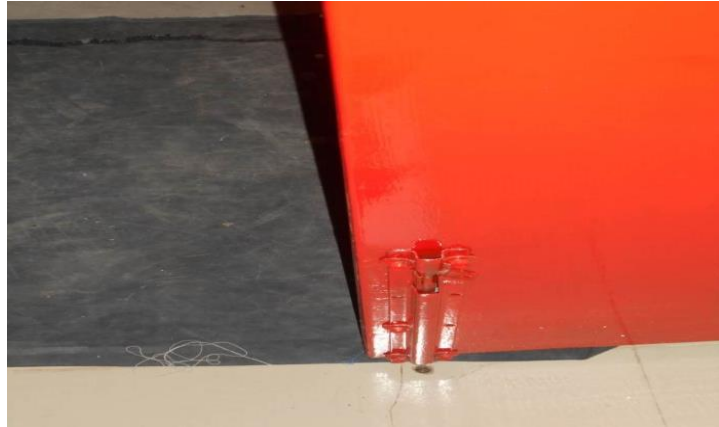
| SI No. | Category | Findings | Required Action | Remediation Time Frame |
|---|---|---|---|---|
| 8 | Egress | Doors along means of egress are provided with non compliant locking system.<br><b>Location: Embroidary section</b> | <ol style="list-style-type: none"> <li>1. Remove all non compliant locking features from egress doors.</li> <li>2. If locks are required for security reasons, utilize special door locking features complying with NFPA 101.</li> <li>3. Doors may be locked where the latch and lock are disengaged with one motion where the occupant load does not exceed 49 persons.</li> <li>4. Doors may be provided with locking hardware from the ingress side provided that a panic bar is installed on any door with an occupant load exceeding 49 persons.</li> </ol> | Immediate |

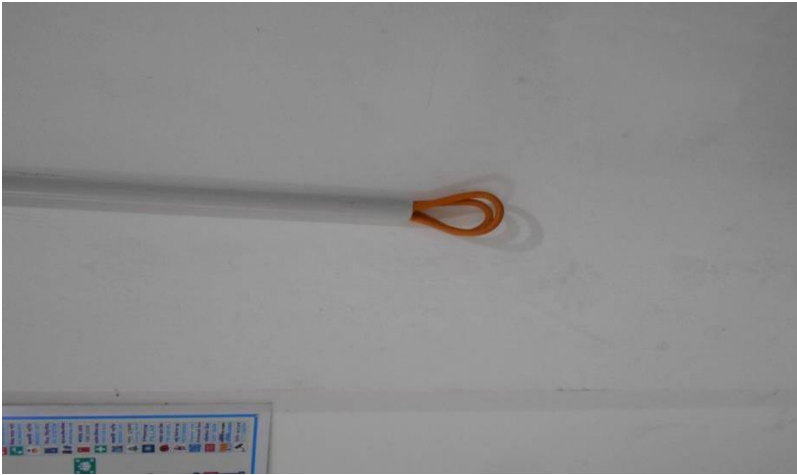
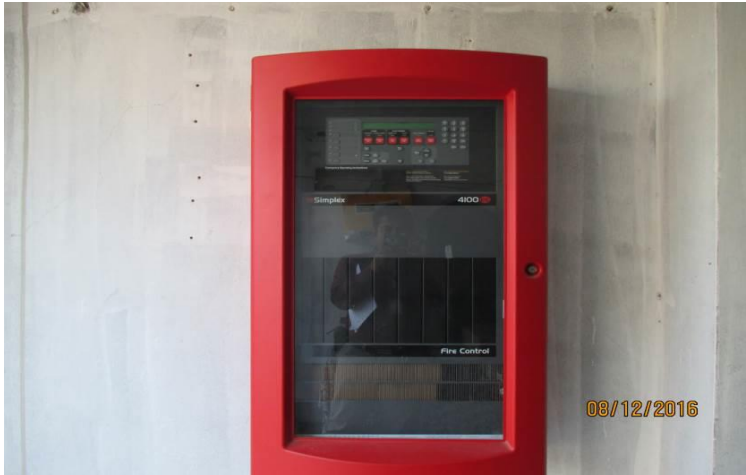
| SI No. | Category | Findings | Required Action | Remediation Time Frame |
|---|---|---|---|---|
| 11 | Fire Protection | Fire detection and alarm system installation is on-going. However drawing is not reviewed and the system is not confirmed to be as per <b>NFPA-72</b> . | Submit the drawing for ACCORD review<br>And<br>Complete installation/modification as per NFPA-72 | Within 6 months |

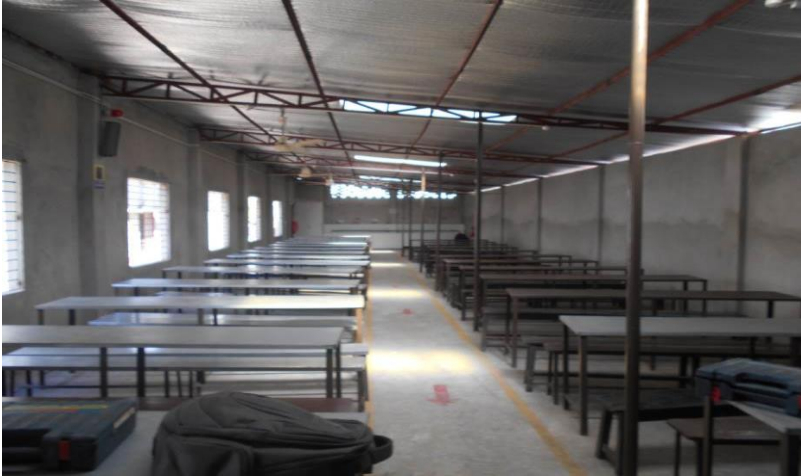
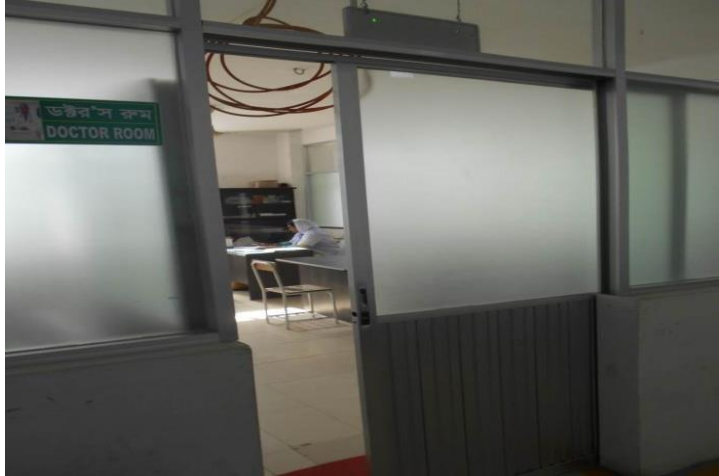
| Sl No. | Category | Findings | Required Action | Remediation Time Frame |
|---|---|---|---|---|
| 19 | Egress Lighting | Emergency light has not been provided at <b>Utility Building, Dinning shed, Medical room and at stores.</b> | Provide emergency lights at all the Location where there is any kind of occupancies. | <b>Within 3 months</b> |

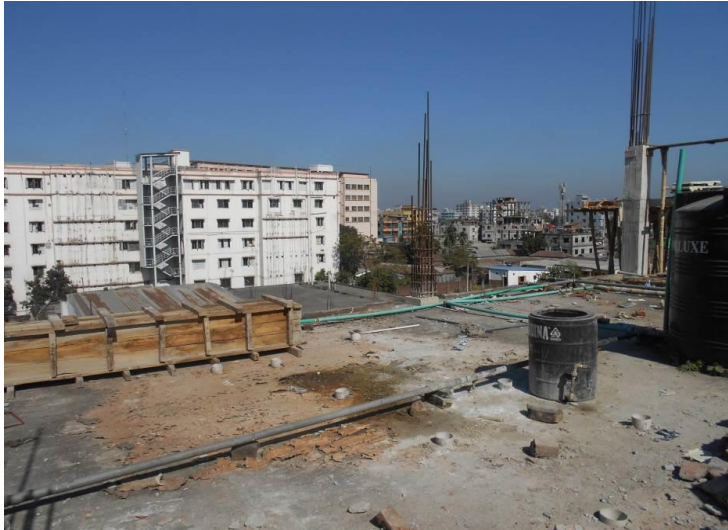
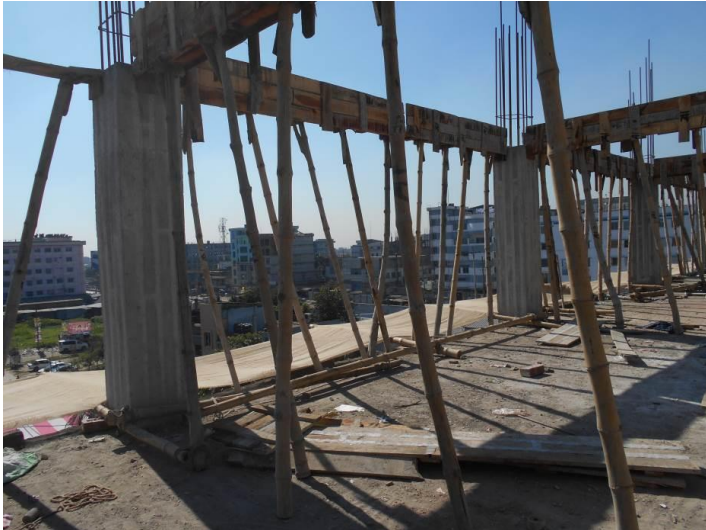
| Sl No. | Category | Findings | Required Action | Remediation Time Frame |
|---|---|---|---|---|
| 20 | Egress | Parapets or guards are not provide in occupiable roof. | Provide parapets or guards with a minimum height of 1067mm (42 inch.). | Within 3 months |
