# **FIRE SAFETY INSPECTION REPORT**

**Factory Name: Day Apparels Limited**

**ACCORD ID: 12483**

**Date: 8th December, 2016**

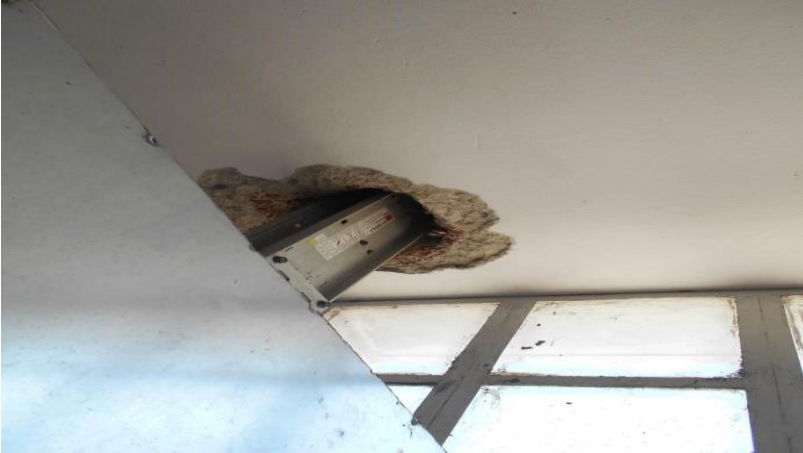
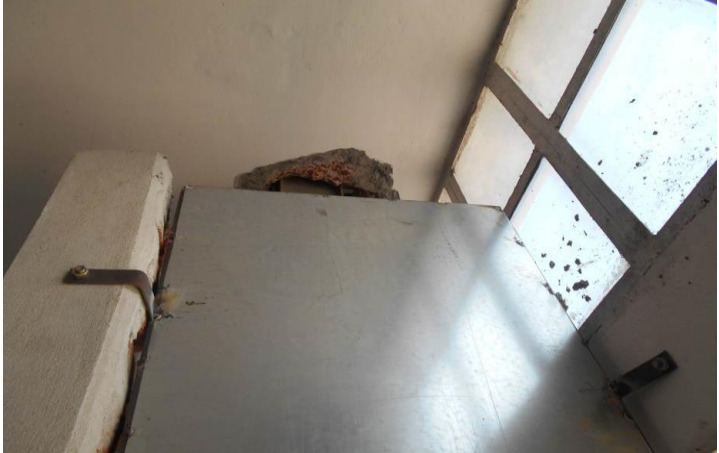
| SI No. | Category | Findings | Required Action | Remediation Time Frame |
|---|---|---|---|---|
| 6 | Fire Rated Construction | <p>Penetrations through floor/ceiling assemblies are found unsealed.</p> <p><b>Location: Electrical shaft near North-east stair.</b></p> | <p>Seal all penetrations and openings in the wall of exit enclosure walls (full thickness of the wall) by fire rated materials to maintain the fire resistance rating.</p> | <p><b>Within 3 months</b></p> |

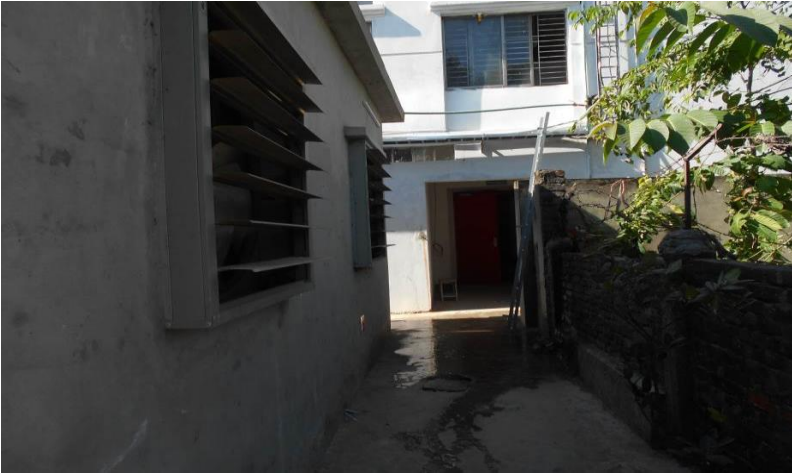
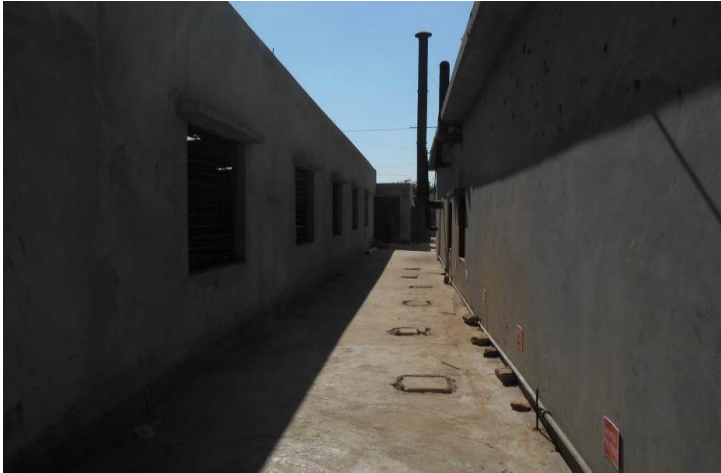
| SI No. | Category | Findings | Required Action | Remediation Time Frame |
|---|---|---|---|---|
| 7 | <b>Fire Rated Construction</b> | The exit discharge path is less than 10 ft wide and is not separated from the building interior.<br><b>Location: East exit stair discharge path</b> | Seal all penetrations and openings to the interior of the building along the discharge path, up to a height of 10 ft. to provide a minimum 1-hr fire separation. | <b>Within 3 months</b> |

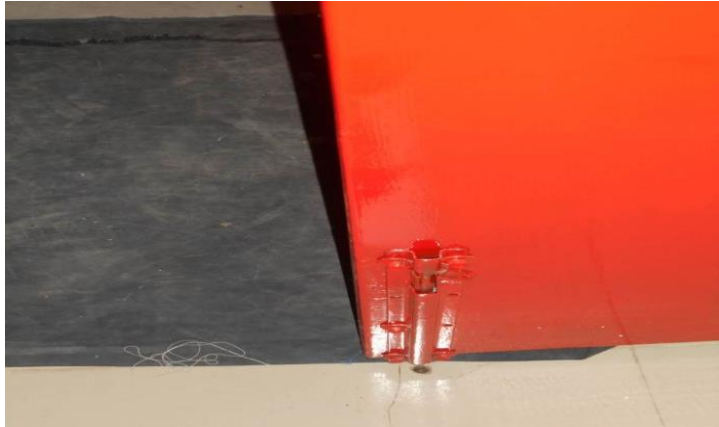
| Sl No. | Category | Findings | Required Action | Remediation Time Frame |
|---|---|---|---|---|
| 8 | Egress | Doors along means of egress are provided with non compliant locking system.<br><b>Location: Embroidary section</b> | <ol style="list-style-type: none"> <li>1. Remove all non compliant locking features from egress doors.</li> <li>2. If locks are required for security reasons, utilize special door locking features complying with NFPA 101.</li> <li>3. Doors may be locked where the latch and lock are disengaged with one motion where the occupant load does not exceed 49 persons.</li> <li>4. Doors may be provided with locking hardware from the ingress side provided that a panic bar is installed on any door with an occupant load exceeding 49 persons.</li> </ol> | Immediate |

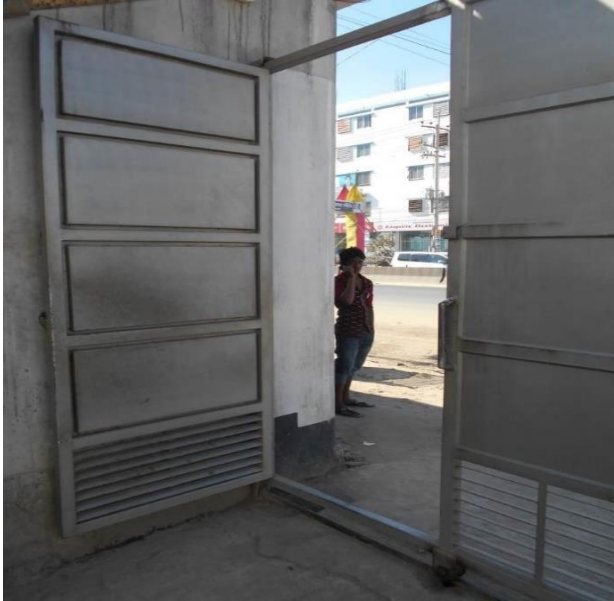
| SI No. | Category | Findings | Required Action | Remediation Time Frame |
|---|---|---|---|---|
| 21 | Egress | Egress door serving 50 or more occupants but does not swing in the direction of egress travel.<br><b>Location: Main exit discharge door</b> | Modify swing direction of egress doors to the direction of egress travel. Doors serving an occupant load of more than 50 shall swing in the direction (out-ward) of egress travel . | <b>Within 3 months</b> |
