# Vancot Apparel Ltd.

Plot #18-20, Sector No 03, Kepz, Chittagong, Bangladesh

12<sup>th</sup> June 2014

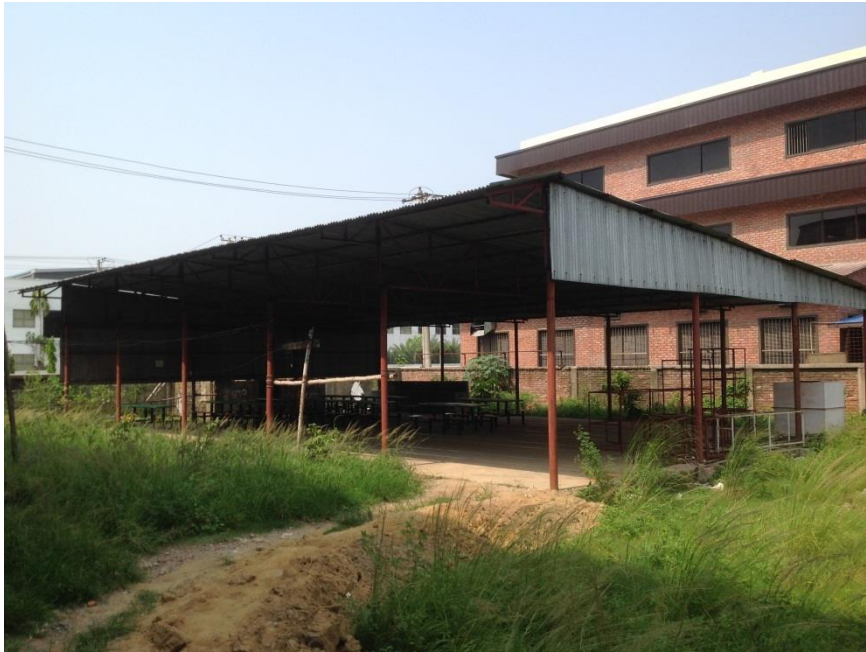
Dining shed

The dining shed structure and a canopy roof between the boiler and compressor room structures appears to be non-engineered. The main issues observed are:

- Overall stability of dining shed structure does not appear to have been considered
- Connection details between roof trusses and perimeter columns/walls appear inadequate
- Some section sizes used appear to be slender
- Connection between plant room roof and walls inadequate

Building Engineer to review stability of these structures and propose strengthening works.

| Item No. | Observation | Recommended Action Plan | Recommended Timeline |
|---|---|---|---|
| 1 | Lightweight steel structures | Building engineer to check the capacity of non-engineered lightweight roofs under horizontal and vertical loading and make any necessary alterations. | 6-weeks |
| 2 | Lightweight steel structures | Ensure all strengthening works proposed by building engineer are fully carried out. | 6-months |

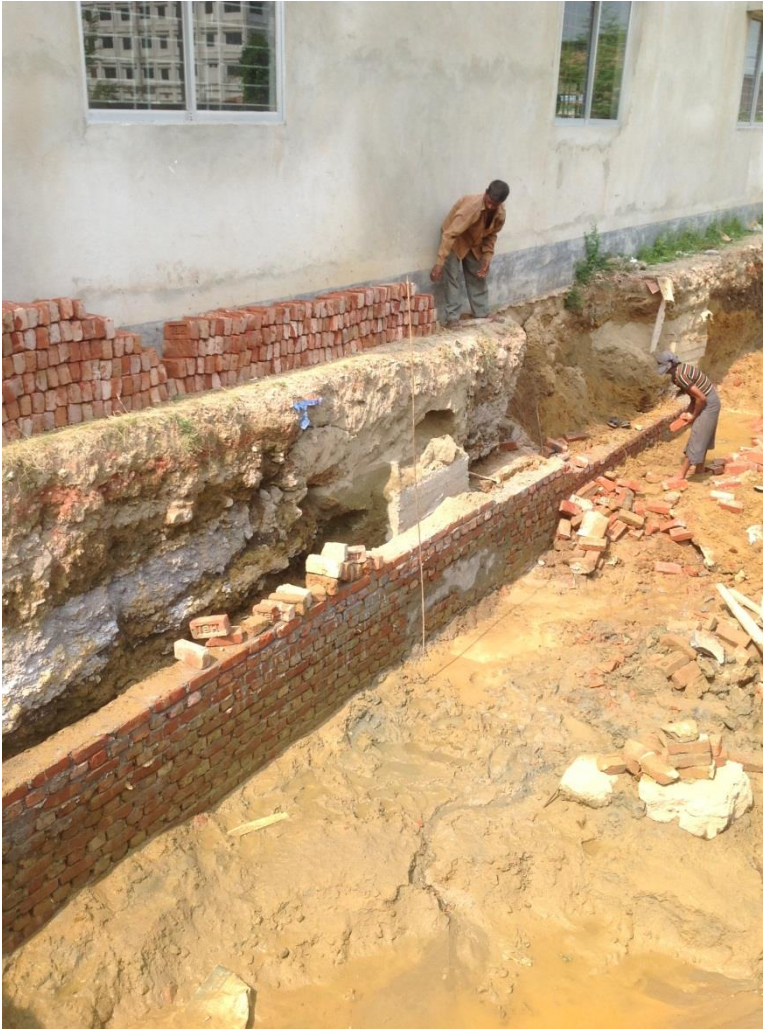
Exposed pad footing under edge column

Construction of fire water reservoir tank underway on day of inspection. Pad footings on eastern side of building exposed during excavation.

Building engineer to confirm foundations have not been undermined.

| Item No. | Observation | Recommended Action Plan | Recommended Timeline |
|---|---|---|---|
| 3 | Foundations exposed during excavation for fire water reservoir tank | Building engineer to confirm foundations have not been undermined in the area identified . | 6-weeks |

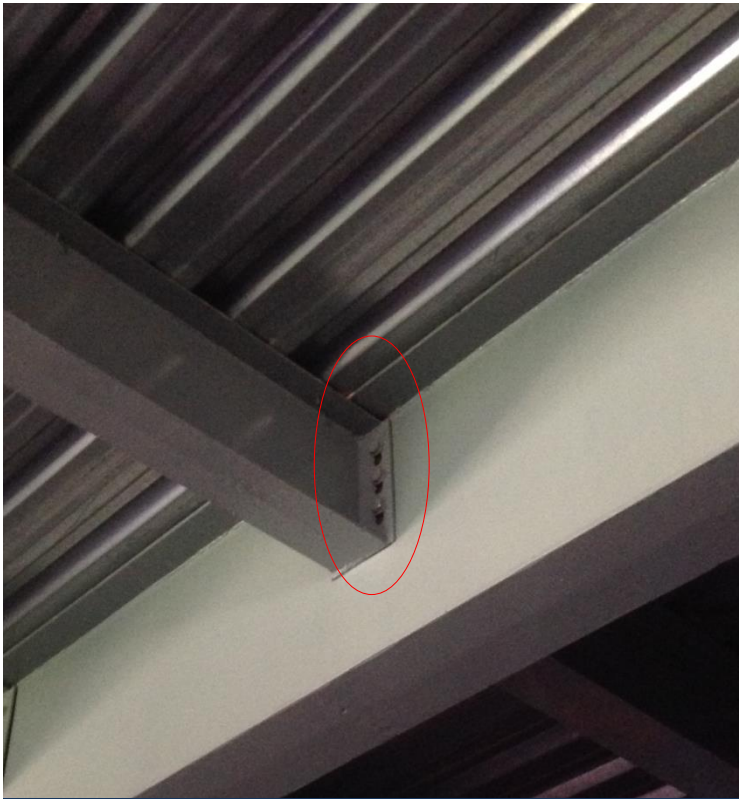
Slotted bolt holes

Some connections were observed to have been modified on site to facilitate frame erection. These modifications included vertical slotting of bolt holes to align beam sections. Building engineer to confirm that the residual connection capacities are sufficient to support loading. Missing nuts on holding down bolt arrangements were observed for some of the edge columns at ground floor level. All nuts are to be provided to all holding down bolt arrangements.

| Item No. | Observation | Recommended Action Plan | Recommended Timeline |
|---|---|---|---|
| 4 | Bolts missing & connections modified | Building engineer to survey all connections, identify those which are not as per design, check capacity and propose remedial action if required. | 6-weeks |

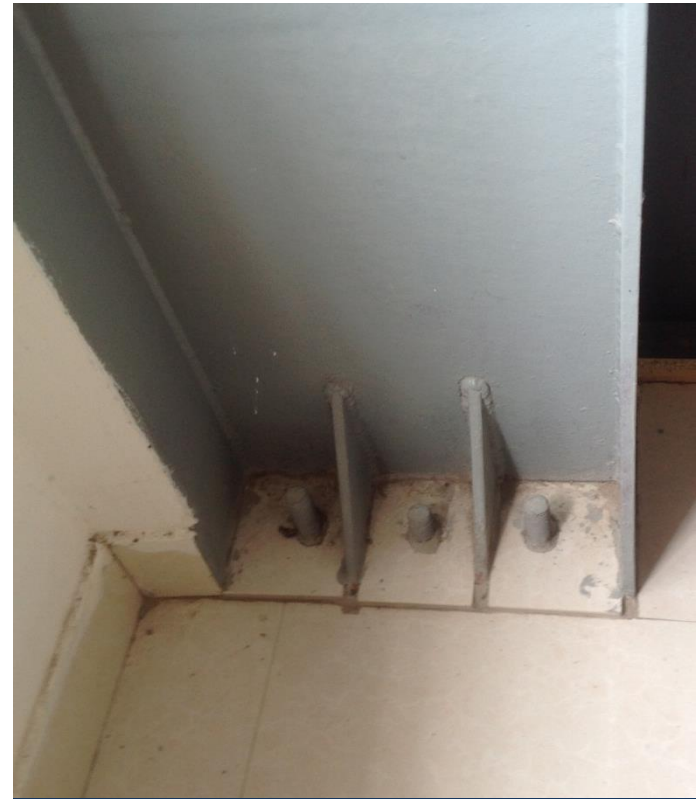
Holding down bolts missing nuts

| Item No. | Observation | Recommended Action Plan | Recommended Timeline |
|---|---|---|---|
| 5 | Bolts missing & connections modified | Nuts to be provided to all holding down bolts. | 6-weeks |

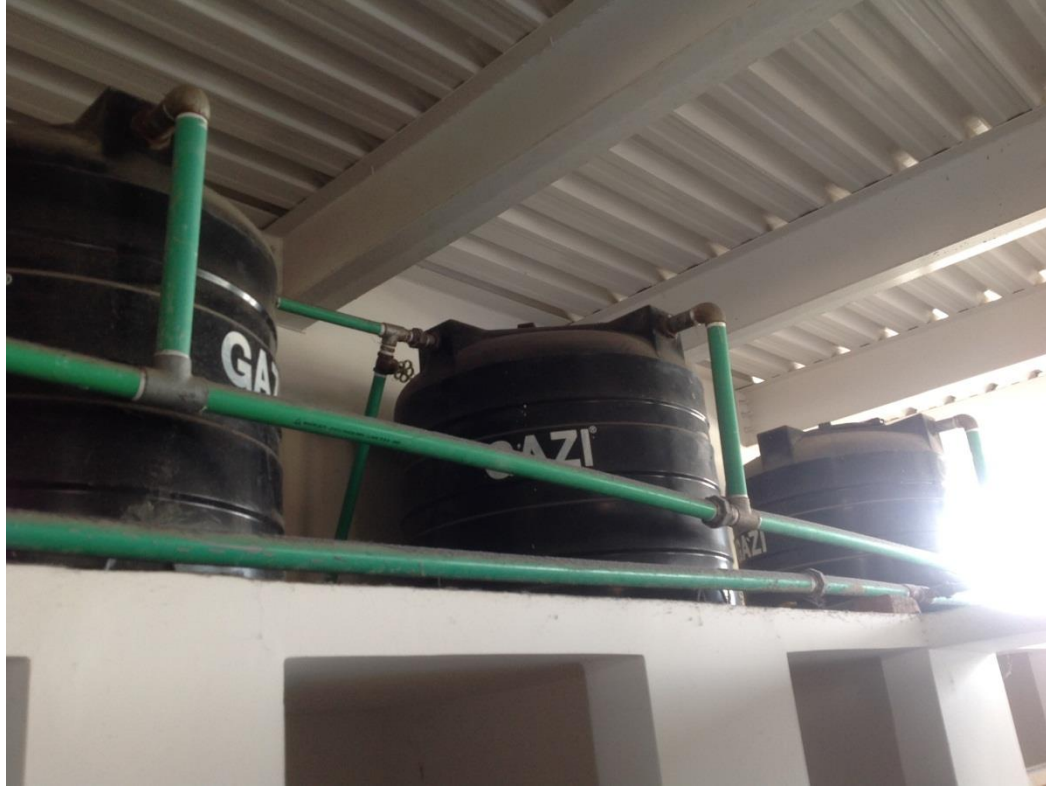
500lt water tanks over toilet ceiling

500lt plastic water tanks were observed over the toilet blocks on each floor. Some flexural cracking was observed in the soffit and face of the toilet block ceiling slab under these tanks. Building engineer to check structural capacity of toilet block to carry load and propose additional strengthening works if required. Building engineer also to confirm that the structure has been designed to support toilet buildup loads.

| Item No. | Observation | Recommended Action Plan | Recommended Timeline |
|---|---|---|---|
| 6 | Water tanks over toilet blocks on each floor | Building engineer to check structural capacity of toilet block to carry load and propose additional strengthening works if required. | 6-months |

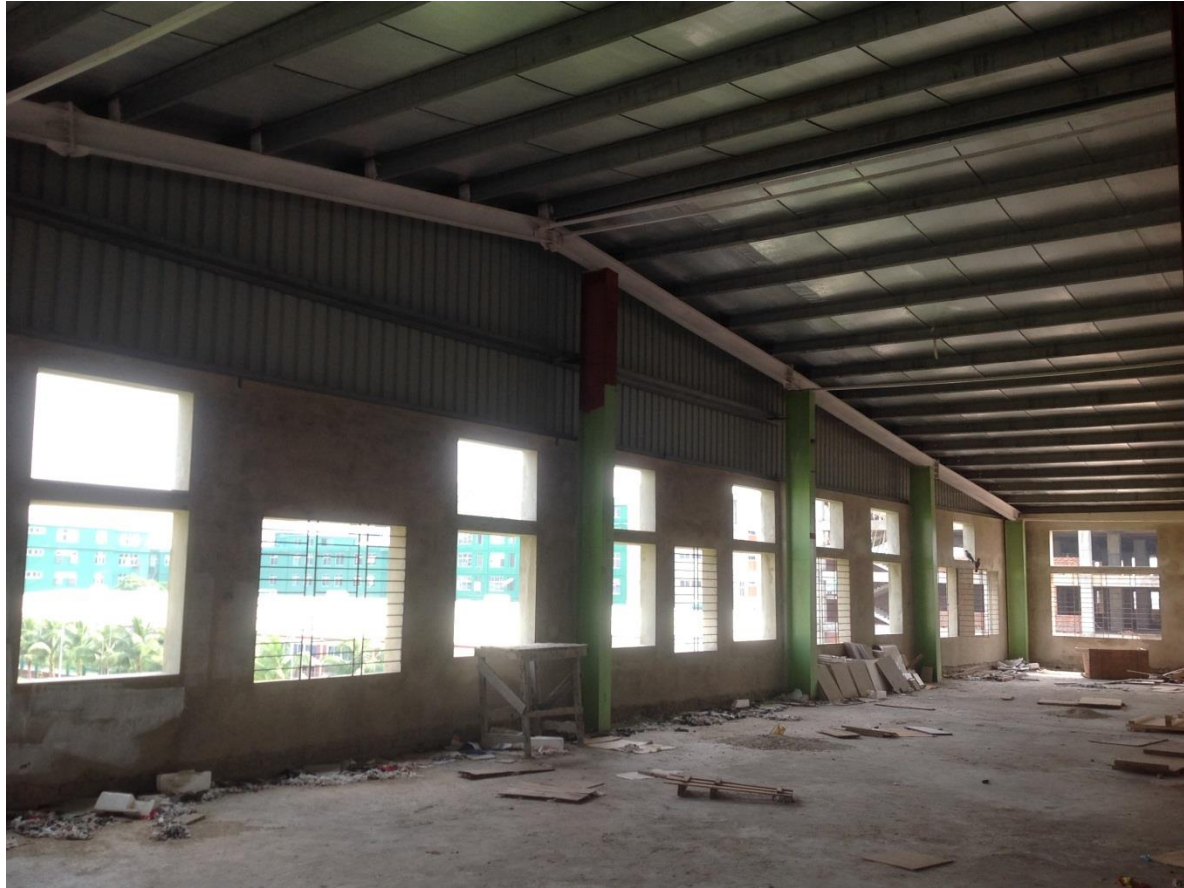
**No bracing to roof structure**

No apparent bracing system provided at roof level, stability system appears to be incomplete. Building engineer to carry out a stability analysis and provide additional bracing as required.

| Item No. | Observation | Recommended Action Plan | Recommended Timeline |
|---|---|---|---|
| 7 | No bracing to roof structure | Building engineer to carry out a stability analysis of roof structure and provide additional bracing as required. | 6-months |

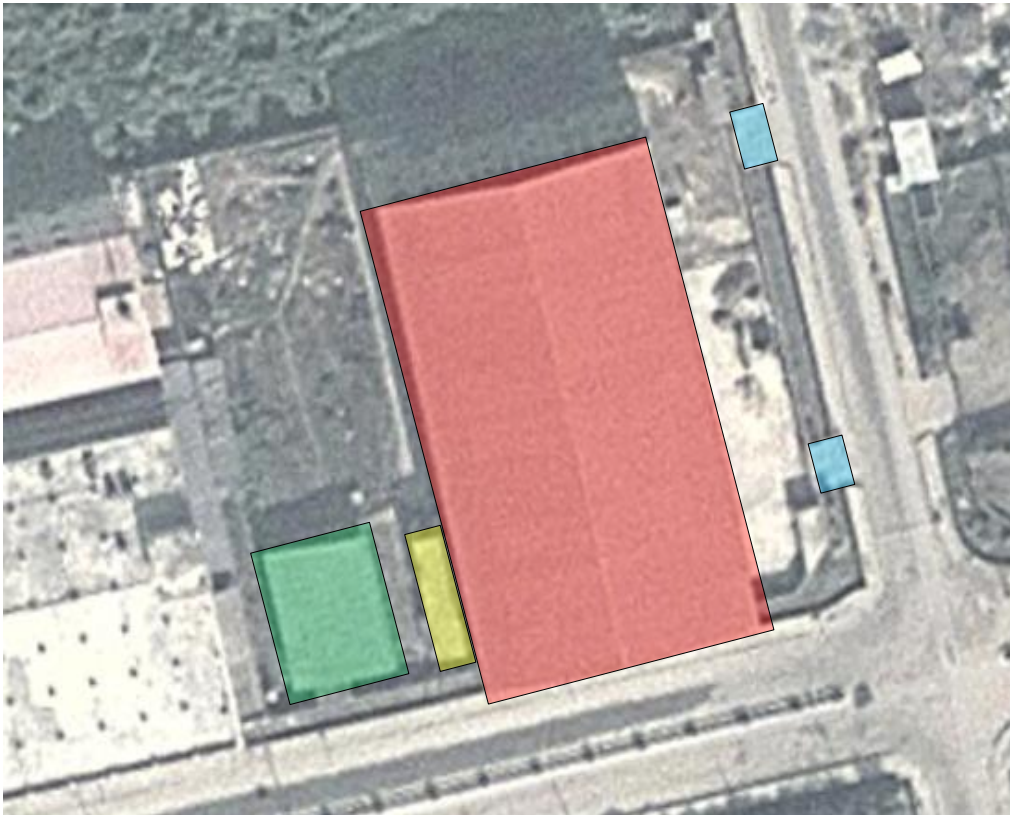
Site Layout

No drawings or documentation provided for dining shed, guard buildings , boiler and compressor rooms.

| Item No. | Observation | Recommended Action Plan | Recommended Timeline |
|---|---|---|---|
| 8 | No drawings or documentation provided for ancillary structures | Building engineer to update site layout plans including all structures in the factory compound. Design checks to be carried out for each of the structures. | 6-months |
