# Dynasty Sweaters (BD) Ltd Dynasty Knit Fashion Ltd

Aukpara, Ashulia, Savar, Dhaka  
(23.878640, 90.297237)  
16th March 2014

# Observations

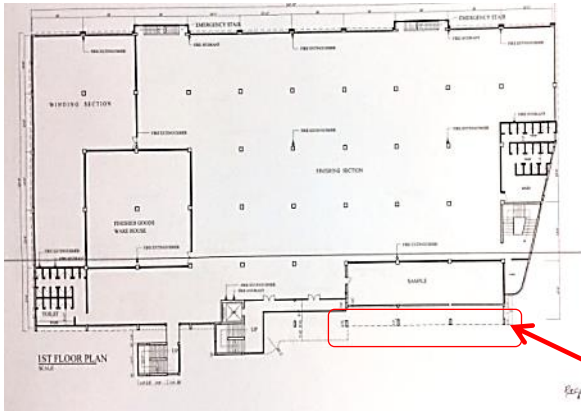
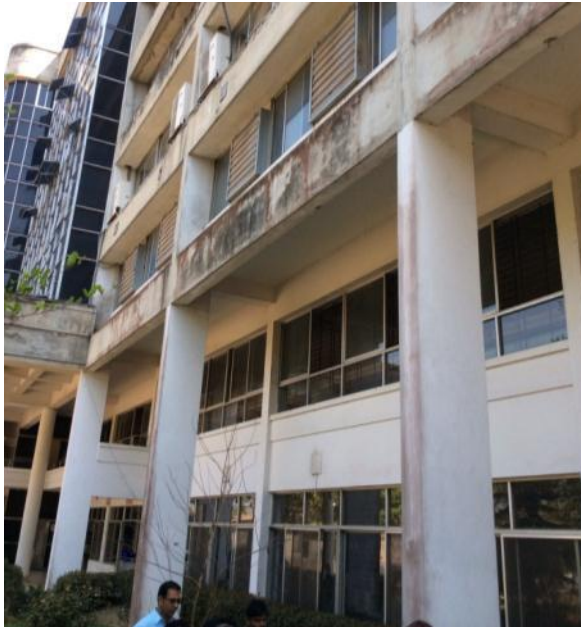
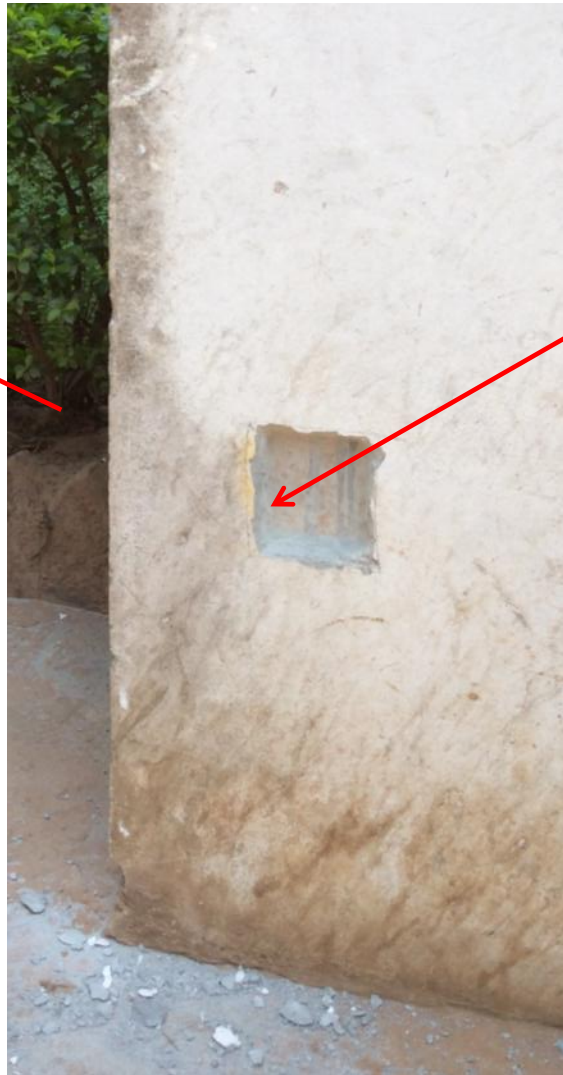
4 (Ground Floor, Grid F1 to J1)

# Slender columns at front of building

Engineering drawing showed column as 300mm wide.

Removal of render suggests as built column of 255mm wide.

- Building Engineer to investigate extent of large stone in column cover zone. Remove render/ concrete in location of crack and repair as advised by Engineer.
- Confirm actual column dimensions by removal of render locally on all faces.
- Measure verticality of all columns double storey columns.
- Building Engineer to commence checking design of all double storey height columns taking account of verticality, actual dimensions, reinforcement and loads.

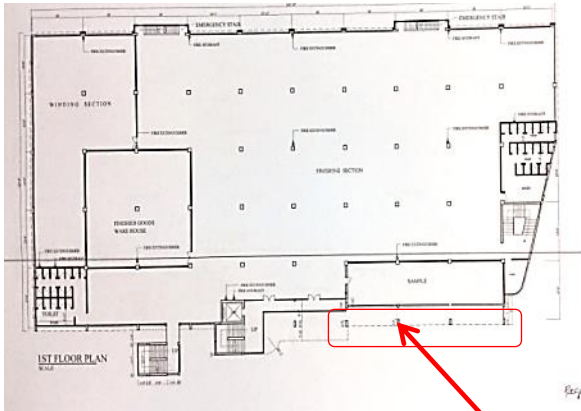
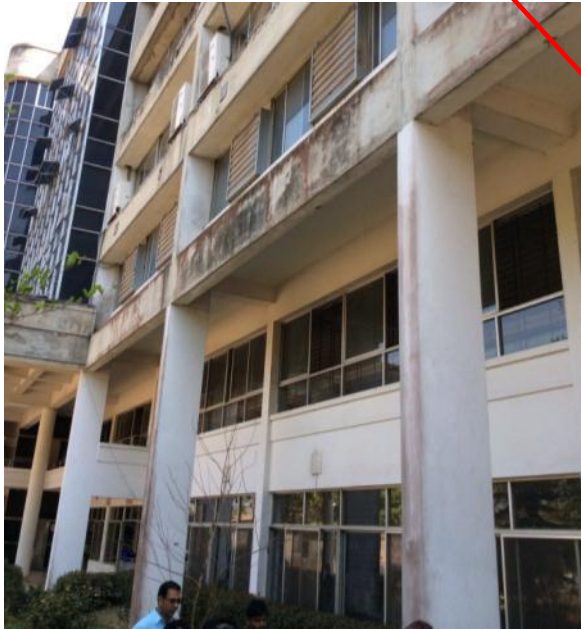
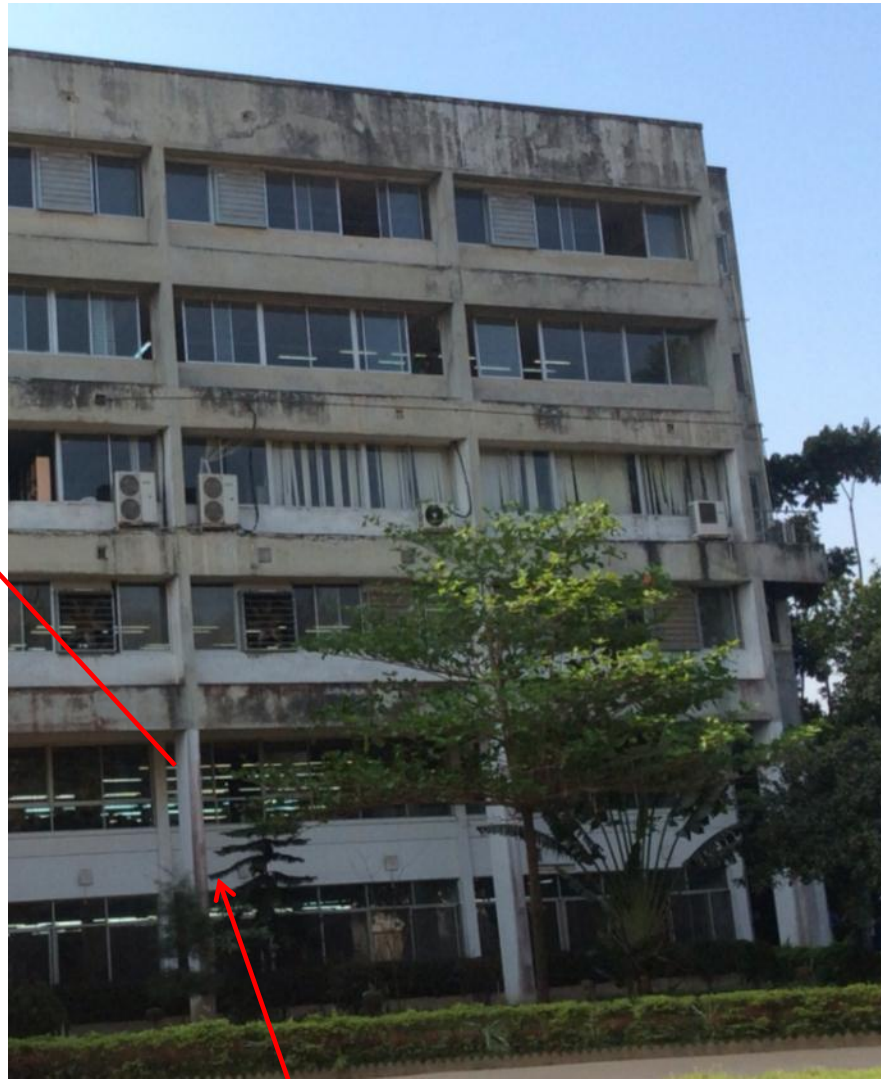
5 (Ground Floor, Grid F1 to J1)

Edge column:  
Apparent lack of verticality

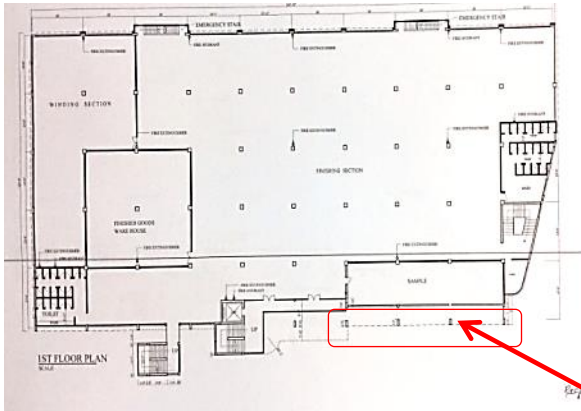
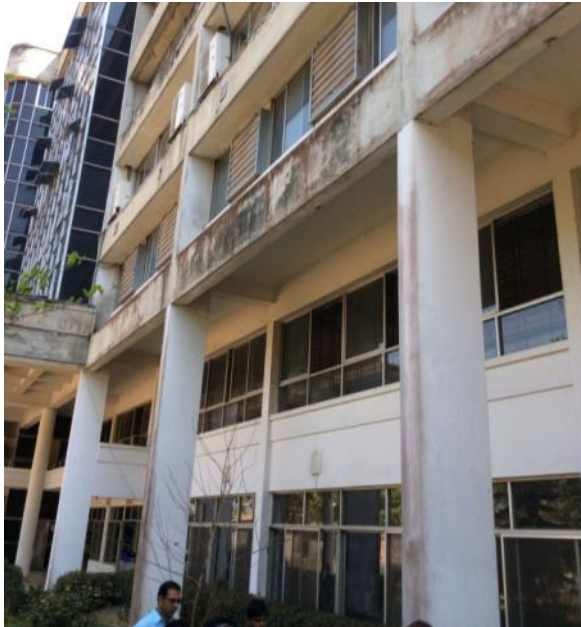
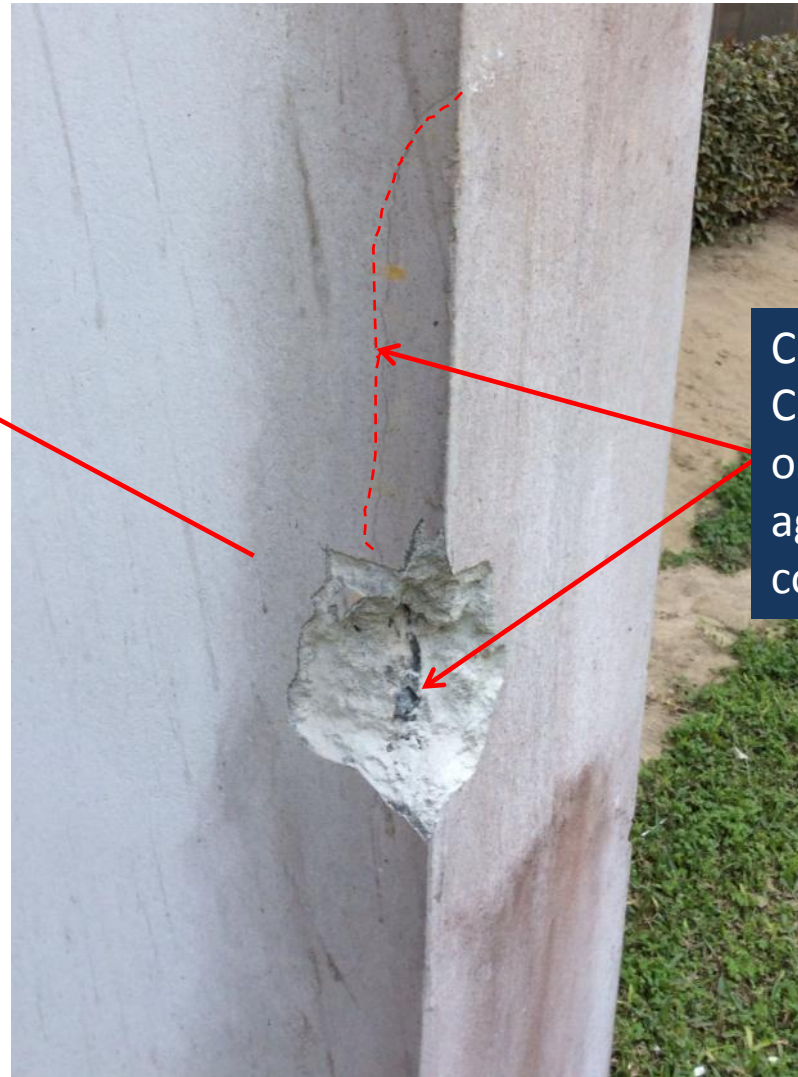
6 (Ground Floor, Grid F1 to J1)

Crack in render.  
Closer inspection  
observed large  
aggregate and poor  
concrete.

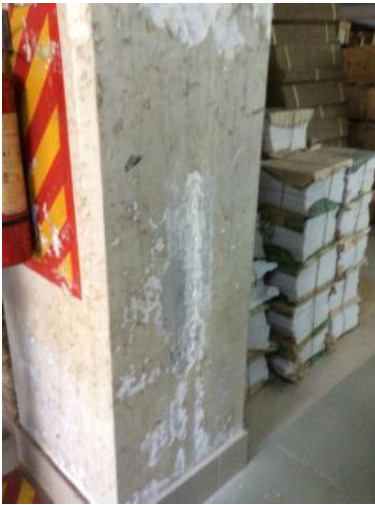
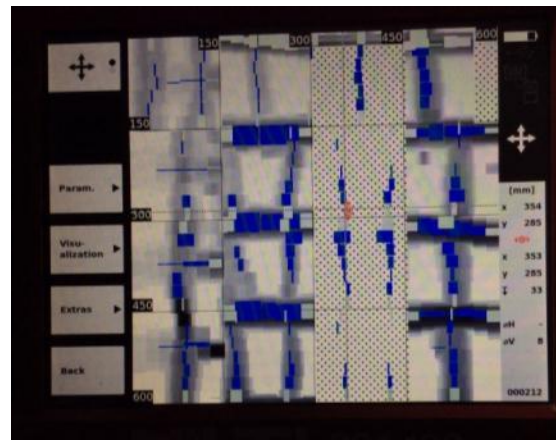
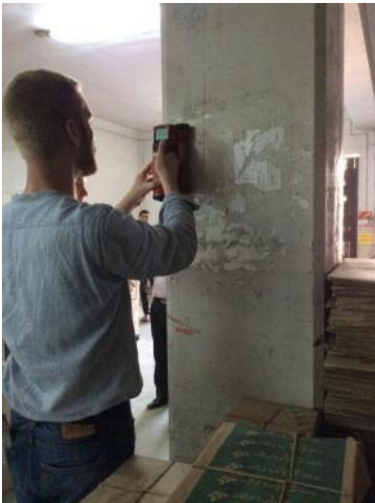
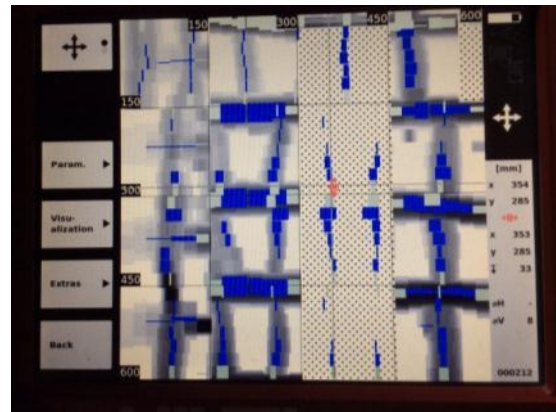
Ferroskans indicate 6 bars in each face, i.e 22 in total

Columns are highly stressed. Engineering drawings show stone aggregate and a high % of reinforcement.

Stone aggregate was confirmed during visit.

No cylinder strength results from construction were available to verify the concrete strength.

The high density of reinforcement could not be conclusively confirmed by the ferroskaner.

- **Create controlled loading plans for all floors**, designating where storage can be placed and can not be placed.
- **Provide calculations showing the structural adequacy of all columns**, taking into account the loading plans and all built structure including additions beyond the original design. Provide concrete strength tests.

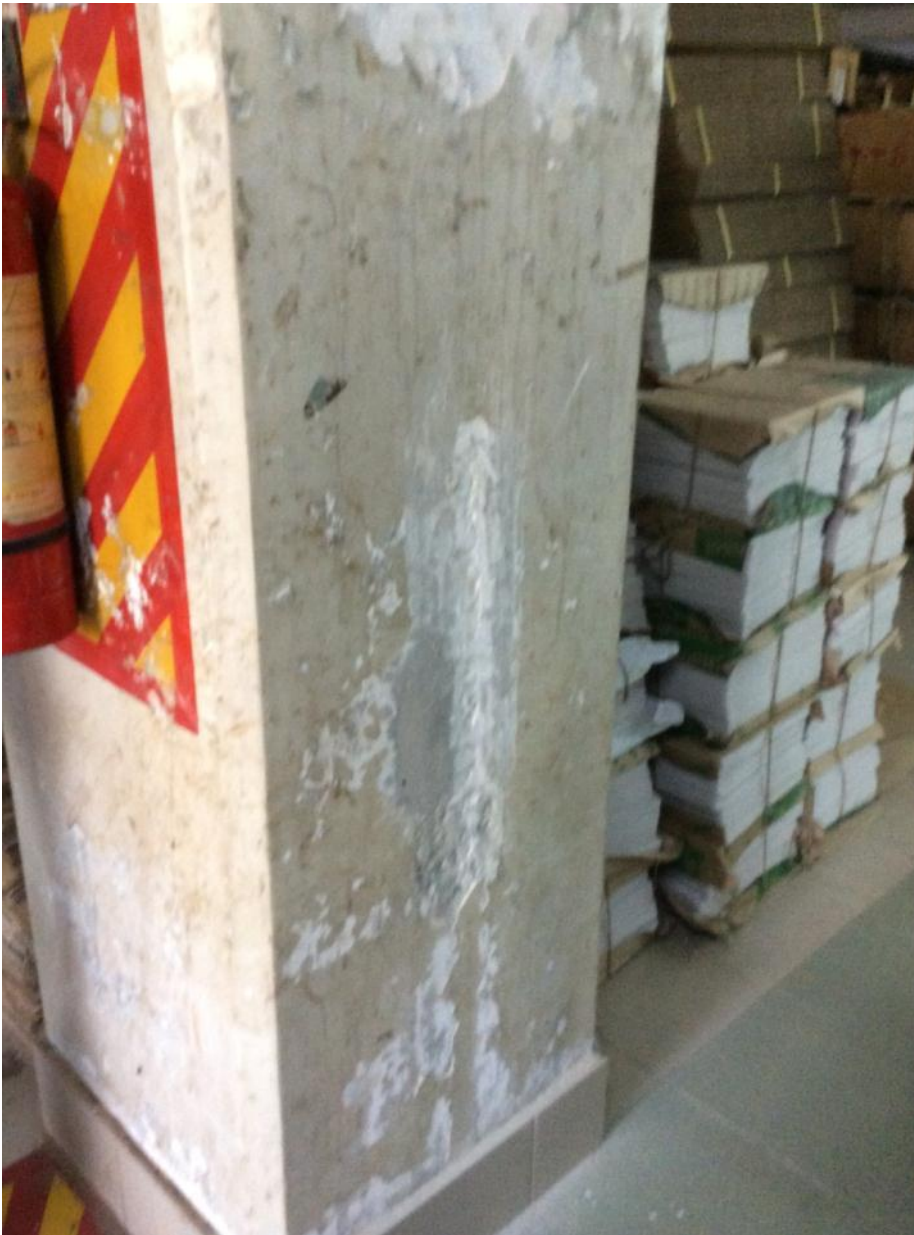
Columns are highly stressed. Engineering drawings show stone aggregate and a high % of reinforcement.

Stone aggregate was confirmed during visit.

No cylinder strength results from construction were available to verify the concrete strength.

The high density of reinforcement could not be conclusively confirmed by the ferros scanner.

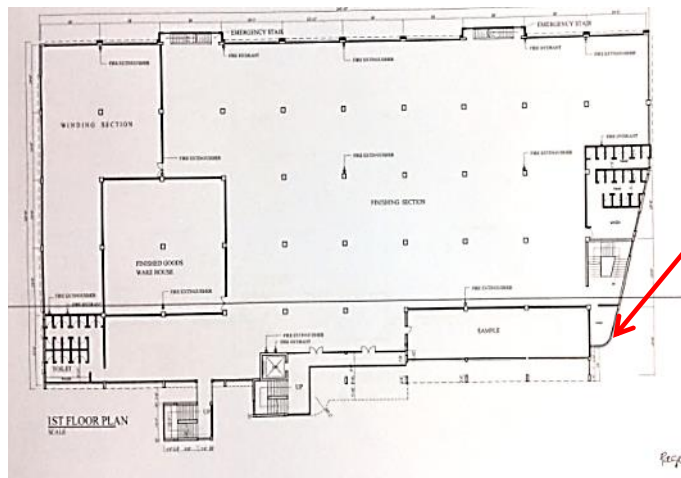
**Corner column not shown on engineering drawing. Connection to slab and foundation size unknown  
(Ground Floor, Grid J'1)**

Corner Column (Grid J'1) is not shown in the drawings

Column was not shown on engineering drawings.

Connection to upper beam/slab and foundation unknown.

Cracking in the brick walls supported by the slab was consistent with cantilevering deflections and therefore the effectiveness of the column is unclear.

Column is also in loading bay so is at risk of vehicle impact.

- Building engineer to produce as-built information for column confirming connection to slab over and foundation detail.

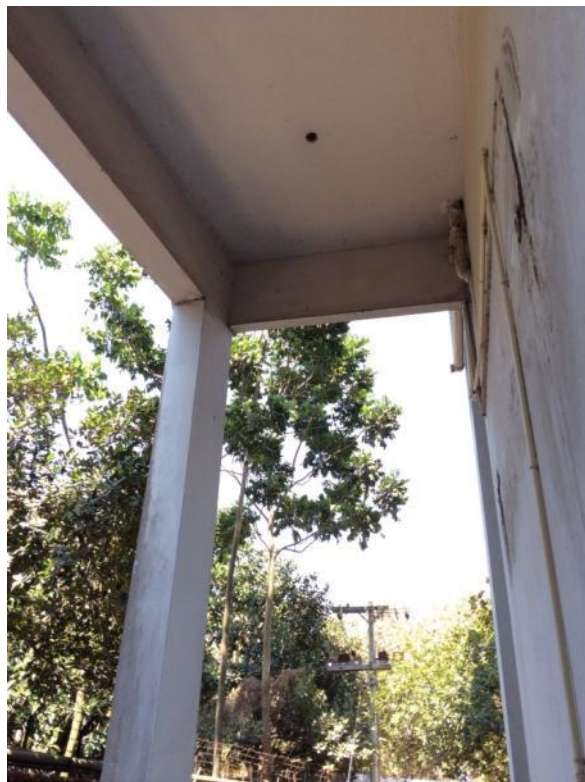
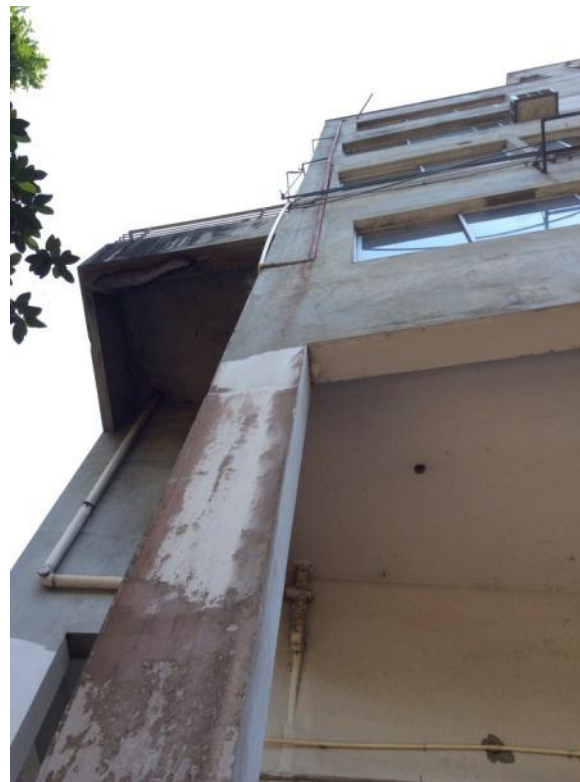
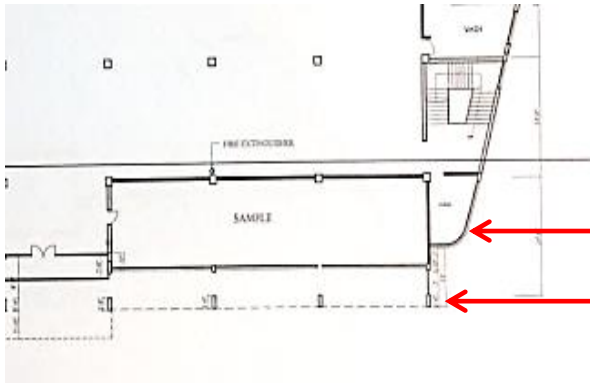
**Lack of protection of vehicle impact  
to corner column  
(Ground Floor, Grid J1 and J'1)**

Risk of accidental damage due to vehicle impact.

Edge protection in form of a side barriere required

- Provide protection to columns against impact from vehicles.

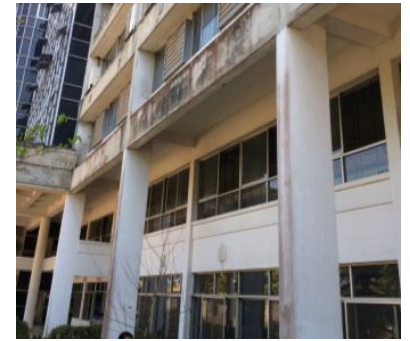
Slender columns at front of building. Removing render showed column to be narrower than shown on Engineering drawing. Column does not appear vertical.

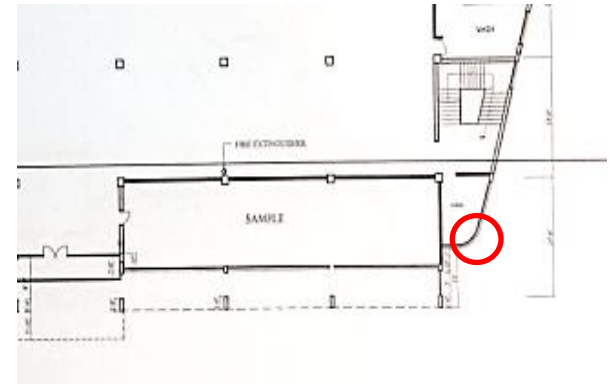
Corner column not shown on Engineering drawing.  
Connection to slab and foundation size unknown

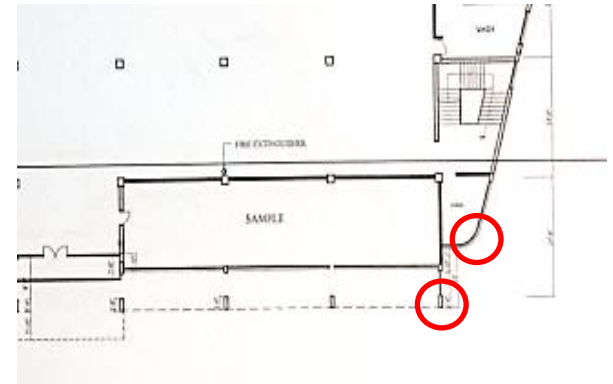
Lack of protection to corner columns against vehicle Impact - (Ground Floor, Grid J1 and J'1)
