# Ashique Dress Design Ltd Ashique Jeans Apparels Ltd Nice Apparels Ind. Ltd.

43 Chalabon, Ashique Complex, Azampur, Uttara, Dhaka  
(23.86794, 90.41752)

30<sup>th</sup> March 2014

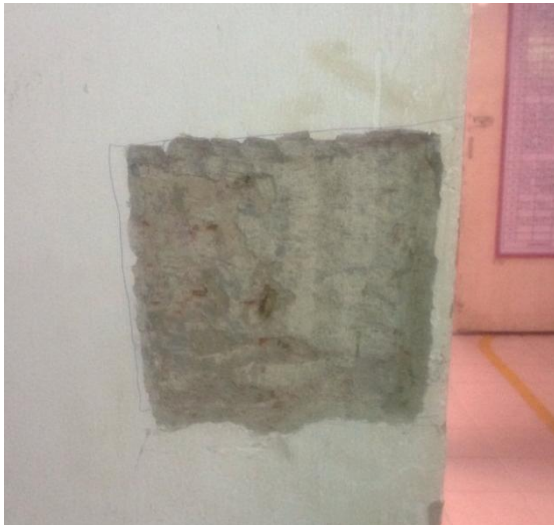
Outline calculations indicate that the working stress of columns at Ground Floor level are at levels that require immediate action. Refer to Action 1.

Tested Ground Floor Column C4 in the Ten Storey Building.

Stone aggregate was noted in the columns.

| Item No. | Observation | Recommended Action Plan | Recommended Timeline |
|---|---|---|---|
| 1 | Columns appear to be stressed to levels that require immediate action. | Floors 9,8,7,6 and 5 are to be closed immediately with all equipment and storage loading also removed immediately pending verification of the column capacities by the Building Engineer | Immediate - Now |
| 3 | Columns appear to be stressed to levels that require immediate action. | Verify insitu concrete strengths either by 100mm diameter cores or existing cylinder strength data for cores from a minimum of 4 columns | Immediate - Now |

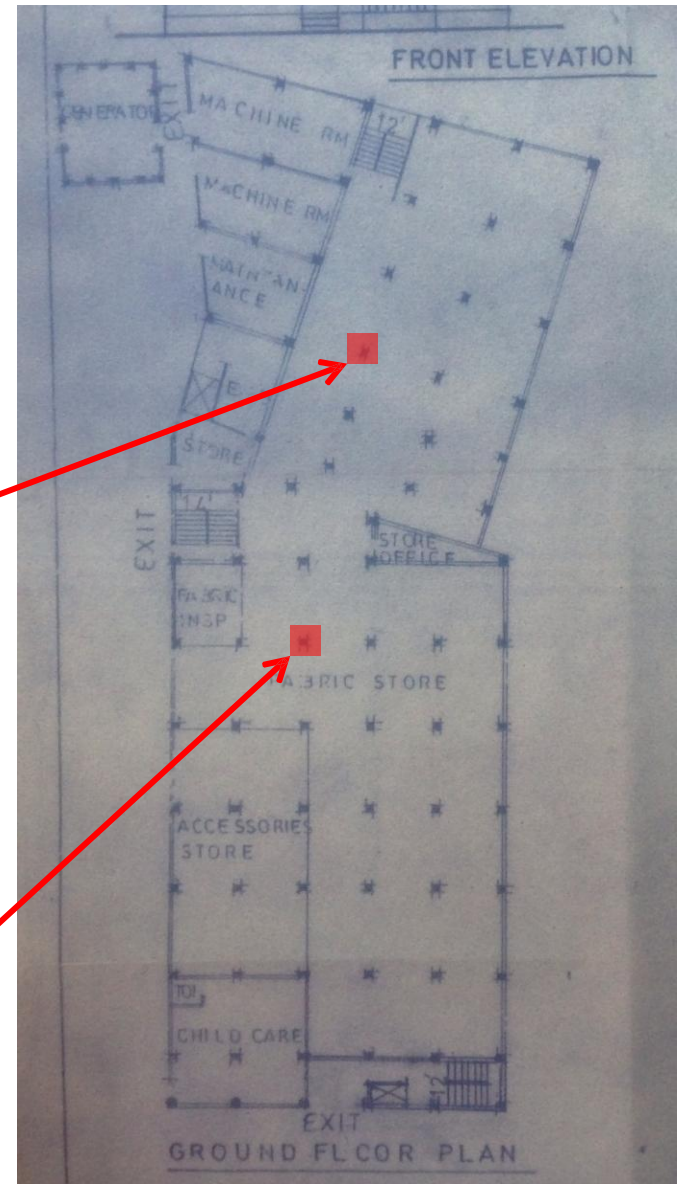
Tested Ground Floor Column C2 in the Eight Storey Building.

Brick aggregate was noted in the columns.

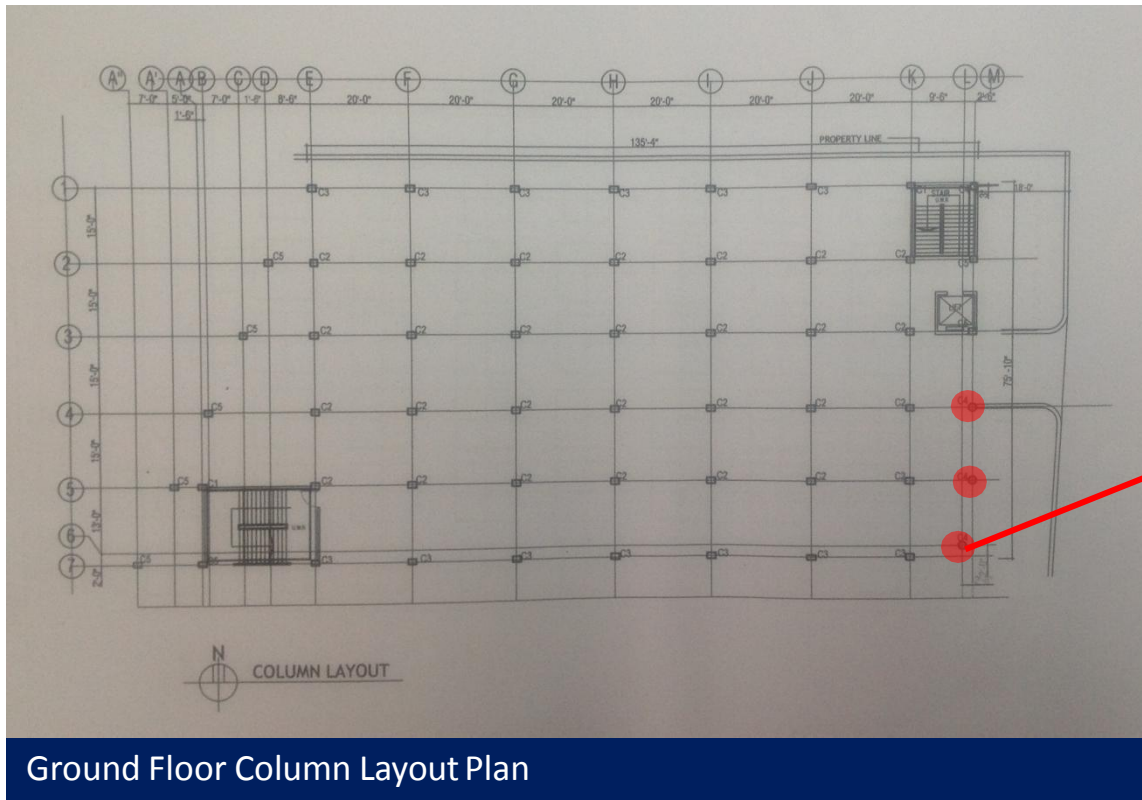
Two-Storey Ground Floor Columns at Risk from Impact

3 no. two-storey columns to the Main East elevation of the building, adjacent to the delivery entrance, are at risk of being accidentally struck by a vehicle. Column protection barriers need to be provided. Also Building Engineer to investigate the robustness of the connection of these columns to the main structure.

| Item No. | Observation | Recommended Action Plan | Recommended Timeline |
|---|---|---|---|
| 8 | The feature columns adjacent to the entrance and car parking area are at risk of being accidentally struck by a vehicle. The robustness of the connection of these columns to the main structure also needs investigation | Building Engineer to check that the columns have been adequately designed for impact loading | 6-weeks |
| 9 | The feature columns adjacent to the entrance and car parking area are at risk of being accidentally struck by a vehicle. The robustness of the connection of these columns to the main structure also needs investigation | Suitable column protection barriers to be designed and constructed | 6-weeks |
| 10 | The feature columns adjacent to the entrance and car parking area are at risk of being accidentally struck by a vehicle. The robustness of the connection of these columns to the main structure also needs investigation | Robustness of connection from columns to building to be investigated and strengthened | 6-weeks |

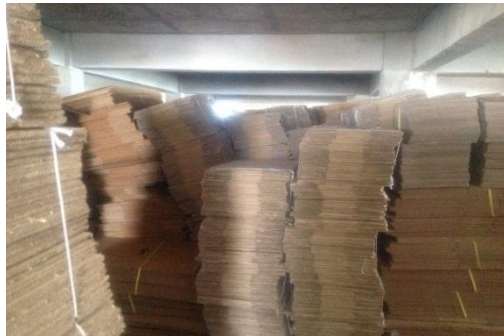
9th Floor - Folded Cardboard

There are large amounts of storage in the Ten Storey building, particularly in the South-West Corner, as indicated.

Building Engineer to check that the beams and slabs have been adequately designed to carry the associated loading.

| Item No. | Observation | Recommended Action Plan | Recommended Timeline |
|---|---|---|---|
| 11 | Design Check required for the storage areas, particularly to the South-West corner of the building, to confirm the capacity of the floor structure | Locations of loading noted to be surveyed and capacity of floor structure to be assessed by the Building Engineer to confirm that the floor structure is designed to carry these loads | 6-weeks |

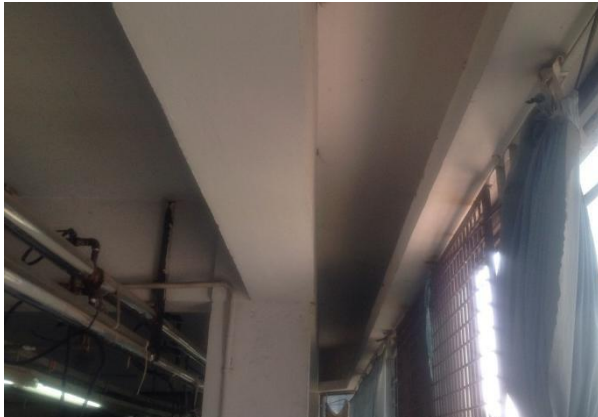
Cantilevering slab to East elevation

In the ten storey building, the slabs cantilever from First Floor level up on the East elevation, and from Seventh Floor level to the North elevation. There are no downstand beams supporting the cantilevering slab. Building Engineer to check that all the floor cantilevers at the suspended floor levels have the capacity to support the floor and façade loading.

| Item No. | Observation | Recommended Action Plan | Recommended Timeline |
|---|---|---|---|
| 14 | Design check required for the floor cantilevers at the suspended floor levels to confirm their load capacity to support floor and façade loading | Building Engineer to confirm the capacity of the slab to support the combination of the floor loading and the façade loading. | 6-months |

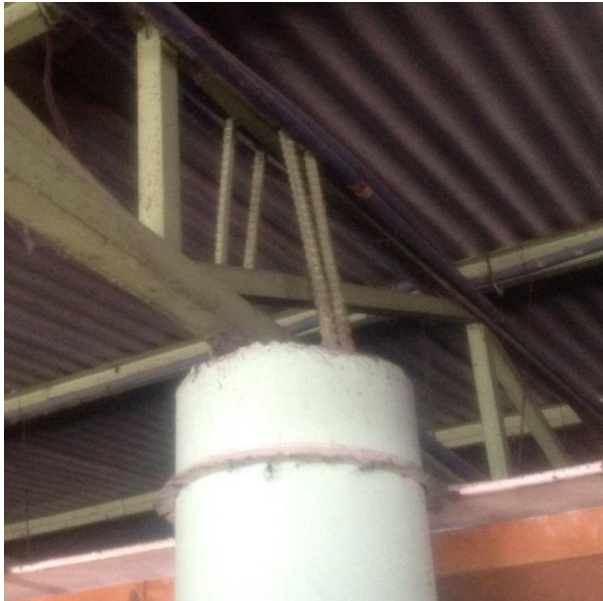
Steel Roof Column Connection

A design check is required for the light-weight steel roof structures to the nine-storey building dining area and to the ancillary buildings to the South of the Main Building to confirm that they are adequate to resist wind loading. Particular emphasis is required on a section of the steel roof above the dining area which appears unstable. Building Engineer to implement any upgrade works to these structures as required.

| Item No. | Observation | Recommended Action Plan | Recommended Timeline |
|---|---|---|---|
| 15 | Design Check required for the light-weight steel roof structures to the 9-storey building dining area and the ancillary buildings as indicated | Building Engineer to provide detailed calculations for the noted structures and the associated light steel roofs. These should confirm their ability to withstand all wind loading pressure, suctions and uplift forces | 6-months |

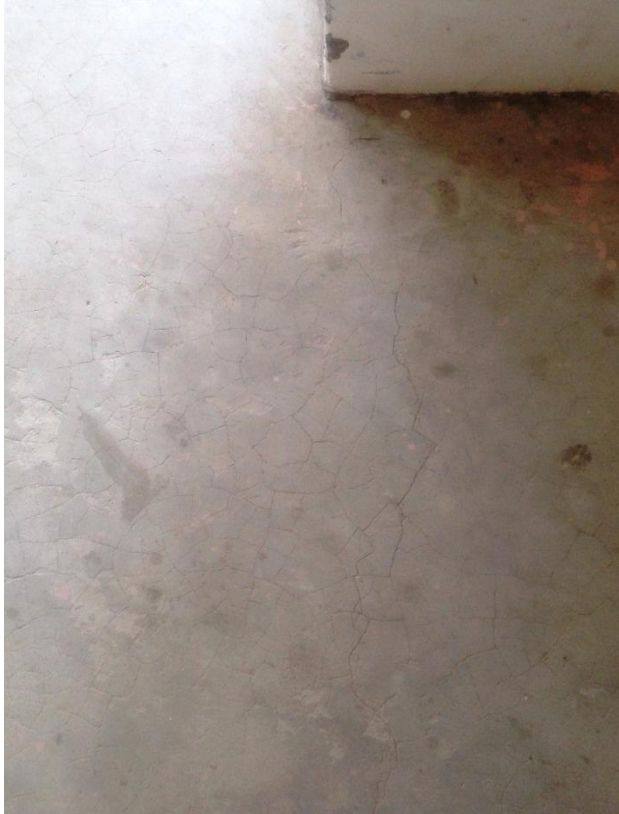
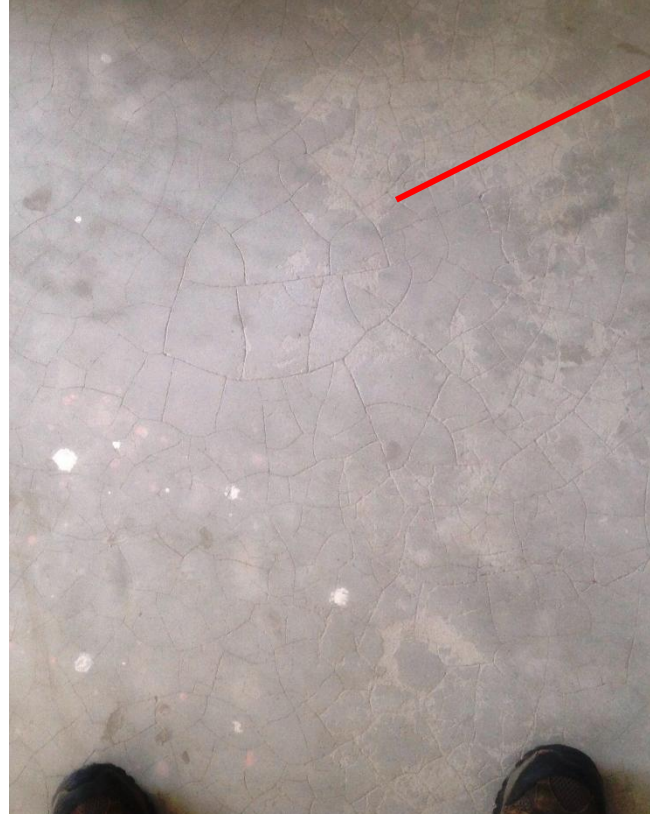
Local Cracking to 8<sup>th</sup> Floor Slab

There is evidence of local cracking to the Eighth Floor slab in the South-West corner of the building.

Building Engineer to investigate and carry out remedial works to the structure as required.

| Item No. | Observation | Recommended Action Plan | Recommended Timeline |
|---|---|---|---|
| 16 | Building Engineer to investigate the cause of the local cracking to the 8th floor level slab in the South-West corner, and to areas of the façade | Building Engineer to investigate the cause of the cracking and implement any remedial measures deemed necessary | 6-months |

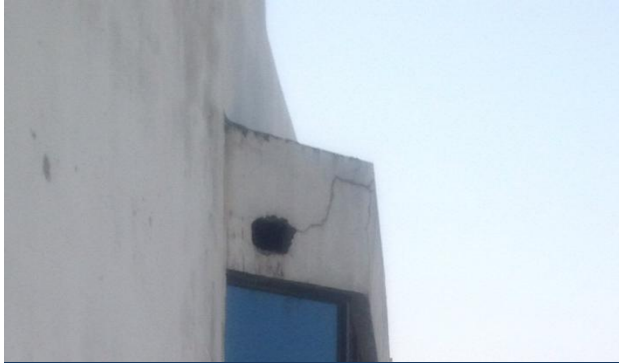
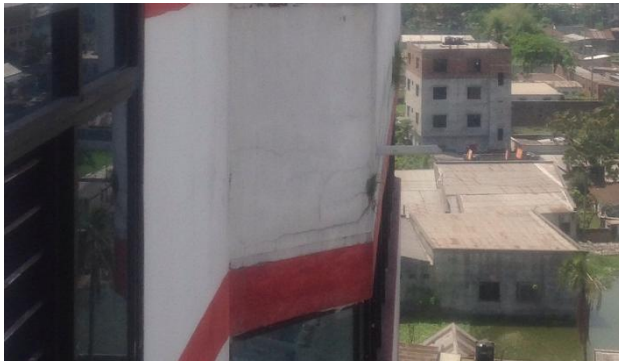
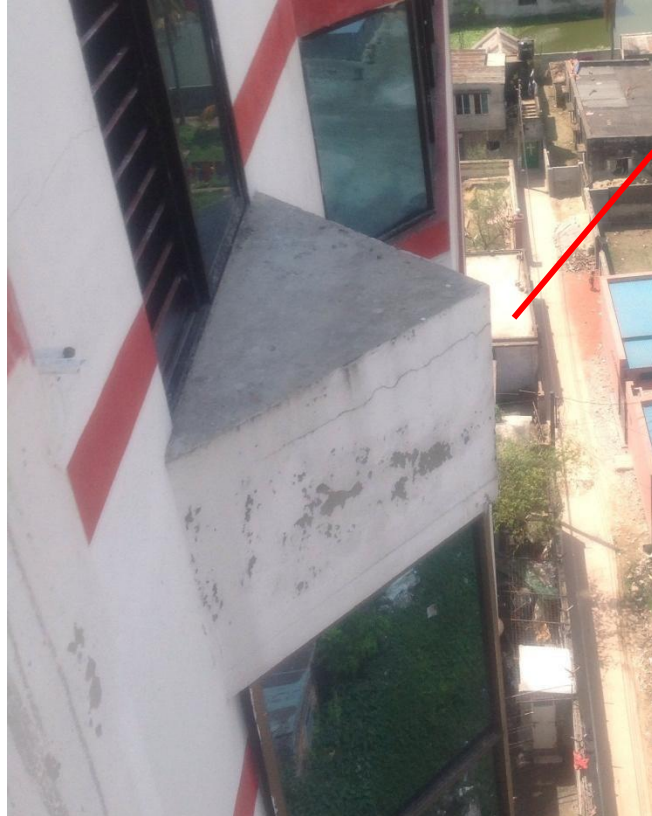
Local Cracking to Façade

There is evidence of local cracking to the façade to the East Elevation of the building.

Building Engineer to investigate and carry out remedial works to the façade as required.

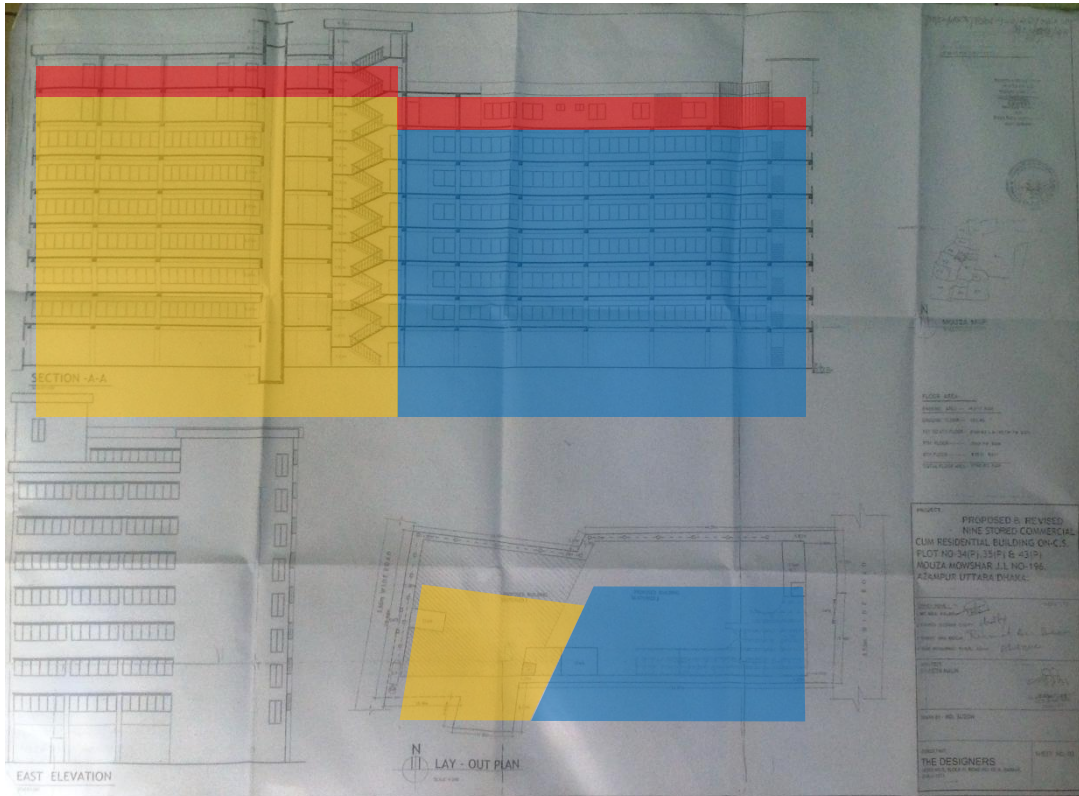
Original Rajuk-Approved Building Permit

There are inconsistencies between the original building permit and the built structure. An additional floor has been included on each structure - the main build consists of a ten-storey building (1999-2004) and a nine-storey building (1998-2001), whereas the original Rajuk-approved building permit (1999) calls up a nine-storey building and an eight-storey building, respectively. Building Engineer to clarify.

| Item No. | Observation | Recommended Action Plan | Recommended Timeline |
|---|---|---|---|
| 17 | Inconsistencies in the Permit and Structural drawings presented | Building engineer to check, collect information and produce accurate and fully complete as-built documentation | 6-weeks |

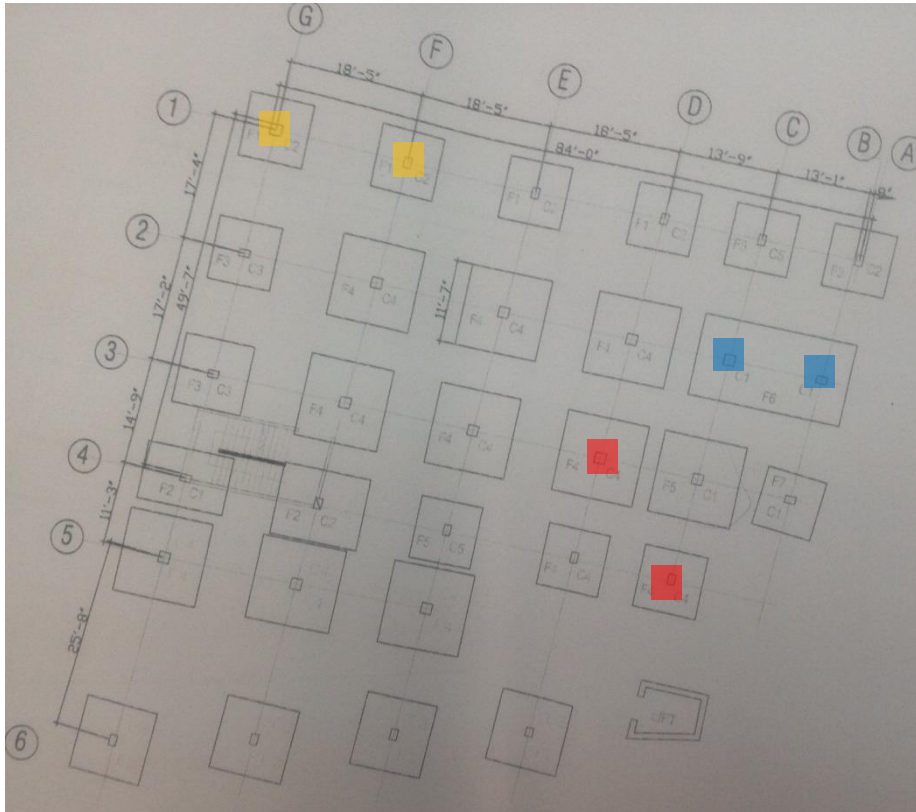
The structural drawings do not match the current arrangement of the building, and there are inaccuracies in the drawings. Building engineer to check, collect information and produce accurate and complete as-built documentation.

Inaccuracy in 10-storey building drawings:  
The shape of the C1 (blue), C2 (yellow) and C4 (red) columns are shown up as both square and rectangular in the structural drawings, as indicated.

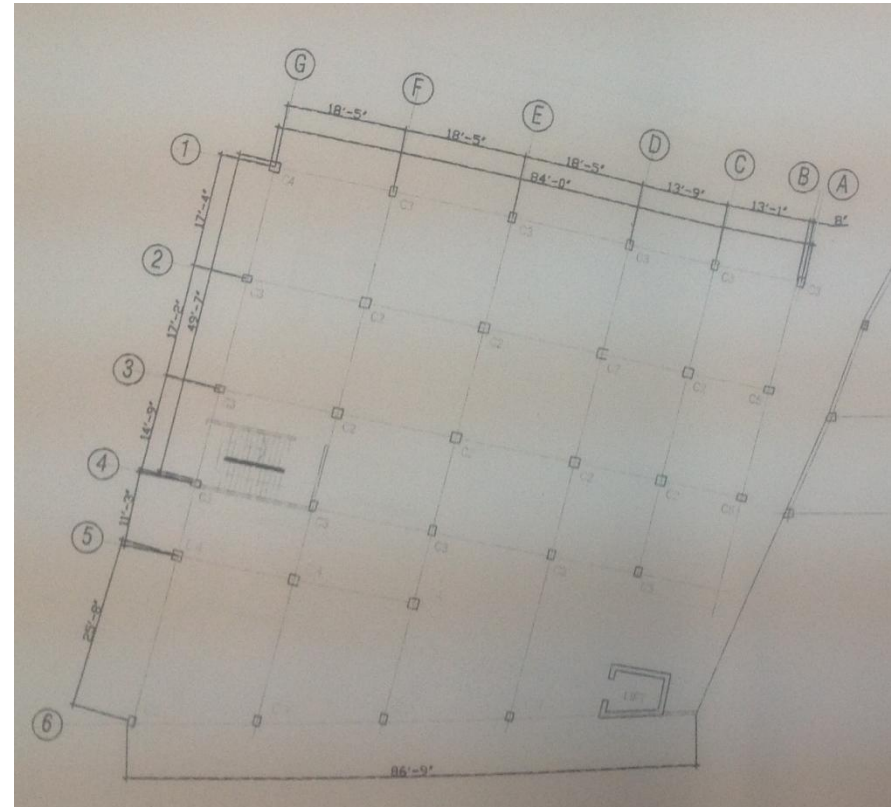
Inaccuracy in 10-storey building drawings:  
The column sizes shown on the Footing Layout Drawing (left) and the Column Layout Drawing (right) do not match.
