# Crown Fashion & Sweater Ind. Ltd. Crown Knitwear Ltd. (Building 3)

Plot 781/782, Vogra, Joydevpur, Gazipur.  
(23.982841, 90.38177)  
02 April 2014

# Observations

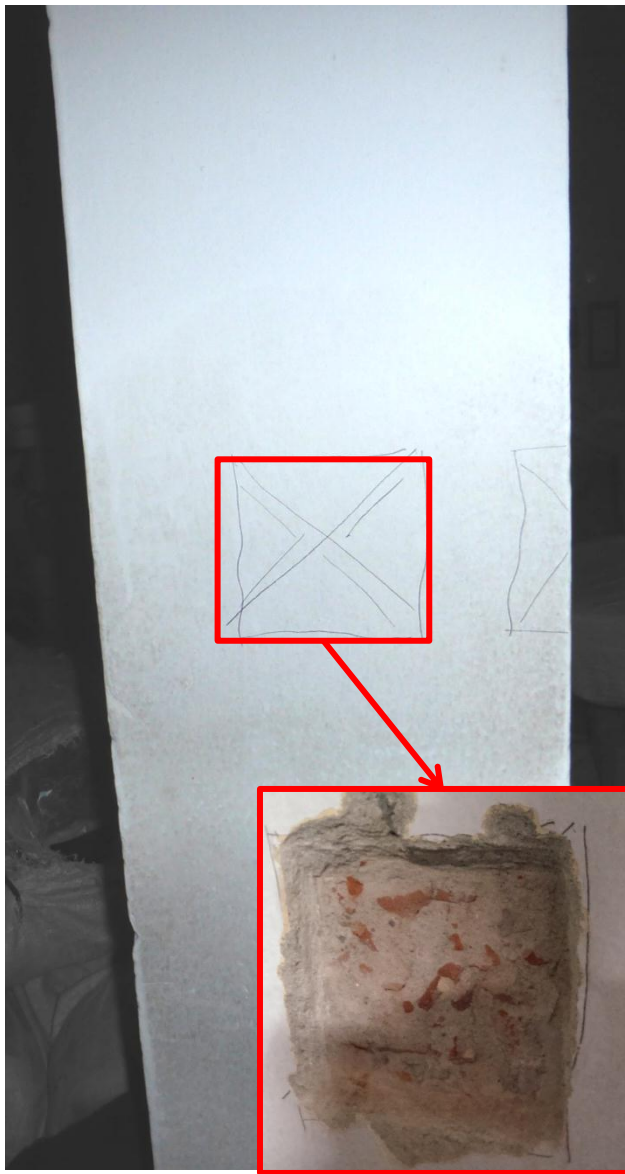
# High Stress in Columns

**Tested column  
at ground level.  
Brick aggregate  
observed.**

Preliminary calculations indicate that some internal and external column working stresses are at a high level.

Scanned reinforcement observed to be less than specified on the engineering drawings.

A Detailed Engineering Assessment is required (see attached Scope) along with Buildings 1, 2 & 4 as outlined in previous report.

Engineer is to perform detailed calculations based on as-constructed dimensions and concrete tests to prove column size is adequate.

Item No.	Observation	Recommended Action Plan	Recommended Timeline
1	High Stress in Columns	Maintain current use of the floors in each building and do not change use or increase occupation, either of which could increase loading	<b>Immediate - Now</b>
2	High Stress in Columns	Building Engineer to review design, loads and stresses in all columns	<b>Immediate - Now</b>
3	High Stress in Columns	<b>A Detail Engineering Assessment of Factory to be commenced, see attached Scope</b>	<b>Immediate - Now</b>
4	High Stress in Columns	Produce and actively manage a loading plan for all floor plates within the factory giving consideration to floor capacity and column capacity. Loading plans to be put on each factory floor	<b>6-weeks</b>
5	High Stress in Columns	Detail Engineering Assessment to be completed	<b>6-weeks</b>
6	High Stress in Columns	Verify in-situ concrete strengths either by 100mm diameter cores or existing cylinder strength data for cores from minimum 4 no. columns	<b>6-weeks</b>

7	High Stress in Columns	Continue to implement load plan	<b>6-months</b>
8	High Stress in Columns	Implement strengthening measures where required	<b>6-months</b>

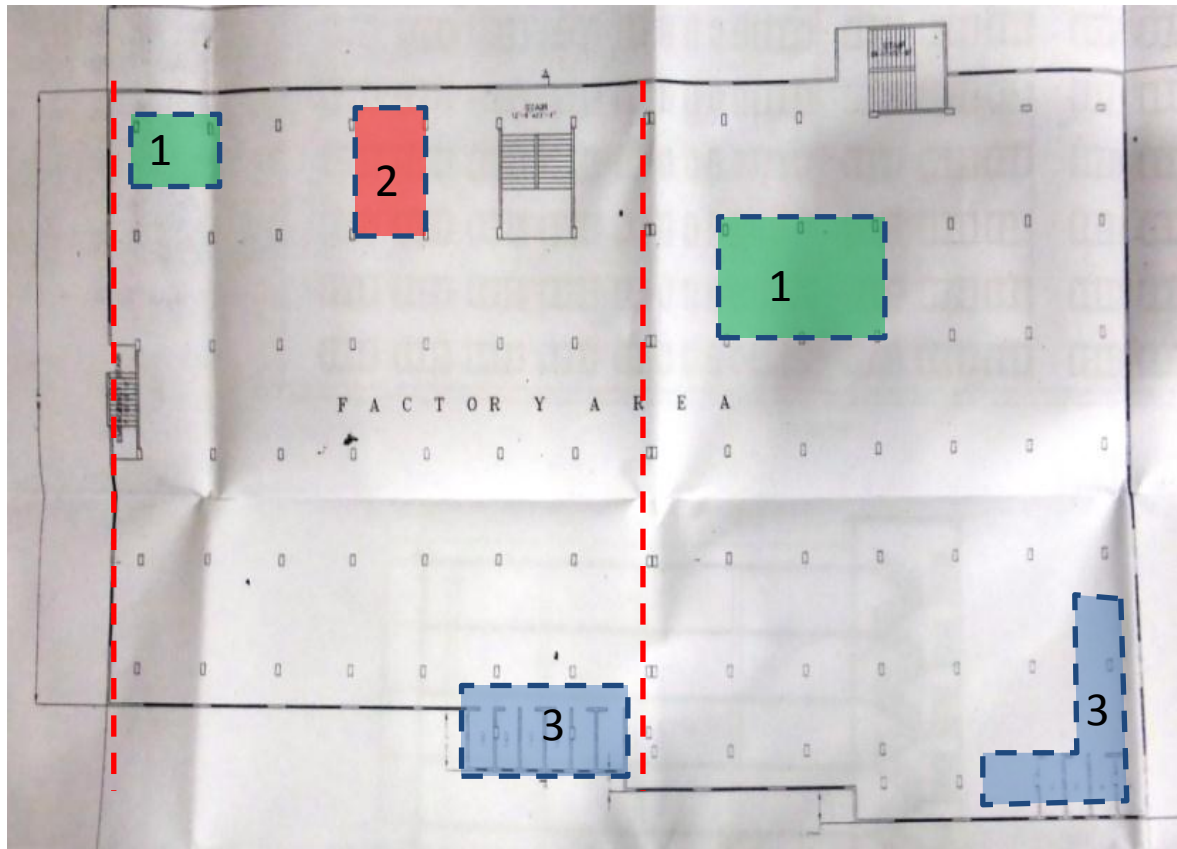
**Local areas of high loading**

Areas were observed with higher than typical loading in the building, including:

1. Water tanks at roof level
2. Storage loading
3. Increased build-ups in toilet blocks at all levels

Storage loading and increased build-ups were observed in a number of other areas, including storage of brick aggregate at roof level.

Item No.	Observation	Recommended Action Plan	Recommended Timeline
9	Localised areas of high loading in buildings	<b>Detail Engineering Assessment to be completed as per Item 1</b>	<b>6-weeks</b>
10	Localised areas of high loading in buildings	Extent of build-up loading in toilet and wash areas to be surveyed and weight of water tanks on roof to be assessed. The capacity of floor & roof slabs to be assessed to confirm if the structure is designed to carry these loads.	<b>6-weeks</b>
11	Localised areas of high loading in buildings	Implement strengthening measures if required	<b>6-months</b>
12	Localised areas of high loading in buildings	Continue to implement load plan as per item 1	<b>6-months</b>
13	Cracks above surface of slabs in a number of locations	As part of Detail Engineering Assessment required under Item 1, confirm if the slabs have sufficient capacity to support applied loading. If cracking continues through to the structural slab, confirm if the cracks are within acceptable limits for normal structural behaviour.	<b>6-weeks</b>

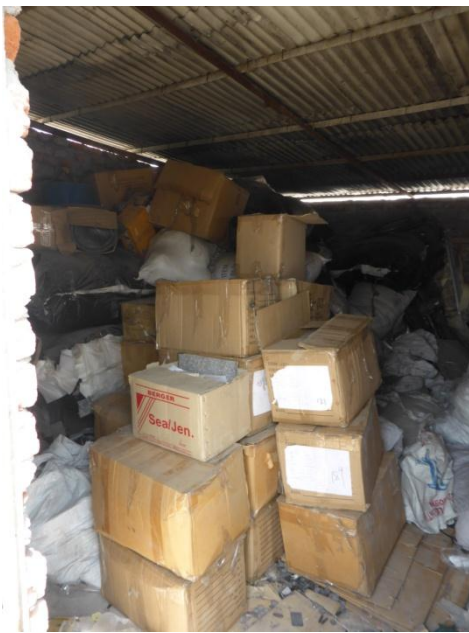
**Material storage on roof**

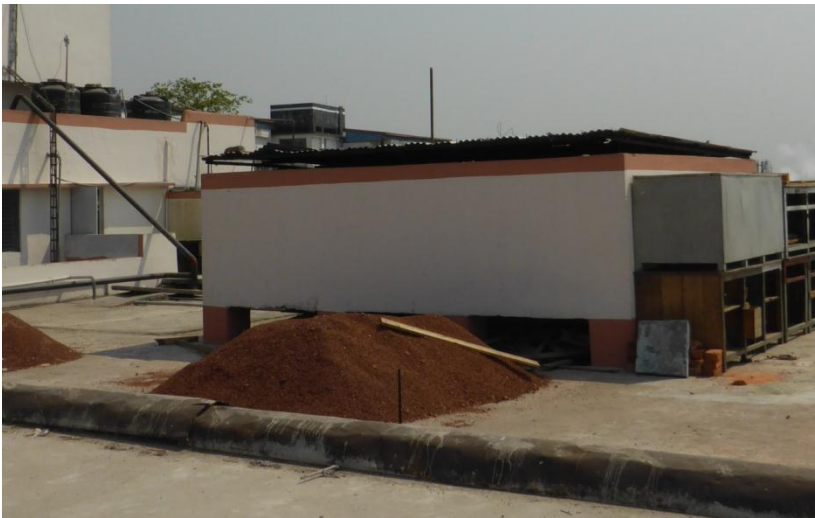
**Water Tank locations at roof level and storage of aggregate.**

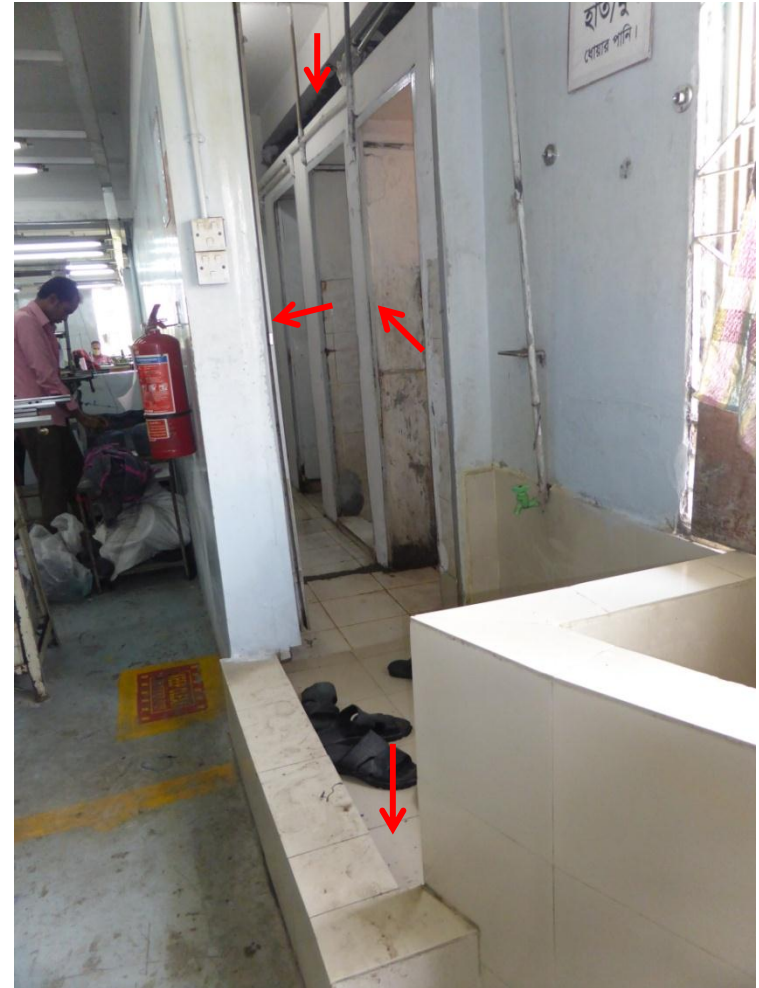
**Increased floor buildup in toilet areas in addition to brick partition walls and 150mm thick concrete ceiling.**

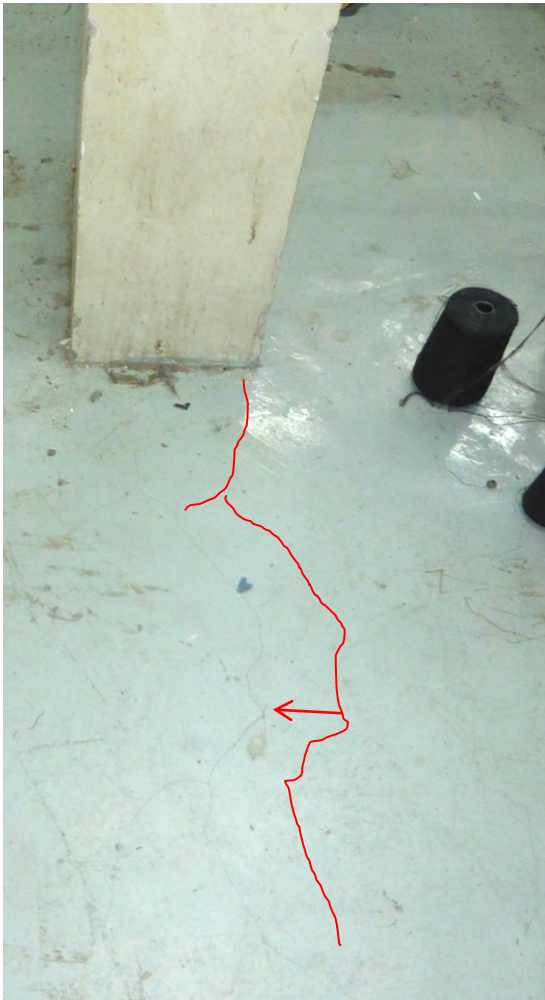
Crack above flat slab in level 4

Cracks have been noted in the finishes on top of slabs in a number of locations and floors for both the flat slab and beam constructions. The crack patterns suggest they arise from flexure over the columns and beams.

14	Cracks above surface of slabs in a number of locations	Punching shear also to be assessed for the flat slab structures in the upper levels	<b>6-weeks</b>
15	Cracks above surface of slabs in a number of locations	Implement strengthening measures if required	<b>6-months</b>
16	Cracks above surface of slabs in a number of locations	Continue to implement load plan as per item 1	<b>6-months</b>

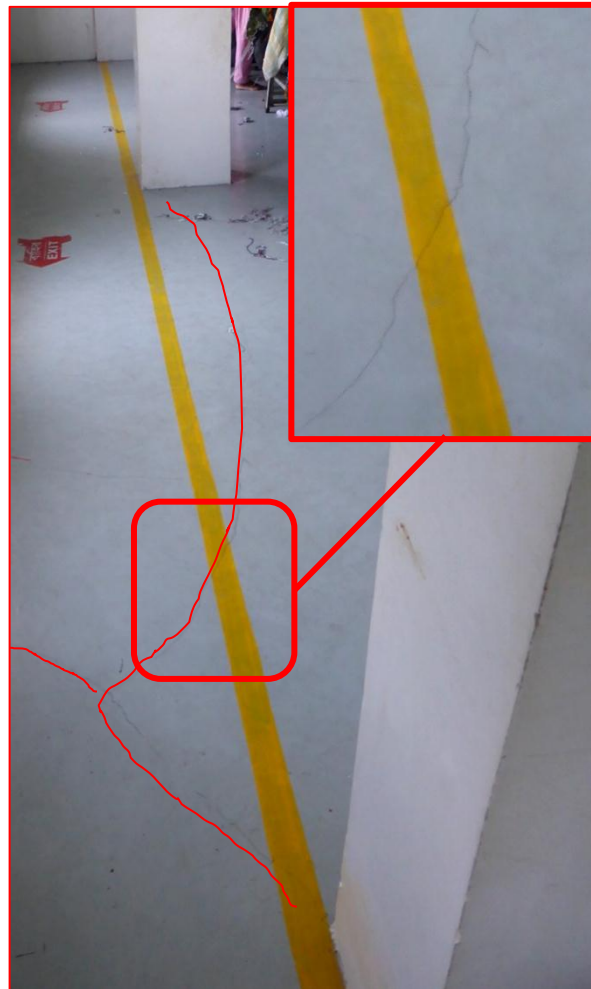
Crack above cantilever beam in level 3

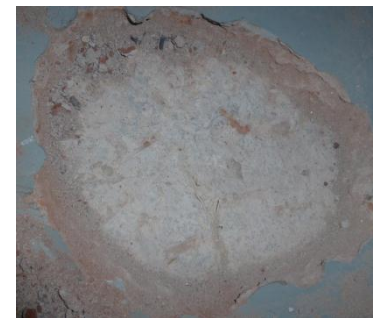
Screed was removed from one location and a hairline crack was noted as continuing through to the structural slab.

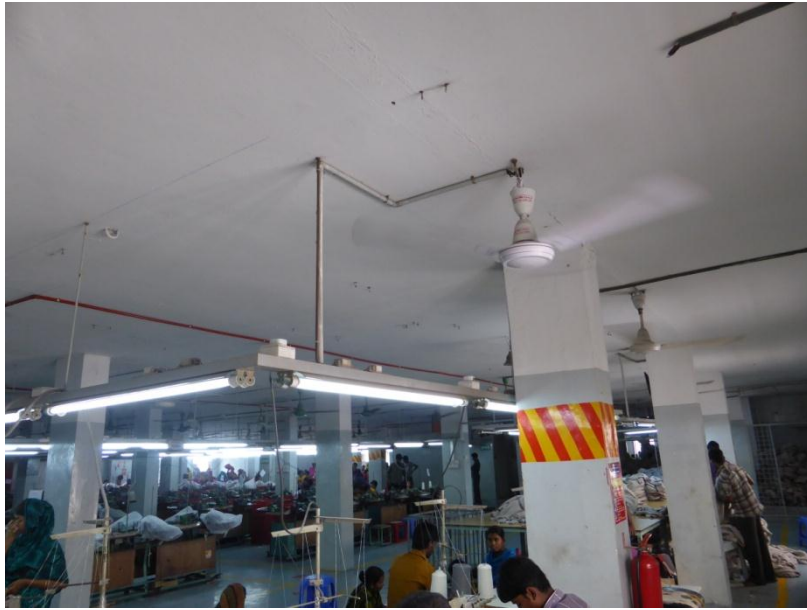
Flat slab – 5<sup>th</sup>  
(part), 6<sup>th</sup> and  
Roof floors

The change in structural system could indicate that Building 3 may have been constructed in a number of phases both horizontally and vertically, contradicting the information given at the Manager Interview that the building was constructed in one phase in 2003.

Building Engineer should check that lateral stability is maintained through the two structural systems.

Item No.	Observation	Recommended Action Plan	Recommended Timeline
17	Change in Structural System in upper floors	As part of the Detail Engineering Assessment of Factory required for Item 1, the change in structural system should be assessed in terms of the overall lateral stability of the building	<b>6-weeks</b>
18	Change in Structural System in upper floors	Complete Detail Engineering Assessment and identify adequacy or otherwise of the lateral stability system	<b>6-weeks</b>
19	Change in Structural System in upper floors	Implement strengthening measures if required.	<b>6-months</b>
20	Undocumented vertical extension on roof.	Building engineer to assess lightweight roof structure and confirm its ability to withstand all wind loading pressure, suctions and uplift forces.	<b>6-weeks</b>
21	Undocumented vertical extension on roof.	Additional loading to main production building to be identified and incorporated in Detail Engineering Assessment for the building.	<b>6-weeks</b>

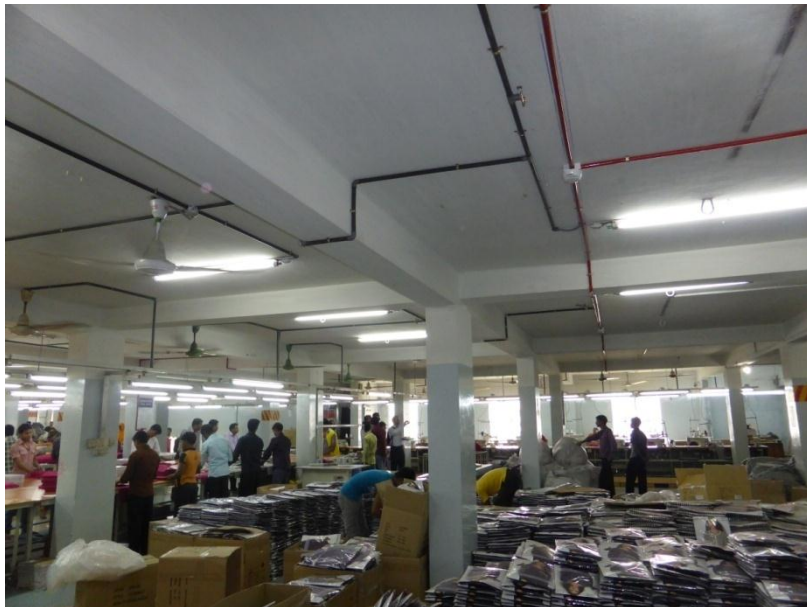
Beam and  
slab system  
1<sup>st</sup> - 4<sup>th</sup> Floors  
and part of  
5<sup>th</sup> floor

Drawings indicate a beam and slab construction at all floors.

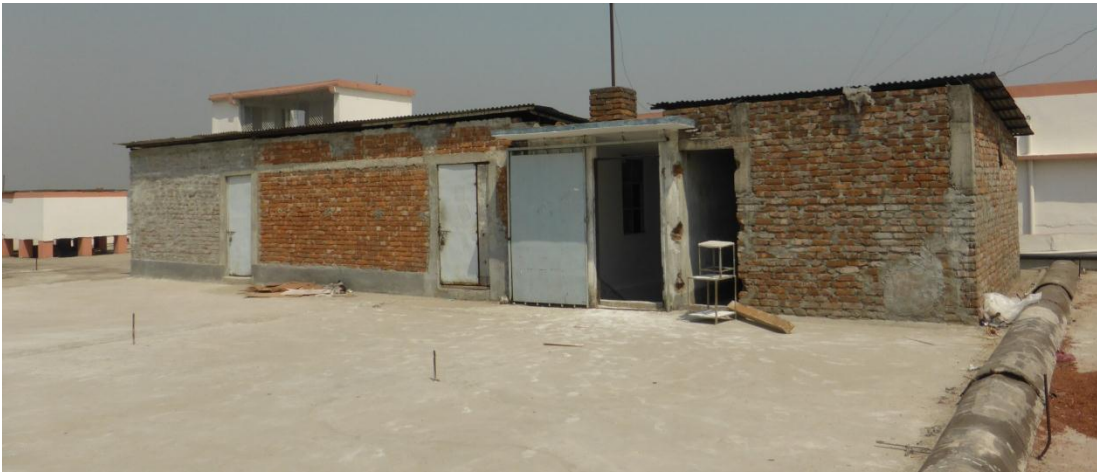
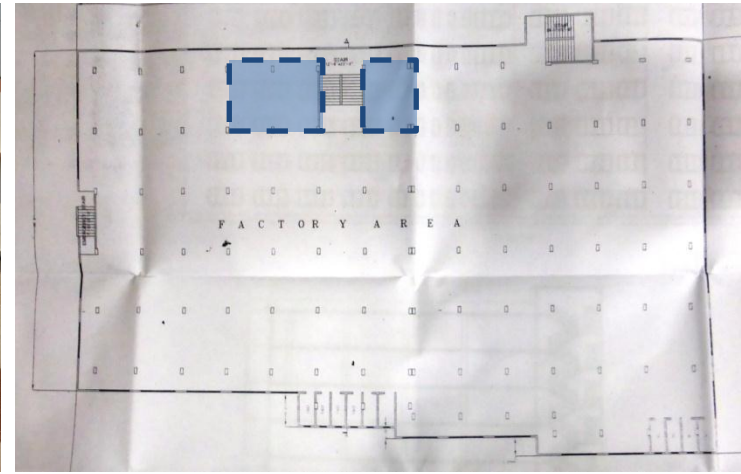
**Undocumented vertical extension on roof comprising brick masonry walls with a lightweight steel roof.**

**No structural or design documentation provided for extensions.**

**Adequacy of tie-downs and lateral stability need to be assessed by Building Engineer.**

**Additional vertical loading applied to building below to be assessed.**

22	Undocumented vertical extension on roof.	Carry out remedial work if required.	<b>6-months</b>

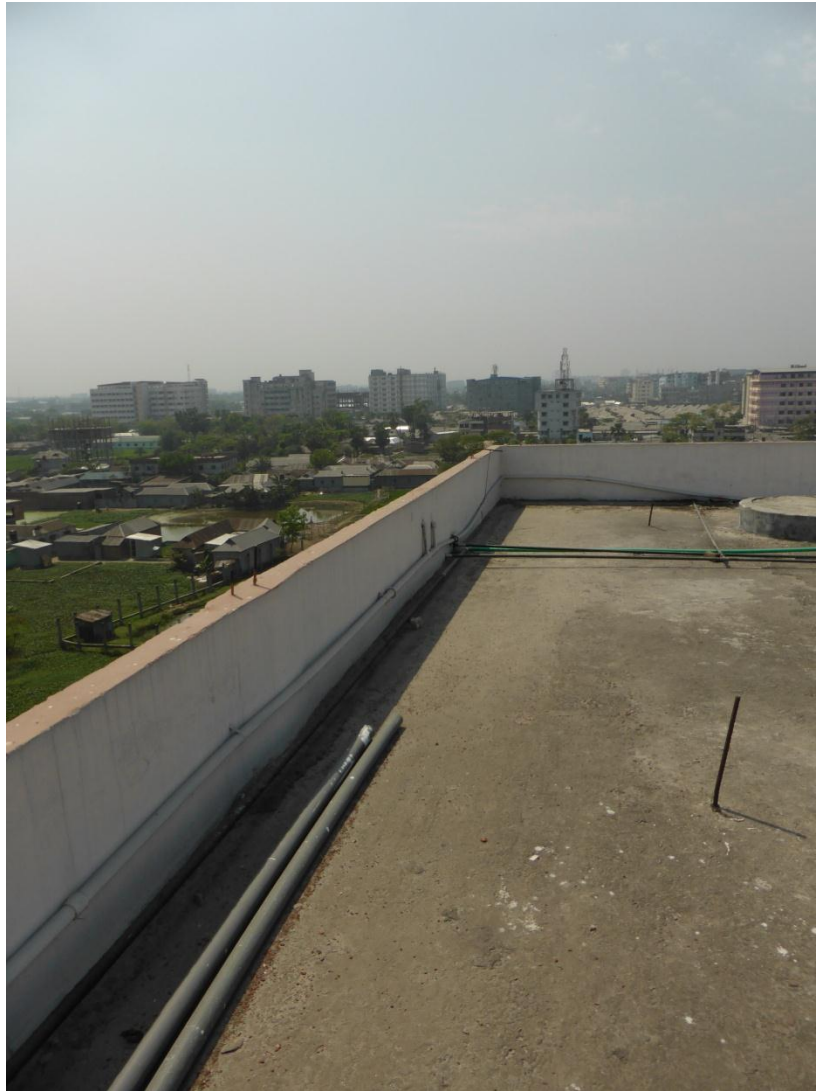
**Unrestrained roof parapets**

Single brick masonry parapets unrestrained at roof level around perimeter of the building.

Item No.	Observation	Recommended Action Plan	Recommended Timeline
23	Unrestrained parapet at roof level	Building engineer to assess stability and condition of the roof parapets.	6-weeks
24	Unrestrained parapet at roof level	Repairs and strengthening to be carried out as required by engineering assessment.	6-months
25	Ill-defined movement joint between Buildings 3 and 1.	Building engineer to investigate extent of this movement joint at all levels.	6-weeks
26	Ill-defined movement joint between Buildings 3 and 1.	Remedial work to be carried out as required by engineering assessment.	6-months
