**SB Style Composite Ltd.  
ZS Apparels  
ZS Embroidery  
Jabber Fashions Ltd.  
Patriot Printing Industry  
Patriot Packaging Industry**

Delpara, Fatullah, Narayanganj  
(23.67101N 90.48441E)  
30<sup>th</sup> April 2014

# Observations

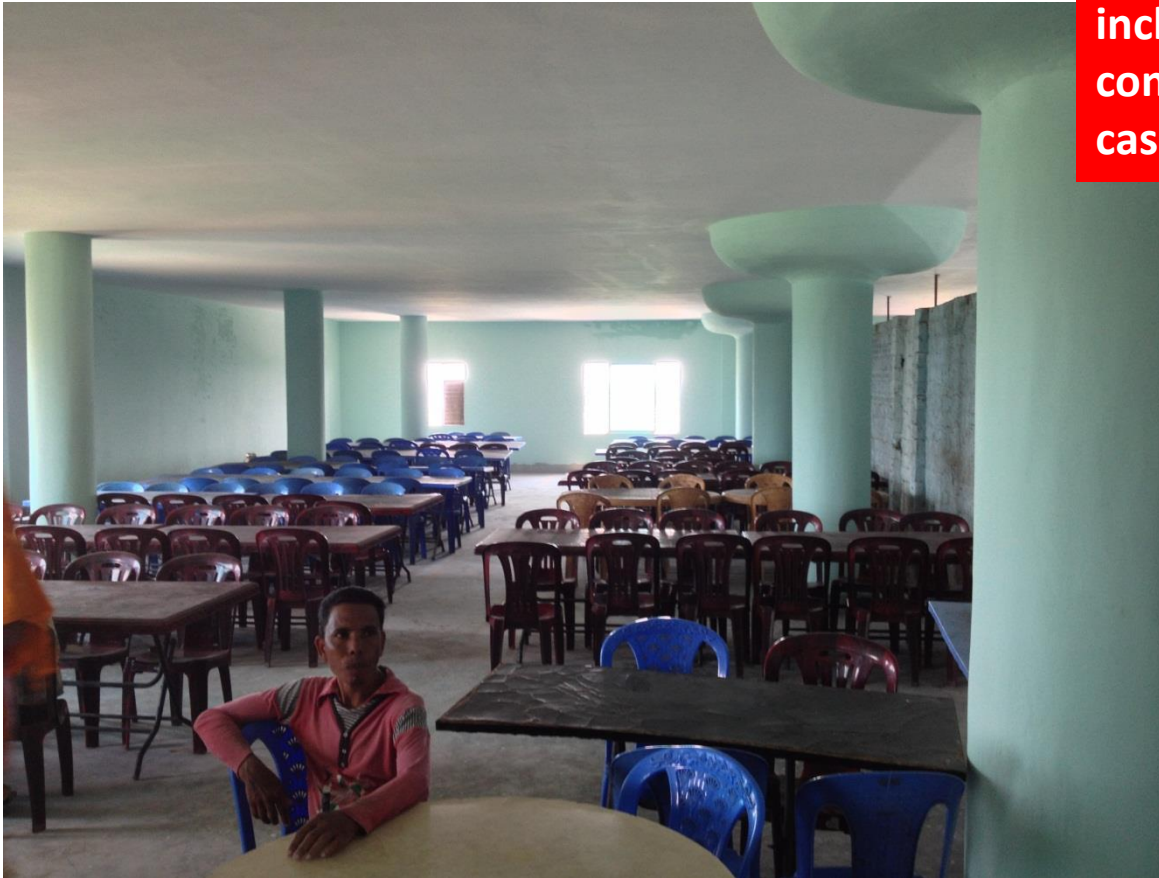
4 Building has no obvious lateral stability

Building has no obvious lateral stability as flat slabs between 170 and 190mm are questionable in terms of adequate frame action. Perimeter Façade walls are half a brick thick (order of 130mm thick including render) and are not continuous to ground in many cases

No lateral stability system evident. Façade construction at high level on-going leading to increasing wind loading on building.

- Qualified Structural Engineer to confirm adequacy of stability system.  
**Must be completed within 3 weeks and remedial actions taken as required.**

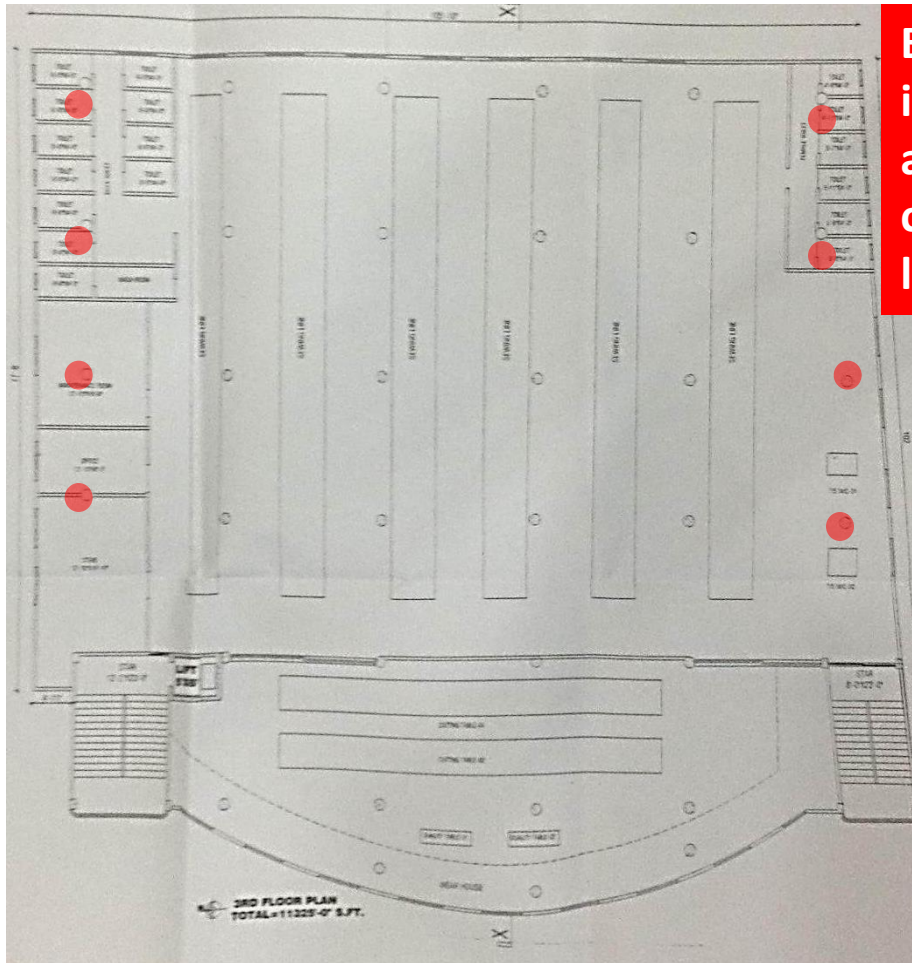
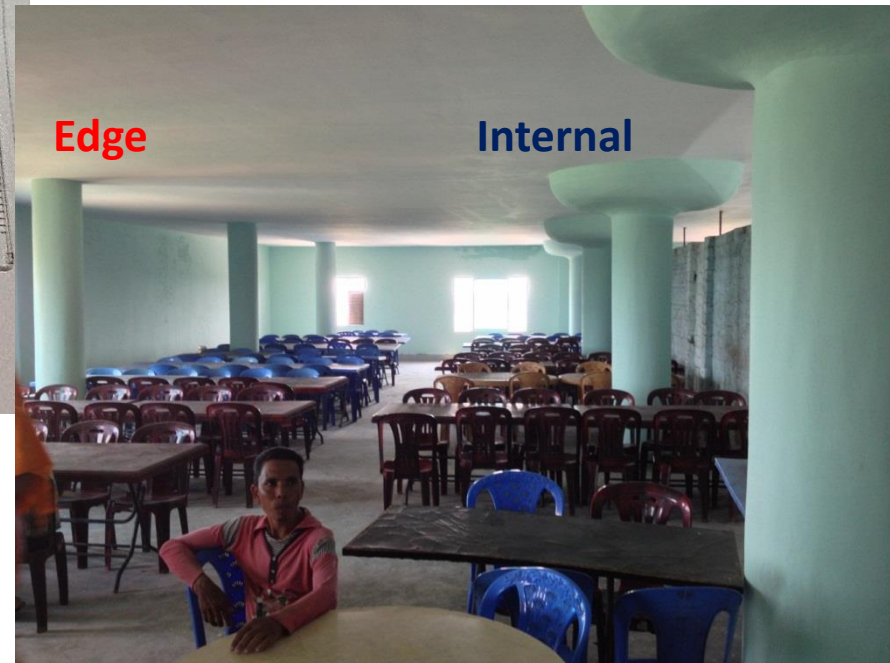
6 Small edge columns without shear heads

Edge columns (red) smaller than internal columns and pick up significant and similar loads to the internal columns due to cantilever and façade loading. They have no shear heads.

Significant punching shear stress in slabs around edge columns without shear heads – reduce floor loads and verify slab capacity.

- Option 1 - Reduce number of toilet cubicles to one male and one female by demolishing all partition wall and removing all floor finishes above slab level as shown overleaf .Demolition works to be carried out with care to avoid impact loads on slab. Option 2 - Alternatively restrict access in toilet areas and install temporary lightweight toilet facilities on each floor as shown overleaf until DEA is complete.
- Qualified Structural Engineer to carry out a Detailed Engineering Assessment of Factory, see attached scope.
- In addition verify insitu concrete strength either by taking 4 no. 100mm diameter cores. Structural Engineer to determine safe locations for coring in centre of bay.

- Produce and actively manage a loading plan for all floor plates within the factory giving consideration to floor capacity.
- Detailed Engineering Assessment to be completed.

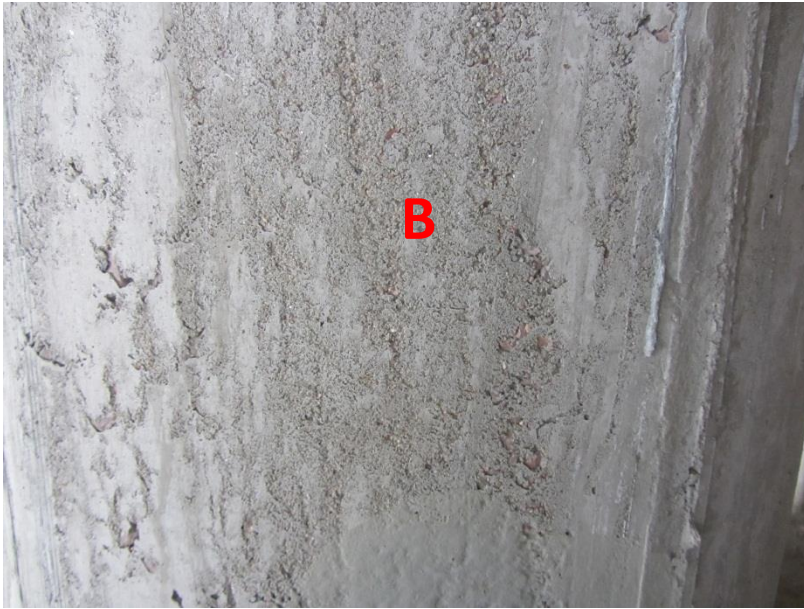
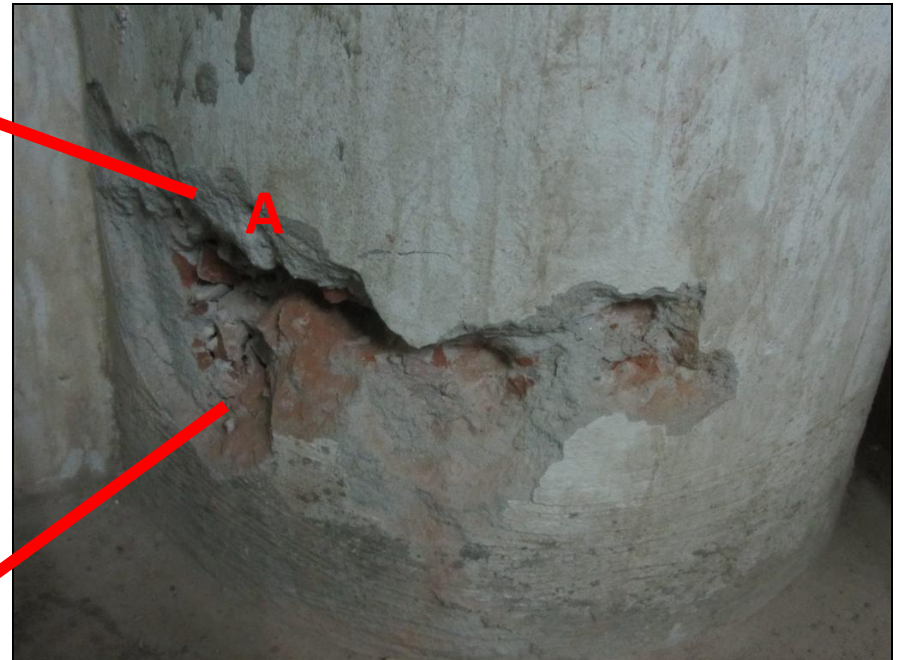
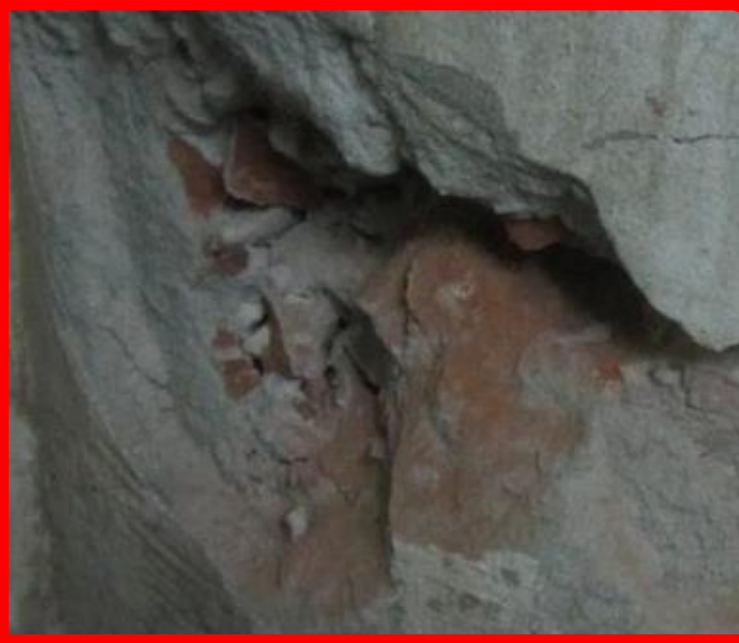
Weak column concrete

No fines concrete observed to ground floor column (A) where accidentally damaged. Observed brick aggregate had open gaps between aggregate.

On new roof columns (B) lack of cement observed.

- Construction activities at high level to be stopped.
- Restrict all floor loads to less than 1.5 kPa. This will involve emptying the areas shown overleaf.
- Qualified Structural Engineer to review design, loads and stresses in all columns as part of Detailed Engineering see Item 2.
- Verify insitu concrete stresses either by 100mm diameter cores or existing cylinder strength data for 4 columns. Factory Engineer to determine safe locations for coring.
- Address overloading of columns supporting toilets as discussed in Item 2.

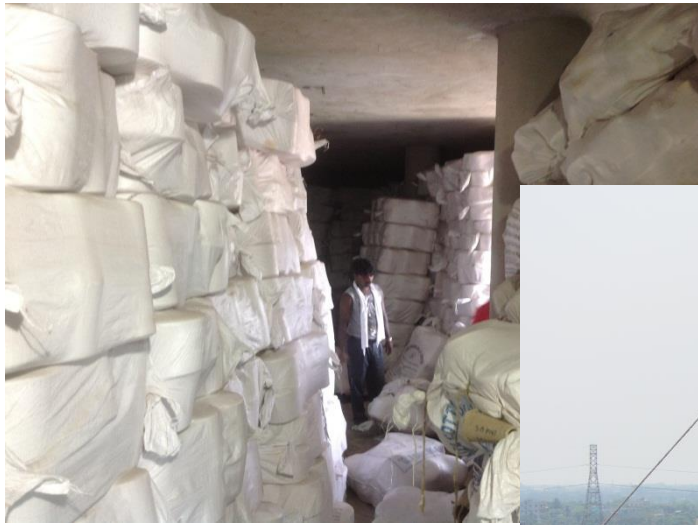
**C**

- (A) Temporary 10,000 litre tank in centre of roof bay
- (B) 10,000 Litre water tank on 7<sup>th</sup> Floor
- (C) Approx 7.5kPa loading from cotton reels on 1<sup>st</sup> floor slab
- (D) Temporary storage of boxed sewing machines on 4<sup>th</sup> floor approx 6kPa
- (E) Approx 8kPa loading on 2<sup>nd</sup> floor at rear of building
- (F) High loading on edge columns from partitions and finishes in toilets.

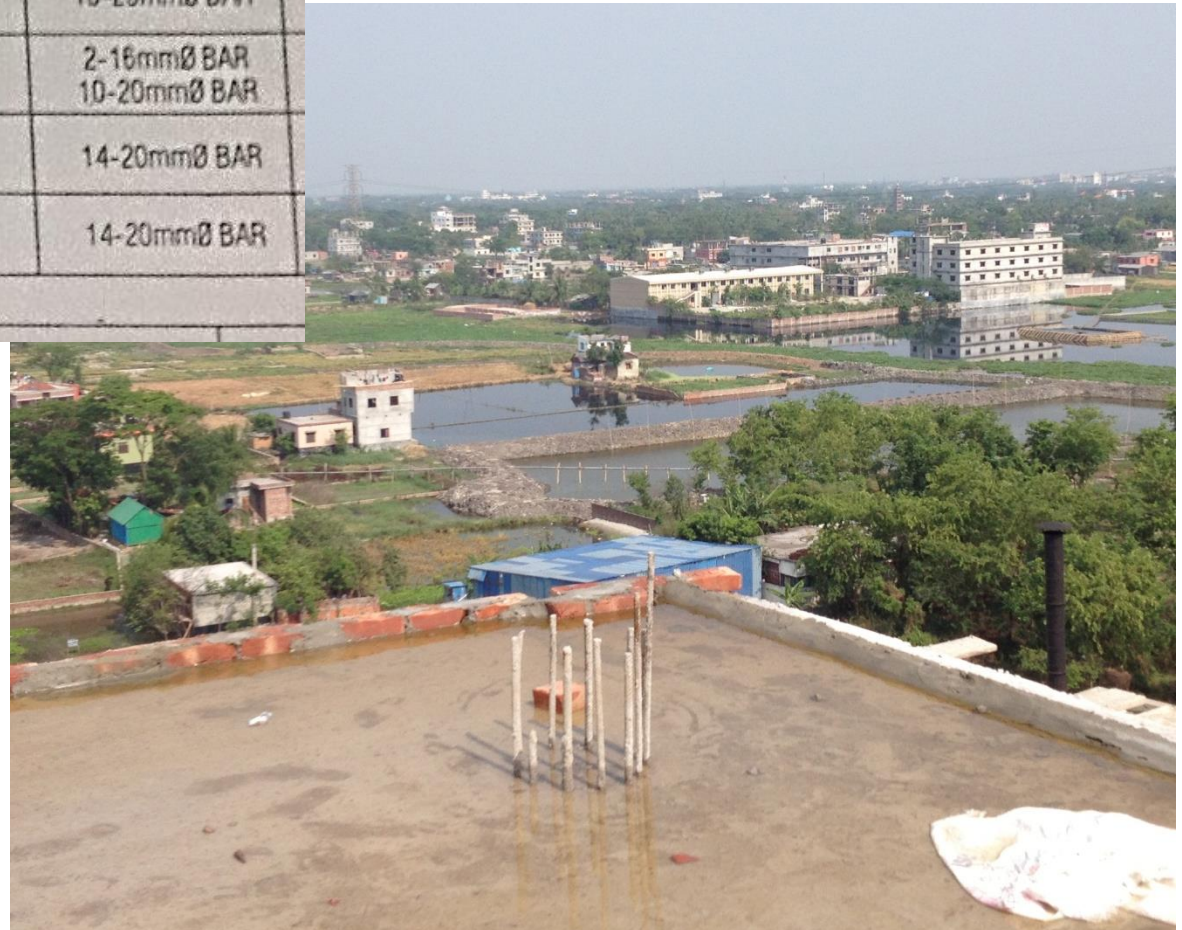
**Edge columns have only 12 vertical bars compared to the 14 shown on the drawing.**

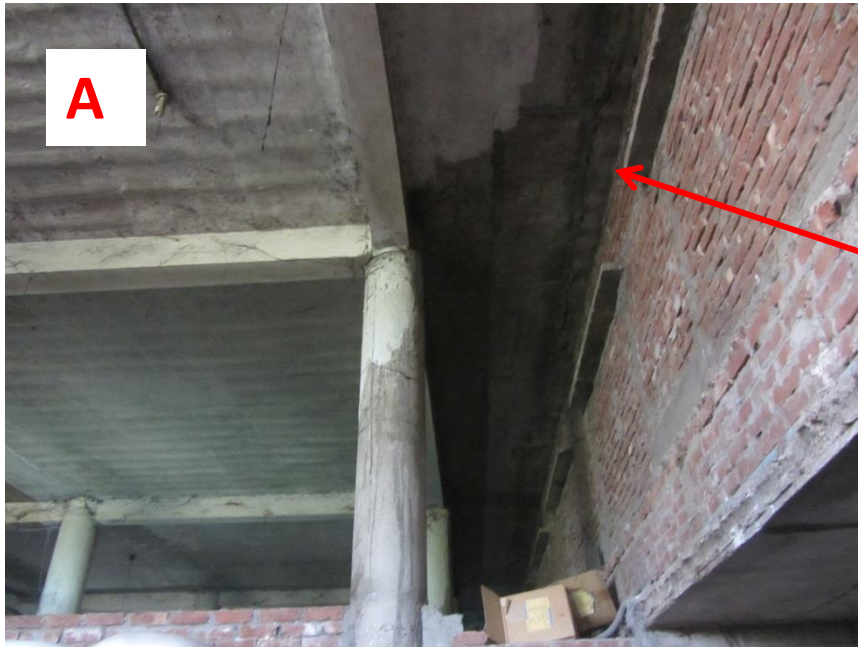
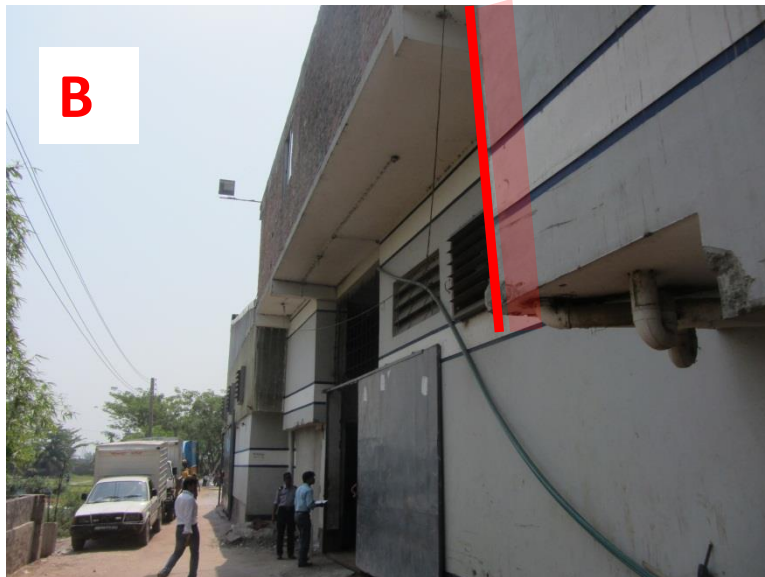
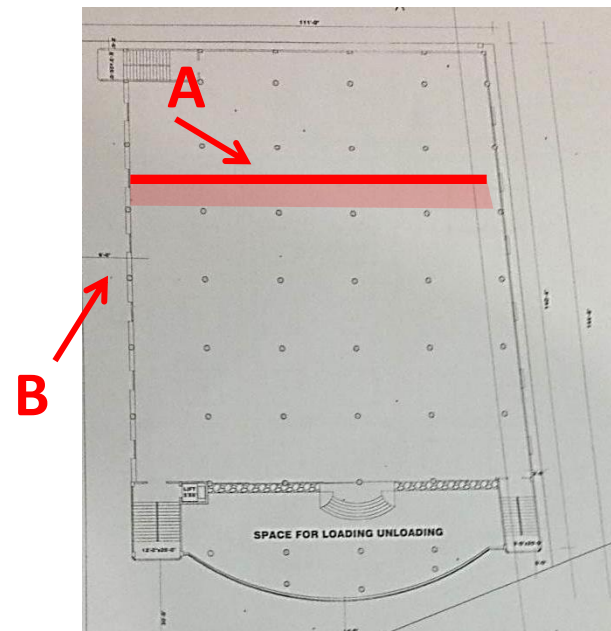
15 Building smaller than shown on drawings

Main building 2 bays smaller than shown on drawings (see red line below). Final 2 bays is effectively a separate building with a double height ground floor and roof slab level with the third floor of the production building, although the slabs are continuous between the two buildings with no visible movement joint.

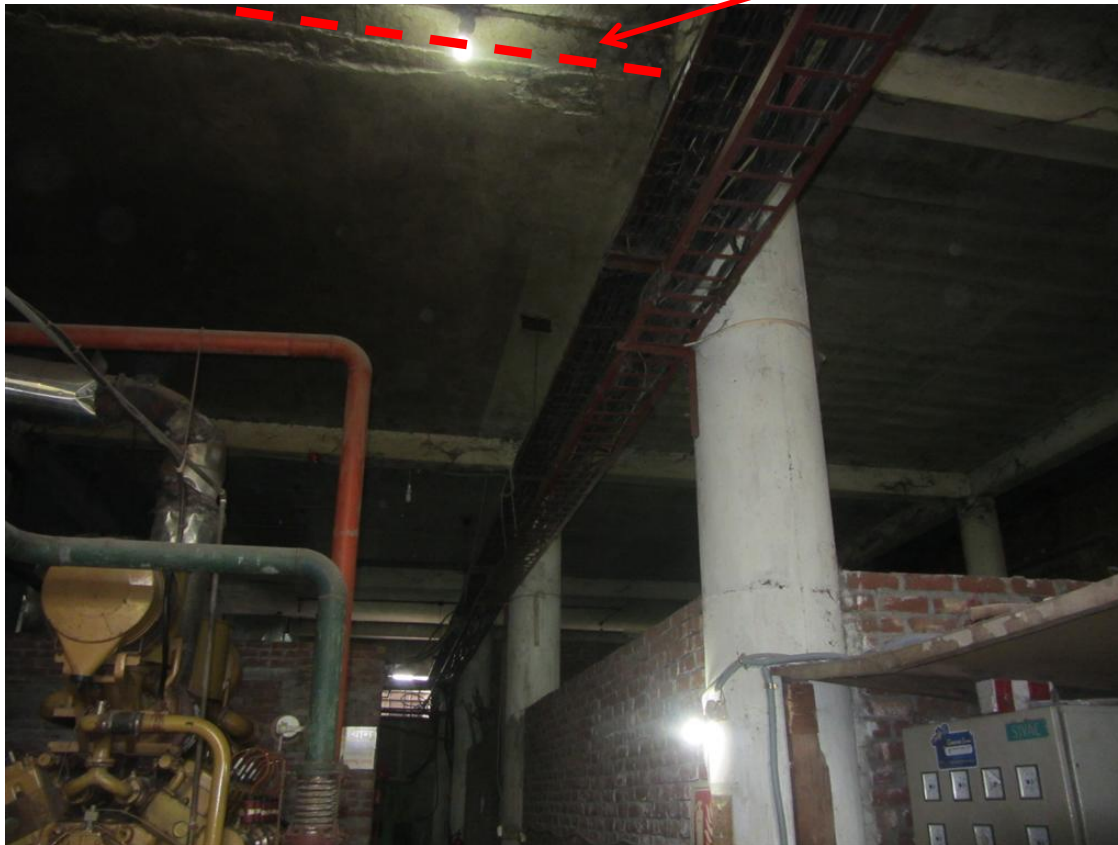
Rear of building appears to be non-engineered

The rear of the building has very long span slabs and a missing downstand beam (there is some evidence of a previous wall on the missing beam line).

High floor loads above generator at rear of building and missing downstand beam

- High floor leads to be removed by completely emptying floor as noted on drawing under Item 1.
- Adequacy of slabs and beams to be confirmed as part of Item 1 Detailed Engineering Assessment.

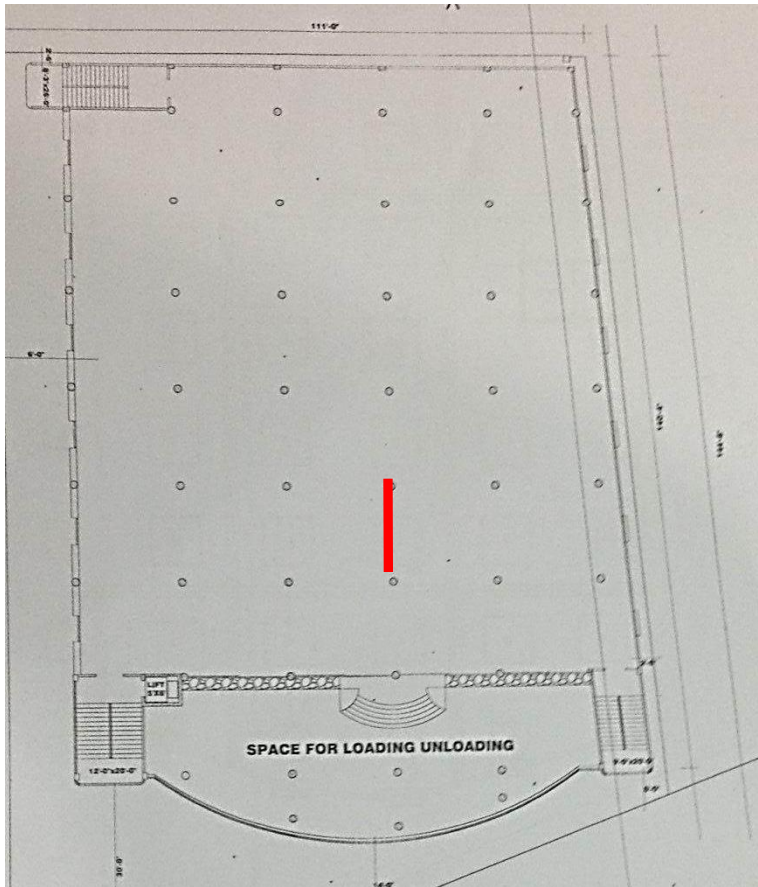
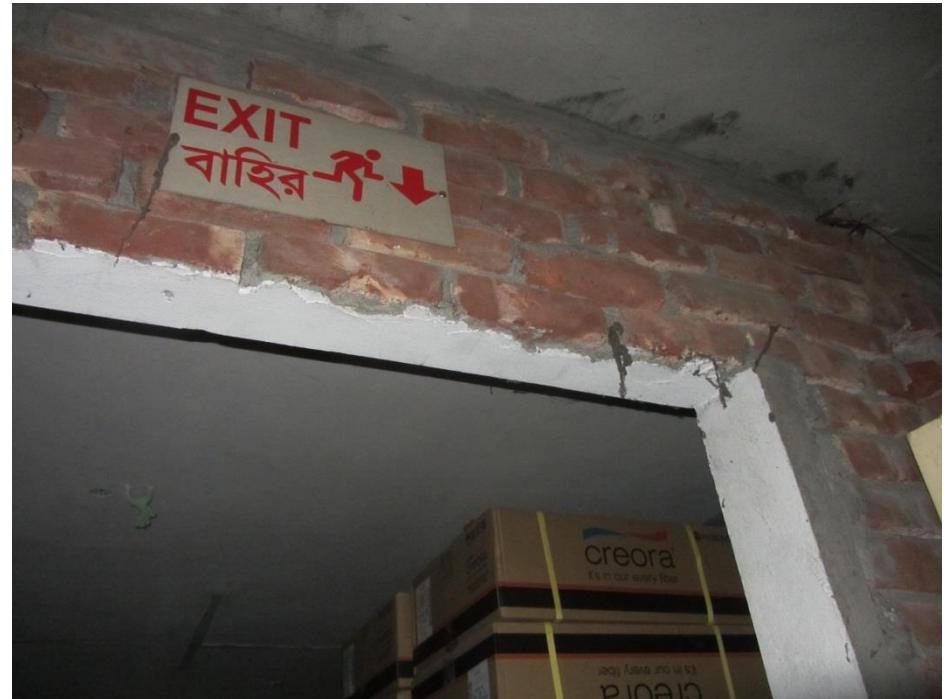
Door opening has been formed without a lintel. Bricks could fall.

- Install lintel or remove masonry above opening

Note: This was raised in the close out meeting. The factory manager agreed to remove the four courses of brick above the opening on 1<sup>st</sup> May

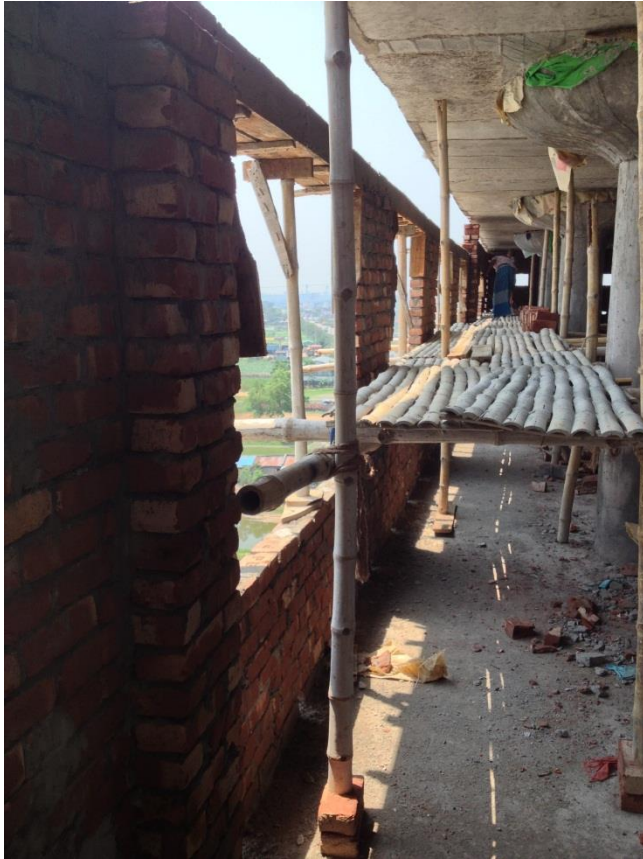
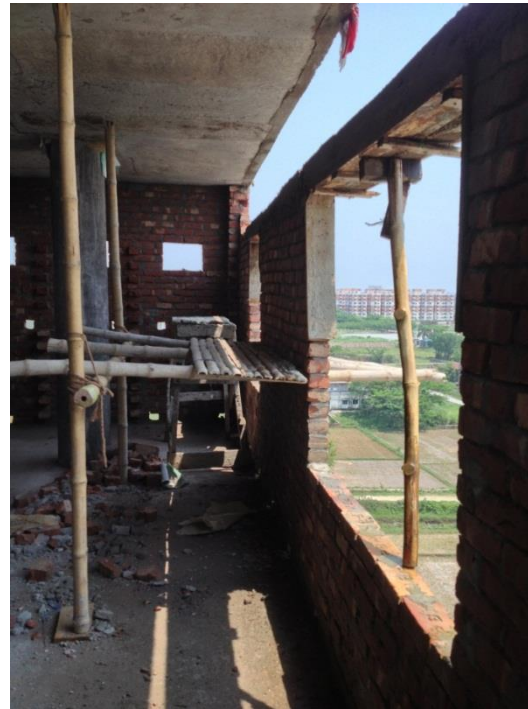
There are long lengths of single skin brick façade without piers that will have limited ability to resist lateral loads from storage, balustrade loading or wind. Problem exists on all floors particularly in NE corner but is most obvious visually at the 8<sup>th</sup> floor which is still being constructed.

- Temporary barrier to be installed around perimeter of building wherever there are missing brick piers to prevent people leaning on masonry façade or materials being stored against it.

- Structural Engineer to confirm that masonry panels are stable horizontally under all possible applied loads, including wind, material storage and balustrade loading.
