# Textown Limited (New Building)

Dewan Idris road, Bara Rangamatia, Ashulia  
(23.9121N, 90.30145E)  
22<sup>th</sup> November 2016

# Observations

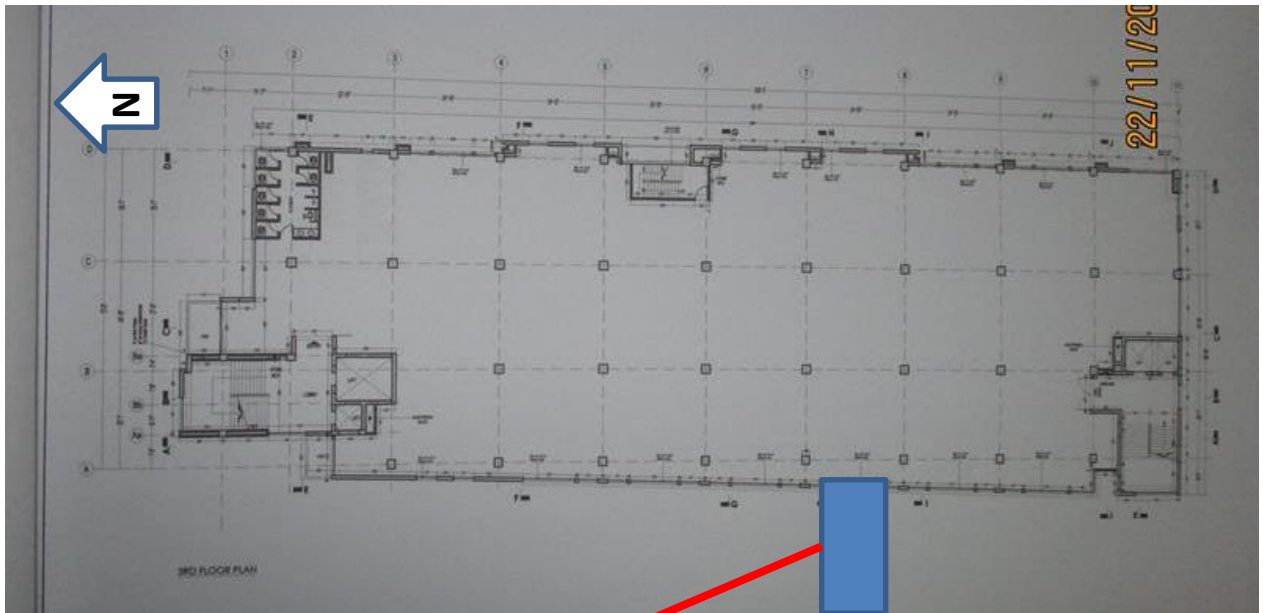
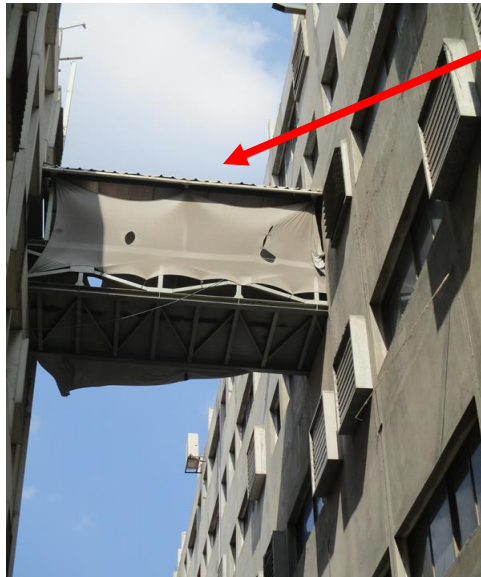
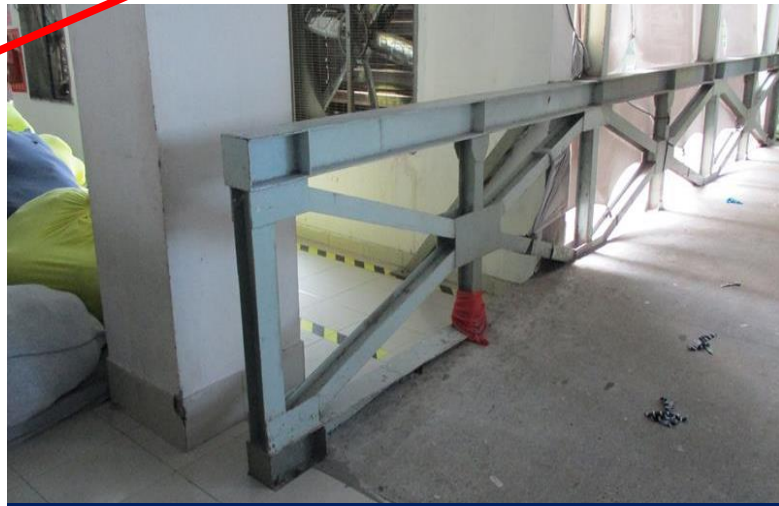
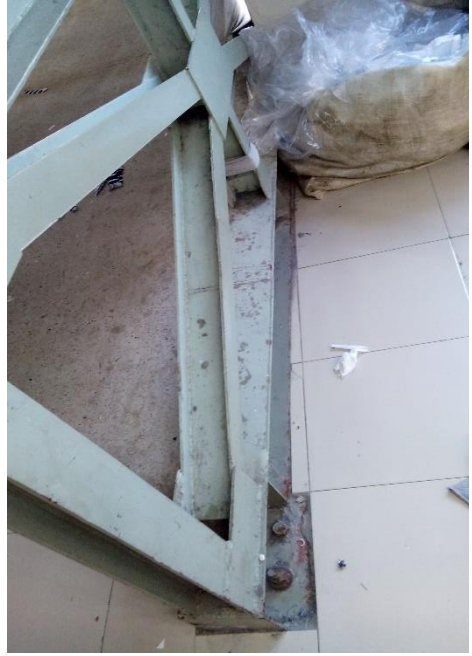
# Beam Adequacy check for additional link bridge

Two adjacent buildings are connected by a link bridge. Link bridge rest on floor beam, which may not be adequate to carry the load from the link bridge. Building Engineer is required to carry out adequacy check of the beam.

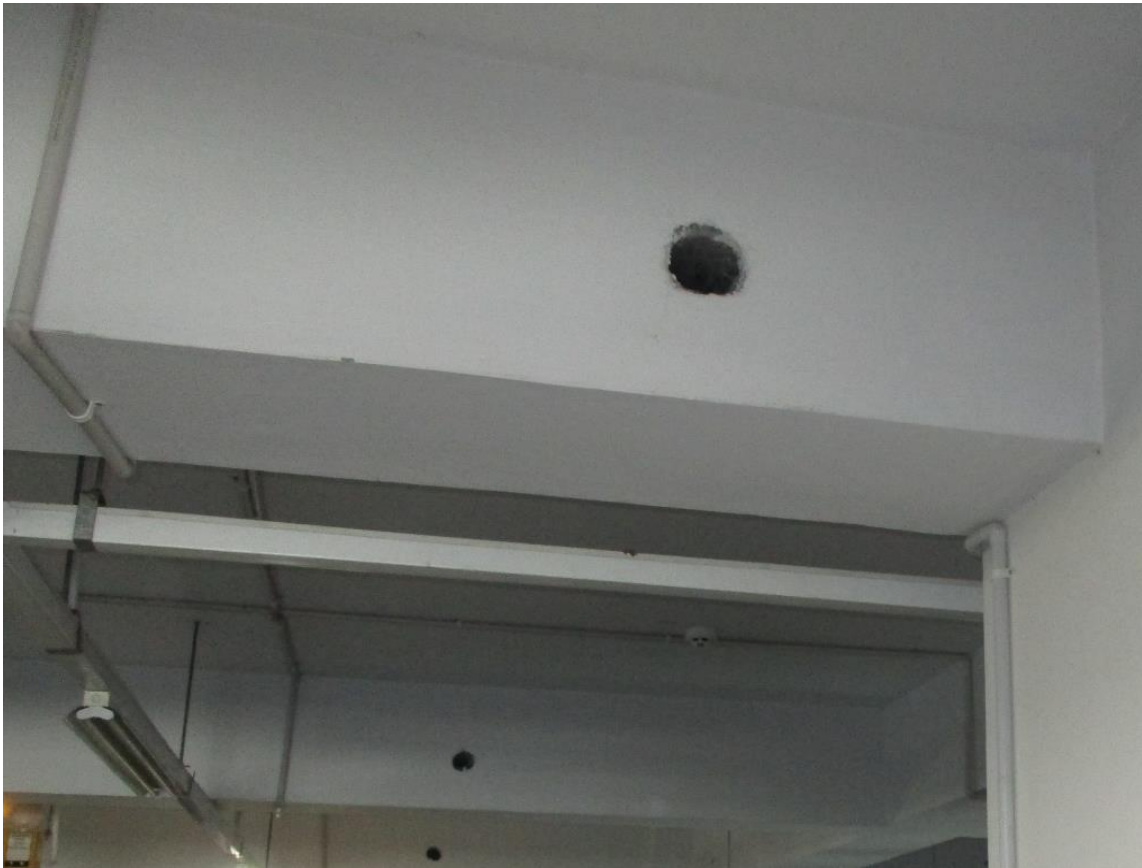
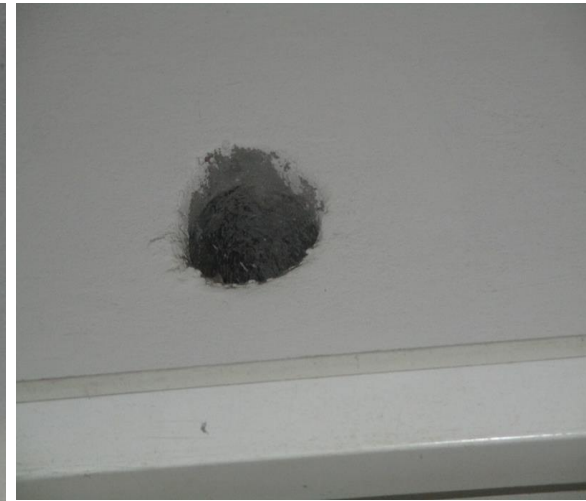
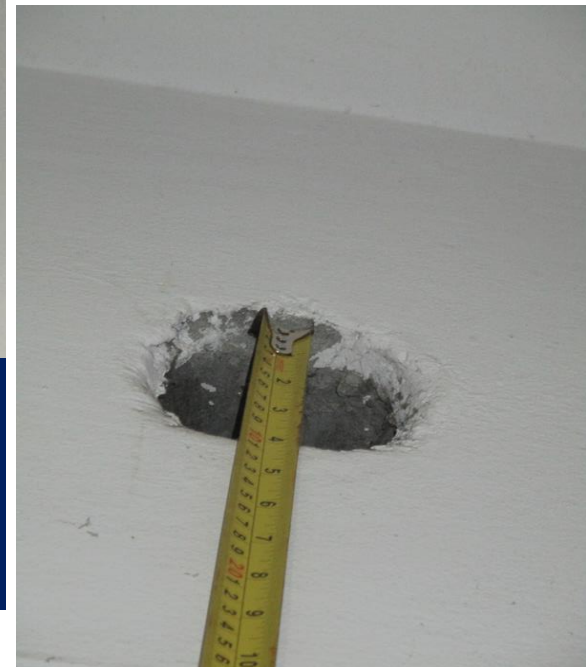
# Existence of holes in beams

Presence of 100 mm dia. holes on most of the beams of building, which may reduce the moment and shear capacity of the beams. The Building Engineer is required to review the beam capacity.

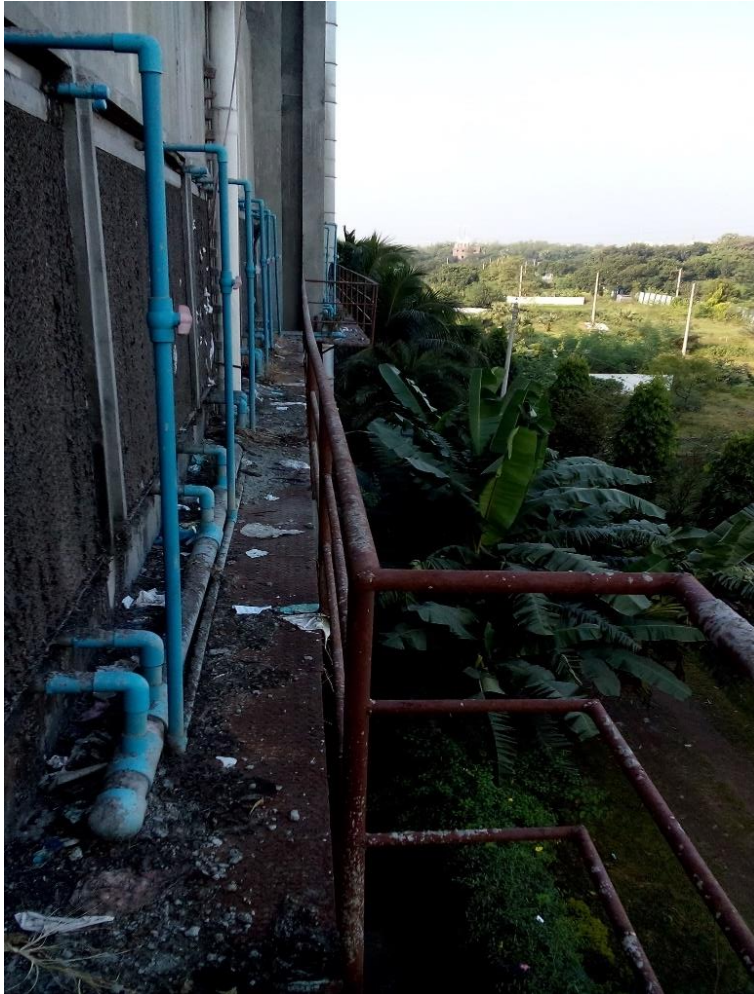
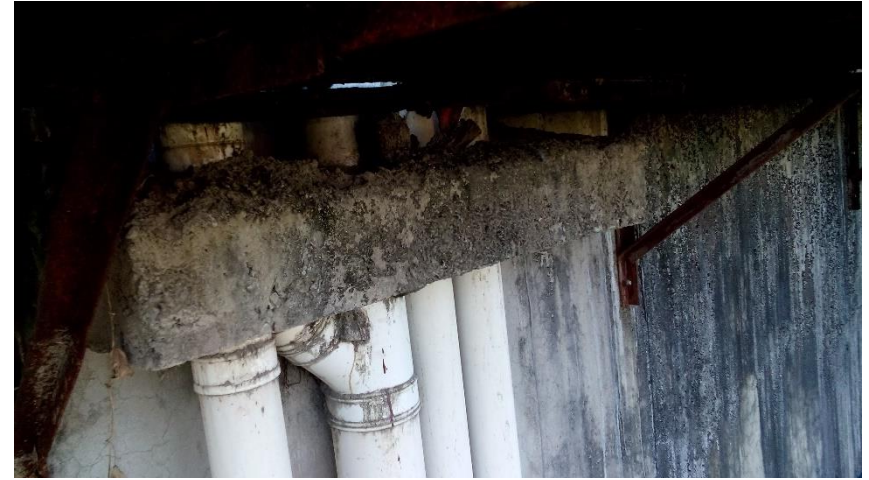
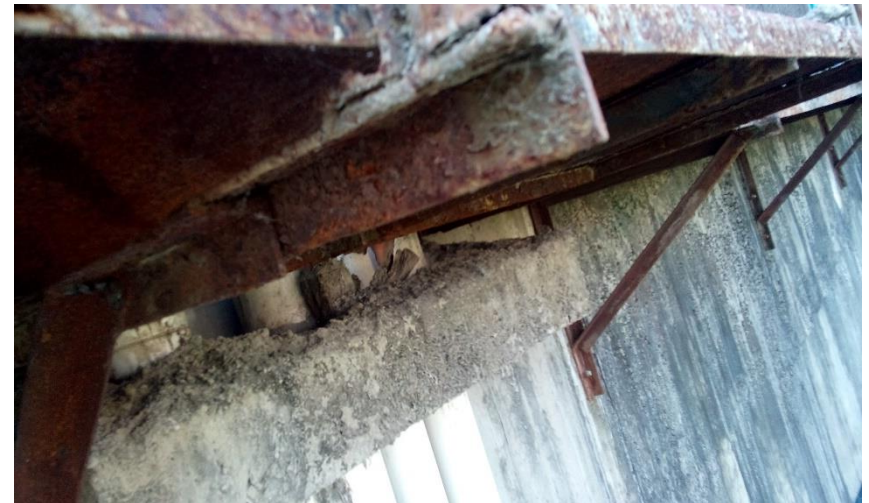
# Existence of unstable walkway at east part of the building

An unstable steel walkway at east part of the building was observed. Building engineer is required to carry out assessment and suggest suitable remedial measure.

6	Existence of unstable walkway at east part of the building	Carry out remedial works arise from assessment if any	6-months

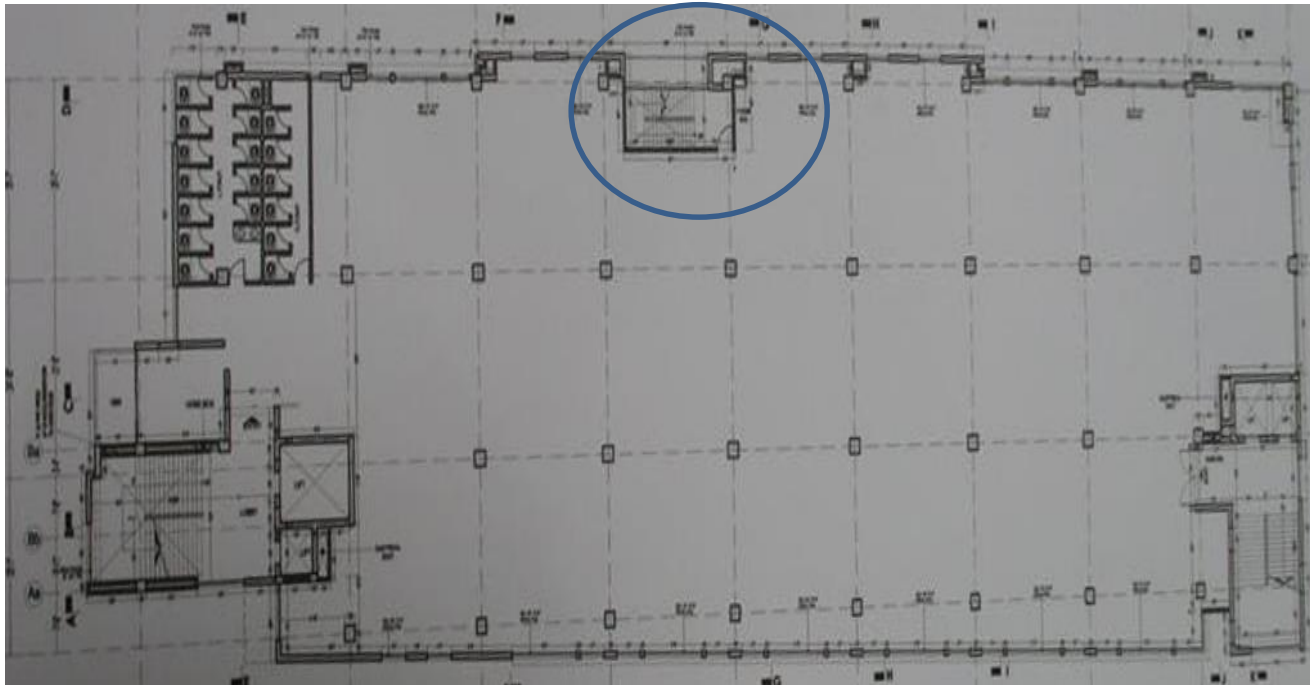
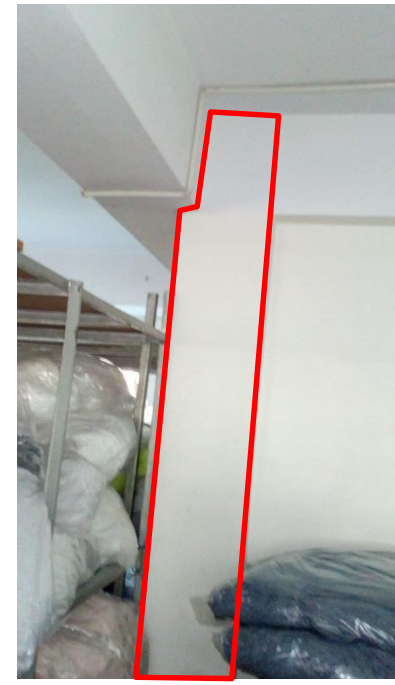
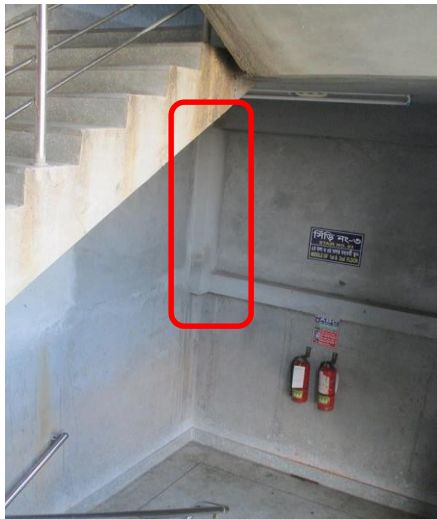
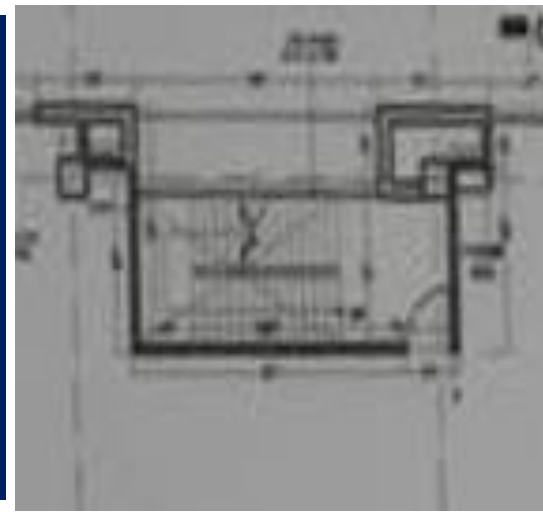
# Inconsistency between drawings and on site observation

Additional Column of 250x250 mm at east side stair was observed which did not continue throughout the structure. Building engineer is required to check the load path of the additional column and adequacy of the support. Also update the drawings.

Item No.	Observation	Recommended Action Plan	Recommended Timeline
7	Inconsistency between drawings and on site observation	Engage a Building Engineer to survey the structure and update a full set of “as-constructed” drawings.	6-weeks
8	Lack of protection around lift core	Provide protection to ensure safe working passage.	Immediate - Now
9	Future Extension to be carried out	If any extension to be carried out. Building engineer requires to conduct Detail Engineering Assessment (DEA) considering BNBC-2006 provision.	6-weeks

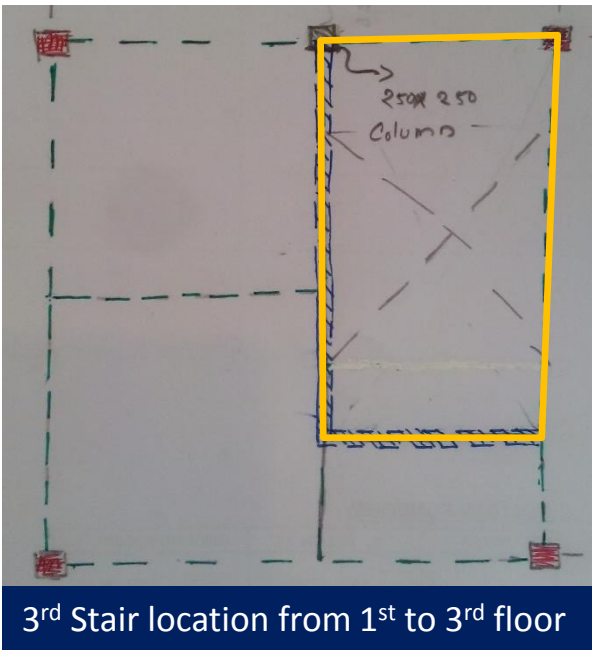
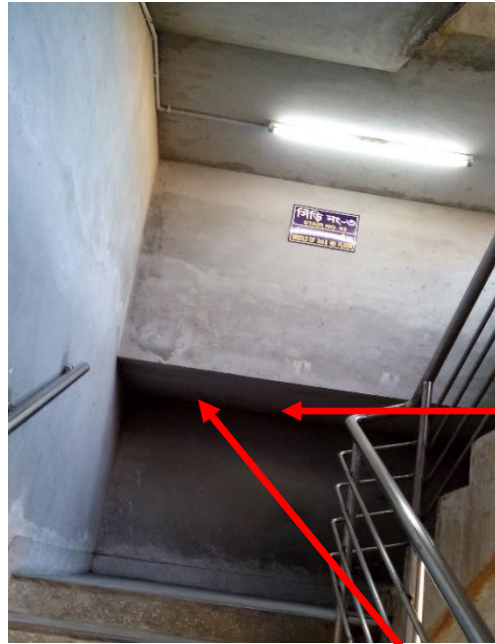
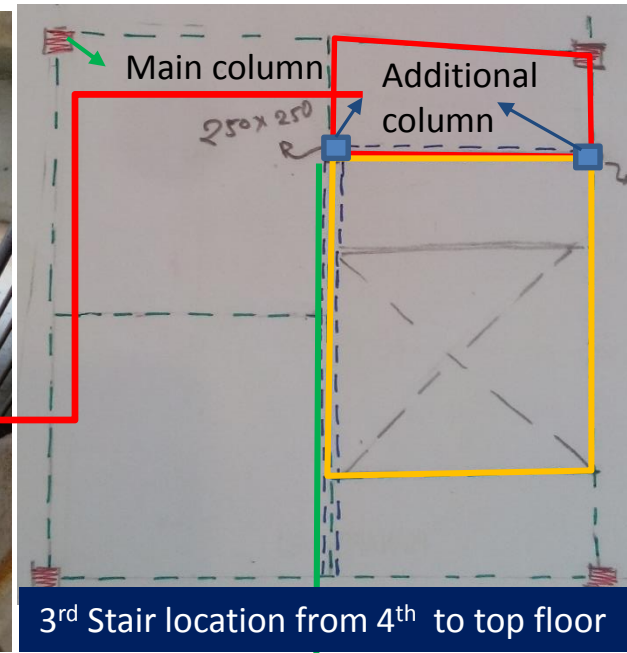
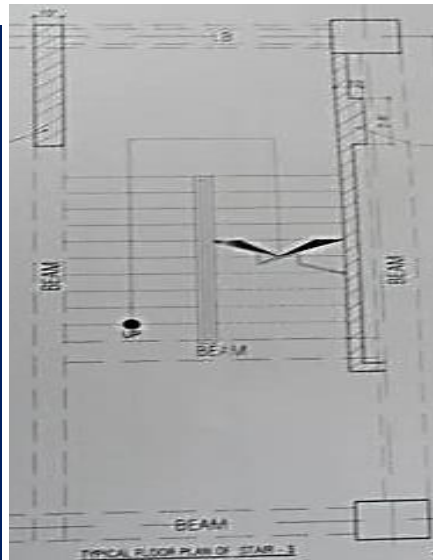
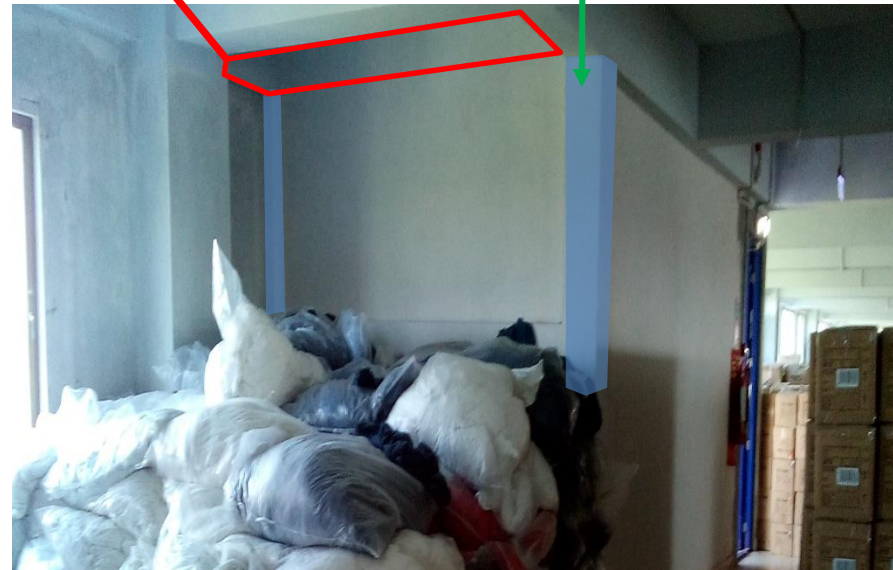
## Inconsistency between drawings and on site observation

3<sup>rd</sup> stair is sited approximately by 4ft from the location shown in structural drawings and the stair beam is found as supported by 2 additional columns which rested on beams.

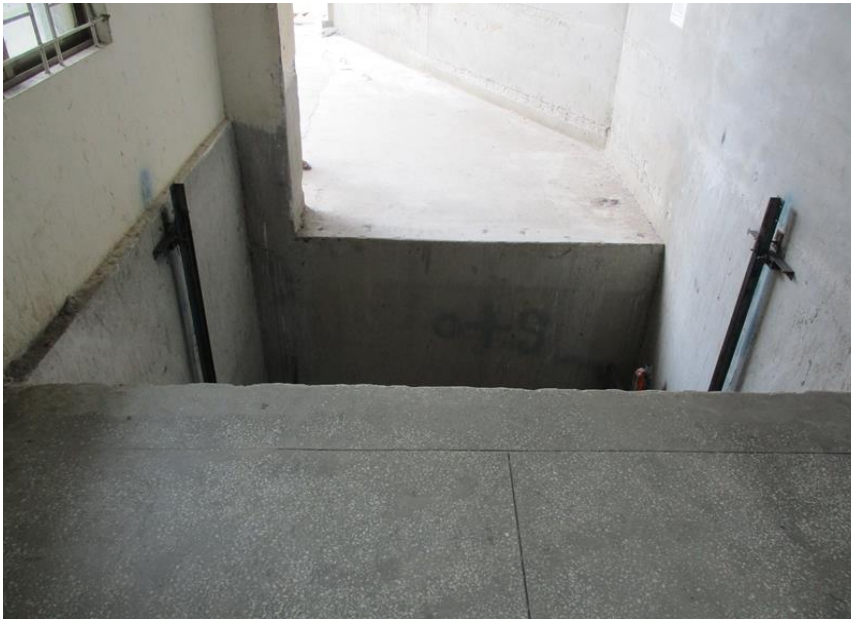
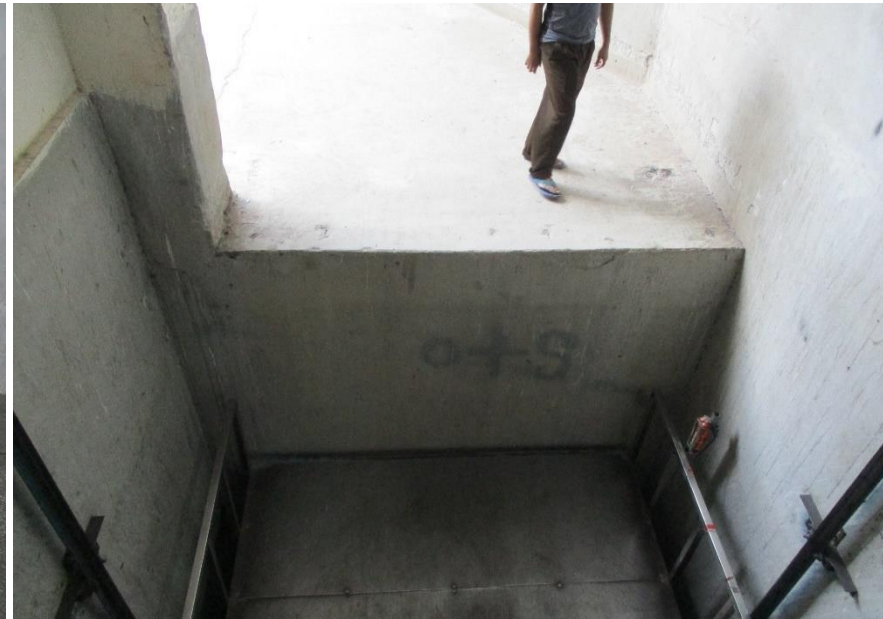
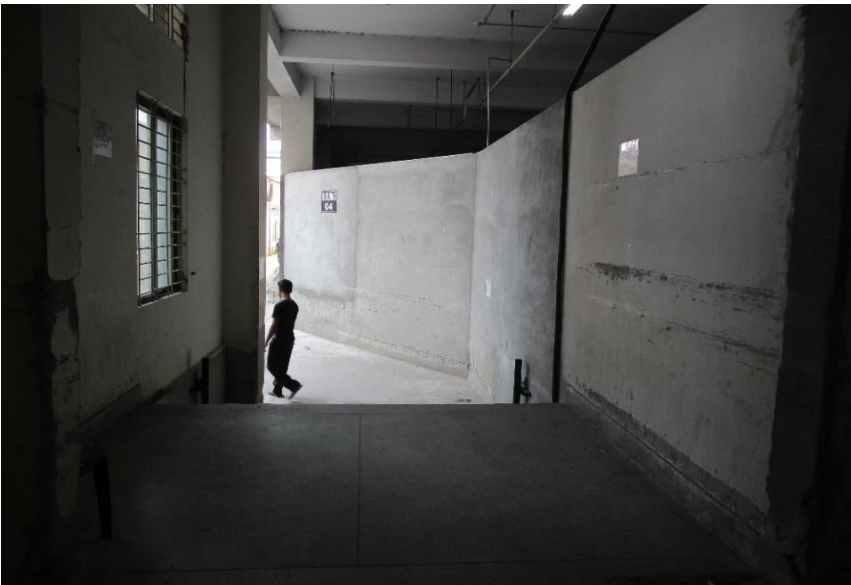
# Lack of protection around lift core

Lack of edge protection around the lift core near stair areas.

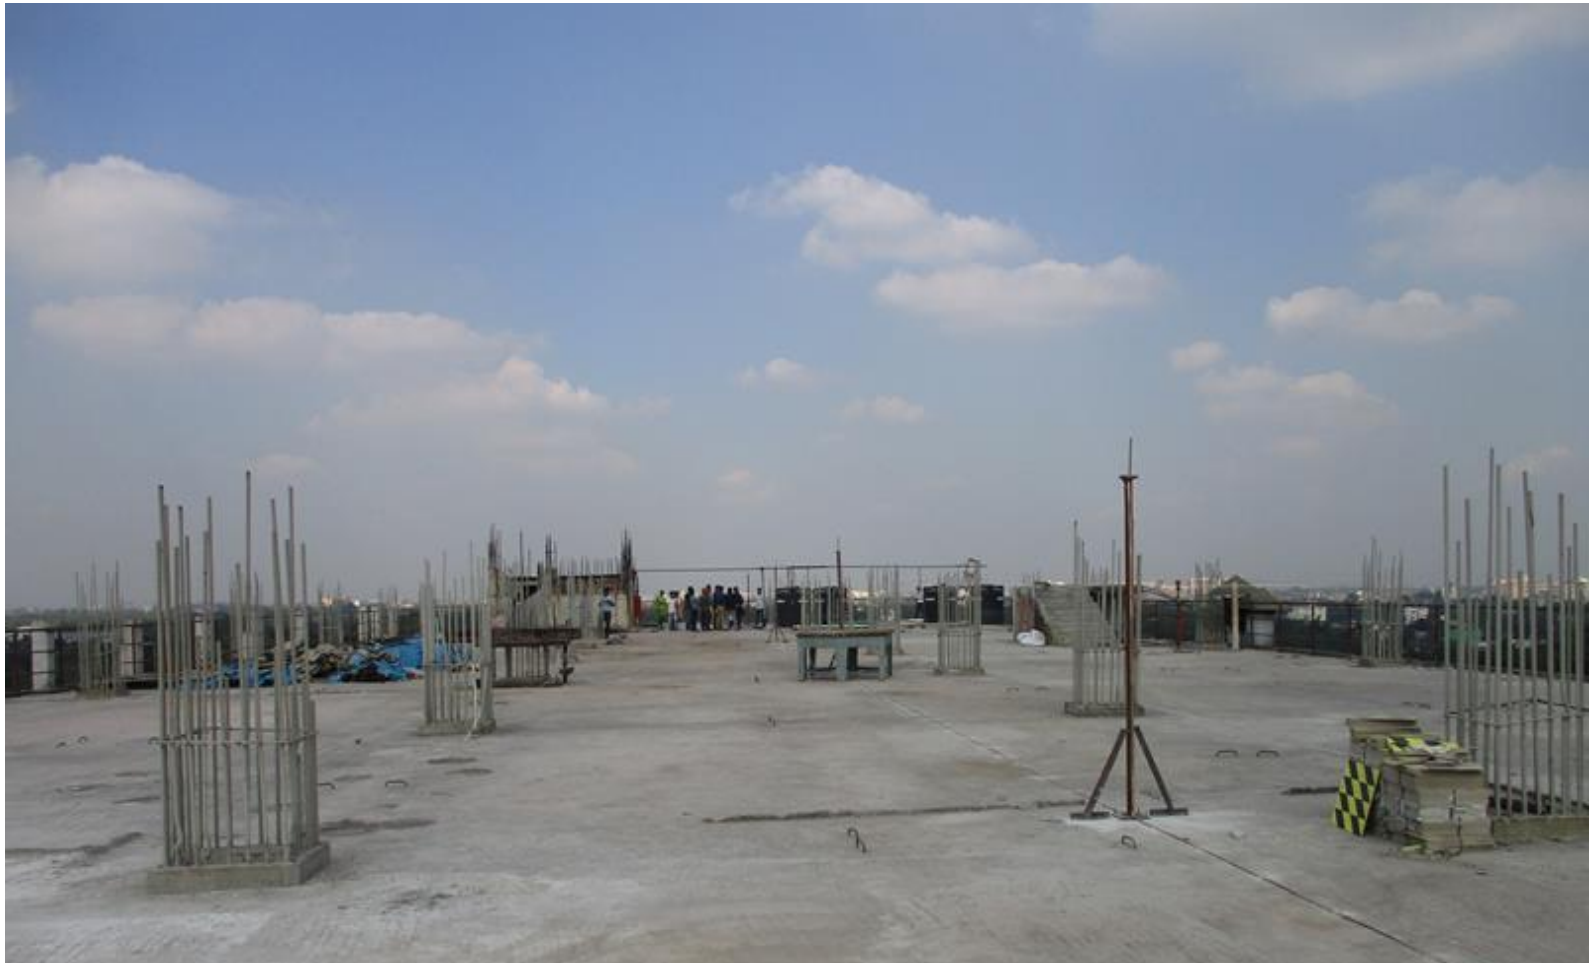
**Future Extension to be carried out**

If any extension is to be carried out, building engineer is required to carry out a Detail Engineering Assessment considering BNBC-2006 provision.
