Genesis Fashions Ltd Columbia Apparels Ltd

228/1, Tin Sarak, Luxmipura, Joydevpur, Gazipur- 1700
(23.99435N, 90.40443E)

2nd March 2014

Observations

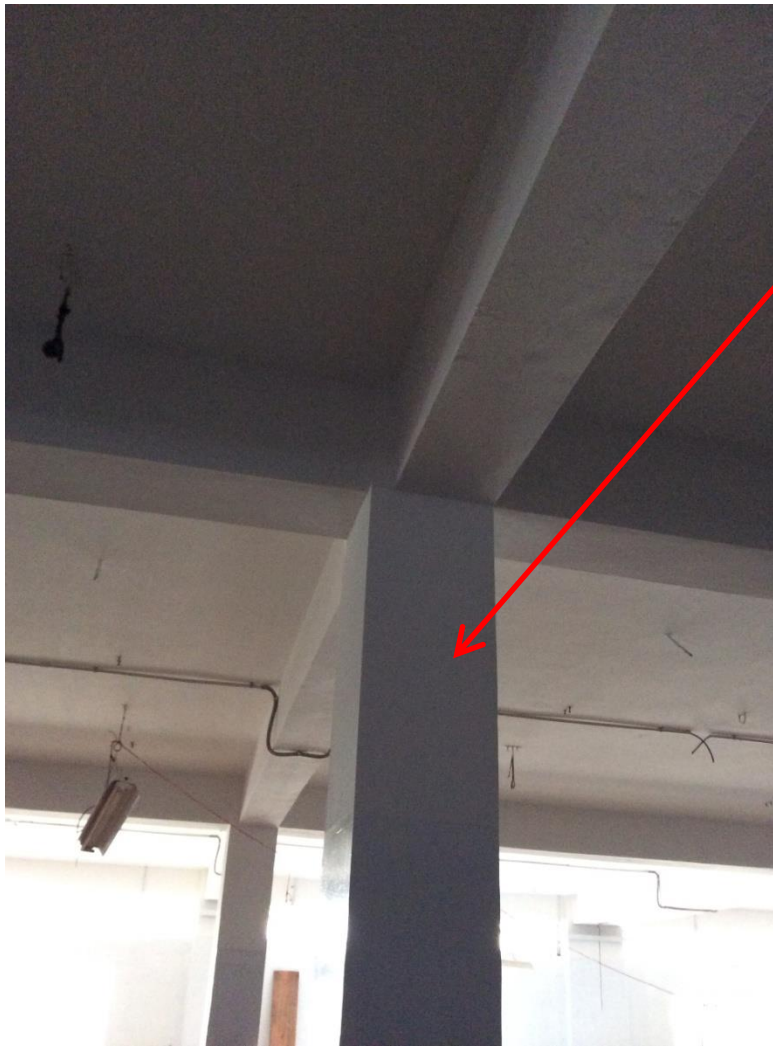
Concrete Strength (Overstressing)

Cursory calculations indicate that columns indicated appear to be smaller than required by code for the applied dead and live load, assuming typical concrete strength
Columns smaller than typical internal columns and seem to have less reinforcement than design drawings

Columns appear to be stressed in excess of normal design limits

Item No.	Observation	Recommended Action Plan	Recommended Timeline
1	Verify concrete strengths in columns (Line of columns 1 bay of east of expansion joint)	Maintain current use of the floors and don't change use or increase occupation, either of which could increase loading.	Immediate - Now
2	Verify concrete strengths in columns (Line of columns 1 bay of east of expansion joint)	Factory Engineer to review design, loads and columns stresses in all columns.	Immediate - Now
3	Verify concrete strengths in columns (Line of columns 1 bay of east of expansion joint)	Verify insitu concrete stresses either by 100mm diameter cores or existing cylinder strength data for cores from 4 columns.	Immediate - Now
4	Verify concrete strengths in columns (Line of columns 1 bay of east of expansion joint)	A Detail Engineering Assessment of Factory to be commenced, see attached Scope.	Immediate - Now
5	Verify concrete strengths in columns (Line of columns 1 bay of east of expansion joint)	Produce and actively manage a loading plan for all floor plates within the factory giving consideration to floor capacity and column capacity.	6-weeks

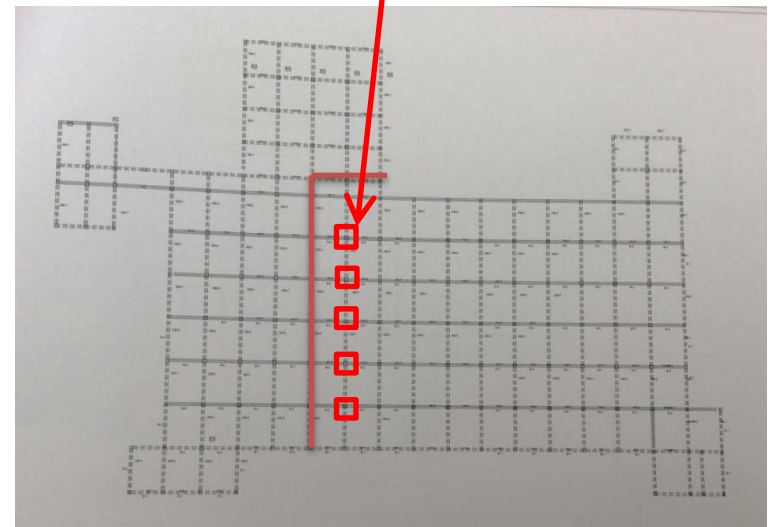
High loading- water tanks or storage

High storage loads on L4 slab

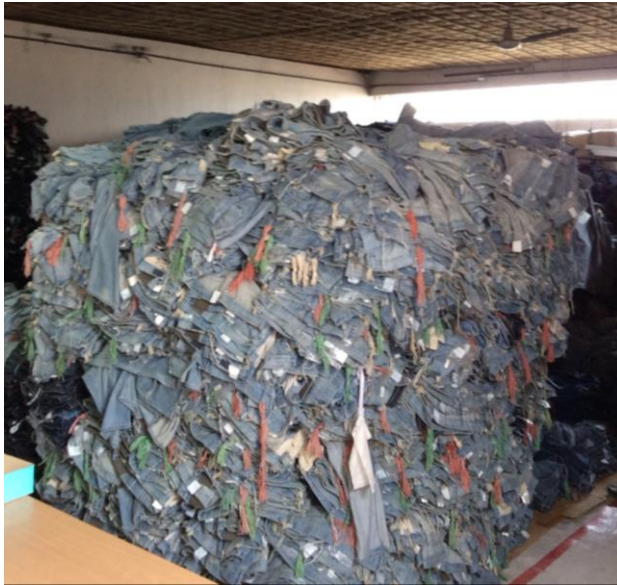
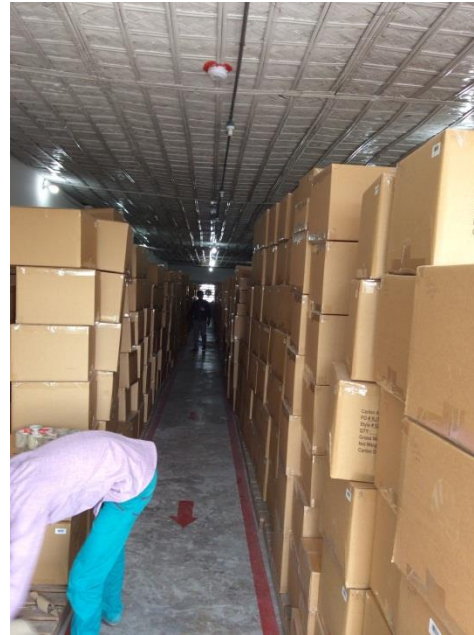
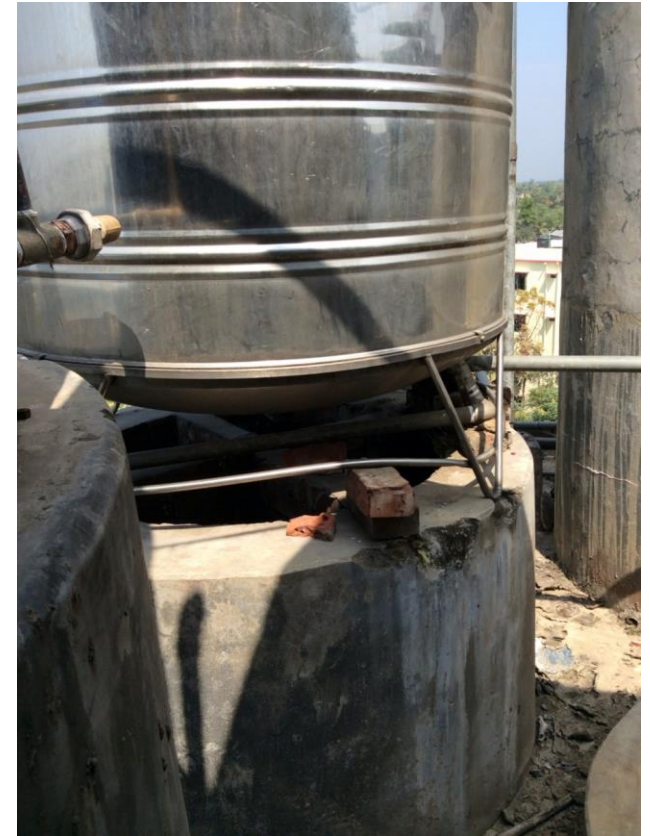
High loading- water tanks or storage

6no. water tanks on L4 slab
above wash rooms

Item No.	Observation	Recommended Action Plan	Recommended Timeline
8	Check required on roof structure from localized high loading from water tanks.	Building Engineer to check that slab has sufficient capacity to support fully filled water tanks and relocate if necessary – note also Item 1 actions	6-weeks
9	Materials stacked in dense piles / storage racks	Ensure that stacks of materials are separated by a 0.5m gap all around.	6-weeks
10	Materials stacked in dense piles / storage racks	Building Engineer to check capacity of existing structure to carry storage loads	6-weeks
11	Materials stacked in dense piles / storage racks	Building Engineer to create controlled loading plans (see also Item 1) for all floors designating where storage can be placed	6-weeks
12	Materials stacked in dense piles / storage racks	Continue to implement loading plan	6-months
13	Column at loading bay of main building vulnerable to vehicle impact	Provide physical barrier or other protection to column to prevent vehicle impact.	6-weeks

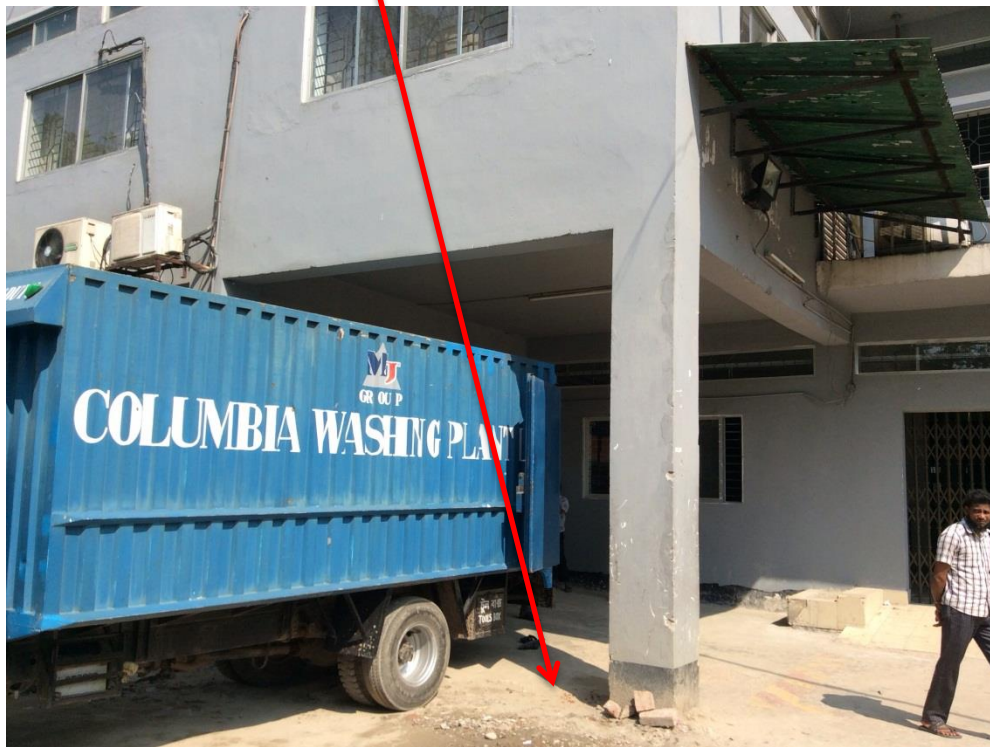
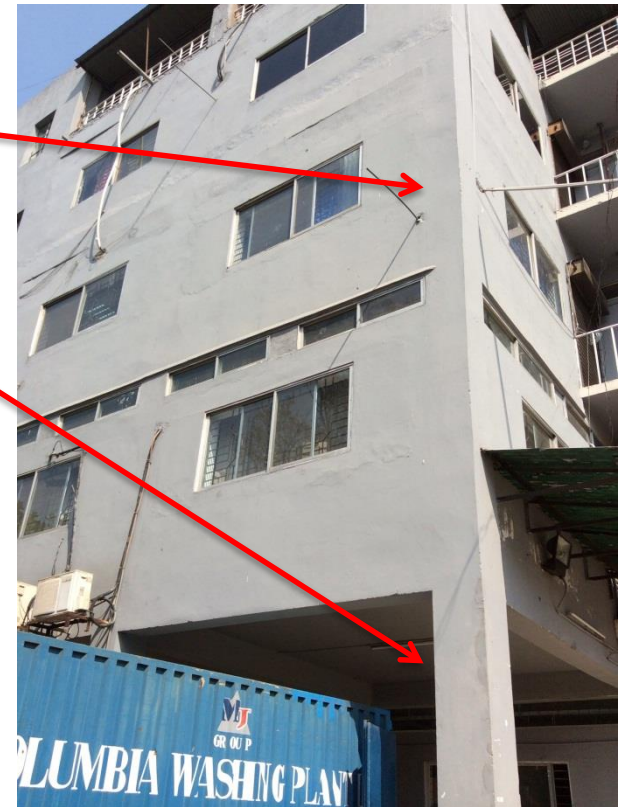
Column exposed to vehicle impact

Column supporting several stories exposed to vehicle impact in loading area
No physical barrier to collision

Risk of vehicle impact to column

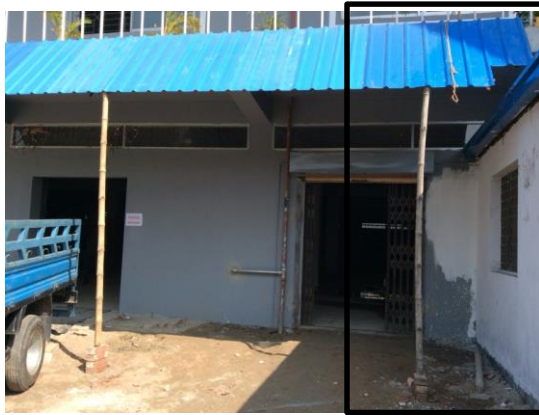
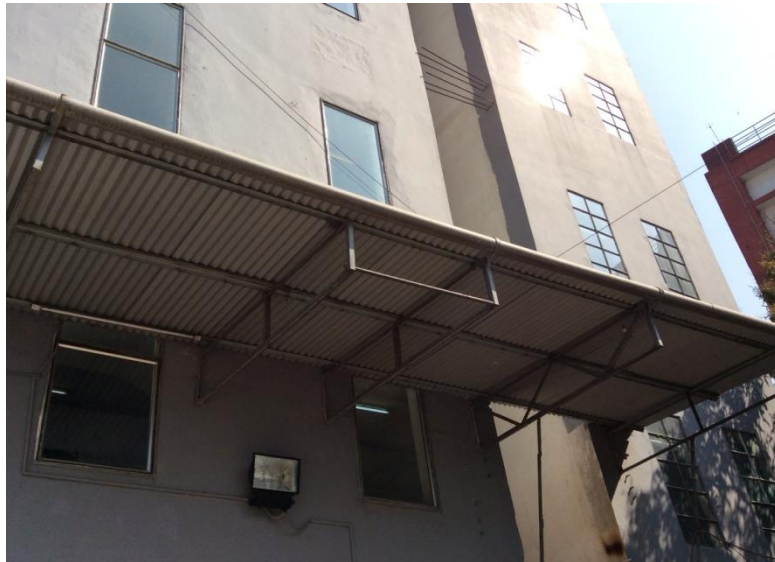
Non-engineered structures - canopies

Canopies and supports seem unstable
Danger of localised collapse

Item No.	Observation	Recommended Action Plan	Recommended Timeline
15	Canopy and supports at main building appear non-engineered	Building Engineer to check the supports and propose revised supports to ensure stability under dead, live and accidental loading.	6-weeks
16	Canopy and supports at main building appear non-engineered	Support details to be upgraded as per building engineer's design.	6-weeks
17	Water causing damage and corrosion on façade due to unmanaged drainage	Manage drainage from above levels and water tanks to downpipes to avoid structural corrosion due to continuous moisture.	6-months
18	Water causing damage and corrosion on façade due to unmanaged drainage	Exposed reinforcement not to be used for any structural applications	6-months
19	Rear wall of security hut/boundary wall appears non-engineered and leaning.	Factory engineer to check stability of wall and propose remedial actions.	6-weeks

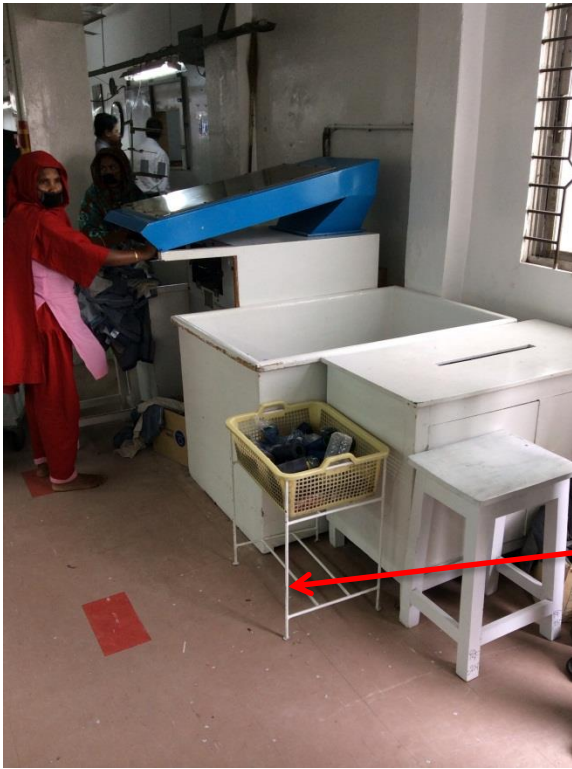
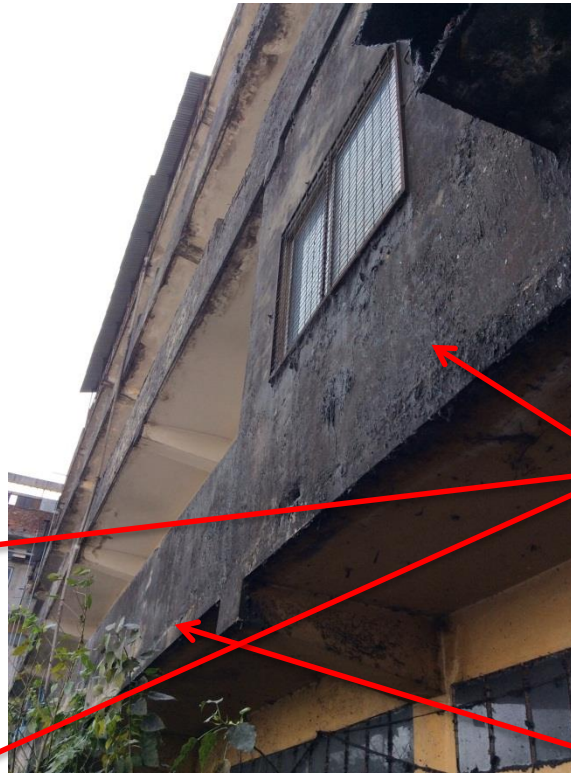
Non-engineered structures – extension onto balcony

Factory floor built out onto balcony with additional masonry walls built to full storey height

Normal balcony (not shown on drawings)

14	Building extension onto cantilever balcony requires engineering check	Building Engineer to check the cantilever beams and slabs to ensure adequate load carrying capacity. Note also Item 1 requirement for DEA	6-weeks

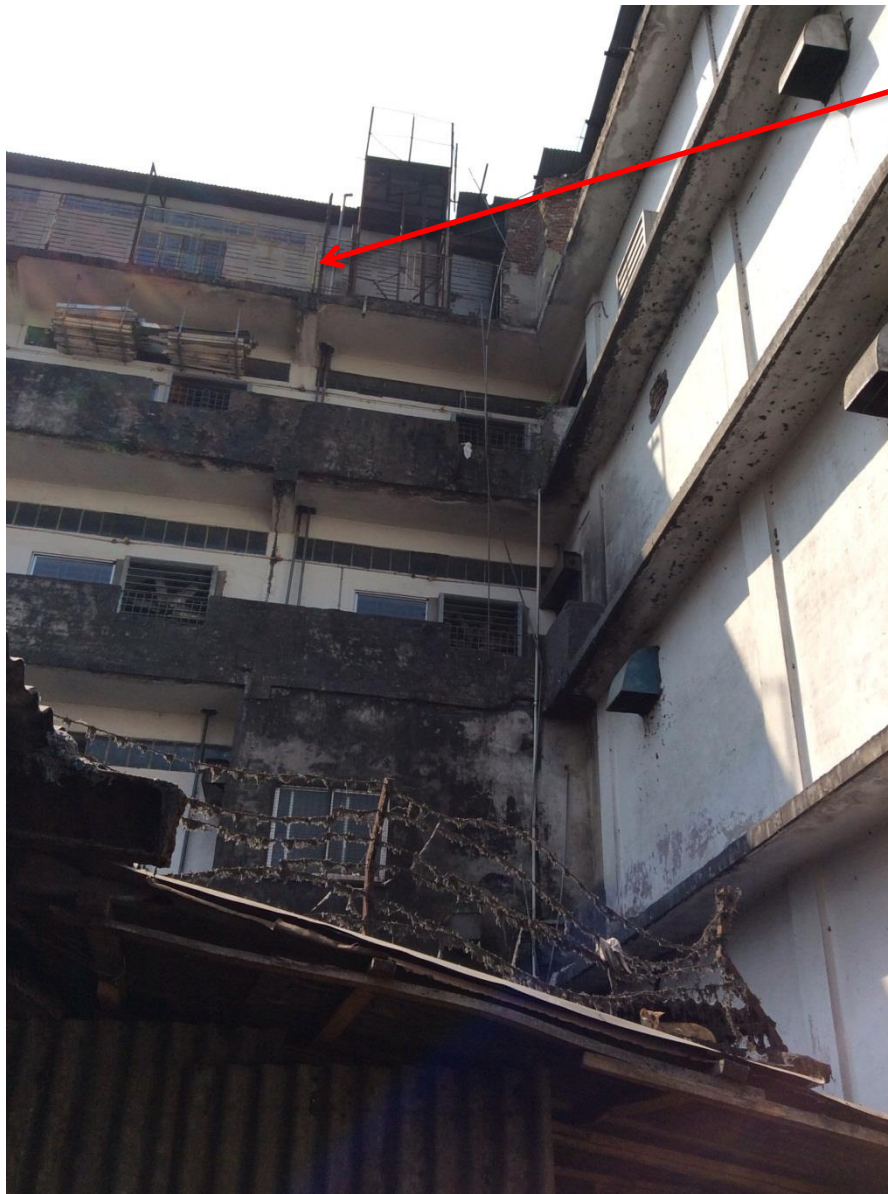
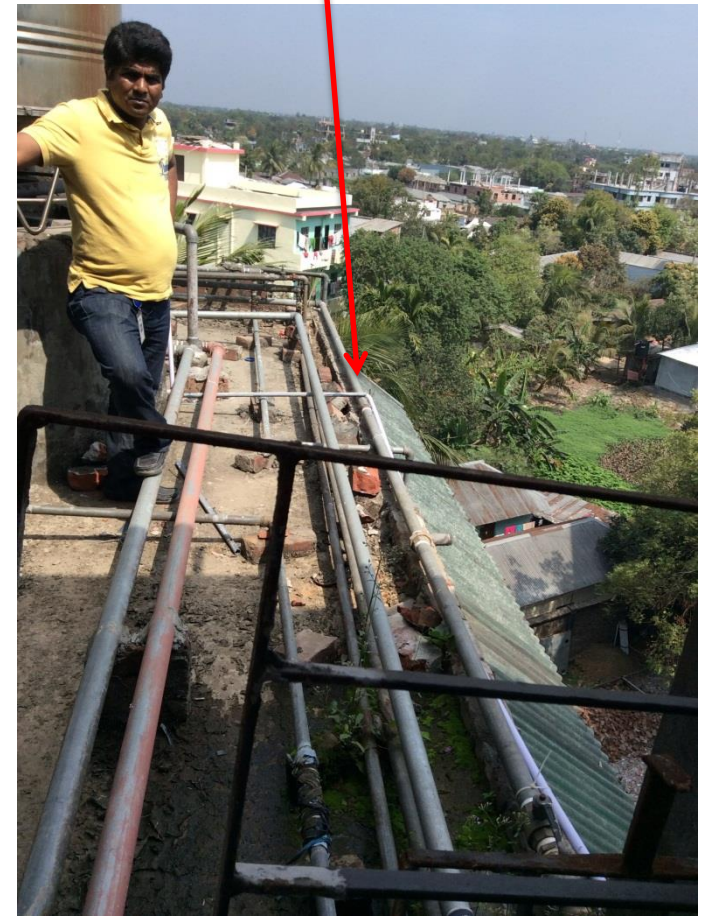
Non-engineered structures – edge protection

Non engineered railing to balcony at high level

Lack of edge protection near water tanks

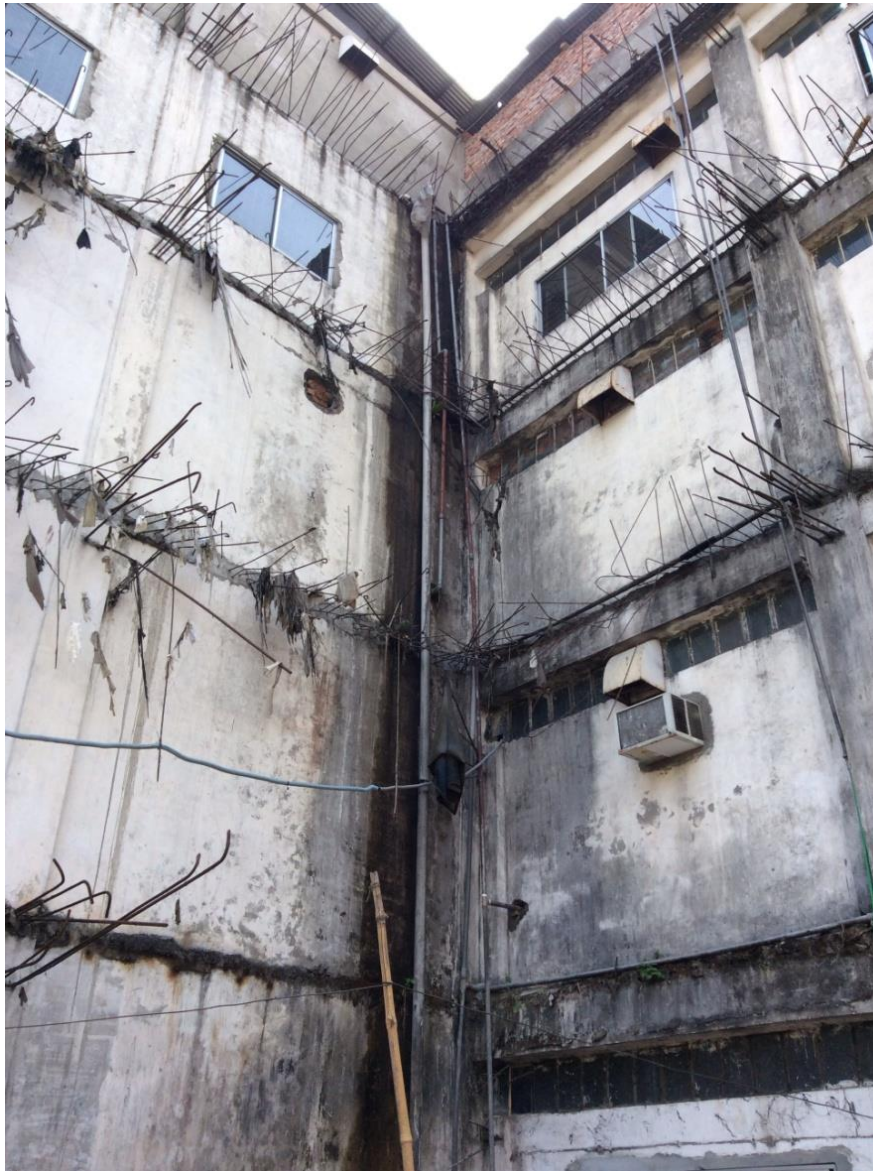
Water causing damage and corrosion

Reinforcement unsuitable for use in future horizontal extensions due to corrosion

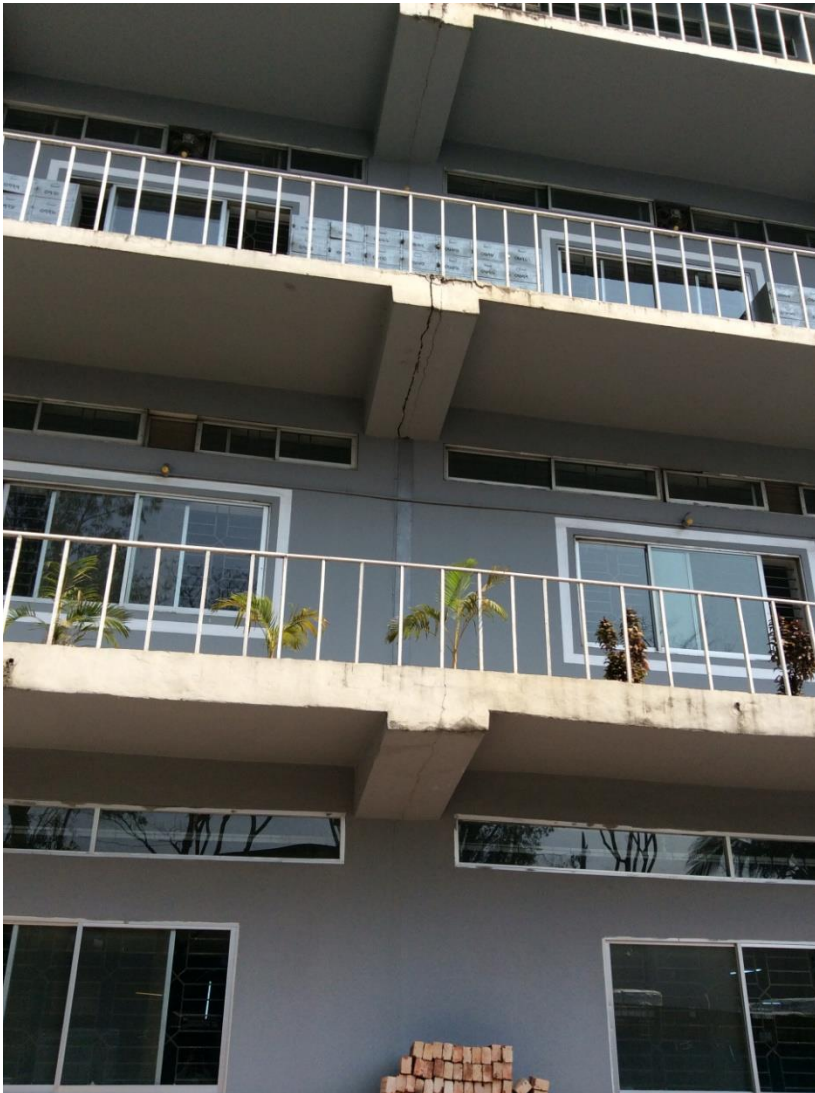
Movement joint cracking (non-structural)

Movement joint cosmetic cracking

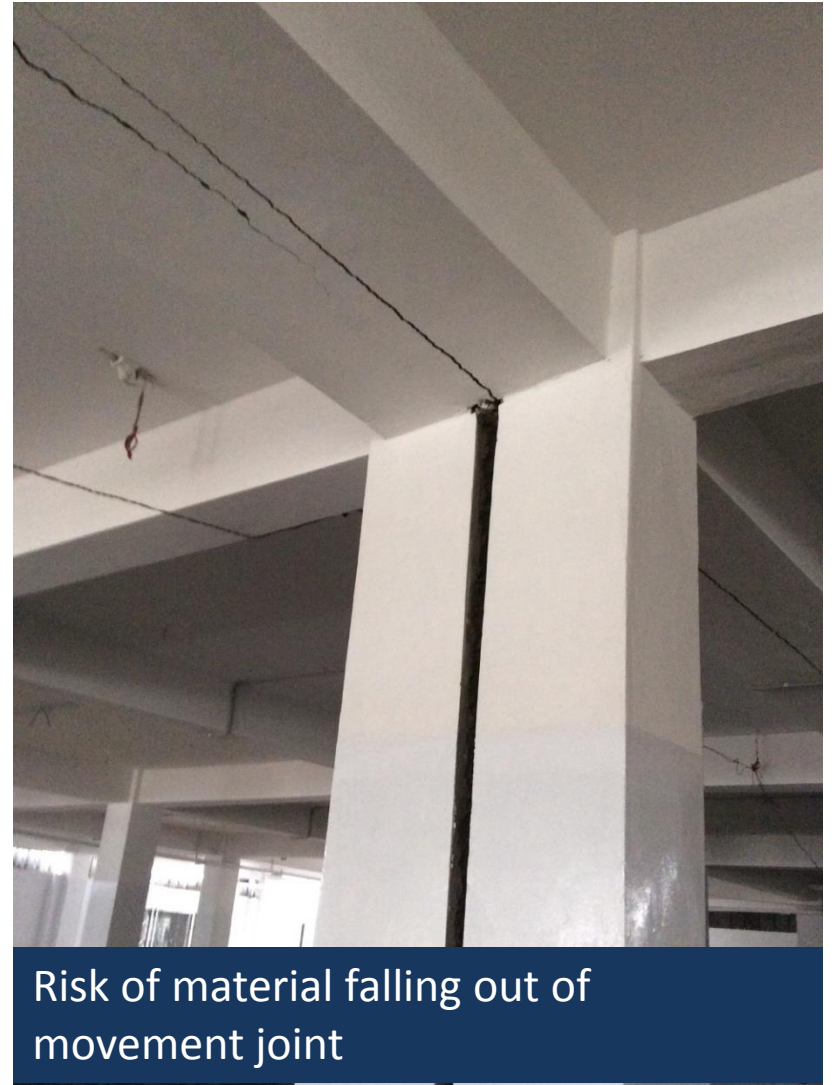
Risk of material falling out of movement joint
