# Mondol Fabrics Ltd

Nayapara, kasimpur, Gazipur  
(23.990028N, 90.317336E0)

8th March 2014

# Observations

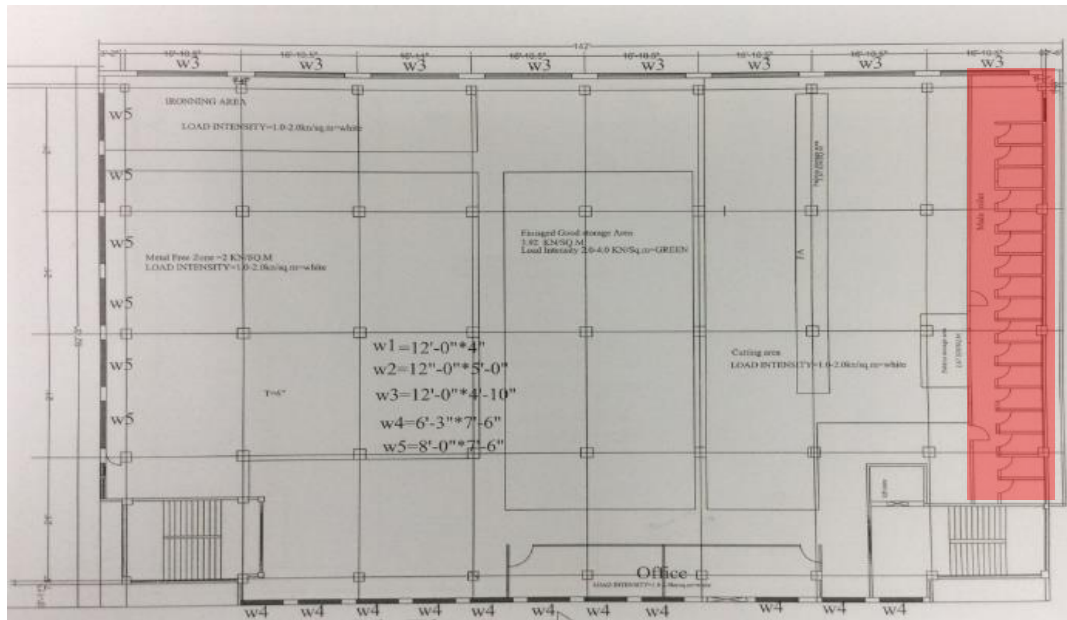
# **Column Stresses in Toilet Area – North of Building**

Cursory calculations indicate that column size appears to be smaller than required by code for the applied live & dead (including floor buildup, brick walls, roof slab over toilets and 2 external walls) live load, assuming typical concrete strength

Building Engineer to perform detailed calculations and concrete tests to prove column size and if required:

- Reduce loads further by removal of heavy walls and floor build-up
- Carry out strengthening works

| Item No. | Observation | Recommended Action Plan | Recommended Timeline |
|---|---|---|---|
| 1 | Column Stresses in toilet area | Building Engineer to review design, loads and columns in the area identified above. | 6-weeks |
| 2 | Column Stresses in toilet area | Verify insitu concrete stresses from existing cylinder strength data or 100mm diameter cores (taken from non critical area as determined by building engineer) | 6-weeks |
| 3 | Column Stresses in toilet area | Update load plans with safe design load as determined by building engineer | 6-months |

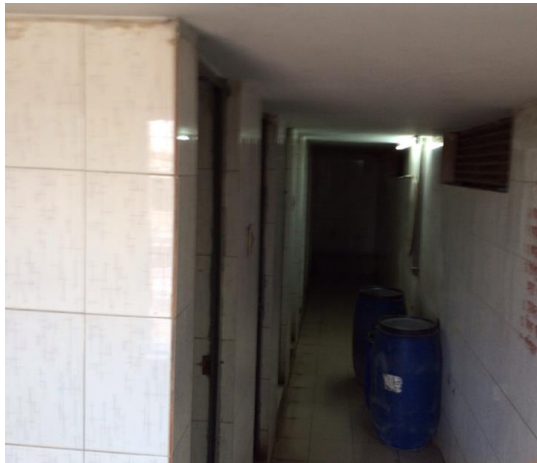
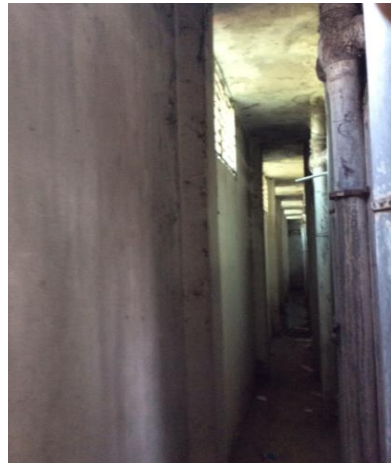
Toilet Area: Columns supporting weight of walls, floor build up, roof slab & 2 façade walls each level.

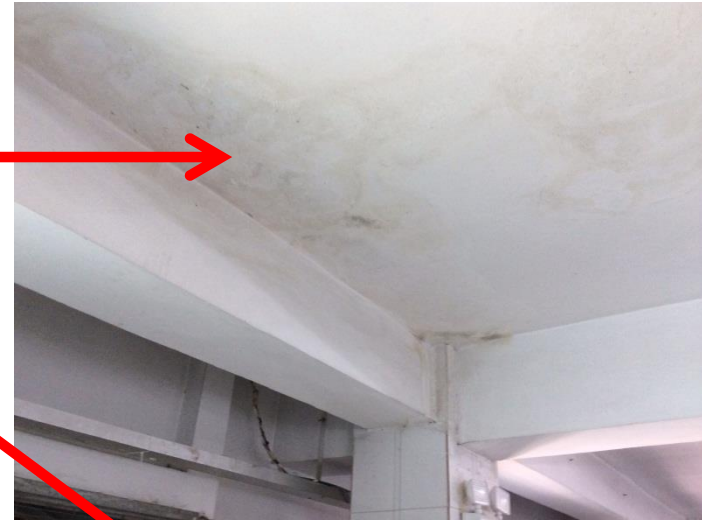
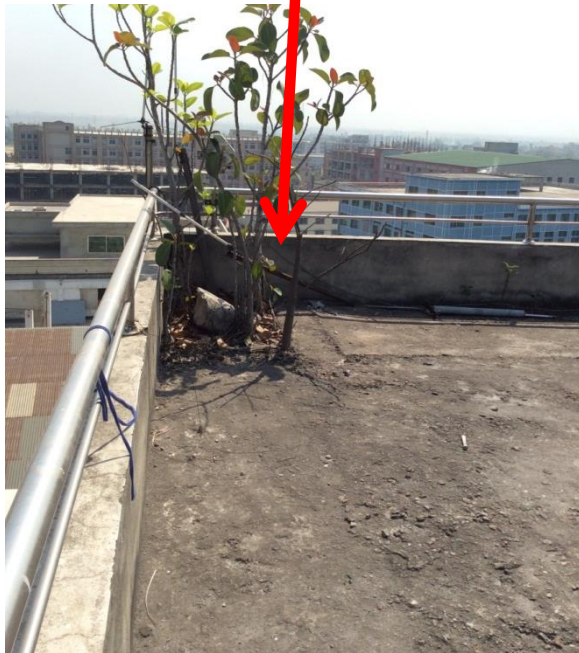
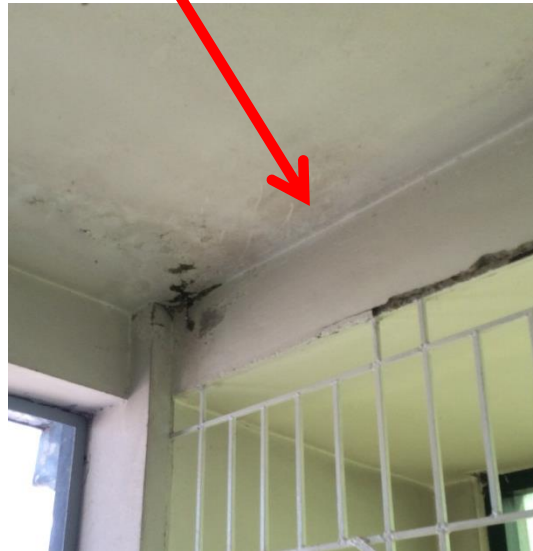
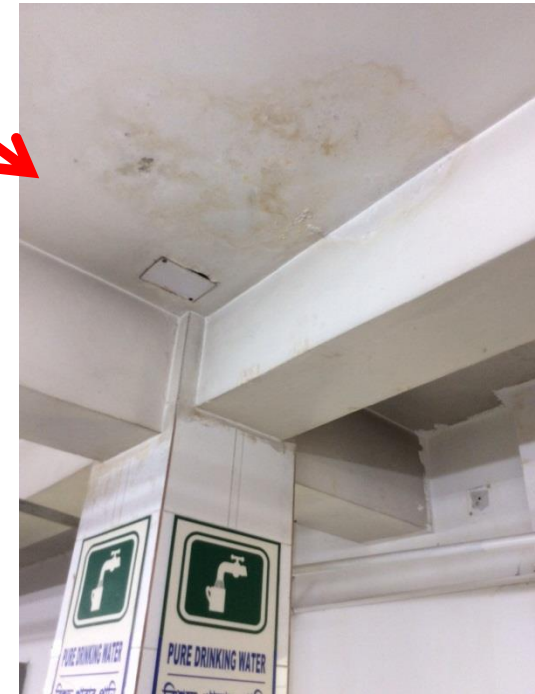
**Water damage - General**

Water damage observed throughout. Building should be generally assessed for sources of leaking water

| Item No. | Observation | Recommended Action Plan | Recommended Timeline |
|---|---|---|---|
| 4 | Water Damage & Vegetation Growth | Roof moisture protection and drainage system to be installed in area where previous roof has been removed | 6-months |
| 5 | Water Damage & Vegetation Growth | Downpipes to be repaired throughout | 6-months |
| 7 | Water Damage & Vegetation Growth | Engineer to inspect water damaged structure including the exterior and propose a suitable repair. | 6-months |

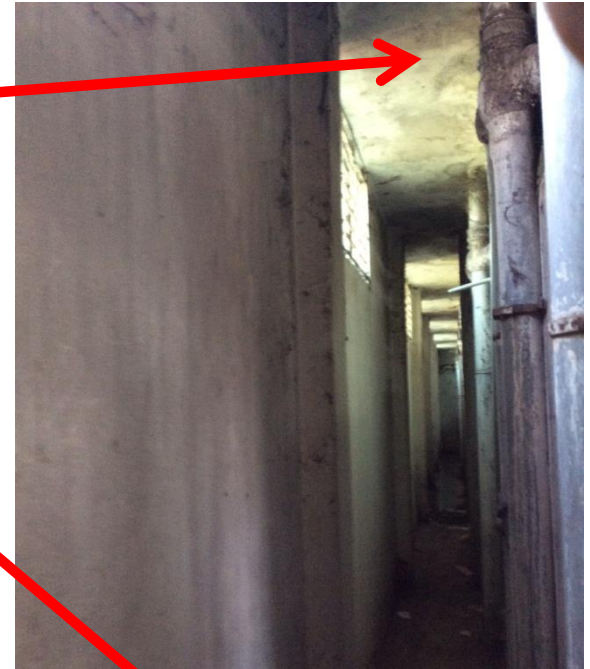
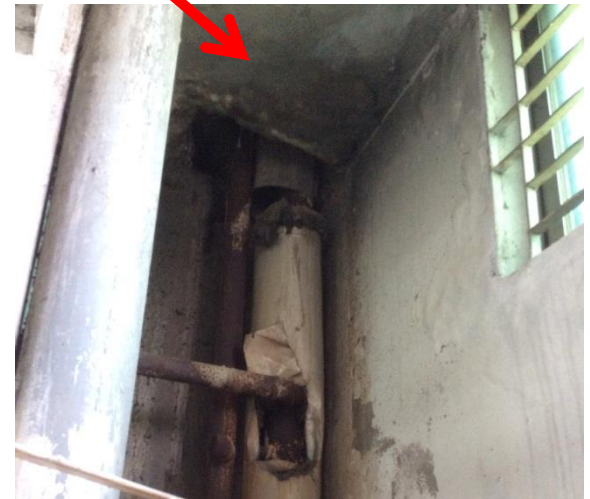
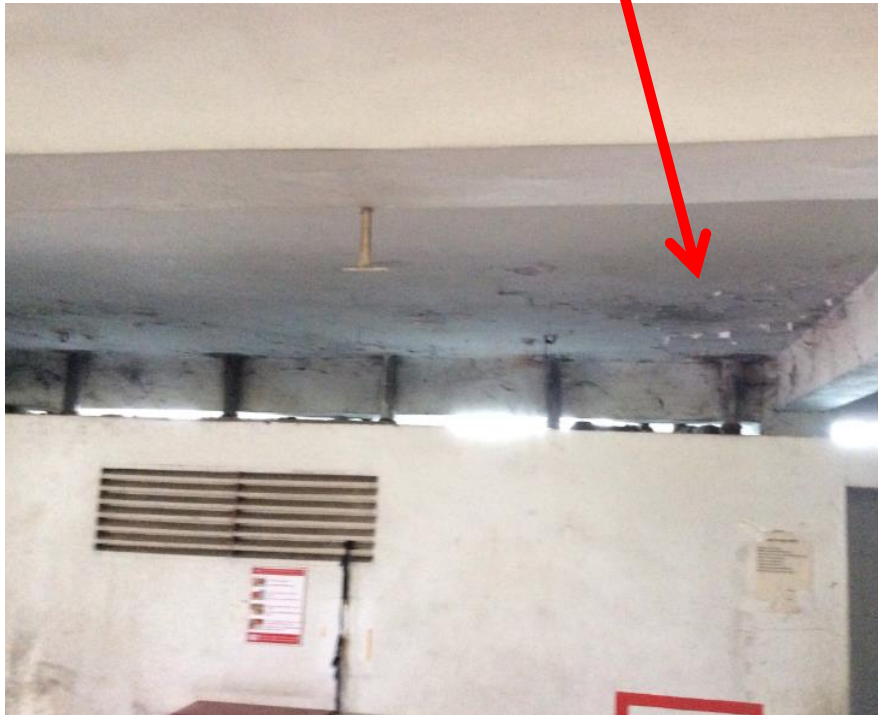
**Water damage – Toilet Area**

Leaking water Pipes in toilet areas causing corrosion to structure

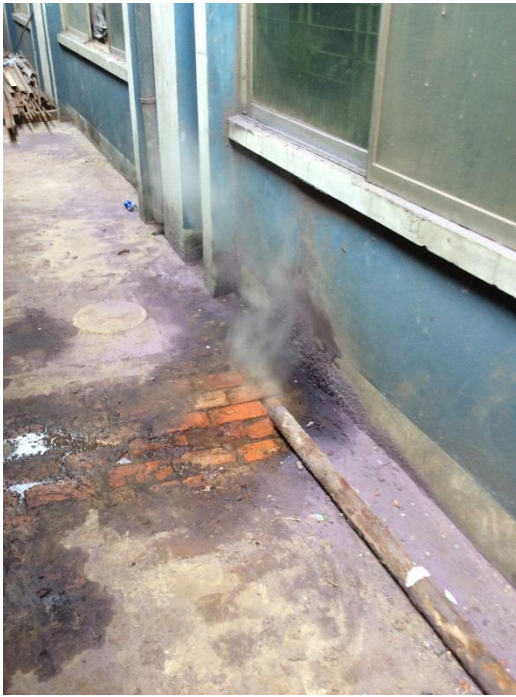
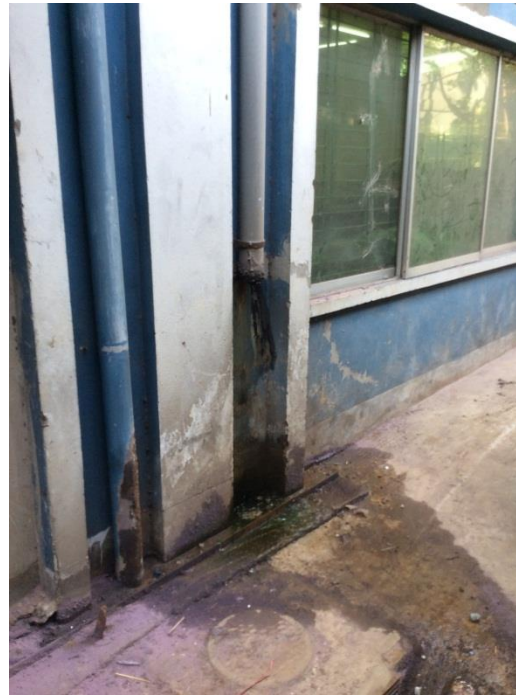
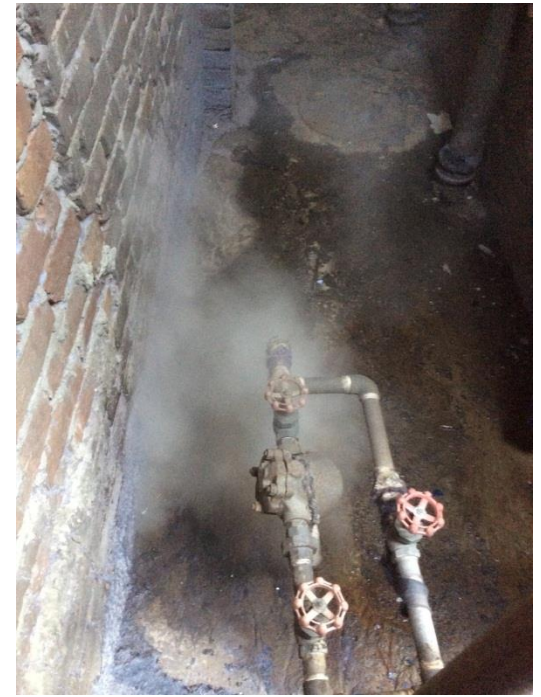
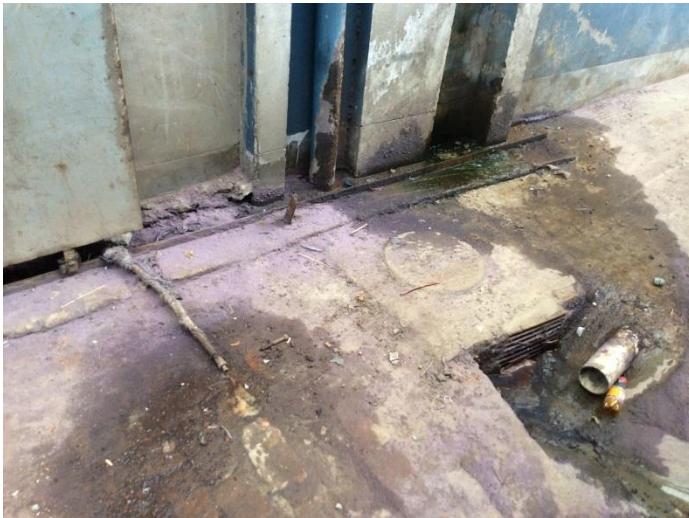
**Water damage**

**Steam rejection causing constant wetting .**

**Unmanaged leaking water drainage from steam pipes causing corrosion to façade and structure.**

| Item No. | Observation | Recommended Action Plan | Recommended Timeline |
|---|---|---|---|
| 6 | Water Damage & Vegetation Growth | Steam-pipes to be repaired throughout | 6-months |

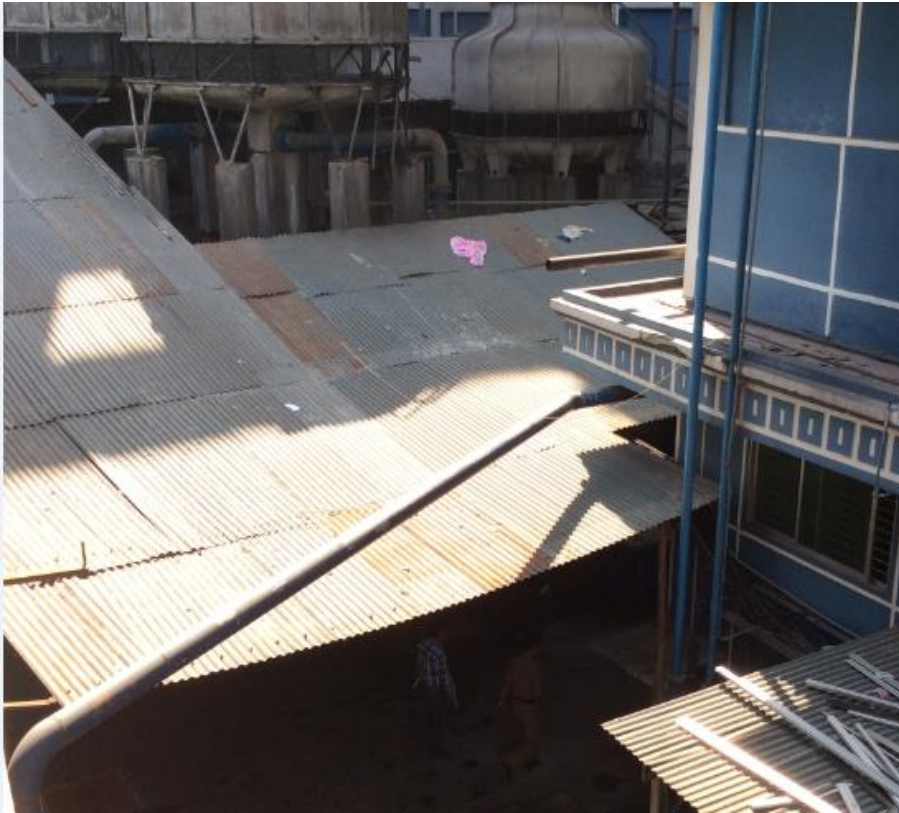
**Non-engineered steel roof structure between building 3 and 1 is unlikely to be able to withstand strong wind events.**

| Item No. | Observation | Recommended Action Plan | Recommended Timeline |
|---|---|---|---|
| 8 | Lightweight Roof Structures | Steel structure should be designed and upgraded to support code vertical and wind loads by the Building Engineer, or alternatively remove. | 6-months |

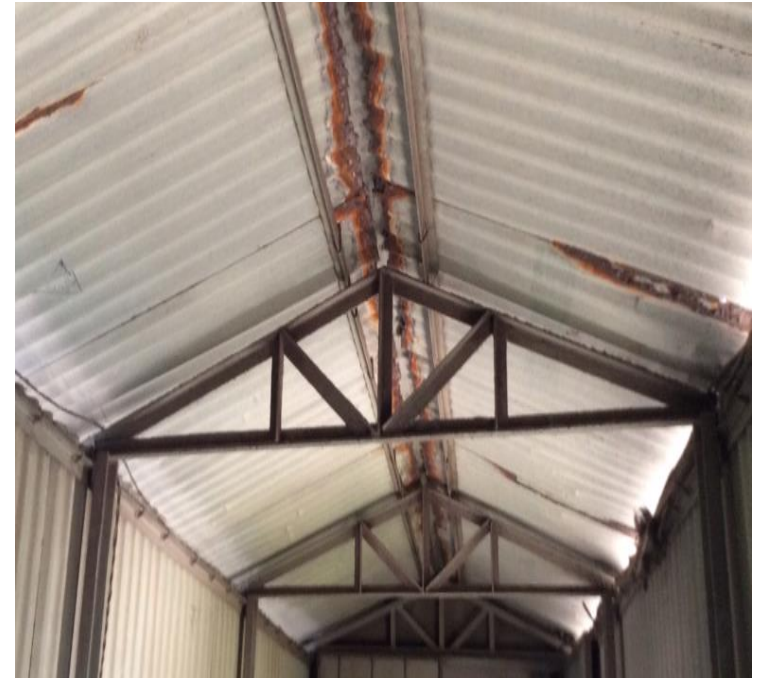
**Corrugated roof sheeting to bridge corroded and in need of repair**

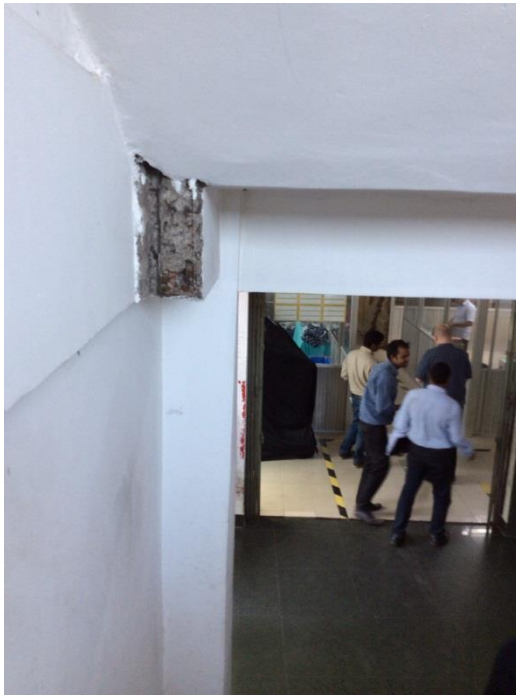
# Beam in northern Stair Core –Soffit of 4<sup>th</sup> Floor

**Exposed beam appears to have been cut back. Building Engineer to assess and confirm adequacy.**

**Repair Mortar to be applied to prevent further corrosion of concrete.**

| Item No. | Observation | Recommended Action Plan | Recommended Timeline |
|---|---|---|---|
| 9 | Beam in North East Stair landing – Soffit of 4th Floor | Building Engineer to inspect beam and confirm that the structure is adequate. | 6-months |
| 10 | Beam in North East Stair landing – Soffit of 4th Floor | Suitable concrete repair mortar to be applied to prevent deterioration of reinforcement | 6-months |

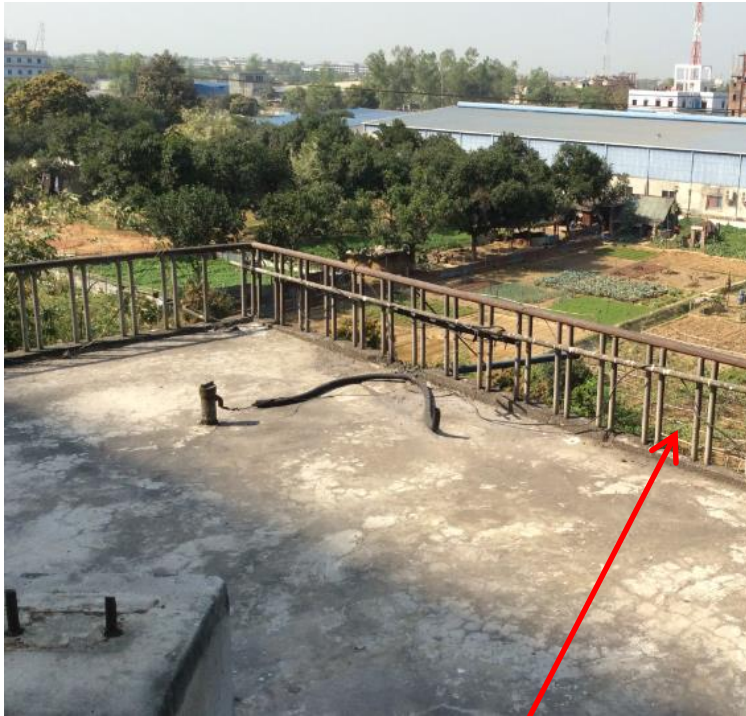
# **Accommodation Building: Low edge protection at Roof Level - Safety Concern**

**Low Barrier is not suitable for safe edge protection roof slab. Adequate edge protection steel balustrade to be installed on all 4 sides of building or prevent access to the roof**

| Item No. | Observation | Recommended Action Plan | Recommended Timeline |
|---|---|---|---|
| 11 | Safety rail in adjacent building | Install Safety barrier to minimum 1.1m height or restrict access | 6-months |
