# S M Knitwears Ltd

Shirichala, Bhabanipur, Gazipur

13<sup>th</sup> April 2014

# Observations

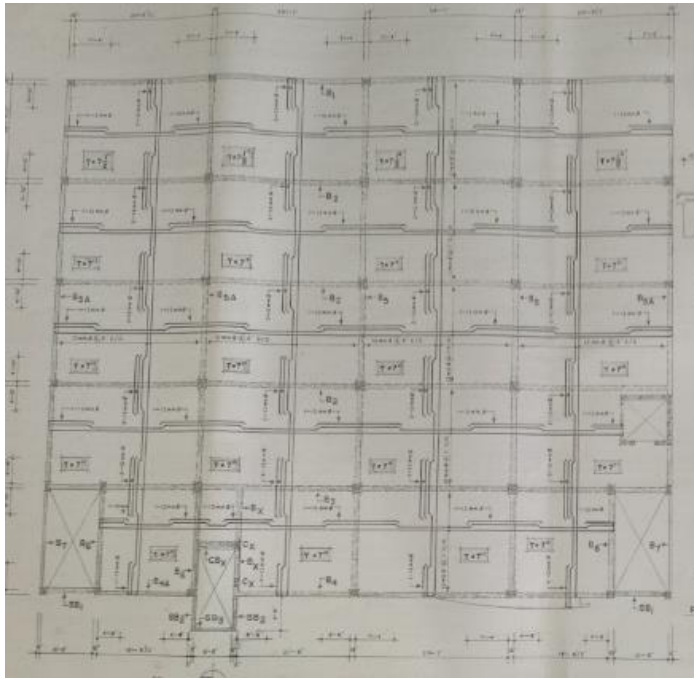
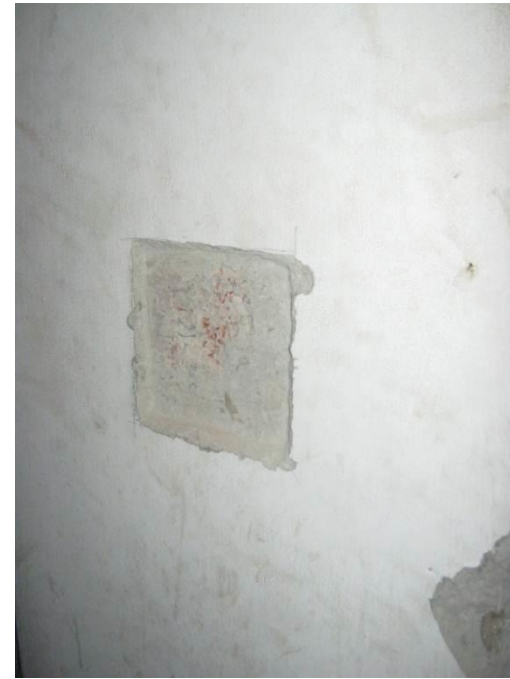
# **Building 1 (Original): Concrete Stress Levels in Columns**

Preliminary calculations indicate that column working stress is at a high level in Building 1 (Original).

A Detailed Engineering Assessment of the building is required (see attached scope). The engineer is to perform detailed calculations based on the 'as constructed' structural arrangement, material properties and loading to verify column size suitability. If required, column loading shall be reduced, and columns possibly strengthened.

| Item No. | Observation | Recommended Action Plan | Recommended Timeline |
|---|---|---|---|
| 2 | Building 1 -<br>Verify load capacity of all columns. | For all columns in building engage a structural engineer to review loads, design, and concrete stress. | <b>Immediate - Now</b> |
| 3 | Building 1 -<br>Verify load capacity of all columns. | Verify insitu concrete stresses either by 100mm diameter cores or existing cylinder strength data for 4 columns. | <b>Immediate - Now</b> |
| 4 | Building 1 -<br>Verify load capacity of all columns. | A Detailed Engineering Assessment of Factory to be commenced; see attached scope. | <b>Immediate - Now</b> |

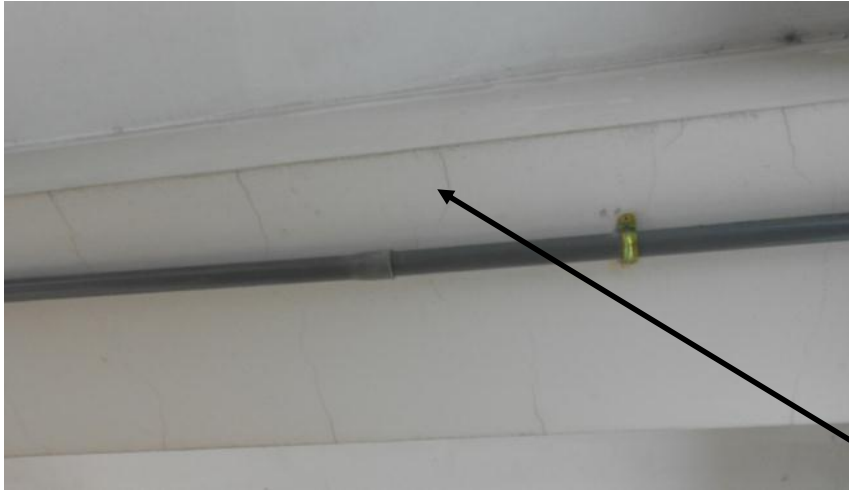
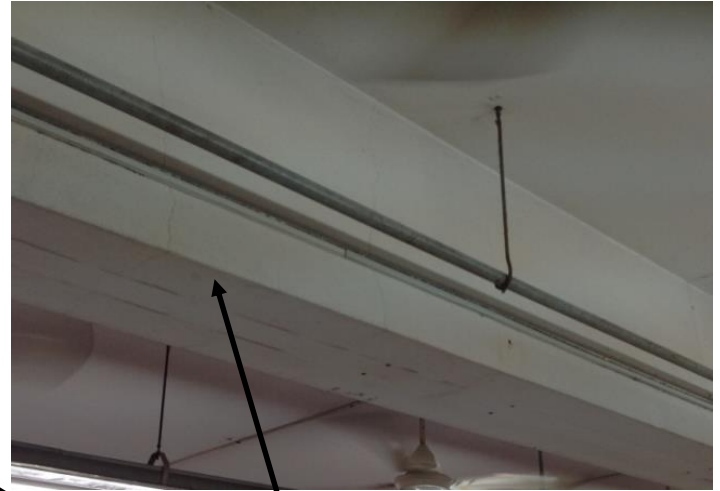
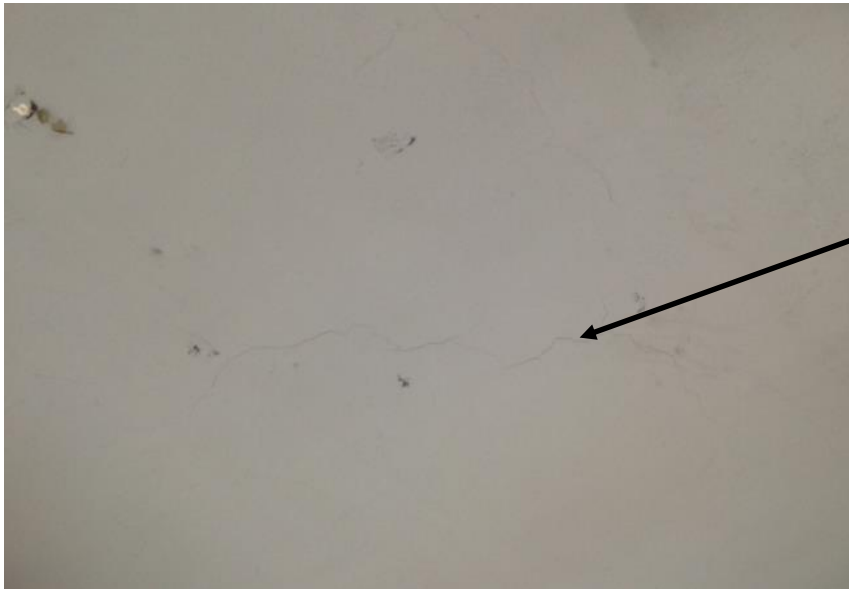
# **Building 1 (Original): Cracking in Beams and Slabs**

Cracking observed to the soffit of beams and slabs in a number of locations.

| Item No. | Observation | Recommended Action Plan | Recommended Timeline |
|---|---|---|---|
| 9 | BUILDING 1<br>Cracking in slabs and beams, and at interfaces between masonry and reinforced concrete | As part of the Detailed Engineering Assessment the Engineer to investigate if cracks are only in the nominal render finish | 6-weeks |
| 10 | BUILDING 1<br>Cracking in slabs and beams, and at interfaces between masonry and reinforced concrete | If cracks are structurally significant, close working areas below the affected areas, and engineer to specify repairs and strengthening. | 6-weeks |
| 11 | BUILDING 1<br>Cracking in slabs and beams, and at interfaces between masonry and reinforced concrete | Carry out above works as required. | 6-months |

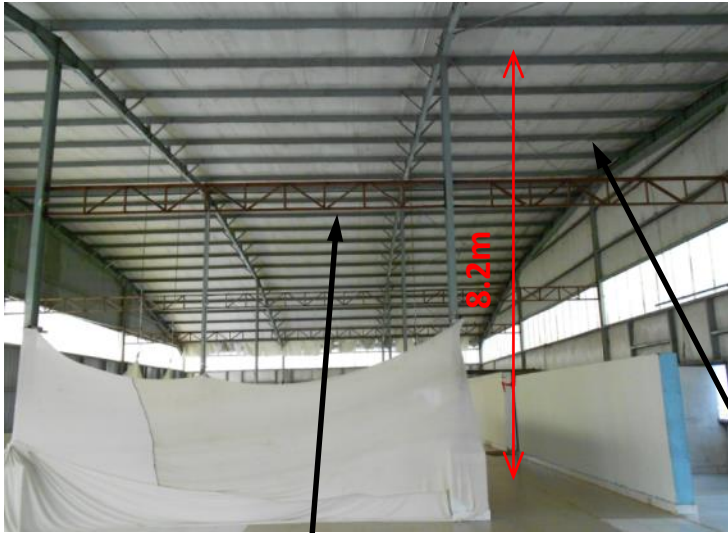
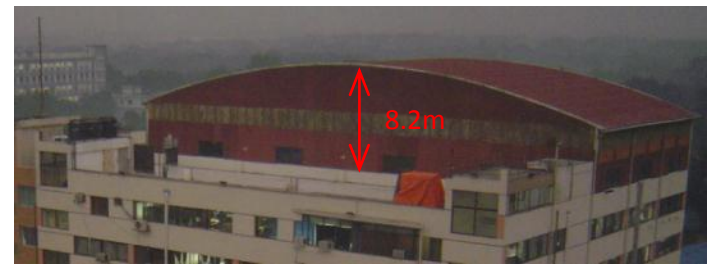
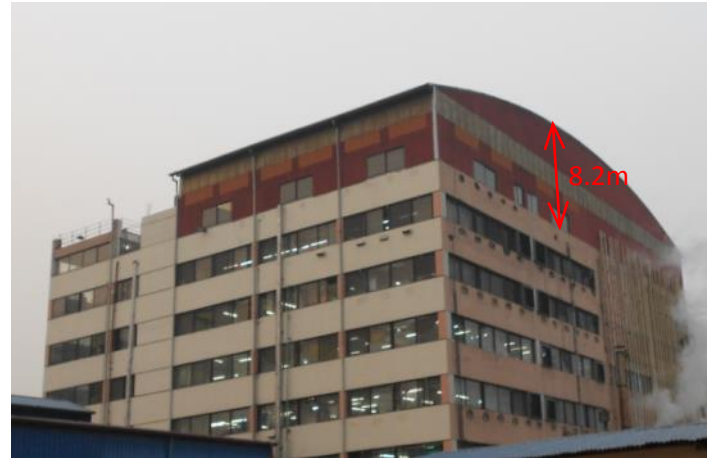
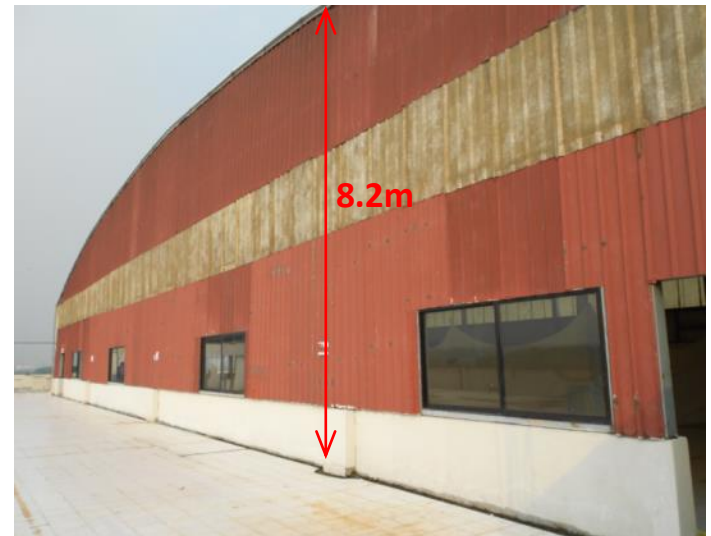
# **Building 1 (Original): Stability of Rooftop Steel Frame**

Trusses assumed installed at a later date than main steel frame.

Cross-bracing.

The stability system of the 8.2m high steel roof appears inadequate for design wind load. Building Engineer to review and design the steel frame for design wind loads.

| Item No. | Observation | Recommended Action Plan | Recommended Timeline |
|---|---|---|---|
| 12 | BUILDING 1<br>Stability of rooftop steelwork shed | As part of the Detailed Engineering Assessment Engineer to undertake calculations to assess the vertical and lateral load-carrying capacity of the rooftop steelwork shed and it's support structure, and to specify any necessary alterations or repairs as required. | 6-weeks |
| 13 | BUILDING 1<br>Stability of rooftop steelwork shed | Carry out works as required. | 6-months |

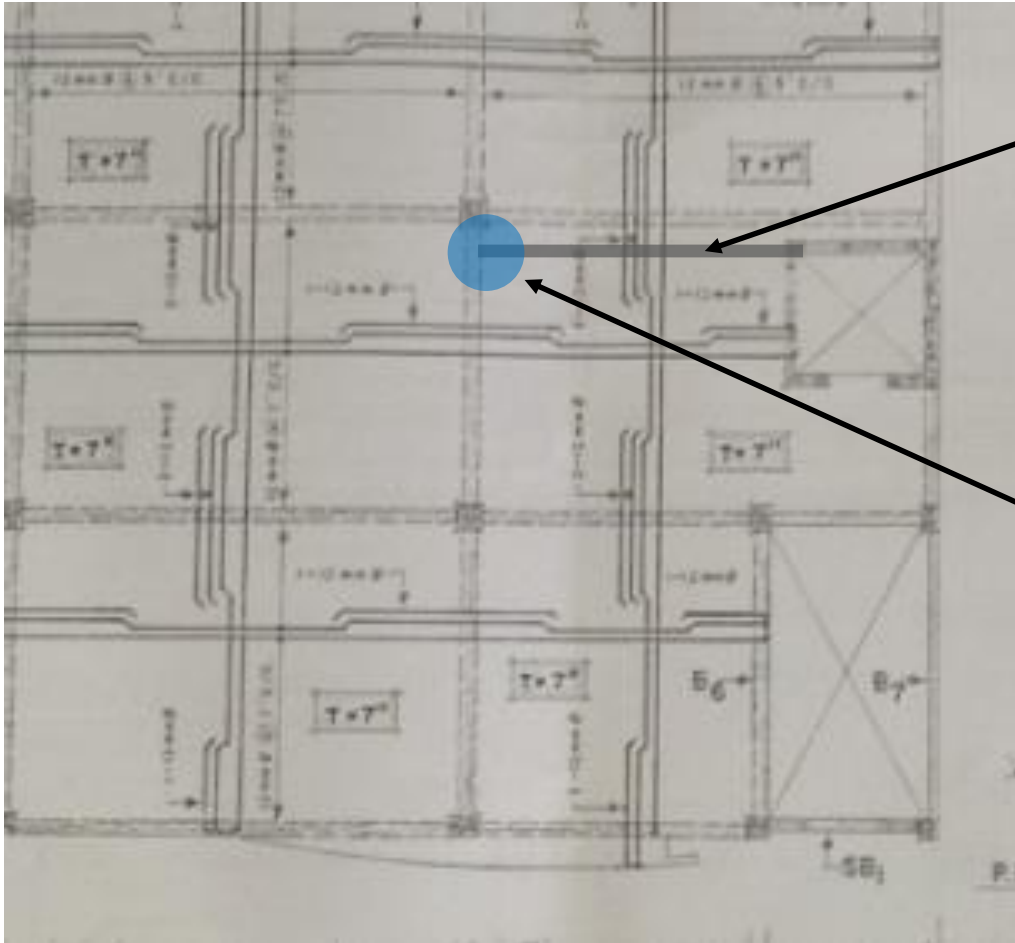
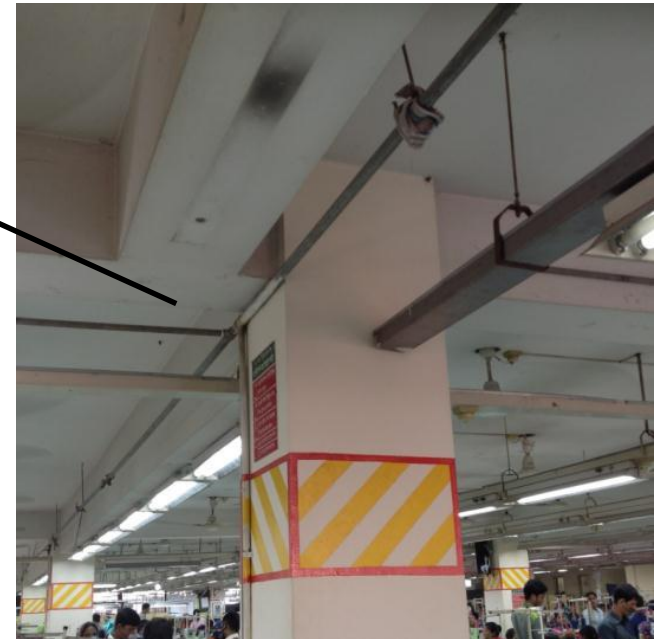
# **Building 1 (Original): Primary/Secondary Beam Arrangement**

Beam 'as-built' aligns with lift wall, which is not reflected on drawings), resulting in 'primary'/ 'secondary' beam arrangement.

| Item No. | Observation | Recommended Action Plan | Recommended Timeline |
|---|---|---|---|
| 14 | BUILDING 1<br>Primary/secondary beam arrangement adjacent to the southern lift core | As part of the Detailed Engineering Assessment Engineer to assess the suitability and capacity of the primary/secondary beam arrangement adjacent to the southern lift core. | 6-weeks |
| 15 | BUILDING 1<br>Primary/secondary beam arrangement adjacent to the southern lift core | Produce 'as-built' general arrangement structural drawings to reflect actual construction. | 6-months |
| 16 | BUILDING 1<br>Primary/secondary beam arrangement adjacent to the southern lift core | Carry out any remedial works as required. | 6-months |

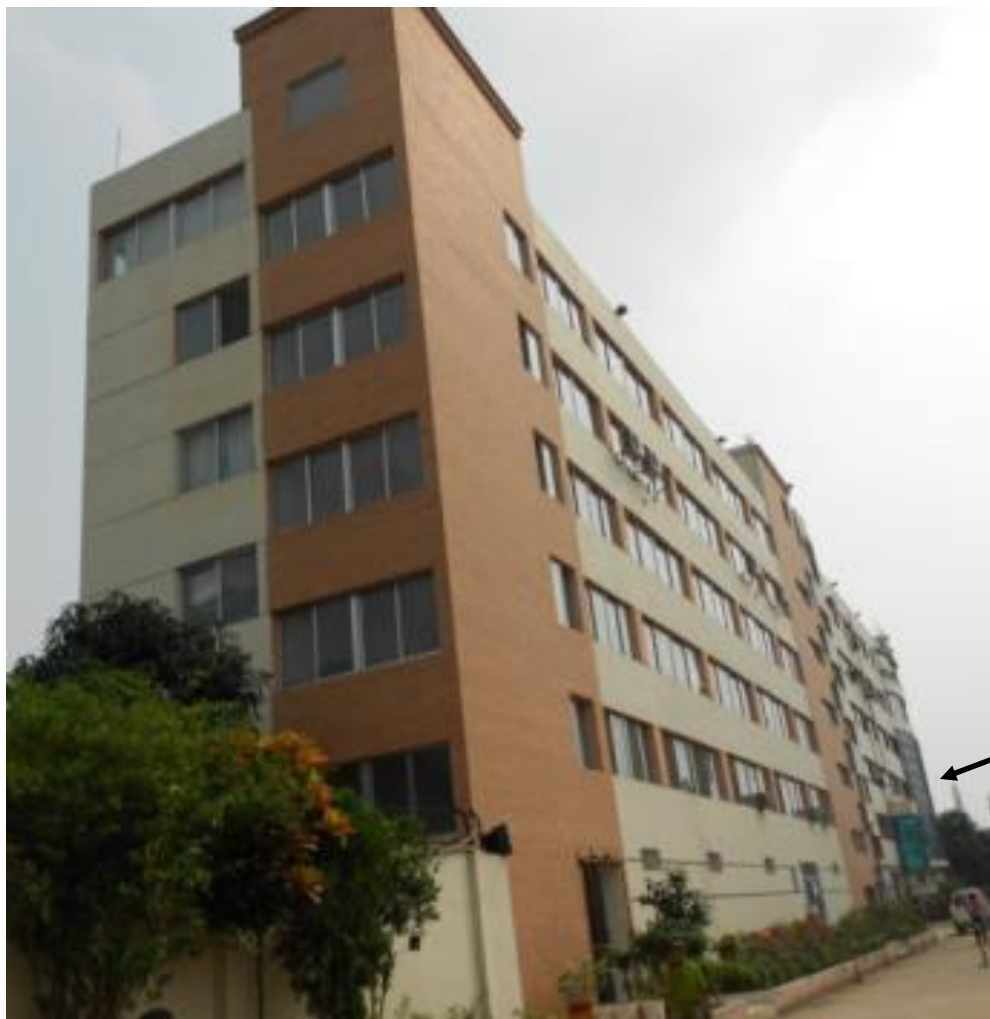
# **Building 1 (Original): Broken Panes of Glass to Main Facade**

Broken panes of glass to main façade presents a significant safety risk to pedestrians on road below and building users.

| Item No. | Observation | Recommended Action Plan | Recommended Timeline |
|---|---|---|---|
| 17 | BUILDING 1<br>Broken panes of glass to main façade | Broken panes of glass to main façade pose significant safety risk, and are to be replaced as soon as practicably possible, and certainly within the six-week timescale noted. | 6-weeks |

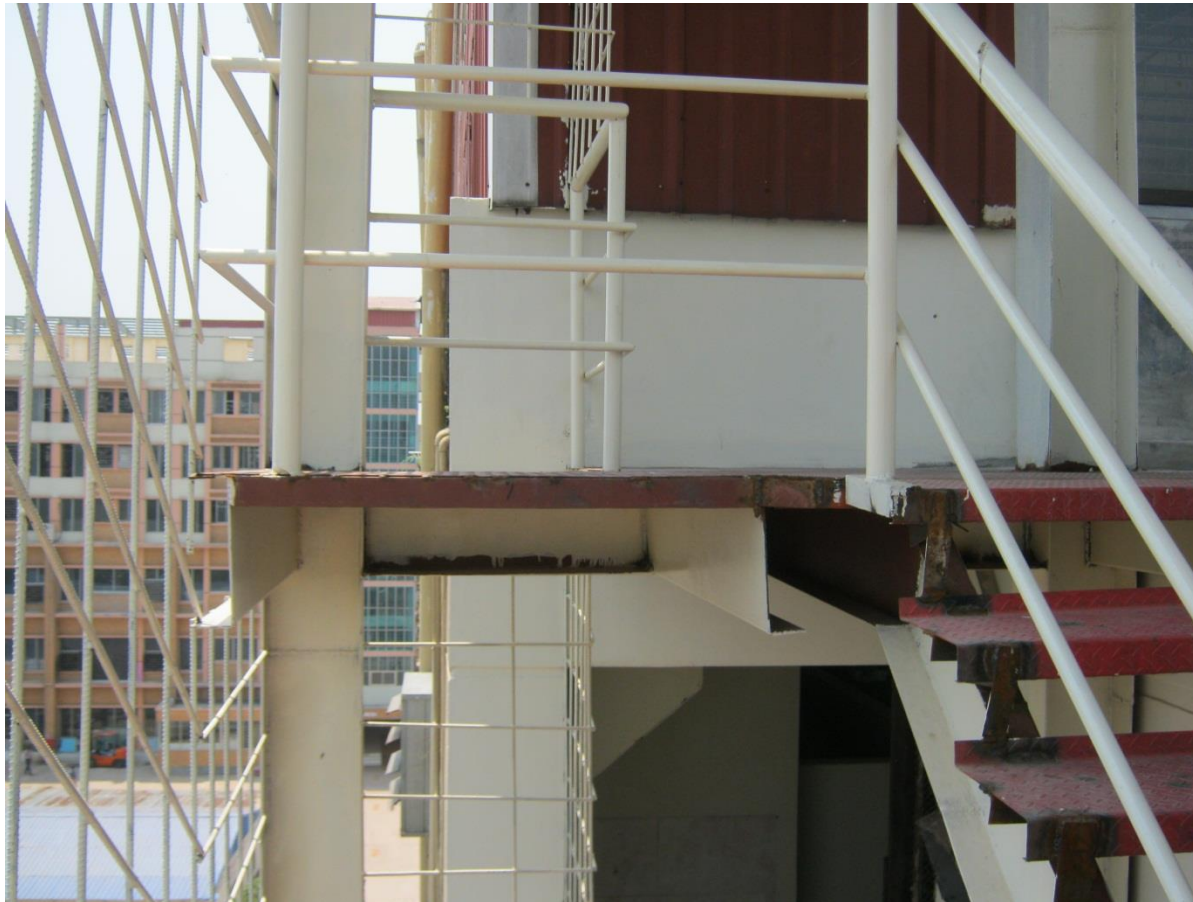
# **Building 1 (Extension): Stability of Steelwork Fire Escape Stair**

The steelwork fire escape stair appeared to be insufficiently braced against lateral loads. Connection details appeared 'non-engineered'.

| Item No. | Observation | Recommended Action Plan | Recommended Timeline |
|---|---|---|---|
| 18 | BUILDING 1<br>Stability of steelwork fire-escape stair | As part of the Detailed Engineering Assessment Engineer to undertake calculations to assess the vertical and lateral load-carrying capacity of steelwork escape stair, and to specify any necessary alterations or repairs as required. | 6-weeks |

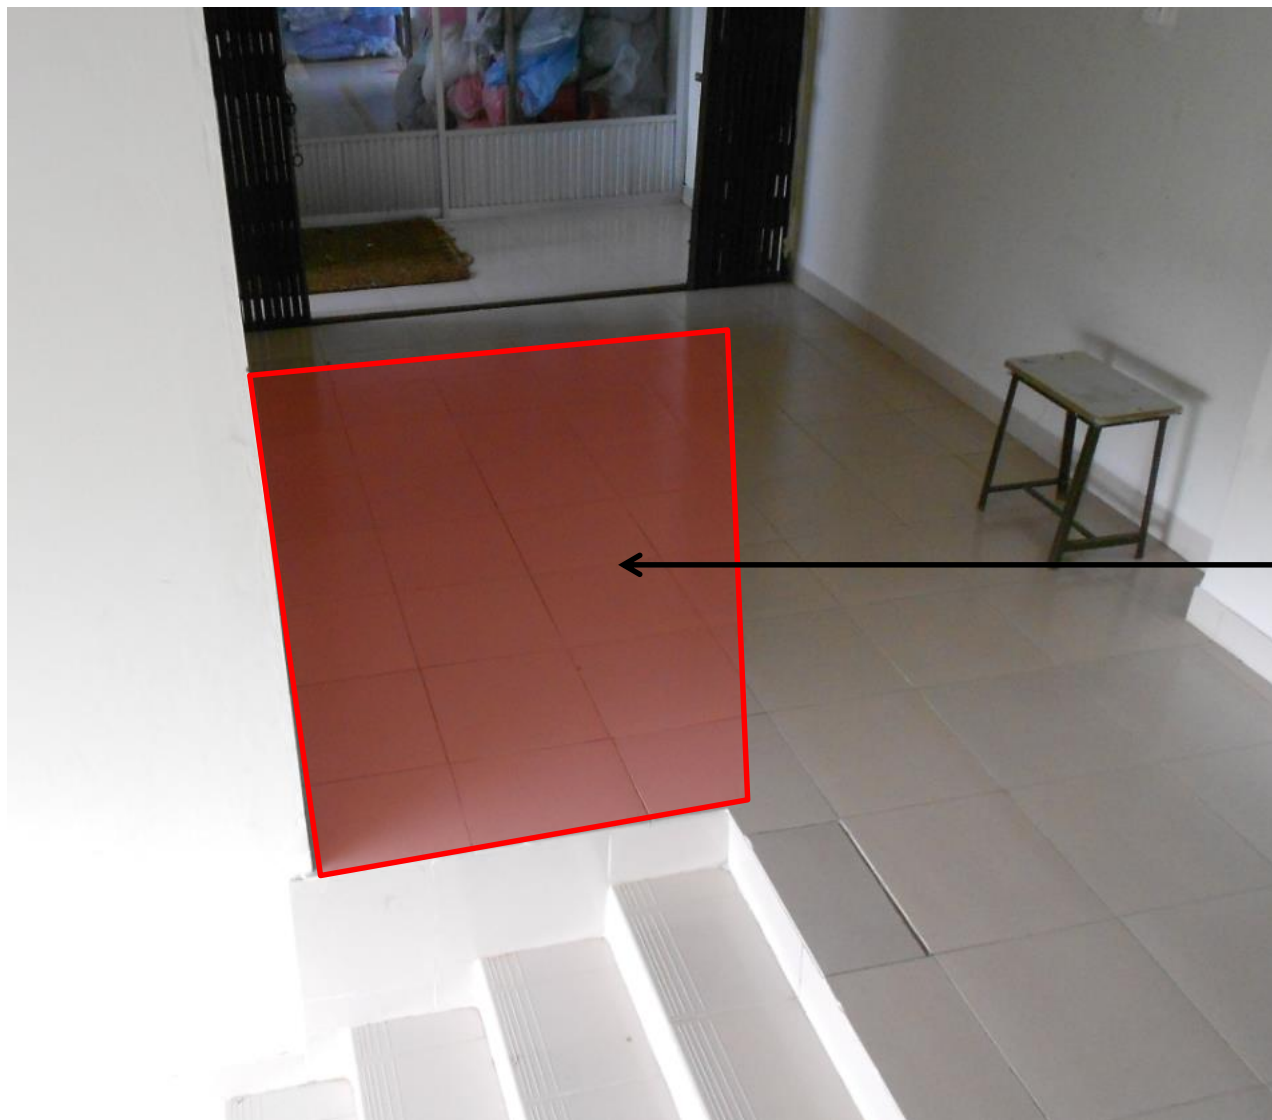
# **Building 1 (Extension): Handrail Required**

Handrail required  
between lift lobby  
and stair at Level 3.

| Item No. | Observation | Recommended Action Plan | Recommended Timeline |
|---|---|---|---|
| 19 | BUILDING 1<br>Inadequate guarding to stair landing | Missing handrail poses significant safety risk. Handrail to be installed as soon as practicably possible, and certainly within the six-week timescale noted. | 6-weeks |

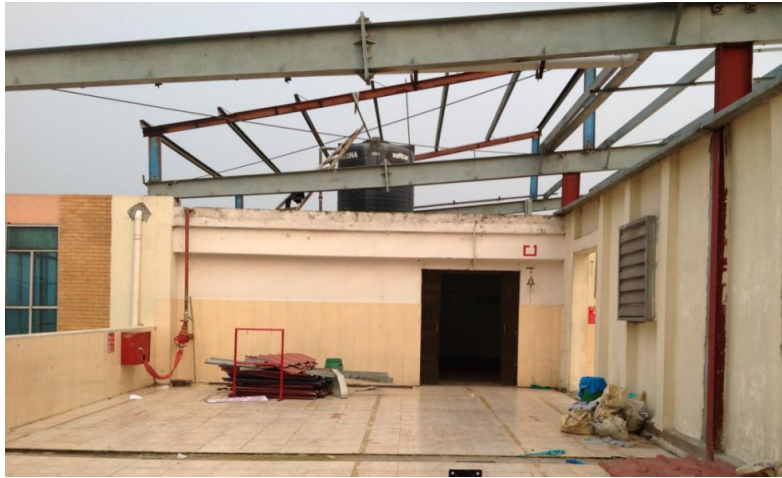
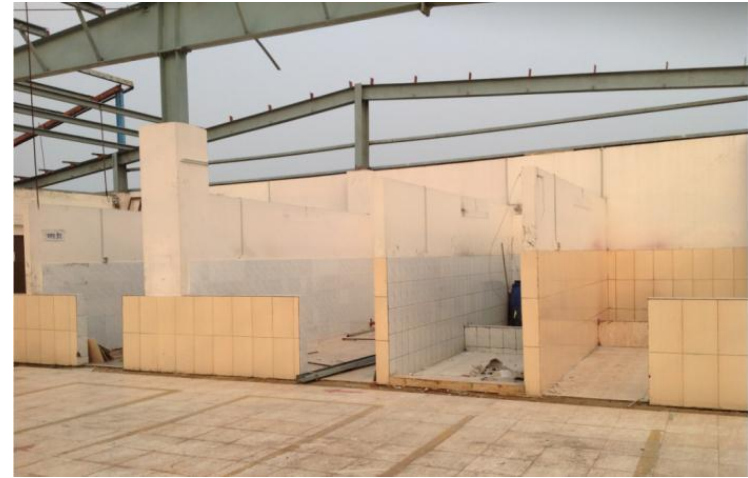
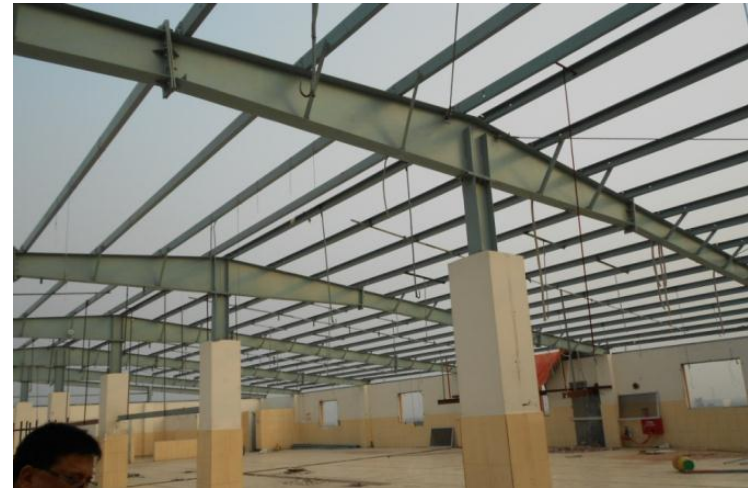
# **Building 2: Rooftop Steelwork Stability & Corrosion Protection**

Stability loadpaths of roof steelwork are unclear; notably the portal frame to the North elevation.

Some areas of corroded steelwork were observed.

Some stockpiled roofing materials were observed.

| Item No. | Observation | Recommended Action Plan | Recommended Timeline |
|---|---|---|---|
| 20 | BUILDING 2<br>Stability of rooftop steelwork frame and corrosion protection | Remove all stockpiled roofing materials (such as roof sheeting) from roof and from building. | Immediate - Now |
| 21 | BUILDING 2<br>Stability of rooftop steelwork frame and corrosion protection | If the rooftop steelwork frame is not being demolished in the forthcoming weeks then as part of the Detailed Engineering Assessment , the Engineer to undertake calculations to assess the vertical and lateral load-carrying capacity of the steelwork frame and it's support structure, and to specify any necessary alterations or repairs as required. | 6-weeks |
| 22 | BUILDING 2<br>Stability of rooftop steelwork frame and corrosion protection | If the rooftop steelwork frame is not being demolished in the forthcoming weeks then any areas of corroded steelwork should be cleaned back to 'bright' and adequate corrosion protection (i.e. paint system) be reinstated. | 6-months |

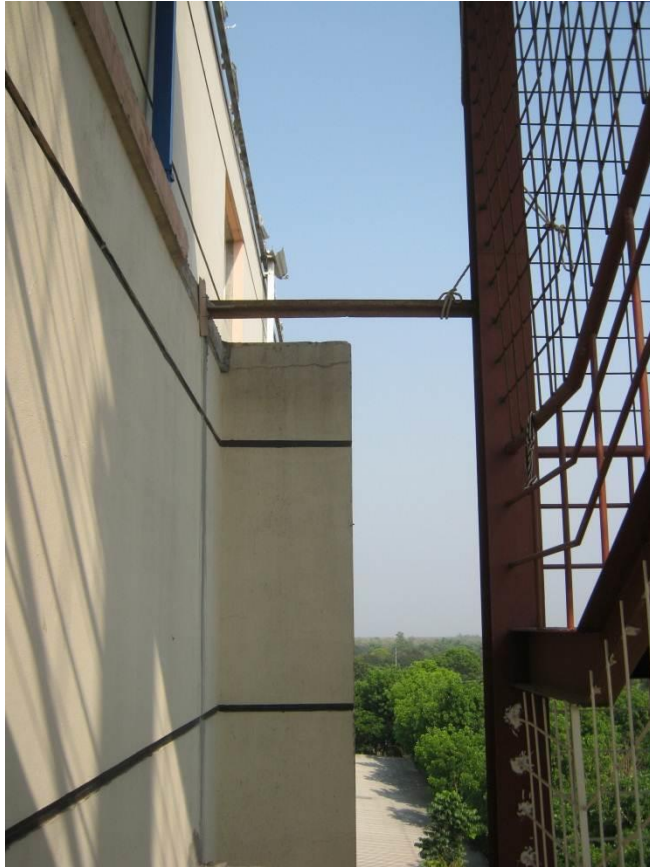
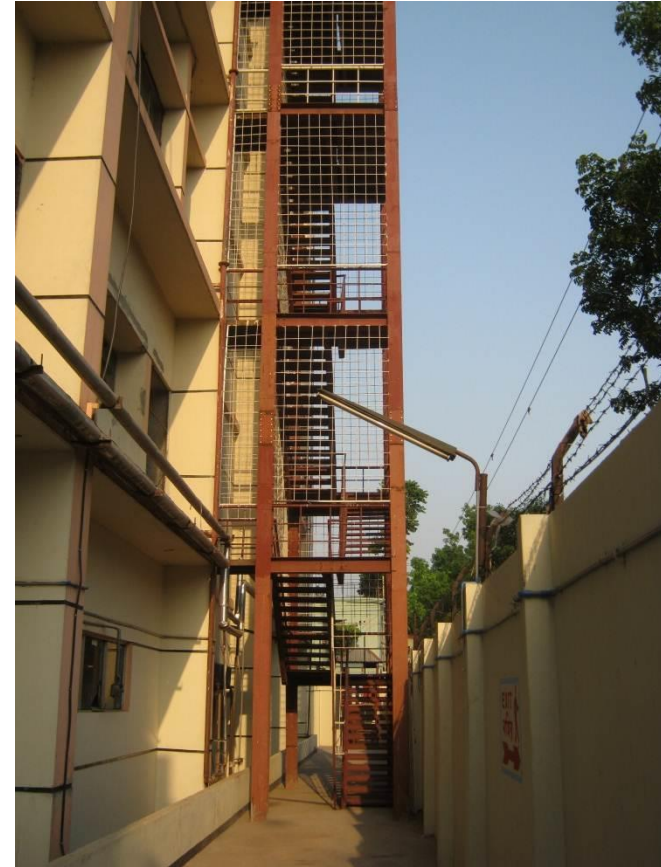
# **Building 2: Stability of Steelwork Fire Escape Stair**

The steelwork fire escape stair appeared to be insufficiently braced against lateral loads, with just a single lateral prop at Level 5 to the 'half-landing' end. Connection details appeared 'non-engineered'.

| Item No. | Observation | Recommended Action Plan | Recommended Timeline |
|---|---|---|---|
| 23 | BUILDING 2<br>Stability of steelwork fire-escape stair | As part of the Detailed Engineering Assessment the Engineer to undertake calculations to assess the vertical and lateral load-carrying capacity of steelwork escape stair, and to specify any necessary alterations or repairs as required | 6-weeks |
| 24 | BUILDING 2<br>Stability of steelwork fire-escape stair | Carry out works as required. | 6-months |

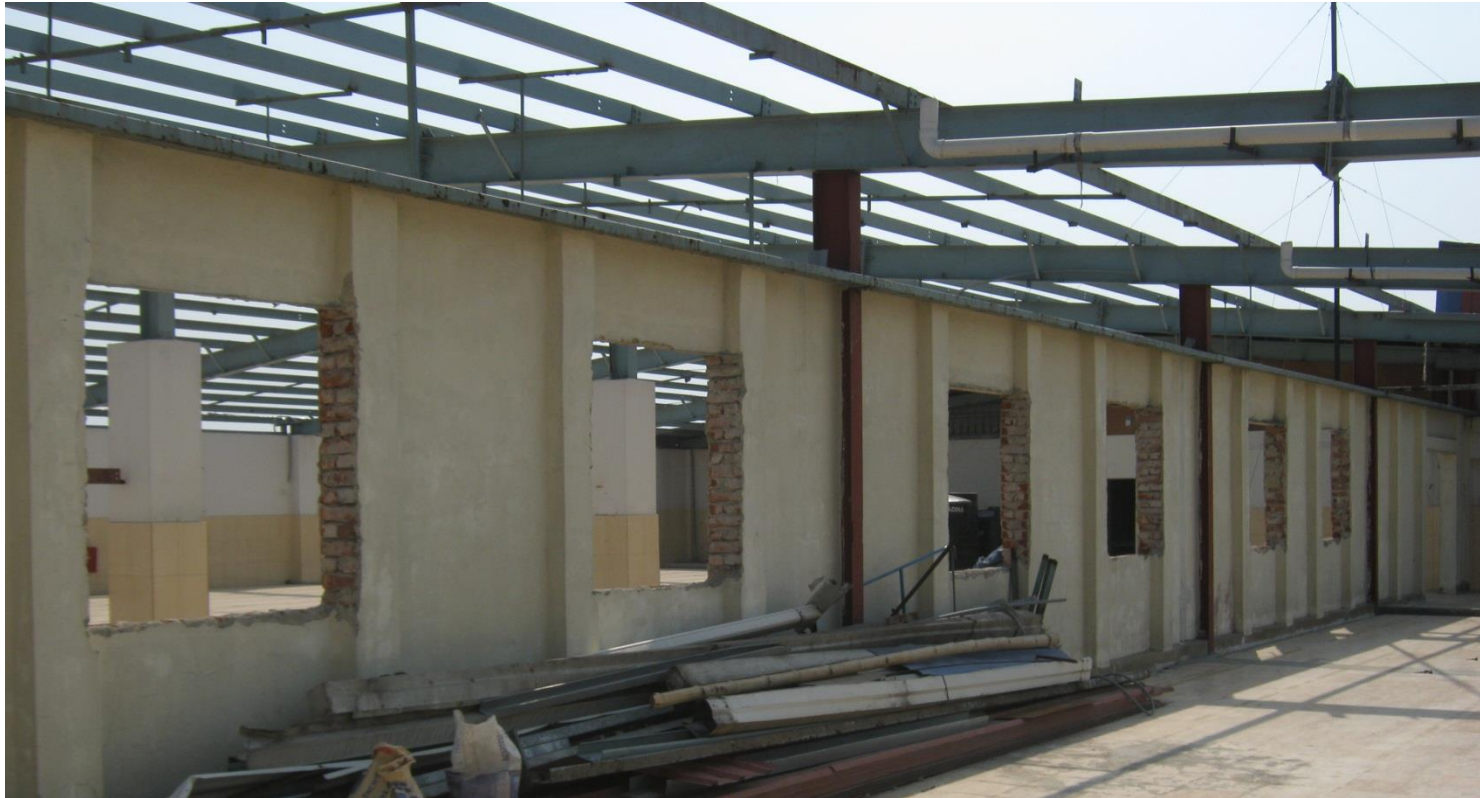
# **Building 2: Stability of Freestanding Masonry Walls to Rooftop**

Freestanding masonry walls were observed with height up to 3.2m, with questionable capacity to resist lateral wind loading.

| Item No. | Observation | Recommended Action Plan | Recommended Timeline |
|---|---|---|---|
| 25 | BUILDING 2<br>Stability of free-standing masonry walls to rooftop | As part of the Detailed Engineering Assessment the Engineer to undertake calculations to assess the lateral stability of the free-standing masonry walls to the rooftop, and to specify any necessary alterations or strengthening as required. Alternatively, where possible free-standing masonry walls to be demolished, giving regard to whether or not they provide stability to other elements of structure. | 6-weeks |
| 26 | BUILDING 2<br>Stability of free-standing masonry walls to rooftop | Carry out works as required | 6-months |

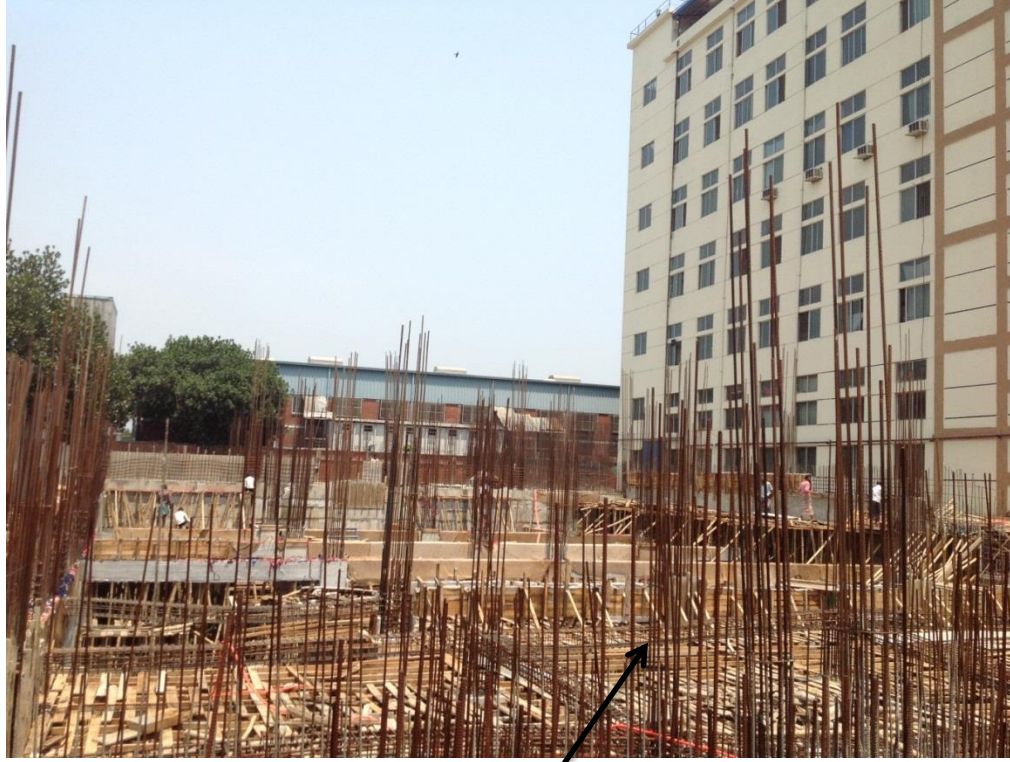
# **Building 3: Deep External Excavation Adjacent to Façade**

Approximately 4m deep excavation for water treatment plant adjacent to west end of Building 3. The interaction between this excavation and the existing foundations of Building 3 is unknown.

| Item No. | Observation | Recommended Action Plan | Recommended Timeline |
|---|---|---|---|
| 27 | BUILDING 3<br>Deep excavation in close proximity to South elevation | Deep excavation is in close proximity to South elevation of Building 3: geotechnical engineer to provide advice to ensure that short term and long term stability of Building 3 foundations are maintained, and that they are not undermined due to adjacent construction works. | 6-weeks |
| 28 | BUILDING 3<br>Deep excavation in close proximity to South elevation | Carry out any works as directed by the Engineer. | 6-months |

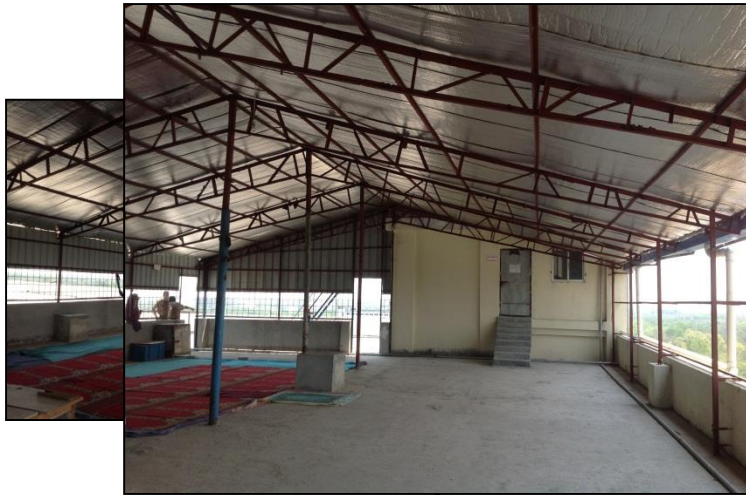
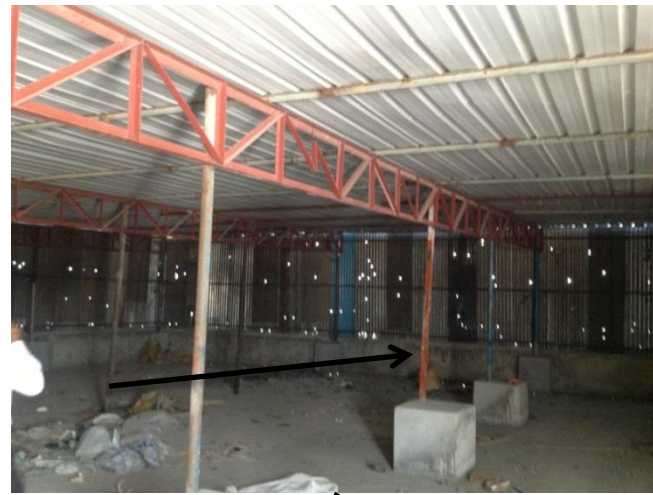
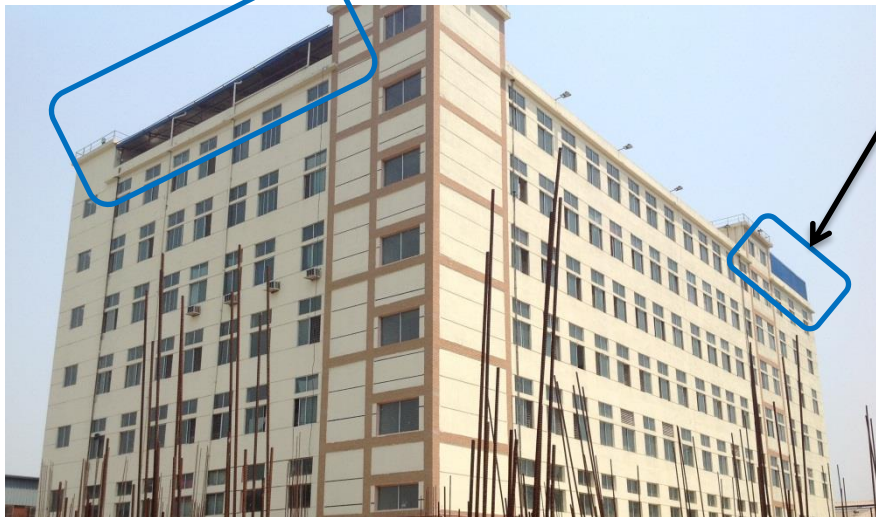
## **Building 3: Apparently Non-Engineered Structures**

The two rooftop steelwork structures to Building 3 appear to be non-engineered.

The stability loadpaths of these structures are unclear, and columns appear very slender.

| Item No. | Observation | Recommended Action Plan | Recommended Timeline |
|---|---|---|---|
| 29 | BUILDING 3<br>Apparently non-engineered rooftop structures | The Engineer to check the vertical and lateral load carrying capacity of the rooftop structures, and specify any necessary structural alterations or repairs as required. | 6-months |

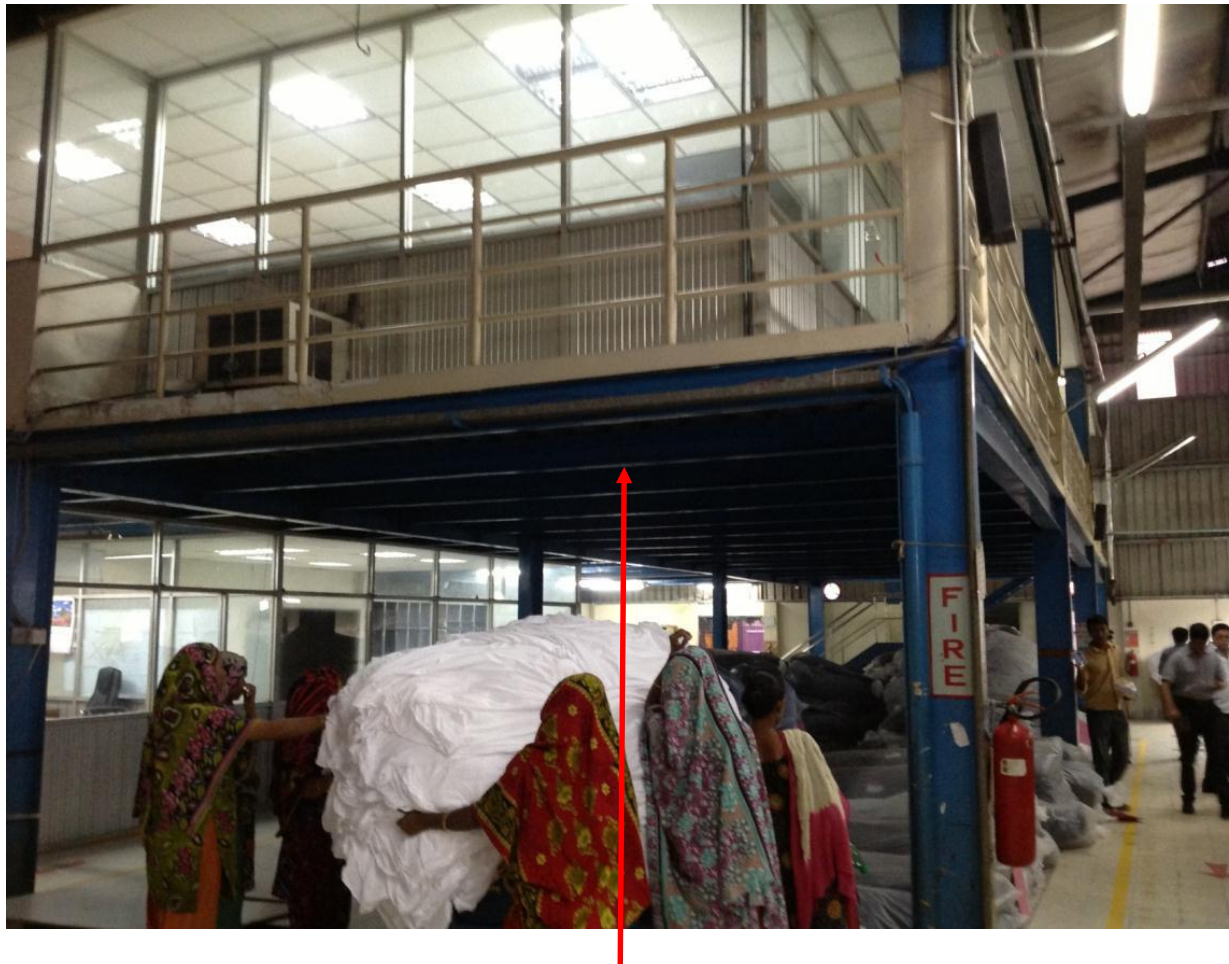
## Ancillary Buildings: Apparently Non-Engineered Structures (Finishing Unit)

Mezzanine floor within Finishing Unit does not appear to be tied to main steel frame and there is no clear stability load-path.

| Item No. | Observation | Recommended Action Plan | Recommended Timeline |
|---|---|---|---|
| 32 | ANCILLARY BUILDINGS<br>Apparently non-engineered structures | The Engineer to check lateral load carrying capacity of mezzanine structure within the Finishing Unit, and specify any necessary structural alterations or repairs as required | 6-months |

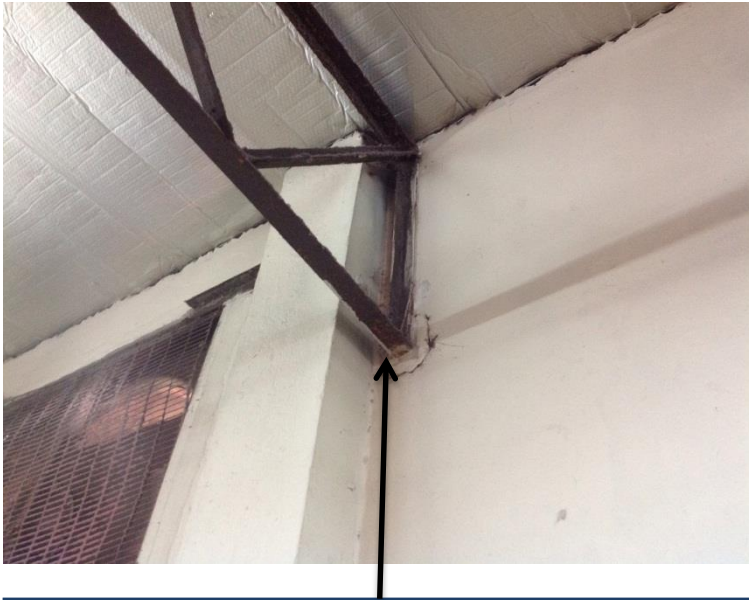
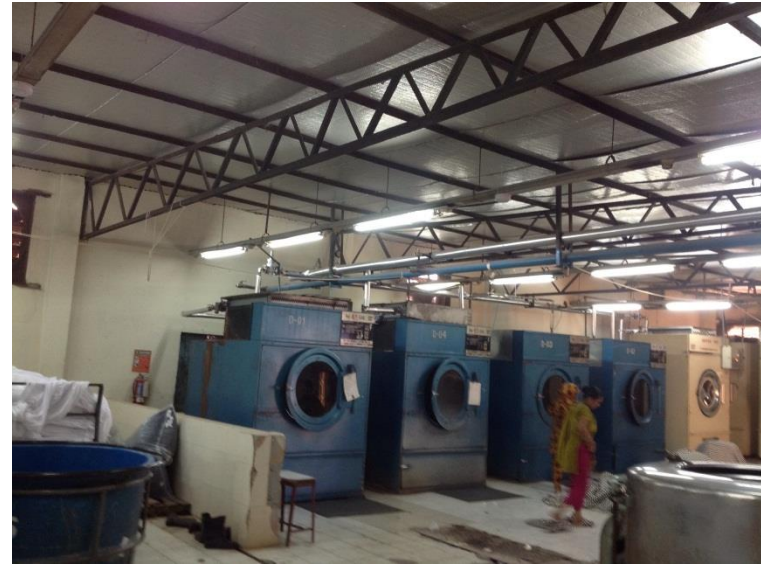
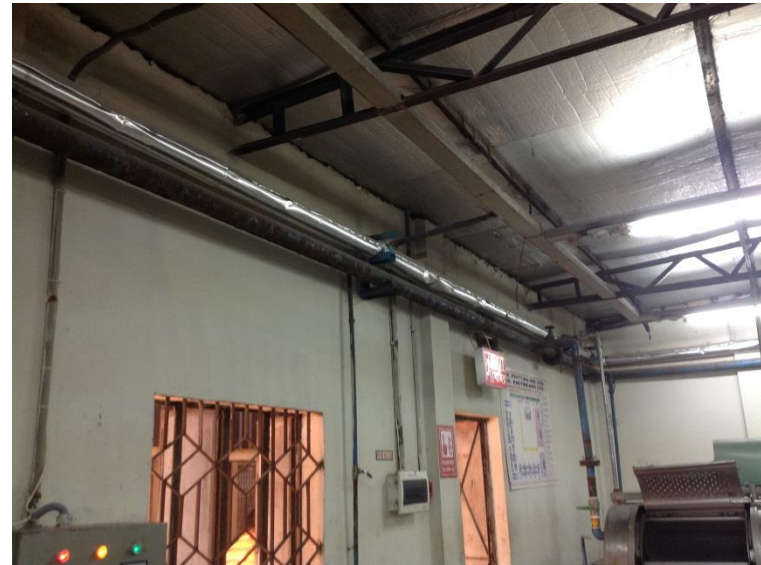
## Ancillary Buildings: Apparently Non-Engineered Structures (Washing Unit)

The roof structure to the Washing Unit appears to be non-engineered. Stability load-paths are unclear. Where trusses bear onto masonry walls there are signs of movement between the steelwork and brickwork.

| Item No. | Observation | Recommended Action Plan | Recommended Timeline |
|---|---|---|---|
| 33 | ANCILLARY BUILDINGS<br>Apparently non-engineered structures | The Engineer to check vertical and lateral load carrying capacity of Washing Unit structure, giving regard to the connections between the roof trusses and masonry support walls. Engineer to specify any necessary structural alterations or repairs as required | 6-months |
