# **FIRE SAFETY INSPECTION REPORT**

**ANANTA GARMENTS LTD**  
**NISCHINTAPUR,ASHULIA,DEPZ ROAD**

March 25, 2014

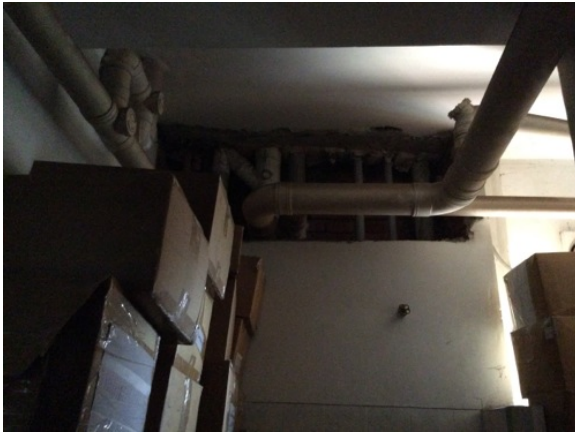
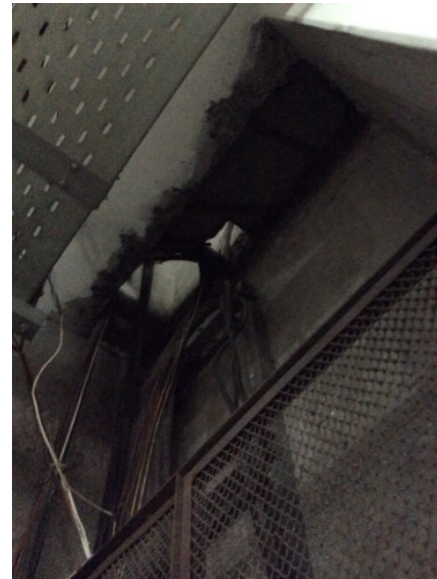
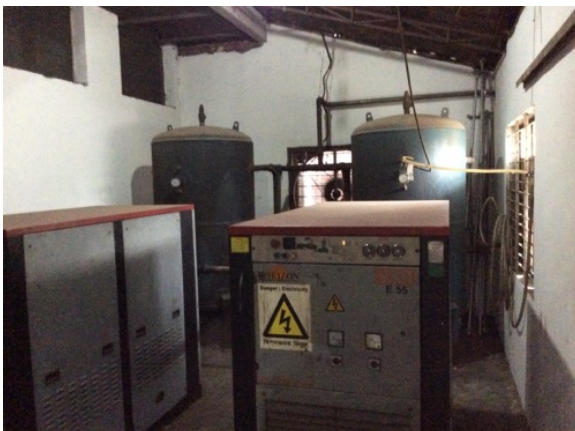
| No. | Category | Finding | Recommendation | Remediation Timeframe |
|---|---|---|---|---|
| F-1 | Fire Rated Construction | Unsealed penetrations and openings are located in the fire-rated walls and ceiling assemblies. | Seal all penetrations and openings in walls and ceiling assemblies to maintain the fire separation. | Within 3 months |

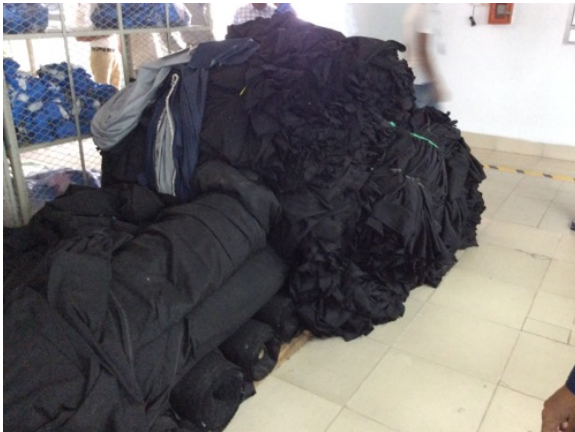
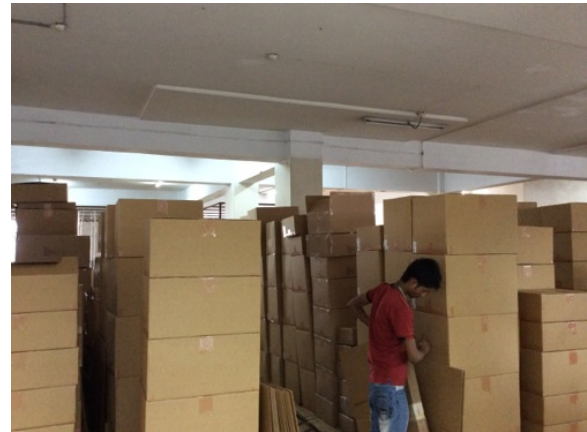
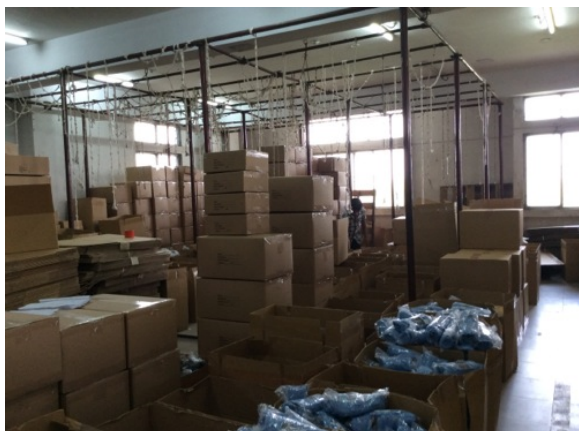
| F-2 | Fire Rated Construction | Areas used for combustible storage are not separated by fire-rated construction. Open to production areas. | <p>Provide dedicated storage rooms separated by minimum 1-hr fire-rated construction.</p> <p>Where separate storage rooms are not feasible, provide defined storage areas and limit the storage arrangement as follows:</p> <ul style="list-style-type: none"><li>- Maximum height of 2.4m and maximum area of 23m<sup>2</sup></li><li>- If sprinkler protected: maximum height of 3.66m and maximum area of 93m<sup>2</sup></li></ul> <p>Separate areas of unenclosed combustible storage by a minimum clear distance of 3m.</p> | Within 3 months |

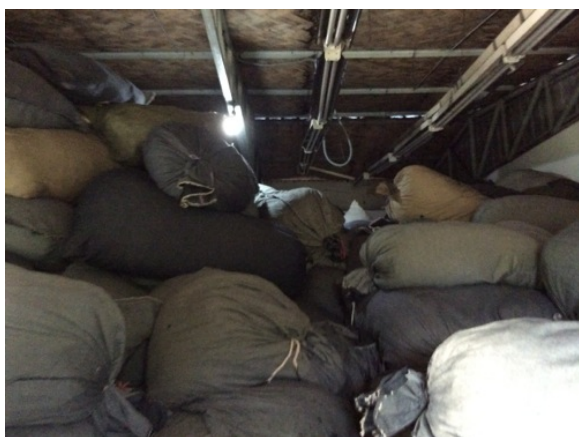
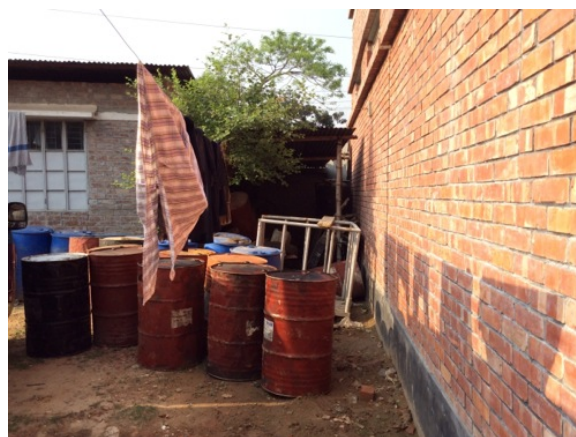
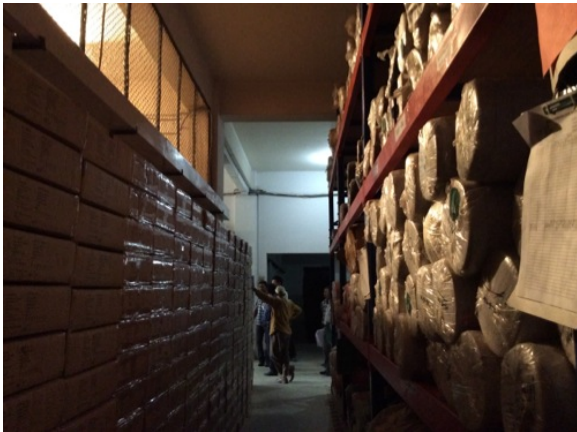
| F-3 | Fire Rated Construction | Hazardous materials storage /flammable liquid area is not separated by fire-rated construction (openings, non-rated doors, penetrations) on ground floor and 1st floor exit routes | Separate the hazardous materials / flammable liquid storage room by a minimum 2-hr fire-rated construction. Seal and/or protected all openings to maintain the required fire separations. | Within 3 months |

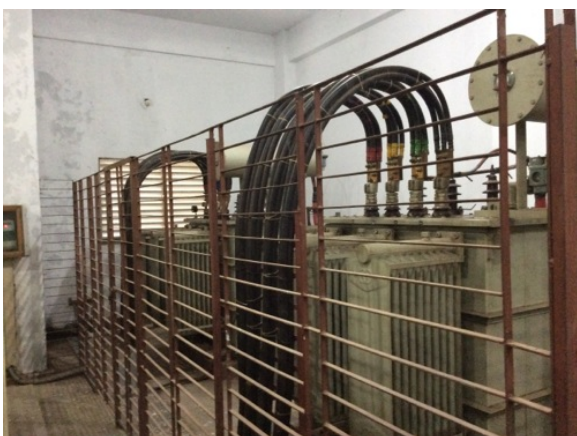
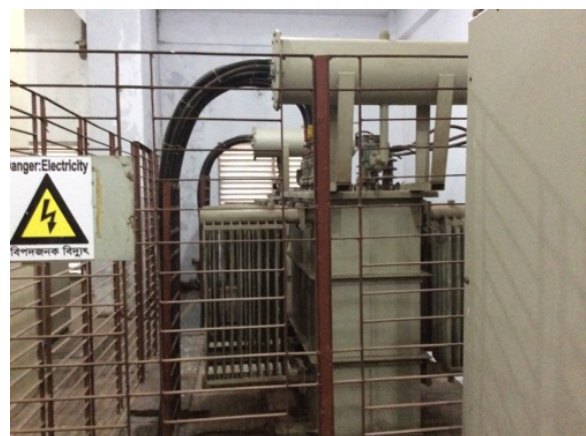
| F-4 | Fire Rated Construction | The transformer room is not separated by fire-rated construction (openings, non-rated doors, penetrations) at ground floor service building. | Separate the transformer room by a minimum 2-hr fire-rated construction. Seal and/or protected all openings to maintain the required fire separations | Within 3 months |

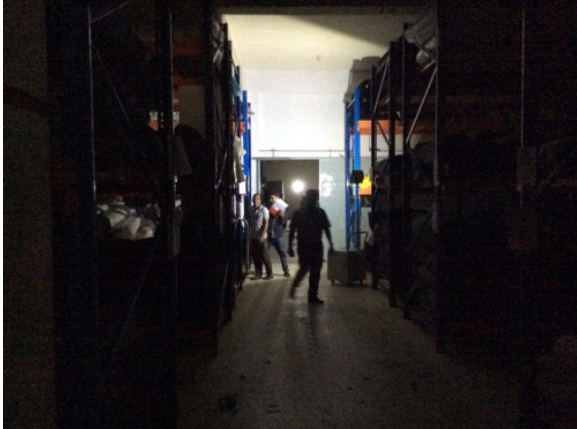
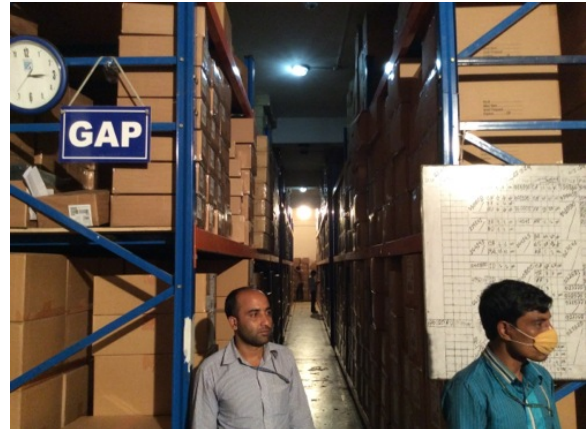
| F-5 | Fire Rated Construction | Areas used for combustible storage are not separated by fire-rated construction at ground floor . | Provide dedicated storage rooms separated by minimum 1-hr fire-rated construction. | Within 3 months |

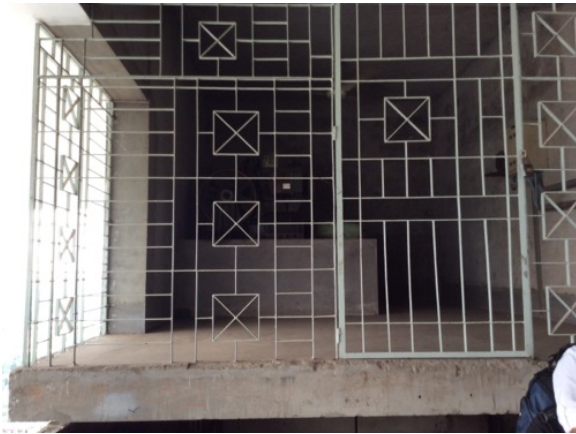
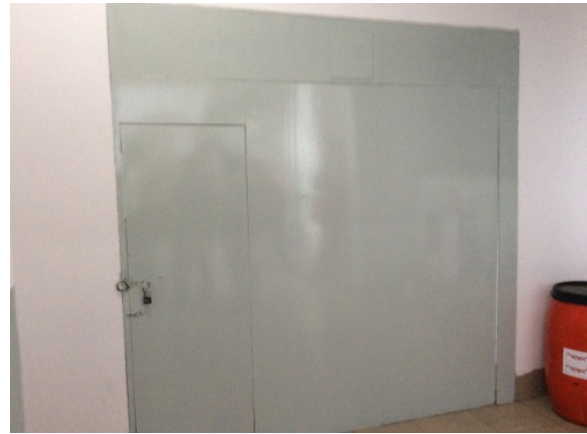
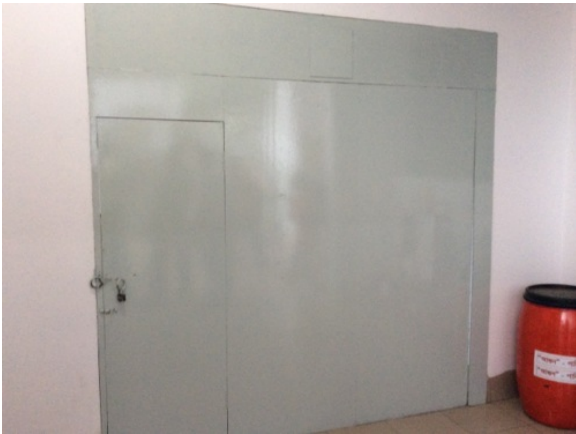
| F-6 | Egress | Egress sliding doors locking features are provided at building exits, exit stairs, , exit discharge in all levels and some exits are locked and closed during the inspection on ground floor,levels 1,2,3,and 4. | Remove locking features from all egress doors / gates.<br><br>If locks are required for security reasons, utilize special door locking features complying with NFPA 101. | Immediate |

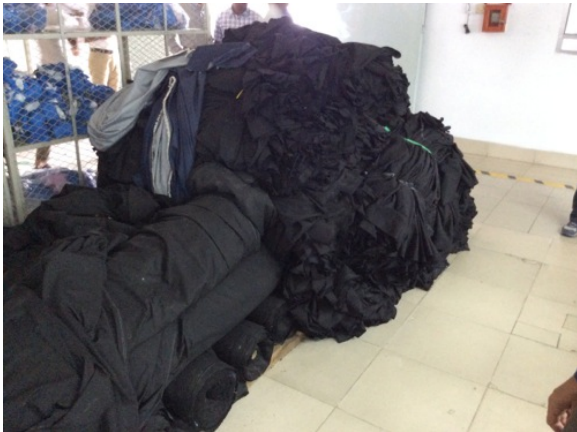
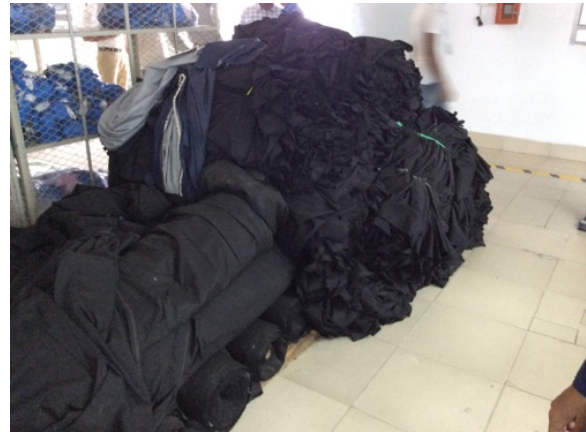
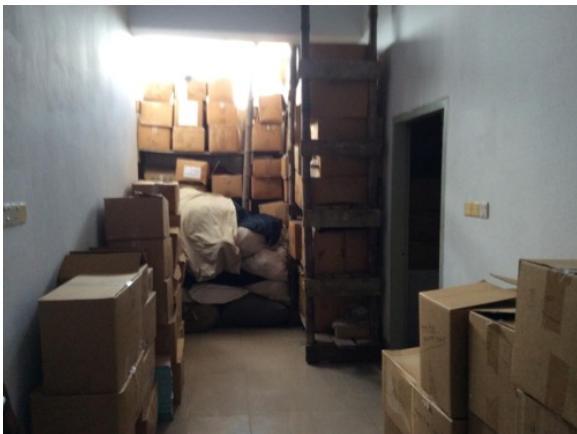
| F-7 | Egress | Storage area was located in the egress paths and open to production floors. | Keep egress paths and stairs clear of storage. | Immediate |

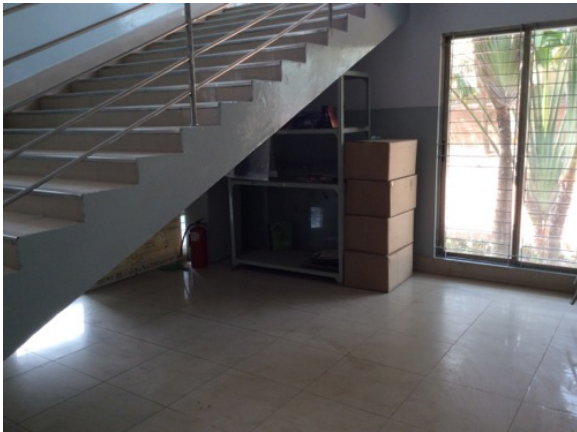
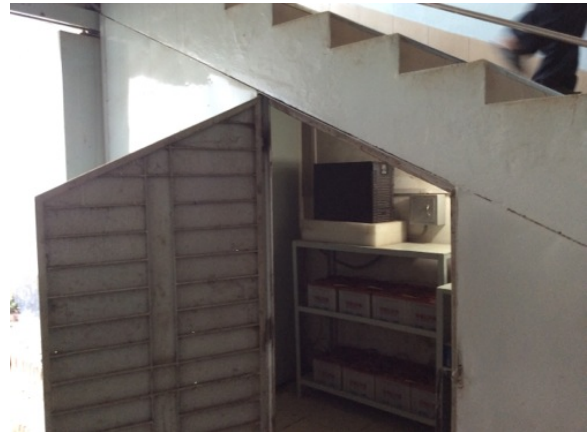
| F-8 | Egress | Storage was located in the exit stair at ground floor east and west side exit stairwell | Remove all storage from exit stairs and egress paths. | Immediate |

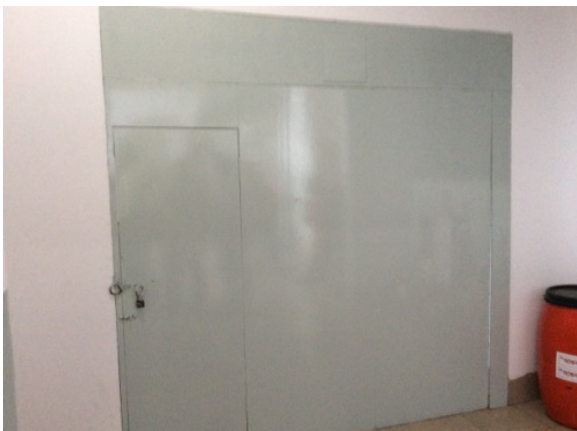
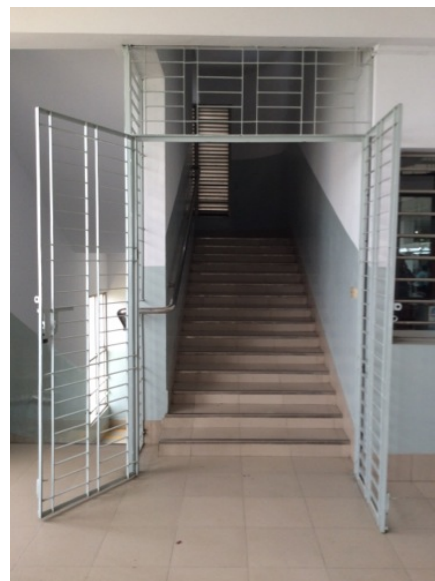
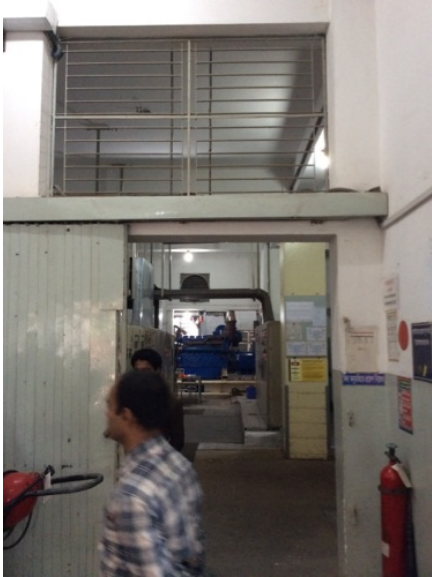
| F-9 | Egress | Collapsible gates and Sliding doors are provided at building exits, exit stairs, exit discharge. In all floors. | Replace all gates / sliding doors along the means of egress with side-hinged, swinging egress doors. | Within 1 month |

| | | | If locks are required for security reasons, utilize special door locking features complying with NFPA 101. | |

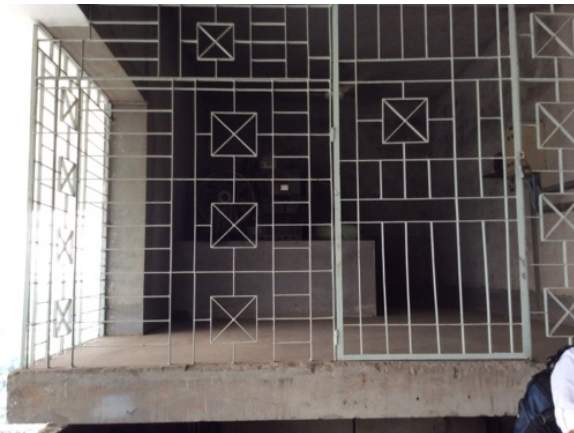
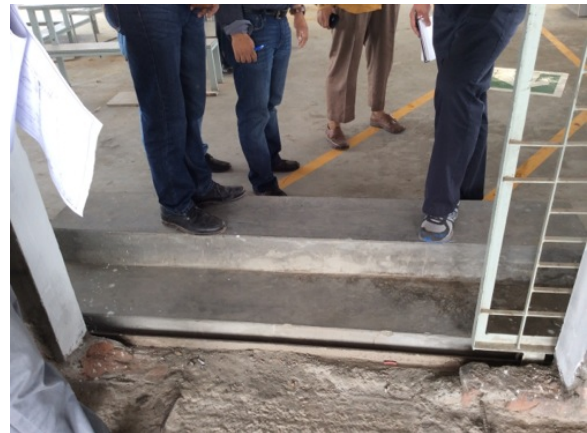
| F-10 | Egress | On the roof top there is a workers /staff dining assembly room serving more than 50 people the door swing for the exit doors are not correct. | Modify the egress door to swing in the direction of egress travel. | Within 3 months |

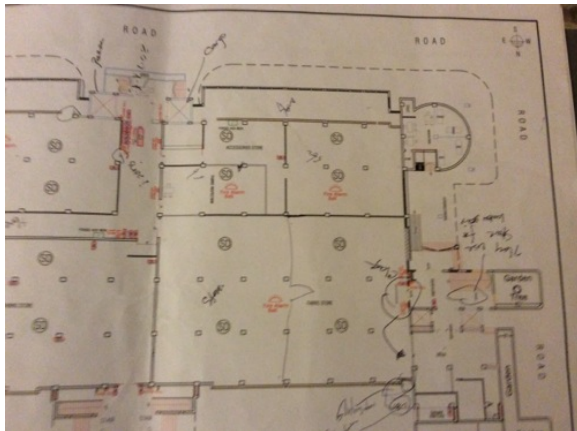
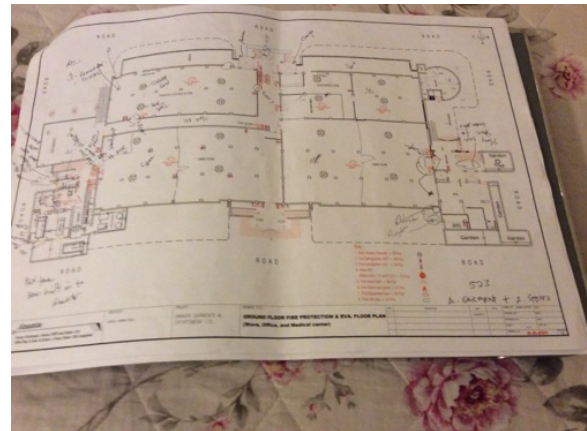
| F-11 | Egress | Common path of egress travel exceeds 30 m between accessories store ,fabric inspection , and storage room at ground floor | Reconfigure the egress arrangement to reduce the maximum common path of travel to not more than 30 m. | Within 3 months |

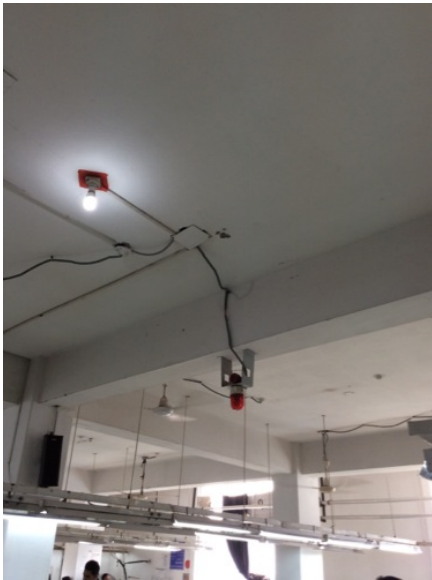
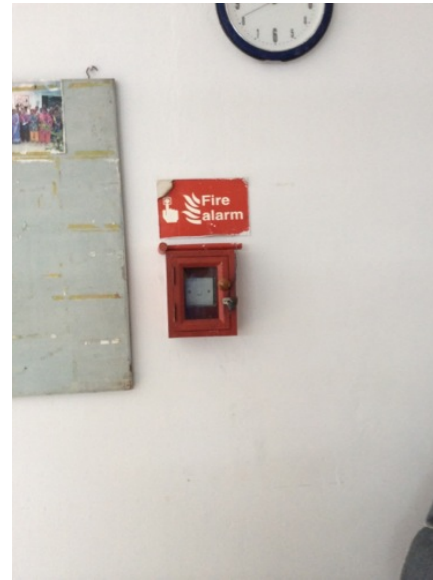
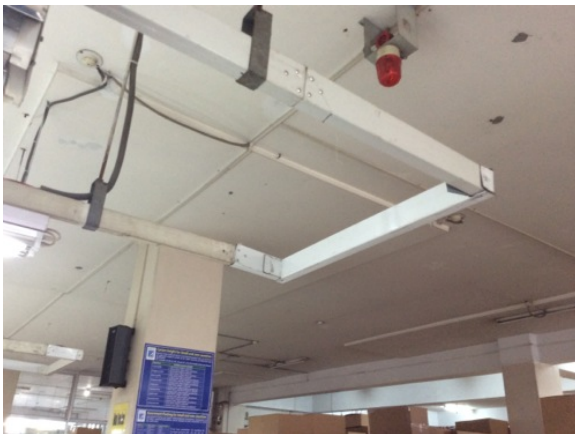
| F-12 | Fire Protection | The fire alarm system is antiquated, not a listed system, and does not provide alarm and notification features consistent with acceptable standards. | Replace the fire alarm system with a new, listed addressable fire alarm system in accordance with NFPA 72. | Design within 4 months, install within 9 months |

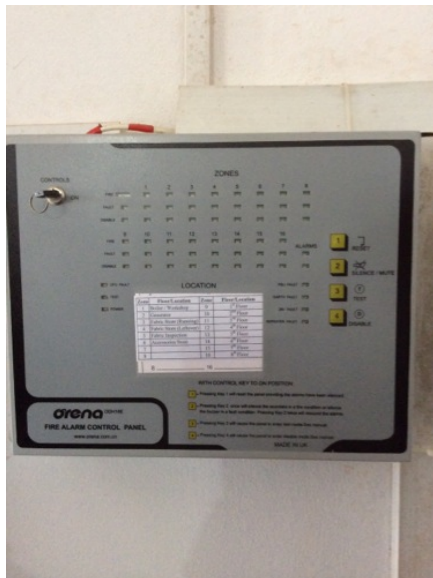
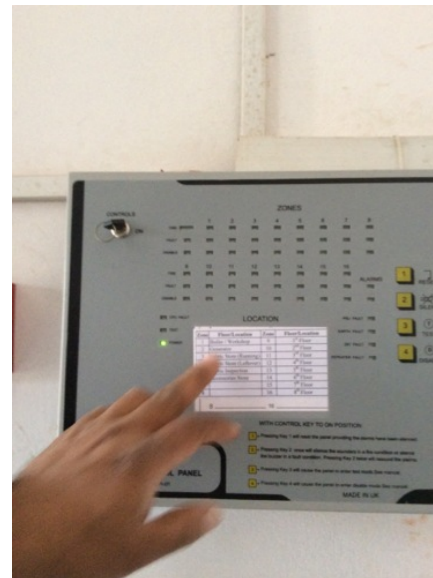
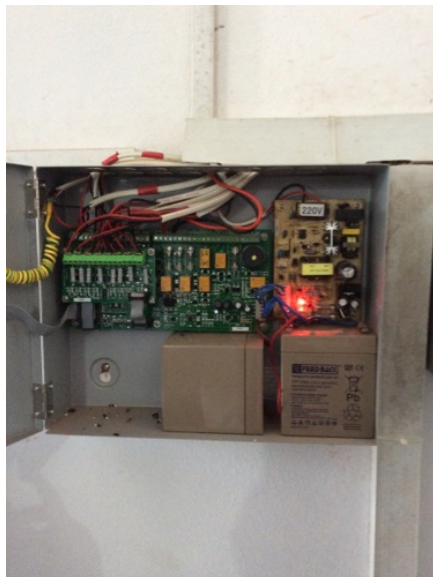
| F-13 | Fire Protection | The fire alarm system is not an addressable type as reported , and does not provide features consistent with acceptable standards. It is found out that loop wiring for the smoke detector have splices and joints.And also old installed wires were used. | Replace the fire alarm system with a new, listed addressable fire alarm system in accordance with NFPA 72. | Design within 4 months, install within 9 months |

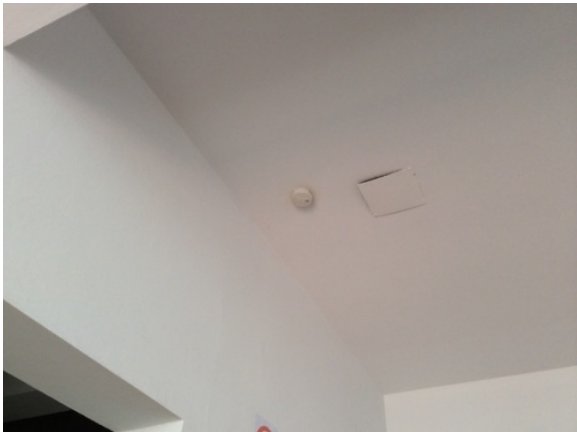
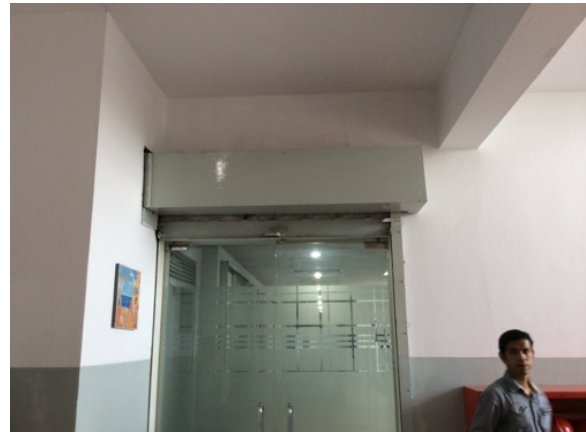
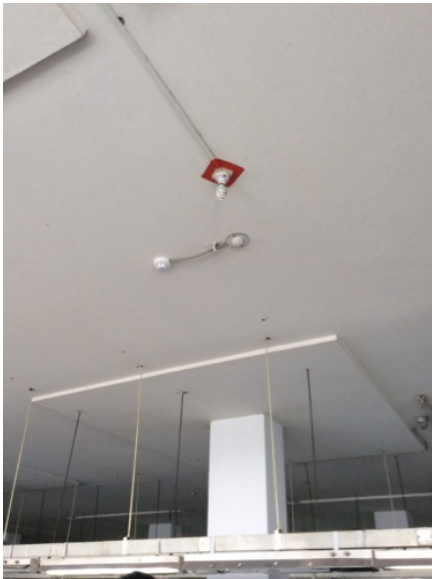
| F-14 | Fire Protection | The high-rise building has an occupied floor greater than 23m (75 ft) and is not provided with automatic sprinkler protection. The large occupant loads, heavy fuel loading, and anticipated extended egress times warrant sprinkler protection. | Provide automatic sprinkler protection throughout the building in accordance with NFPA 13. | Design-6 months;<br>Installation -12 months |

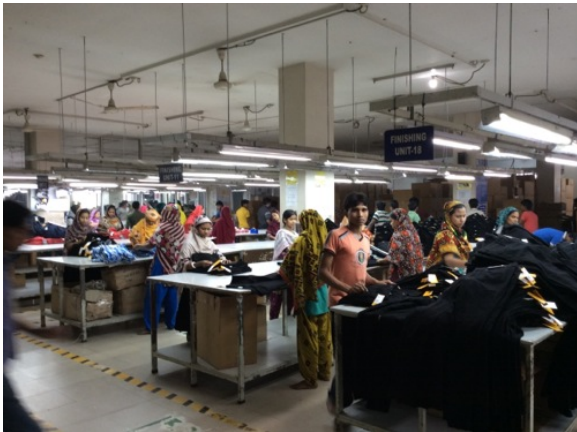
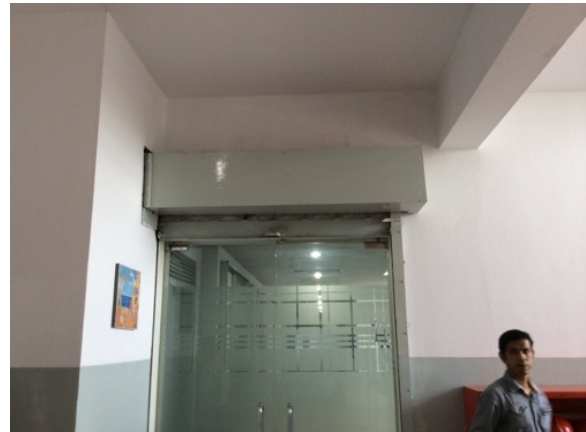
| F-16 | Fire Protection | Smoke detectors quantities installed is not the same with the quantities shown in layout drawing. | Provide additional notification appliances such that the fire alarmsystem is audible throughout the building in accordance with NFPA 72. | Within 3 months |

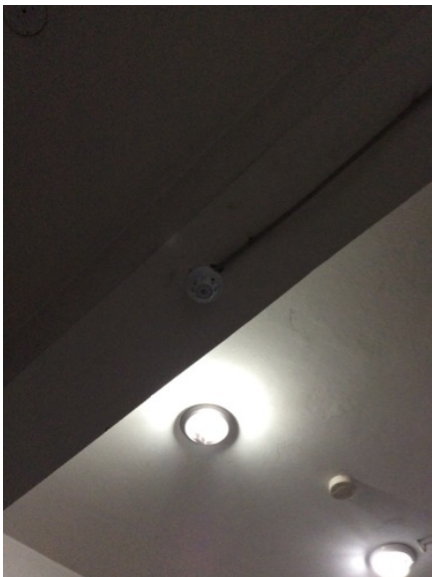
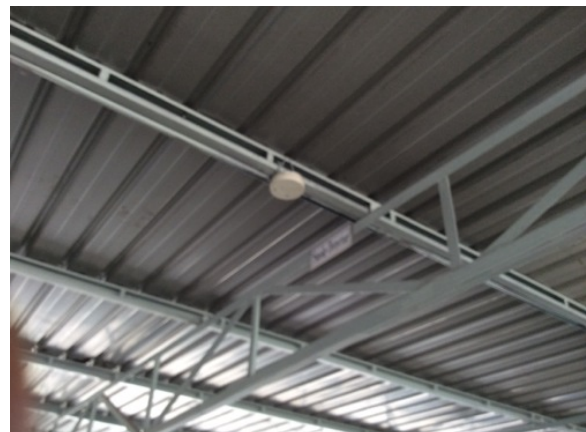
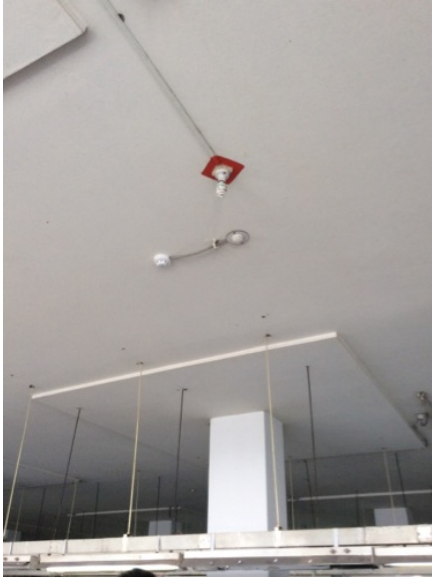
| F-17 | Fire Protection | The building is equipped with single-station smoke alarms. Smoke alarm activation sounds only a local alarm and does not provide automatic fire alarm notification of occupants. | Replace the single-station smoke alarms with automatic smoke detectors tied into the fire alarm system. Configure the fire alarm system to initiate occupant notification upon activation of any two smoke detectors in addition to the manual fire alarm stations. | Within 6 months |

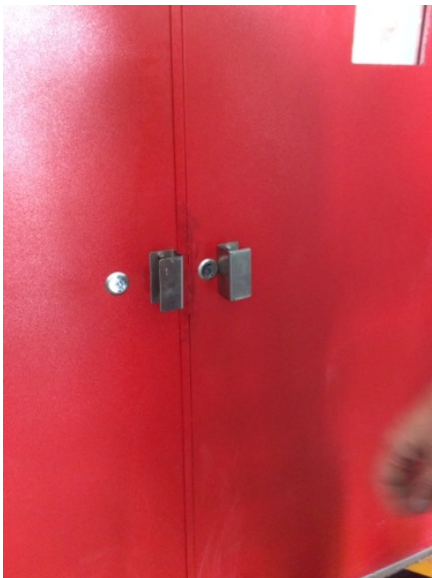
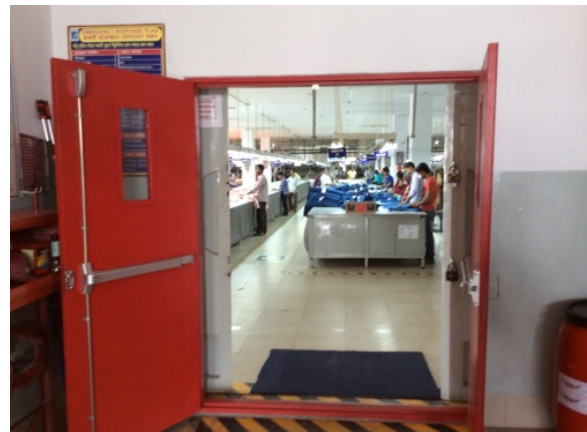
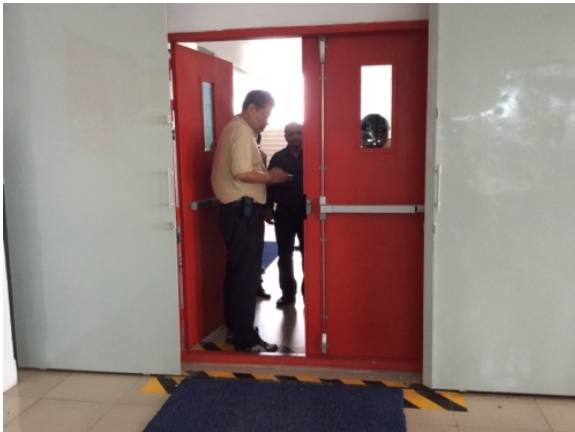
| F-18 | Fire Protection | Fire doors was provided in exit stairwells but not UL listing is not indicated and automatic door closer is missing , and also door handle is not provided | Provide automatic door closer and shall be tested and inspected in accordance to NFPA-80 | Within 6 months |

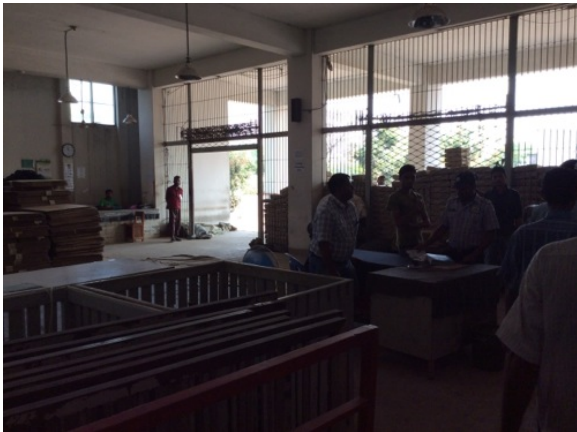
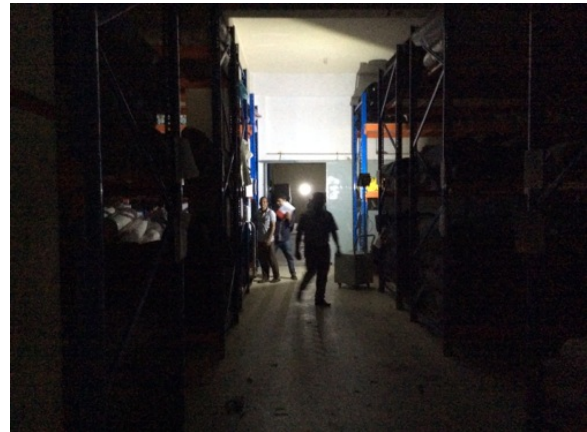
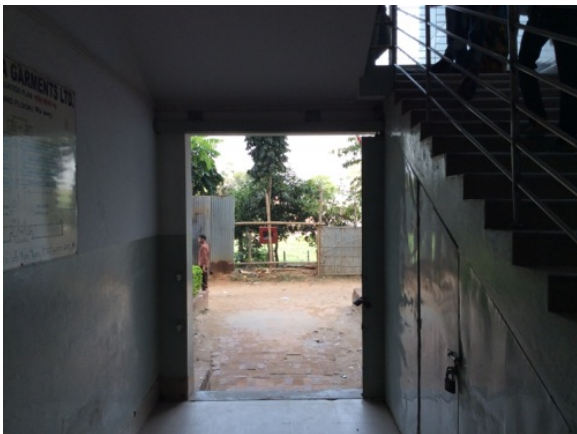
| F-20 | Egress Lighting | Based on the number and location of emergency lights observed, adequate illumination levels are not anticipated along egress routes. at ground floor store room there is not enough emergency lighting | Test the emergency lighting system on each floor and provide additional emergency fixtures to provide adequate illumination along the means of egress. Provide a minimum illumination of 10 lux at the floor level within exit stairs and exit discharge paths and minimum 2.5 lux along exit access aisles. | Within 3 months |
