# Day Apparels(12483) Day Fashion(12571)

M H Tower, 21, Vogra, Gazipur – 1704  
(23.981525N, 90.381451E)

8<sup>th</sup> December 2016

# Observation

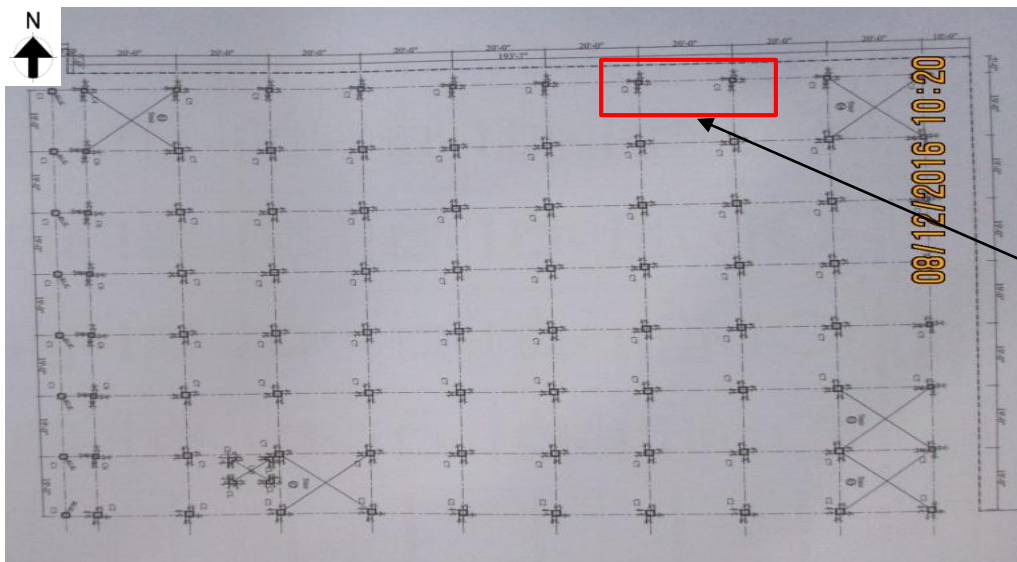
Factory Building

Cursory calculations shows risk of punching shear due to heavy loading on flat slab due to built up

From the cursory calculations flat slab was appeared to be stressed by punching shear due to loads from the toilet build-up and partition walls in typical floor level.

| Item No. | Observation | Recommended Action Plan | Recommended Timeline |
|---|---|---|---|
| 1 | Apparently high punching stress in flat slab | Building engineer to conduct a engineering assessment to check the adequacy of the flat slab and foundation of the building . | 6-weeks |
| 2 | Apparently high punching stress in flat slab | Verify in-situ concrete stresses by 100mm dia. cores from 4 nos areas of flat slab –not located within the column/slab punching zone. | 6-weeks |
| 3 | Apparently high punching stress in flat slab | Produce and actively manage a loading plan for all floor plates within the Building, giving consideration to floor capacity and column capacity. | 6-months |

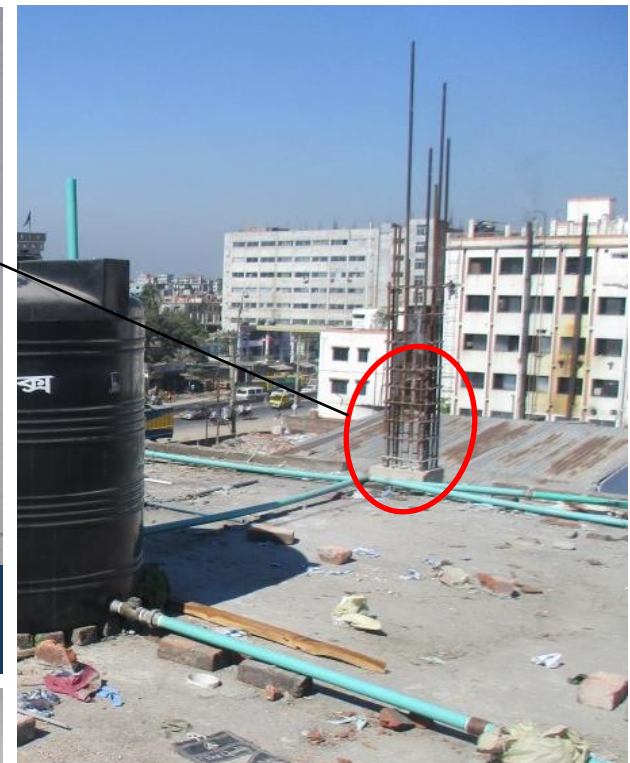
Over stress area due to punching stress

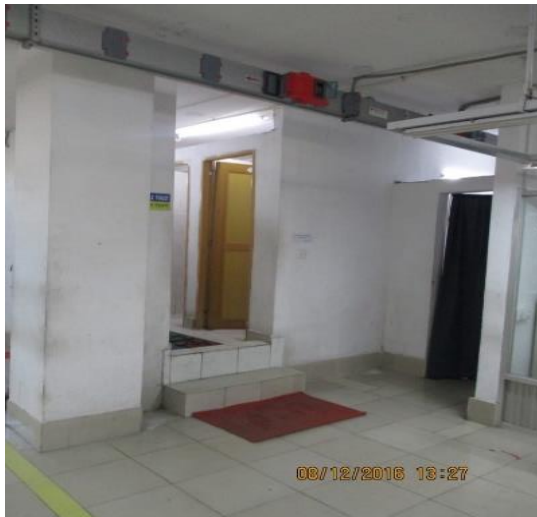
Build-up in toilet portion

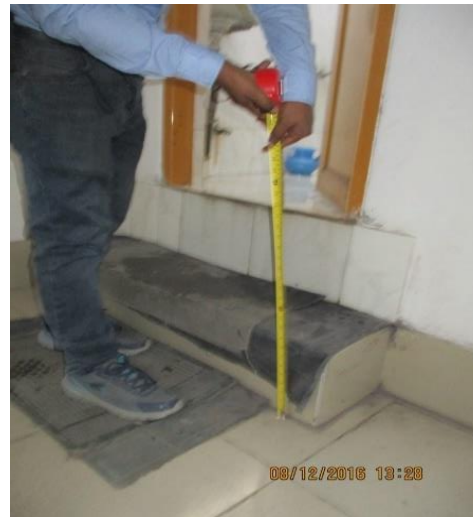
Depth of built-up

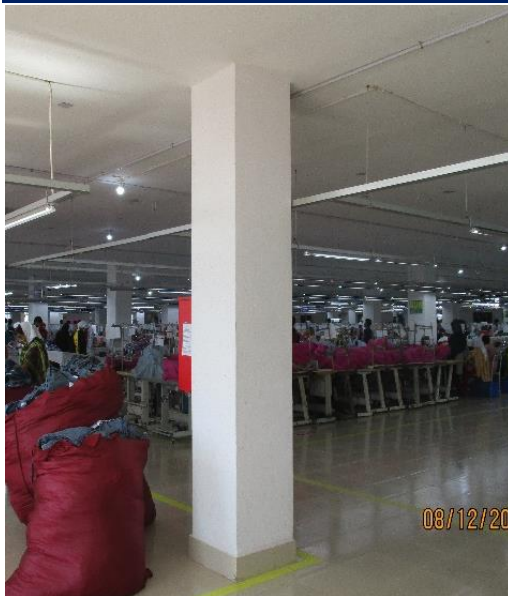
Flat slab from  
GF to 3<sup>rd</sup> Floor

Due to combination of flat slab and beam column structural system, the lateral load path is not clear. Building engineer to check lateral stability of the building against lateral load as per BNBC load.

| Item No. | Observation | Recommended Action Plan | Recommended Timeline |
|---|---|---|---|
| 5 | Apparently Lack of Lateral stability | Building Engineer to review the lateral stability of the building for the BNBC recommended lateral load as part of engineering assessment. | 6-weeks |
| 6 | Apparently Lack of Lateral stability | Carry out remedial works resulting from engineering assessment if necessary. | 6-months |

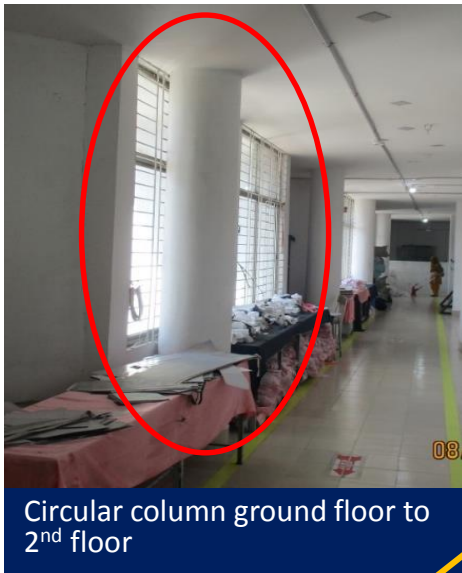
Circular column ground floor to 2<sup>nd</sup> floor

C1 type columns were found square shape on 3<sup>rd</sup> and 4<sup>th</sup> floor and circular shape from ground to 2<sup>nd</sup> floor where in column schedule, this column shape was shown as circular on all floor

| Item No. | Observation | Recommended Action Plan | Recommended Timeline |
|---|---|---|---|
| 7 | Discrepancy found between as built condition and provided drawing | Building engineer to survey the whole building and produce as-built documentation reflecting the as constructed condition. | 6-weeks |

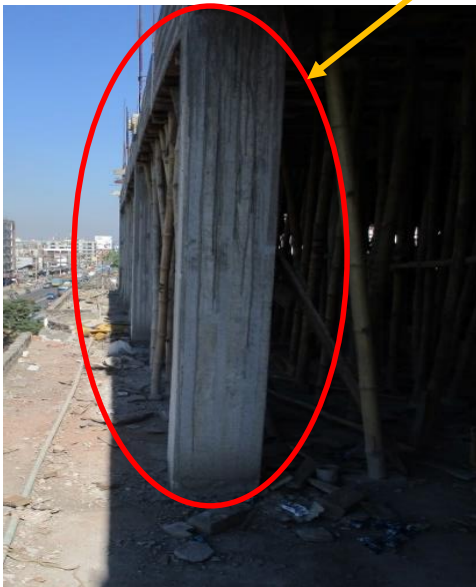
Square column 3<sup>rd</sup> to roof top

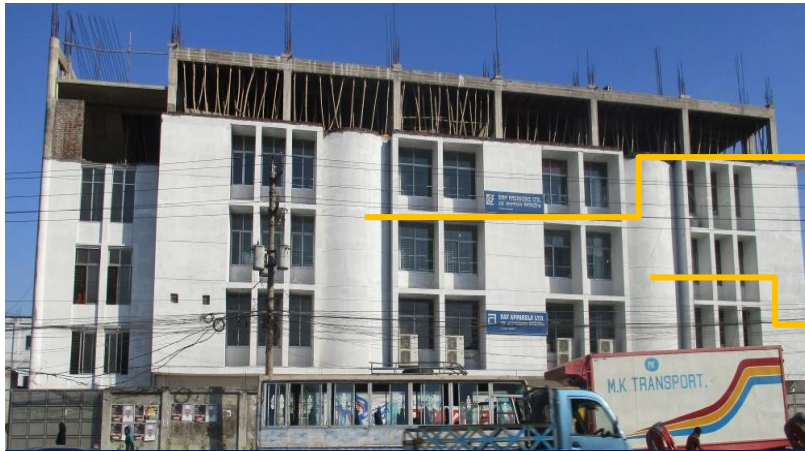
Circular shape brick wall was observed instead of straight wall in drawing

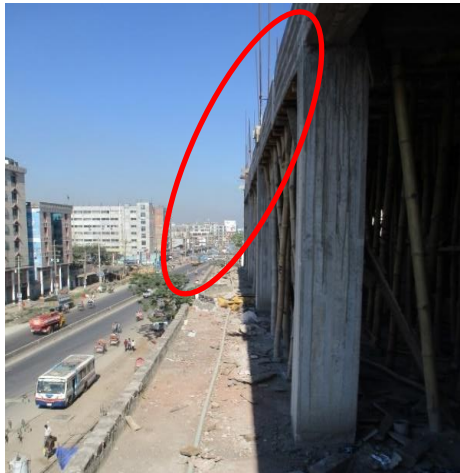
No Cantilever portion on 4<sup>th</sup> floor top Slab was observed which was present in drawing

Front elevation did not match with provided architectural drawing. Also the cantilever was absent which was shown in drawing.

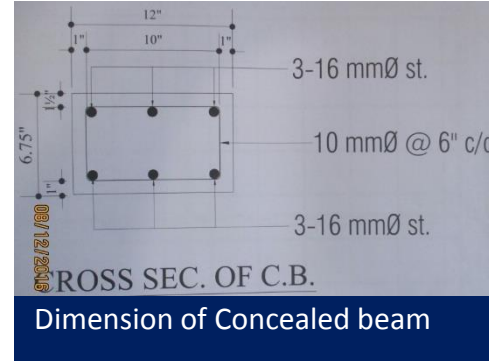
Beam was observed under 4<sup>th</sup> floor top slab and around stair case where as-build structural drawing showed concealed beam through the typical floor slab

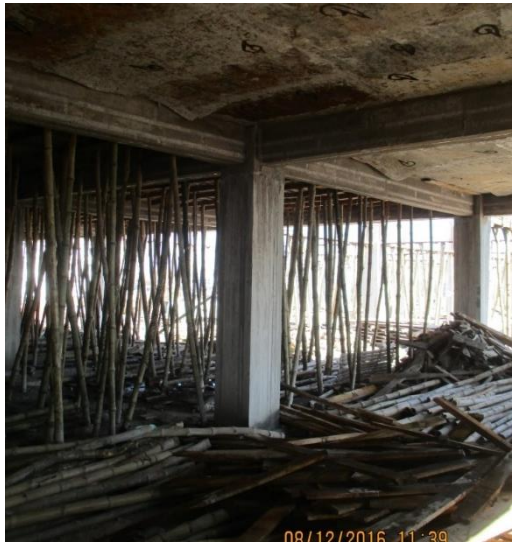
Beam under the 4<sup>th</sup> floor top slab

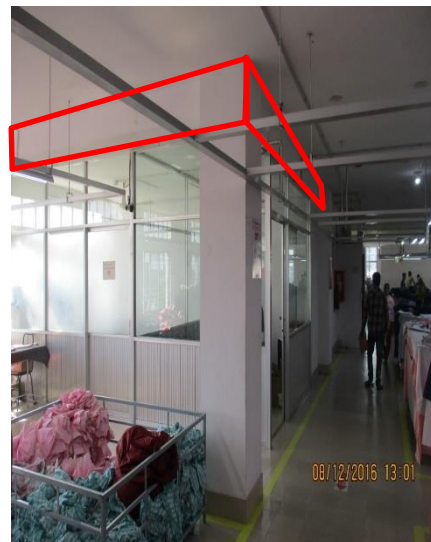
Beam was observed beside the stair case

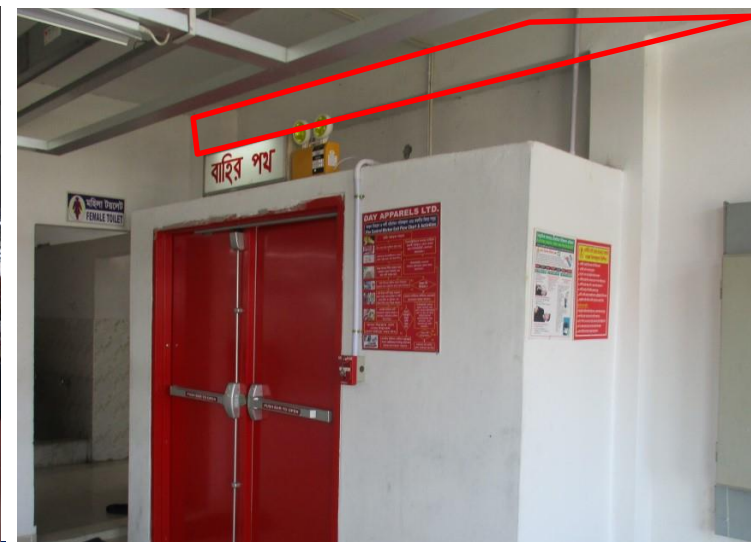
Beam was observed around stair case

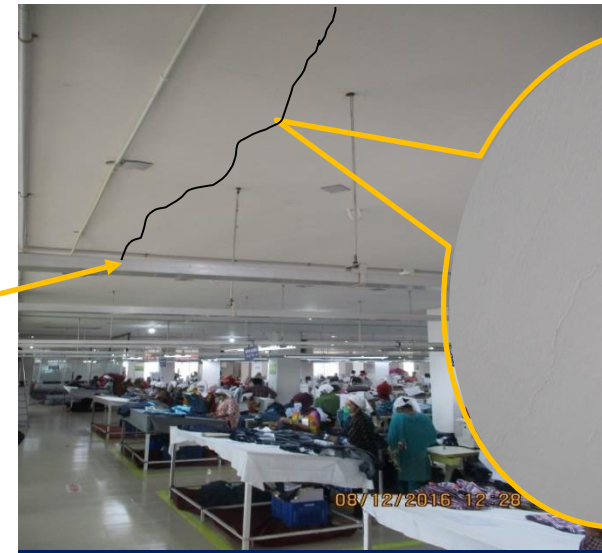
Crack observed under 3<sup>rd</sup> floor roof slab

Hair line crack was observed on 3<sup>rd</sup> floor roof slab. Cracks were appeared under waist slab, on 3<sup>rd</sup> and 2<sup>nd</sup> floor.

| Item No. | Observation | Recommended Action Plan | Recommended Timeline |
|---|---|---|---|
| 8 | Cracks on Slab & Stair | Sections of plaster finish to be removed to investigate if cracks penetrate the building structure. | 6-weeks |
| 9 | Cracks on Slab & Stair | As part of Engineering Assessment, Factory Engineer to carry out design check on the affected areas | 6-weeks |
| 10 | Cracks on Slab & Stair | Carry out remedial works resulting from engineering assessment if necessary. | 6-months |

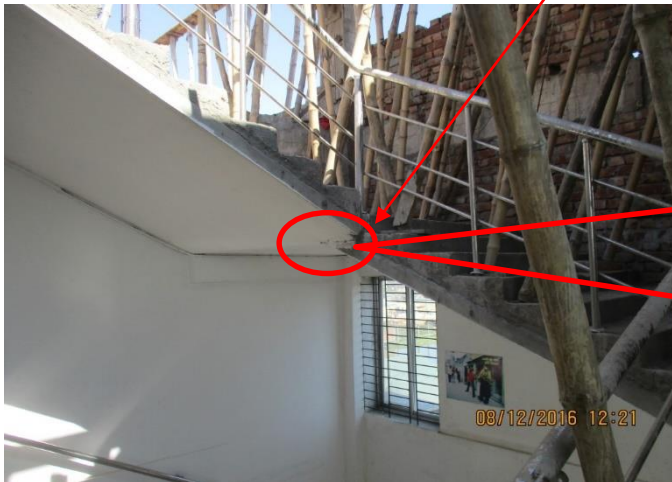
Crack on 3<sup>rd</sup> floor waists slab of South East stair

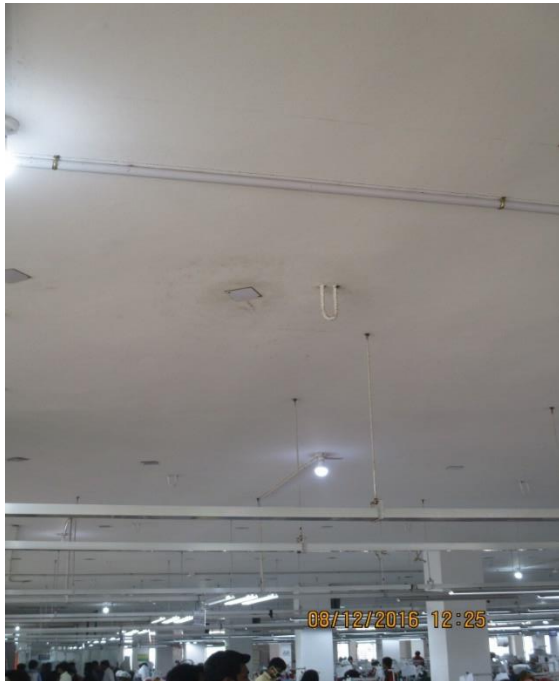
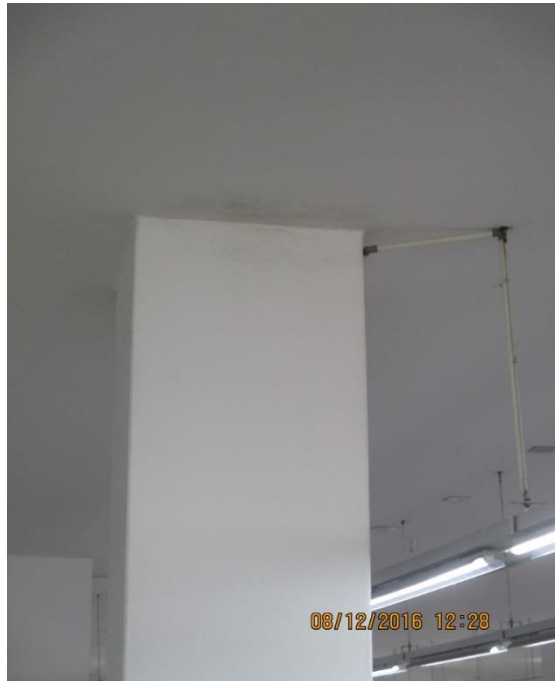
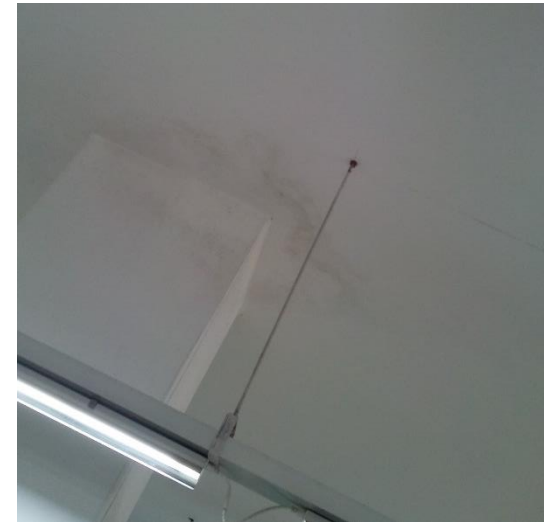
Water Dampness found on 3<sup>rd</sup> floor roof slab on several places

Water dampness was observed on several places due to water intrusion. Factory is required to take necessary remedial measures.

| Item No. | Observation | Recommended Action Plan | Recommended Timeline |
|---|---|---|---|
| 11 | Water intrusions in several places | Factory Engineer to inspect water-damaged structure and identify the source of the water ingress. | 6-weeks |
| 12 | Water intrusions in several places | Eliminate the source of water ingress. | 6-weeks |
| 13 | Water intrusions in several places | Implement structural repairs. | 6-months |

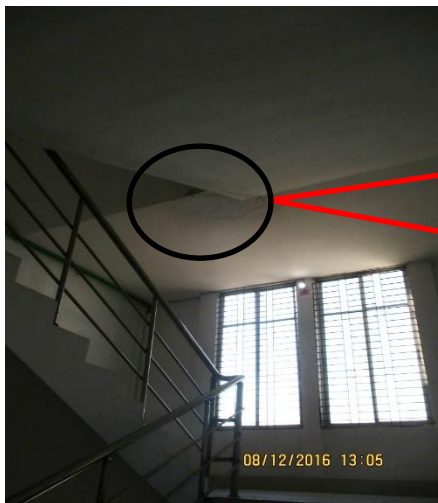
Water Dampness found on North East stair case

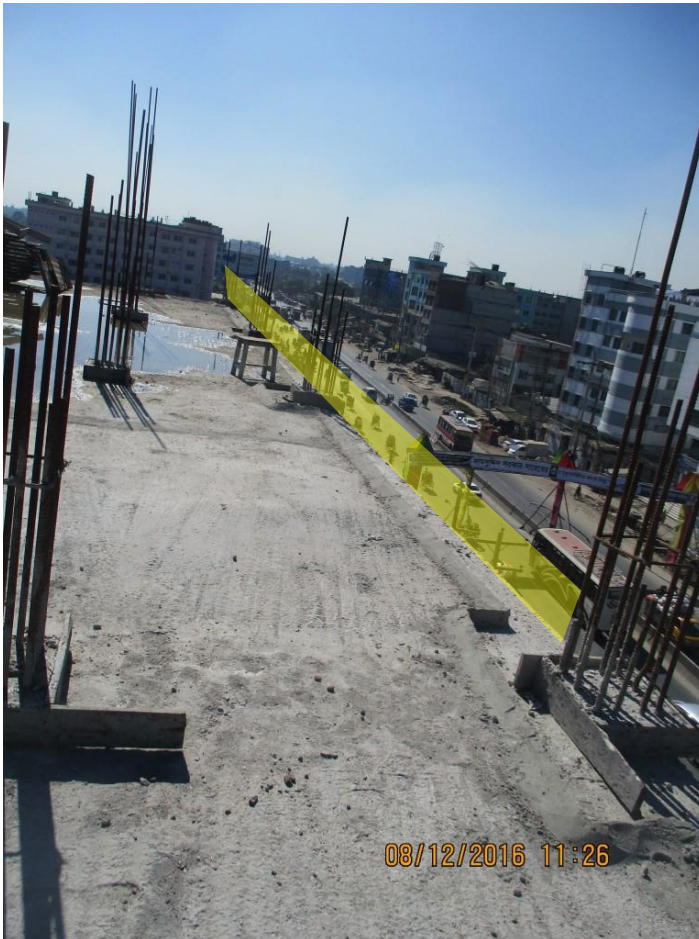
No edge protection was observed on existing roof

No edge protection system was found in construction area. Factory is required to provide edge protection immediately to avoid falling hazard.

| Item No. | Observation | Recommended Action Plan | Recommended Timeline |
|---|---|---|---|
| 14 | Lack of edge protection | Install adequate edge protection on roof level as per suggestion of factory engineer. | 6-weeks |

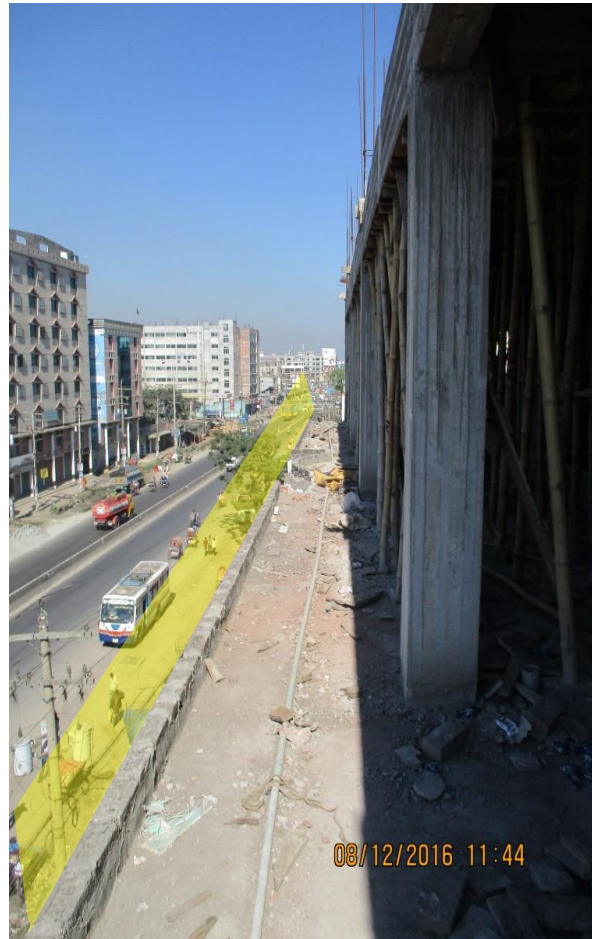
No edge protection was observed on 4<sup>th</sup> floor

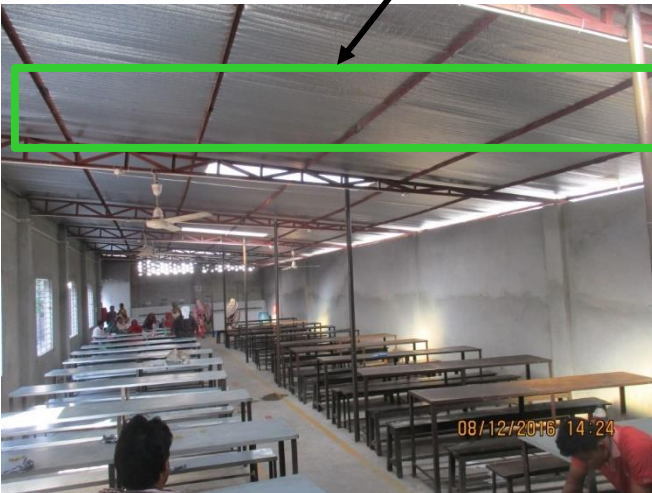
Observed seven purlin in the shed

During inspection, only seven purlin were found instead of eight purlin in drawing. Also no truss was observed at the both end of the shed.

| Item No. | Observation | Recommended Action Plan | Recommended Timeline |
|---|---|---|---|
| 15 | Discrepancy found between as built condition and provided drawing | Building engineer to survey the whole building and produce as-built documentation reflecting the as constructed condition | 6-weeks |

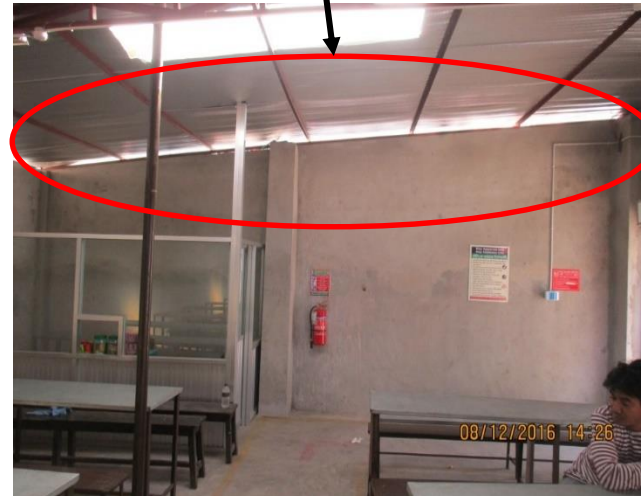
Truss was absent at both end of shed

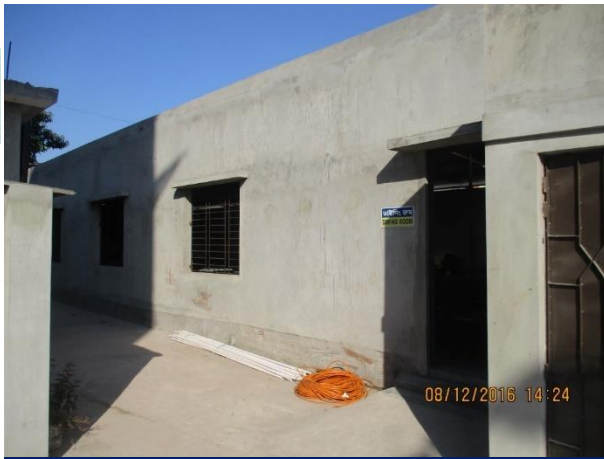
Canteen shed

The support condition of roof top shed was non engineered due to poor detailing.

| Item No. | Observation | Recommended Action Plan | Recommended Timeline |
|---|---|---|---|
| 16 | Light weight Roof shed of Canteen appears non engineered | Building engineer to check the capacity of the lightweight steel roofs under lateral and vertical loading following BNBC. | 6-weeks |
| 17 | Light weight Roof shed of Canteen appears non engineered | Carry out remedial works resulting from engineering assessment if necessary. | 6-months |
