# Regency Three Limited (Unit-5)

Plot 27-30 & 43-48, Sector-8, CEPZ, Chittagong, Bangladesh

20<sup>th</sup> November, 2016

# Observations

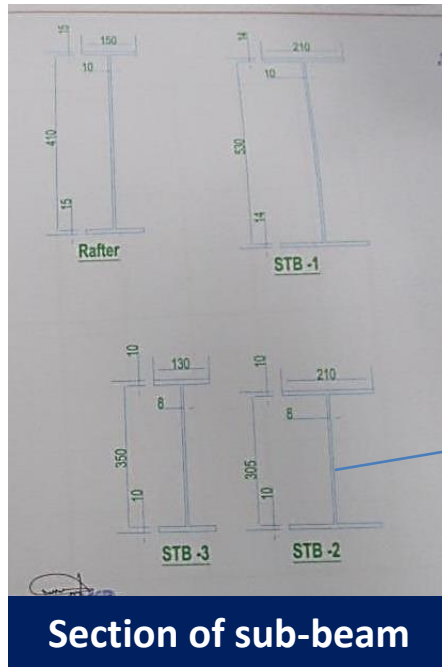
Section of sub-beam

The thickness of flange does not match with drawings. The size of sub beam did not match with provided drawings. Factory engineer required to update the as built drawing and also check the adequacy of structure member as per site condition.

| Item No. | Observation | Recommended Action Plan | Recommended Timeline |
|---|---|---|---|
| 1 | Discrepancies Between As-Built Structural Drawing and On Site Condition | Factory engineer to check, collect information and produce accurate and complete as-built documentation. | 6-weeks |
| 2 | Discrepancies Between As-Built Structural Drawing and On Site Condition | Factory engineer required to check the adequacy of structure member against vertical and lateral load. | 6-weeks |

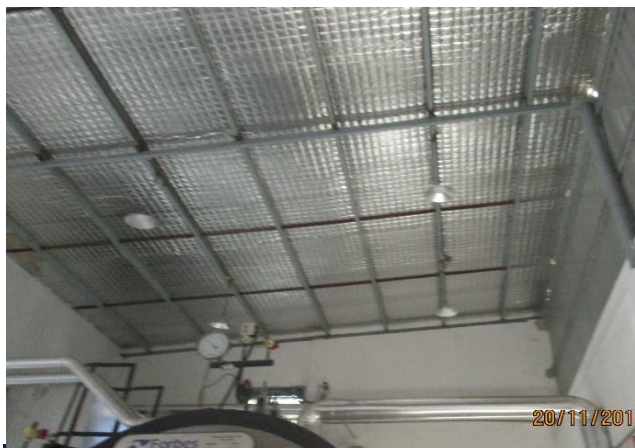
**Boiler and Compressor room**

steel sheeting supported by steel purlin/angle system on wall or steel posts. Connections appear non-engineered. Factory engineer to verify the adequacy of connection and steel member against wind load.

| Item No. | Observation | Recommended Action Plan | Recommended Timeline |
|---|---|---|---|
| 3 | Non Engineered sheds | Factory engineer to check the adequacy of connection and steel member against wind load. | 6-weeks |
| 4 | Non Engineered sheds | Implement any necessary action suggested in analysis | 6-months |

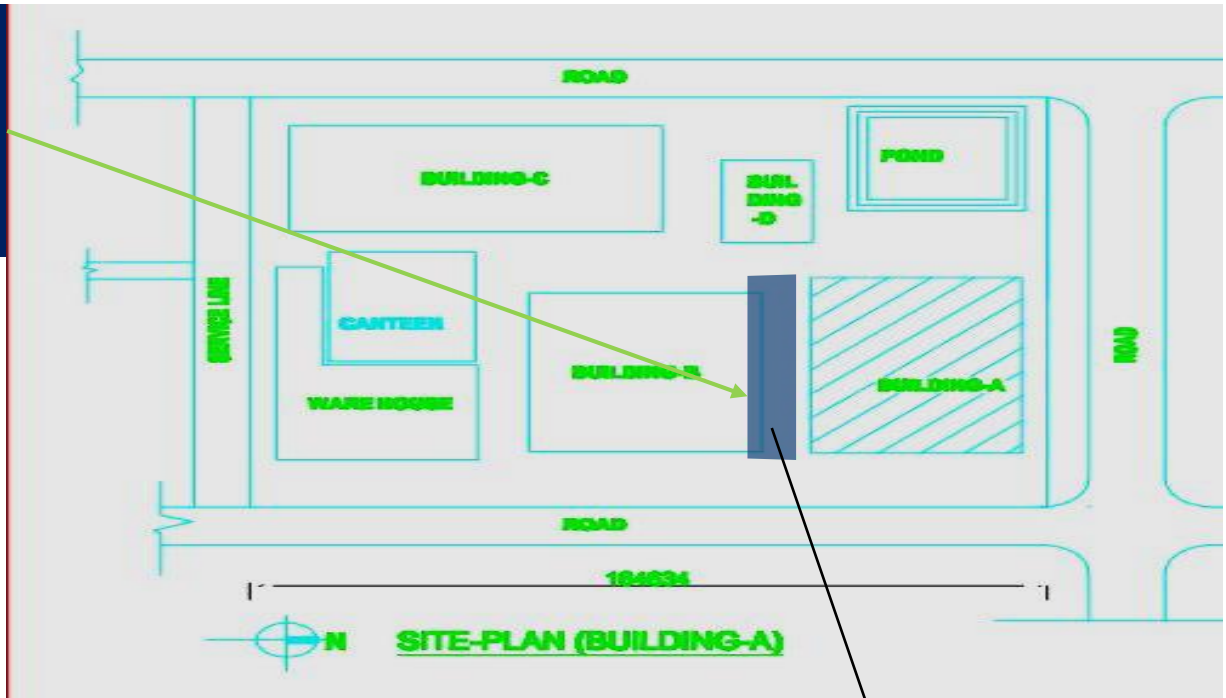
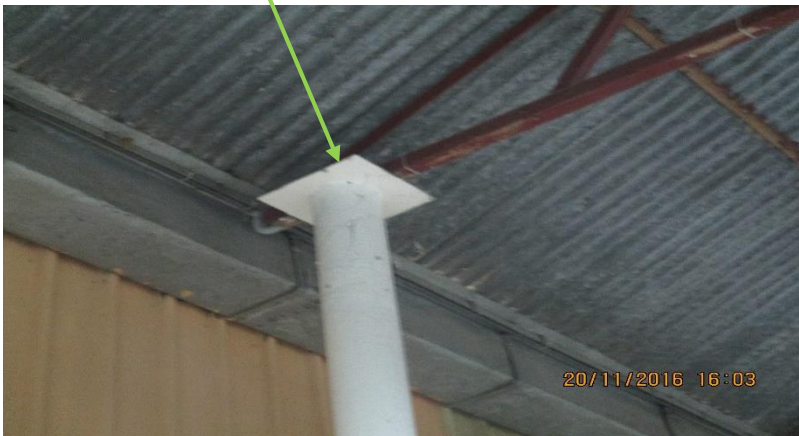
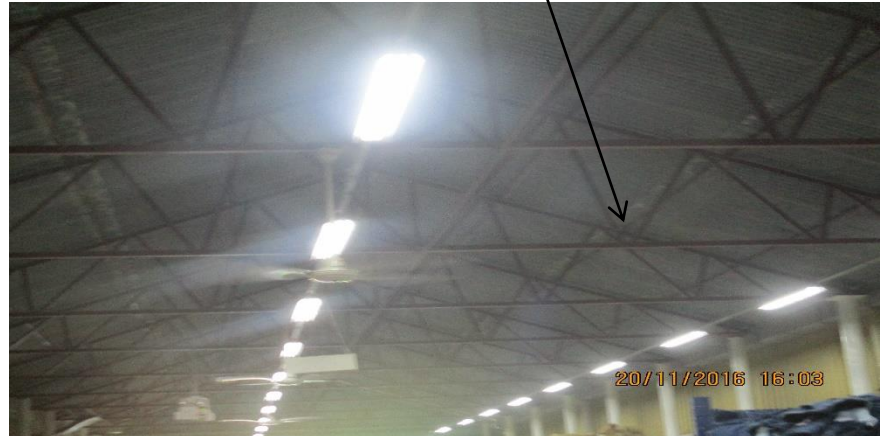
A Non Engineered shed was observed in between Building A & B

Connections appeared to be non-engineered. Factory engineer to verify the adequacy of connection and steel member against wind load.

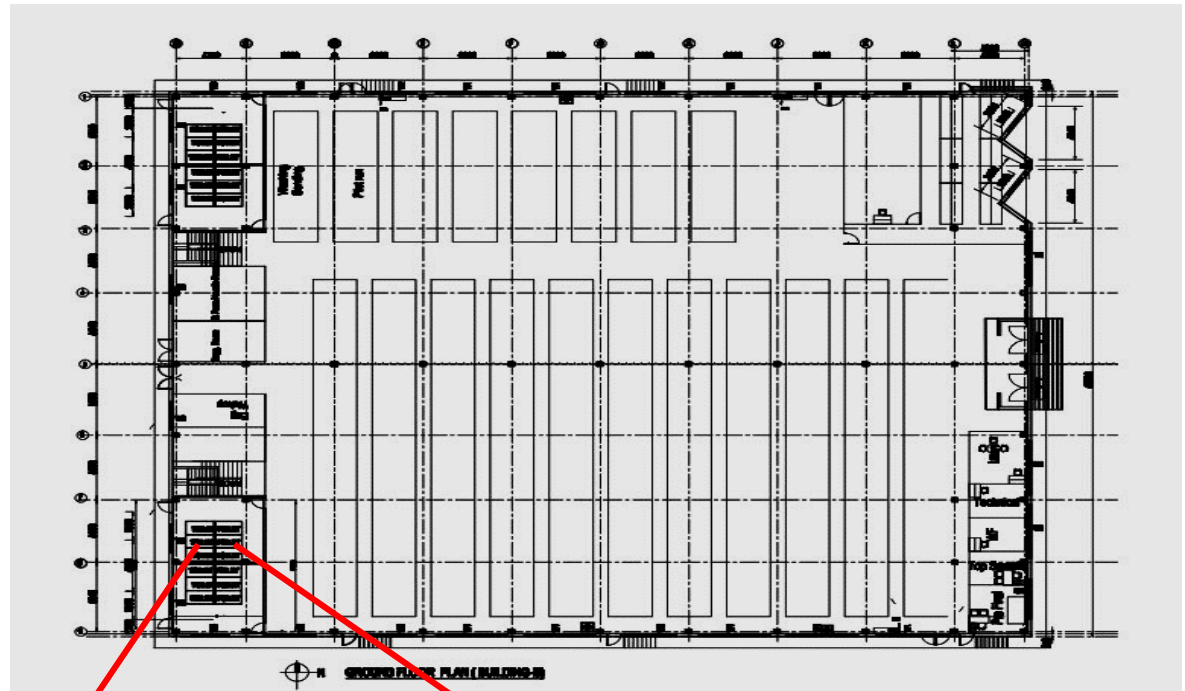
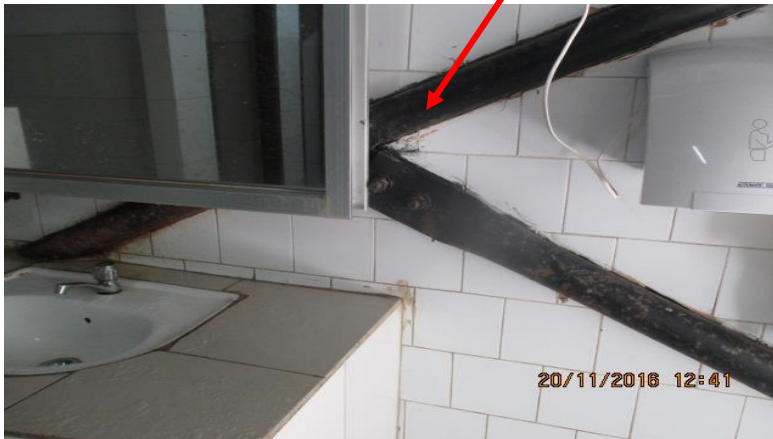
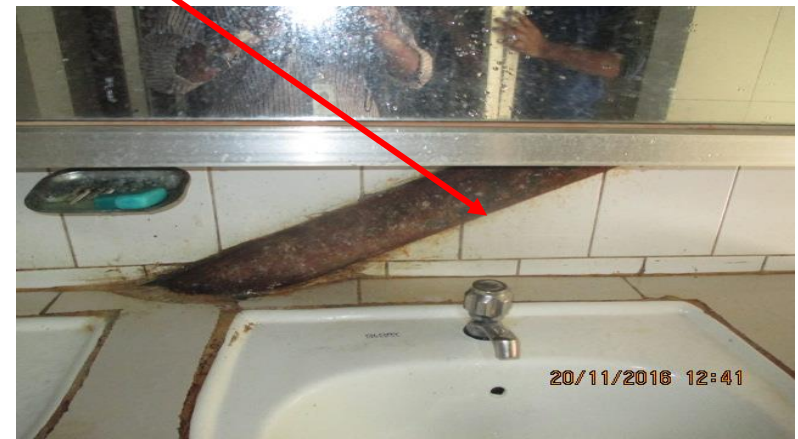
**Corrosion on Vertical Bracing at Building B**

Vertical bracing in the toilet zone in Building B was seen badly corroded.

| Item No. | Observation | Recommended Action Plan | Recommended Timeline |
|---|---|---|---|
| 5 | Corrosion on Vertical Bracing at Building B | Complete further testing on areas of deterioration and have a qualified structural engineer develop a remediation plan. | 6-weeks |

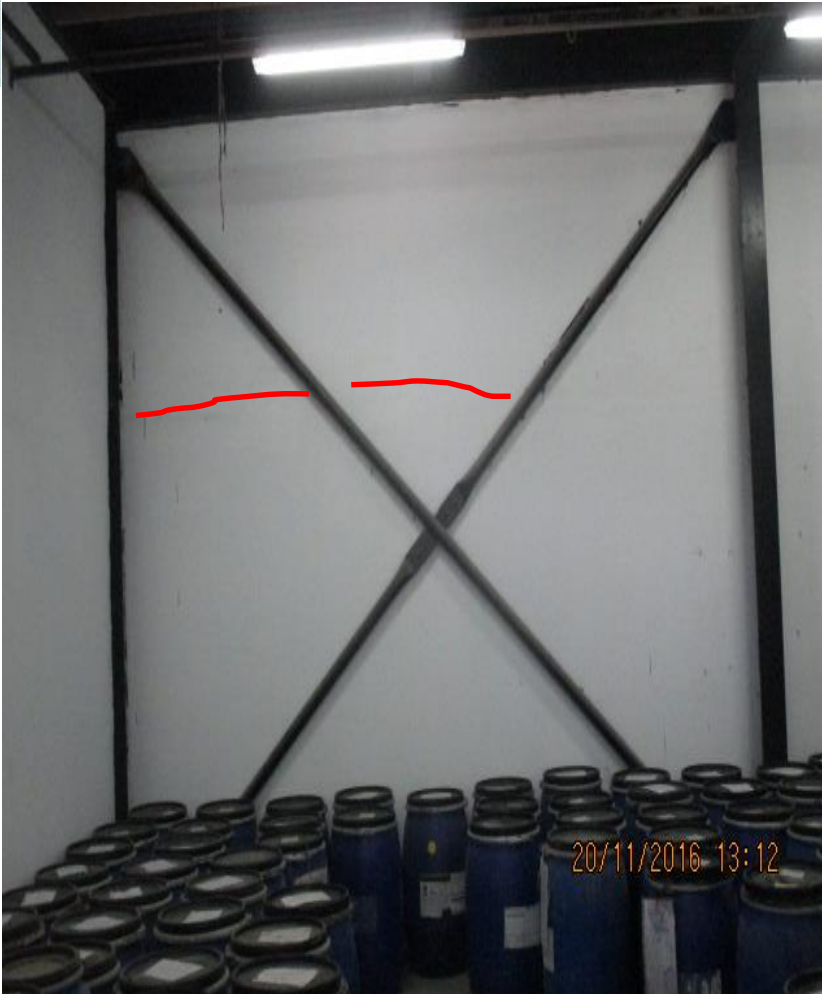
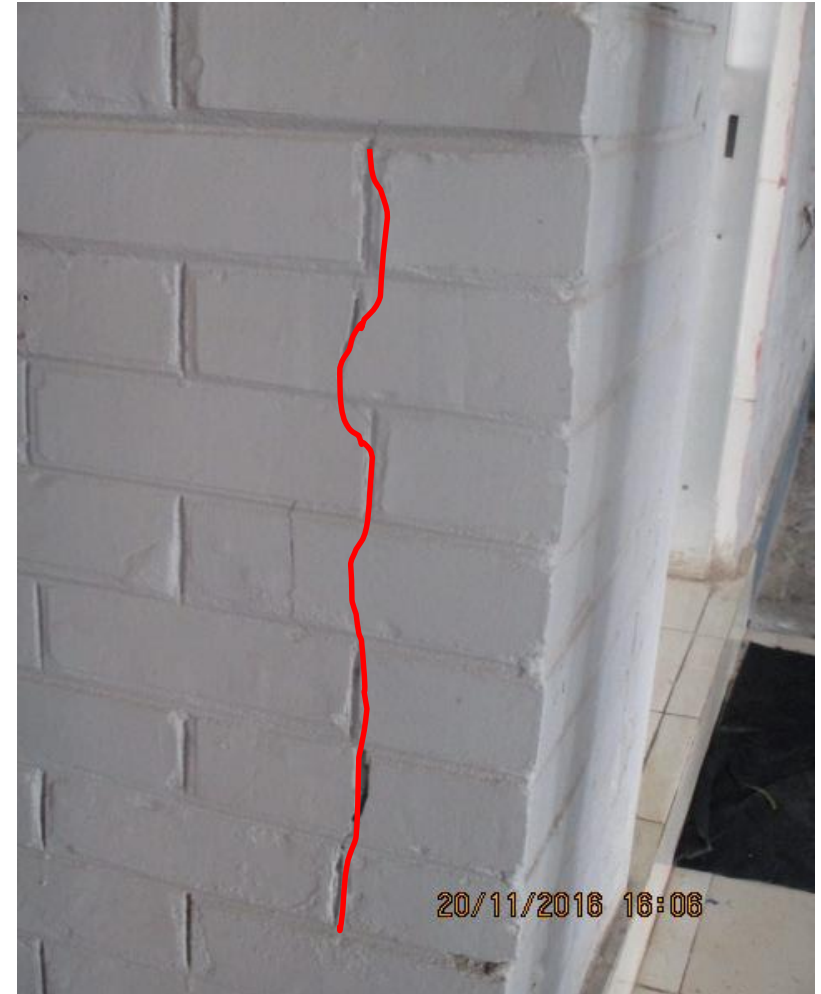
Crack n the masonry walls in Building A , B and C.

| Item No. | Observation | Recommended Action Plan | Recommended Timeline |
|---|---|---|---|
| 6 | Appearance of Cracks on Masonry Walls at Building- A,B &C | Factory engineer to find out the extent of cracking and suggest proper remedial measures. | 6-weeks |
| 7 | Appearance of Cracks on Masonry Walls at Building- A,B &C | Implement any necessary action suggested by the engineer | 6-months |
