# Echotex (Extension) Ltd

Chandra, Palli Biddut, Kaliakoir, Gazipur

6<sup>th</sup> December ,2016

# Observations

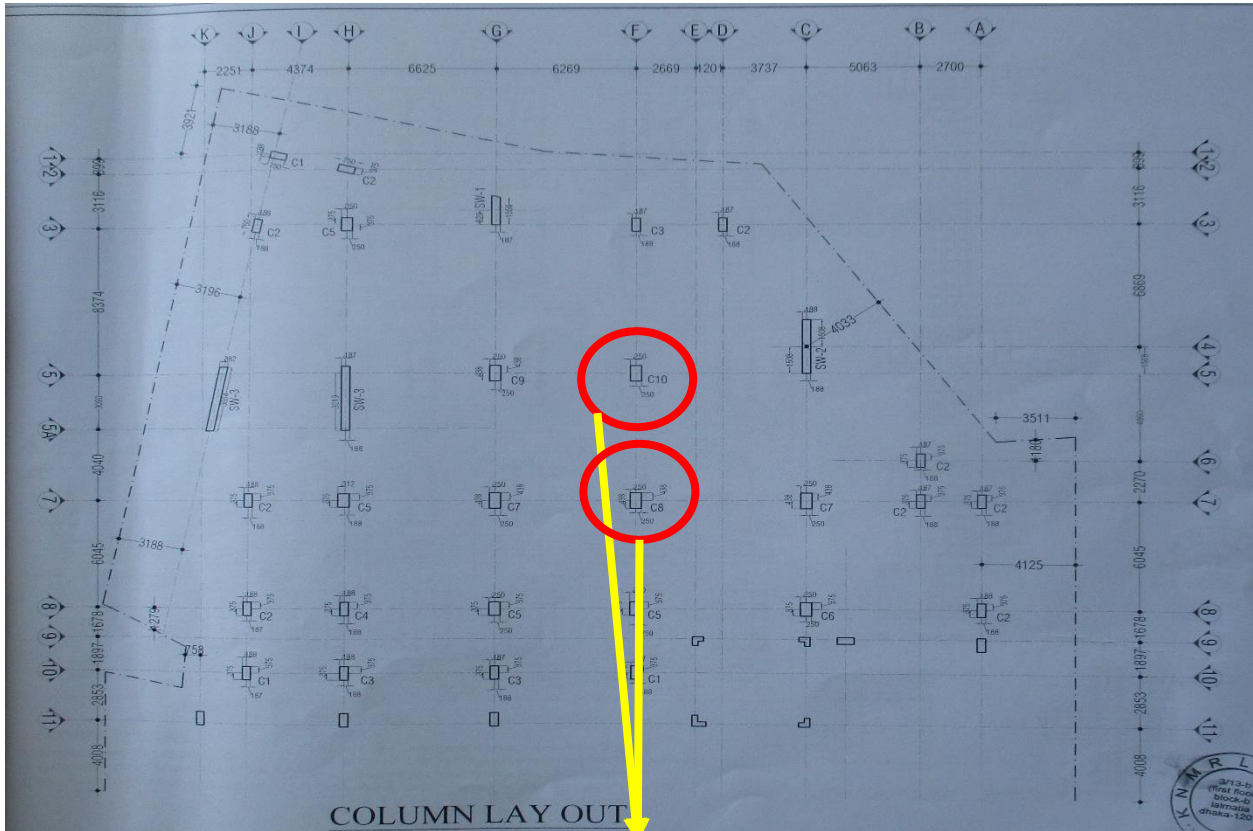
# Column to be stressed above normal design limits

High Stressed Columns

Cursory calculation indicates that the working stresses of the ground floor columns are at a level that required to review.

Item No.	Observation	Recommended Action Plan	Recommended Timeline
1	Column to be stressed above normal design limits	Factory Engineer to review design, loads and columns stresses in area identified above.	6-weeks
2	Column to be stressed above normal design limits	Verify in-situ concrete strength (using min. 4 nos. 100mm dia. Cores and/or assessment of available concrete strength data) and as constructed reinforcement for all columns.	6-weeks
3	Column to be stressed above normal design limits	Implement any remediation work if required	6-months
4	Heavy Loading was observed on floors	Loading must be kept within 2Kpa on all floor area.	6-weeks
5	Heavy Loading was observed on floors	Produce and actively manage a loading plan for all floor plates within the factory giving consideration to floor capacity and column capacity.	6-weeks
6	Heavy Loading was observed on floors	Continue to implement load plan.	6-months

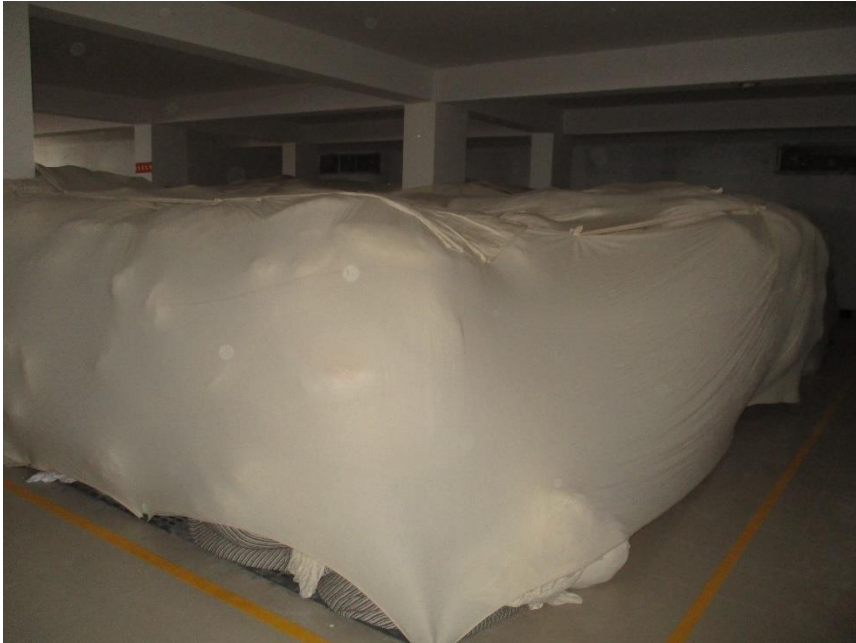
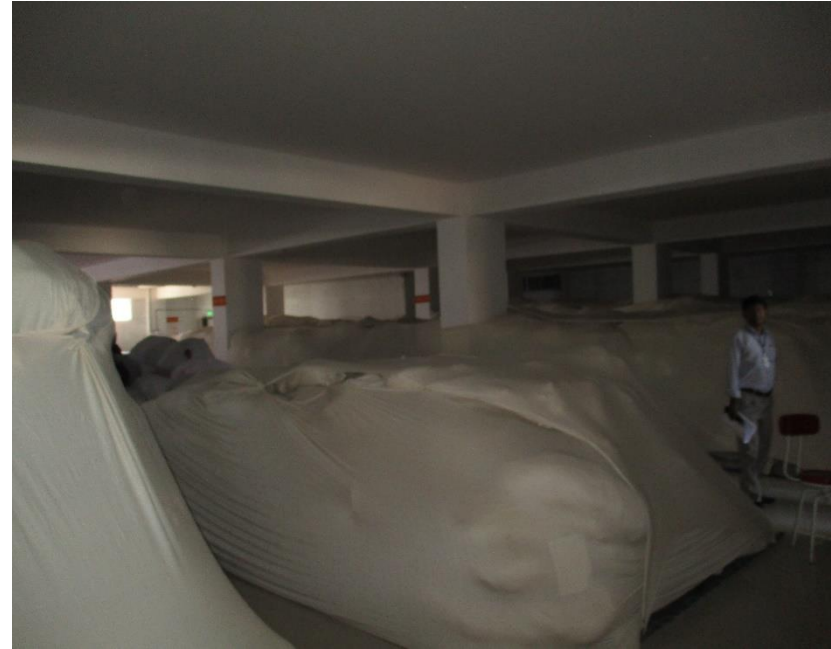
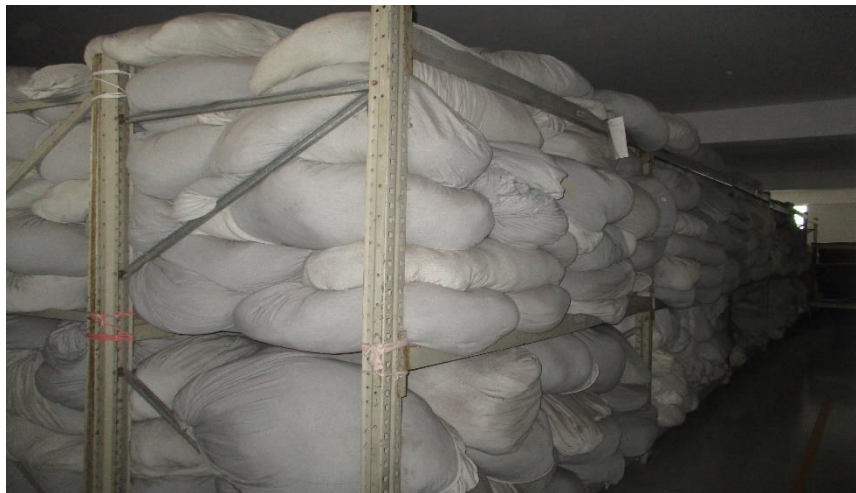
**Heavy Loading was observed on floors**

Heavy loading was observed on 9<sup>th</sup> floor which was measured as 102 psf on typical floor panel. Besides, Heavy loading was also found on several floors which exceeds 42 psf. A load plan was found where mentioned the floor capacity was 80 psf which required to review.

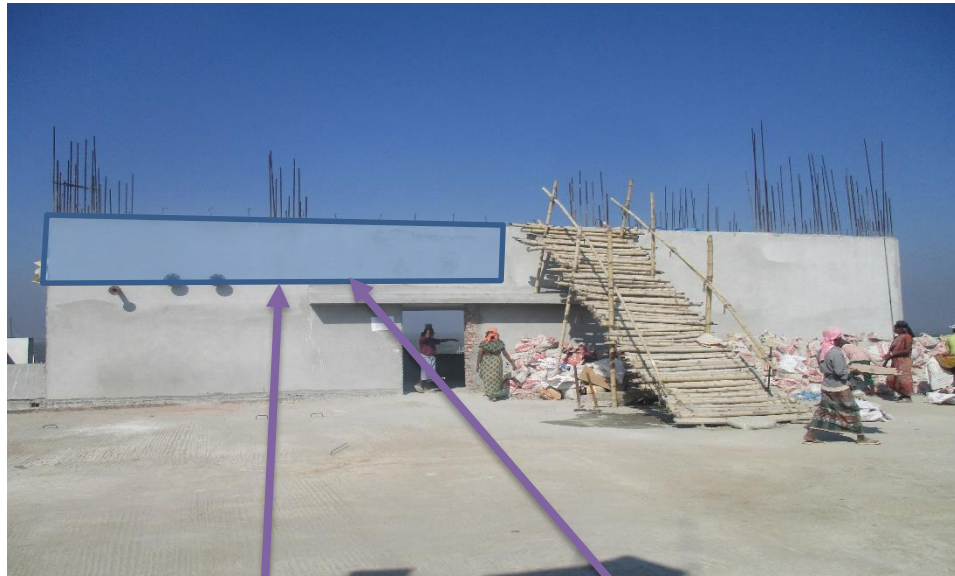
During inspection, RCC water Tank was observed on Roof which was not mentioned on As-Built Drawing

7	Inconsistency between As Built Drawings and on-site condition	Update As- Built drawing in accordance with actual condition and Incorporate the changes in As- Built Drawings.	6-weeks
8	Exposed Rebar on roof	All exposed reinforcement is to be protected from corrosion which may cause degradation of the concrete.	6-weeks

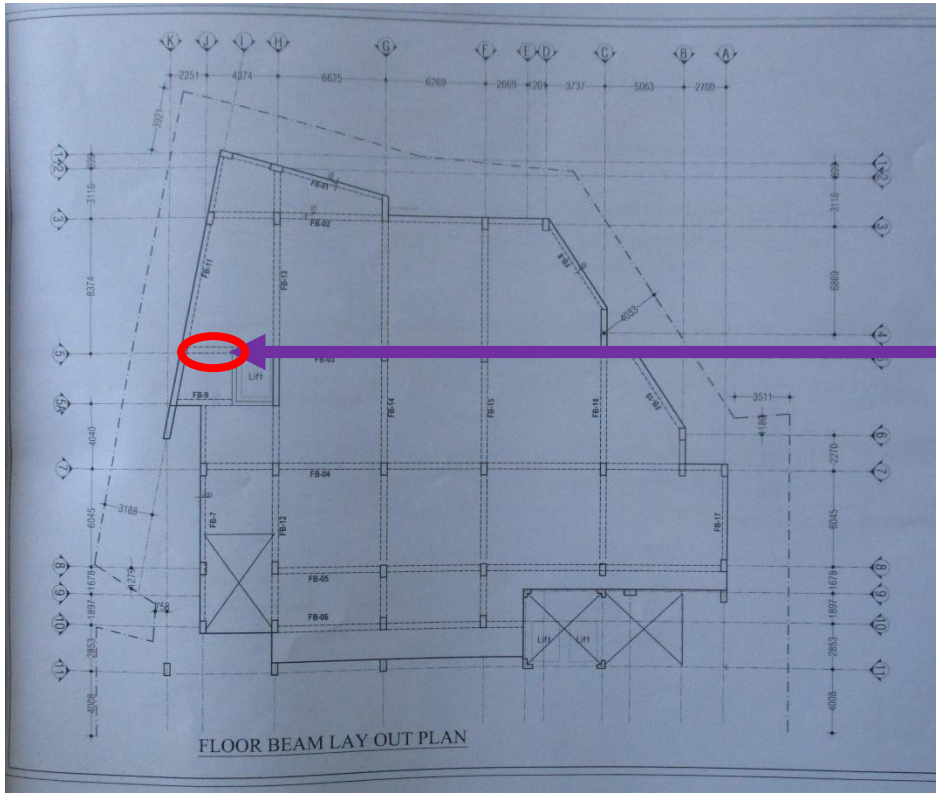
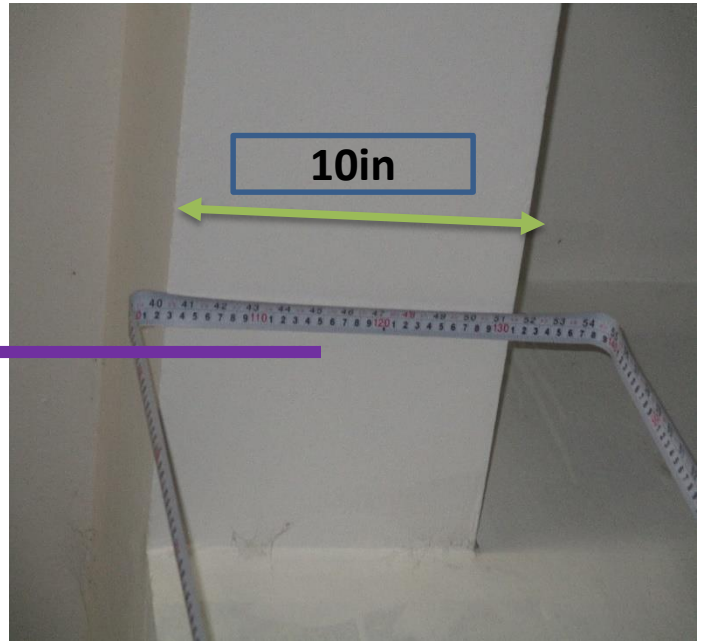
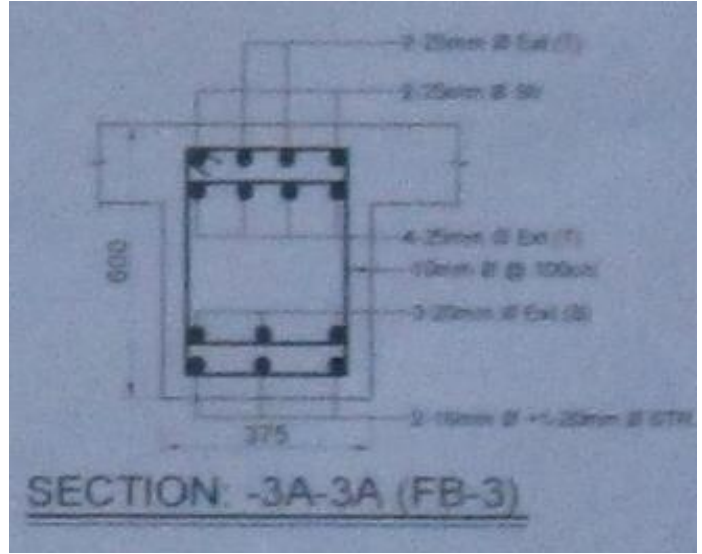
Floor Beam width of the highlighted portion was observed 10 inch instead of 15 inch on each floor

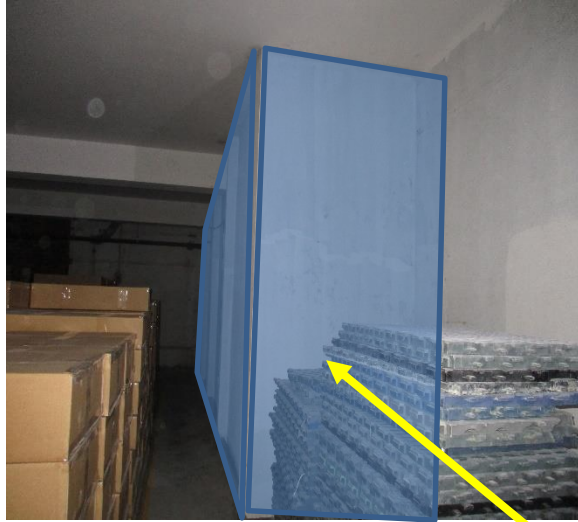
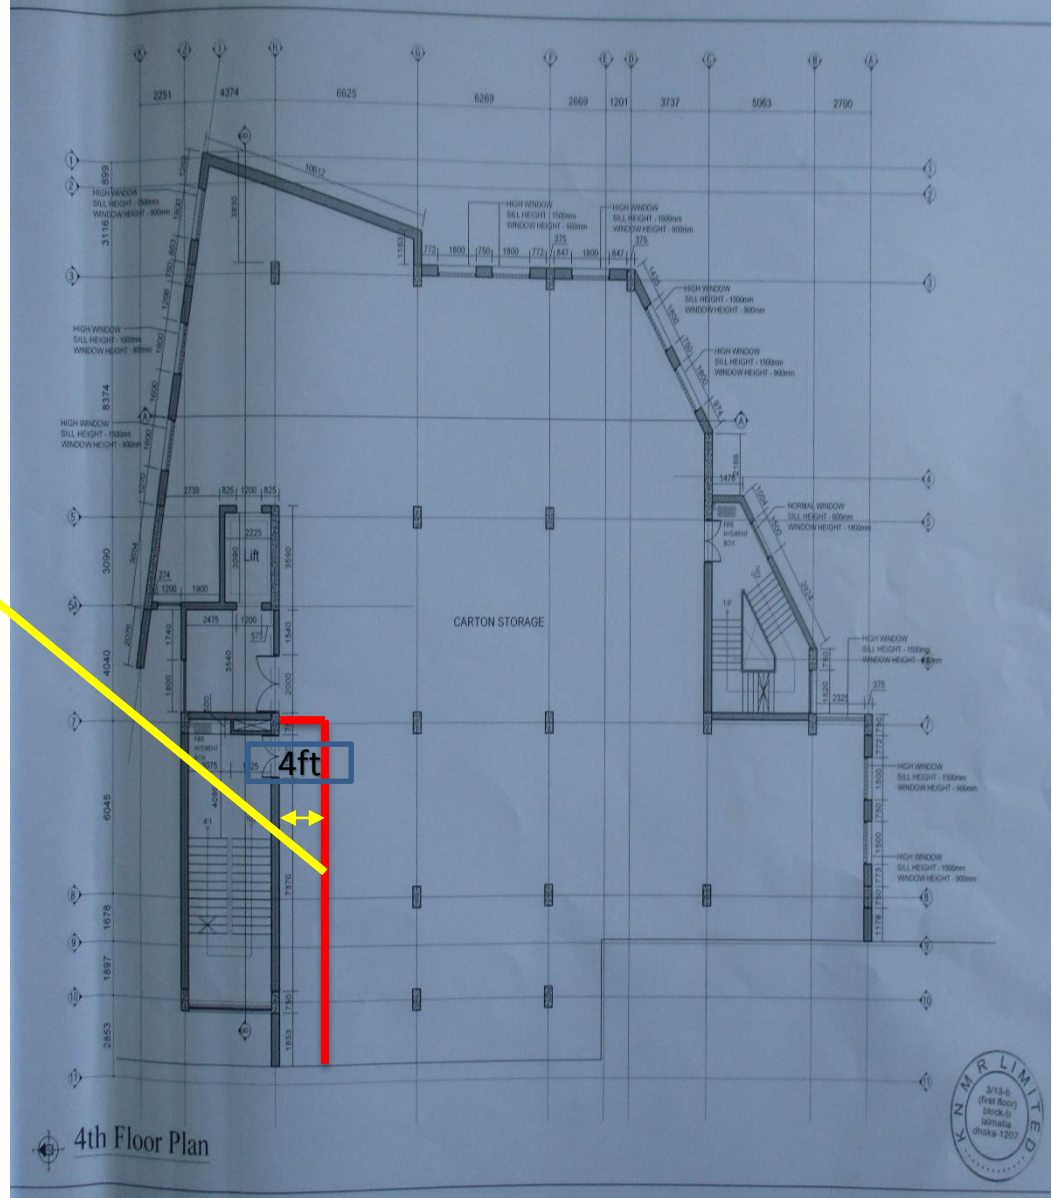
Additional brick wall (5 inch thickness) observed beside stair on 2<sup>nd</sup>, 4<sup>th</sup> & 5<sup>th</sup> Floor(not mentioned in As Built Drawings)

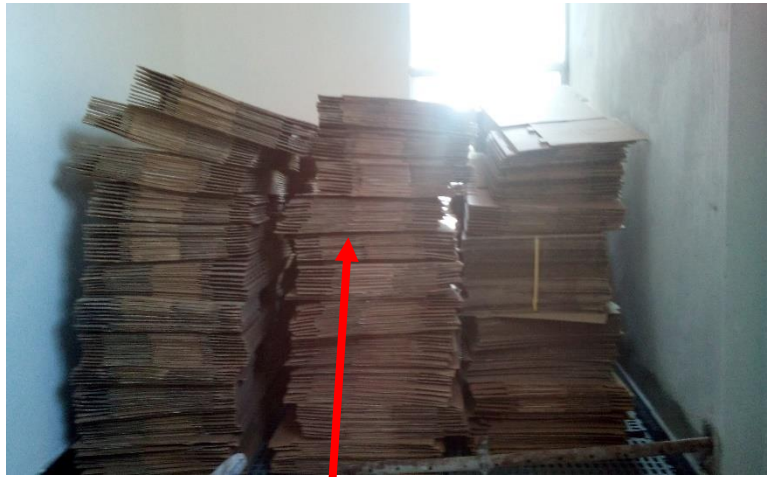
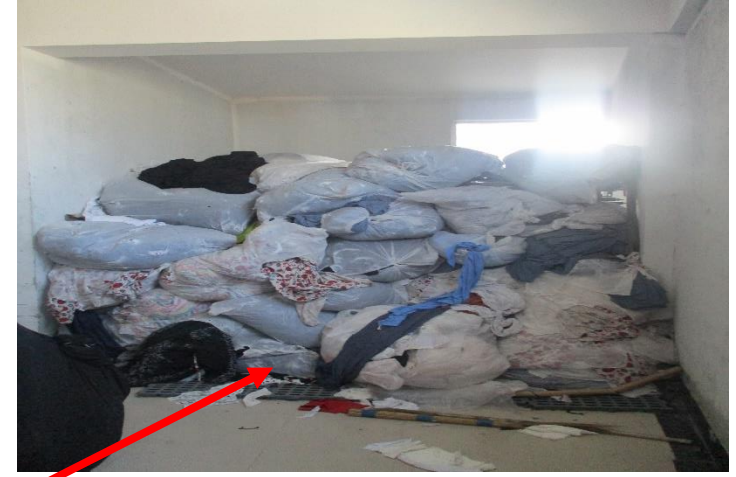
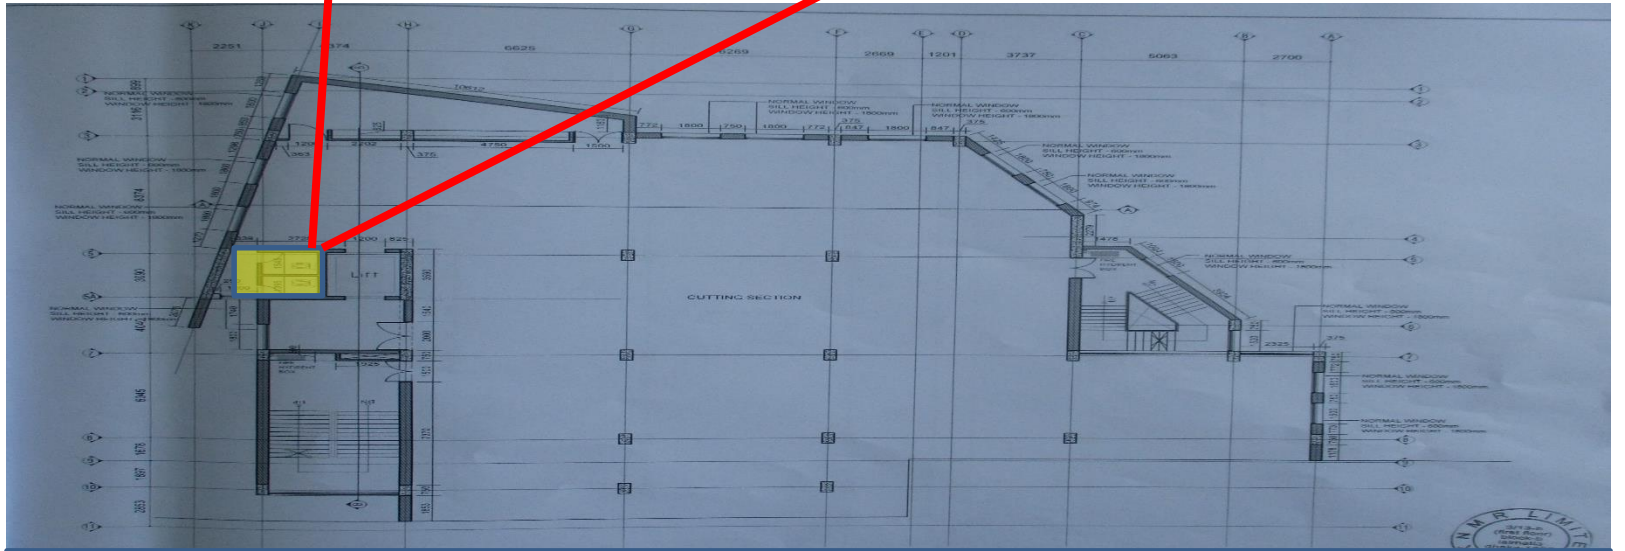
On As Built drawings Toilet Area was showed on highlighted portion of 8th, 6<sup>th</sup> and 2<sup>nd</sup> Floor but actually there was no toilet area.

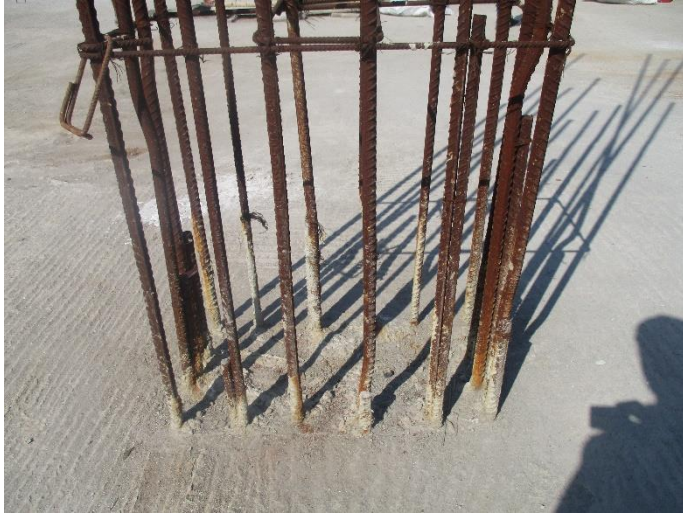
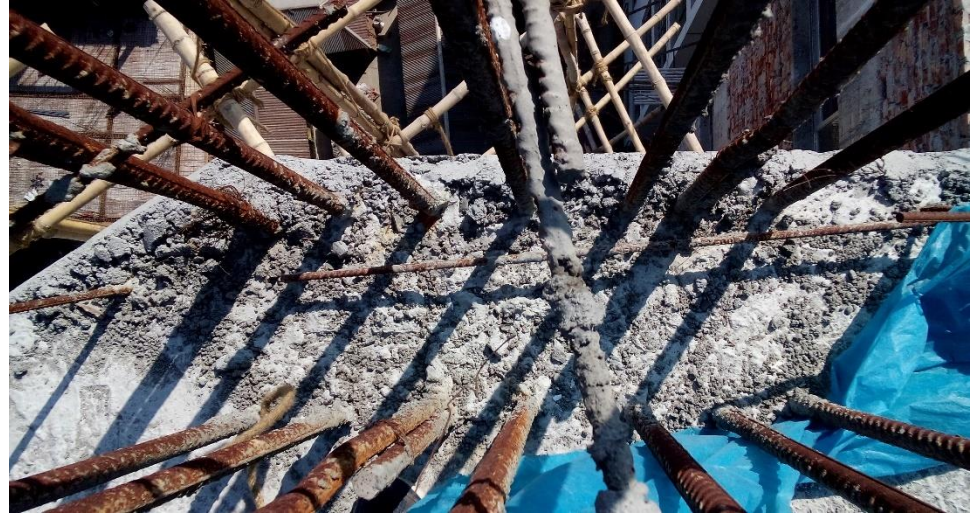
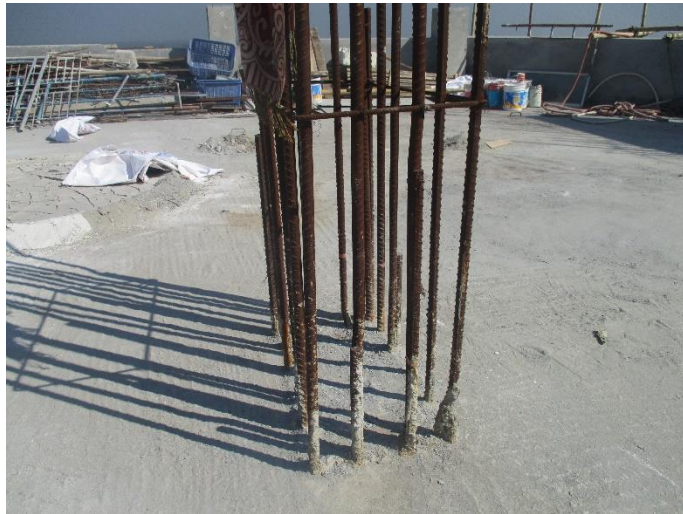
# Exposed Rebar on Roof

Exposed Rebar was observed on roof that is susceptible to corrosion
