# Jamuna Knit Concern. Patriot Fashion Ltd.

Road# 1 House#34 Kutubail, Fatullah, Narayanganj 1400 ,Bangladesh.  
(23.644765, 90.495215)

08<sup>th</sup> January 2017

# Observations

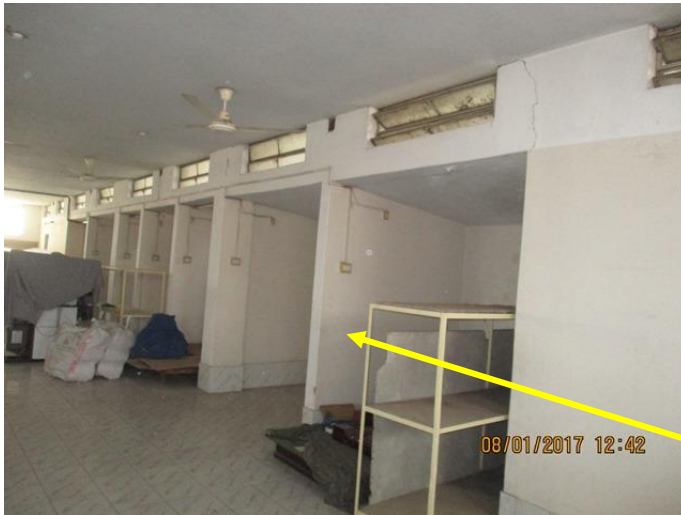
Cantilever at west with toilet area

Cursory calculations indicate that the working stress of the ground floor columns are at a level that requires immediate design review.

| Item No. | Observation | Recommended Action Plan | Recommended Timeline |
|---|---|---|---|
| 1 | Column to be stressed above normal design limits. | Verify in-situ concrete strength and aggregate type from min. 4 no. 100mm dia. core samples from columns. | 6-weeks |
| 2 | Column to be stressed above normal design limits. | Factory Engineer to review design, loads and columns stresses. | 6-weeks |
| 3 | Column to be stressed above normal design limits. | Produce and actively manage a loading plan for all floor plates within the factory, giving consideration to floor capacity and column capacity. | 6-weeks |

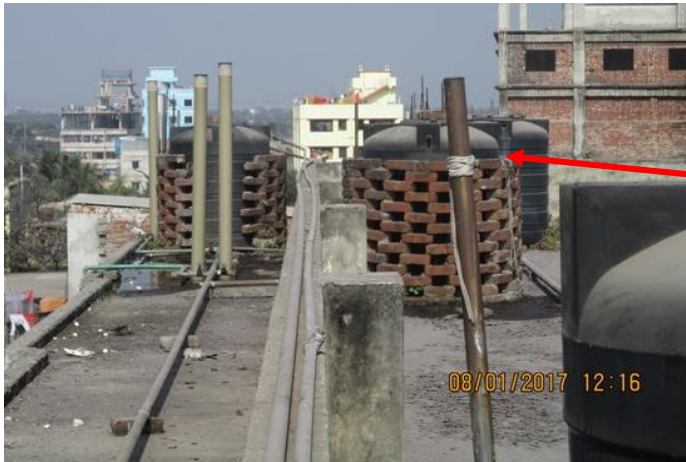
Plastic water tank on roof

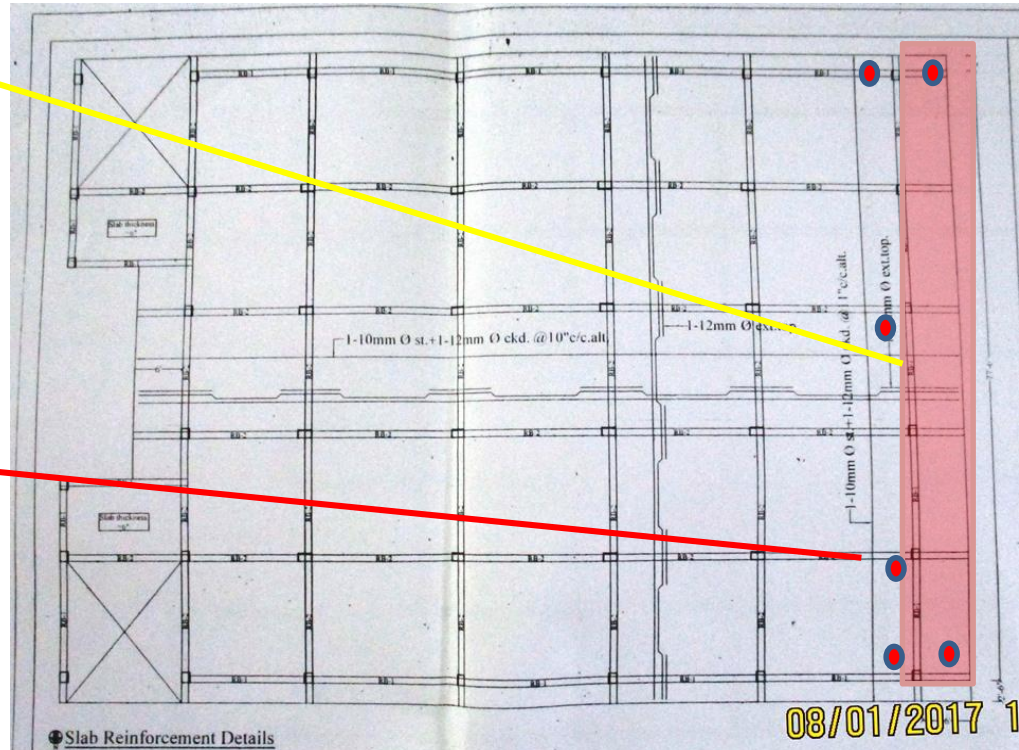
Slab and beam details

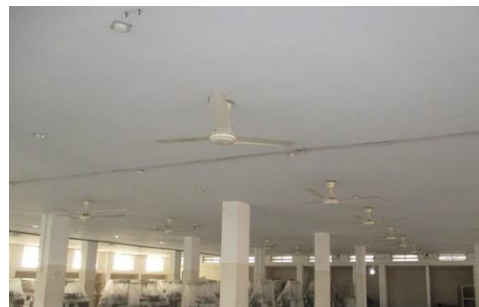
Column layout didn't fully matched with as built condition. Also (corner & stair) column size and nos. of rebar were not matched with column schedule. At east side two columns are not found and which is marked as red on drawings.

Both beam slab and flat slab were shown in provided structural drawing. But during inspection flat slab found in all floors.

| Item No. | Observation | Recommended Action Plan | Recommended Timeline |
|---|---|---|---|
| 5 | Discrepancies between provided drawings and on site condition | Building Engineer to survey as-built structure and prepare accurate as-built survey information, including all columns, beams and slabs. | 6-weeks |

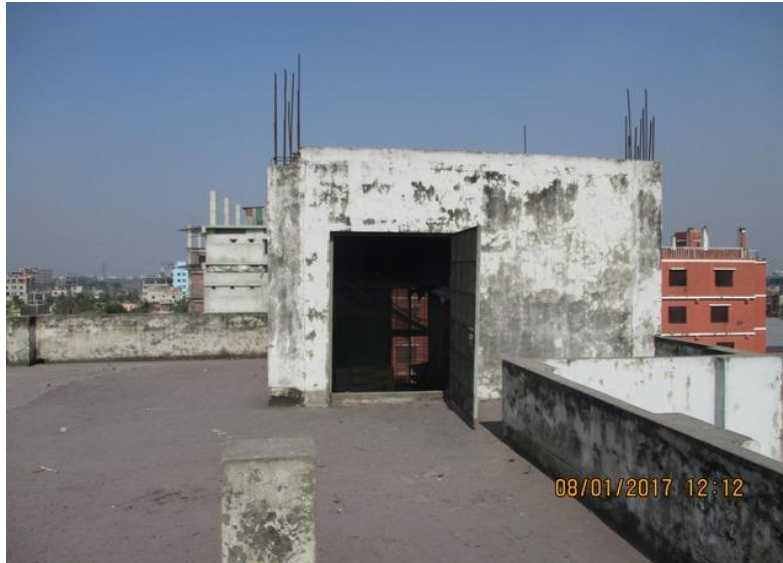
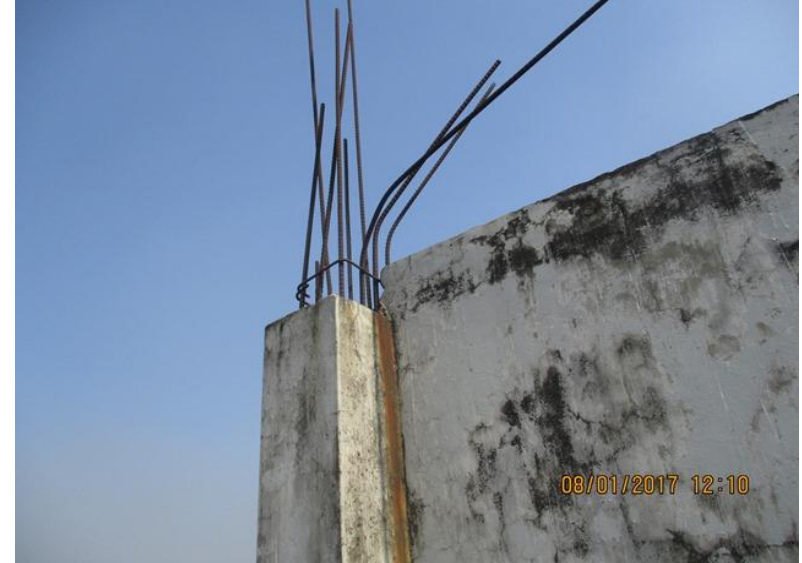
Exposed & corroded rebar found in stair case

Exposed & corroded rebar found in some column at roof level of factory building. Also non-engineered steel roof found at stair core. Factory is suggested to provide rust proofing materials to exposed rebar.

| Item No. | Observation | Recommended Action Plan | Recommended Timeline |
|---|---|---|---|
| 6 | Corroded and exposed rebar at roof. | All exposed reinforcement is to be protected from corrosion which may cause degradation of the concrete. | 6-weeks |
| 7 | Corroded and exposed rebar at roof. | Complete further testing on areas of deterioration and have a qualified structural engineer develop a remediation plan | 6-months |

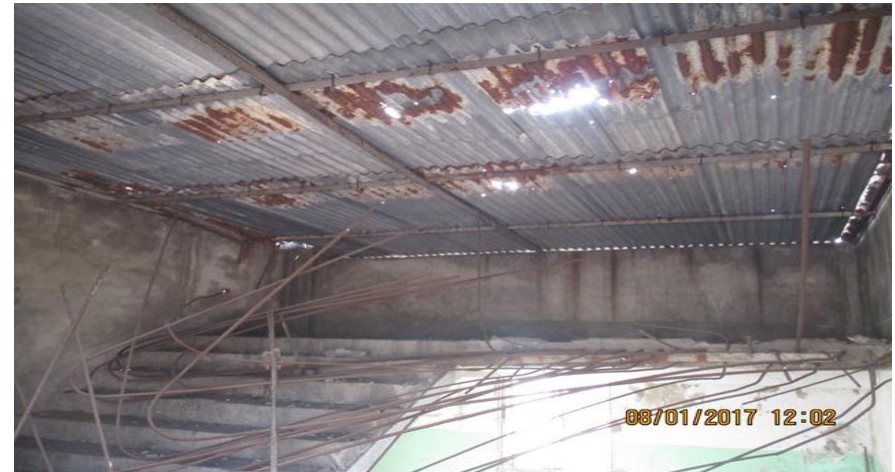
Non-engineered steel roof with corrosion

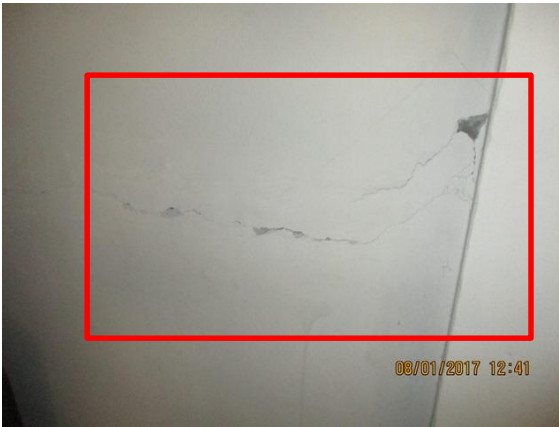
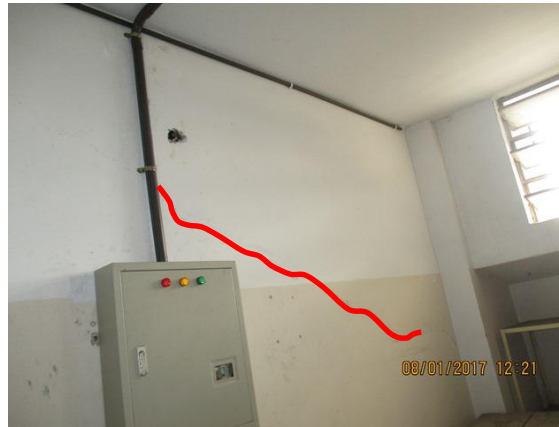
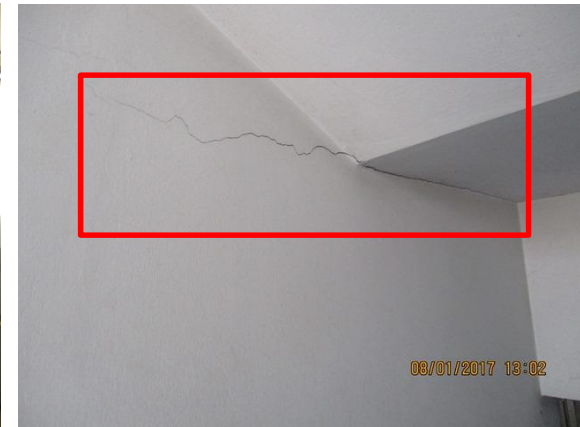
Diagonal cracks found in brick wall at 3<sup>rd</sup> floor and below stair landing.

| Item No. | Observation | Recommended Action Plan | Recommended Timeline |
|---|---|---|---|
| 8 | Appearance of cracks in several location | Have a qualified structural engineer provide further analysis of the identified cracks to determine the appropriate cause of corrective action. | 6-weeks |
| 9 | Appearance of cracks in several location | Carry out remedial work if required as directed by the Building Engineer. | 6-months |

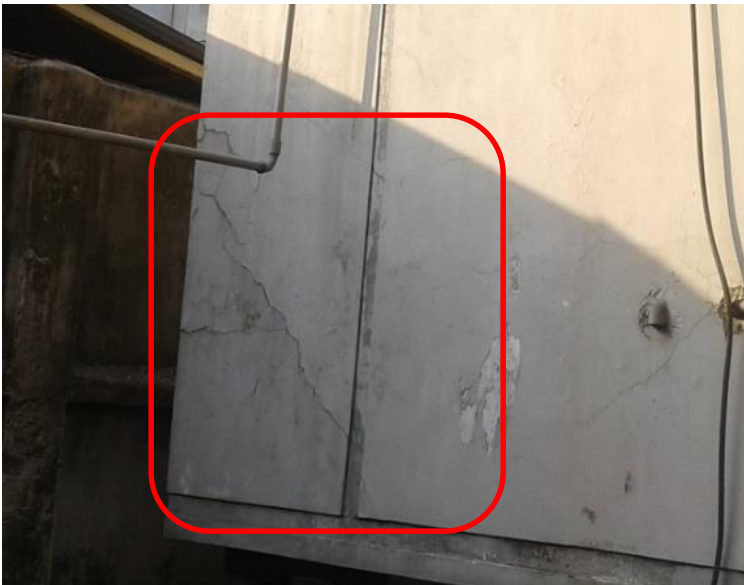
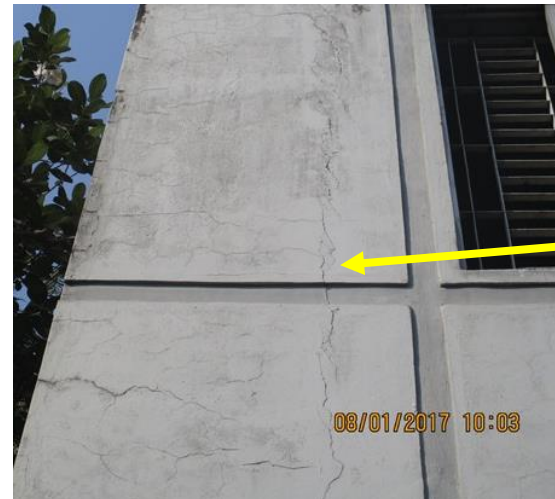
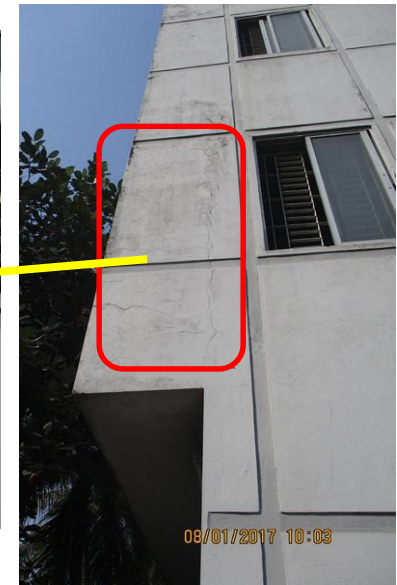
Cracks also found at south façade.

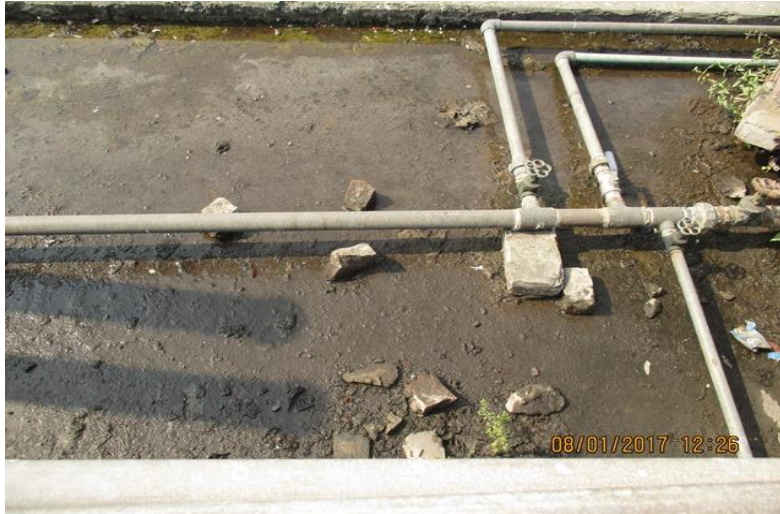
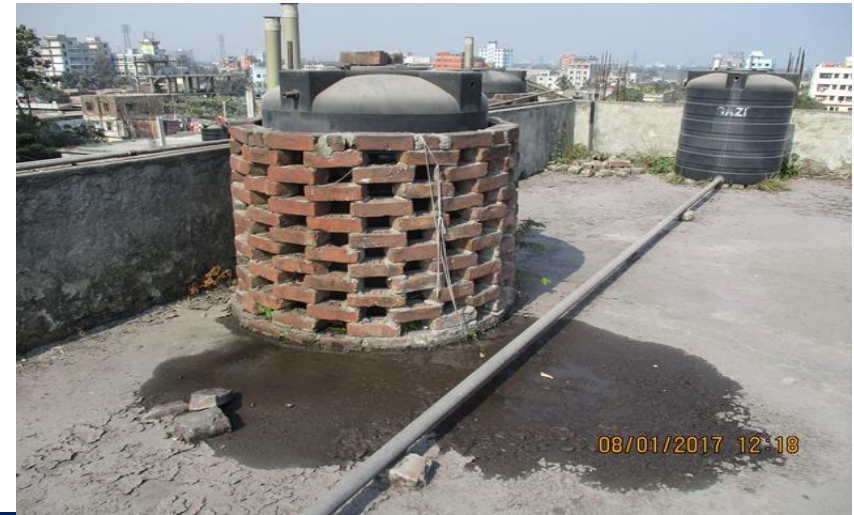
Proper drainage system not found at roof and due to leakage of water tank water ponding also observed at roof.

| Item No. | Observation | Recommended Action Plan | Recommended Timeline |
|---|---|---|---|
| 10 | Lack of proper drainage system at roof & dampness in several location. | Waterproofing on the roof slab is to be applied. In addition, the roof slab drainage system should be investigated and improved if required. | 6-weeks |

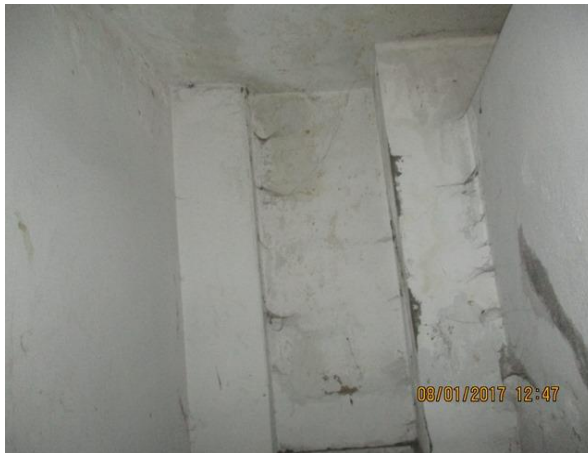
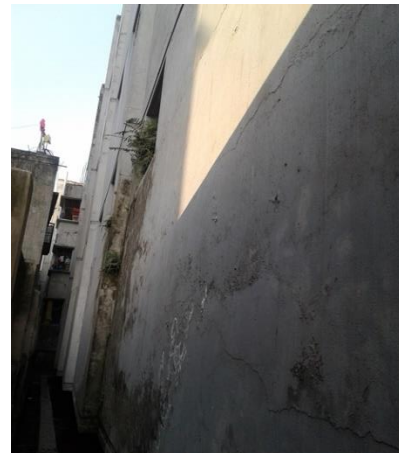
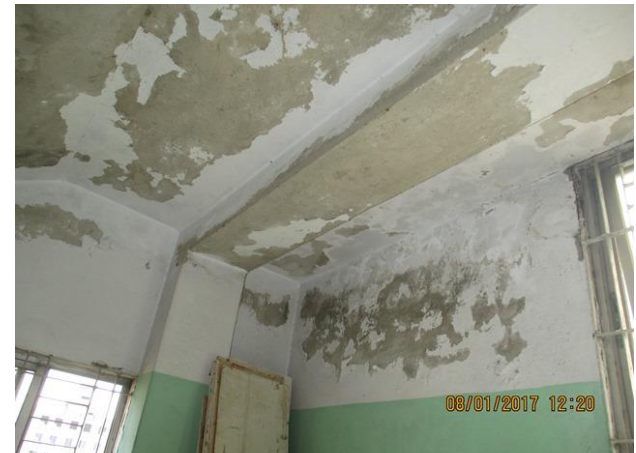
Dampness found in several places of the factory building specially toilet zone and façade wall.

| Item No. | Observation | Recommended Action Plan | Recommended Timeline |
|---|---|---|---|
| 11 | Lack of proper drainage system at roof & dampness in several location. | Factory engineer to identify the cause of dampness & suggest appropriate remedial action. | 6-weeks |
